# MEMORANDUM

REVISED DATE: October 14, 2013

RE: Centennial Brook Watershed: Retrofit Field Findings Summary

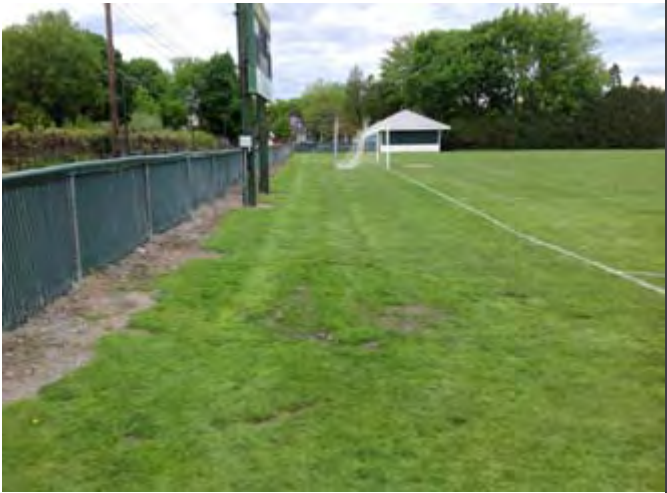
ID#: Retrofit 12A					
<b>Name:</b> University Rd. soccer field

<b>Concept Description:</b> UVM proposed a dry swale along the western edge of the soccer field to capture a poriton of University Road. The site has been designed (K&L) and is currently under construction.					
<b>Notes/Feasibility:</b> The portion of the soccer field that does not flow to practice drains and infiltrates under bleachers. University Rd. was recently paved. West side of University Rd. is the drainage/watershed boundary.					
GENERAL SITE INFORMATION	RETROFIT DETAILS				
<b>Site Contact Info:</b> UVM	<b>Project Candidate:</b> Ok				
<b>Ownership:</b> Public	<b>Retrofit of new or existing BMP:</b> New BMP				
<b>Land Use 1:</b> Institutional	<b>Proposed Retrofit Practice 1:</b> Dry Swale				
<b>Land Use 2:</b> -None Selected-	<b>Proposed Retrofit Practice 2:</b> -None Selected-				
<b>Existing BMP on site?</b> No	<b>Non-Structural Controls:</b> -None Selected-				
<b>Is site a hotspot?</b> No	<b>Non-Structural Other:</b> -None Selected-				
<b>Sources/pollutants 1:</b> Nutrients / Organics	<b>Maintenance Burden:</b> Low				
<b>Sources/pollutants 2:</b> Sediment	<table border="0" style="width: 100%;"> <tr> <td style="vertical-align: top; width: 50%;"> <b>Benefits:</b>                      Storage: NO                      Water Quality: YES                      Recharge: YES                      Demo: YES                      Repair: NO                      Reuse: NO                 </td> <td style="vertical-align: top; width: 50%;"> <b>Conflicts:</b>                      Soils: NO                      Access: NO                      Land Use: NO                      Utilities: NO                      Polluted: NO                      High WT: NO                      Wetlands: NO                 </td> </tr> <tr> <td colspan="2"><b>Other:</b> None</td> </tr> </table>	<b>Benefits:</b> Storage: NO Water Quality: YES Recharge: YES Demo: YES Repair: NO Reuse: NO	<b>Conflicts:</b> Soils: NO Access: NO Land Use: NO Utilities: NO Polluted: NO High WT: NO Wetlands: NO	<b>Other:</b> None	
<b>Benefits:</b> Storage: NO Water Quality: YES Recharge: YES Demo: YES Repair: NO Reuse: NO		<b>Conflicts:</b> Soils: NO Access: NO Land Use: NO Utilities: NO Polluted: NO High WT: NO Wetlands: NO			
<b>Other:</b> None					
<b>Soils:</b> Good Infiltration					
<b>Use in Retrofit DA:</b> Street and field					
SIZING INFO					
<b>Drainage Area (ac):</b> 1.16					
<b>Impervious Area (ac):</b> 0.31					
<b>Practice Area Available (ft<sup>2</sup>):</b> 3,200					
<b>Existing Head Available?</b> --

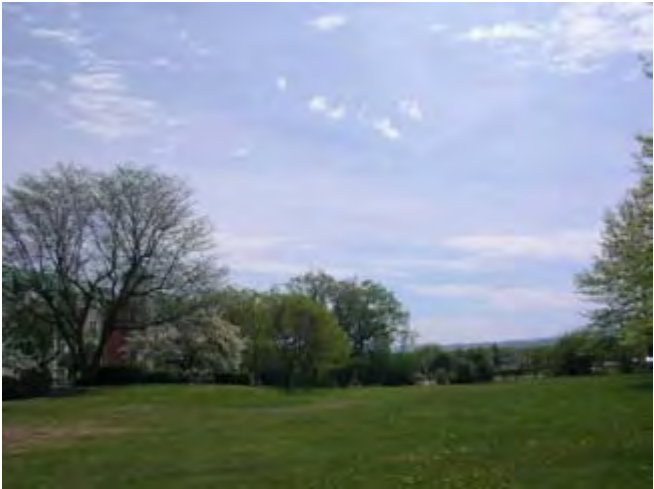
<b>Concept Description:</b> Underground detention structure, possibly infiltration – flow diversion from drainage inlets in Williston Road.					
<b>Notes/Feasibility:</b> Feasibly but not terrible cost effective. Small drainage area, private ownership (Sheraton) + coordination with VTTrans required (drains to I-89 interchange), depth of pipe (~7.5 ft) require 6 – 8 ft deep facility, daylight to pipe system within I-89 R/W just barely works.					
GENERAL SITE INFORMATION	RETROFIT DETAILS				
<b>Site Contact Info:</b> Sheraton	<b>Project Candidate:</b> No, suggest #16 or #16B				
<b>Ownership:</b> Private	<b>Retrofit of new or existing BMP:</b> New BMP				
<b>Land Use 1:</b> Commercial	<b>Proposed Retrofit Practice 1:</b> Underground Detention				
<b>Land Use 2:</b> -None Selected-	<b>Proposed Retrofit Practice 2:</b> Pretreatment structure needed				
<b>Existing BMP on site?</b> No	<b>Non-Structural Controls:</b> -None Selected-				
<b>Is site a hotspot?</b> Yes	<b>Non-Structural Other:</b> -None Selected-				
<b>Sources/pollutants 1:</b> Sediment	<b>Maintenance Burden:</b> Medium				
<b>Sources/pollutants 2:</b> Metals	<table border="0" style="width: 100%;"> <tr> <td style="width: 50%; vertical-align: top;"><b>Benefits:</b> Storage: YES Water Quality: YES Recharge: NO Demo: NO Repair: NO Reuse: NO</td> <td style="width: 50%; vertical-align: top;"><b>Conflicts:</b> Soils: YES Access: YES Land Use: YES Utilities: YES Polluted: 0 High WT: NO Wetlands: NO</td> </tr> <tr> <td colspan="2"><b>Other:</b> -None Selected-</td> </tr> </table>	<b>Benefits:</b> Storage: YES Water Quality: YES Recharge: NO Demo: NO Repair: NO Reuse: NO	<b>Conflicts:</b> Soils: YES Access: YES Land Use: YES Utilities: YES Polluted: 0 High WT: NO Wetlands: NO	<b>Other:</b> -None Selected-	
<b>Benefits:</b> Storage: YES Water Quality: YES Recharge: NO Demo: NO Repair: NO Reuse: NO		<b>Conflicts:</b> Soils: YES Access: YES Land Use: YES Utilities: YES Polluted: 0 High WT: NO Wetlands: NO			
<b>Other:</b> -None Selected-					
<b>Soils:</b> Poor – HSG D					
<b>Use in Retrofit DA:</b> Williston Rd					
SIZING INFO					
<b>Drainage Area (ac):</b> 1.6 ac					
<b>Impervious Area (ac):</b> ~ 0.7					
<b>Practice Area Available (ft<sup>2</sup>):</b> ~11,500					
<b>Existing Head Available?</b> Yes, but only about 2-3 ft.

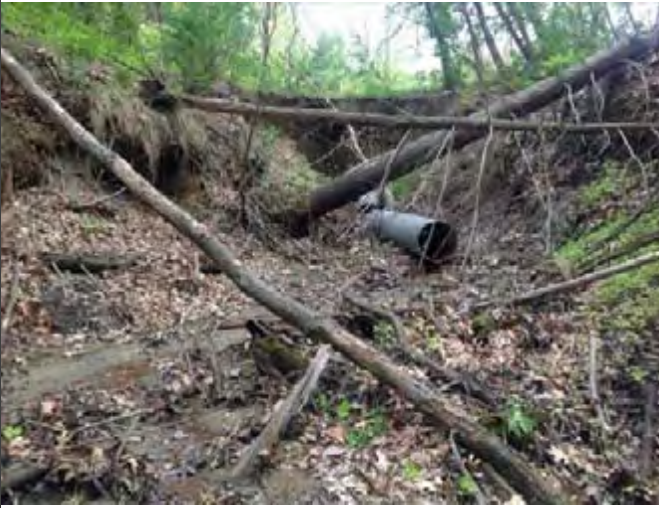
<p><b>Concept Description:</b>                      Outfall is located north of Best Western. Site drainage area currently includes only the Best Western property. Outfall is severely eroded and is headcutting to the east and may soon reach the paved access road. Concept includes stabilizing the outfall and constructing a detention basin within the existing gully. Expand the current drainage area to intercept runoff from the Williston Road drainage network and redirect drainage from abutting commercial properties.</p> <p>The proposed drainage network is depicted by the magenta lines in the concept drainage area map.</p>	
<p><b>Notes/Feasibility:</b>                      Priority project. The proposed site could manage a large drainage area that is currently unmanaged and unstable. Since the outfall is in need of immediate repair, feasibility is high. Planning considerations include the redirection of flow from abutting commercial properties.</p>

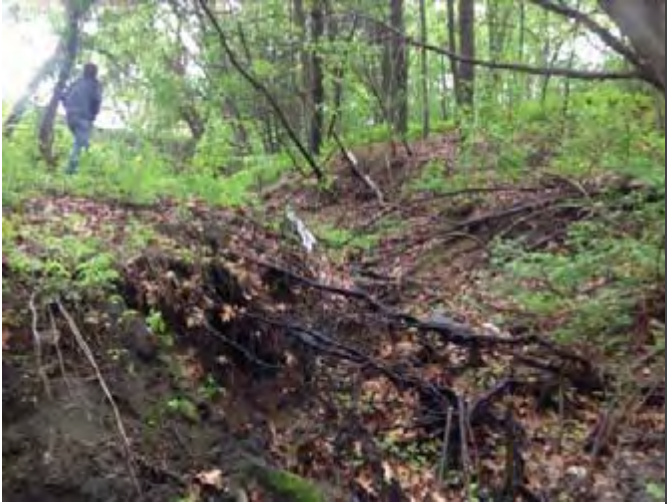
<p><b>Concept Description:</b> Outfall is located west of Best Western. Site drainage area currently includes only the Best Western property. Moderate erosion has occurred. Concept includes stabilizing outfalls and constructing a detention basin within the existing gully. Expand the current drainage area to intercept runoff from the Williston Road drainage network. A portion of this drainage area could be directed to Retrofit 22, if necessary.</p>	
<p><b>Notes/Feasibility:</b> Good. May make economic sense to divert some or all of this area to Retrofit site #22.</p>	
GENERAL SITE INFORMATION	RETROFIT DETAILS
<b>Site Contact Info:</b> Tom Dipietro, S. Burlington	<b>Project Candidate:</b> Yep, Love It
<b>Ownership:</b> Private	<b>Retrofit of new or existing BMP:</b> New BMP
<b>Land Use 1:</b> Commercial/Industrial	<b>Proposed Retrofit Practice 1:</b> Pond

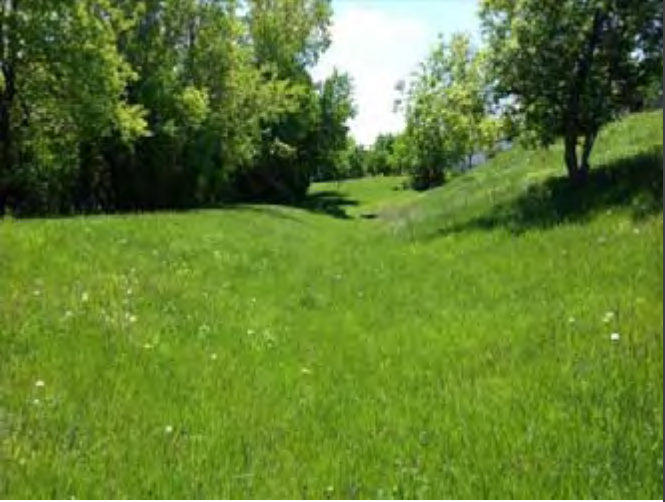
<b>Concept Description:</b> Retrofit of existing dry basin to an infiltration basin. Increase contributing drainage area and add riser to outlet structure for improved flow control. Redirect road drainage from Centennial Court to basin. Site only takes runoff currently from a portion of the apartment roofs.							
<b>Notes/Feasibility:</b> Very good. Must adjust existing sewer manhole located with basin. This currently discharges to the UVM East Campus Pond.							
GENERAL SITE INFORMATION	RETROFIT DETAILS						
<b>Site Contact Info:</b> UVM / Art Shields (property manager)	<b>Project Candidate:</b> Yep, Love It						
<b>Ownership:</b> Public	<b>Retrofit of new or existing BMP:</b> Existing BMP						
<b>Land Use 1:</b> Multi-family Residential	<b>Proposed Retrofit Practice 1:</b> Pond						
<b>Land Use 2:</b> Campus Apartments	<b>Proposed Retrofit Practice 2:</b> -None Selected-						
<b>Existing BMP on site?</b> Yes	<b>Non-Structural Controls:</b> -None Selected-						
<b>Is site a hotspot?</b> No	<b>Non-Structural Other:</b> -None Selected-						
<b>Sources/pollutants 1:</b> Sediment	<b>Maintenance Burden:</b> Low						
<b>Sources/pollutants 2:</b> -None Selected-

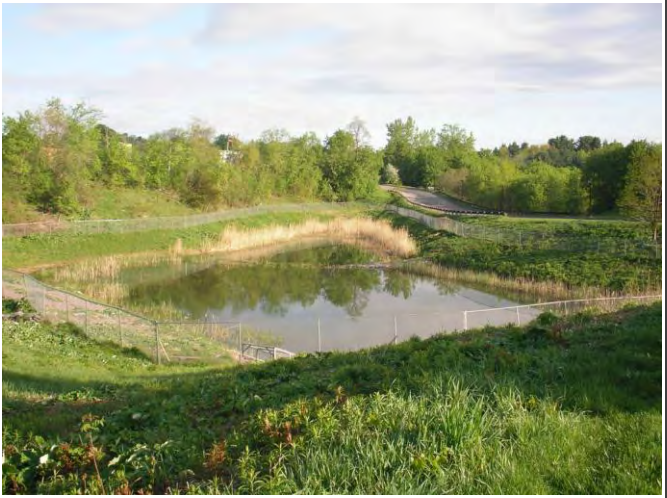
<b>Concept Description:</b> Retrofit of the existing East Campus Pond outlet structure to maximize storage and attenuation for to target design storm(s).					
<b>Notes/Feasibility:</b> Priority location with high feasibility. No significant space available for expansion of the facility. Low cost improvement.					
GENERAL SITE INFORMATION	RETROFIT DETAILS				
<b>Site Contact Info:</b> UVM	<b>Project Candidate:</b> Yep, Love It				
<b>Ownership:</b> Public	<b>Retrofit of new or existing BMP:</b> Existing BMP				
<b>Land Use 1:</b> Institutional	<b>Proposed Retrofit Practice 1:</b> Outlet structure modification				
<b>Land Use 2:</b> -None Selected-	<b>Proposed Retrofit Practice 2:</b> --				
<b>Existing BMP on site?</b> Yes	<b>Non-Structural Controls:</b> -None Selected-				
<b>Is site a hotspot?</b> No	<b>Non-Structural Other:</b> -None Selected-				
<b>Sources/pollutants 1:</b> No	<b>Maintenance Burden:</b> Low				
<b>Sources/pollutants 2:</b> -None Selected-	<table border="0" style="width: 100%;"> <tr> <td style="width: 50%; vertical-align: top;"> <b>Benefits:</b>                      Storage: YES                      Water Quality: YES                      Recharge: NO                      Demo: NO                      Repair: NO                      Reuse: NO                 </td> <td style="width: 50%; vertical-align: top;"> <b>Conflicts:</b>                      Soils: YES                      Access: NO                      Land Use: NO                      Utilities: NO                      Polluted: NO                      High WT: NO                      Wetlands: NO                 </td> </tr> <tr> <td colspan="2"><b>Other:</b> None</td> </tr> </table>	<b>Benefits:</b> Storage: YES Water Quality: YES Recharge: NO Demo: NO Repair: NO Reuse: NO	<b>Conflicts:</b> Soils: YES Access: NO Land Use: NO Utilities: NO Polluted: NO High WT: NO Wetlands: NO	<b>Other:</b> None	
<b>Benefits:</b> Storage: YES Water Quality: YES Recharge: NO Demo: NO Repair: NO Reuse: NO		<b>Conflicts:</b> Soils: YES Access: NO Land Use: NO Utilities: NO Polluted: NO High WT: NO Wetlands: NO			
<b>Other:</b> None					
<b>Soils:</b> Poor Infiltration					
<b>Use in Retrofit DA:</b> -None Selected-					
SIZING INFO					
<b>Drainage Area (ac):</b> 69.80					
<b>Impervious Area (ac):</b> 43.67					
<b>Practice Area Available (ft<sup>2</sup>):</b> --					
<b>Existing Head Available?</b> --

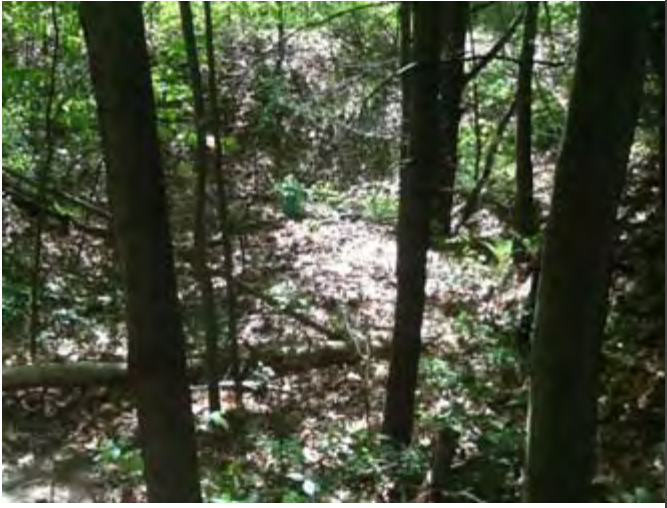
<b>Concept Description:</b> Existing dry detention pond. Modify outlet to create an infiltration basin. Existing pond might predate subdivision (newer PVC outlet connects to older CMP barrel). Facility appears to have additional storage capacity to expand drainage area (level run confirmed this is feasible).					
<b>Notes/Feasibility:</b> Old CMP barrel New 15" PVC outlet Sink hole evidence – top of existing embankment Scour hole at barrel outlet Incoming 15" HDPE Eroded inflow channel					
GENERAL SITE INFORMATION	RETROFIT DETAILS				
<b>Site Contact Info:</b> Queensbury HOA	<b>Project Candidate:</b> Yes.				
<b>Ownership:</b> Private	<b>Retrofit of new or existing BMP:</b> Existing BMP				
<b>Land Use 1:</b> Single Family Residential	<b>Proposed Retrofit Practice 1:</b> Infiltration Basin				
<b>Land Use 2:</b> -None Selected-	<b>Proposed Retrofit Practice 2:</b> 0				
<b>Existing BMP on site?</b> Yes	<b>Non-Structural Controls:</b> -None Selected-				
<b>Is site a hotspot?</b> No	<b>Non-Structural Other:</b> -None Selected-				
<b>Sources/pollutants 1:</b> Sediment	<b>Maintenance Burden:</b> Low				
<b>Sources/pollutants 2:</b> -None Selected-	<table border="0" style="width: 100%;"> <tr> <td style="width: 50%;"><b>Benefits:</b> Storage: YES Water Quality: YES Recharge: YES Demo: NO Repair: NO Reuse: NO</td> <td style="width: 50%;"><b>Conflicts:</b> Soils: NO Access: NO Land Use: NO Utilities: YES Polluted: NO High WT: NO Wetlands: NO</td> </tr> <tr> <td><b>Other:</b> 0</td> <td><b>Other:</b> 0</td> </tr> </table>	<b>Benefits:</b> Storage: YES Water Quality: YES Recharge: YES Demo: NO Repair: NO Reuse: NO	<b>Conflicts:</b> Soils: NO Access: NO Land Use: NO Utilities: YES Polluted: NO High WT: NO Wetlands: NO	<b>Other:</b> 0	<b>Other:</b> 0
<b>Benefits:</b> Storage: YES Water Quality: YES Recharge: YES Demo: NO Repair: NO Reuse: NO		<b>Conflicts:</b> Soils: NO Access: NO Land Use: NO Utilities: YES Polluted: NO High WT: NO Wetlands: NO			
<b>Other:</b> 0		<b>Other:</b> 0			
<b>Soils:</b> Good Infiltration					
<b>Use in Retrofit DA:</b> Streets, single family res.					
SIZING INFO					
<b>Drainage Area (ac):</b> 7.67					
<b>Impervious Area (ac):</b> 3.05					
<b>Practice Area Available (ft<sup>2</sup>):</b> 8,930					
<b>Existing Head Available?</b> n/a

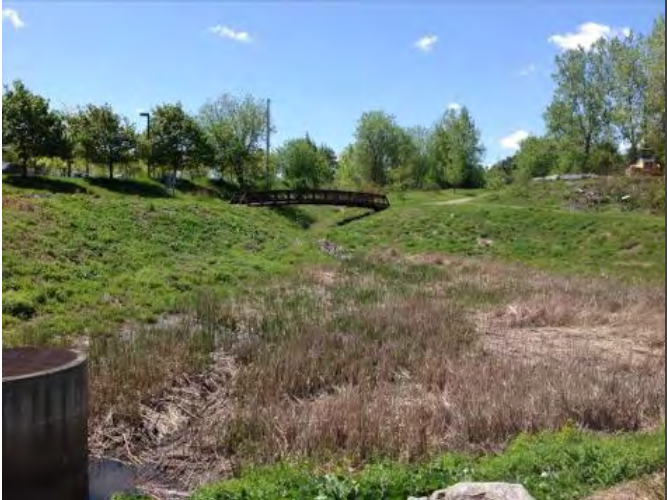
<b>Concept Description:</b> The Main Street Pond outlet structure is currently not functioning properly and must be repaired. Two potential retrofit options include: <b>M5A</b> involves converting the existing basin to a forebay for proposed Retrofit #24; <b>M5A2</b> involves expanding the existing Main St. Pond southward toward Williston Rd. and excavating to a deeper depth (see attached sketch). HW expanded upon the proposed K&L design of this facility to include a modified outlet structure and a concrete wall for additional storage and attenuation. The parking lot to the north (currently draining to M1 East Campus Pond, was rerouted here in the model).					
<b>Notes/Feasibility:</b> Priority location with high feasibility. Retrofit <b>M5A2</b> will likely require significant ledge removal for the proposed construction activities. Ledge removal is not anticipated for the <b>M5A/24</b> retrofit scenario.					
GENERAL SITE INFORMATION	RETROFIT DETAILS				
<b>Site Contact Info:</b> UVM	<b>Project Candidate:</b> Yep, Love It				
<b>Ownership:</b> Public	<b>Retrofit of new or existing BMP:</b> Existing BMP				
<b>Land Use 1:</b> Institutional	<b>Proposed Retrofit Practice 1:</b> Forebay for Retrofit 24 (M5A)				
<b>Land Use 2:</b> -None Selected-	<b>Proposed Retrofit Practice 2:</b> Expand ex. basin (M5A2)				
<b>Existing BMP on site?</b> Yes	<b>Non-Structural Controls:</b> -None Selected-				
<b>Is site a hotspot?</b> No	<b>Non-Structural Other:</b> -None Selected-				
<b>Sources/pollutants 1:</b> No	<b>Maintenance Burden:</b> Low				
<b>Sources/pollutants 2:</b> -None Selected-	<table border="0" style="width: 100%;"> <tr> <td style="width: 50%; vertical-align: top;"> <b>Benefits:</b>                              Storage: YES                              Water Quality: YES                              Recharge: NO                              Demo: NO                              Repair: NO                              Reuse: NO                         </td> <td style="width: 50%; vertical-align: top;"> <b>Conflicts:</b>                              Soils: YES                              Access: NO                              Land Use: NO                              Utilities: NO                              Polluted: NO                              High WT: NO                              Wetlands: NO                         </td> </tr> <tr> <td colspan="2" style="vertical-align: top;"> <b>Other:</b> None                         </td> </tr> </table>	<b>Benefits:</b> Storage: YES Water Quality: YES Recharge: NO Demo: NO Repair: NO Reuse: NO	<b>Conflicts:</b> Soils: YES Access: NO Land Use: NO Utilities: NO Polluted: NO High WT: NO Wetlands: NO	<b>Other:</b> None	
<b>Benefits:</b> Storage: YES Water Quality: YES Recharge: NO Demo: NO Repair: NO Reuse: NO		<b>Conflicts:</b> Soils: YES Access: NO Land Use: NO Utilities: NO Polluted: NO High WT: NO Wetlands: NO			
<b>Other:</b> None					
<b>Soils:</b> Poor Infiltration					
<b>Use in Retrofit DA:</b> -None Selected-					
SIZING INFO					
<b>Drainage Area (ac):</b> M5A/24 74.04; M5A2 67.93					
<b>Impervious Area (ac):</b> M5A/24 31.12; M5A2 29.04					
<b>Practice Area Available (ft<sup>2</sup>):</b> 61,000					
<b>Existing Head Available?</b> --	<b>Other:</b> Ledge at bottom of existing pond
