STORMWATER MANAGEMENT PLAN FOR THE TOWN OF ENOSBURGH AND VILLAGE OF ENOSBURG FALLS

FINAL REPORT

Stone Project ID 112475-W

March 1, 2013

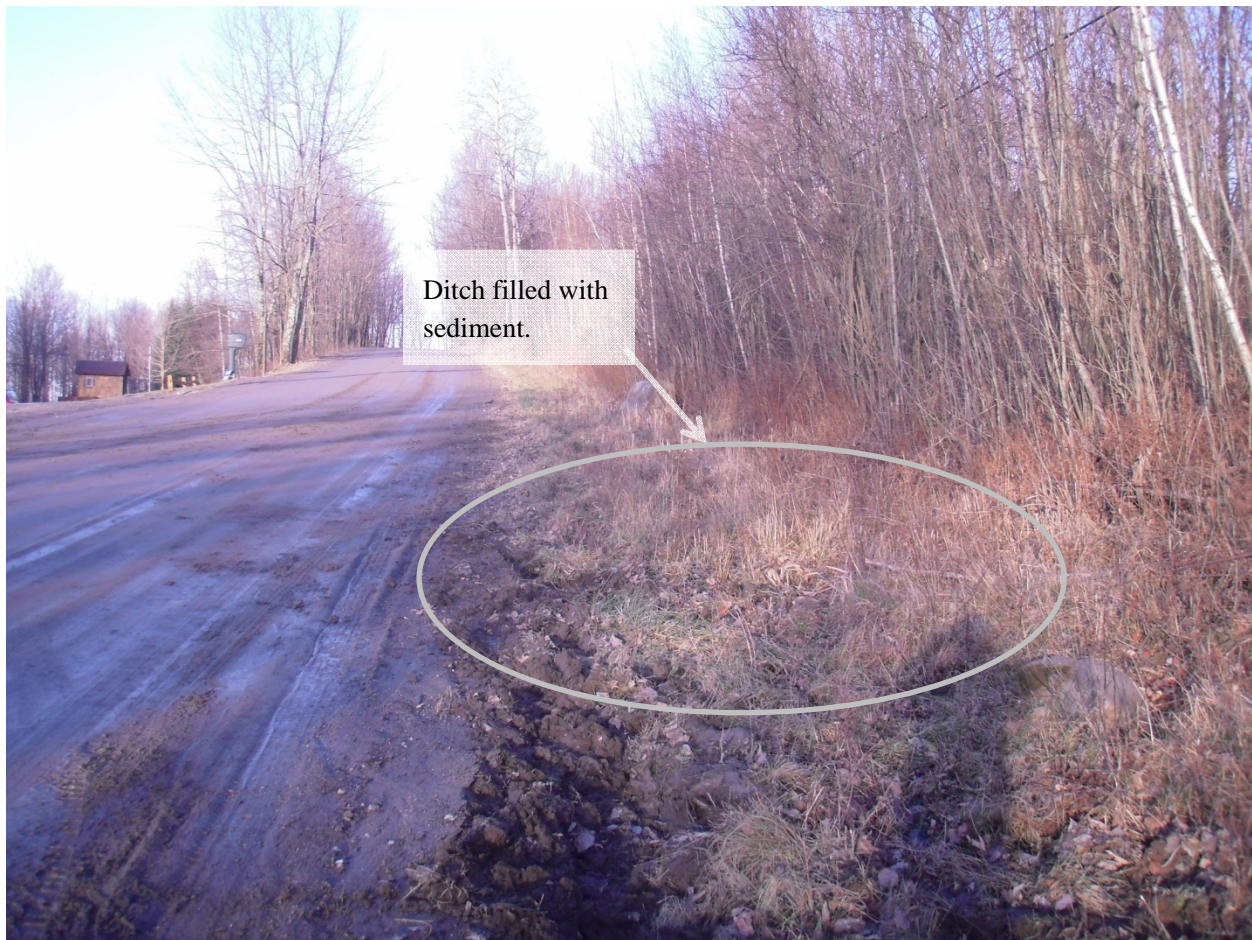
A portion of the road side ditch appears to be in need of cleaning (see Figure). In the ditch's existing condition, water has been diverted down and across the road, causing damage to the road surface and to a neighboring property. At the time of inspection, recent repairs have been made to the eroded section of road and adjacent property but the ditch had not been cleaned.

Figure 5. Ditch along Perley Road has become filled in. Diverted water is eroding the road surface.

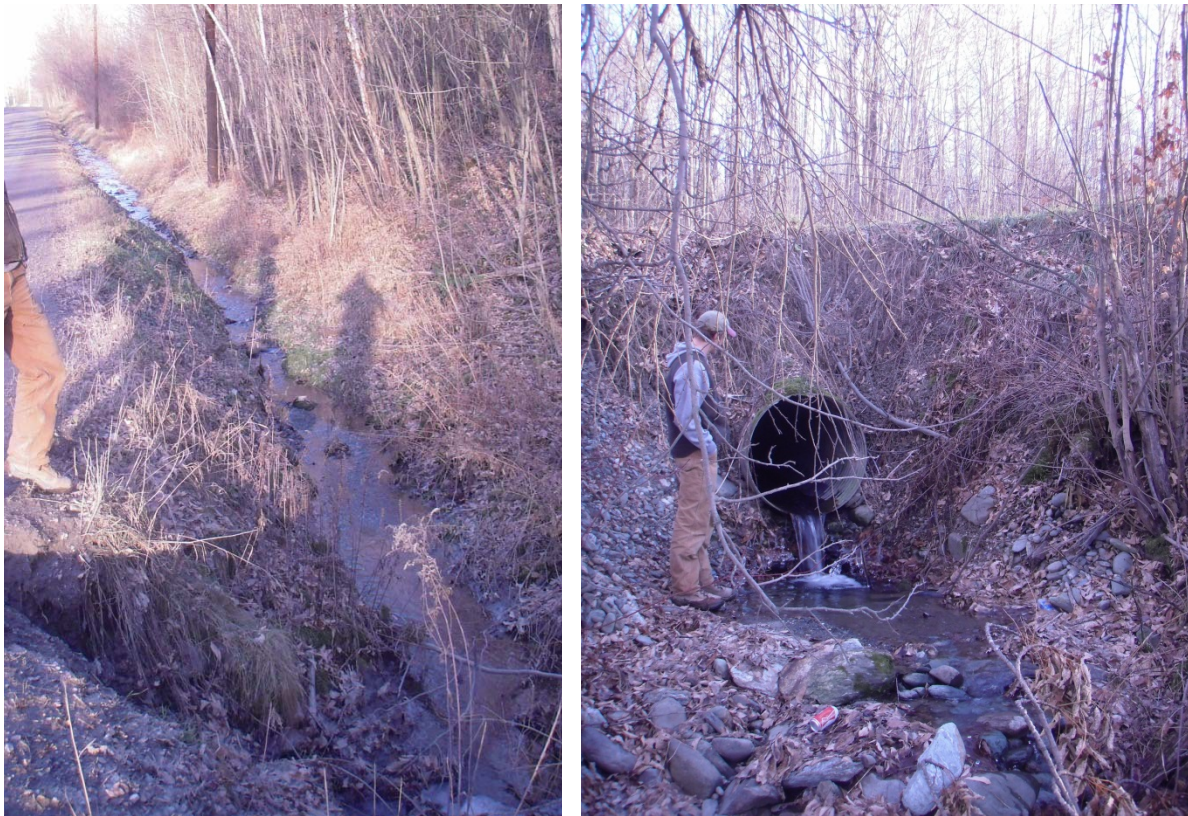
The ditch-relief (cross drain) culvert located near 2982 Perley Road is too short for the current width of the road. The short culvert forces the road embankment to be too steep. The resulting approximately 1:1 (horizontal to vertical) slope has created unstable conditions at both the inlet and the outlet to this 36" culvert (Figure). Generally, vegetated slopes should be limited to 2:1 to maintain stable conditions. The erosion of this over-steepened slope is resulting in deteriorating road conditions and impacts to water quality.

In addition, the existing culvert pipe is significantly corroded. It is likely that this culvert was of adequate length for the width of road when it was installed. Over time, through routine grading and re-surfacing, the road width may have increased, leading to over-steepened banks. Given the deteriorating condition of the culvert, it is a good candidate for replacement. The replacement culvert should be long enough to accommodate 2:1 slopes at the inlet and outlet of the culvert.

Figure 6. This culvert near 2982 Perley Rd. is too short, resulting in steep, erodible banks. Culvert inlet shown on left; Outlet is on the right.

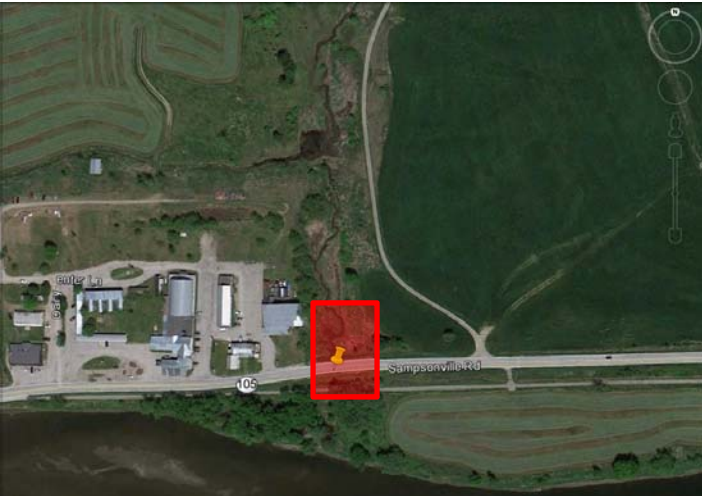
Watershed:	Missisquoi River													
Location:	VT Route 105, just east of the Dairy Center													
Problem Type:	Bridge/Culvert Issue													
Identification Source:	VTrans Bridge/Culvert Report													
Ownership:	Local													
Classification Level:	2b													
Problem Description:														
VT Route 105 culvert failing due to erosion and scouring.

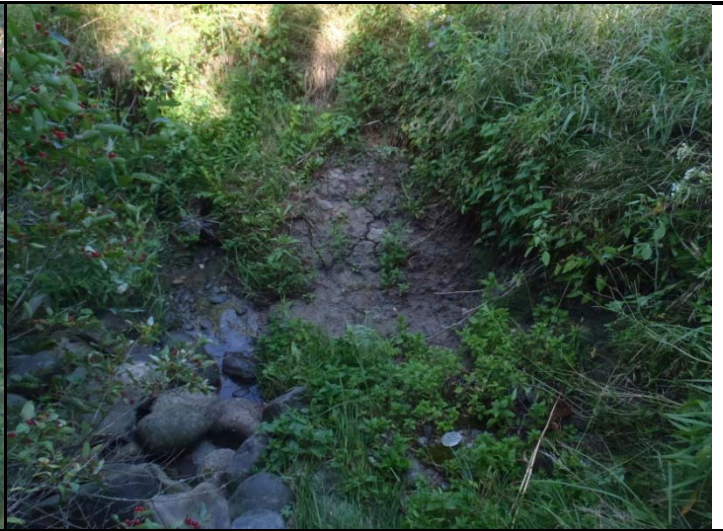
Watershed:	Missisquoi River													
Location:	Missisquoi Valley Rail Trail, near the end of Bismark St													
Problem Type:	Drainage/Future Developments													
Identification Source:	Missisquoi Basin Urban Areas Stormwater Mapping Project													
Ownership:	Local													
Classification Level:	4													
Problem Description:														
Active erosion being caused by flows from two storm sewer outfalls.

Photo 2. Bank erosion

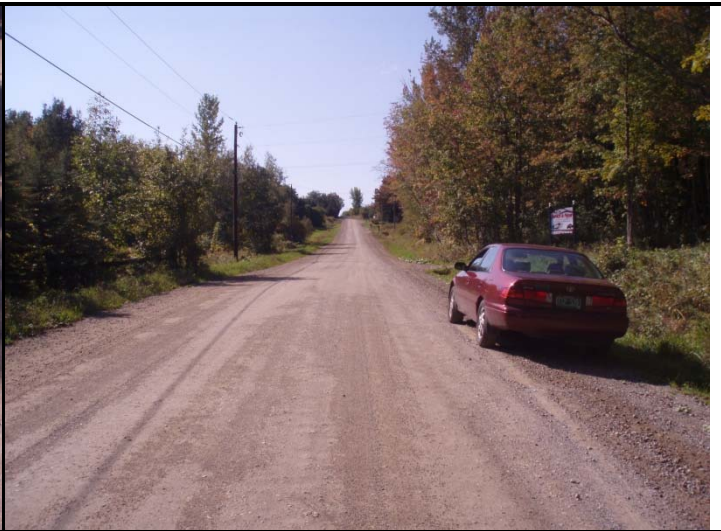
Photo 1. Road falling into ditch

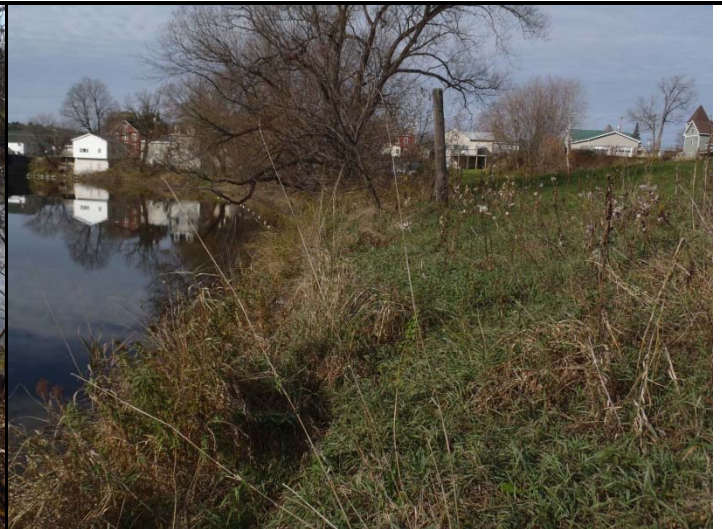
Photo 2. Bank erosion due to lack of vegetation

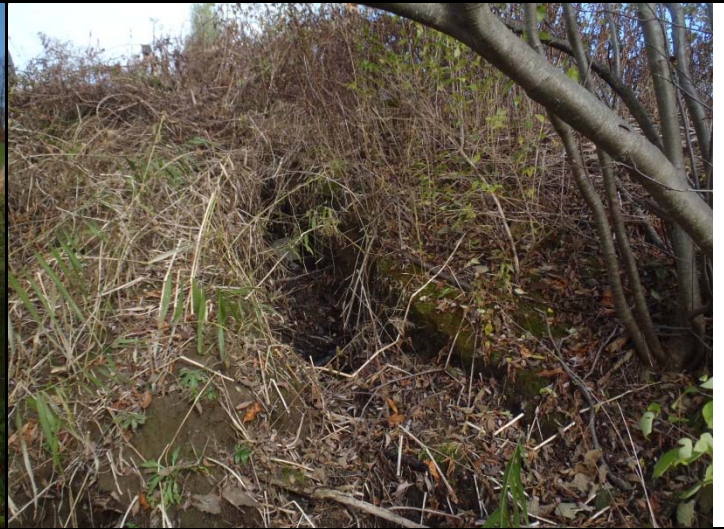
Photo 2. Ultimately causes 3 foot head cut (above)

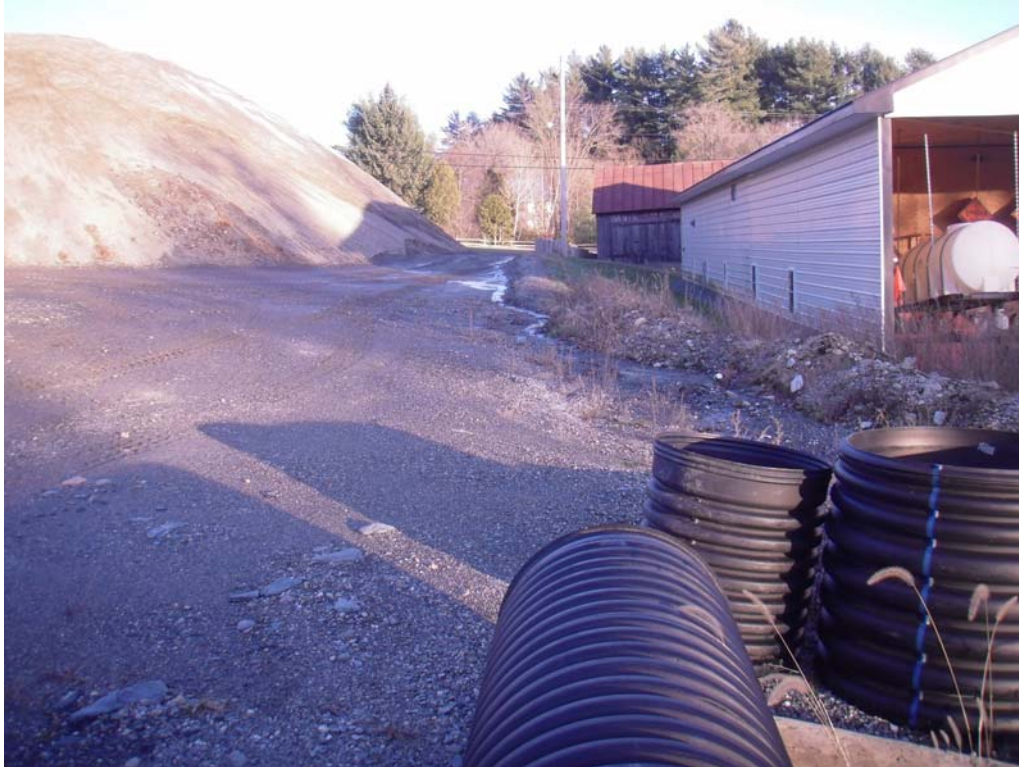
Figure 2. Material erodes from the stockpile and is carried offsite via the swale shown in center of photo.

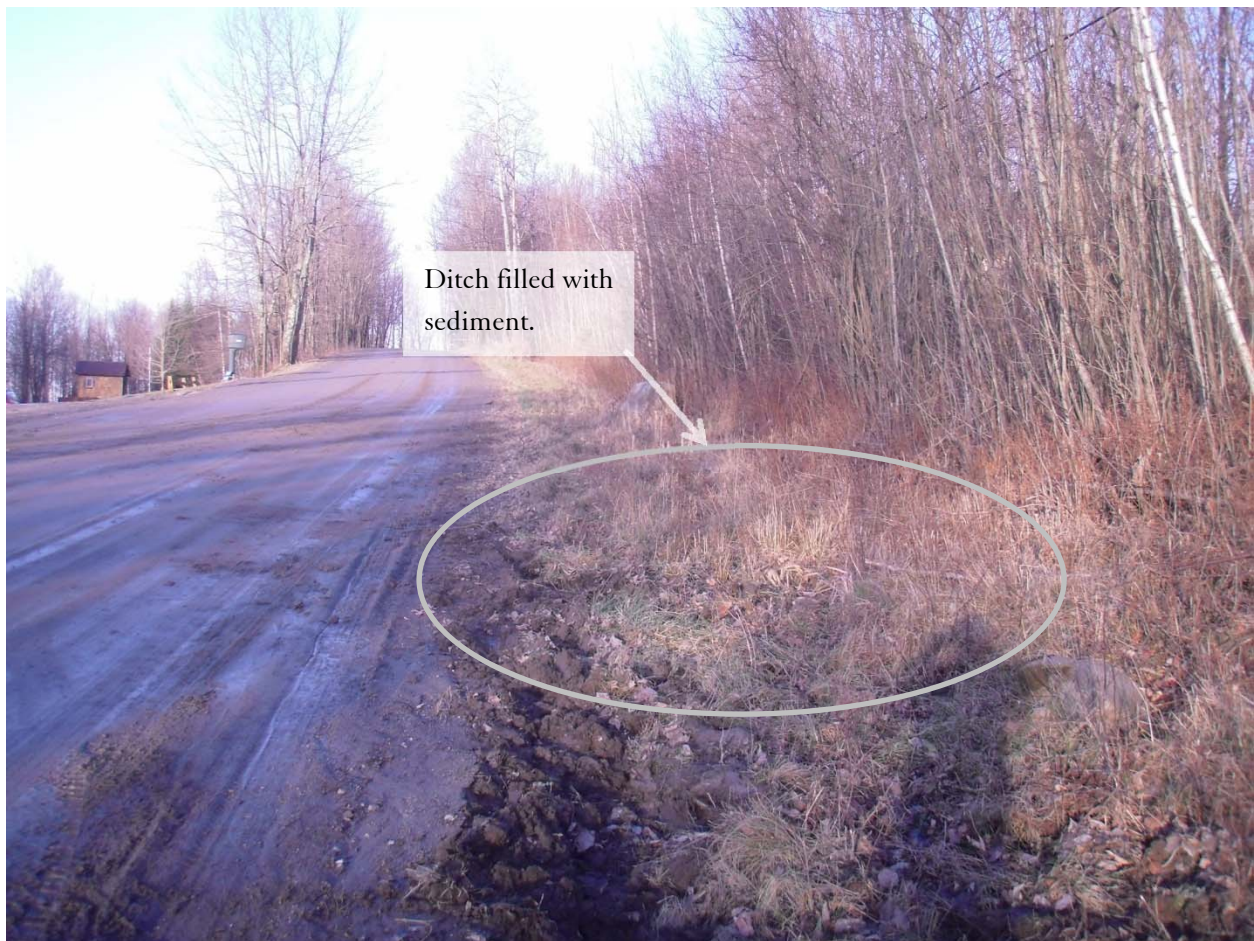
Figure 21. Ditch along Perley road has become filled in. Diverted water is eroding the road surface.

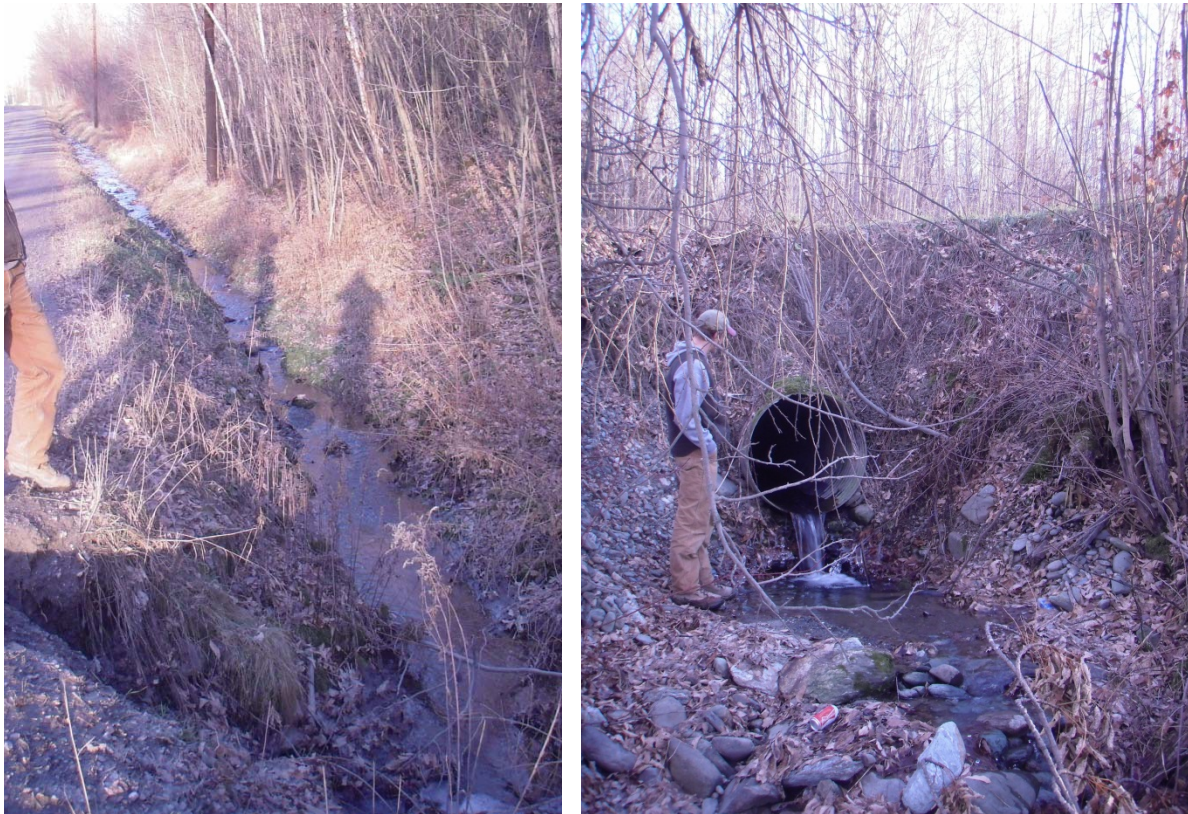
Figure 22. This culvert near 2982 Perley Rd. is too short, resulting in steep, erodible banks. Culvert inlet shown on left; Outlet is on the right.

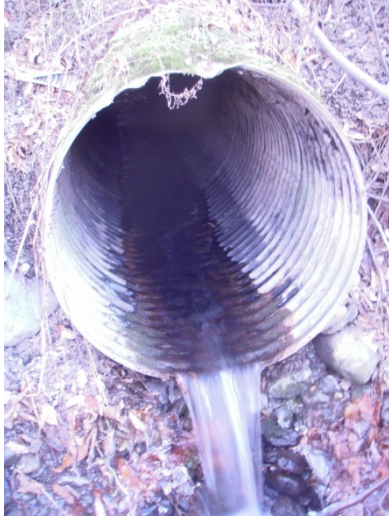
Figure 23. Corroded 36" culvert on Perley Road.
