Deer Brook Georgia, Vermont

Georgia Industrial Park,
Deer Brook Watershed

Georgia Stormwater
Management Planning

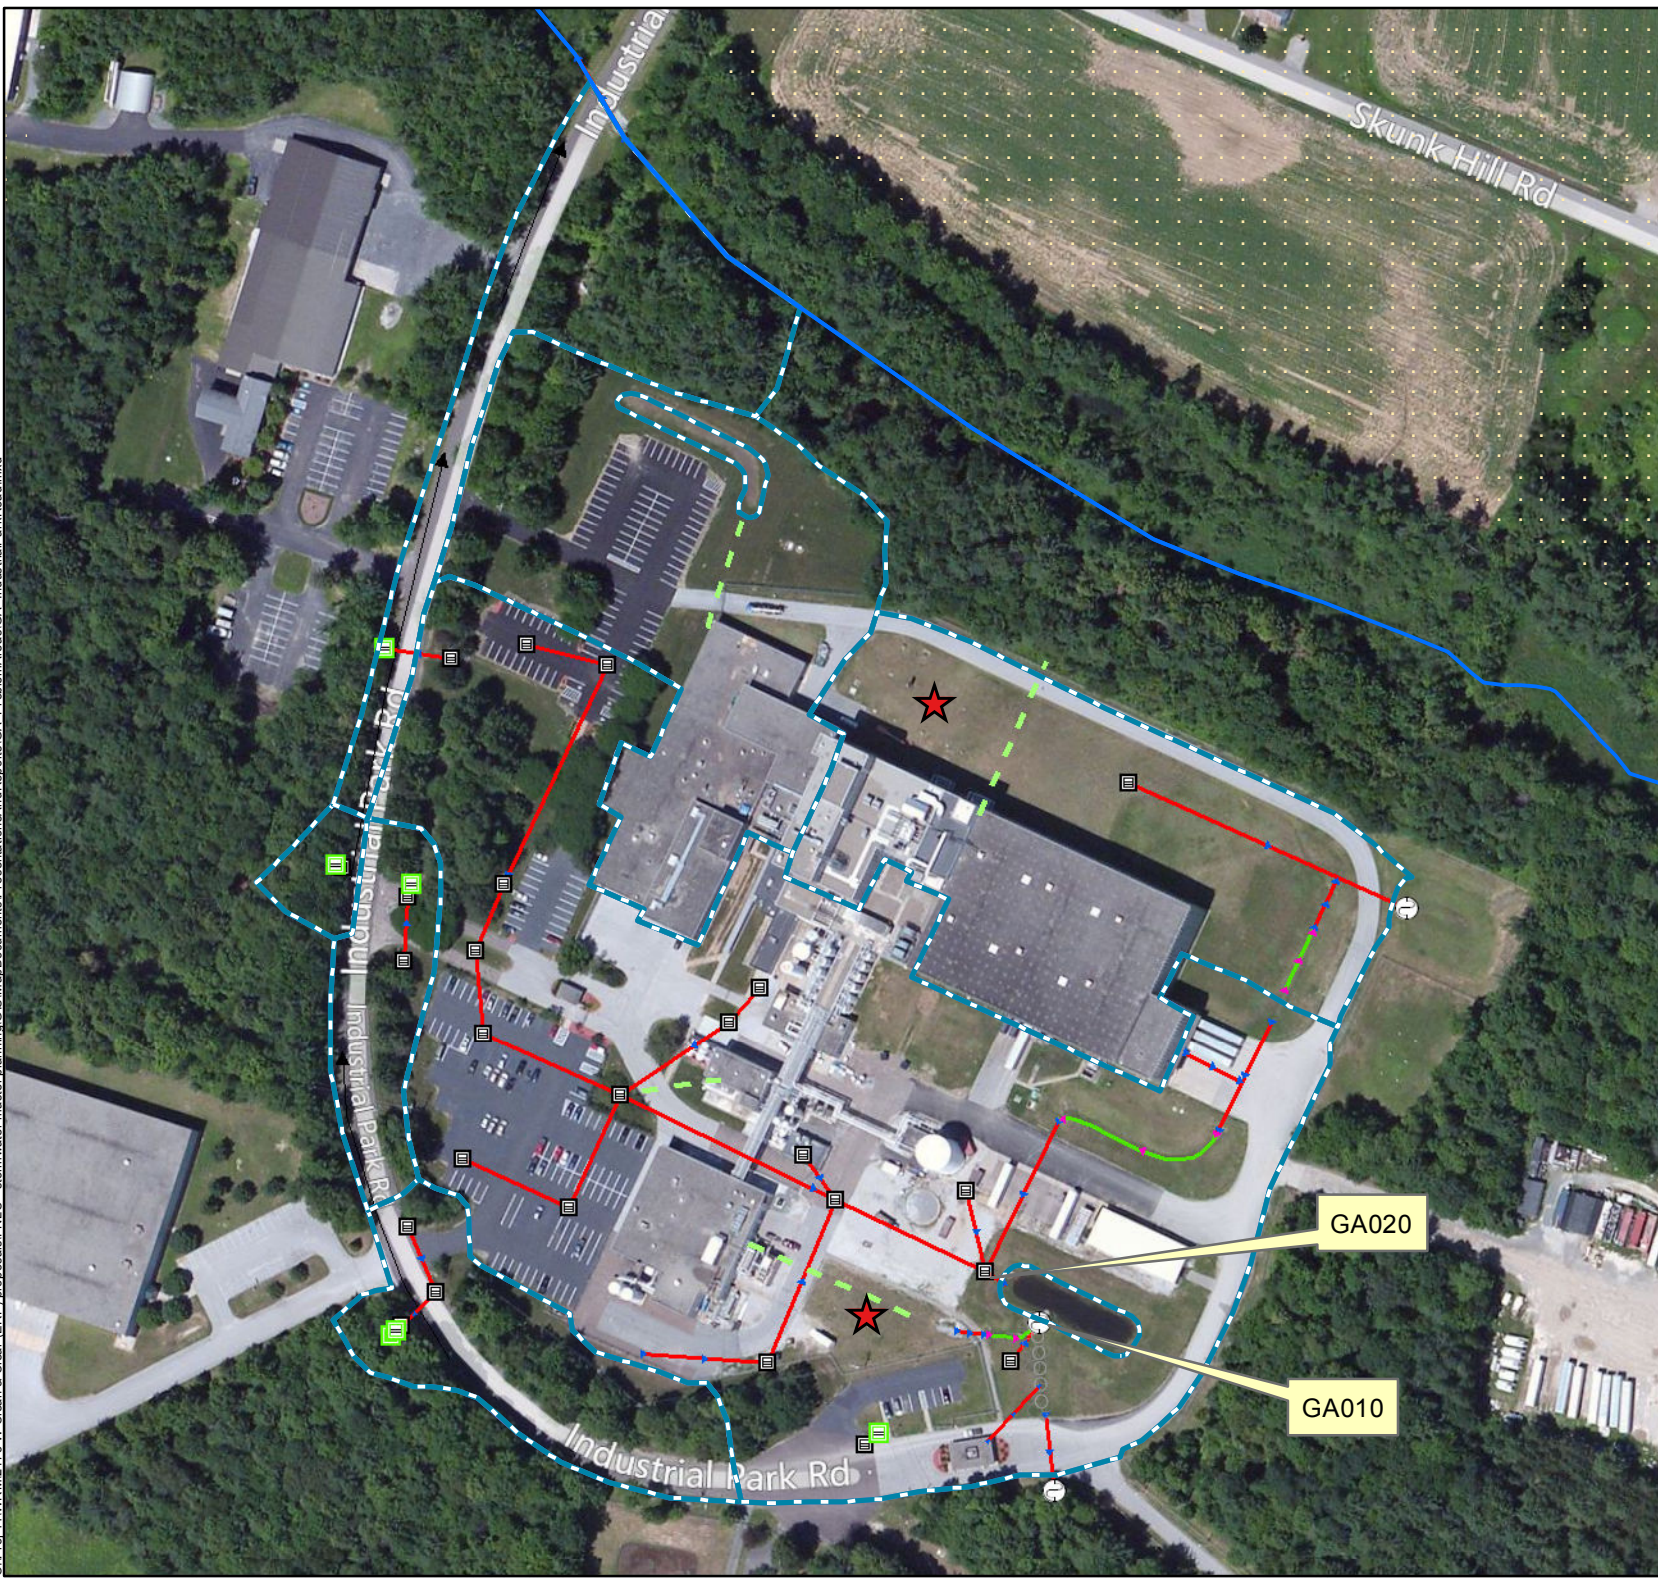
Action List 1
Subwatershed: 17

This map shows high priority subwatersheds which are ranked by connectedness, percent of impervious cover, field observations, and potential retrofit measures and locations.

Treatment Opportunity:
Evaluate opportunities for retrofitting existing stormwater management facilities (any basins) in the Georgia Industrial Park to improve performance; first step would be to assess frequency of overflow events.
