Project: AB-2 **Problem Area Summary**

Project: AB-3		Problem Area Summary
Lake Segment	Malletts Bay Direct	
Location	Allen Drive	
Land Ownership	Town ROW/Private	
BMP Type	Subsurface Infiltration	
Drainage Area/Impervious	1.18 / 0.90 acres	
% Impervious	76	
Estimated Project Cost	\$33,800	
P Efficiency (\$/lb removed)	\$26,400	
Project Priority	Moderate

Project: BB-2		Problem Area Summary
Lake Segment	Malletts Bay Direct	
Location	Woodcrest Cir	
Land Ownership	Town	
BMP Type	Subsurface Infiltration	
Drainage Area/Impervious	5.15 / 1.47 acres	
% Impervious	29	
Estimated Project Cost	\$35,000	
P Efficiency (\$/lb removed)	\$29,400	
Project Priority	High

Project: BB-4		Problem Area Summary
Lake Segment	Malletts Bay Direct	
Location	Hemlock Rd	
Land Ownership	Private	
BMP Type	Subsurface Infiltration	
Drainage Area/Impervious	1.38 / 0.20 acres	
% Impervious	15	
Estimated Project Cost	\$10,000	
P Efficiency (\$/lb removed)	\$28,300	
Project Priority	High

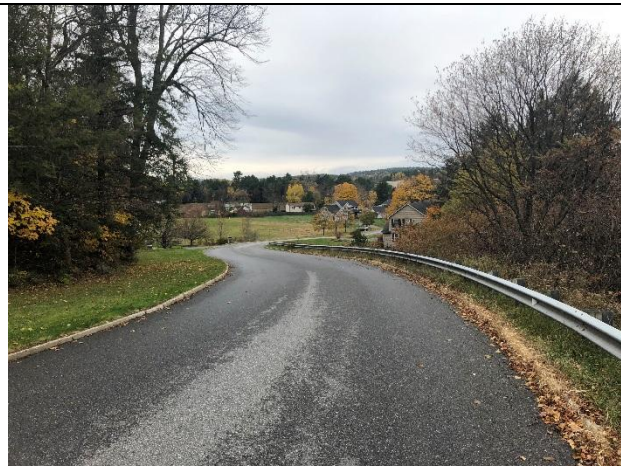
Site Description: Two storm lines draining a wide residential road empty directly to Allen Brook. The eastern drainage is very steep and flows down a rock lined ditch with some gully erosion near the brook.

Photo 1: Top of drainage looking west towards Allen Brook

BMP Description: Route runoff from the two catchbasins to a new infiltration feature located on the terrace north of the road. The infiltration feature will have a stone lined overflow spillway to the floodplain. Underlying soils are mapped as having a high infiltration rate. **Subsurface infiltration may be possible for additional treatment volume.**

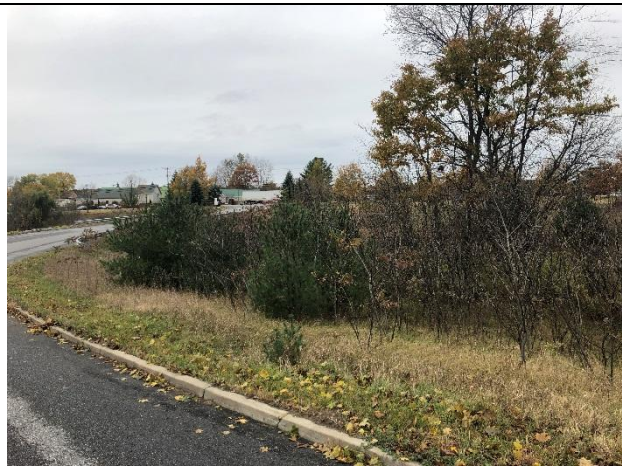
Photo 2: Location of proposed infiltration BMP – terrace located along the side of road above floodplain.

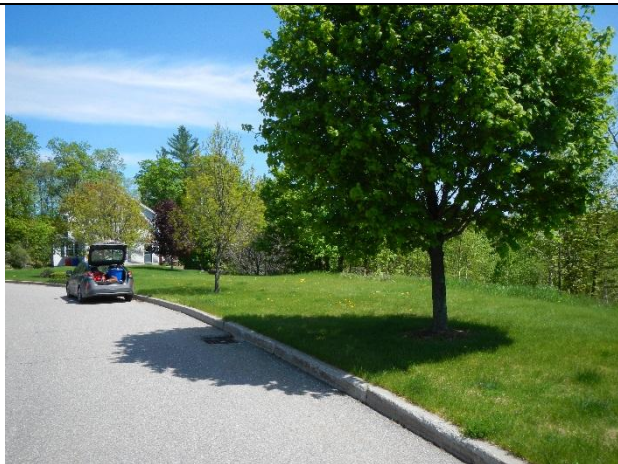
Photo 1: Area for subsurface infiltration feature adjacent to catchbasin discharging east (right)

BMP Description: Retrofit the existing catchbasin to direct WQv to an underground treatment system in grassed area east of road

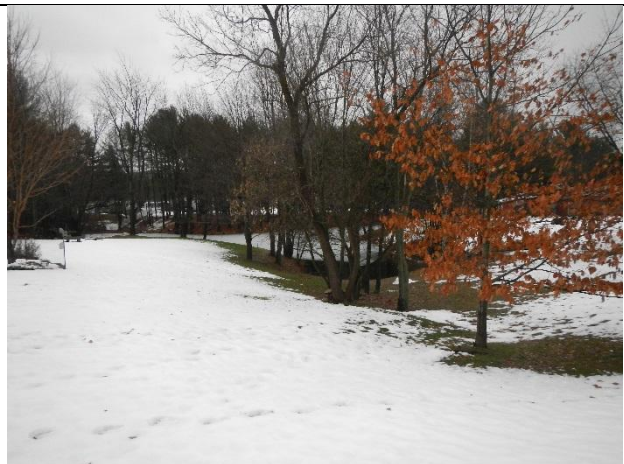
Photo 2: Swale flows through a small forested area with pond in the background

BMP Description: Widen the swale and install check dams to increase water storage volume to infiltrate most of the WQv.

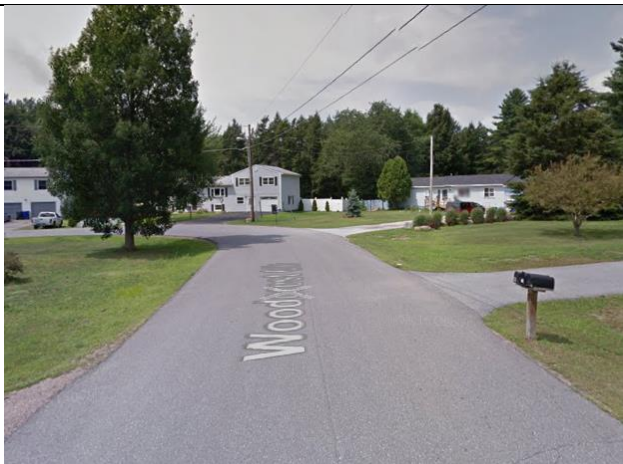
Site Description: Two existing dry wells are likely insufficient for the size of the drainage area along the northern portion of Woodcrest Cir. Both dry wells have some pre-treatment from grassed swales. All runoff eventually infiltrates with the existing system.

Photo 1: Location of proposed dry wells (Picture from Google Street View)

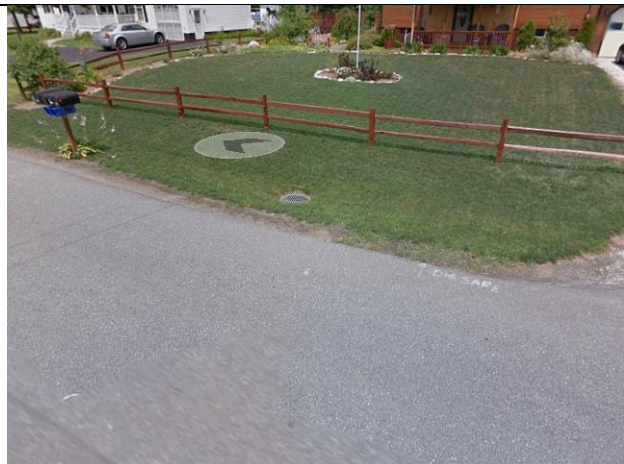
Photo 2: Existing dry well with grassed swale pre-treatment (Picture from Google Street View)

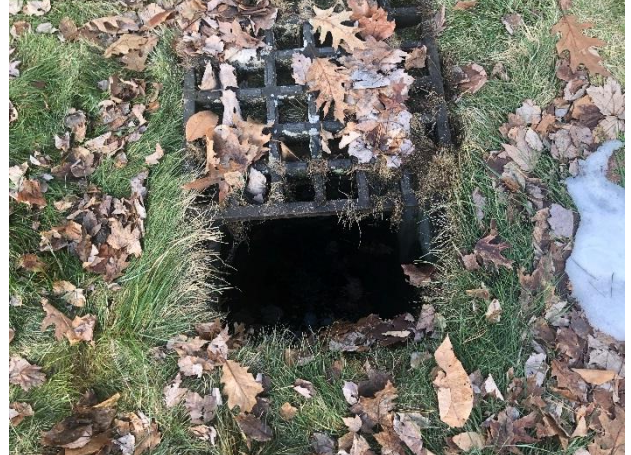
Photo 2: New 4-way shallow catch basin

BMP Description: All 6-7 of the dry wells in the existing drainage network should be drained and cleaned. We expect that several of these should be replaced. Pre-treatment (deep sump catch basin) should be incorporated into any dry well replacements, or retrofits if possible. A large new dry well should replace the catch basin north of Hemlock Road. The overflow pipe from the 3 dry wells should be routed to the newer existing dry well north of Hemlock Road. The outlet pipe to the south should be cleaned or replaced.

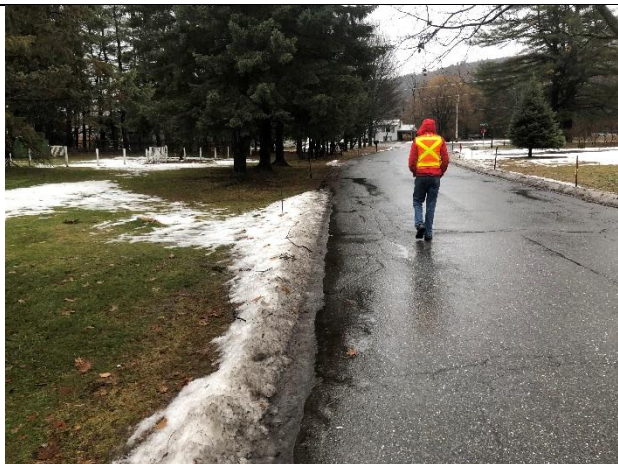
Photo 1: Location of proposed grass ditch along Hemlock Rd

BMP Description: Install grassed ditches on both sides of Hemlock Road to improve infiltration and function as pre-treatment. The ditch on the south side will require 2 driveway culverts. The two dry wells likely need to be replaced.

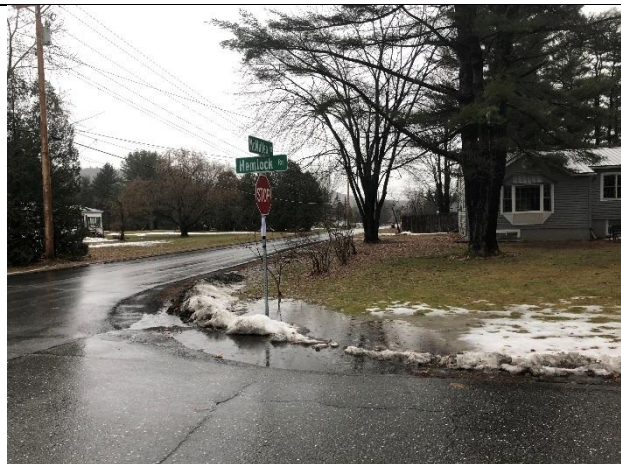
Site Description: Two dry wells located at the intersection of Hemlock and McMullen are under performing, leading to frequent and sustained ponding at the intersection.

Photo 2: Ponding 6" over dry well during a small runoff event

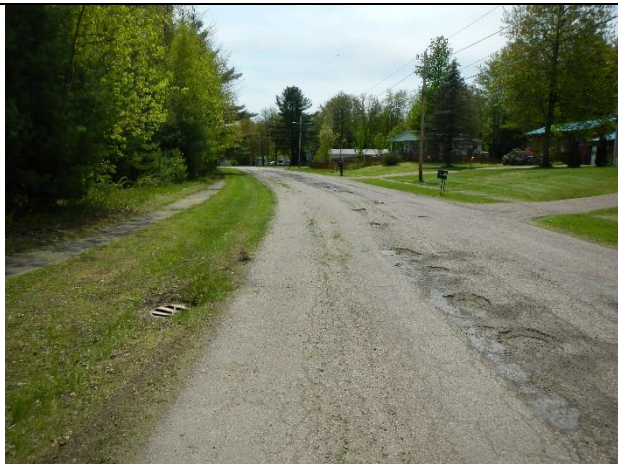
Site Description: High water table caused significant damage to the paved road winter 2018/2019. Existing road drainage is poor in the northern section, stormwater is collected in two catchbasins and piped north to the stream.

Photo 1: Potholes and pavement damage in low point of road at catch basins.

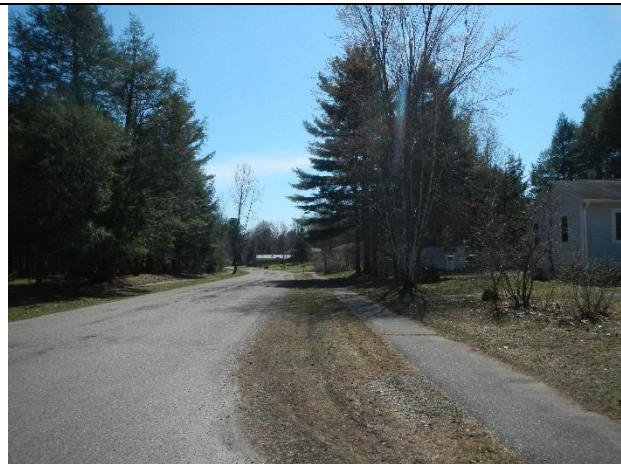
Photo 2: Gravel and grass shoulder along the west side of Kingswood Drive provides some room for stormwater treatment.

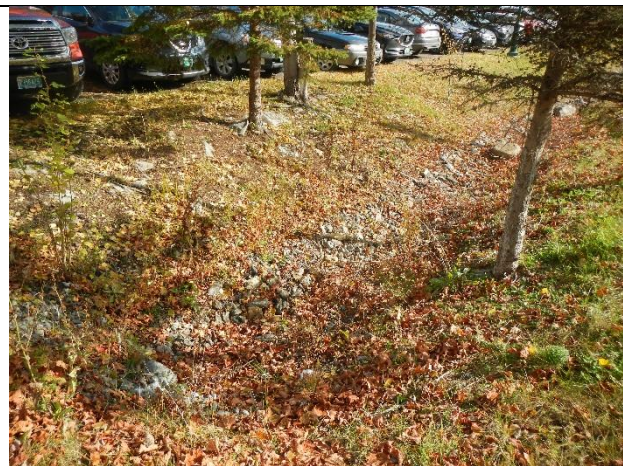
Photo 2: Existing swale outlet limits ponding and retention

BMP Description: Retrofit the outlet of each swale to increase ponding volume and retention time. Additional check dams will be necessary to maximize treatment volume. Each swale could be regraded to increase volume. Plantings or reduced mowing are recommended to improve nutrient removal.

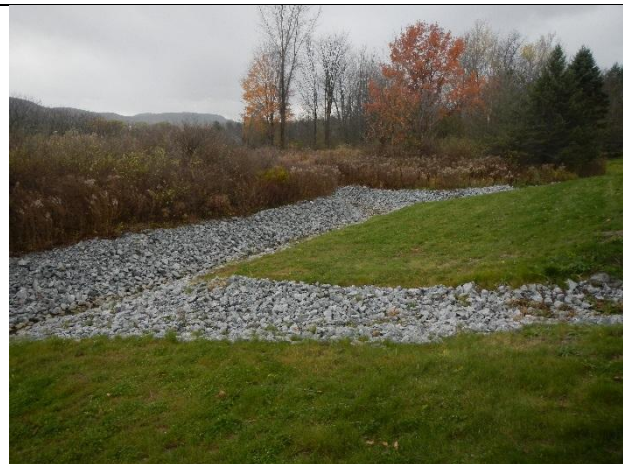
Photo 2: Outlet from wet pond draining to the southern end of the stone lined swale.

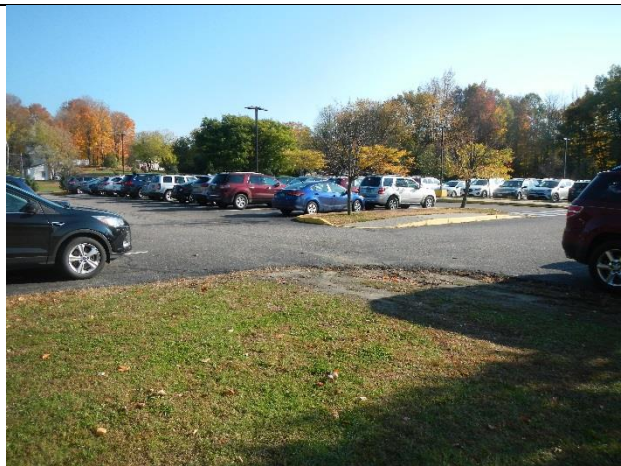
Photo 1: Parking lot draining to project area

BMP Description: Install a surface infiltration area with an overflow to the existing catch basin. Catch basin could be retrofitted to raise elevation or infiltration area could be designed to pond above the catch basin rim with a stable overflow. Plantings should be included to enhance the educational and aesthetic benefits of the project.

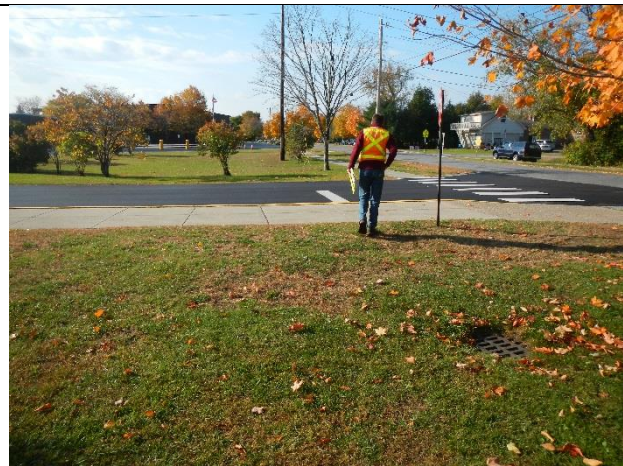
Photo 2: Catch basin draining south to large dry well and stream

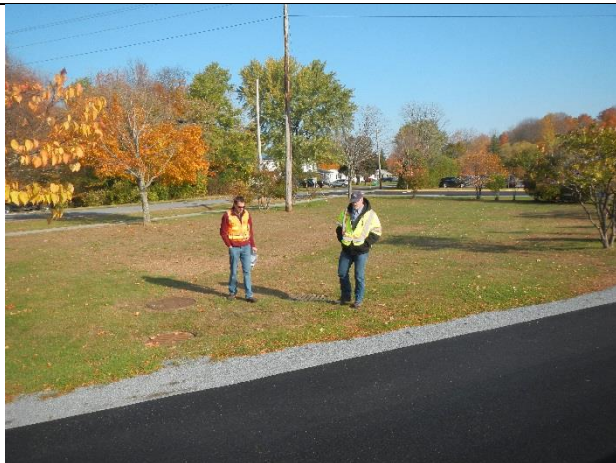
Photo 1: Grassed area at school entrance with multiple dry wells and catch basins

BMP Description: Install a large underground infiltration system in the grassed area adjacent to the existing drainage network. Retrofits to the existing drainage network may be required to adjust water elevations and to direct a portion of the runoff to the new infiltration feature. Existing closed drainage system needs to be better mapped/understood to determine required treatment volumes and benefits/costs.

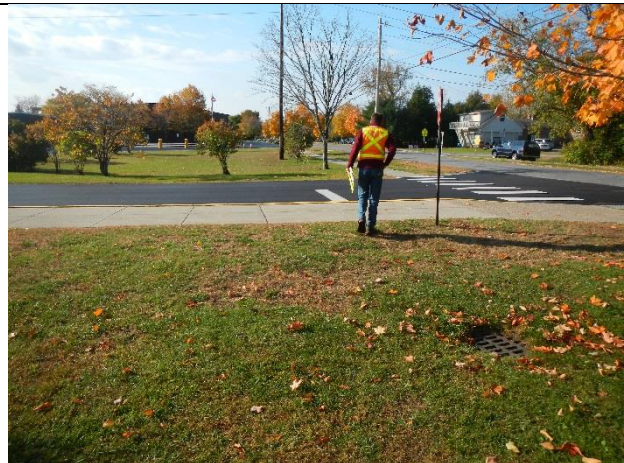
Photo 2: Catch basin connecting north parking areas to main drainage system

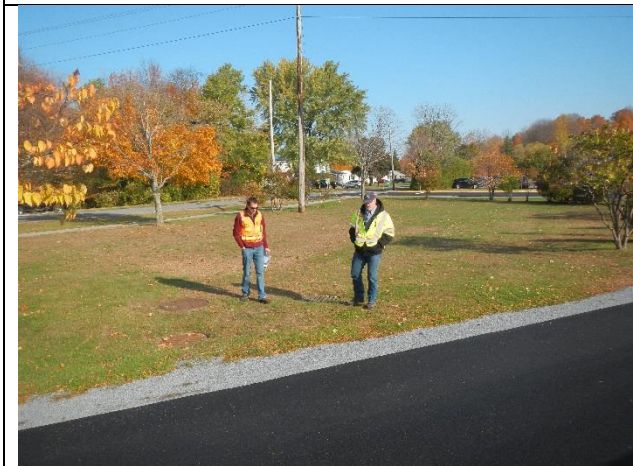
Photo 1: Grassed area along inside of curved entrance road (6a)

BMP Description: Install bioswale or other linear rain garden type feature along the edge of each paved area. For 6a it is recommended to leave a bench of grassed area to serve as a snow shelf. Bioswales should be designed for infiltration and planted with native vegetation.

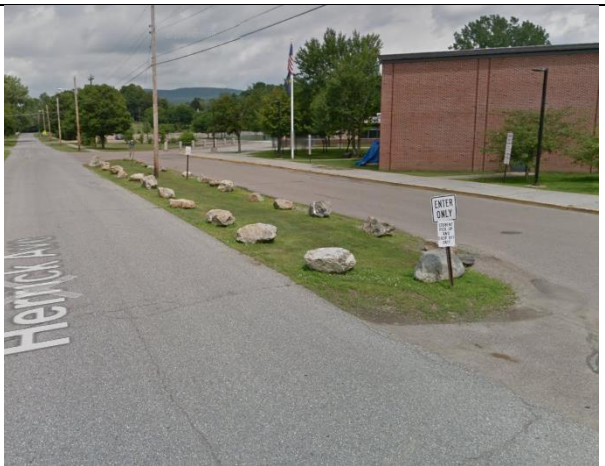
Photo 2: Grassed area along Herrick Ave (photo from Google Street View)

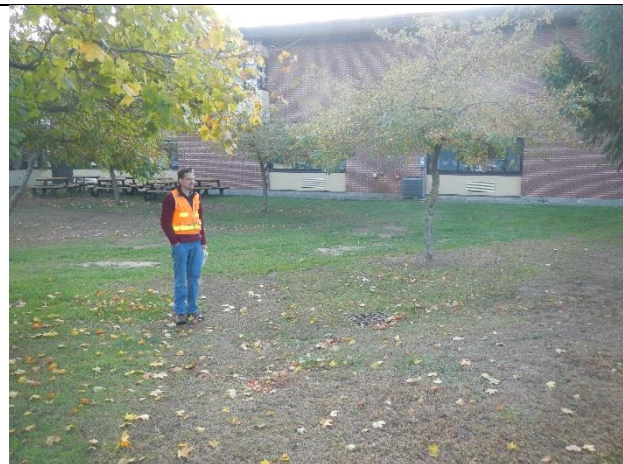
Photo 2: Catch basin along sidewalk in grassed area (4b)

BMP Description: Install small rain garden features in a depression around each existing catchbasin. New rain garden features at each catch basin will increase sediment and nutrient retention and provide some additional infiltration. Minor modifications to the catchbasin may be necessary.

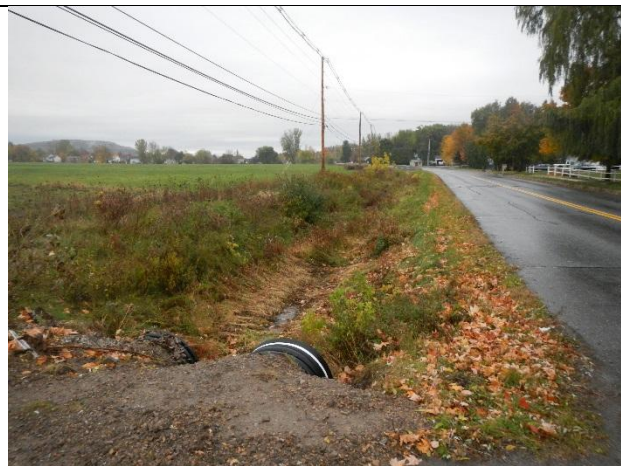
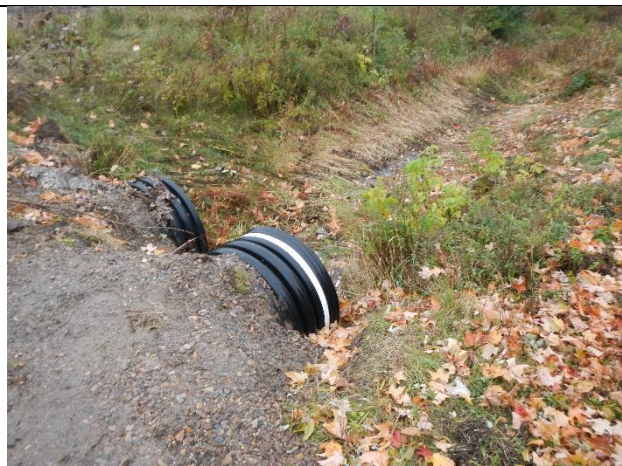
Site Description: A long roadside ditch/swale along the east side of North Road collects runoff from portions of the roadway and from a large agricultural field and dairy barn to the east. Several intermittent stream channels drain to the ditch and moderate to severe erosion was observed along the ditch at a farm road access. Vegetation cover was fair to good for most of the ditch, with some areas of ditch erosion.

Photo 1: Ditch looking south from farm road crossing **Photo 2:** Erosion on farm road crossing

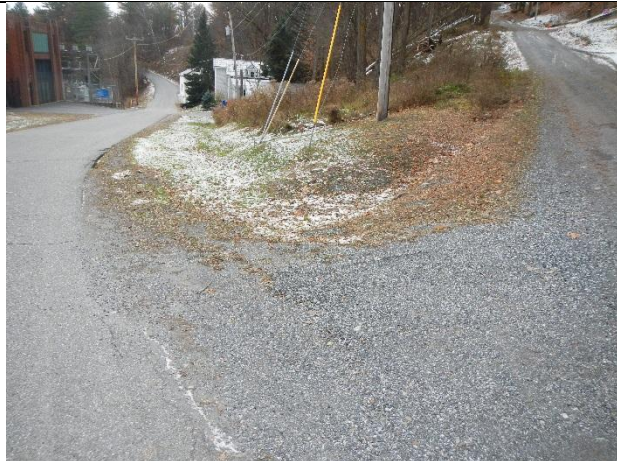
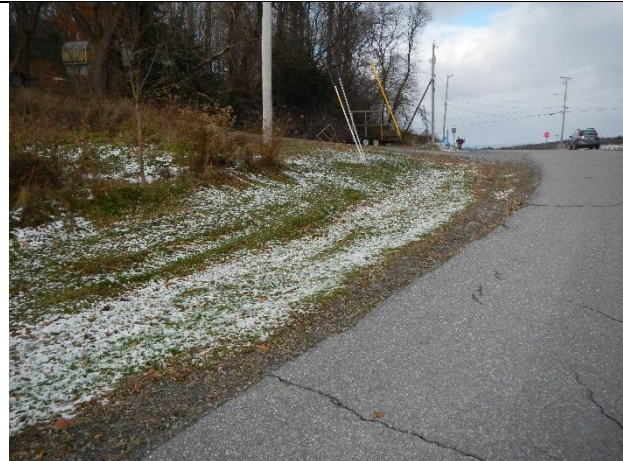
Site Description: A steep gravel road (Crest Dr – Private) drains onto a town road (Howard Dr). A very steep turn at the intersection and poor grading directs runoff onto Howard Drive partially bypassing the grassed ditch. High sediment loads are delivered from Crest Dr and additional erosion was observed along Howard. The runoff flows down Howard or re-enters the ditch and is conveyed directly to the River through a cross-culvert.

Photo 1: Sharp bend at bottom of Crest Dr, runoff flows on to Howard Dr **Photo 2:** Grassed ditch along Howard Drive

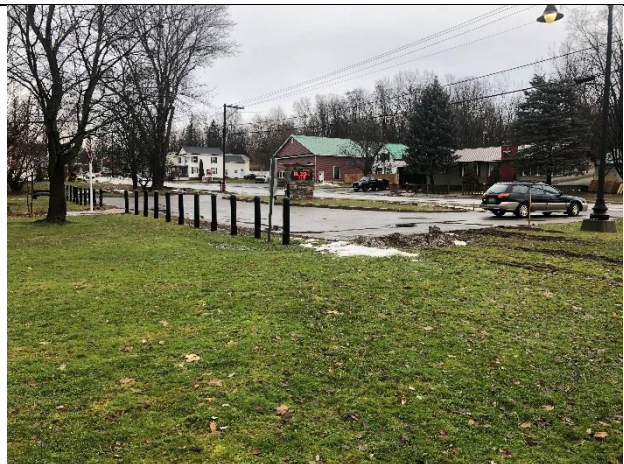
Photo 1: Runoff draining to southwest corner of parking area

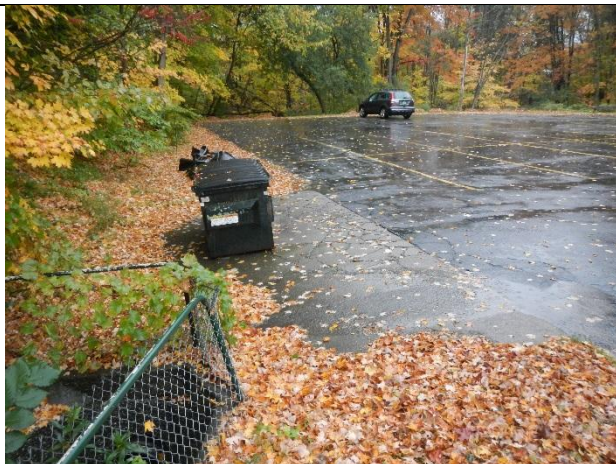
Photo 1: Tributary flowing under parking lot to outlet at southwest corner (near car)

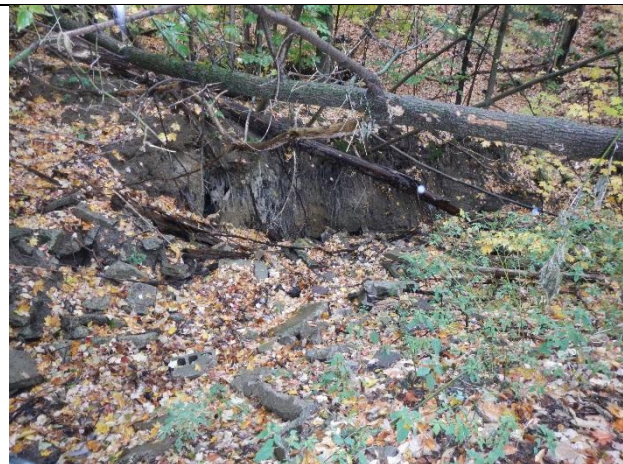
Photo 2: Large and active gully erosion from corner of parking lot to perennial stream channel

BMP Description: Stabilize the gully with rock and install a surface infiltration feature to capture some of the parking lot runoff. The available treatment area is very small compared to the parking lot size. **Further treatment is possible with underground storage; however, it would be very challenging and expensive to increase treatment volume to the WQv.**

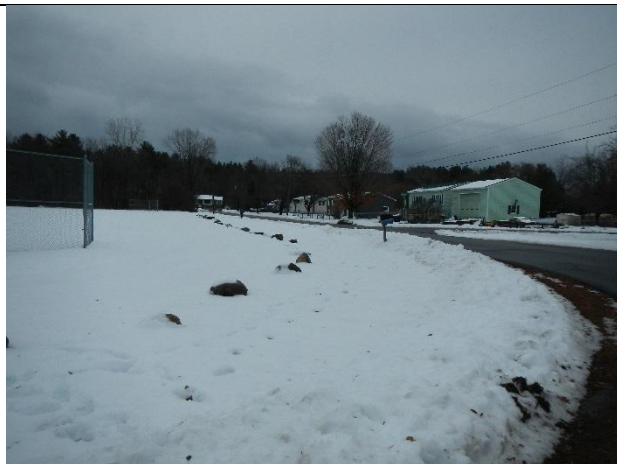
Photo 1: Grassed swale along Bradley Ave with a low point on bend.

BMP Description: Install a small rain garden in the low area behind home plate to increase P removal. A larger rain garden could be installed, however all runoff currently infiltrates in the existing swale.

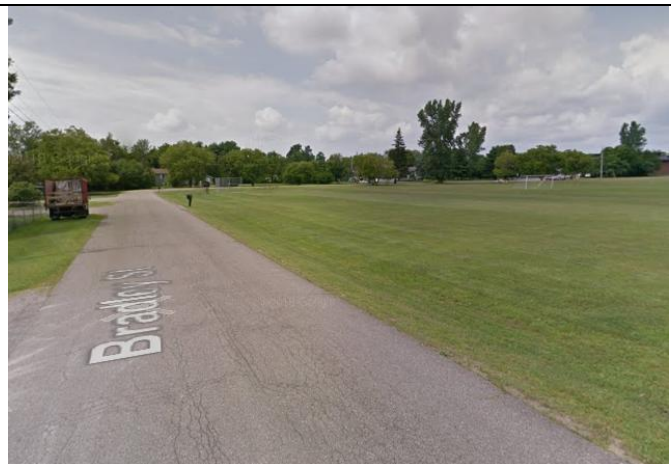
Photo 2: Grassed swale looking west (photo from Google Street View)

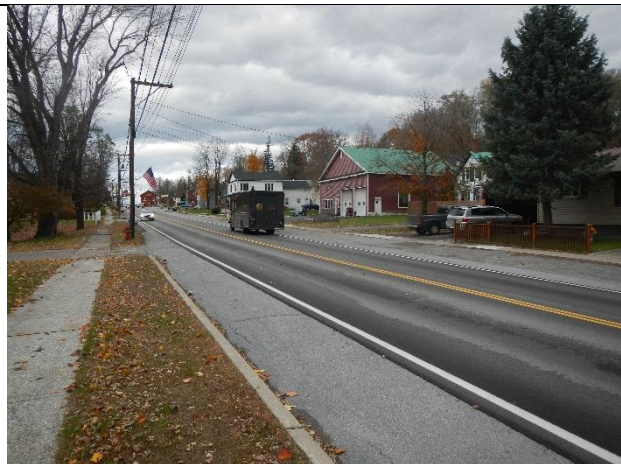
Photo 1: Wide shoulder and catch basin looking south from Cherry St

BMP Description: Install tree box filters or other rain garden type structures along the road shoulder. Treatment features should receive surface runoff and incorporate overflow drainage into the existing storm line. **Additional subsurface detention could be incorporated to increase treatment and infiltration volume.**

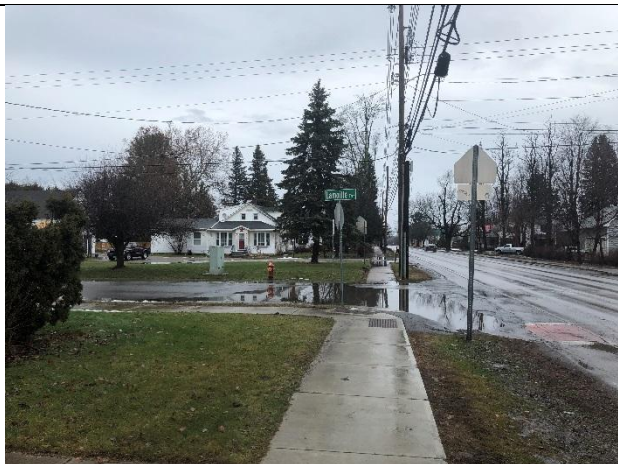
Site Description: The intersection of Lamoille Terrace and Route 7 lacks appropriate drainage infrastructure. Runoff ponds on Lamoille Terrace and eventually infiltrates into the adjacent grassed areas. This intersection is a recurring issue for the Public Works Department, especially during winter months.

Photo 1: 3 Culvert under entrance to storage facility

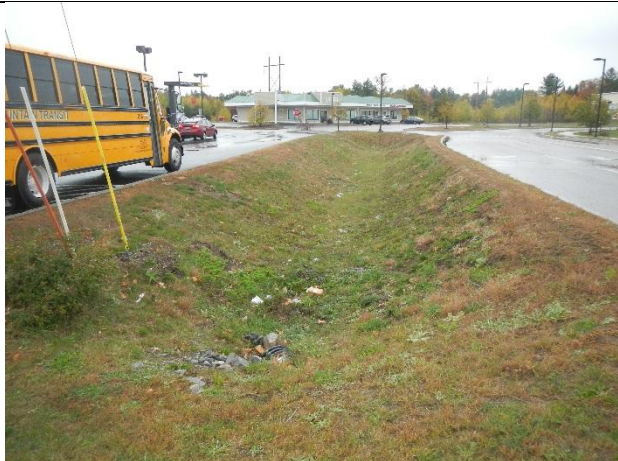
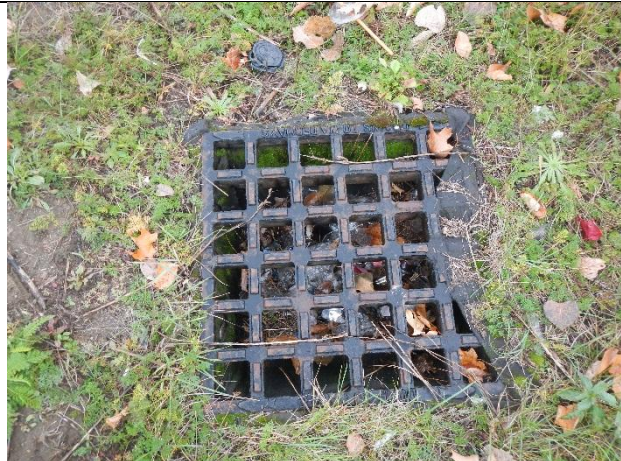
Photo 1: Grassed basin looking north from Route 7

BMP Description: Install earthen/stone check dams and raise the outlet elevation by 1 foot to increase water storage volume and detention time. Side slopes should be stabilized and revegetated as needed. The outlet grate could be replaced with a beehive grate or similar structure to reduce the risk of blockage from trash and debris. **Full WQv treatment may be possible if depth to SHWT is sufficient to include subsurface storage and infiltration. The existing Hannafords stormwater permit should be reviewed in more detail to determine whether this area is already treated for WQv.**

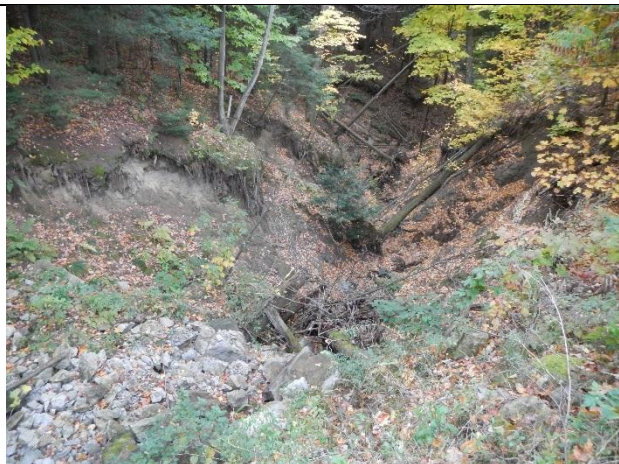
Site Description: The road surfaces and some of the houses and driveways along Stacy Street drain to a simple storm drainage system with a single outlet pipe south of the Edward St intersection. The runoff from this neighborhood has caused a very large gully to form.

Photo 1: Large and active gully at the outlet of the Stacy St storm drainage system

BMP Description: Replace existing catch basins with dry wells and install a new underground infiltration practice between the roadway and the gully. May be possible to reroute some of the runoff north into the Edward St drainage system, if this will not cause additional water quality issues.

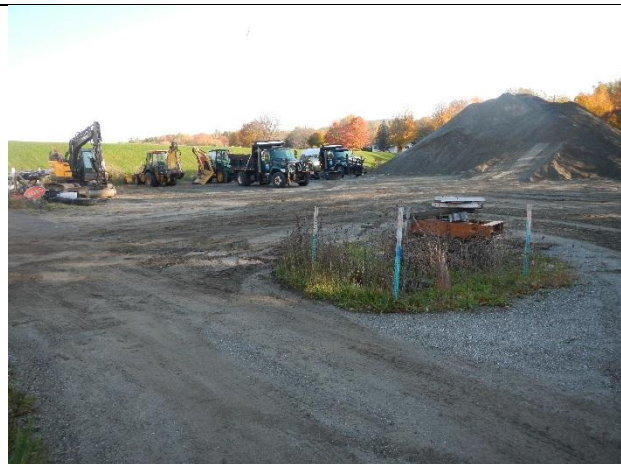
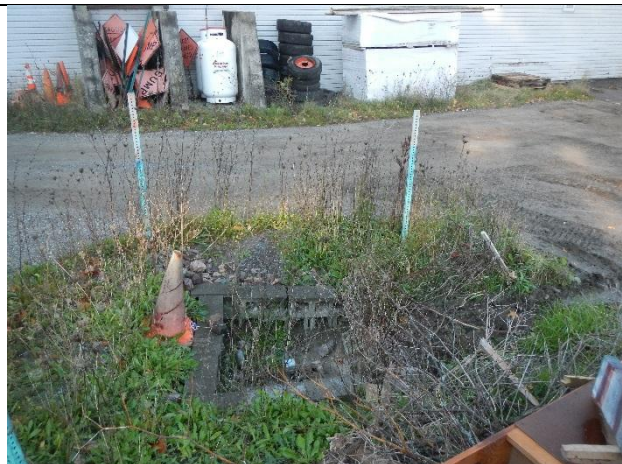
Site Description: The back half of the Town garage drains onto a large gravel parking area with additional road sand and other materials stored nearby. Runoff flows to a single catch basin which is piped southwest and empties directly into the River. Rill erosion was observed at the catch basin inlet.

Photo 1: Large gravel/dirt area draining to catch basin

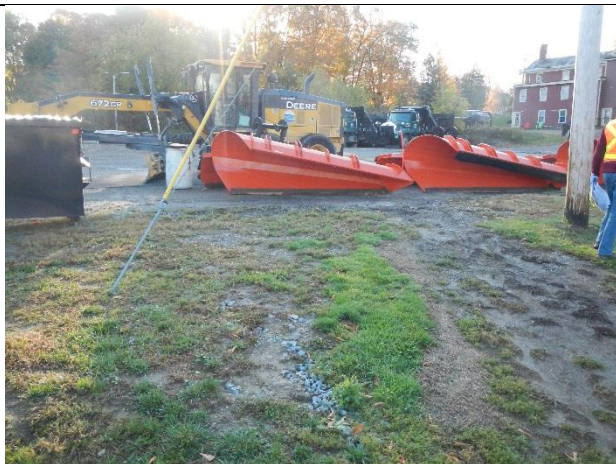
Photo 1: Flow path from parking lot

BMP Description: Install a sediment trap and surface infiltration feature in grassed area between parking lot and steep cliff to river. Divert roof runoff way from salt loading area. A grassed filter strip should be maintained along the edge of the parking area for pre-treatment.

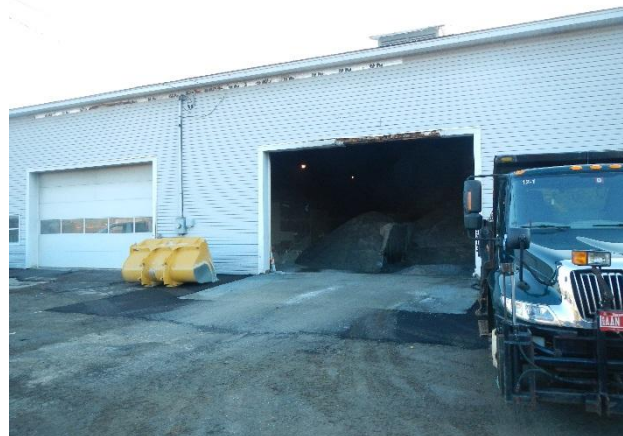
Photo 2: Roof drains onto parking area with high sediment and salt loads

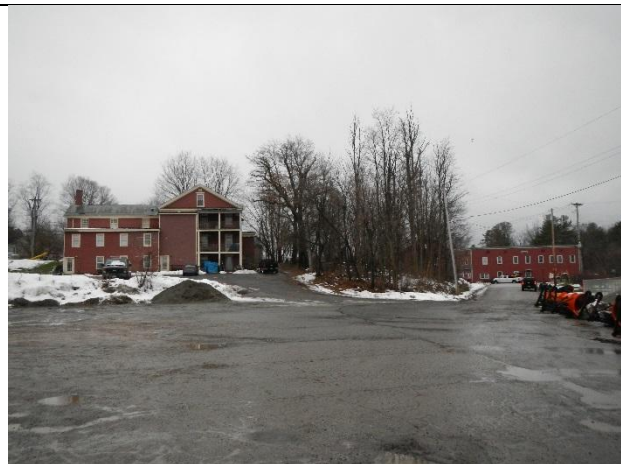
Photo 1: Flow path from parking lot

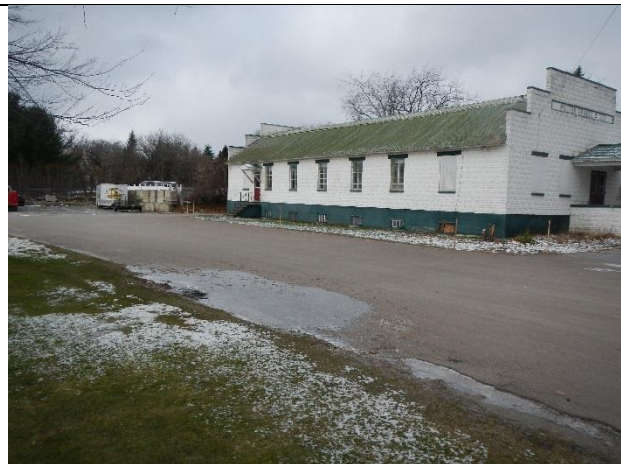
Photo 1: Grassed area with ponded water along southern edge of parking lot

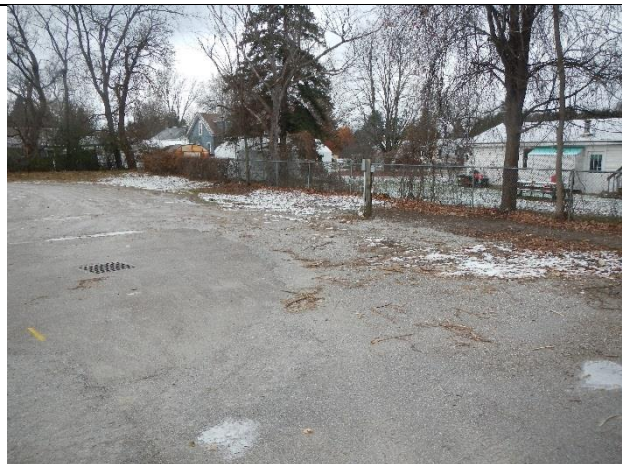
Photo 2: Dry well in unpaved portion of parking lot

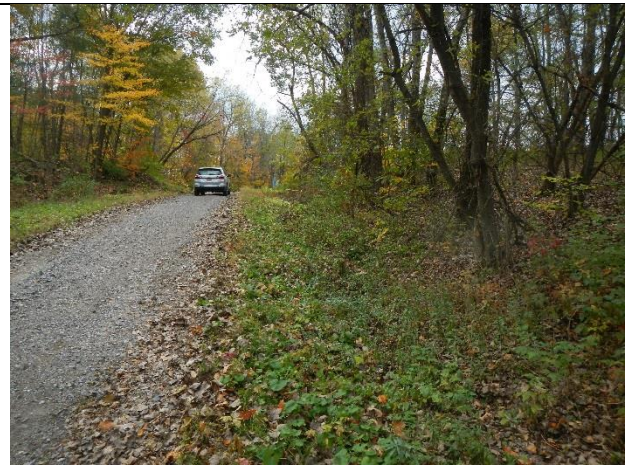
Site Description: An unmapped/unclassified road continuing north from the transfer station is maintained by the Town as an access to the sand and gravel storage areas by the capped landfill. The road drops at approximately 10-11% slope for a 300 ft length to the wetland complex. The road surface is poorly crowned with rill erosion and the west ditch has several areas of minor gully erosion.

Photo 1: Minor gully erosion in ditch

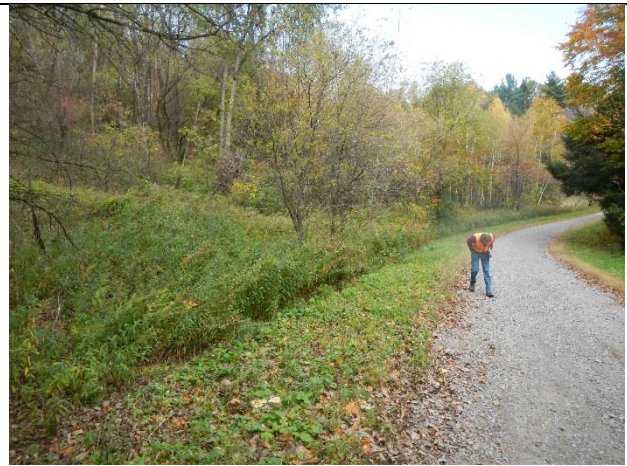
Photo 2: Rill erosion on road surface

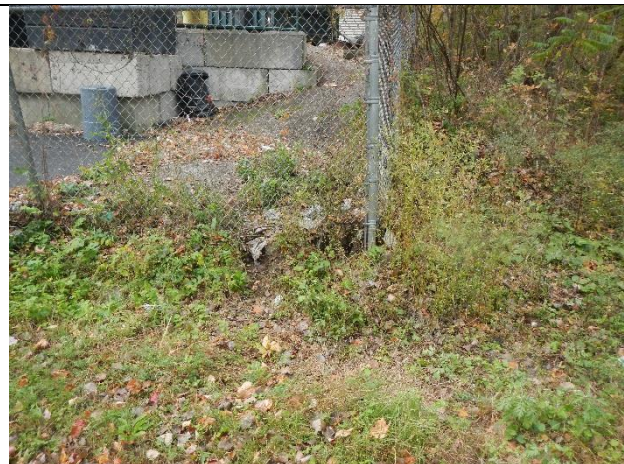
Site Description: The Town transfer station drains the northeast corner and flows into a road ditch. The ditch drains north down the steep slope emptying into a large wetland complex. Some erosion was visible where the runoff exits the transfer station.

Photo 2: Flow path from transfer station to ditch

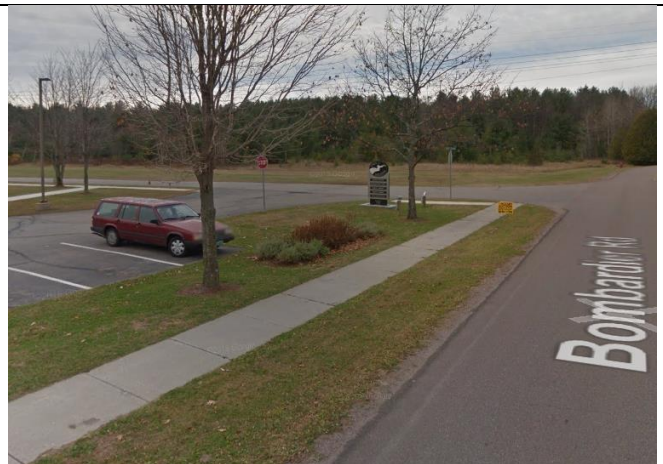
Photo 2: View of project area from Bombardier Rd (photo from Google Street View)
