STORMWATER MANAGEMENT PLAN FOR SWANTON TOWN AND VILLAGE

FINAL REPORT

Stone Project ID 112475-W
February 21, 2013

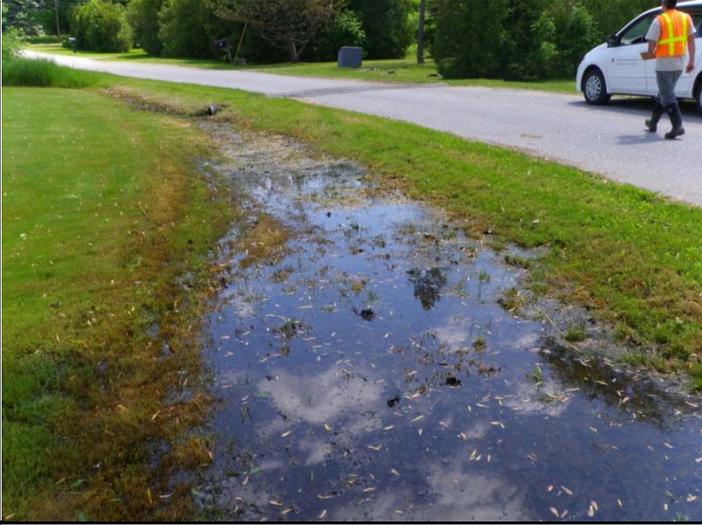
Photo 1. Ponding on North side of road	Photo 2. Drainage ditch coming from neighborhood

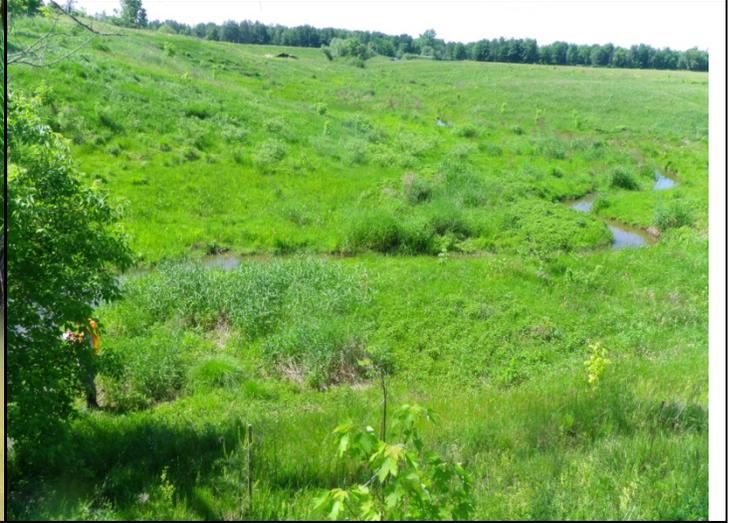
Photo 4. Floodplain leading to culvert (C2)

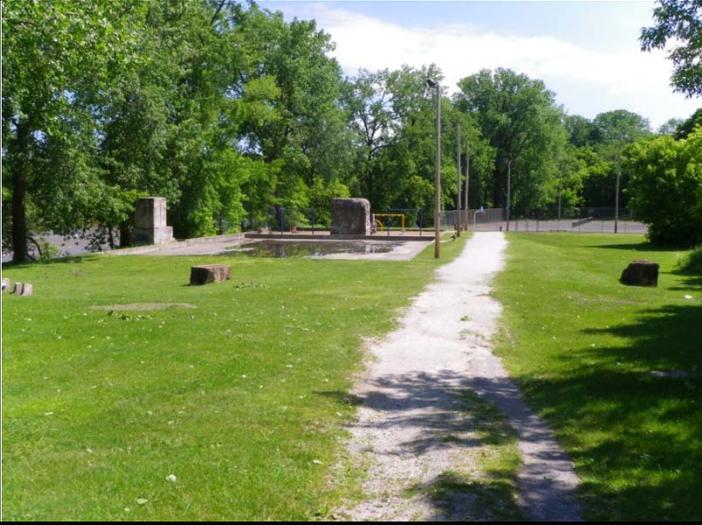
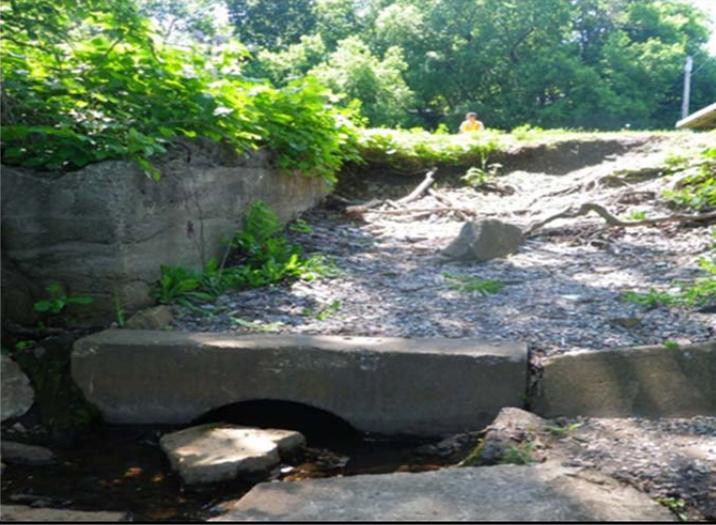
Photo 1. Erosion in access road/path	Photo 2. Washout and outfall, in park near river

Description of Observed Conditions:
Erosion present in road/path to the park, runoff coming from parking lot above. Signs of standing water areas along southern end of park before the tennis courts. Washout area leading from park to rivers edge, with concrete outfall at the bottom. Outfall serves as storm water runoff from streets/village above the park. 4" of water flowing from drains.
The Village is currently working with NWRPC and VT DEC to implement a comprehensive treatment solution.

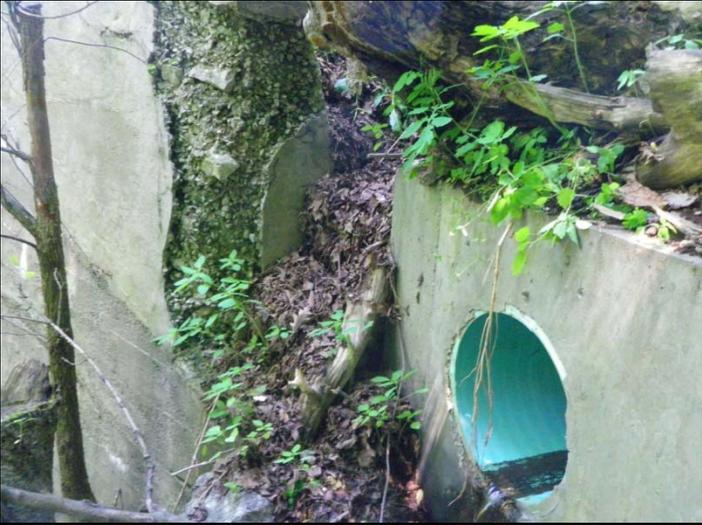
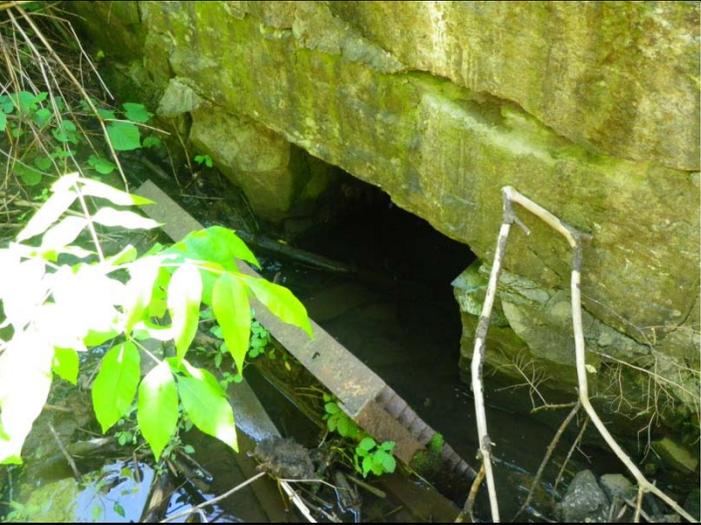
Photo 1. Stormwater pipe outfall into ravine	Photo 2. Box culvert running under Grand Ave.

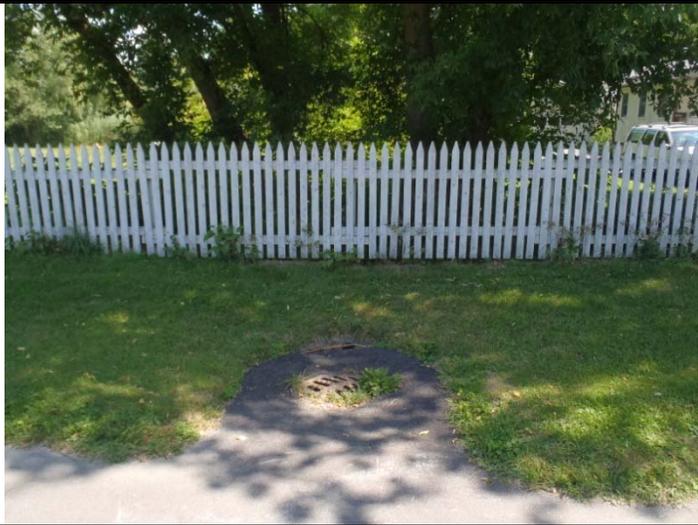
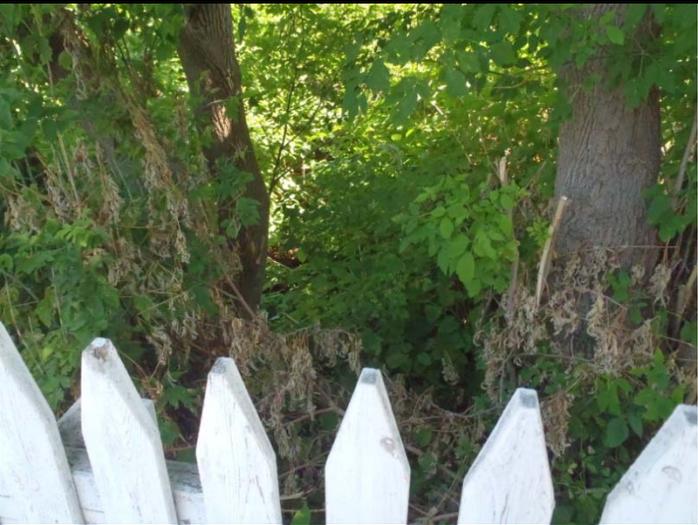
Photo 1. Stream from Greenwich, looking east	Photo 2. Stream below bridge/culvert

Description of Observed Conditions:
The stream appears to begin in the vicinity of First and Liberty Streets, and runs coincident with a stormline through the Village. Further investigation is needed to determine the extent of the system and any potential for retrofits or daylighting.

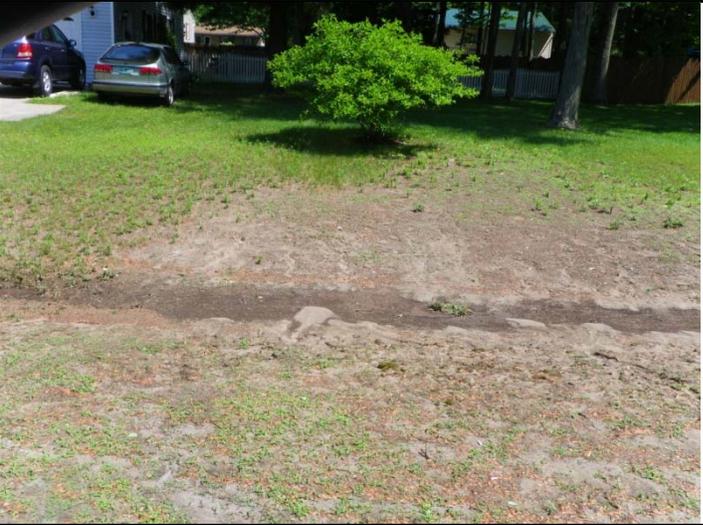
Problem Description:			
Jones Ct. ongoing problems with flooded basements.			
Date of Field Data Collection: <u>5/30/2012</u>			
Field Photos

<p>Photo 1. Catch basin (in background) seem to be working and flowing throughout neighborhood</p>	<p>Photo 2. Evidence of ponding water and localized erosion</p>

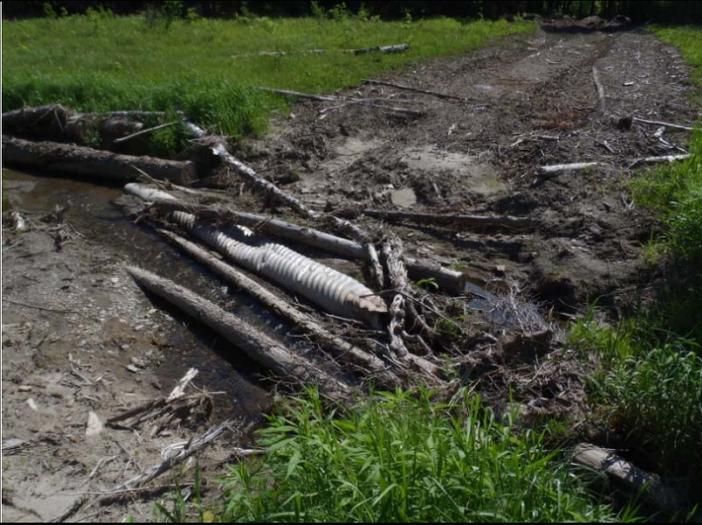
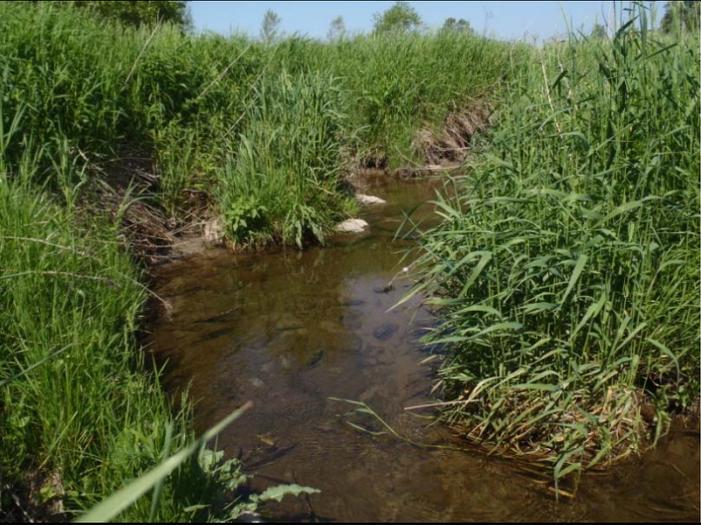
Photo 1. Destroyed Culvert	Photo 2. Bank undercutting downstream

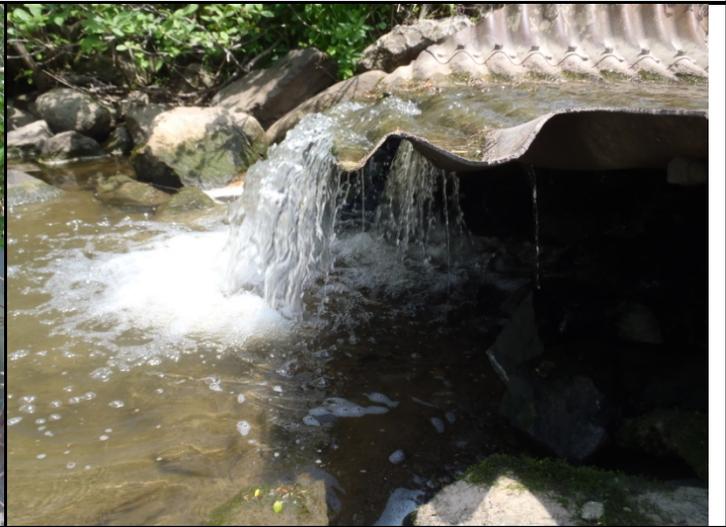
Photo 6. Outfall waterfall C3

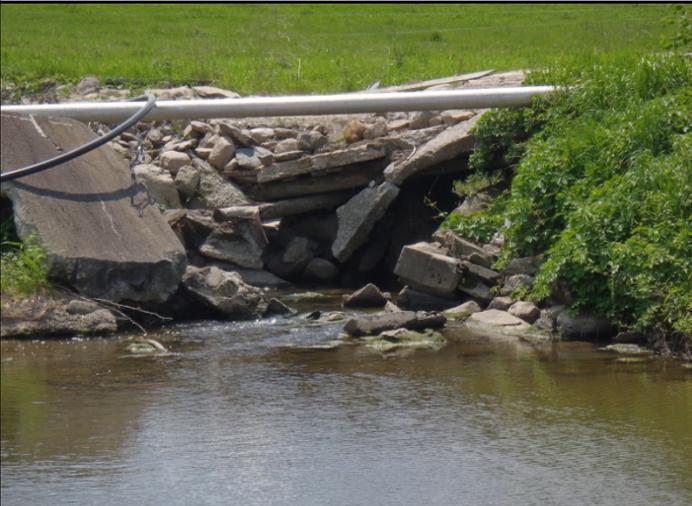
Photo 5. Extensive damage C4

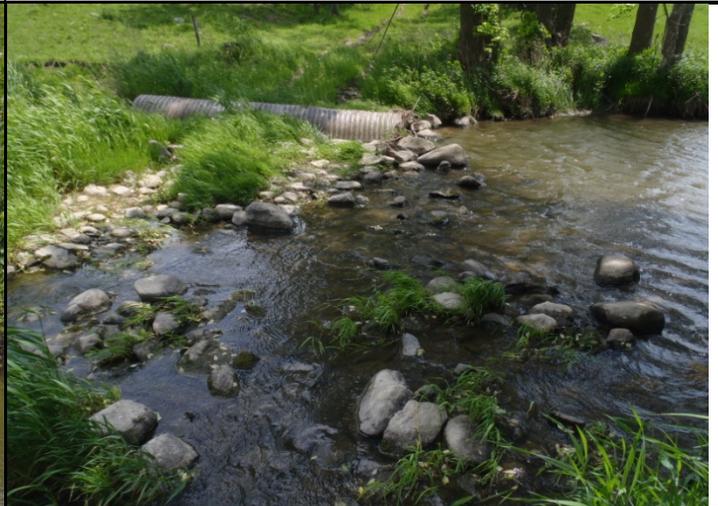
Photo 6. Brook bypassing culvert C5

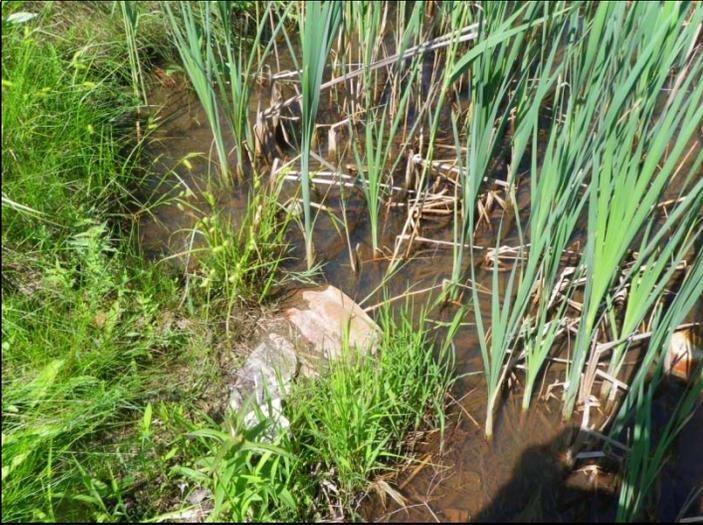
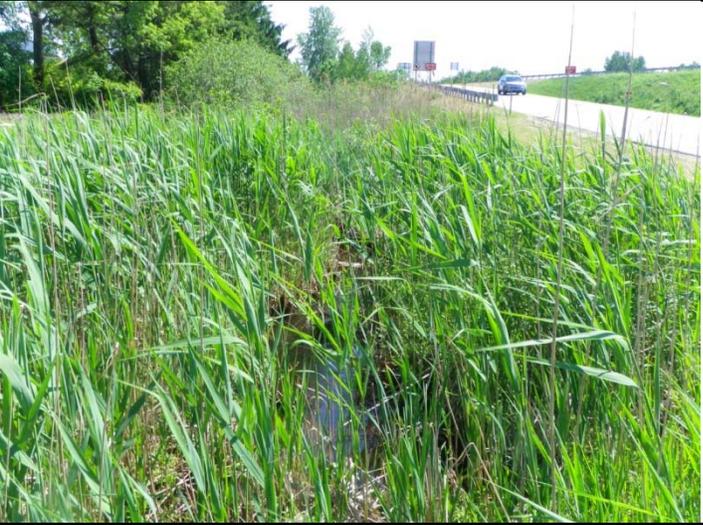
Photo 1. Partially clogged culvert	Photo 2. Reach R3S2.01 of Missisquoi

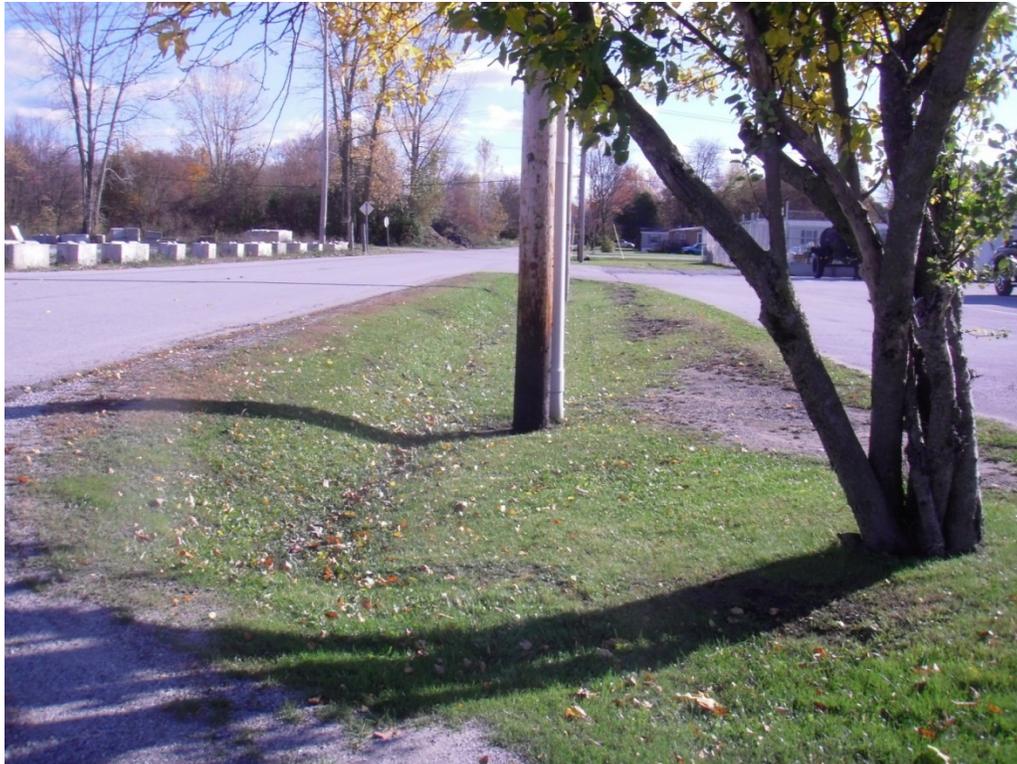
Figure 2. The absence of curbs along the large green strip at the Village garage simplifies design and construction of stormwater treatment practices at this location.

The existing swales along Elm St. provide excellent opportunities for relatively simple, yet effective infiltration-based STPs (potential locations for these practices are shown in Figure 2 through Figure 4). The presence of underground utilities in the area will need to be fully and carefully investigated as part of any future design.

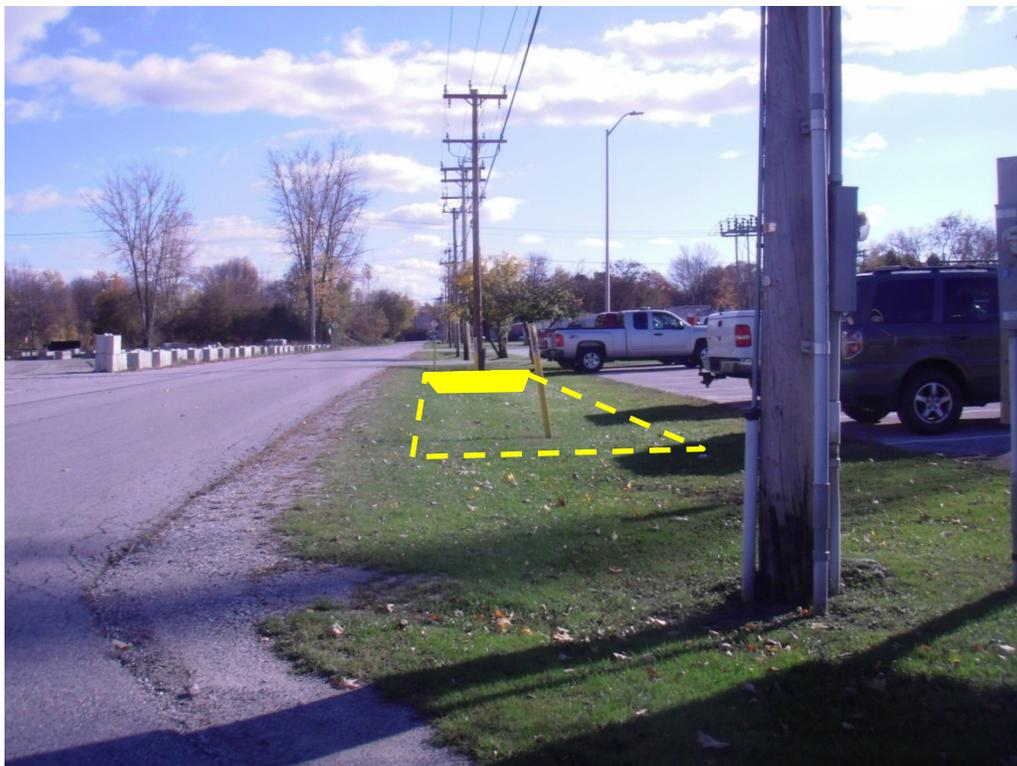
Figure 3. The existing shallow swale could easily be modified to enhance infiltration of stormwater runoff.

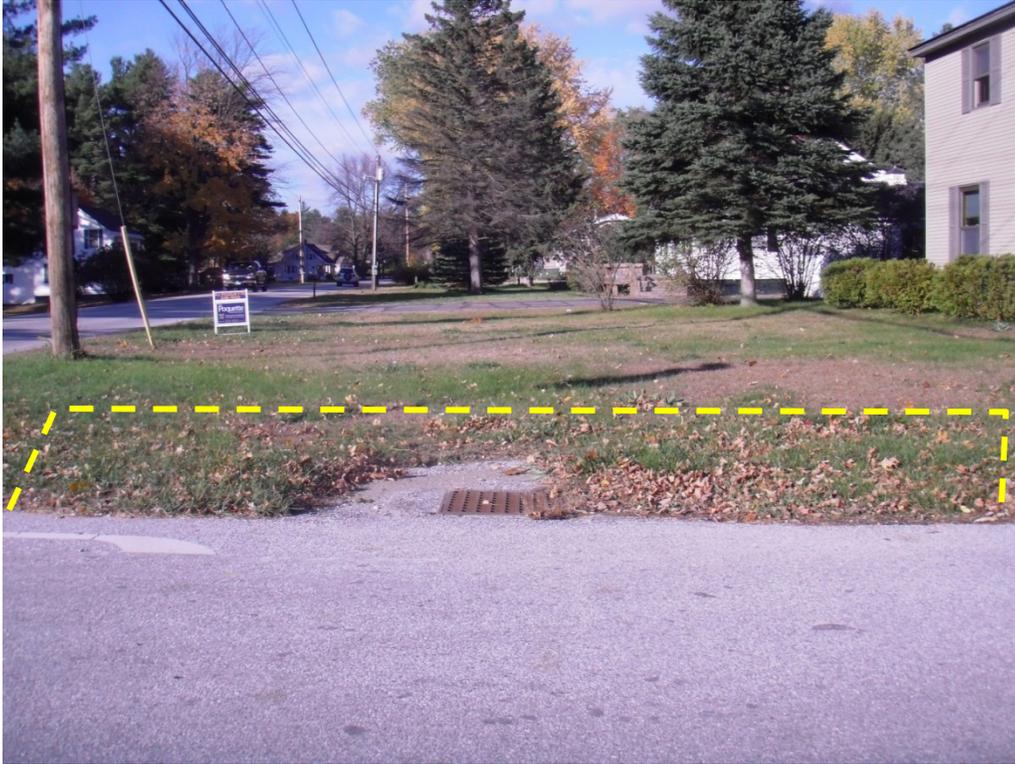
Figure 22. Catch basin on the corner of Thibault Pkwy and Spring St. could be retrofitted with an STP, such as a rain garden.

A catch basin adjacent to Thibault Parkway could be retrofitted and utilized as part of an STP, such as a simple rain garden. Site conditions, including Windsor loamy fine sand (HSG A) and a deep water table, would enable detention and infiltration of a significant portion of stormwater runoff from 0.04 acres of impervious surface draining to the existing catch basin.

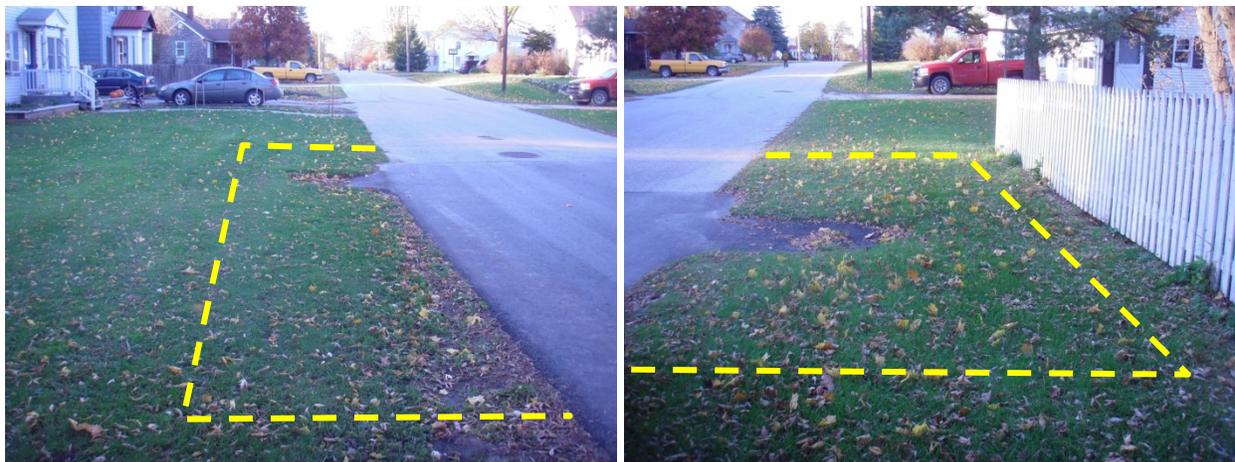
Figure 24. Catch basins on along Greenwich St. could be modified and used as overflow relief for an infiltration focused STP.

The predominant soil type is reported to be Windsor loamy fine sand (HSG A) with a deep water table. This means that there is potential to soak away a large portion of the stormwater draining from this neighborhood. The existing catch basins could then act as overflow relief for an infiltration-based STP.

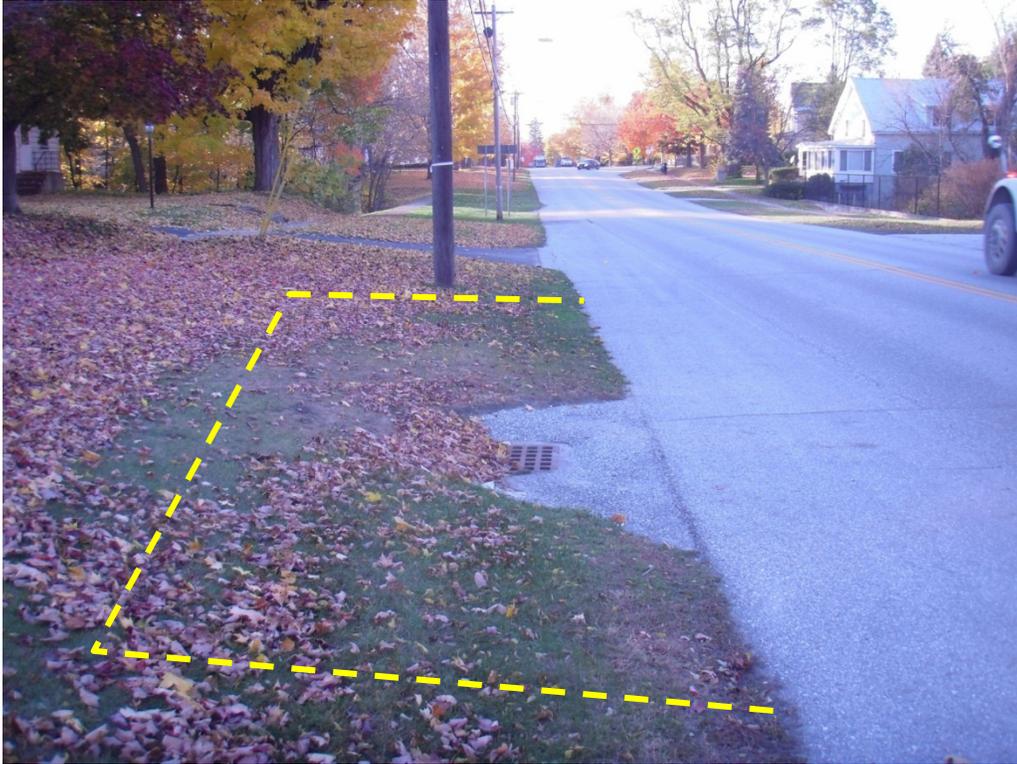
Figure 26. Catch basin on north side of Grand Ave. that could be modified as part of an STP.

Given the well-drained soils and position of existing catch basins, stormwater from this section of Grand Ave., could be treated with an infiltration-based STP (see Figure 26 and Figure 27). Water would infiltrate the underlying soils, or otherwise be slowly released with sediment removal occurring through settling and filtration.
