TOWN OF WILLISTON TOWN-WIDE WATERSHED IMPROVEMENT PLAN - PHASE 2

FINAL REPORT

Stone Project ID 12-055
September 10, 2013

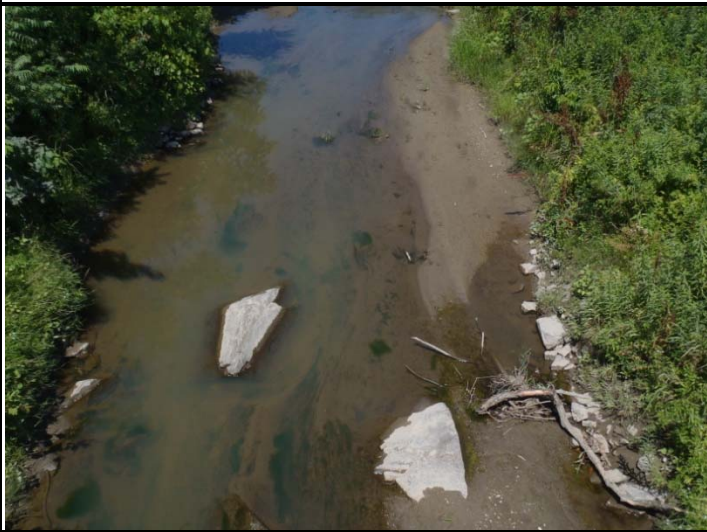
Photo 1. Evidence of significant sedimentation

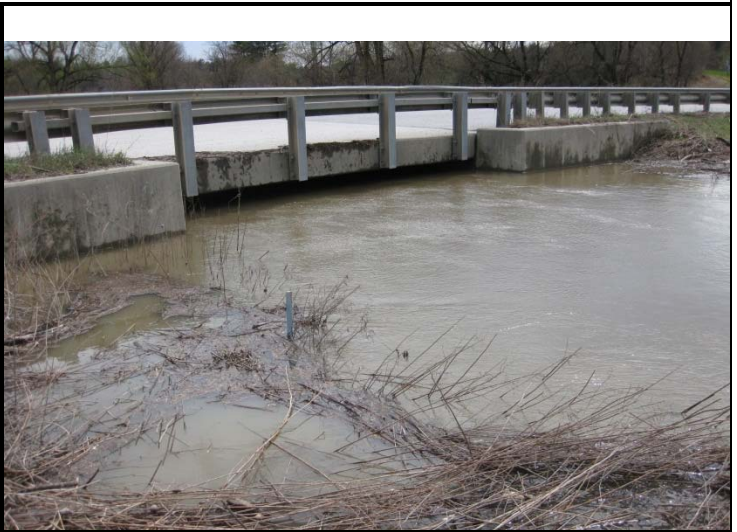
Photo 2. Downstream view of River Cove Road bridge during flood stage (4/28/2012)

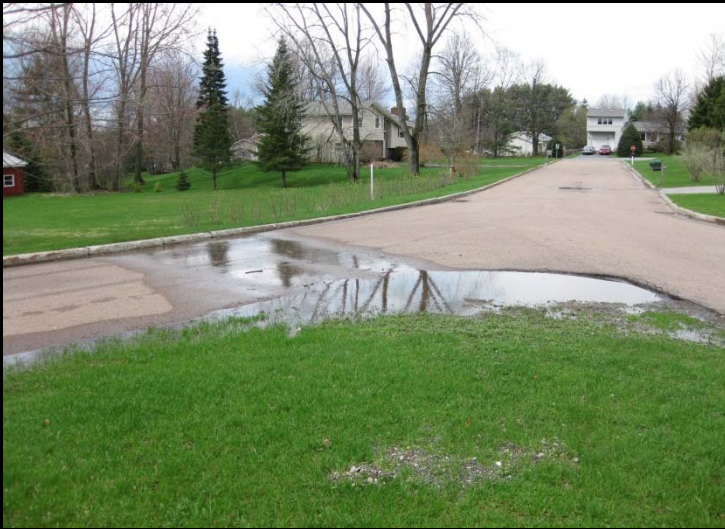
Photo 2. Runoff ponding in the cul-de-sac and overflowing to the north along Palmer Court.

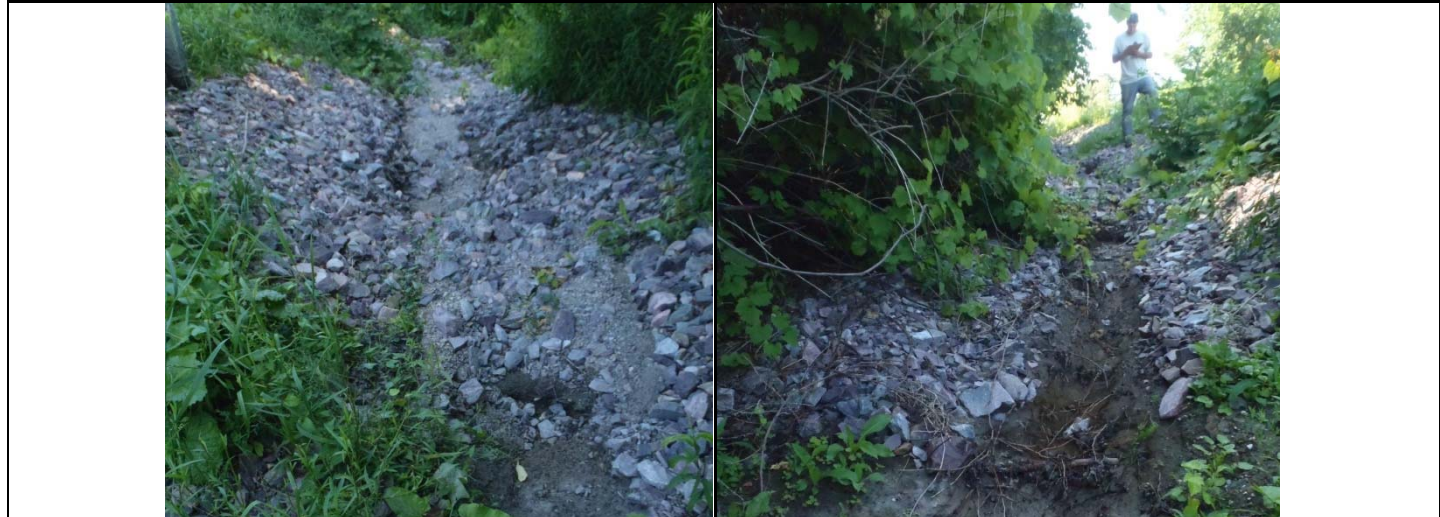
Photo 1. Looking down riprap **Photo 2.** Looking up riprap, channeling

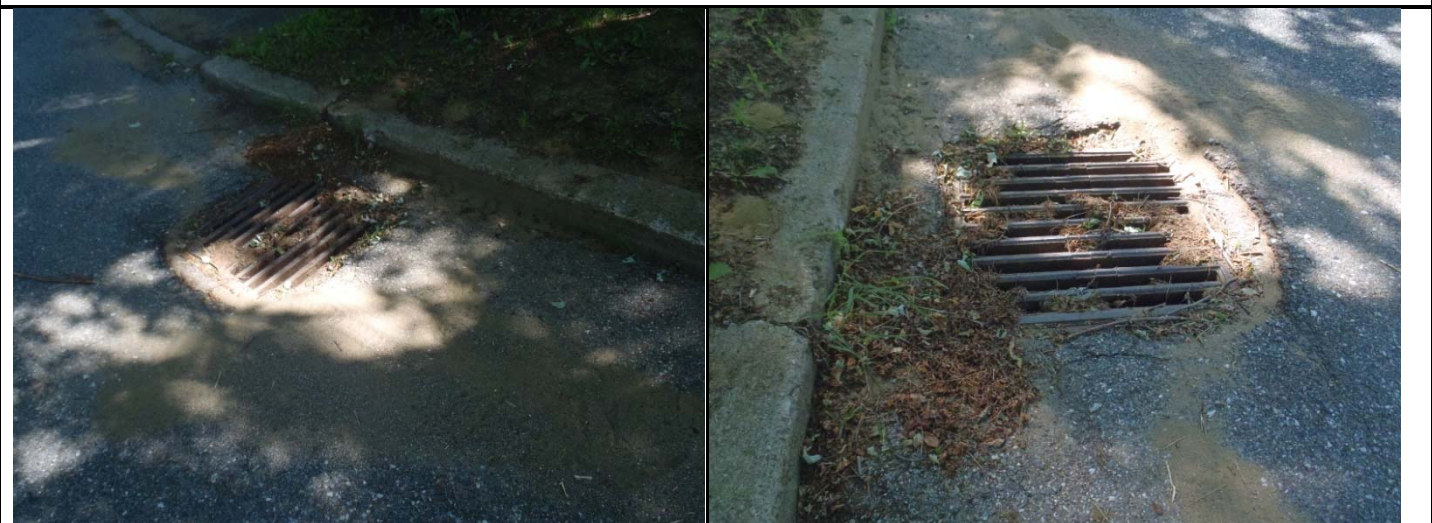
Photo 1. Clogged catch basin **Photo 2.** Debris accumulated at catch basin inlet

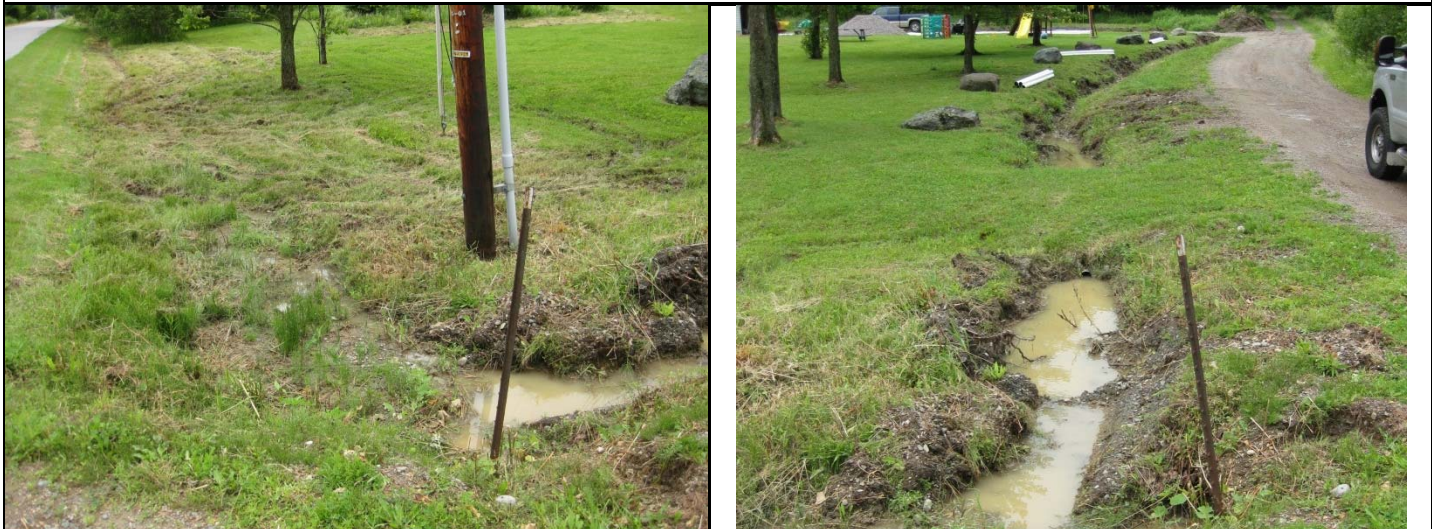
<p>Photo 1. Water ponding along Old Stage Road at the intersection with Amber Lane</p>	<p>Photo 2. Water ponding along Amber Lane</p>
---	---

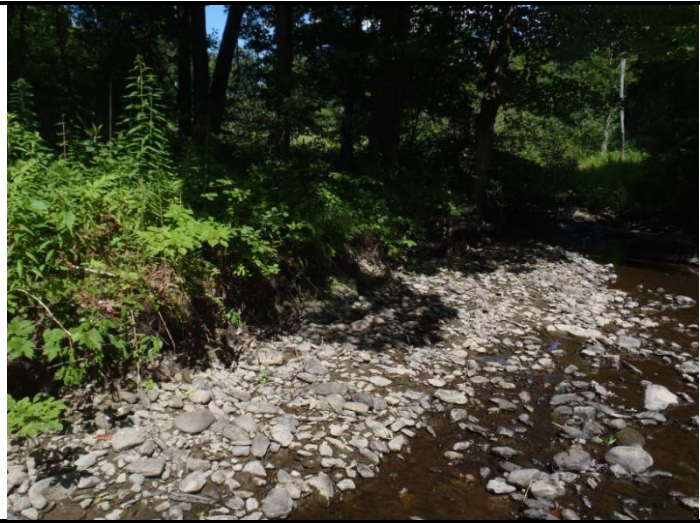
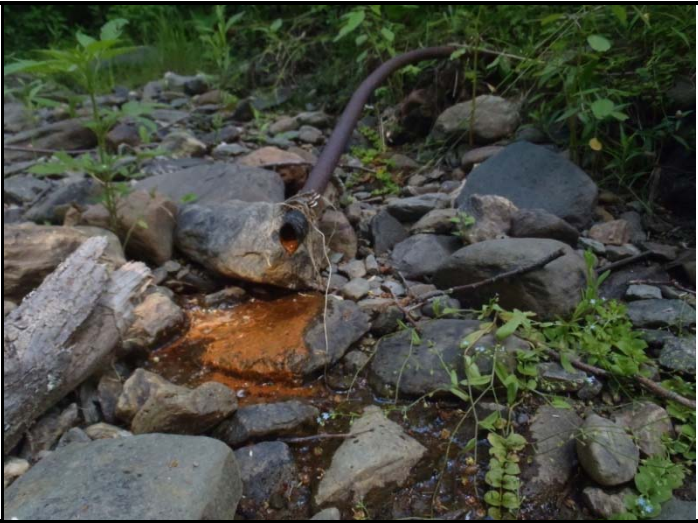
Photo 1. Bank cutting	Photo 2. Old metal pipe outlet

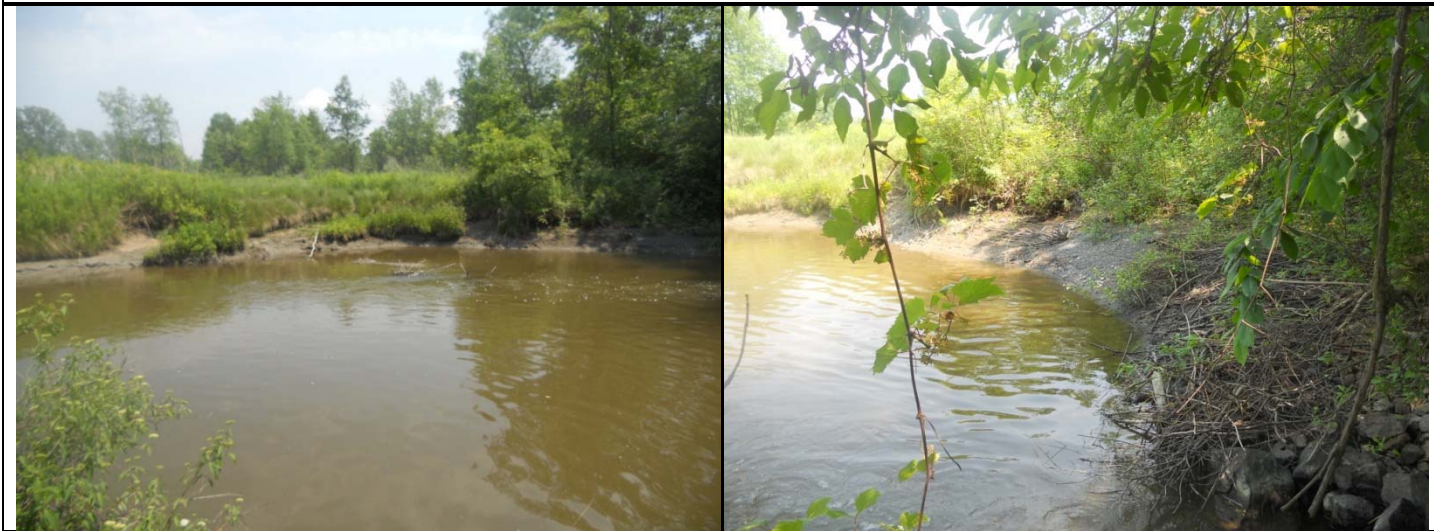
Photo 1. Scour pool at outfall

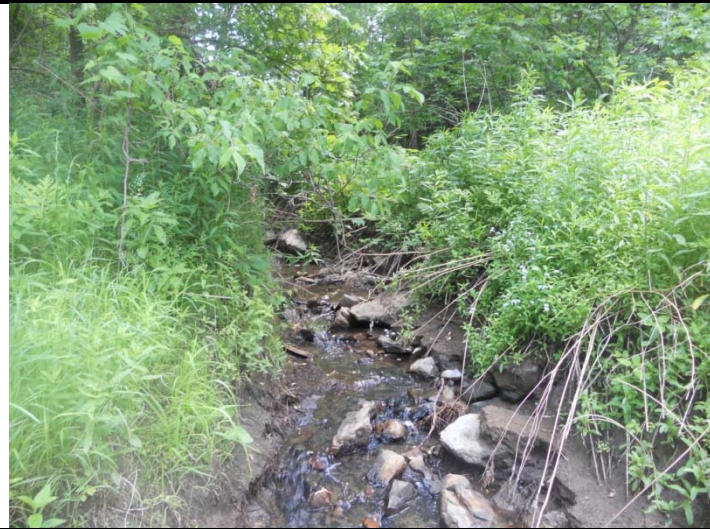
Photo 1. Bank erosion in tributary

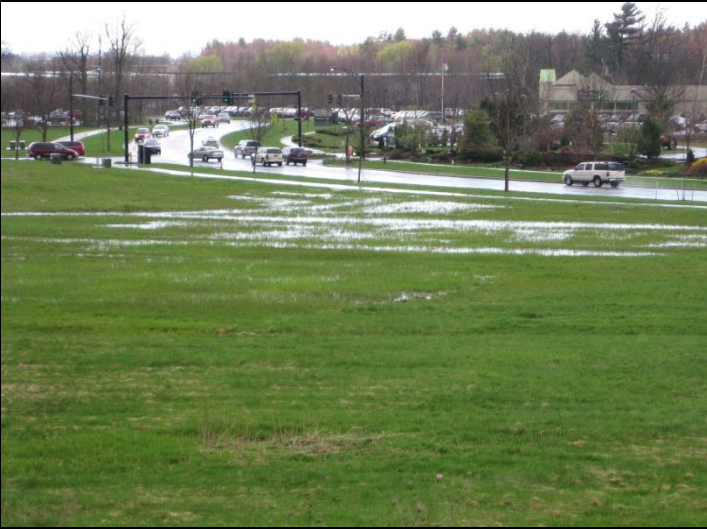
Photo 1. Evidence of poor drainage

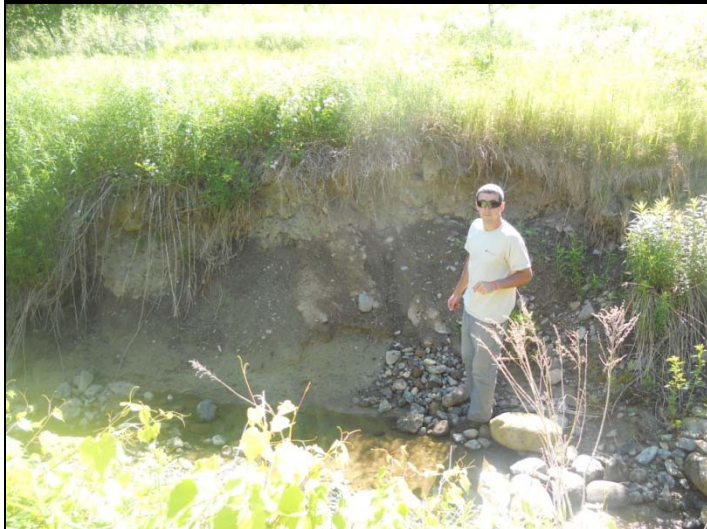
Photo 1. Under cutting

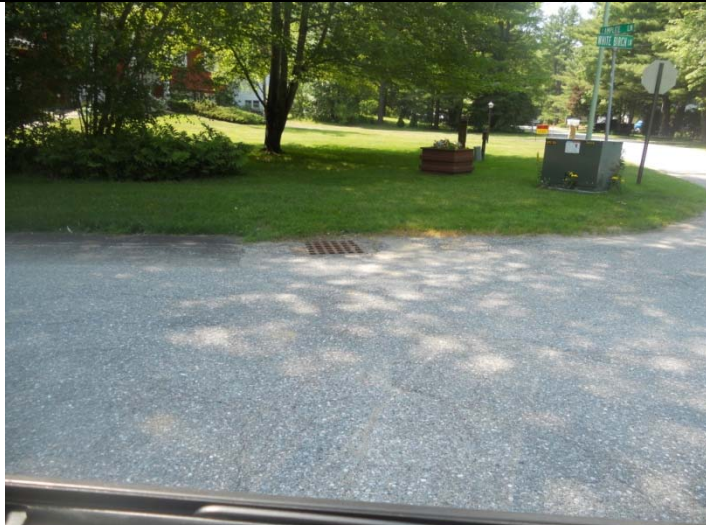
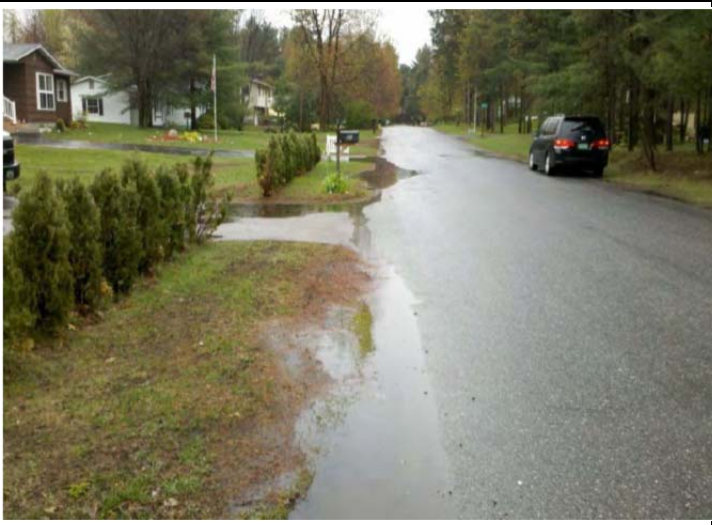
<p>Photo 1. Limited storm sewer infrastructure in Lamplite Acres</p>	<p>Photo 2. Ponded water on roadways in Lamplite Acres following rainfall</p>

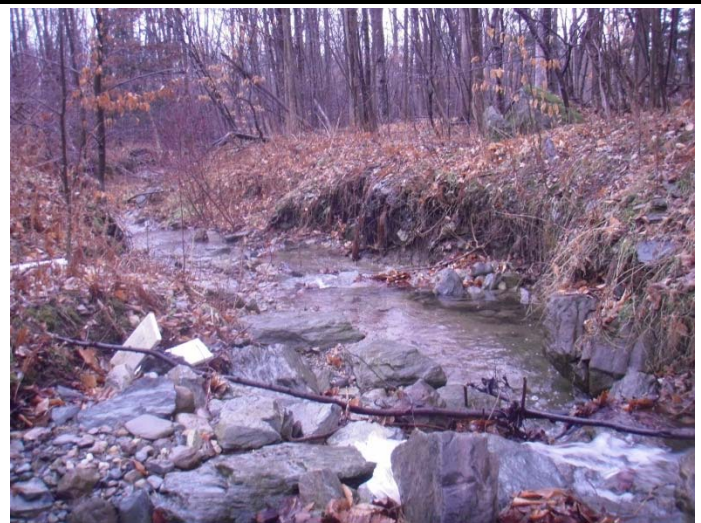
Photo 2. Looking downstream from culvert under I-89.

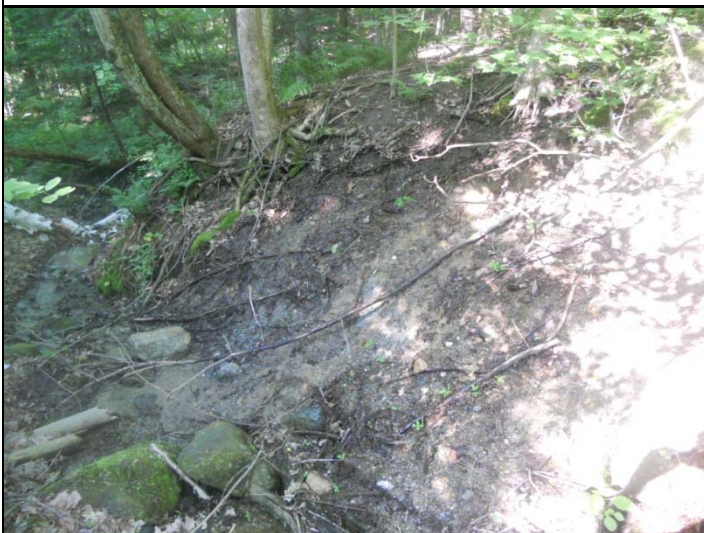
Photo 1. Bank erosion in channel

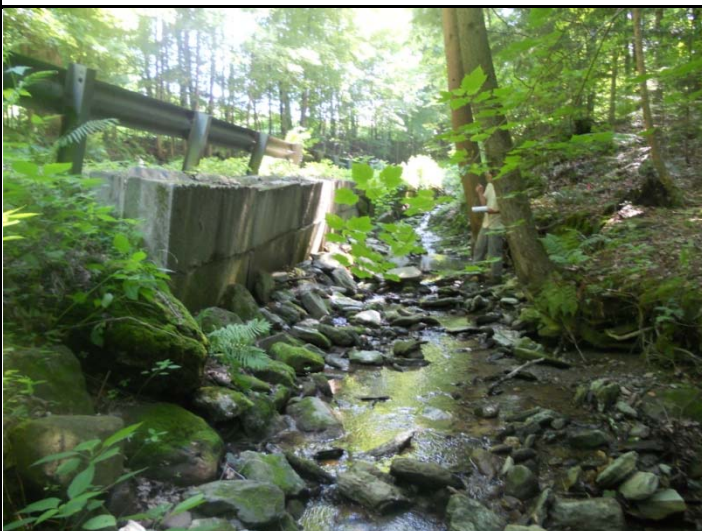
Photo 1. Retaining wall (looking upstream)

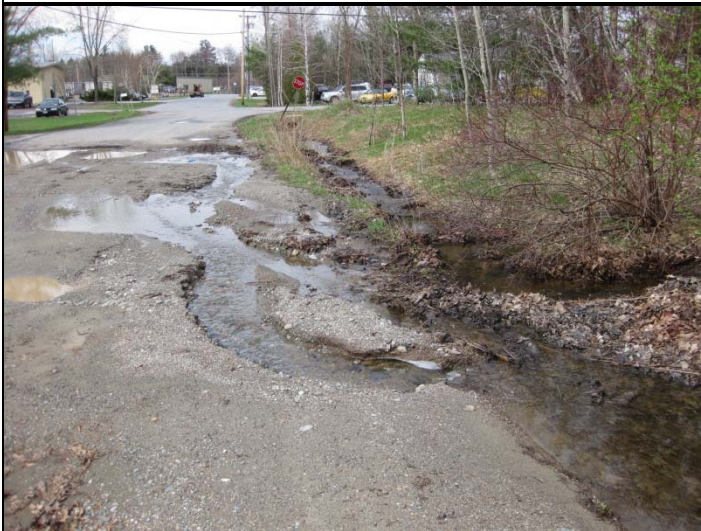
Photo 1. Roadway washout.

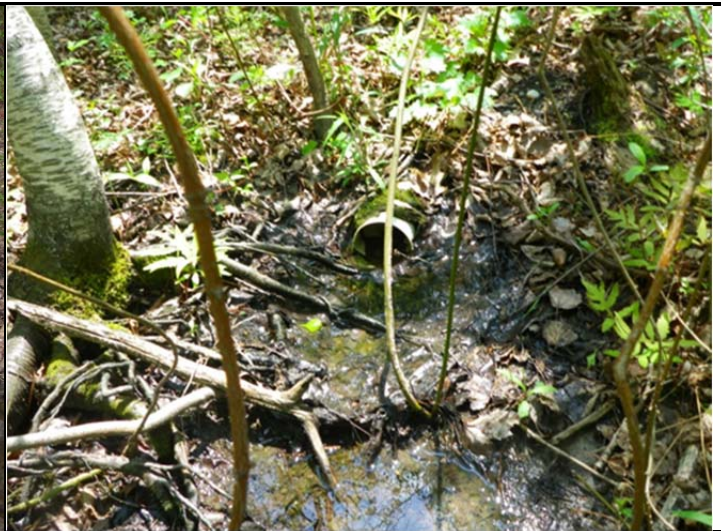
Photo 2. Primary source of runoff.

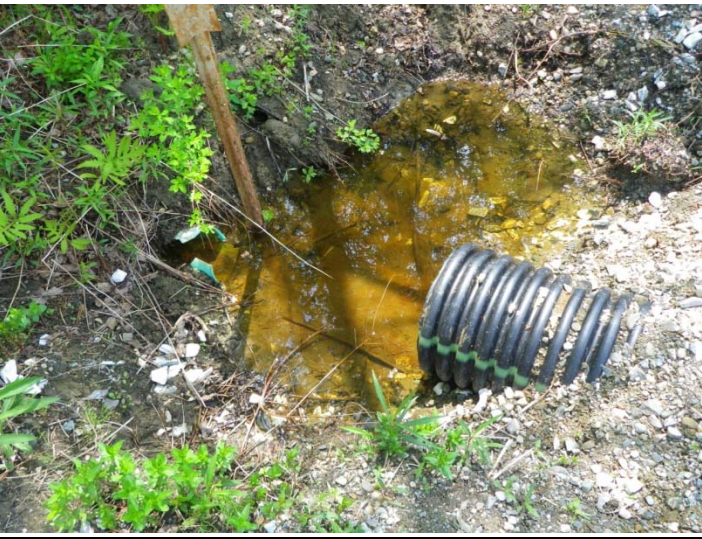
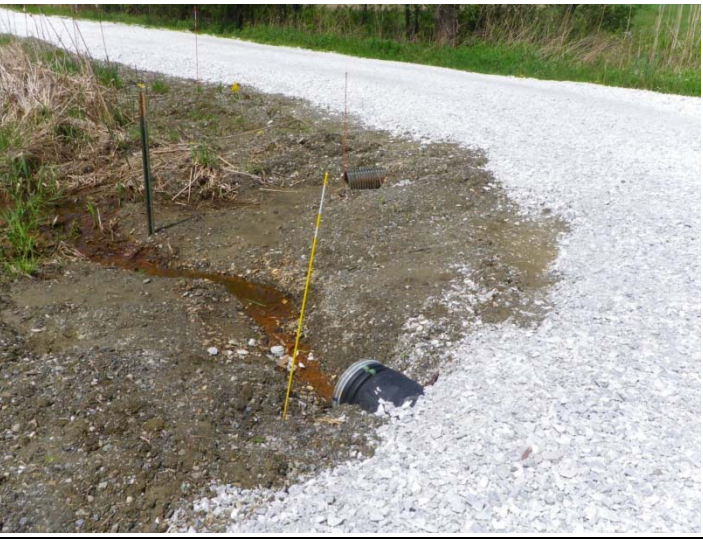
Photo 1. New 12" culvert flowing into small 6" pipe	Photo 2. New culverts

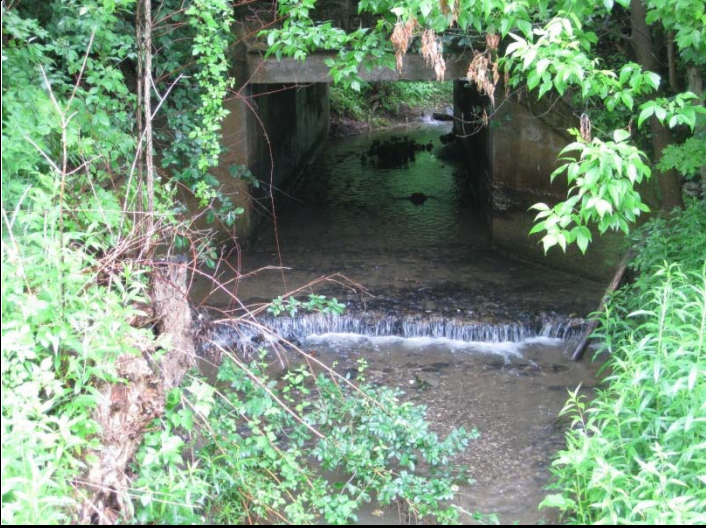
Photo 1. Headcut at the outlet of box culvert under railroad bed.	Photo 2. South bank undercutting

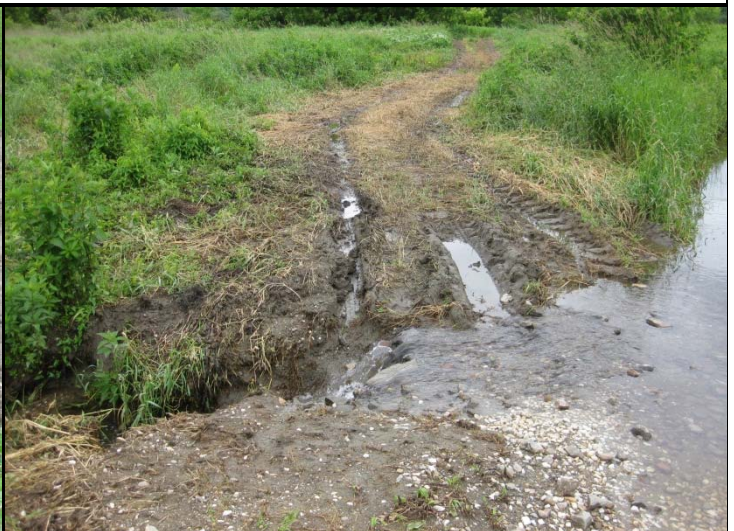
Photo 2. Erosion occurring at the discharge point.

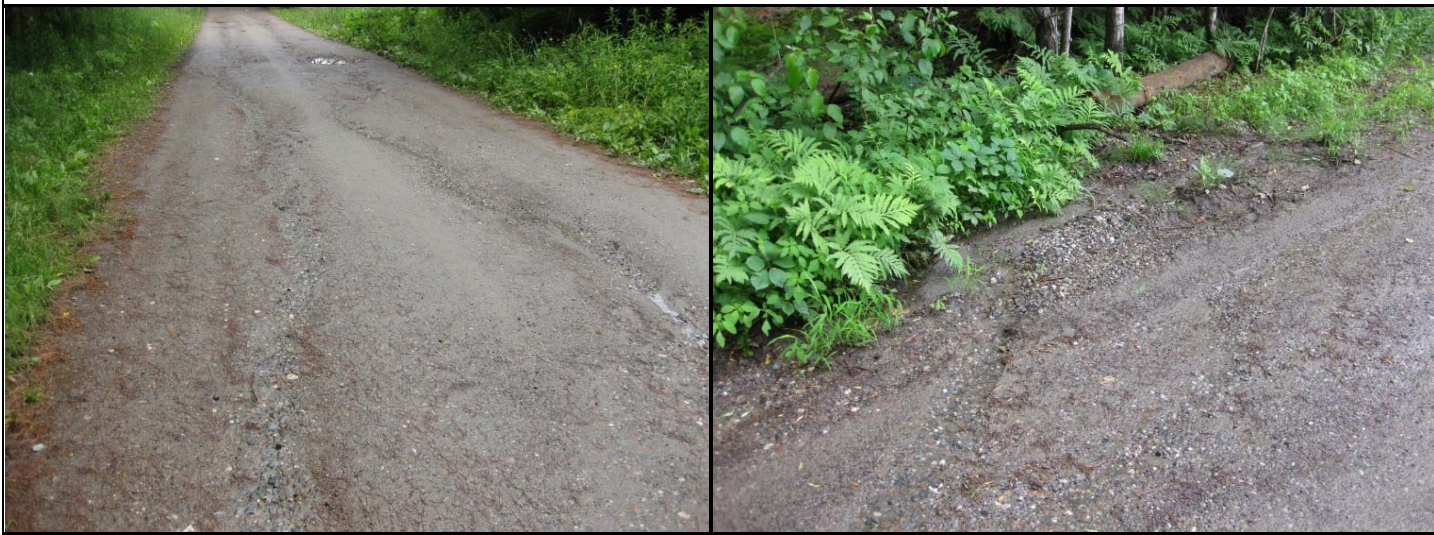
Photo 1. Erosion in the roadway. **Photo 2.** Sediment discharge along road shoulder.

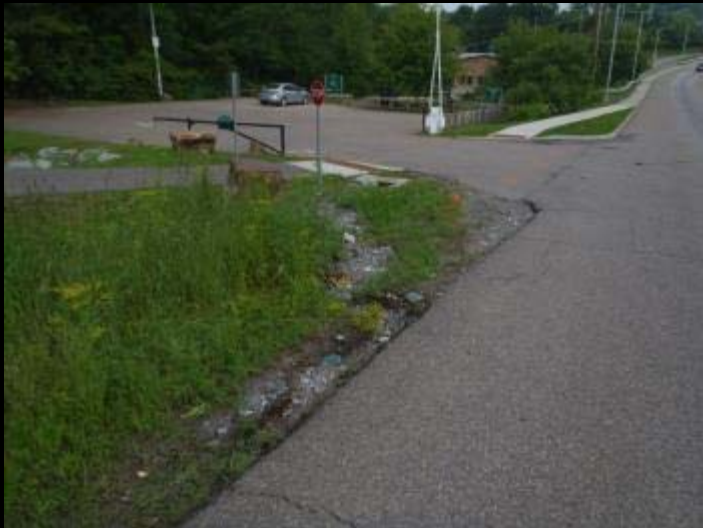
Photo 2. Erosion at approach to catch basin near parking lot entrance

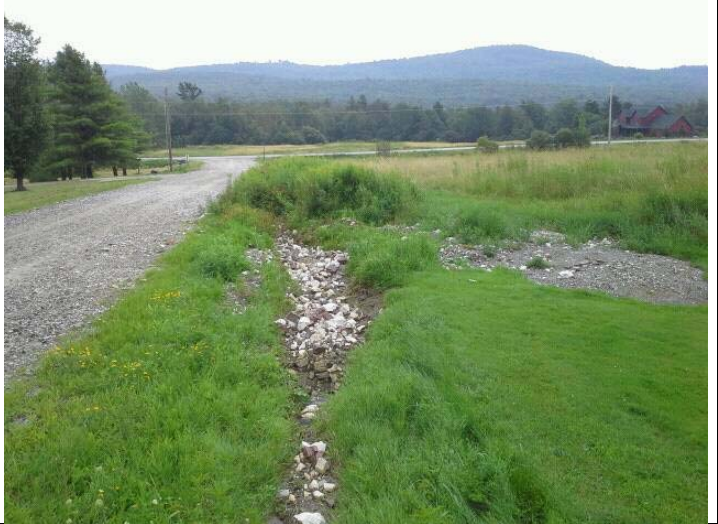
Photo 1. Incised ditch (facing west towards St. George)	Photo 2. Incised ditch and sediment deposit (facing east towards Oak Hill Rd.)
