# MOREHOUSE BROOK FLOW RESTORATION PLAN

Stone Project ID: 13-239 September 14, 2016

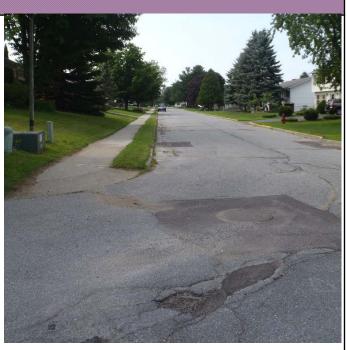
Wide, flat street w/ room for on-street parking. A number of roof leaders discharge onto driveways. Opportunities for traffic-calming bump-outs to manage road runoff. In addition, existing green space between sidewalk and road could be repurposed as a "green gutter".

Utilities in this neighborhood are buried and may limit

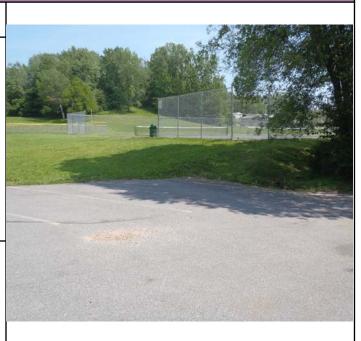
There is considerable rill erosion on the slope to the south of the tennis courts, which appears to be attributable to runoff from the courts. In addition, a portion of the parking lot drains to the north and east. A bioswale could be constructed at the toe of the court-side slope to convey runoff to the corner of the parking lot, where an infiltration basin could be constructed in place of several existing parking spots.

Existing dumpster should be relocated. Parking could be reconfigured and/or a paved swale added to encourage additional area to drain to the north and east.

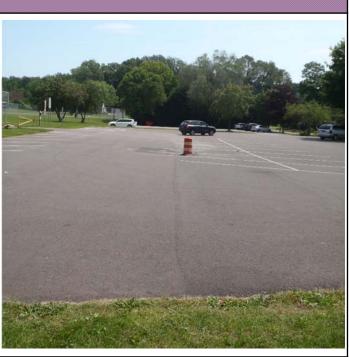
Western half of the parking lot at Landry Park drains to DI that is currently failed (e.g., collapsed). Soils surrounding the parking lot are HSG A; if parking lot is to be redone, consideration should be given to grading the lot to shed water toward adjacent green space and disconnect it from the storm drain system. There is also space off the northwest corner of the lot where an infiltration area could be established. Some potential for larger practice to north/west of lot near skate park; will required detailed review of existing infrastructure mapping.

Although it is clear the City needs to take action to address the failed DI, it is not clear how extensive the renovation may be. Storm sewer maps indicate that Industrial Park pond drains to sewer line that passes thru/under park.

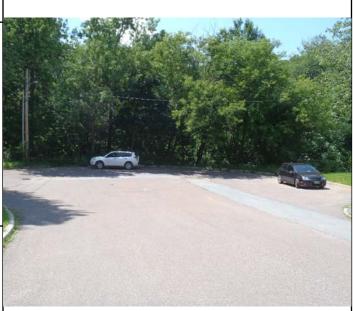
Cul-de-sac at the south west end of Young St has two DIs. Significant erosion was evident below the storm drain outfall connected to these structures. The cul-de-sac could be reconfigured to reduce the impervious area and create space for storage/infiltration. This area is mapped as having highly infiltrative soils.

Need to understand Colchester requirements for cul-de-sac layout to determine area eligible for practice; may be able to cover next set of Dis to the north on Young St to increase drainage area

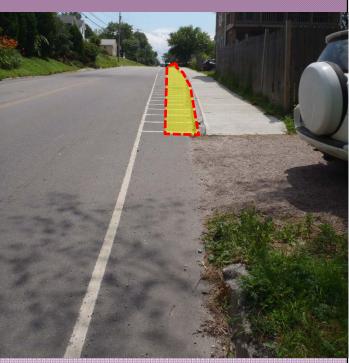
Near where Malletts Bay Ave crosses over Morehouse Brook, there is a swath of unused pavement that is neither available for parking or as part of the travel lane. This area could be depaved and a green gutter installed.

There is considerable bike traffic along Malletts Bay Ave and care would need to be taken to ensure that enough room remains for both bikes and cars to travel safely.
