Fluvial Erosion Hazard Mapping and Phase 2 Assessment Report

For the Municipalities of
Georgia, Highgate and Saint Albans City

~Northwest Regional Planning Commission~
February 2008

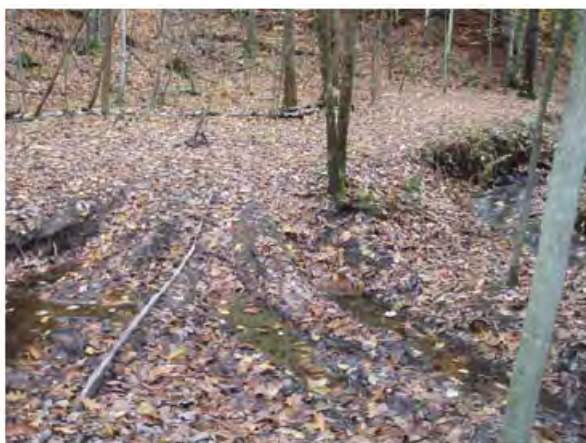
No stormwater inputs or flow regulation structures were observed on the two assessed reaches (R4S1.1S1.01 and R4S3.01) of the Missisquoi Black to Hungerford watershed. The land use adjacent to R4S1.1S1.01A was mostly forested, though several ATV trails were observed

Figure 3: Missisquoi River- R4S1.1S1.01- ATV trails on stream bed

Significant erosion and/or mass failure were observed in the two assessed reaches (R4S1.1S1.01 and R4S3.01) of the Missisquoi Black to Hungerford watershed, and as such, each reach was observed to contain greater than five depositional features per mile. Several ATV trails were observed in the corridor and on the stream bed of R4S1.1S1.01A, which has caused

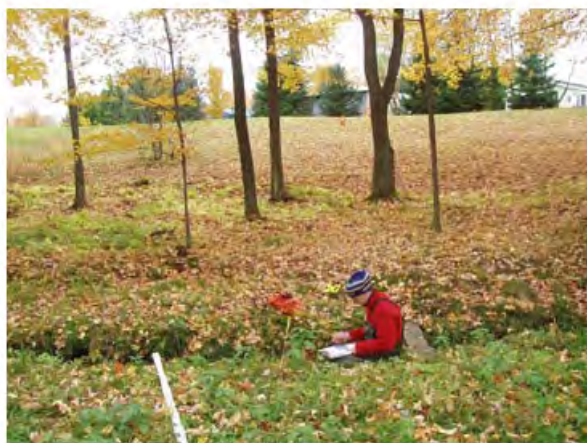
within the corridor and on the stream bed (See Figure 3). R4S3.01B had much of the riparian buffer removed and replaced with development, which has likely resulted in a moderate increase in runoff to the stream (See Figure 4). While some wetland loss has occurred within the watershed, very little has occurred in the vicinity of the two assessed reaches. Urban land use; however, remains fairly high, between 5 and 20% of the watershed, which is likely contributing increased flows to the streams. Overall, it appears that there is a small increase in hydrologic inputs based on the two assessed reaches and the surrounding land use.

Figure 4: Missisquoi River- R4S3.01B- Riparian Buffer

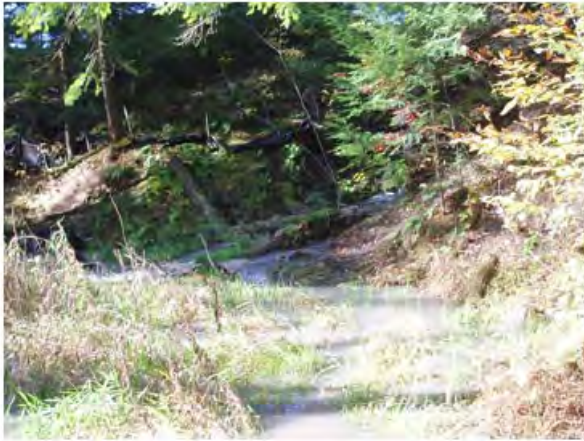
Three stormwater inputs were observed in R3S4.03 of the Missisquoi Mouth watershed. One of these inputs was from road runoff directly entering the stream through a swale, and the other two were from the adjacent rock quarry (located west of the stream). One input appeared to be a drainage tile and was not running during the assessment. The downstream-most input appeared to be an overflow from a settling pond in the quarry, and was periodically discharging major volumes of water and suspended silt into the stream (See Figure 5). An active beaver dam was observed within a few hundred feet downstream of this input, and is likely helping to attenuate some of the increased flows and sediment. Within the two downstream reaches, R3S4.01 and R3S4.02, a significant portion of the riparian buffer has been removed, and the

Figure 5: Missisquoi River- R3S4.03- Stormwater Input with Suspended Sediment

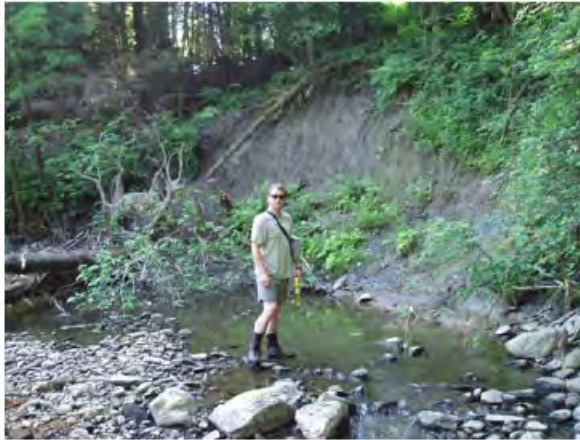
Overall each assessed reach had less than 30 percent erosion; however, concentrated areas of erosion were observed mostly in the downstream sinuous reaches (M01 and M02) of Deer Brook, where the area is already impacted by increased flows and sediment from stormwater inputs and the adjacent commercial/industrial area. This area also has a high concentration of mass failures supplying significant sediment to the reach (Photo 5). Very little erosion was noted throughout the middle of the mainstem, and somewhat significant erosion was again noted in M5S3.01, where the stream appears to be attempting to recover from historic straightening.

Figure 6: Deer Brook M02- Mass Failure

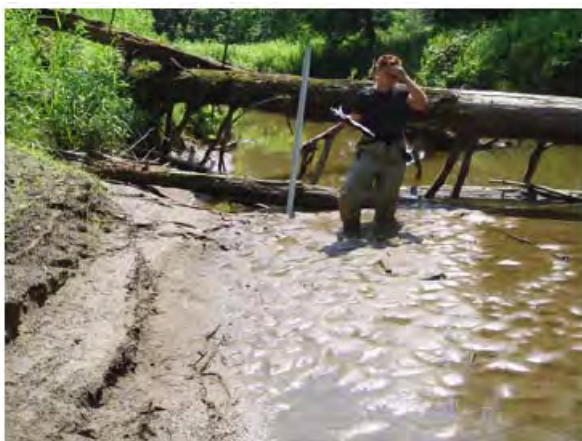
In general, the sediment supply has increased throughout the watershed, and is most prevalent in the two ends of the mainstem: M5S3.01, where erosion and mass wasting are occurring in response to historic straightening; M02, where the reach is adjusting to several sources of sediment input from the adjacent urban land use and includes several mass failure locations; and M01, where a large accumulation of very fine sediment was observed on the bed (See Figures 7 and 8).

Figure 7: Deer Brook M02- Silt Accumulation

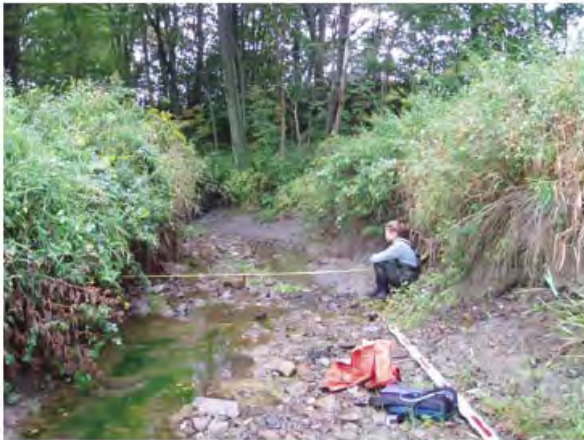
Figure 9: Mill River M2T2.2S1.2S2.01B- Severe Erosion

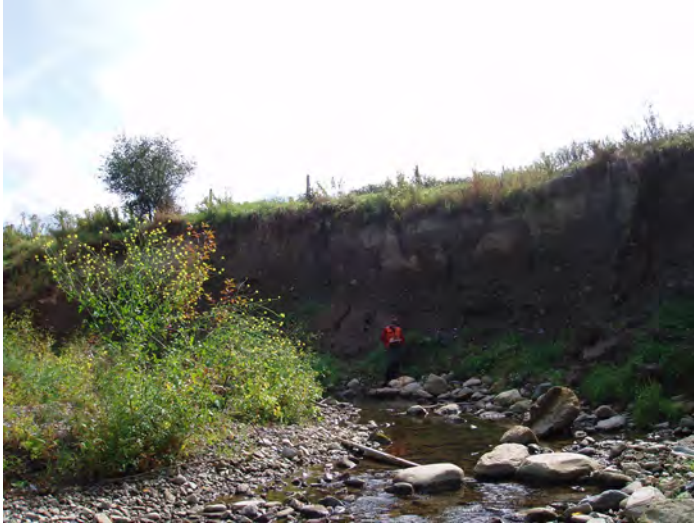
On the Rugg Brook mainstem, five of the thirteen stream segments had significant erosion (erosion on greater than 20% of bank length) or mass failures including: M01, M02, M05B, M07B and M08A). Five stream segments had more moderate erosion of 5 to 20% bank erosion and only three segments had less than 5% erosion on both banks (See Figure 11). Mass failures were observed in M02 and M03 (See Figure 12). The erosion observed in these segments is considered to be a response to several different stressors including straightening, increased flows and stormwater inputs. Rejuvenating tributaries were also observed in segments M03, M05A, M06A, M06B, M07B and M08B. These rejuvenating tributaries add sediment to the stream as the elevated tributary stream bed degrades to meet the elevation of the receiving segment.

Figure 11: Rugg Brook M02- Severe Erosion

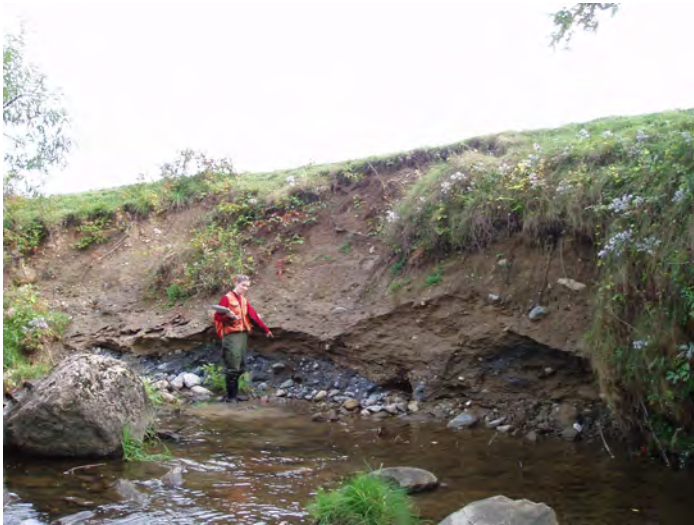
Figure 12: Rugg Brook M02- Mass Failure with Undercut Bank

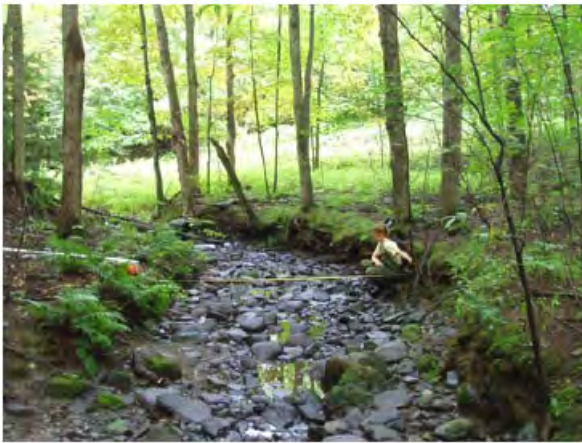
Figure 13: Stonebridge Brook M5S1.01- Erosion

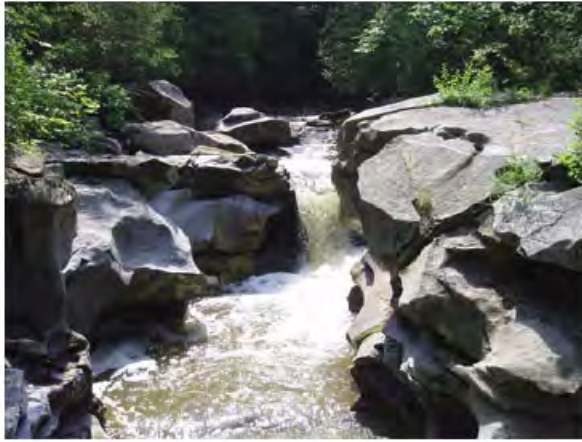
Figure 16: Mill River M01B- Natural Grade Control

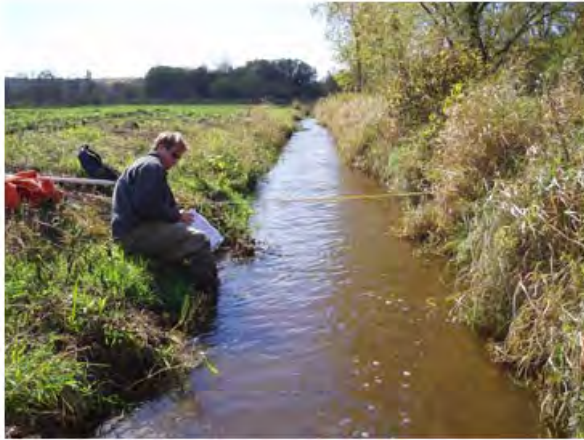
Figure 17: Missisquoi River R3S4.01- Straightening

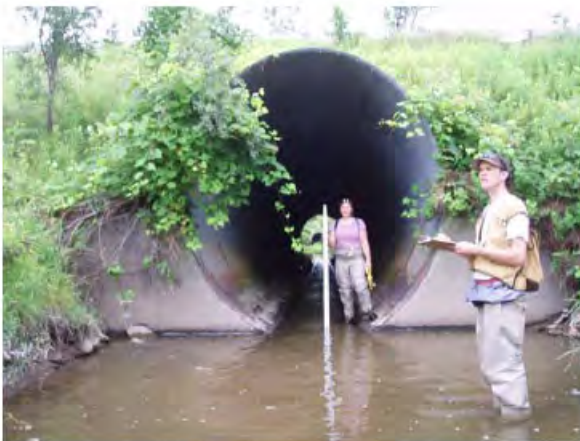
There are generally very few natural constraints to vertical and lateral adjustment in Deer Brook. Natural bedrock grade controls were observed on the stream bed of M03A and M03B. Most other constraints consist of bridges and culverts, and associated revetments. There are few crossings located in the upper portion of the mainstem, and there is little riparian buffer, so meander development in these straightened segments is not likely significantly impacted. The culverts located in M03A are causing the most significant impact because not only are they constricting the channel, but the road approaches are built up above the floodplain, causing a disconnect when flooding occurs (See Figure 18). In addition, a series of human constructed weirs are located below a small foot bridge, and are acting as a vertical constraint; however, it does not appear to be affecting the segment at this time.

Figure 18: Deer Brook M03A- Major Culvert

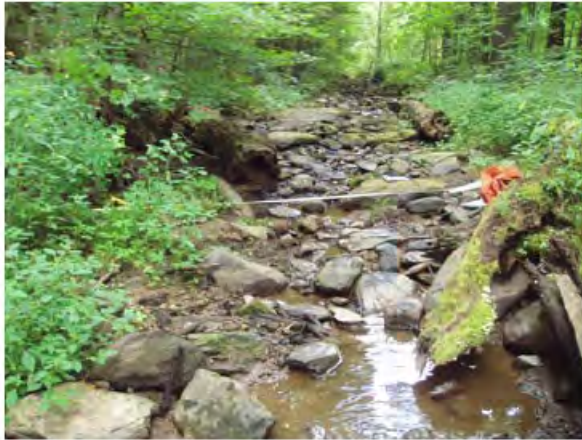
The sensitivity ratings on the assessed reaches of Stonebridge Brook watershed ranged from high to very high. One stream type departure was observed in M06A, due to major degradation, which has caused widening and plane bed features (See Figure 21). The remaining segments remain highly sensitive due to the active adjustments processes (M02, M05, M06B, M5S1.01A, M5S1.01B) in response to stressors, and segments that are generally in equilibrium (M03B and M04) remain sensitive due to inherent stream bed properties, such as fine grain size, which causes them to respond readily to any lateral and/or vertical adjustments.

Figure 21: Stonebridge Brook M06A- Plane Bed Features
