# Waterbury, Vermont Middle Winooski River Corridor Plan

December 15, 2015

Prepared by:  
Bear Creek Environmental, LLC  
149 State Street, Suite 3  
Montpelier, Vermont 05602

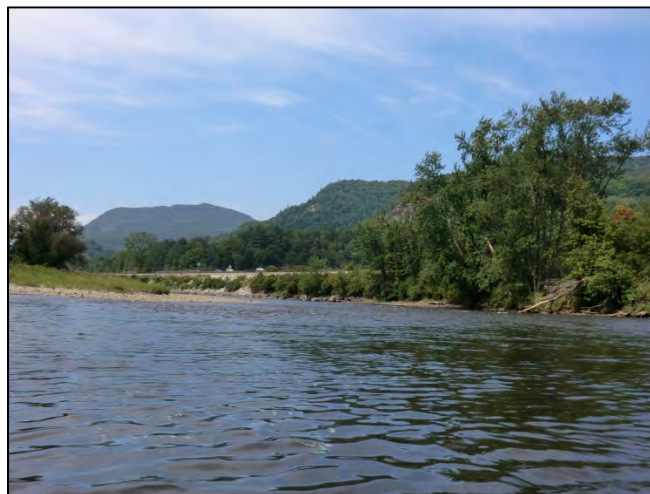
The downstream segment on R11 is characterized by an unnaturally straight channel due to historic straightening along the railroad/I-89 and River Road/Duxbury Road. The encroachment of I-89/the New England Central Railroad, one of the most important travel corridors in Vermont, has caused significant narrowing of the river valley. This, as well as the presence of a major dam just upstream, has led to channel incision, stream type departure, and loss of floodplain access. Riprap is prevalent along both banks of the river within R11-A, especially in areas where it flows directly along a road or railroad. Bank erosion is scattered between the riprap. The Winooski River is in the process of widening in R11-A, but lateral planform adjustment is restricted by the aforementioned encroachments. For these reasons, R11-A is in **fair** geomorphic condition. This segment is also in **fair** habitat condition due to altered channel planform, impacted banks and buffers, and lacking instream cover.

**Figure 5.7.** M2.01 impacted by valley width changes by placement of I 89 and Route 2 bridges.

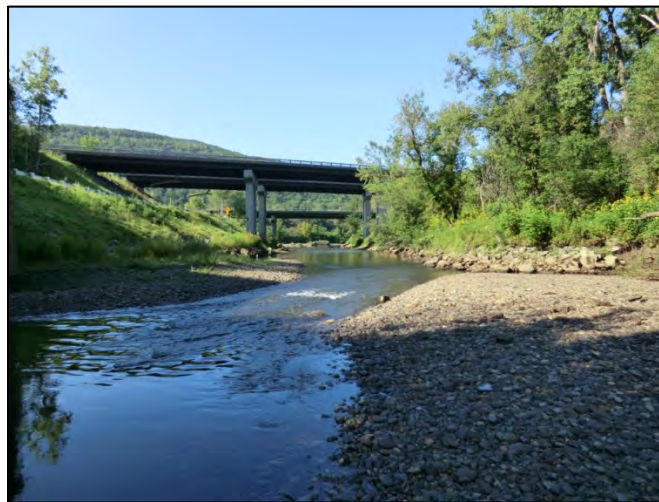
The most downstream reach on the Little River is 3,000 feet in length and was not segmented during assessment. Extreme channel incision has resulted in M2.01 from historic channel straightening and the upstream dam. This channel degradation has led to a stream type departure and loss of floodplain access. The natural valley in M2.01 has been altered from broad to narrow due to I-89 and Route 2 crossing the Little River just upstream of the confluence with the Winooski River. Incision has led to extreme widening and major aggradation and planform change. One mass failure is present in the reach and is contributing sediment to the channel. This reach’s riffle-pool bedform is not well defined, and a featureless, plane bed system is subdominant. It is also lacking in large woody debris and has poor bed substrate cover. M2.01 is in **poor** geomorphic condition due to extreme historic incision and widening. The segment is also in **fair** habitat condition due to the lack of diverse bed features and flow alteration.

Figure 5.12. M2.01 impacted by valley width changes by placement of I 89 and Route 2 bridges.

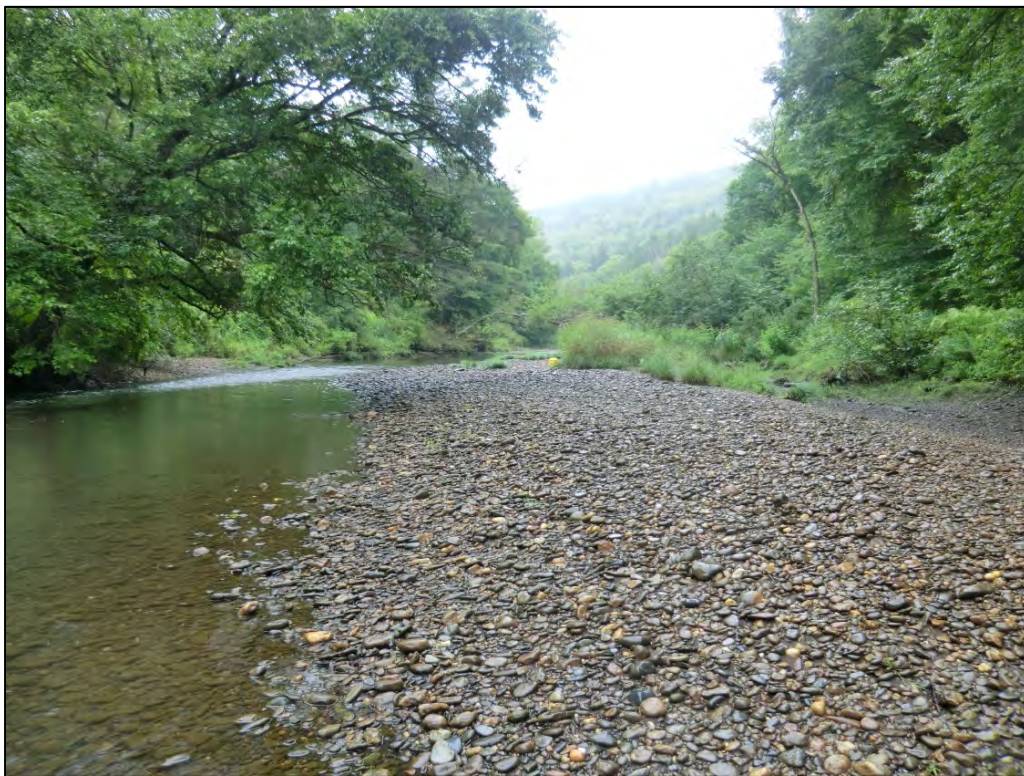
This reach was not segmented and begins just upstream of the start of the Little River State Park. It continues upstream for approximately 3,750 feet to just above a large meander where the valley narrows naturally. Extensive channel straightening and the presence of a major dam upstream have led to the geomorphic instability observed in this reach. The channel has incised, causing a stream type departure and loss of floodplain access. Major aggradation, widening and planform change have followed the incision process. Like M2.01, plane bed is the subdominant bedform in this reach due to a poorly-defined riffle-pool pattern. Bed cover has also been compromised with increased fining and algae growth. This reach is in **fair** geomorphic condition due to the aforementioned adjustments and processes. M2.02 is in **fair** habitat condition due to its channel morphology, lack of diverse bed features, abundant aggradation and flow alteration.

**Figure 5.13.** Cross section of M2.02 showing major aggradation and widening.

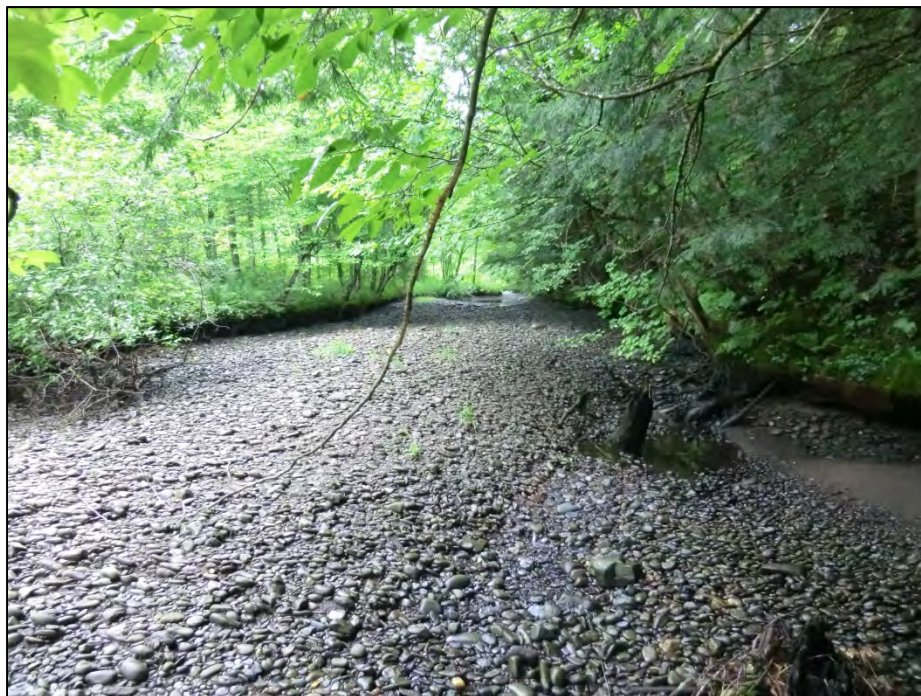
Segment M2.03-A begins where the valley becomes more confined and continues upstream for approximately 900 feet until the bedrock gorge. M2.02-A was similar to M2.02 with major channel incision. Flow alteration from the dam upstream at Waterbury Reservoir has most likely led to a series of events beginning with the channel incision due to the dam “starving” the channel of sediment by holding it back. The stream flow is regulated from this dam with scheduled releases daily to every other day. The decrease in sediment in the channel from the dam has historically caused the channel to cut into the bed followed by minor channel widening and major planform change as seen through islands and large flood chutes. M3.02-A is in **fair** geomorphic condition as a result of the flow alteration and processes that have followed. The segment is in **fair** habitat condition due to the presence of algae on the substrate, a lack of large woody debris, and channel morphology.

Figure 5.14. Large flood chute in cross section of M2.03-A.

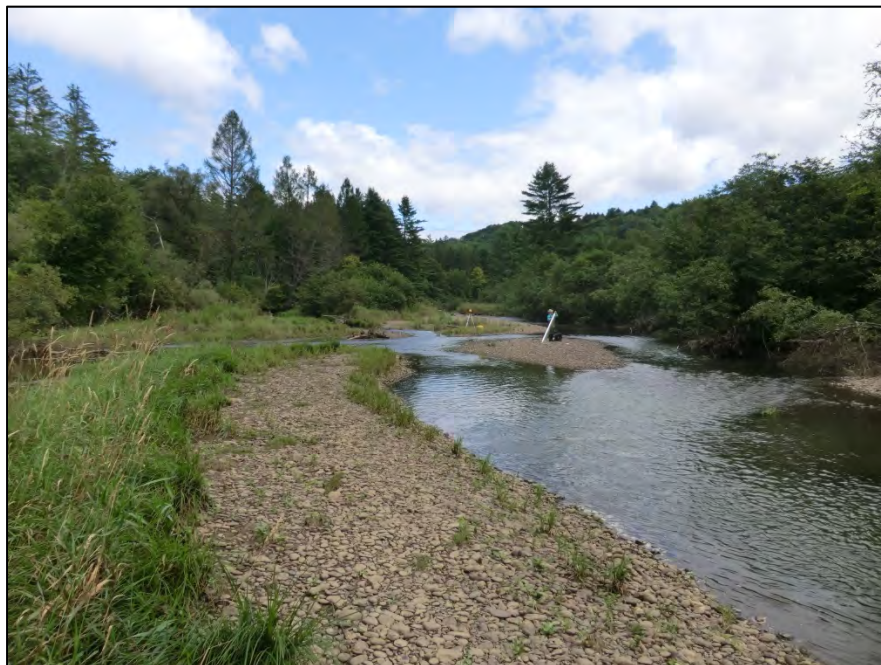
This segment begins just above the bedrock gorge where there is an old concrete dam and continues upstream for approximately 900 feet. The channel flows through a broad valley and there has been a stream habitat type departure from riffle-pool to braided due to extreme channel aggradation and planform change. Flow alteration from the Waterbury Dam has resulted in major historic incision and subsequent severe widening. The incision caused a stream type departure. Major planform adjustment is also occurring in this segment as water flows around depositional features and islands. The old dam and constriction at the bedrock gorge downstream in M2.03-B have likely exacerbated aggradation in M2.04-A. Due to extreme geomorphic processes occurring in M2.04-A, it is in **poor** geomorphic condition. The flow alteration, channel morphology, and lack of large woody debris have resulted in **fair** habitat condition.

**Figure 5.16.** Extreme aggradation and braided condition in M2.04-A.

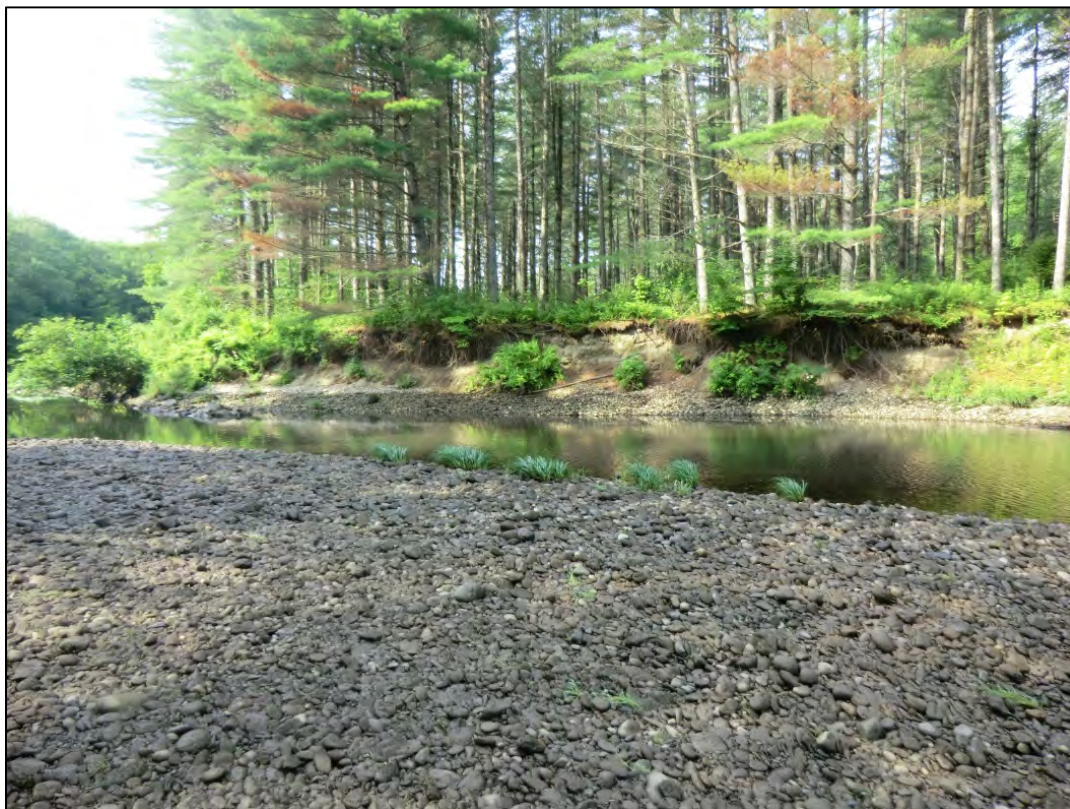
The upstream-most segment assessed on the Little River begins about 275 feet downstream of the Vermont Association of Snowmobile Trails (VAST) bridge crossing and continues to approximately 900 feet below the Waterbury Reservoir Dam. As in the downstream segment, M2.04-B has adjusted vertically and horizontally. The channel degradation is a result of the Waterbury Dam holding back sediment, although in this segment the incision is more severe than downstream (incision ratio = 4.2). The channel is also extremely wide and has abundant bank erosion, resulting in minor planform adjustment and aggradation. Frequent releases from the dam (daily or every other day) have formed the channel and are likely responsible for the over-widening. M2.04-B is in **fair** geomorphic condition due to the extreme incision and widening. Habitat condition is **fair** due to changes in channel morphology, flow alteration, unstable river banks, and lack of large woody debris.

Figure 5.17. Bank erosion along western bank in M2.04-B.

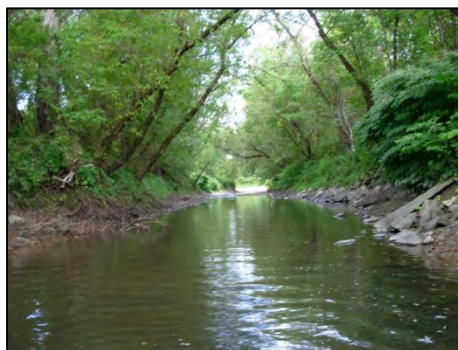
The downstream-most segment on Graves Brook begins at the confluence with the Winooski River and ends between the Armory Drive and I-89 bridges. Almost this entire segment was historically straightened around development in the Village, which caused major historic incision. The stream channel is deep and narrow and abundant bank armoring is preventing widening throughout the majority of the segment. Development is dense in R13.S1.01-A and the New England Central Railroad, Armory Drive, and Union Street encroach upon the stream channel. Stormwater inputs to Graves Brook are abundant in this segment, especially where it flows under road and railroad crossings. R13.S1.01-A is in **fair** geomorphic condition as a result of historic straightening and boundary factors limiting further adjustment. It is also in **fair** habitat condition due to lacking habitat features and a conversion of its natural riffle-pool bedform to featureless plane bed.

**Figure 5.18.** Graves Brook has a narrow and deep channel with abundant bank armoring in R13.S1.01-A.

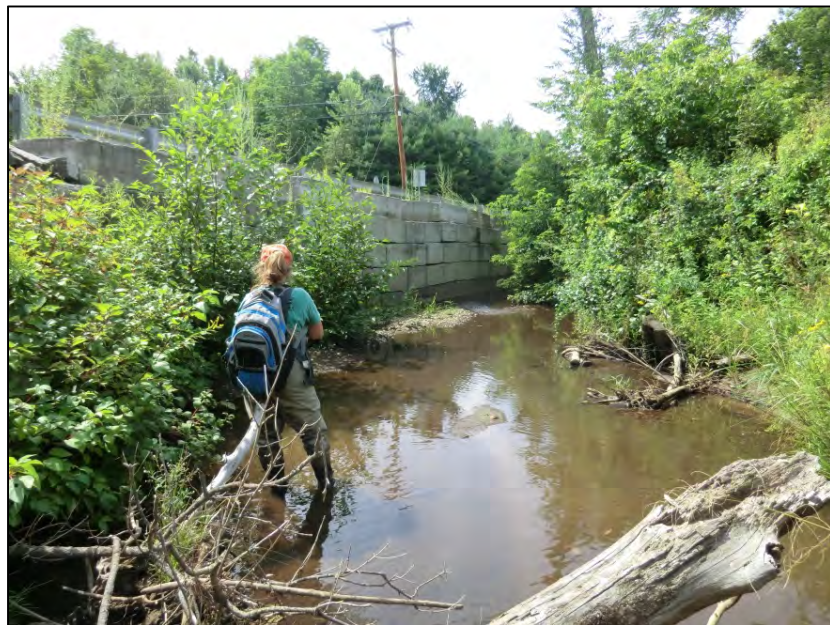
The most downstream segment assessed on Graves Brook is approximately 900 feet in length, beginning at the confluence with Thatcher Brook and continuing upstream where Perry Hill Road exits the river corridor. This section of the reach has been extensively straightened and armored for development. The channel alteration has resulted in degradation and a stream type departure due to the channel becoming deeper but not wider. Abundant bank armoring is preventing widening throughout R13.S1.03-A; however, where armoring is lacking the banks are eroding. The downstream portion of the segment is more incised and entrenched than the upstream end. The stream bed substrate feels soft underfoot from fine sediments, and the channel has lost its riffle-pool bedform, which is now dominated by plane bed. Major channel incision and increased fine sediment coupled with extensive channel alteration have caused R13-S1.03-A to be in **fair** geomorphic condition. Due to unstable river banks, a featureless bed, poor riparian buffers, and channel alterations, habitat conditions in this segment are **fair**.

**Figure 5.22.** Concrete block wall against Lincoln Street armoring the stream bank along Graves Brook.

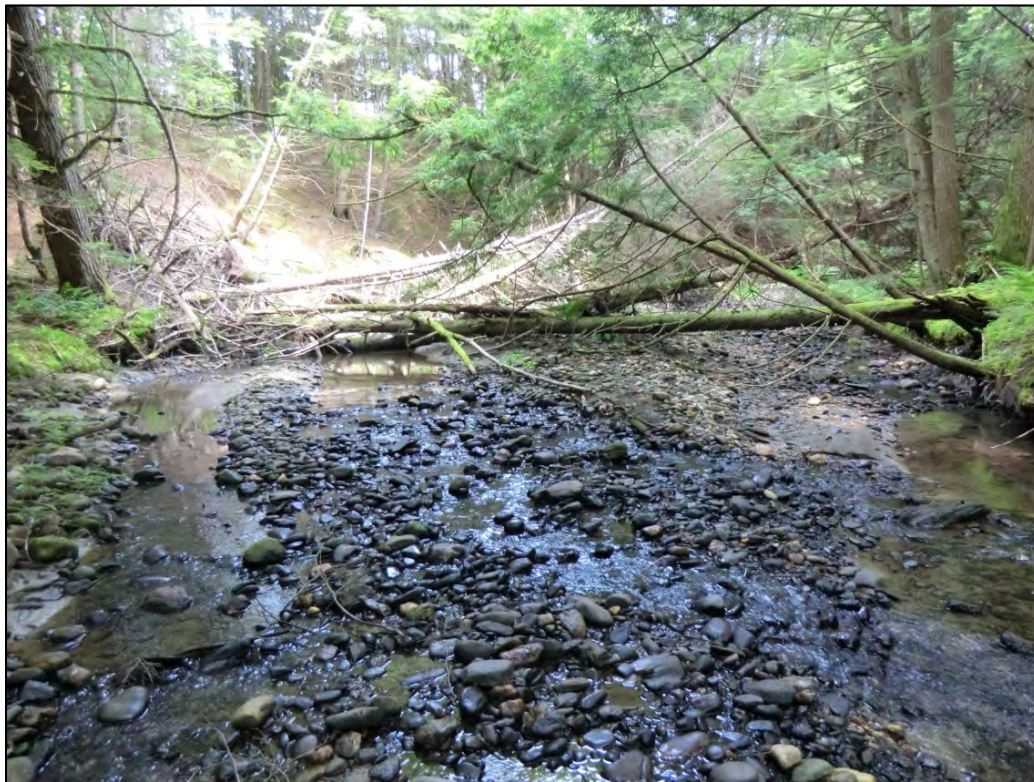
The most upstream segment assessed on Graves Brook begins at the upstream end of the golf greens at the Waterbury Country Club, where the valley becomes narrower, and continues approximately 4,000 feet until the reach break for R13.S1.04. Although the valley is narrower on the downstream end of the segment, the channel flows through a very broad valley for much of the segment. The riparian area and stream banks are well forested and there is very little human disturbance in the corridor of this segment. Nonetheless, the channel has incised slightly and has abundant bank erosion indicating that the channel is now widening. There are numerous depositional features and flood chutes as the channel seeks to navigate around the bars and a few debris jams. Mass failures and gullies are introducing sediment to the channel. Overall, R13.S1.03-C is in **fair** geomorphic condition due to various adjustment processes occurring in the segment. Despite the fair geomorphic condition, its habitat condition is **good** due to abundant large woody debris, good substrate cover and well preserved riparian habitat.

**Figure 5.24.** Planform change in R13.S1.03-C as channel navigates through debris and aggradation.

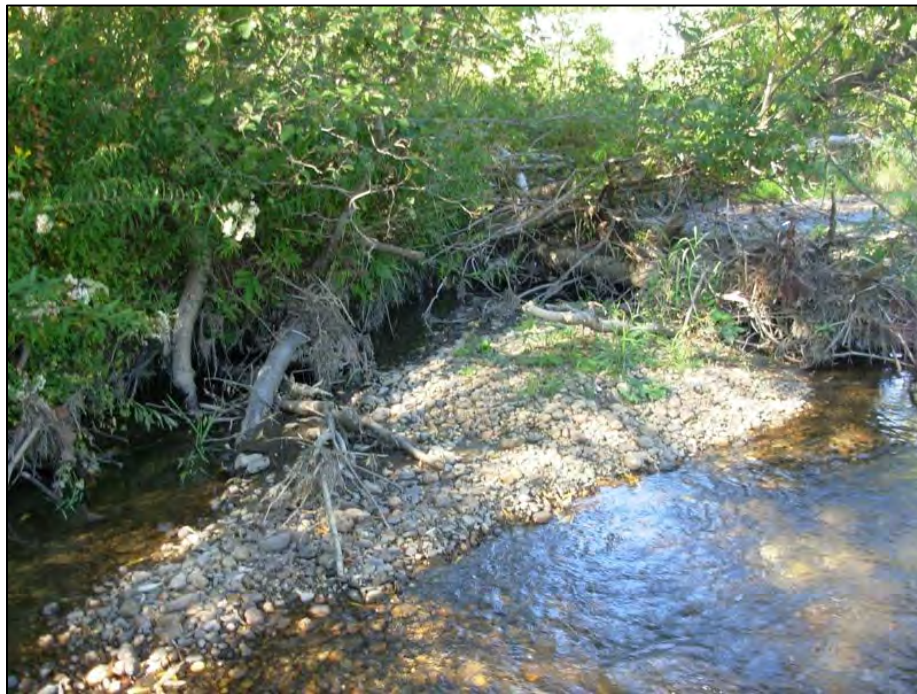
The third reach on Thatcher Brook is approximately 3,700 feet in length, extending from just above the confluence of Unnamed Tributary 1 to Thatcher Brook to just above the confluence of Unnamed Tributary 2 to Thatcher Brook. The reach was not split into any segments during assessment. The majority of this reach was likely subjected to channel straightening in the past due to surrounding development and agricultural land. Despite this, the channel has not undergone any incision. Aggradation is the major process in this reach that is driving adjustment. As sediment accumulates in the channel, widening and planform adjustment are occurring in response. Bank erosion is common along both banks as the brook works to establish lost meanders. Flood chutes are abundant in R13.S1.02-S1.03, crossing over deposited material and meander bends. The brook’s riffle pool bedform has been impacted by sedimentation, creating mostly short, steep riffles. This reach is in **fair** geomorphic condition as a result of the aggradation-driven adjustments observed. It is in **good** habitat condition, though, because woody debris, pools, and bank vegetation create good instream cover for aquatic organisms.

**Figure 5.30.** Aggradation and debris jams are driving adjustments in R13.S1.02-S1.03.

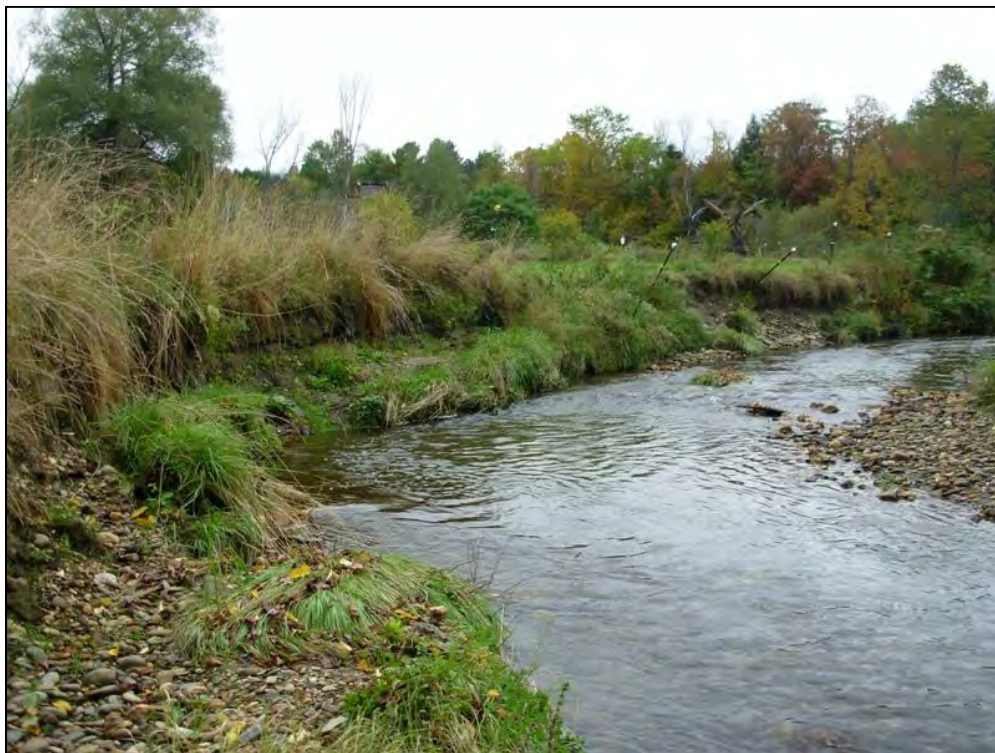
This segment begins approximately 1,000 feet below the Guptil Hill Road Bridge and continues for 2,250 feet just downstream of where the stream goes away from Thatcher Brook Road. Similar to the downstream segment, riparian buffers are poorly vegetated, which has created unstable, eroding banks. Stormwater inputs from field ditches, overland flow, and tile drains are abundant but channel alteration is not as extensive as the downstream segment. Two gullies and one mass failure are present contributing sediment to the channel. The major processes that have occurred are historic channel incision followed by aggradation, widening and planform adjustment. The geomorphic condition is **fair** as a result of the incision and subsequent processes. Habitat conditions in this segment are also **fair** due to impacted hydrologic characteristics from land use change and stormwater and compromised river banks and riparian buffers.

Figure 5.32. Bank erosion and lack of riparian buffer along pasture in R13.S1.02-S1.04-B.

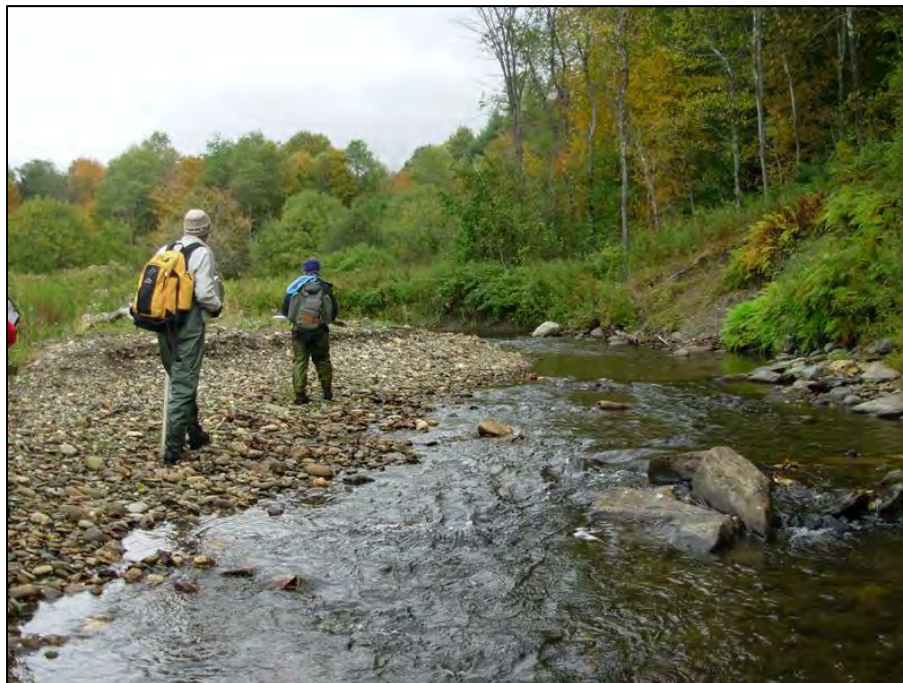
The most upstream segment in this reach begins approximately 1,300 feet upstream from the Guptil Road Bridge near Thatcher Brook Road and continues to about 1,000 feet downstream of the Loomis Hill Road Bridge. Riparian buffers are well vegetated along the southeastern bank and the upstream end of the northwestern bank in this segment. Corridor encroachments are minimal and pasture is limited to the downstream end of the northern side of the channel. Historic channel degradation and subsequent widening has led to major aggradation as seen by the formation of numerous depositional features. Major planform adjustment has resulted as the channel has sought equilibrium from the widening and aggradation forming many flood chutes and one channel avulsion. The channel has mostly moved past the widening stage and is building a new floodplain on larger bars. Similar to downstream segments, mass failures and gullies are present contributing sediment to the channel. The geomorphic condition is **fair** due to the abundance of deposition, widened channel and planform change. Bank conditions and compromised riffle-pool patterns and hydrologic characteristics due to sedimentation have led to the **fair** habitat condition in this segment.

Figure 5.33. Large bar in R13.S1.02-S1.05-C causing major channel widening.

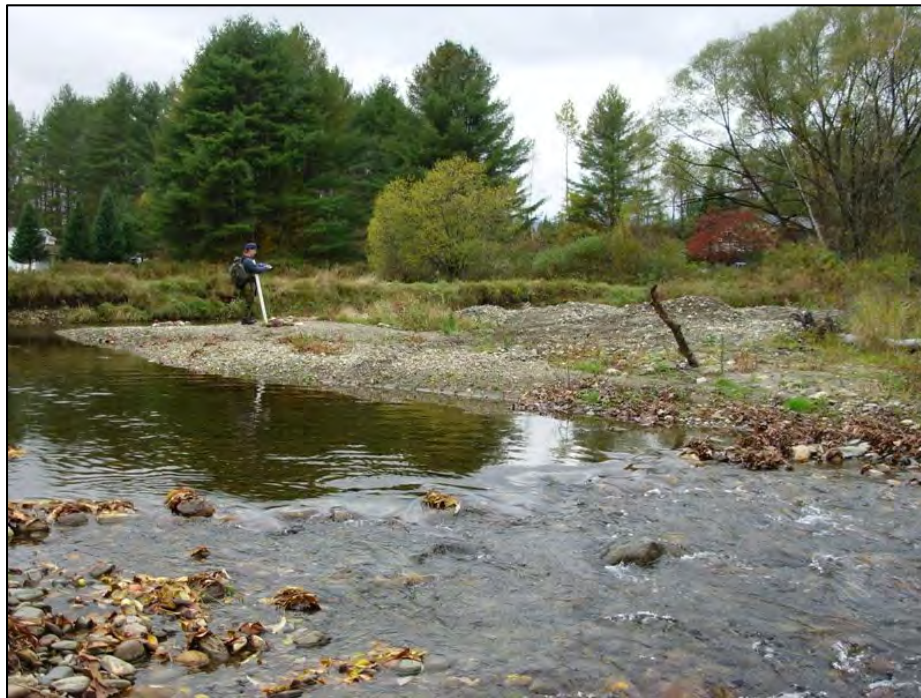
This segment begins approximately 1,125 feet downstream of the Loomis Hill Road Bridge and continues for 3,660 feet upstream. The bedform in R13.S1.02-S1.05-A is riffle-pool by reference but it has been altered to plane bed as a result of extensive historic channel straightening for agriculture. Gravel mining was noted in two locations during the 2010 assessment. This channel alteration likely resulted in incision, followed by aggradation, widening and planform adjustment. River scientists observed greater aggradation and widening in 2014 than 2010, before Tropical Storm Irene. The segment is in **fair** geomorphic condition due to the various processes resulted from channel alteration and **good** habitat condition as a result of abundant large woody debris and good bank vegetation.

**Figure 5.34.** Large bar in R13.S1.02-S1.05-A where gravel mining appears to have occurred.

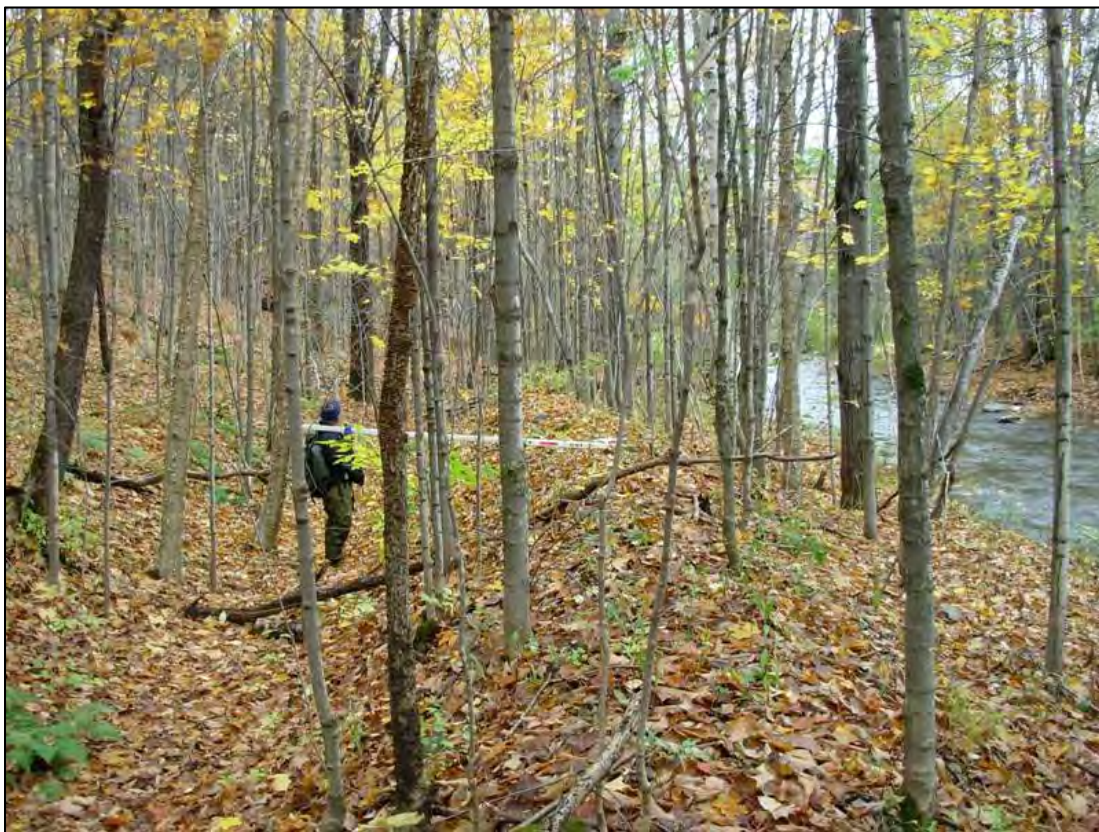
Segment B begins approximately 2,500 feet upstream of the Loomis Hill Bridge and continues for 800 feet to the confluence of a tributary. Like the downstream segment, the dominant reference bedform of riffle-pool has been converted to plane bed as a result of historic channel straightening. Berms are common along both banks, most likely from previous windrowing of the channel. Thatcher Brook has incised in this segment but has not yet widened. Aggradation was observed to be more pronounced in 2014 than in 2010, most likely due to Tropical Storm Irene. The geomorphic condition is **fair** due to channel alterations and incision. R13.S1.02-S1.05-B is also in **fair** habitat condition as a result of lacking woody debris, poor pool habitat, and past channel alterations.

Figure 5.35. Historic berm preventing floodplain access in R13.S1.02-S1.05-B.

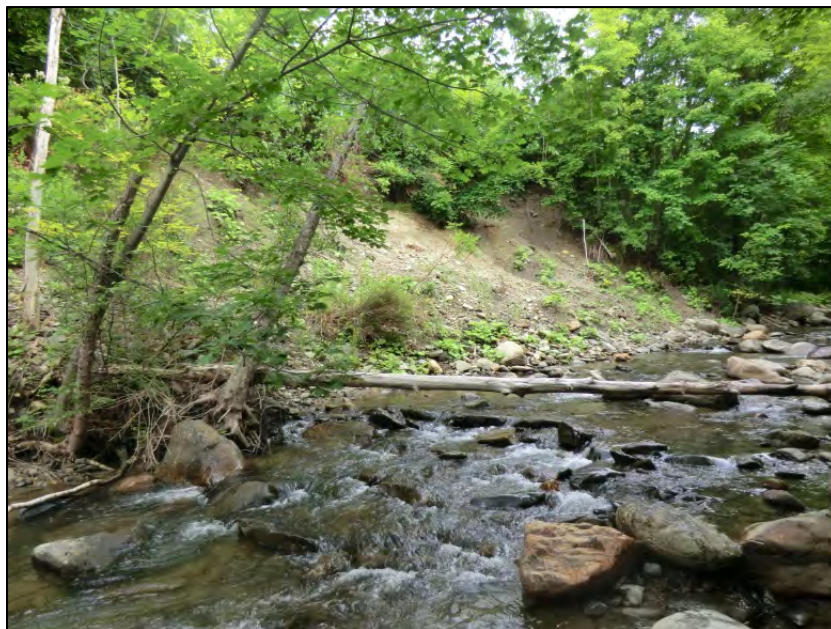
This segment flows through a very broad valley and is characterized by a historically straightened depositional channel whose banks contain many mass failures and abundant erosion. R13.S1.01-S1.06-A begins approximately 3,200 feet upstream of the Loomis Hill Road crossing and continues upstream for another 3,200 feet along Maple Street. Floodplain access is variable throughout the segment but mostly it is incised and currently widening. Planform change is evident as there are many flood chutes and islands. Three mass failures in this segment are contributing to bank instability and increased sediment to Thatcher Brook. The riparian buffers are well forested on the eastern side of the segment but the western side has areas lacking a vegetated woody buffer. The segment is in **fair** geomorphic condition due to adjustment processes resulting from channel alteration. Reduced large woody debris, lacking bank vegetation, and the straightened planform have contributed to the **fair** habitat condition.

Figure 5.36. One of three mass failures in R13.S1.02-S1.06-A contributing sediment to the channel.

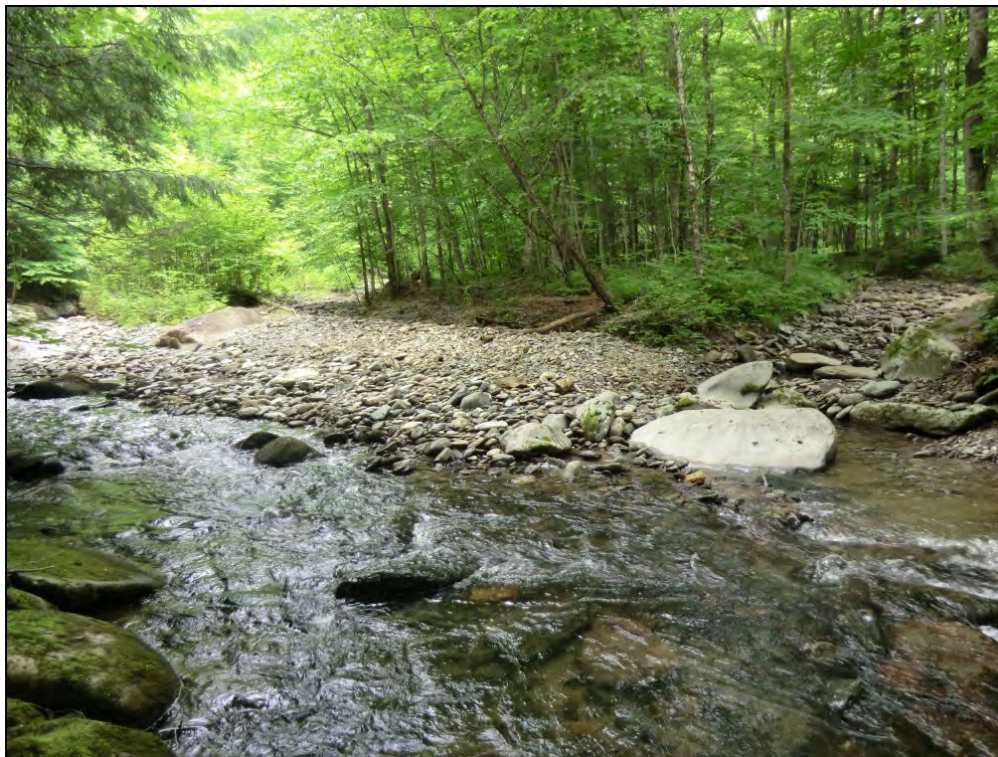
**Figure 5.38.** Large point bar where material from TSI may have been deposited.

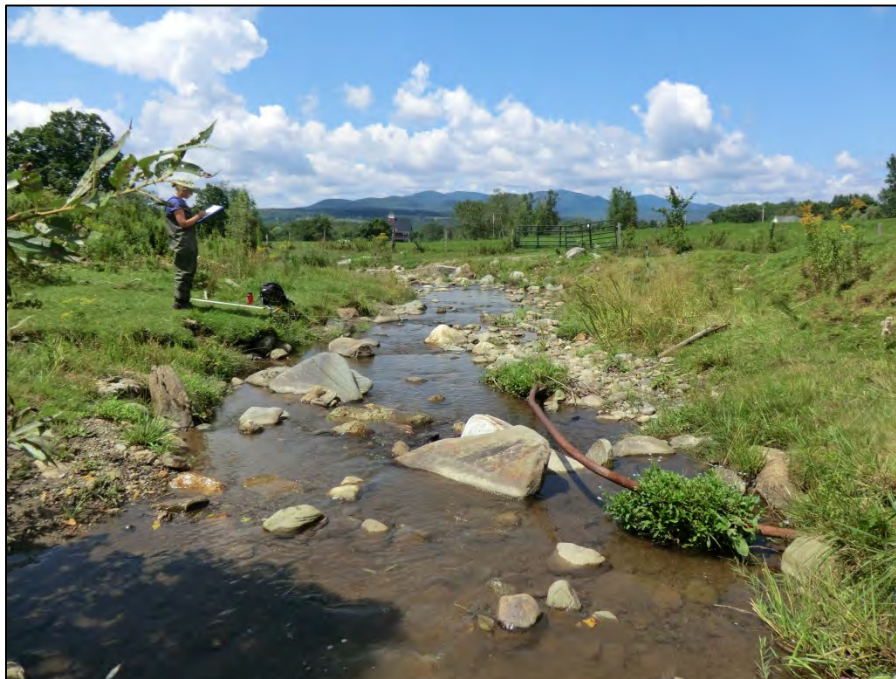
Figure 5.49. R13.S1.02-S1.02-S1.01-E flows through pastured lands and is impacted by grazing animals.

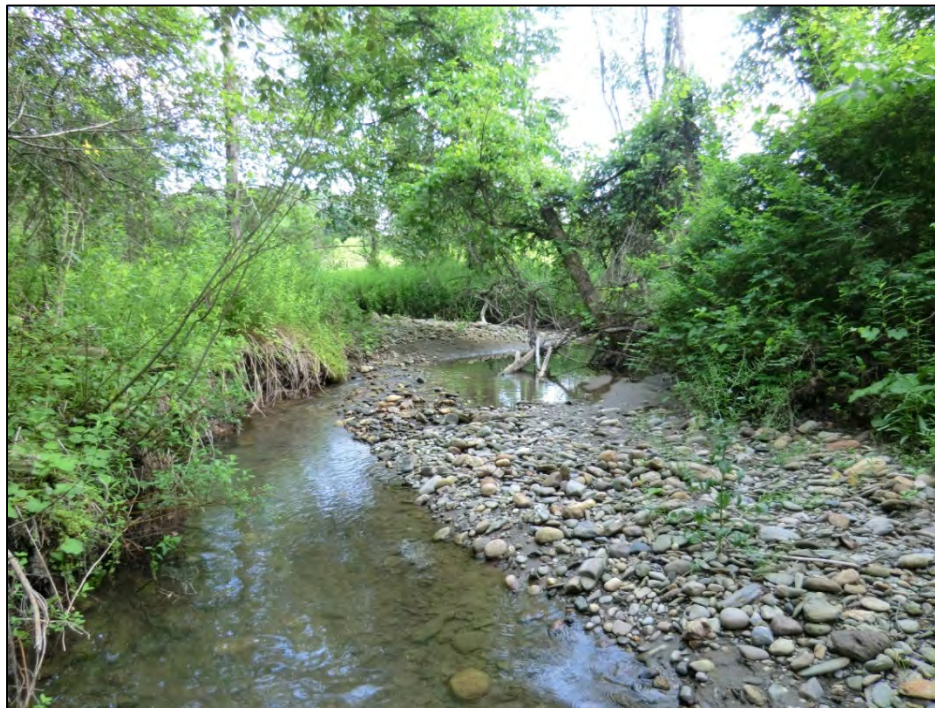
Figure 5.53. Aggradation is driving planform adjustment in R13.S1.02-S1.03-S1.01-B.

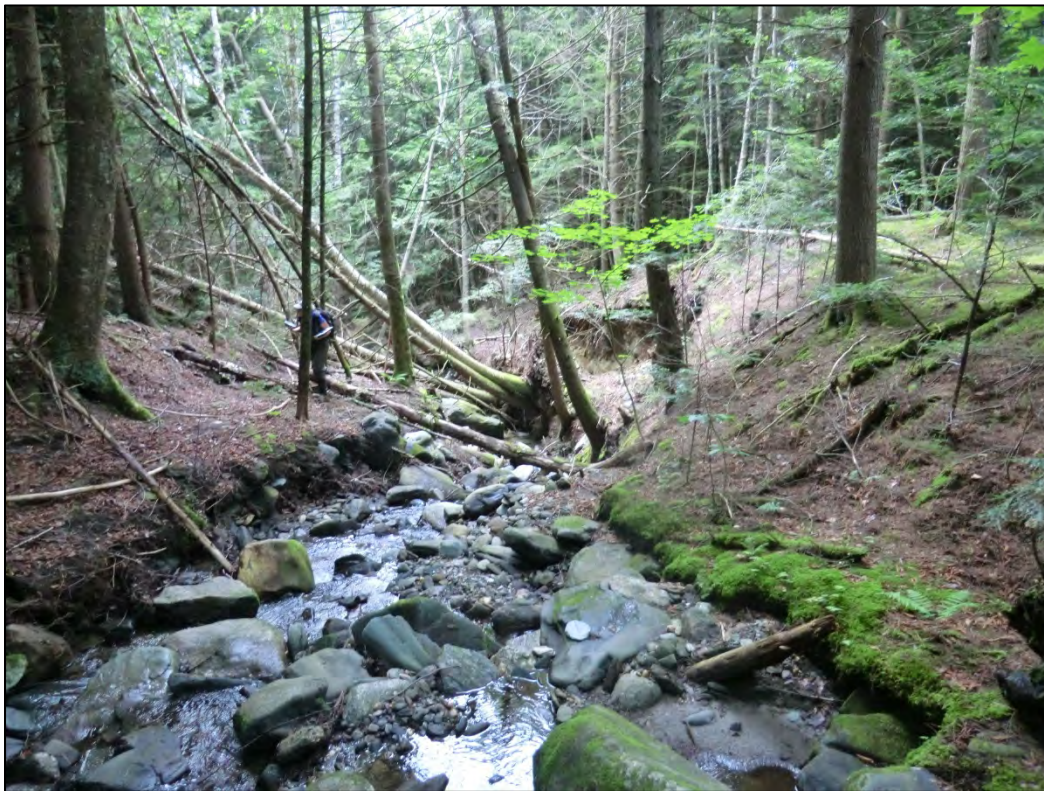
Figure 5.57. R13.S1.02-S1.03-S1.02-C is actively incising via headcuts.

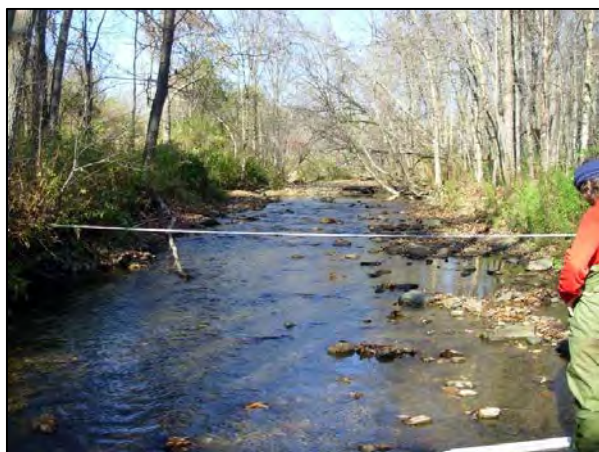
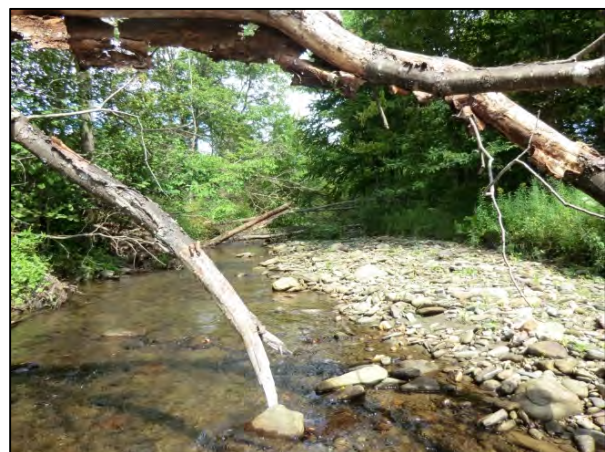
**Figure 27.** Cross section R13.S1.02-S1.05-A in 2009 (left) and 2014 (right)-more aggradational.
