# River Corridor Plan for the Saxtons River Watershed Windham County, Vermont

September 30, 2010

**Fitzgerald Environmental Associates, LLC.**  
316 River Road  
Colchester, VT 05446

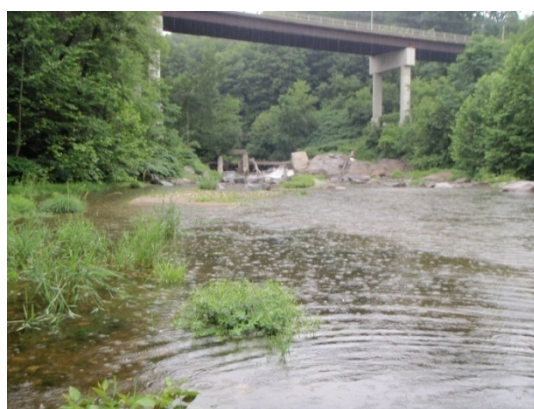
Figure 4.2 Several mid-channel bars in the widened channel

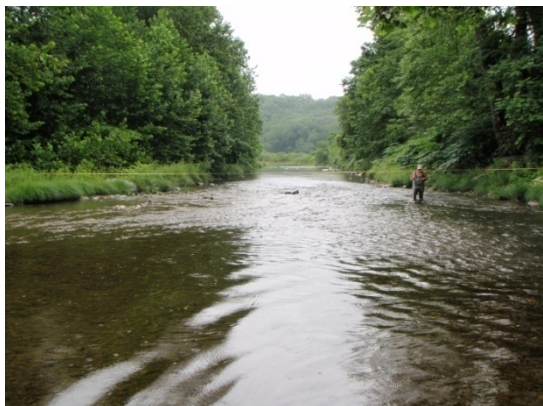
It should be noted that the high incision ratio in the reach may be exaggerated by the height of a glacial terrace (not a recently abandoned floodplain) above the current bankfull channel. Although the soils surrounding this reach are mapped by NRCS as “alluvium”, it is unclear whether this apparent floodplain was formed by recent river processes (hundreds of years old), or whether it is a relict of older, glacial processes (thousands of years old).

Figure 4.5 M02 cross-section location w/ F-type geometry

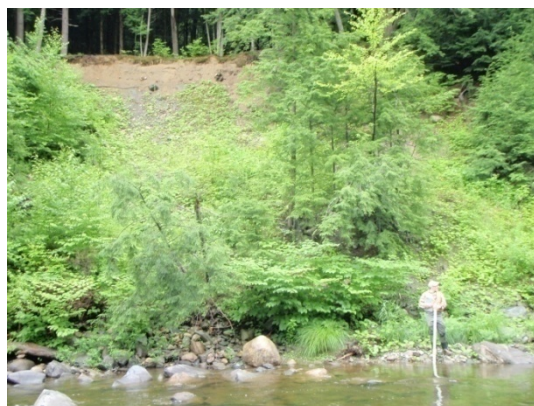
Figure 4.8 Mass failure located on right bank

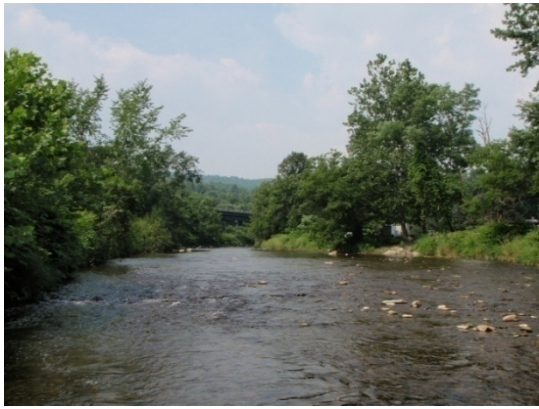
Figure 4.9 Widening looking upstream at cross-section location

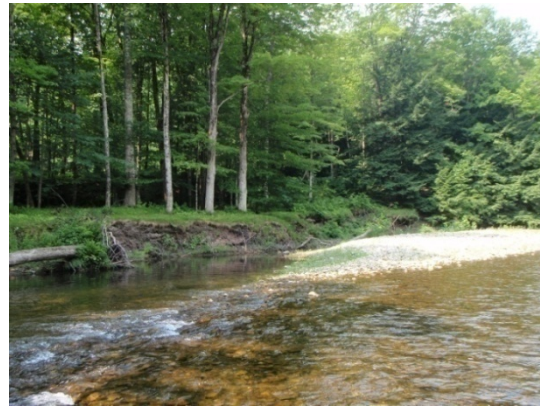
Segment M03-B begins just upstream of the Covered Bridge Road crossing and extends upstream about 1.1 miles to the reach break about 800 feet upstream of the I-91 crossing. The channel geometry is indicative of C-type morphology and the bedform is plane bed. The bed slope is approximately 0.5% and the confinement type is narrow. The bed substrate is predominately cobble (46%) and coarse gravel (28%) with gravel median substrate (55mm). The width-to-depth ratio observed at the cross-section seems to be slightly lower than widening observed in other parts the segment (WDR = 30.8; Figure 4.9). The entrenchment ratio is characteristic of C-type channel morphology (ER = 2.9) and the incision ratio suggests moderate degradation (IR = 1.5). The lower end of this segment has significant aggradation upstream of the grade control at the road crossing. There, the sediment has formed several large bar features suggesting past incision, widening, and now a shift in planform (Figure 4.10).

Figure 4.10 Diagonal bar upstream of segment break

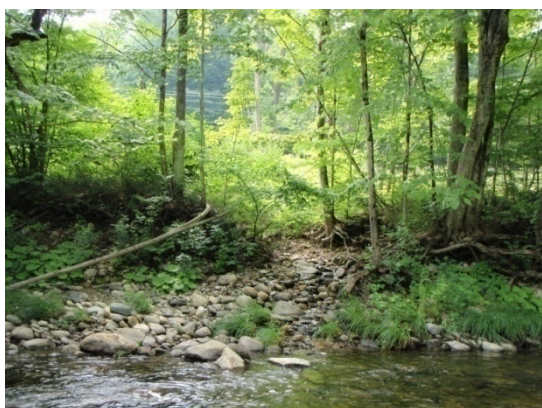
Figure 4.11 Rejuvenating tributary located mid-reach

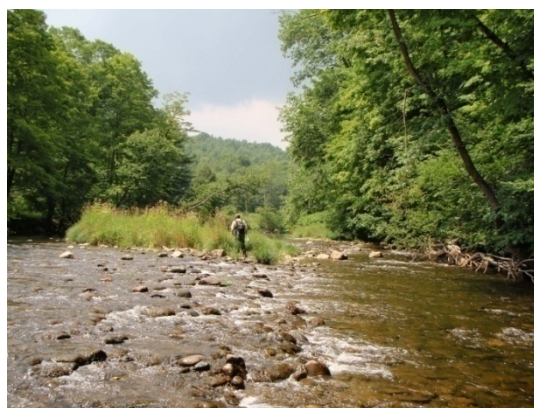
Figure 4.12 Diagonal riffle located mid-reach

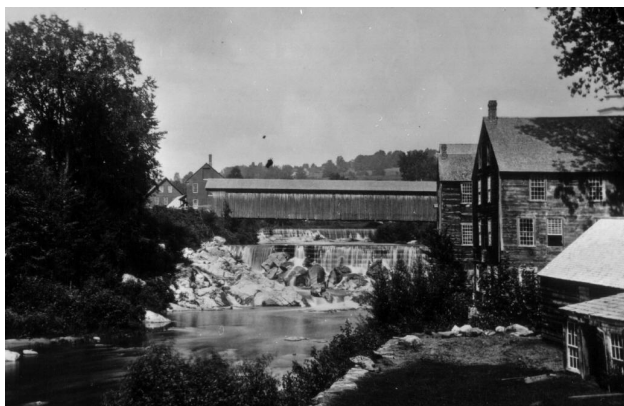
Figure 4.15 Crib dams located at the old Westminster Street crossing

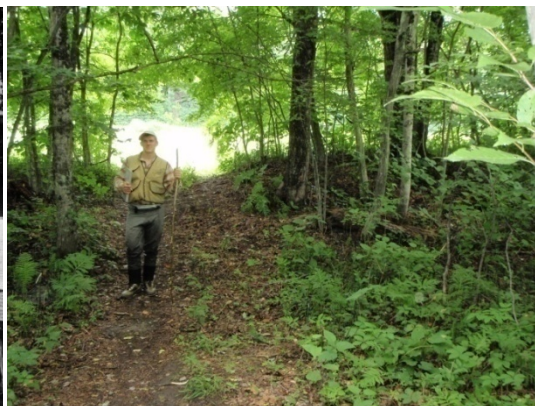
Figure 4.16 Berm observed along the left bank in upper reach

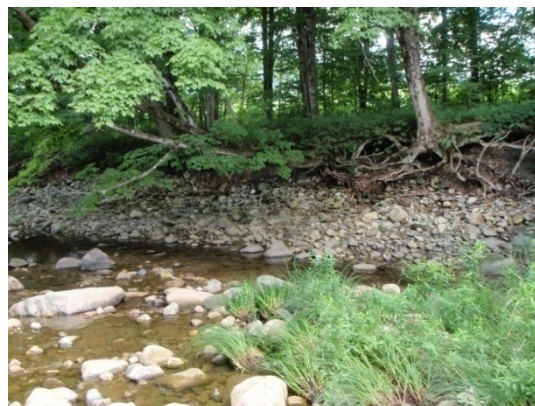
Figure 4.18 Bank erosion on the right bank

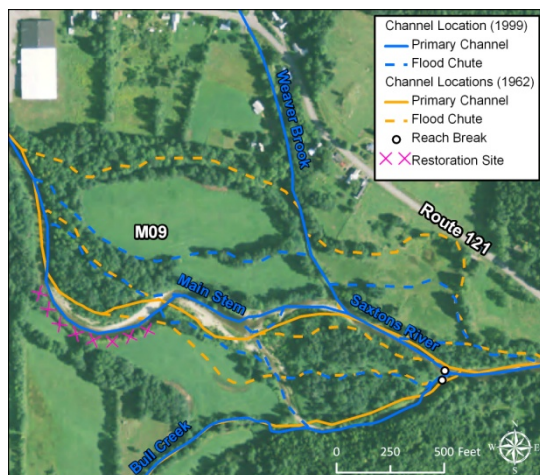
The multiple flood chutes present, along with aggradation and side bar development indicates widening and planform changes. The geomorphic condition is highly unstable and the lack of grade controls has likely led to the advanced stage of the CEM (RGA score = "Fair"; CEM stage = IId, D-model). Some restoration efforts were made on the right bank (Figure 4.21). There, willow plantings and rip-rap were installed to prevent further channel migration and potential avulsions out into the hay field to the southeast. The habitat was influenced by the shallow nature of the channelized flow (Figure 4.22). Pools were limited (pools/mile = 9), and the channel was often too shallow to support a diverse assemblage of aquatic species. Woody debris was quite low (LWD/mile = 17) and the habitat condition seemed to reflect the geomorphic condition (RHA score = "Fair").

Figure 4.21 Channel migration and braiding in the last 50 years

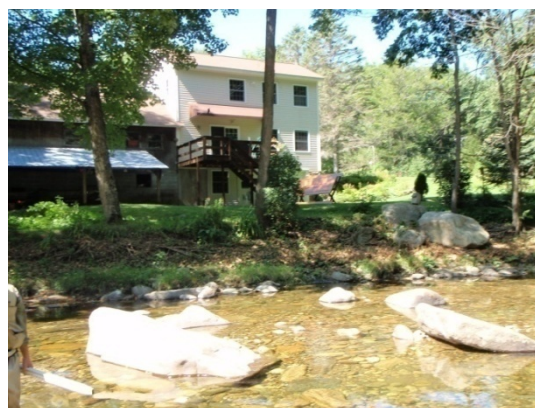
Figure 4.24 Buffer width <25ft and development on right bank

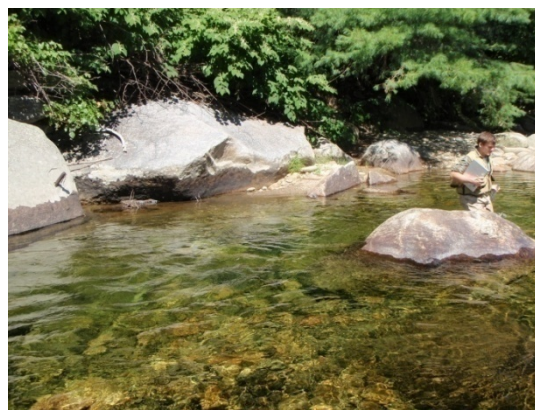
Figure 4.25 Cross-section looking upstream at C-type geometry Figure 4.26 Deep pool feature downstream of Rt 121 crossing

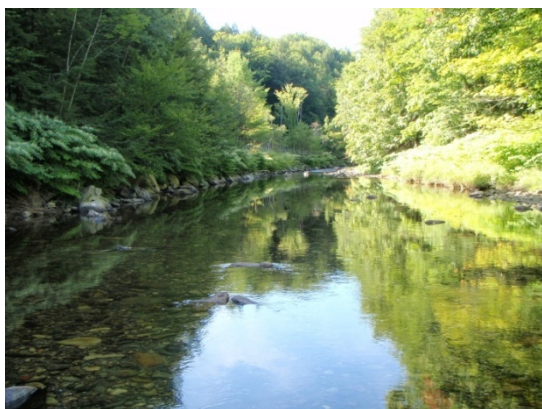
The channel is encroached upon entirely by Route 121, which has led to substantial changes in the natural geomorphic adjustment processes. Incision caused by road encroachment has caused a stream type departure, from C to B<sub>c</sub> due to lack of extensive floodplain (RGA score = "Fair"). The stream is in stage II of the F-model of CEM. Some meandering profile and habitat formation was noted in the lower reach, but extensive historical channel encroachment has led to a simplified form with limited habitat. Fine sediment deposition also reduces the viable habitat (RHA score = "Fair"; Figure 4.28).

Figure 4.27 Plane bed, featureless channel along Route 121

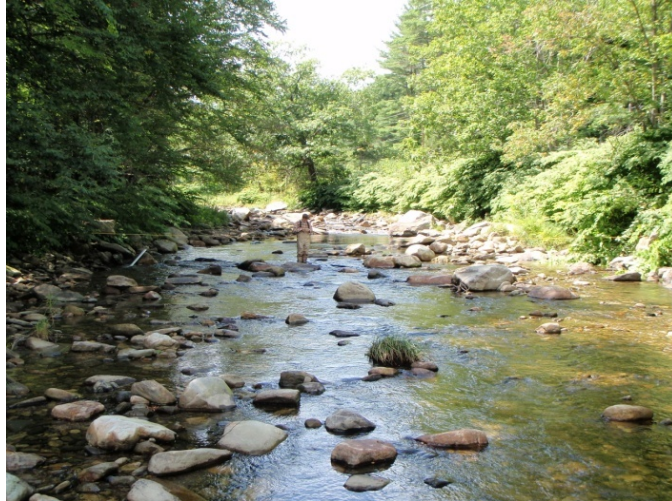
Figure 4.29 M13 cross-section with human elevated floodplain on right

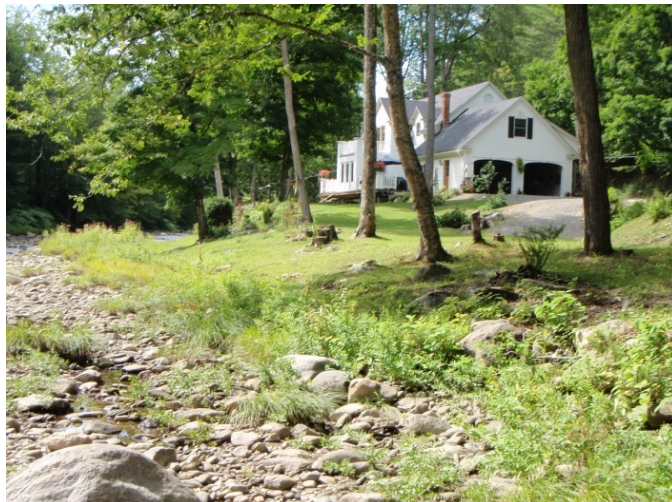
The encroachment from Route 121 has reduced the floodprone width and led to channel incision and loss of habitat. The reach is primarily adjusting by degradation and the channel is in stage II of the CEM (RGA score = "Fair"). Additional clearing in the buffer and along the left bank has further reduced LWD recruitment potential (LWD/mile = 29; Figure 4.30). Two large mass failures on right bank are supplying a moderate amount of sediment downstream. Also, a road ditch/tributary input off the left bank is rejuvenating and causing significant sediment to be washed downstream. Fine sediment in pools (pools/mile=22) and the loss of bank and buffer stability through encroachment and development has led to a decrease in the habitat quality (RHA score = "Fair").

Figure 4.30 Buffer clearing and development in the left corridor

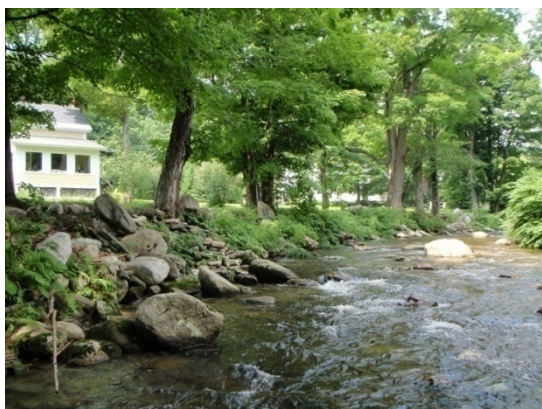
median particle size of 68mm. Rip-rap and hard bank armoring were observed from the reach break to about 200 feet upstream of the Main Street crossing (Figure 4.31). The total armoring spanned 46.5% and 17.5% of the channel length for the right and left banks, respectively (Figure 4.32). The armoring has limited the channel from its floodplain in some places natural floodplain is slightly raised (IR = 1.3). The Main Street crossing in Grafton Village is constricting the channel and causing some fine sediment to deposit upstream in a steep riffle.

Figure 4.31 Rip-rap on the right bank downstream of Main St

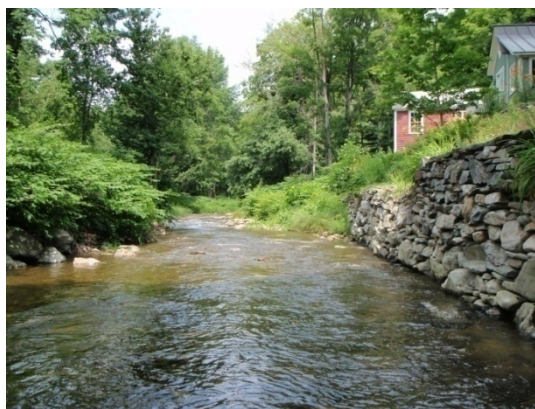
Figure 4.32 Hard bank upstream of the Main Street

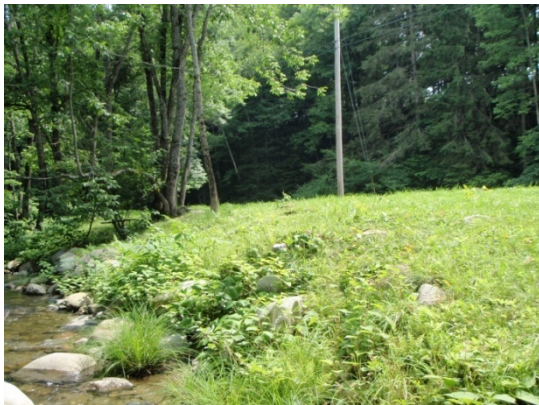
**Figure 4.33** No buffer and encroachment on the left bank

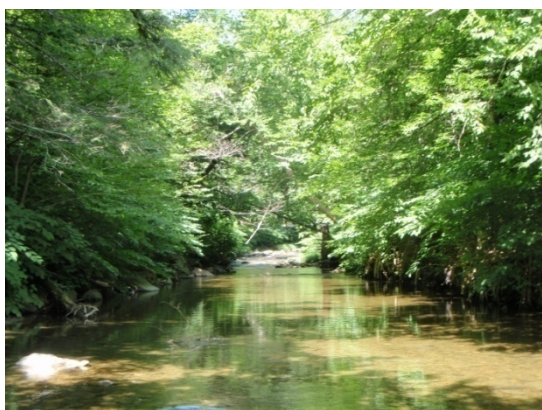
amount of fine sediment depositing upstream with very high embeddedness (Figure 4.36; Figure 4.37). Limited pools (pools/mile = 10) and woody debris (LWD/mile = 12), along with the encroachment reduced the habitat condition (RHA score = "Fair").

**Figure 4.36** Looking upstream at area with aggradation

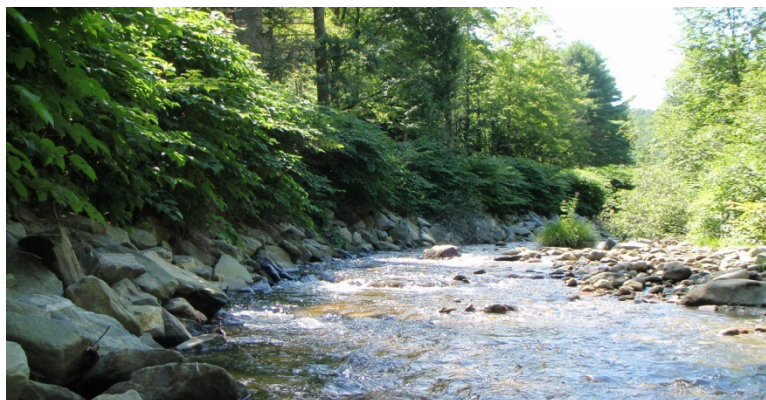
**Figure 4.38** Rip-rap and road fill on the right bank

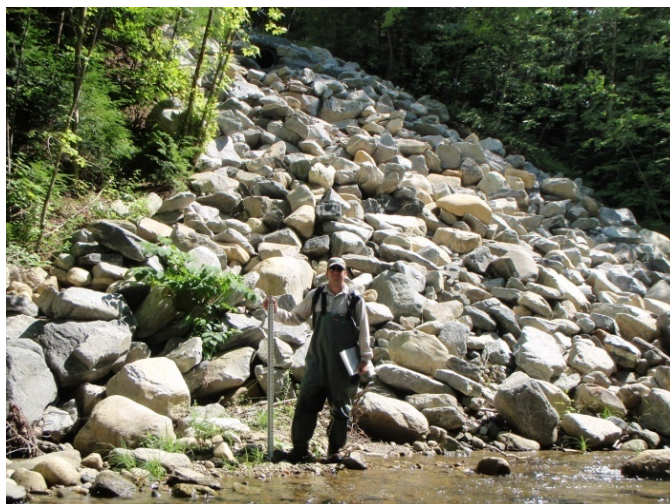
Figure 4.39 Mass failure on the right bank that has been heavily armored

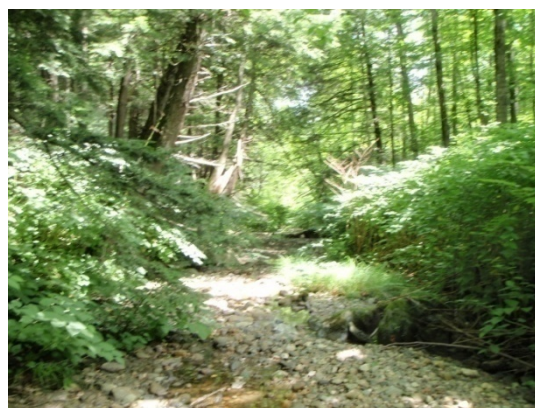
Figure 4.41 Flood chute off left bank that parallels Rt 121

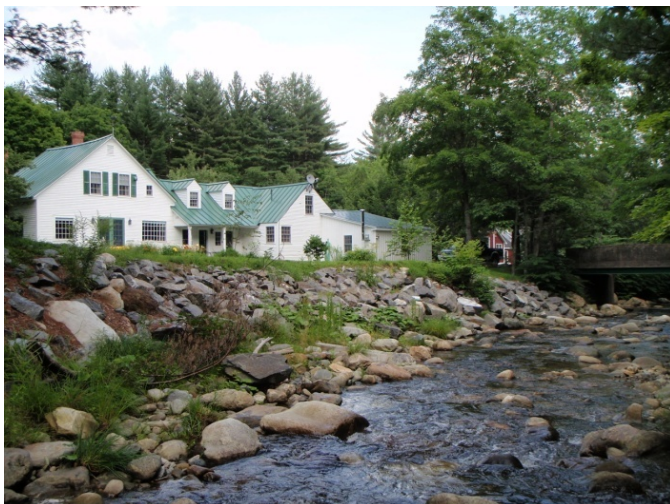
M19 is 1.1 miles long, with an average channel slope of about 3.4%. This reach begins at the change in confinement near the open field and continues along Route 121. Although the reach follows the road, the channel is not encroached heavily like most of the reaches downstream. The channel exhibits B-type morphology with step-pool bedform. The width-to-depth and entrenchment ratios are both indicative of the stream type, with no incision observed (WDR = 21.9; ER = 1.3; IR = 1.0). The dominant substrate is cobble (44%), with a median particle size of 63mm. There seems to be more of a plane bedform and a shallower slope on the downstream end of this reach, however, no segmentation was made because the downstream channel shared the same geometry as the area where the cross-section was taken upstream. The crossing at Cabell Road acts as a constriction to both the bankfull and the floodprone channel width and it is causing sediment to deposit upstream. The left bank both up and downstream of the structure is heavily rip-rapped and the buffer width is less than 25 feet (Figure 4.42).

Figure 4.42 Armoring and no buffer upstream of the Cabell Road Crossing on the left bank

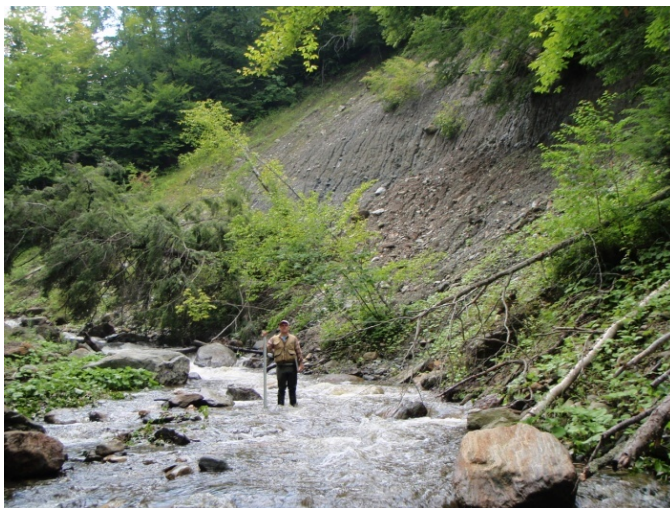
Figure 4.46 Large slope failure on the left valley wall

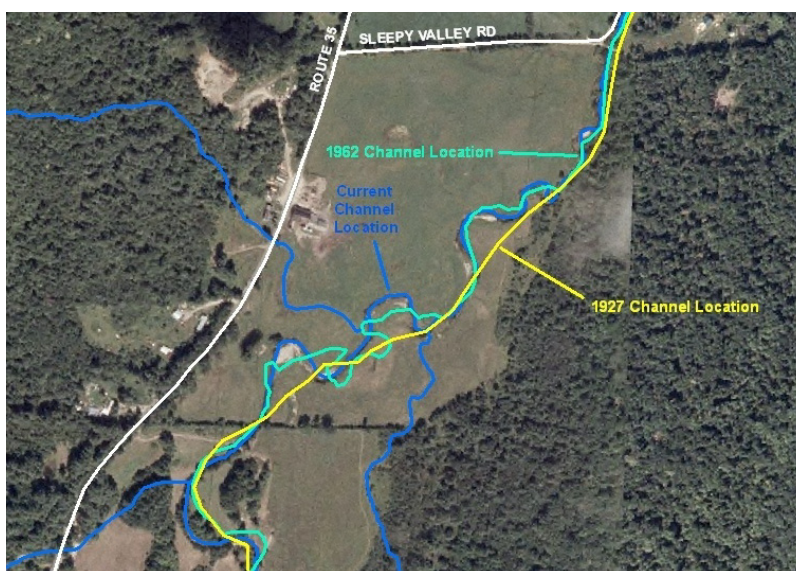
Figure 4.49 Historical channel straightening and redevelopment of meanders in T4.01-A, lower Bull Creek

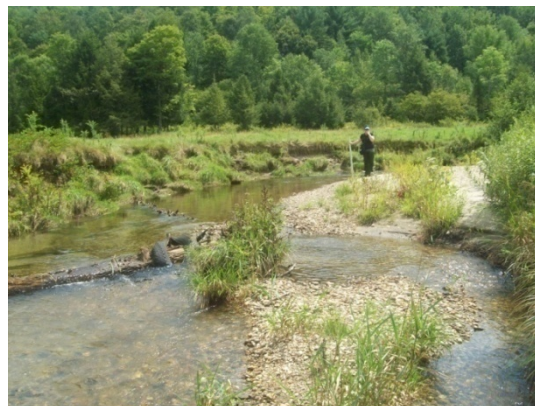
Figure 4.51 Bank erosion and widening in lower T4.01-A

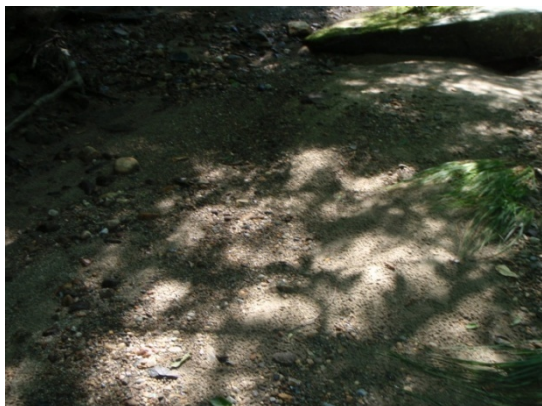
**Figure 4.55** Fine substrate deposits behind a boulder

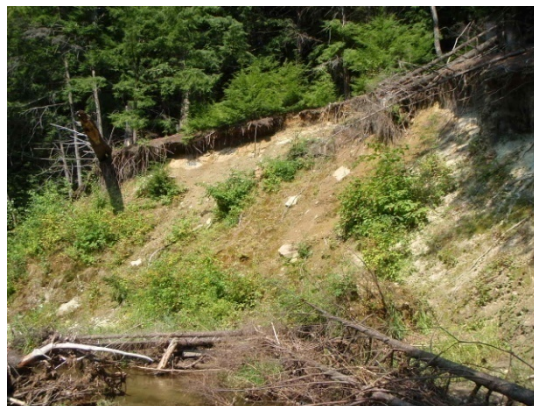
**Figure 4.56** Looking downstream at the mass failure

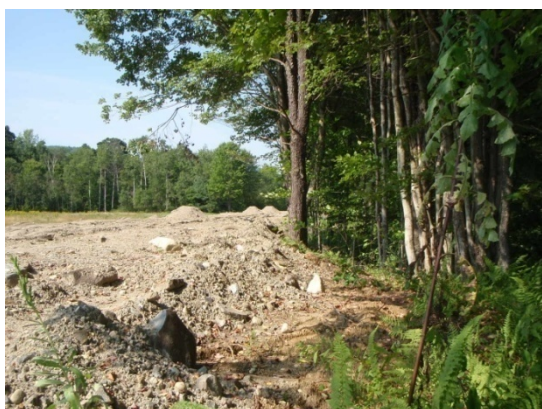
**Figure 4.57** Exposed surficial material with no sediment BMPs

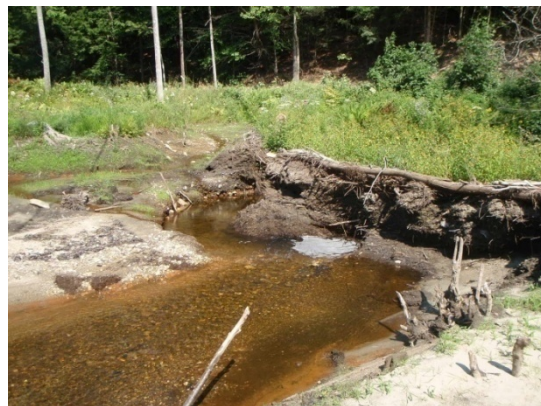
Figure 4.63 Looking downstream at the second breached dam

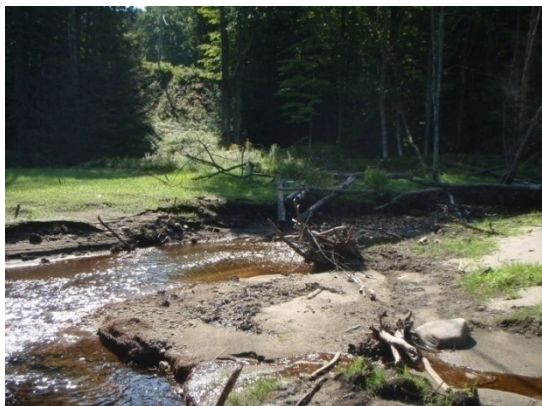
Figure 4.64 Widening channel upstream of the second dam

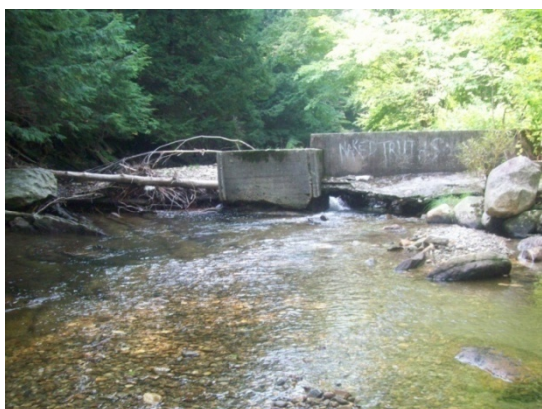
Figure 4.68 Breached dam upstream of Kidder Hill Road

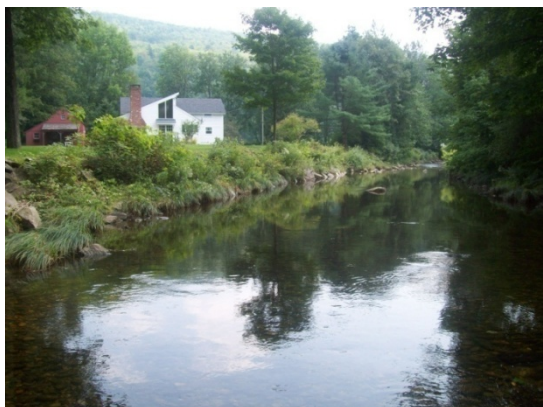
Figure 4.70 Bank armoring and development in the upper reach

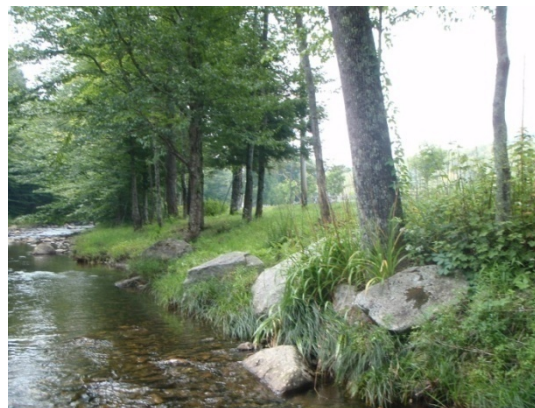
**Figure 4.73** Townshend Rd. encroachment with HEF and B<25ft

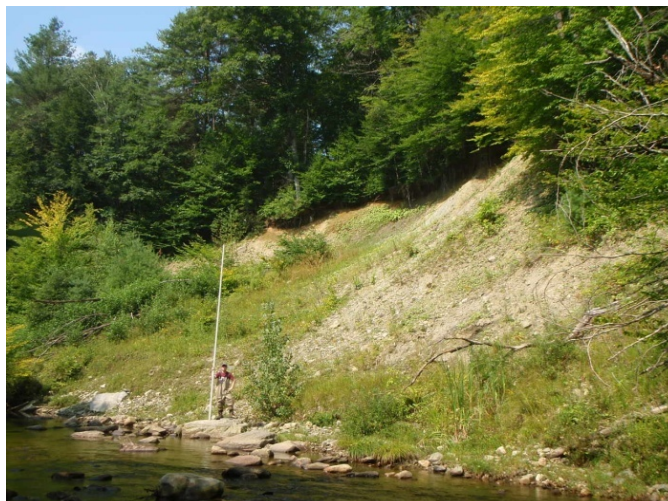
**Figure 4.74** Large mass failure located in the lower reach on the left valley wall

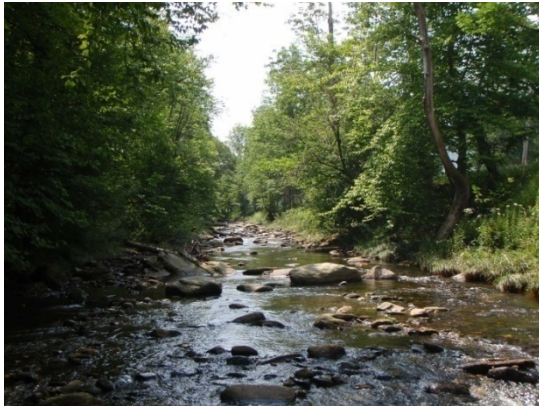
**Figure 4.75** Straightened channel with encroachment

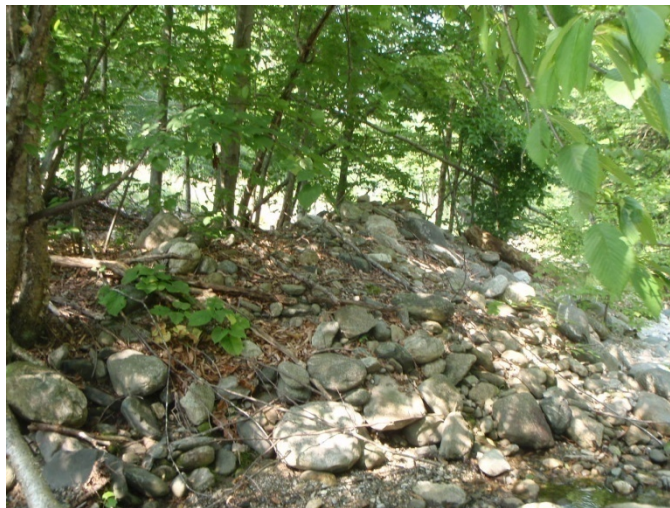
**Figure 4.77** Dredged materials on the left bank near the confluence with Willie Brook in the upper reach

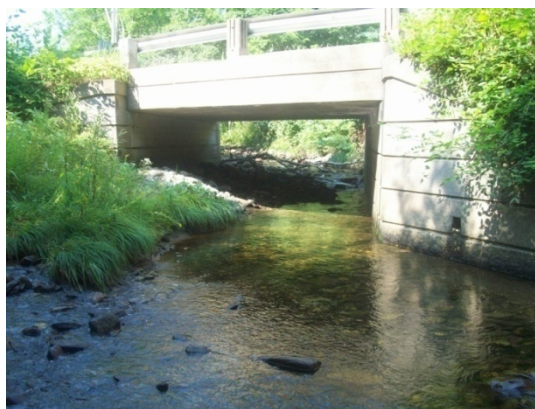
Figure 4.79 Sediment deposition within undersized bridge

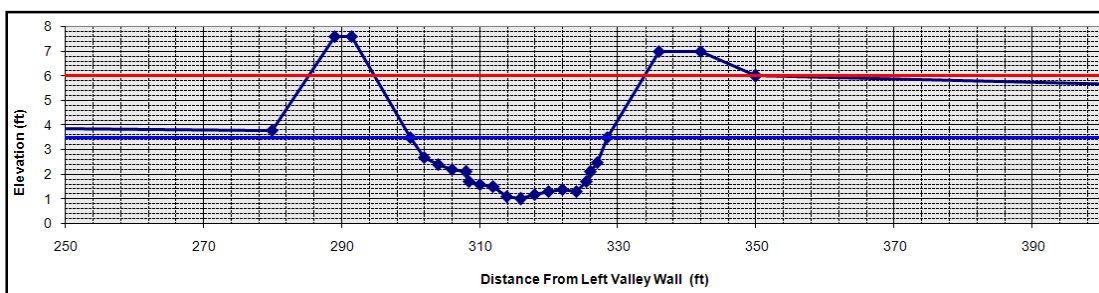
Figure 4.82 Cross-section of Willie Brook, showing berms along both channel banks

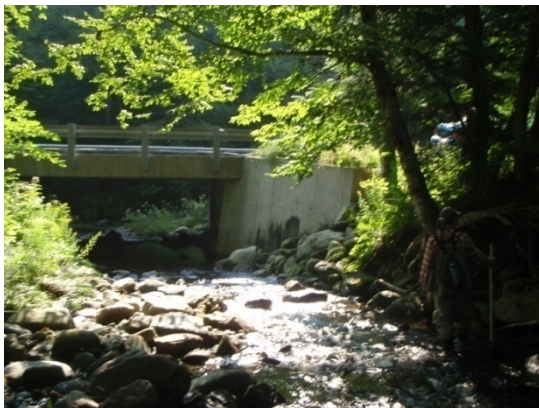
**Figure 4.84** Townshend Road crossing; dredging location

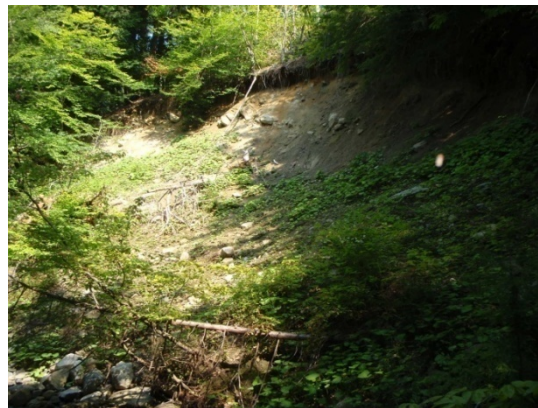
**Figure 4.85** Mass failure on the left bank

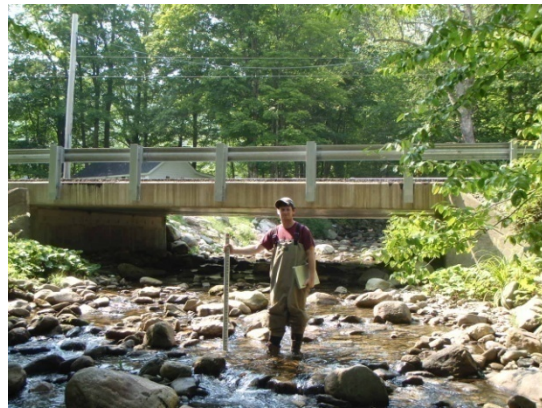
**Figure 4.89** Undersized crossing at Townshend Road
