**East Creek Corridor Plan
East Creek Watershed
Addison and Rutland Counties, Vermont
May 25, 2011**

Prepared for:
Vermont Agency of Natural Resources
River Management Program

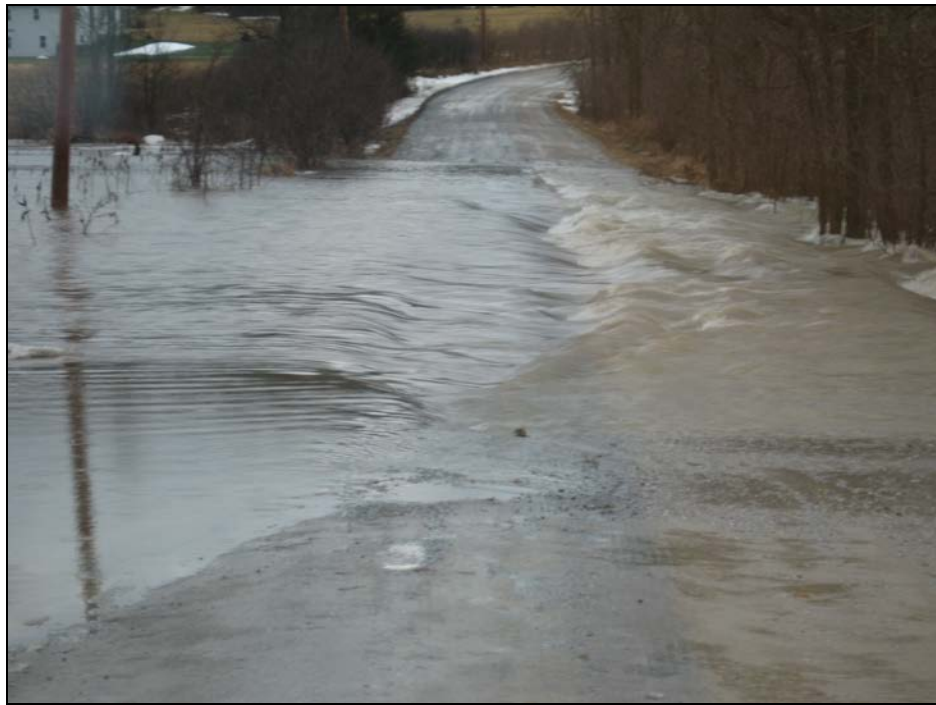
According to an East Creek watershed resident, the January 2006 flood event produced 10” of rainfall resulting in flooding within the watershed. In addition to North Cross Road at the confluence of the north and south forks (Reach M07), Old Stage Road flooded along the South Fork (Reach M06). Flooding was observed over the banks of the South Fork at the Cranberry Swamp Tributary confluence (Reach M09), as well as over Route 22A (south of the Route 73 intersection) by the Orwell Village Tributary (Reach T5).

Figure 5. Flooding of the South Fork (M07) at North Cross Road, January 18, 2006 (Photo provided by David Fedor-Cunningham)

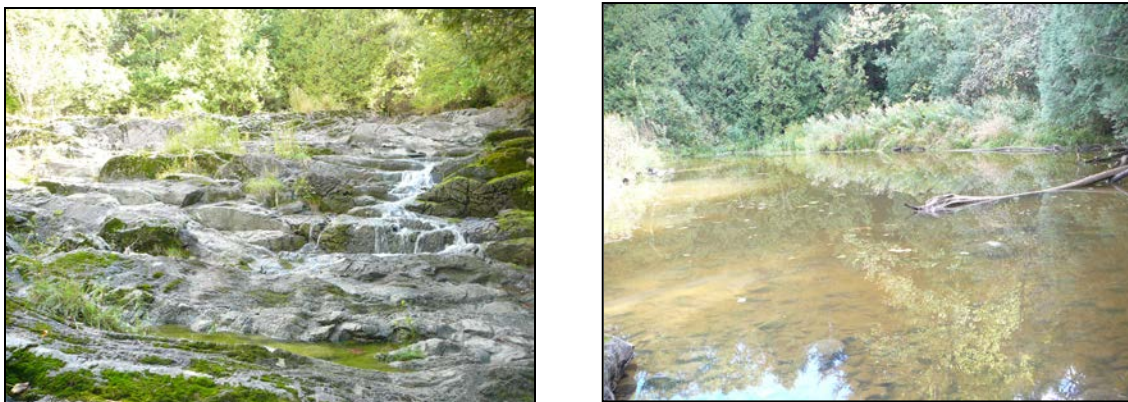
Figure 8. Bedrock Channel and large pool at upstream end of segment

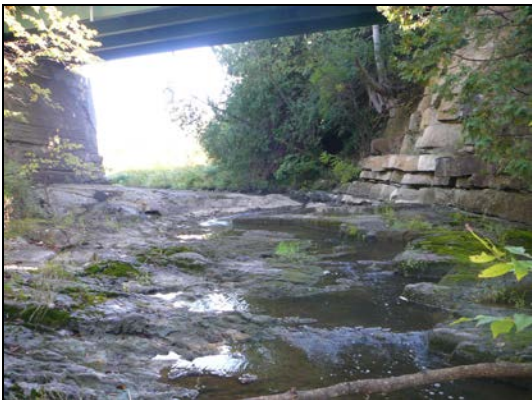
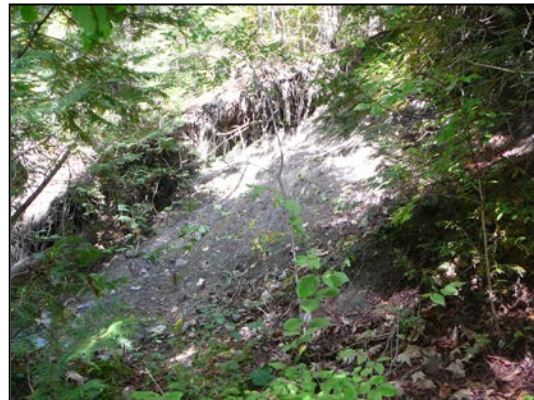
Figure 10. Photos looking downstream to the Route 73 bridge; and at a mass failure

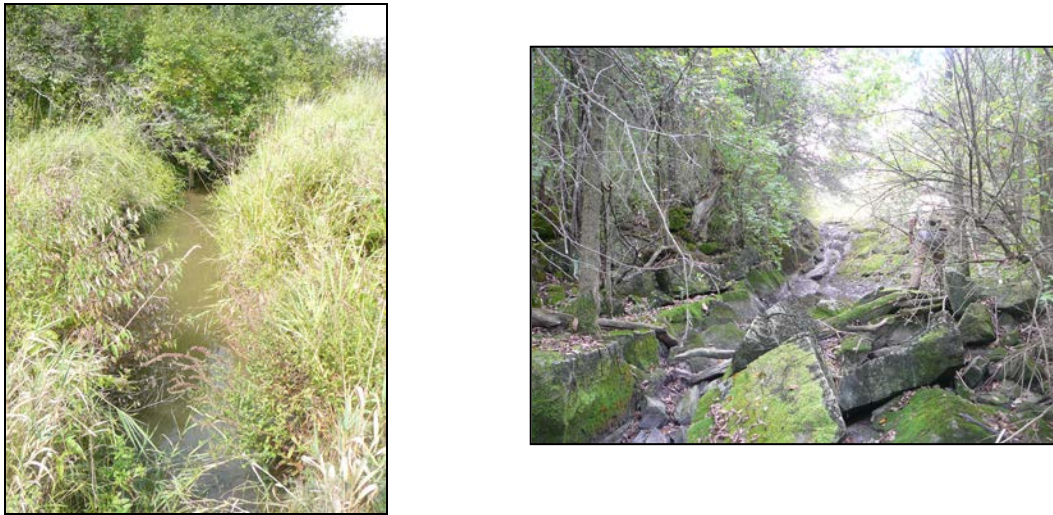
Figure 11. Photos at cross section and the upstream end of a bedrock grade control

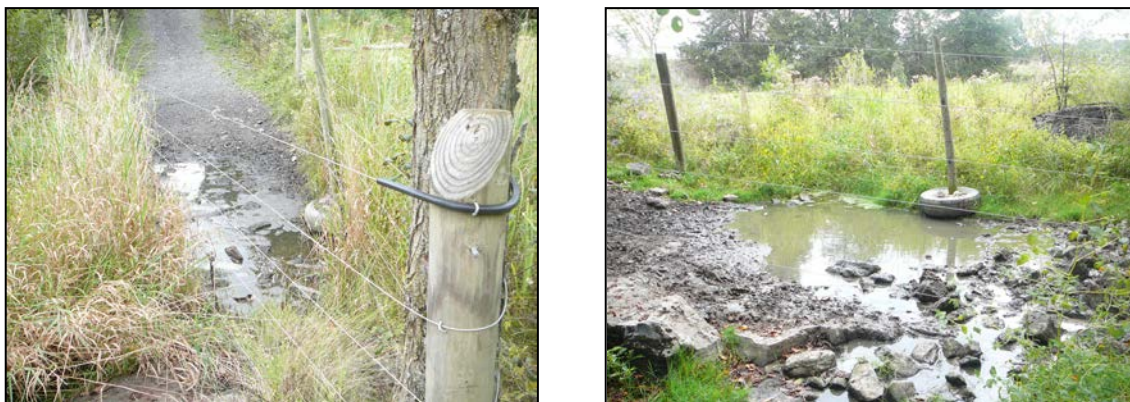
Figure 12. Cattle watering access and cattle crossing point

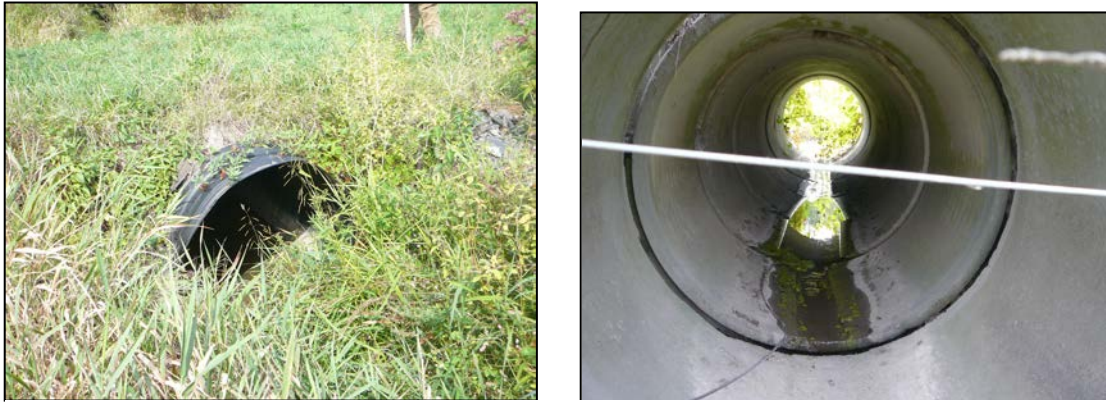
There are two undersized culverts within the reach. The Brown Lane culvert is only wide enough to support 45% of a bankfull flow event. Scour was observed at the upstream and downstream end of this structure. This culvert is made of concrete sections which have separated under the roadway. Water is flowing through the sections and undermining the structure. There is a 1' freefall drop from the culvert to the water surface at the outlet. There is a large pool at the downstream end of this structure. A single watering access is now located on the upstream end of the culvert. The farm road culvert, just downstream of the T4.02.S2.03 reach break, can only

support 27% of a bankfull flow event. Scour was not observed upstream or downstream of this structure.

Figure 13. Undersized culverts for a farm road and Brown Lane

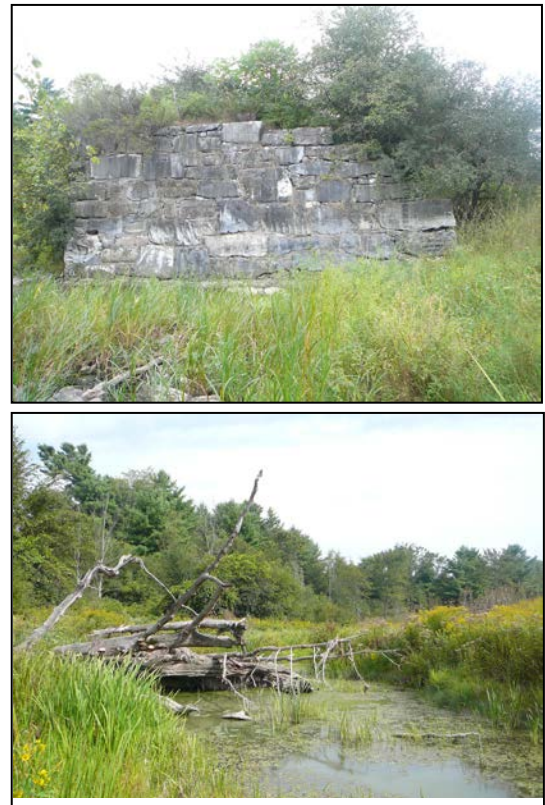
Figure 14. Old abutment on right bank and partial debris jam

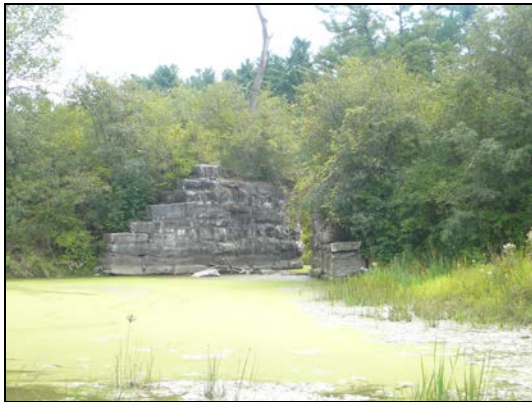
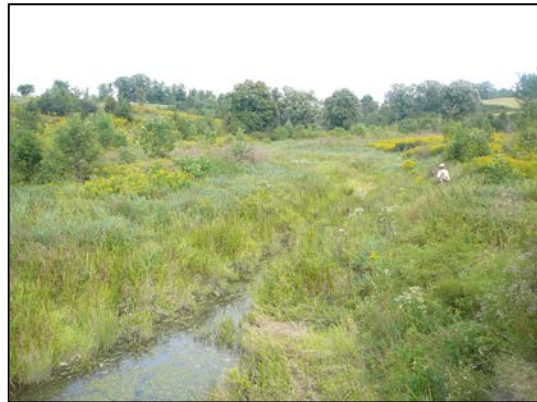
There are two structures (Rte 22A culvert and a farm bridge) within the reach, both of which support the bankfull flow event. Scour was observed at the upstream and downstream end of both structures. There is also an historic abutment at the downstream end of the reach. This abutment is not acting a channel constriction.

Figure 15. Old abutment on left bank and upstream view of channel from the farm bridge

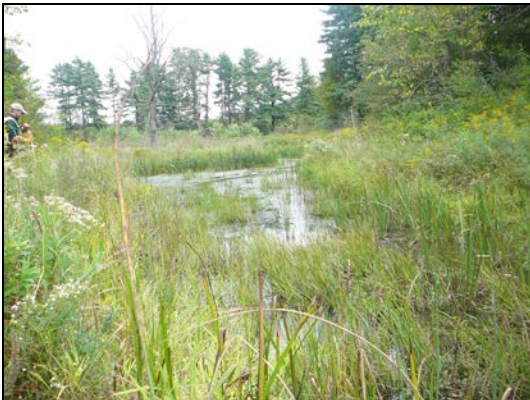
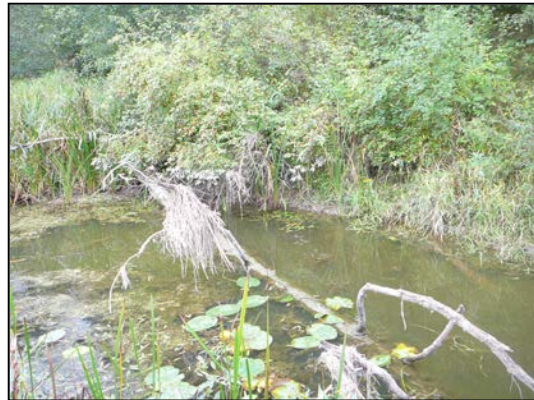
Figure 16. Photos of pool area created by artificial rock impoundment; and pool along the outside channel bend at the toe of the valley wall

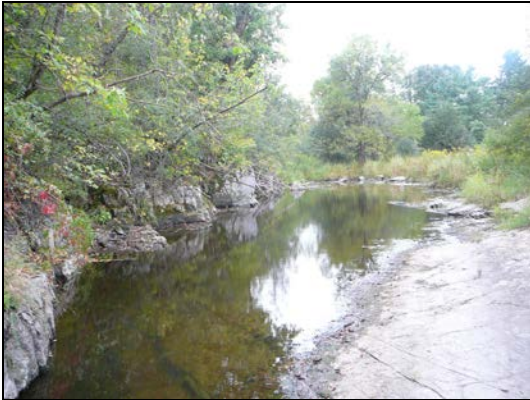
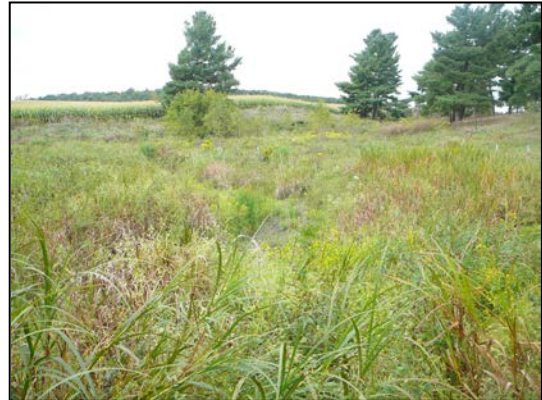
Figure 17. Pool downstream of grade control and dry channel downstream of beaver dam

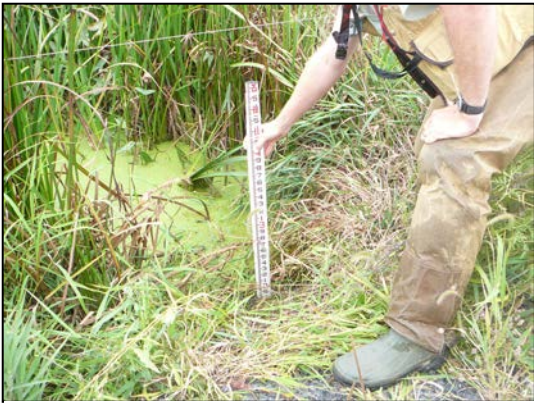
Figure 21. Undersized farm road culvert

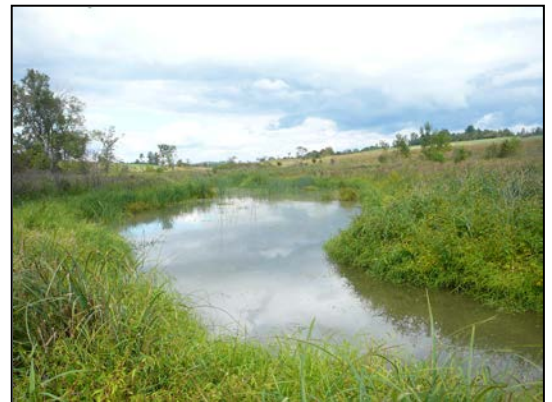
Figure 22. Impounded area at beaver dam

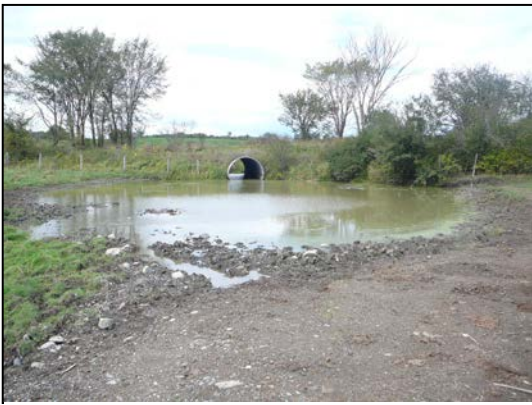
Figure 24. Upstream cattle crossing and watering hole

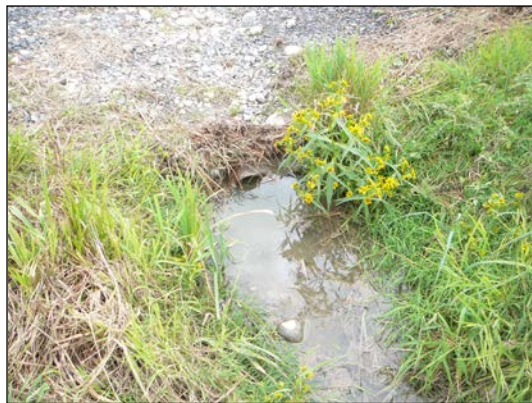
Figure 25. Undersized, squashed culvert

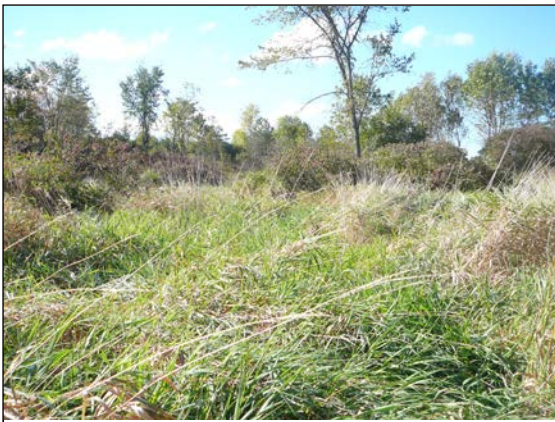
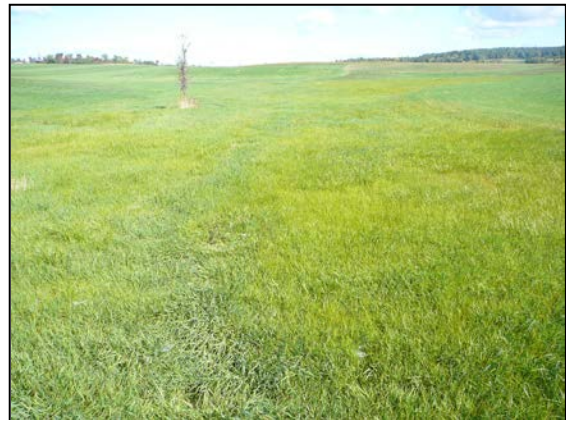
Figure 26. Dry channel meandering through reed canary grass and dry channel downstream of Route 73 culvert

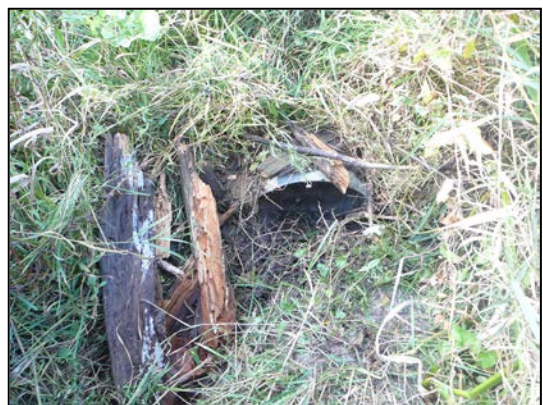
There are three instream culverts within the segment, two of which (Rte 22A and Rte 73 crossings) support the bankfull flow event. The Rte 22A culvert is partially backwatered at the outlet. The bottom of this culvert is rotten with water flowing around and under the structure. The third culvert is associated with a farm road at the upstream segment break and is only wide enough to support 42% of a bankfull flow event. A sag in the roadway was observed possibly indicating a

Figure 27. Upstream invert of farm road culvert

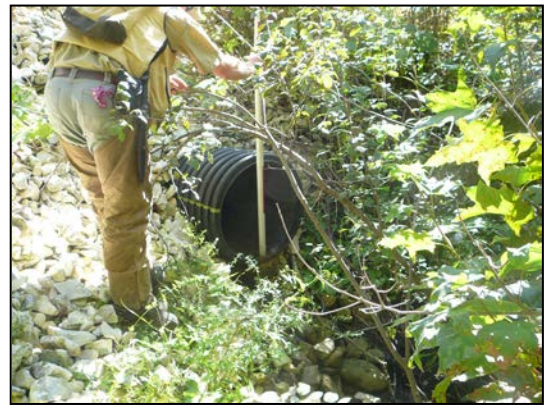
There is one instream culvert in the segment, under North Orwell Road, that is only wide enough to support 33% of a bankfull flow event. Scour was not observed at the upstream or downstream end of this structure. This culvert has a 3' freefall drop at the outlet.

Figure 29. North Orwell Road culvert

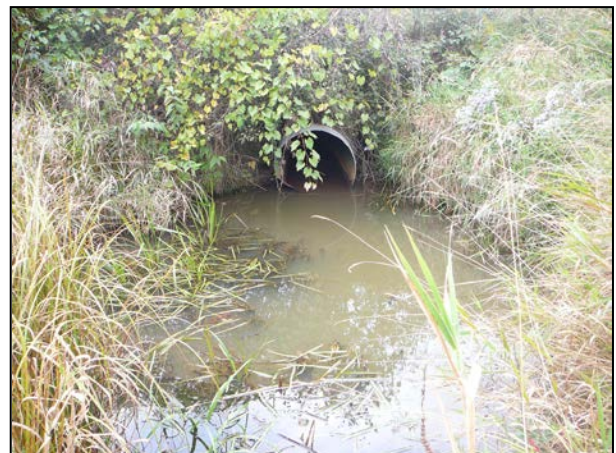
Figure 32. Outlet of Old Stage Road culvert

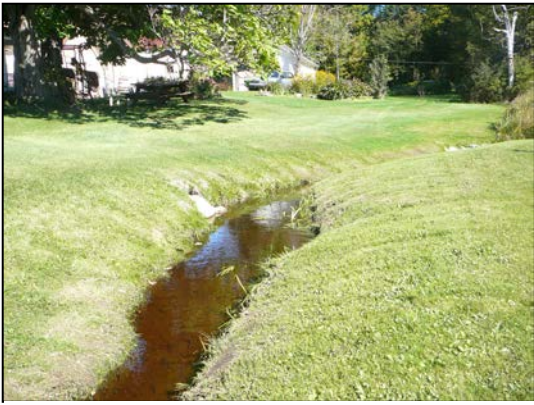
Figure 35. Poor buffers at downstream end of segment

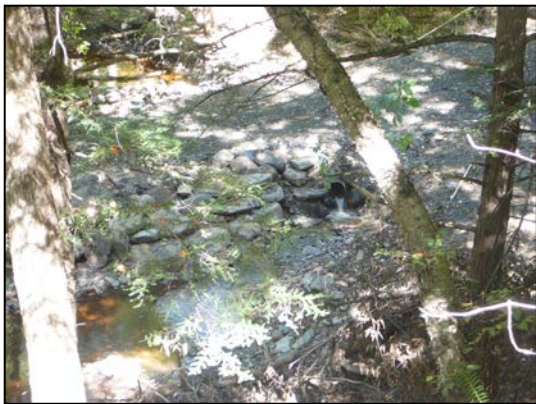
the valley wall has occurred in this location as well as a stream excavation and installation of what appears to be an undersized culvert. The stream was not accessed in this location due to difficult access conditions.

Figure 36. Private culvert with 12' freefall

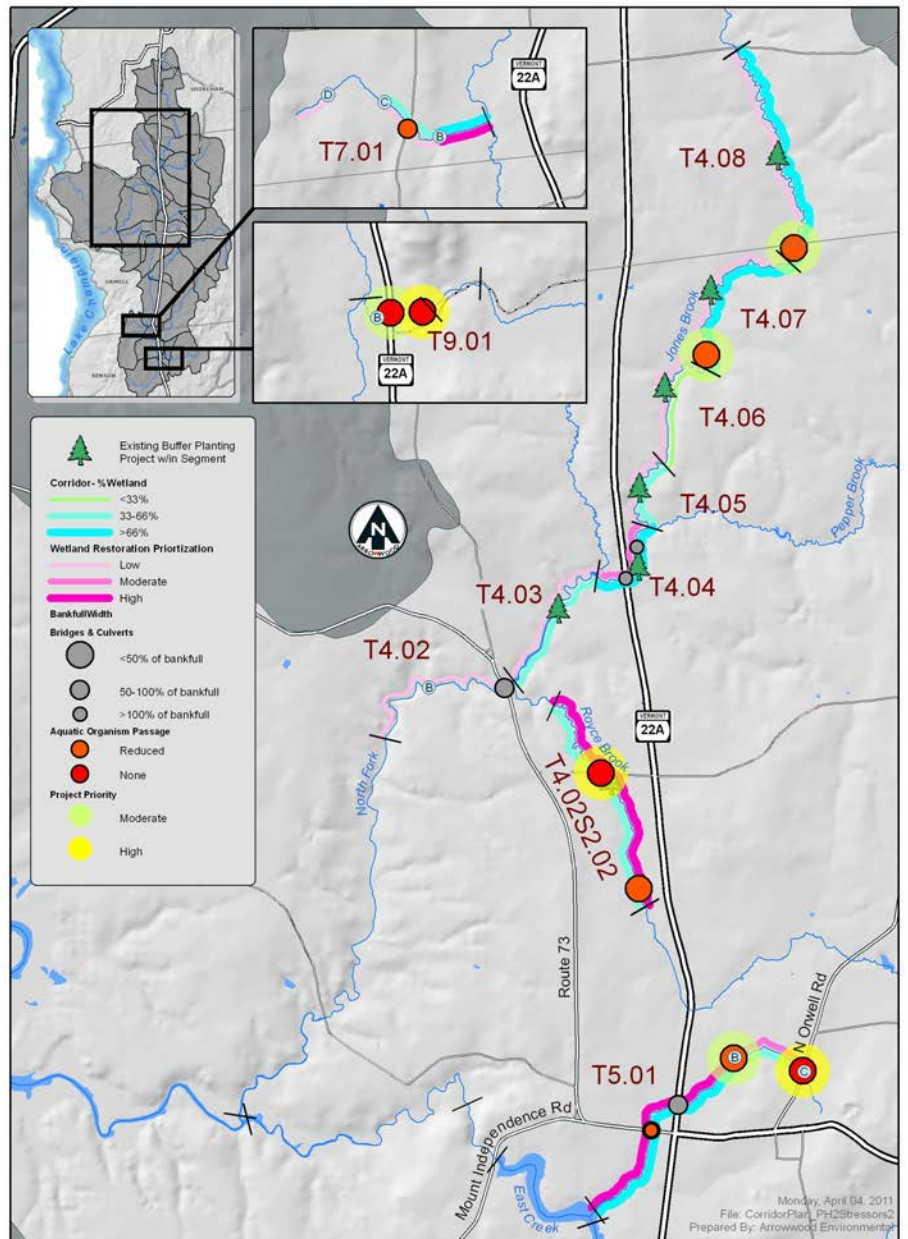
Eight structures were identified during the Phase 2 field assessments as priority projects for repair or replacement. These priority structures are located in T4.02S2.02 (Brown Lane culvert and a farm road culvert), T4.07 (farm road culvert), T4.08 (farm road culvert), T5.01A (farm road culvert), T5.01B (North Orwell Road culvert), and T9.01B (Private Drive off of Perch Pond Road and Route 22A culvert). Figure 38 presents the problem structures with the watershed study area based on percentage less than bankfull.

Figure 38. Problem Structures and Wetland Restoration Potential Map
