# River Corridor Plan for Mill Brook in Windsor, West Windsor, and Reading, Vermont

May 29, 2015

**Fitzgerald Environmental Associates, LLC.**

**Southern Windsor County Regional Planning  
Commission**

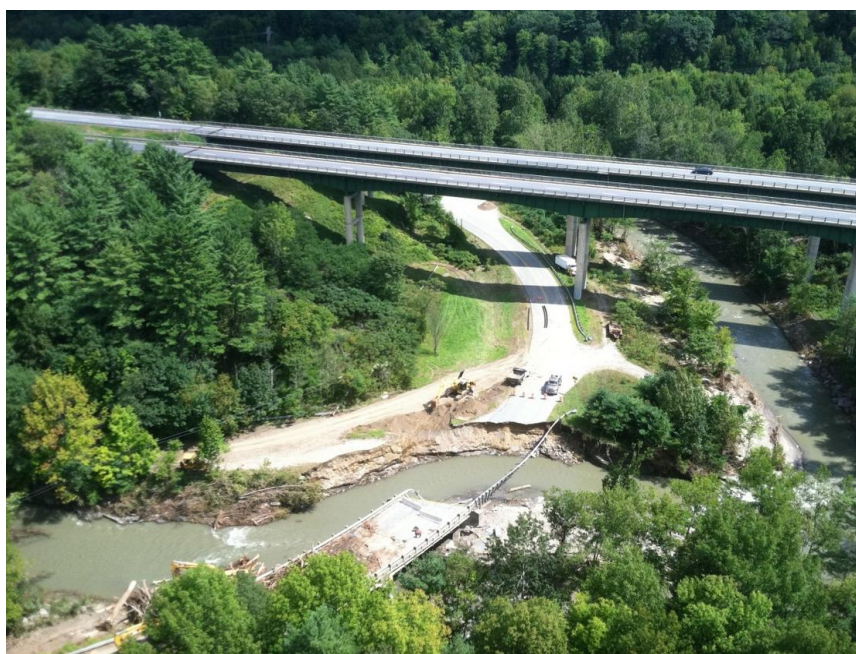
**Figure 1.9:** Route 44 bridge approach destroyed in Reach M04.

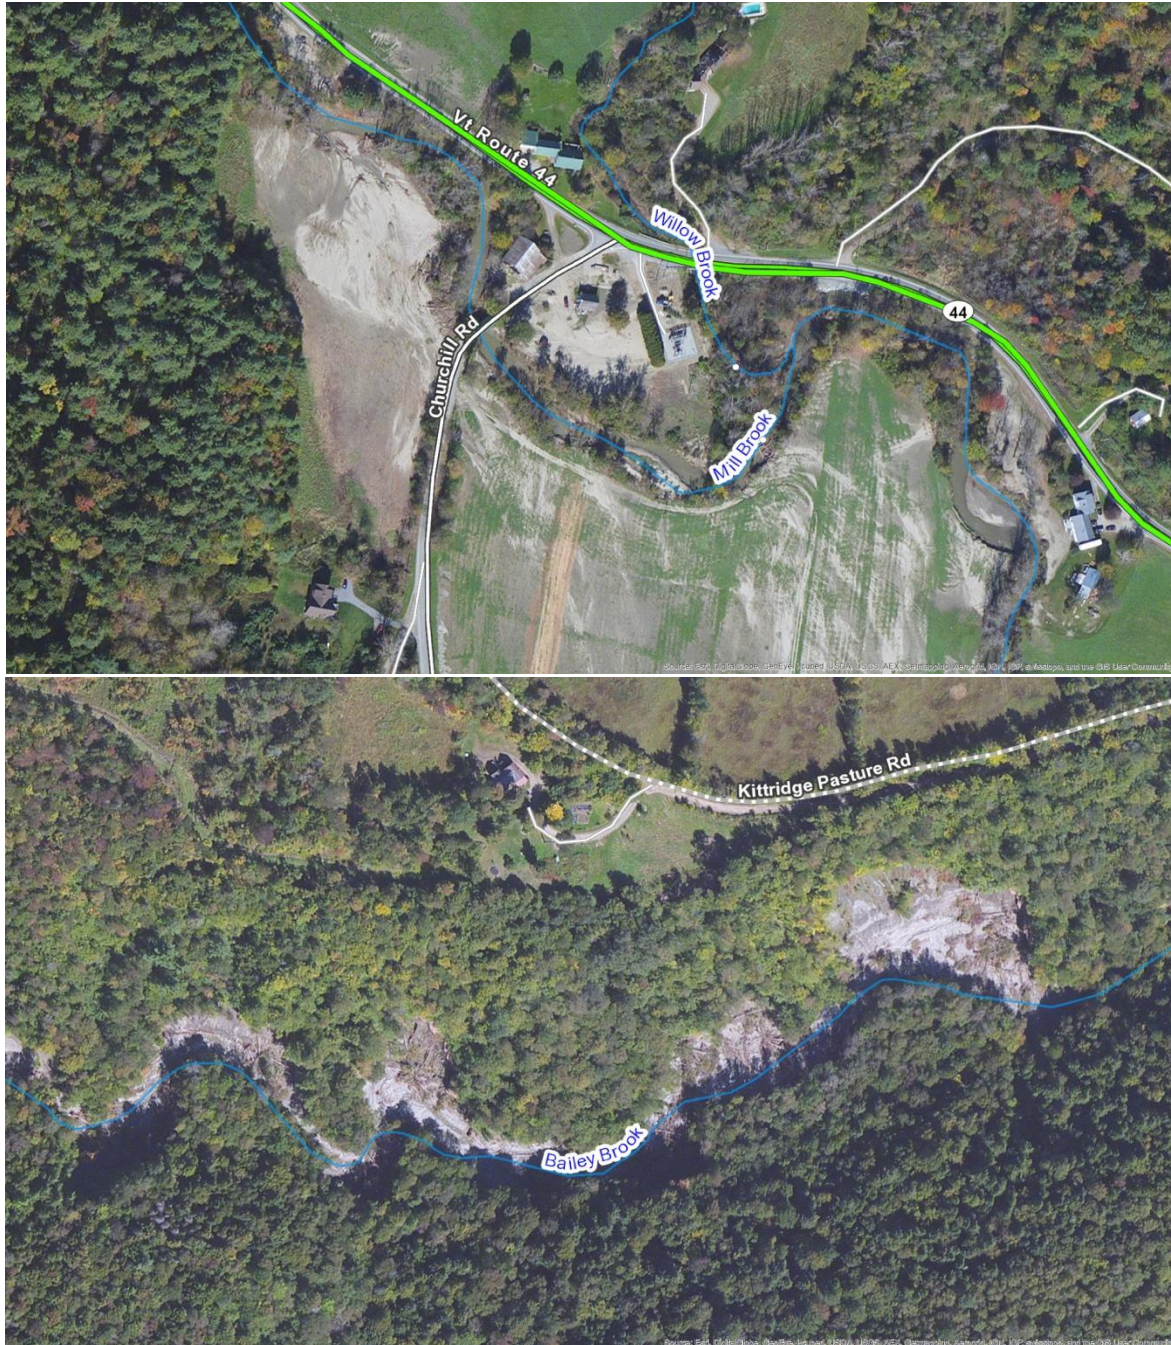
**Figure 1.10:** Evidence of major flooding, erosion, and bank failure along Mill Brook Reach M10 (upper) and Reach T4.02 (lower).

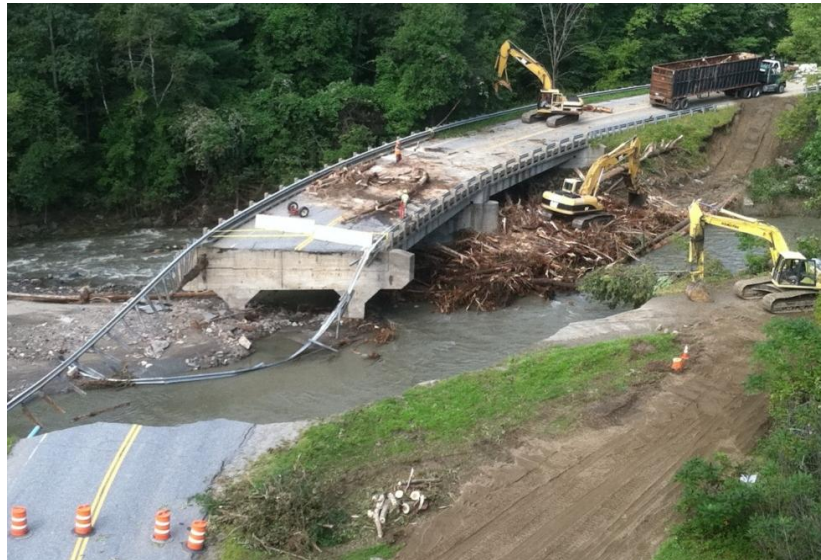
**Figure 5.1:** Tropical Storm Irene damage to the Route 44 bridge over Mill Brook in reach M04 (photo from [www.windsorvt.org](http://www.windsorvt.org)).

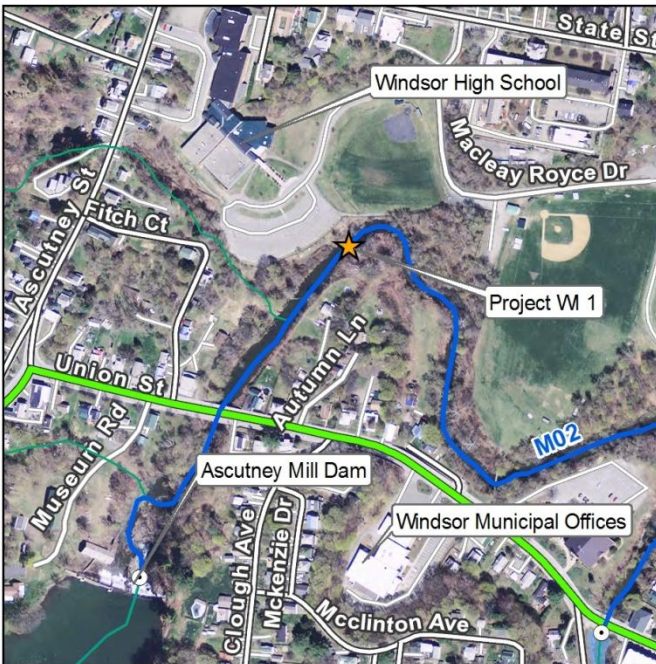
### Project WI 1 - Windsor High School Sewer Line

Reach M02 is bounded by the small dam near the American Precision Museum and by the large Ascutney Mill Dam creating Mill Pond. The reach flows through a densely developed residential and commercial area in downtown Windsor. As a result of historical straightening and bank armoring, the channel is incised and floodplain access is limited to the left bank along the Windsor High School athletic fields during large storm events. An active sewer line from the High School crosses Mill Brook approximately 650 feet downstream of the Union Street bridge. The sewer line is protected by a steel casing and is supported by three concrete piers, one of which is located in the center of the channel. The sewer line spans the channel at approximate bankfull elevation, and becomes fully submerged during large

We recommend an alternatives analysis to assess options to re-route the sewer line or replace the existing structure to improve flood capacity and reduce the risk of debris jamming. We discussed this site with Mike Reynolds, an operator at the Windsor Sewer Plant, and they are aware of the issues and concerned about flooding risks. Potential project partners and funding sources for this project include the Town of Windsor and FEMA.

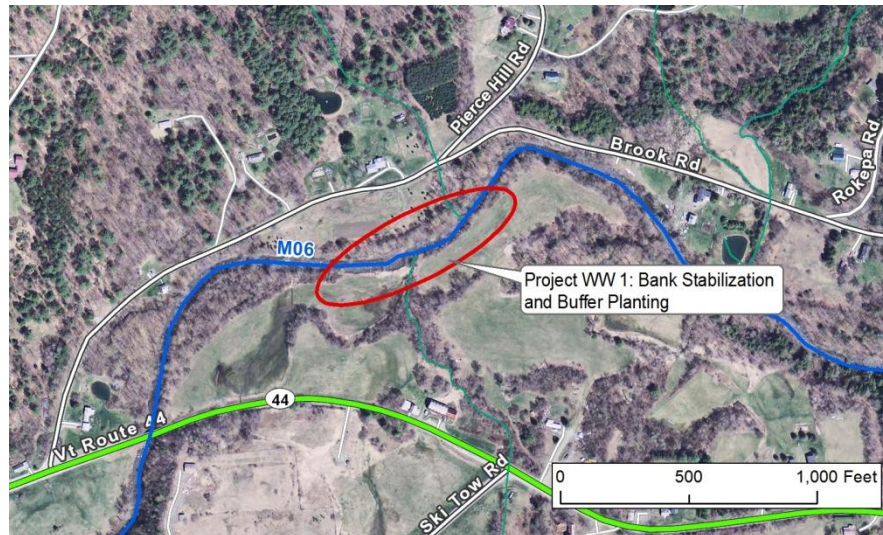
### Project WW 1 - Bank Erosion along Hayfield

A large bank erosion site is located in Reach M06 where the right bank is carving into a hayfield with minimal woody bank/buffer vegetation. This reach was likely straightened historically causing the channel to incise and limit floodplain access. Tropical Storm Irene triggered some widening and planform adjustment leading to bank erosion in areas with reduced stabilization from bank and buffer vegetation. Project WW 1 is a 750 foot long eroding bank that is typically 7 feet high.

Based on pre-Irene aerial imagery, the channel has migrated approximately 70 feet to the southeast over the last five years. This erosion will continue to contribute large volumes of sediment to the Brook, and may accelerate with ongoing planform adjustments. A utility pole is located near the middle of the project area and is currently 25 feet from the top of the eroding bank.

We recommend an alternatives analysis to determine the feasibility of re-grading and stabilizing the bank. A "do nothing" approach may be appropriate to allow the channel to develop a meander sequence and build an accessible floodplain area. Bank and buffer plantings should also be considered and could be paired with stabilization using rock or wood along the toe of the bank. The utility pole should be moved or monitored for stability. VTANR ERP, private landowner, VLT, and ONRCD Trees for Streams are all potential project partners.

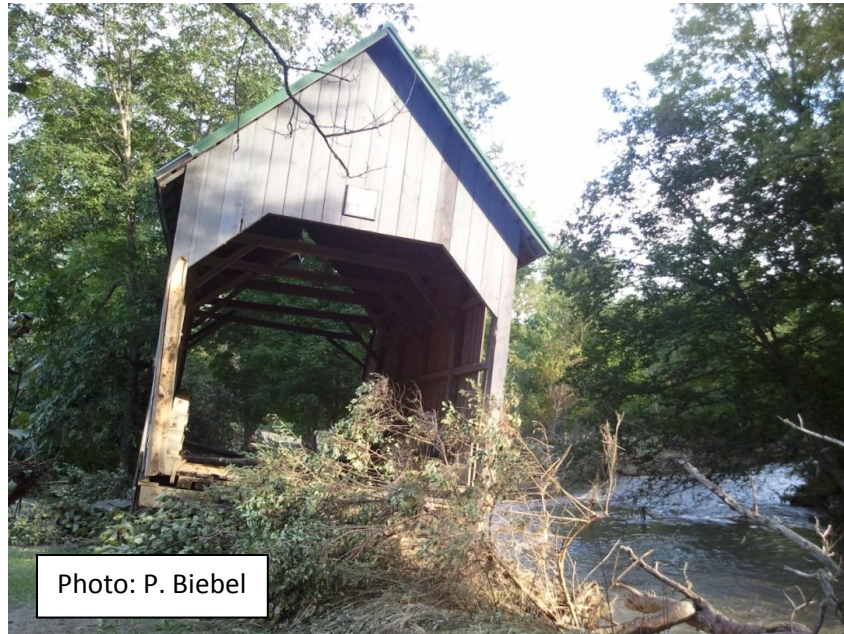
### Project WW 5 - Bible Hill Road Covered Bridge

The Bowers covered bridge on Bible Hill Road crosses Mill Brook at the upstream end of Segment M07.B. The original bridge was constructed in 1919 and was heavily damaged in T.S. Irene when the bridge was lifted off of the abutments and carried downstream to the Biebel property. The original abutments were a major channel constriction and caused increased flooding and debris jamming during T.S. Irene. The covered bridge was rebuilt and installed in 2012, however the new concrete abutments are also a major channel constriction at 36 feet. The predicted bankfull channel width and the measured bankfull width are 54 feet and 51 feet, respectively.

We recommend replacing the bridge with an appropriately sized structure to increase geomorphic compatibility and reduce flooding risk. The bounding reaches are incised and fairly stable so a structure designed to the bankfull channel width will be sufficient. The covered bridge could be relocated to a crossing where the span is appropriate. VTrans and the Town of West Windsor are potential partners for this project.

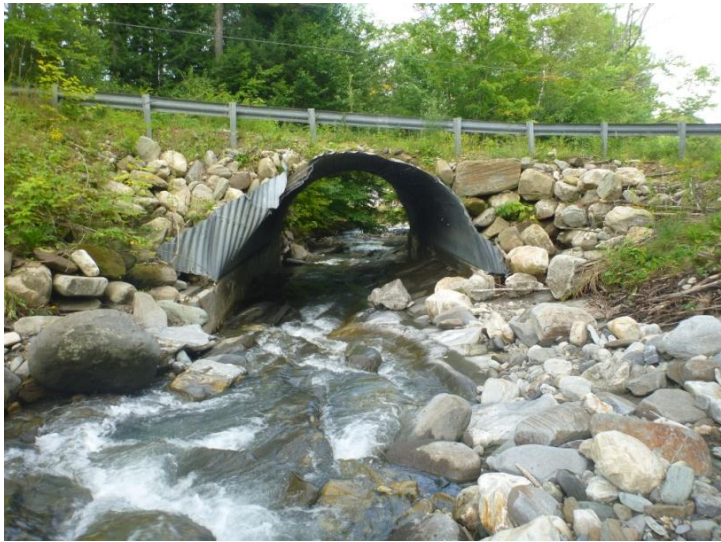
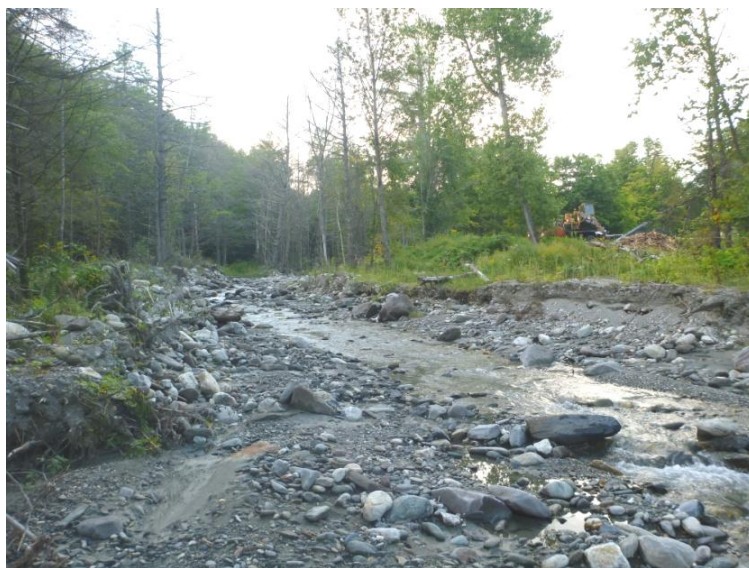
### Projects RE 20 and RE 21 – Bailey Brook Alluvial Fan Restoration and Flood Mitigation

Bailey Brook flows out of steep, mountainous terrain and reaches a significant transition point near the intersection of Baileys Mills Road and Town Farm Road. At this point (Segment T4.01.A), the slope of the river decreases and the river valley widens. In geologic terms, this area is referred to as an “alluvial fan,” where the sediment and debris carried by the brook settles out across the valley. Exacerbating this natural deposition process is a bridge-arch structure underneath Baileys Mills Road that is undersized for the channel. The post-Irene channel width varies between 40 and 50 feet in segment T4.01.A, while the arch width is only 19 feet. During Tropical Storm Irene flooding, tremendous amounts of sediment and debris generated from upstream mass failures along Bailey Brook were deposited over this alluvial fan. The debris field extended over 1,000 feet upstream along Bailey Brook and Town Farm Road. The channel is actively carving and braiding through these deposits. Many of the trees within the pine/hemlock floodplain forest along Town Hill Road are dead due to girdling from flood sediments. Berms are disconnecting the floodplain in one location, and bank erosion is severe throughout.

Given the severe instability of the upstream banks and valley walls, and the amount of sediment and debris in the river corridor waiting to be carried down to the alluvial fan in the next flood, we expect the degree of risk and conflict at this site to worsen during future floods. We recommend that the Town

complete an alternatives analysis to evaluate options for alluvial fan management. Options may include: 1) Replace arch with a larger structure to maximize capacity over the bedrock grade control; 2) Road or intersection realignment to southwest to accommodate alluvial fan flooding; 3) Berm removal, dead tree removal, and re-vegetation of the floodplain along Town Farm Road. With any of these alternatives, local flood hydraulics and sediment transport will need to be analyzed carefully to ensure that risks to downstream property are not increased. If this area has experienced repeat flood damage, it may be eligible
