# Cambridge, Vermont Seymour River Corridor Plan

May 31, 2018

Prepared by:  
Bear Creek Environmental, LLC  
149 State Street, Suite 3  
Montpelier, Vermont 05602

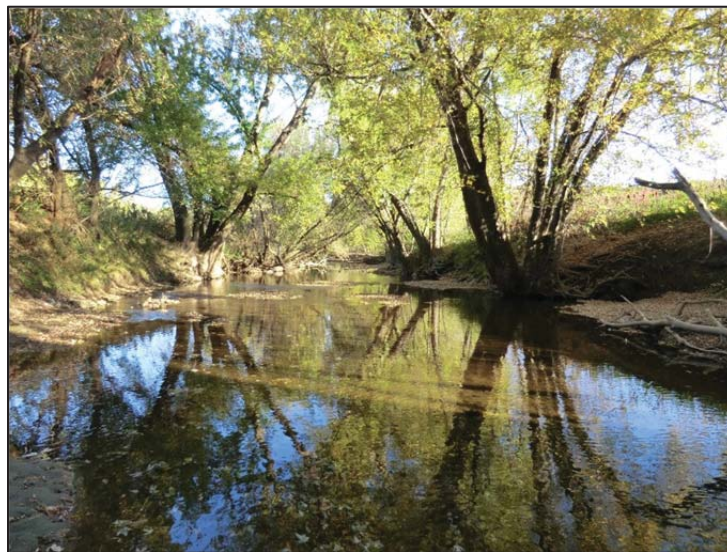
The downstream segment on reach M01 begins at the confluence with the Lamoille River and continues upstream for just over 500 feet to the Gates Covered Bridge. This segment is characterized by a very low slope and plane bed bedform, having very few channel features such as riffles and pools. The entirety of the segment appears to have been historically straightened due to the presence of adjacent agricultural lands and Vermont Route 15 just to the west of the river. This historic straightening has led to severe historic incision, causing a stream type departure and loss of floodplain access in M01-A. Areas of bank armoring and very large trees growing on the river banks are preventing channel widening from occurring here. For these reasons, M01-A is in **fair** geomorphic condition. The Seymour River is also in **fair** habitat condition in this segment due to lacking riffle and pool features and impacted riparian buffers.

Figure 5.1. Straightened, featureless channel in M01-A.

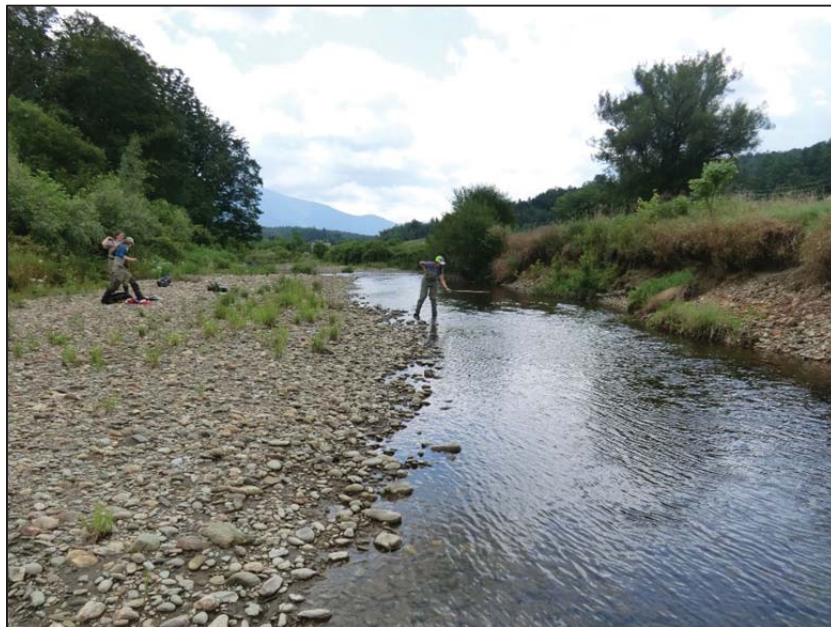
The downstream segment on reach M06 begins just downstream of the first bridge on Lower Pleasant Valley Road and extends upstream for approximately 2,600 feet to near 1680 Lower Pleasant Valley Road. The Seymour River flows through a very broad valley in this segment and is characterized by abundant large depositional features, as well as planform change. The stream channel has aggraded and widened within this segment, which has resulted in a stream type departure. As aggradation continues over time, the channel will likely narrow again as the depositional features form a juvenile floodplain. Moderate historic incision has occurred within M06-A, and historic channel straightening was noted at and downstream of the Lower Pleasant Valley Road bridge. M06-A was placed in **fair** geomorphic condition due to abundant adjustments currently occurring within the segment. Similarly, it is in **fair** habitat condition as a result of the wide, shallow channel found throughout most of the segment and the lack of bank and buffer vegetation.

**Figure 5.7.** Cross section of M06-A showing major aggradation and widening.

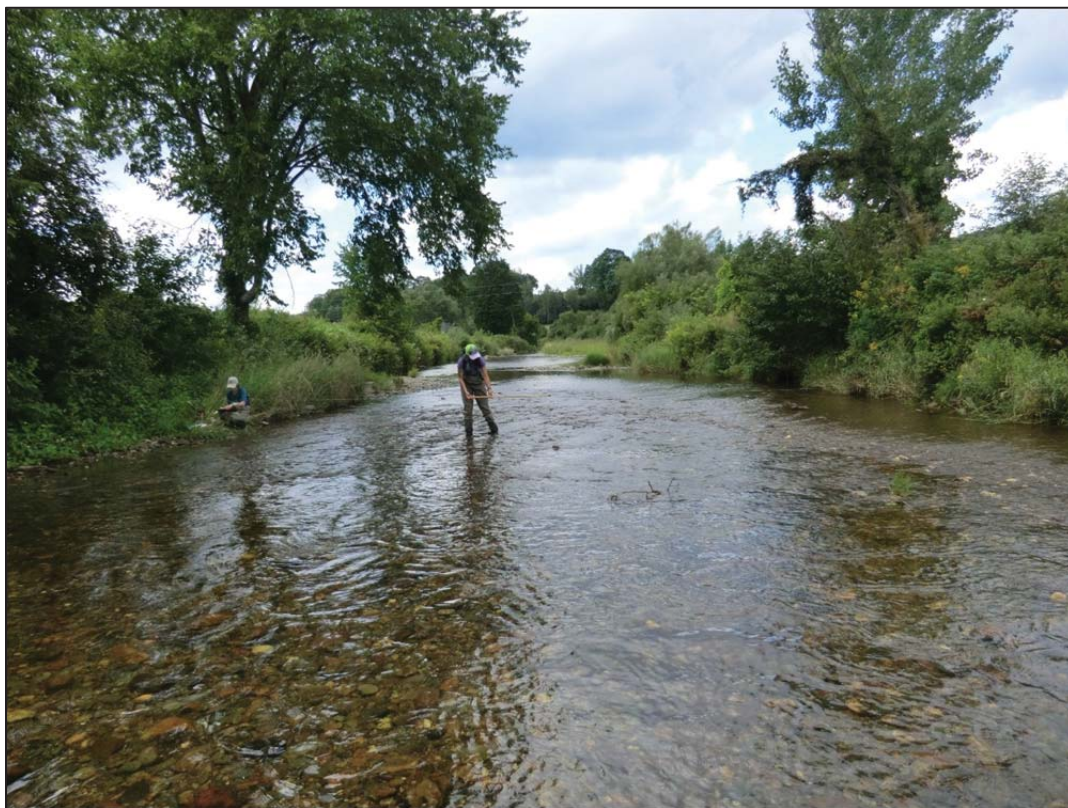
**Figure 5.8.** Straightened channel in M06-B.

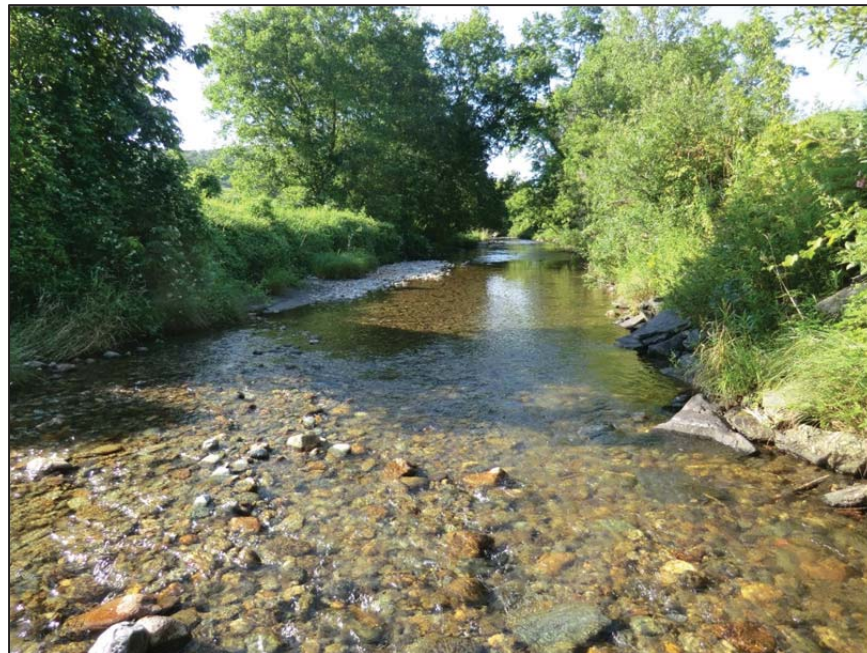
The downstream segment on reach M08 flows for roughly 1,200 feet through a very broad valley along agricultural lands. This segment appears to have been historically straightened in its entirety due to surrounding land uses. Riprap is common along both banks throughout the segment. Major historic incision has occurred within M08-A as a result of historic channel management, however, a stream type departure was not noted based on channel dimensions. Channel widening is prevented by abundant bank armoring. For these reasons, M08-A is in **fair** geomorphic condition. Additionally, historic straightening and degradation have resulted in the loss of riffle-pool bedform within this segment and conversion to a featureless, plane bed system. This, in addition to lacking woody debris cover and reduced bank and buffer vegetation, led to the placement of M08-A in **fair** habitat condition.

**Figure 5.11.** Straightened, featureless channel in M08-A.

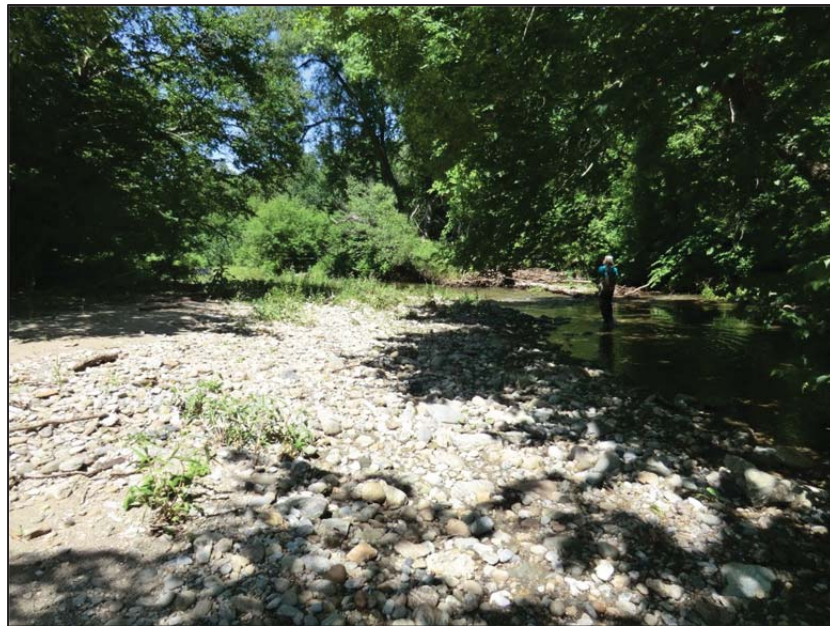
**Figure 5.15.** Large bar feature and very wide channel characteristic of M10-B.

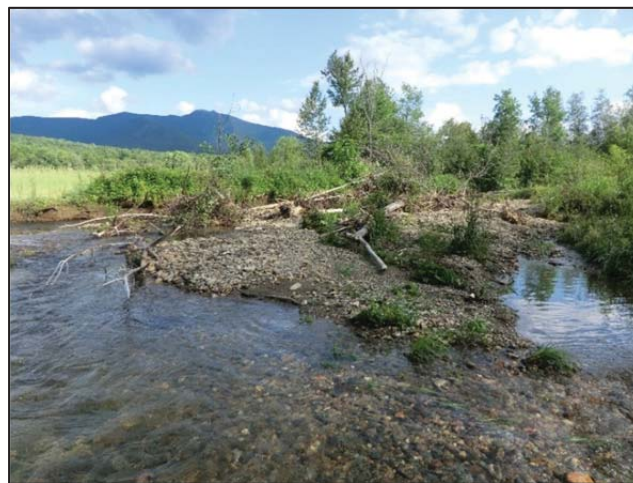
The downstream segment on reach M12 is characterized by extreme aggradation. The river flows through a very broad valley for roughly 3,000 feet from near the intersection of Lower and Upper Pleasant Valley Road downstream to the town line upstream. Adjacent lands in this segment are primarily agricultural. The upstream half of the segment appears to have been historically straightened due to adjacent land uses. The channel slope in this segment is low, and its location immediately above a bedrock gorge contributes to its extreme aggradation. Aggradation is the primary process driving adjustments within M12-A. It has led to major widening in this segment and low flow braiding. There are multiple side channels and large flood chutes throughout the segment, indicating active planform change. Floodplain connectivity is excellent in this segment, and this section of river is providing attenuation of sediment, nutrients and flood flows. M12-A scored **fair** for geomorphic condition due to its abundant active adjustments. The segment received a rating of **good** for habitat condition, with its abundant low and high flow refuge, diverse pool features, large woody debris, and floodplain connectivity.

**Figure 5.17.** Depositional features are large and abundant in M12-A.

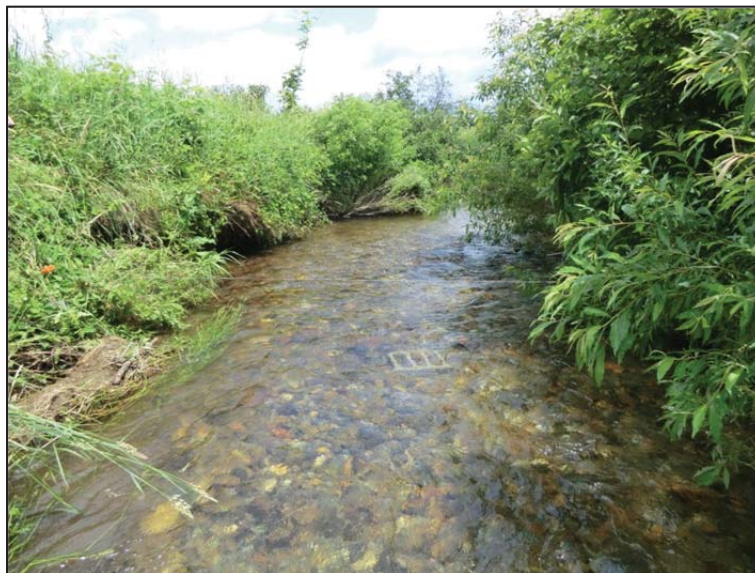
Reach one on Settlement Brook is 1,700 feet long and spans the stretch between the confluence with the Seymour River to just upstream of the arch on Lower Pleasant Valley Road near the intersection of County Farm Road. Settlement Brook flows through a very broad valley in T1.01 and adjacent lands are mainly agricultural. Lower Pleasant Valley Road runs along the west side of the brook for much of the reach. The majority of T1.01 appears to have been historically straightened due to the placement of Lower Pleasant Valley Road and management for agricultural lands to the east of the brook. Riprap is common along both banks in this segment, and bank erosion is present in some areas where riprap has failed. Despite historic channel management practices, very little adjustments are occurring within T1.01. For this reason, the reach scored **good** for geomorphic condition. The brook lacks in-channel large woody debris, as well as diverse bank and buffer vegetation, which contributed to its rating of **fair** for habitat condition.

Figure 5.18. Narrow, straight channel characteristic of T1.01.

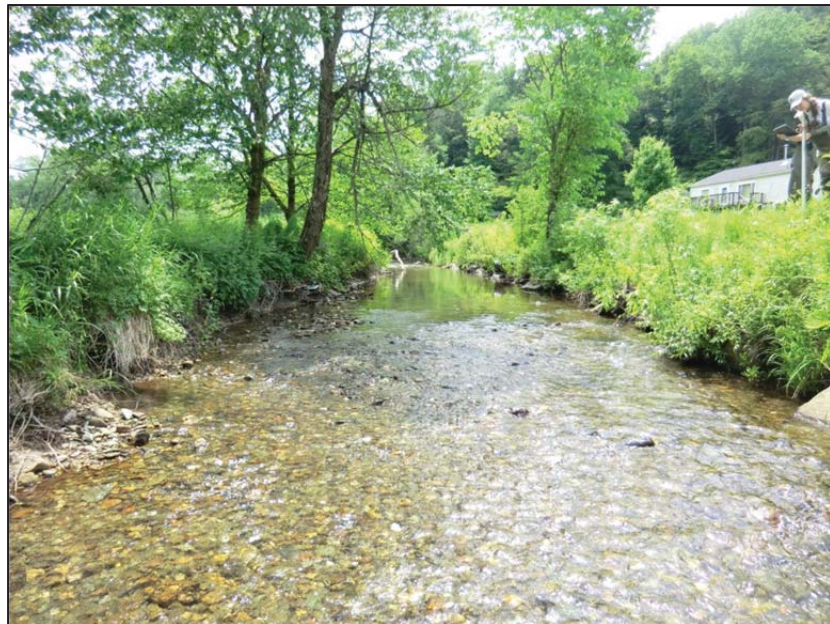
The downstream-most segment on reach T1.02 is nearly 750 feet long and flows directly along County Farm Road for its entire length. This segment of the brook was extensively historically straightened due to the placement of the road. This straightening has led to moderate channel incision. Widening is being prevented in some portions of this segment due to bank armoring. Bank erosion was observed in many areas that are not armored. The extensive alteration of channel planform and historic moderate incision led to the placement of T1.02-A in **fair** geomorphic condition. The brook is lacking large woody debris, a well-defined riffle-pool bedform, and bank and buffer vegetation in this segment, which is why it was also placed in **fair** habitat condition.

**Figure 5.19.** Straightened channel and road encroachment in T1.02-A.

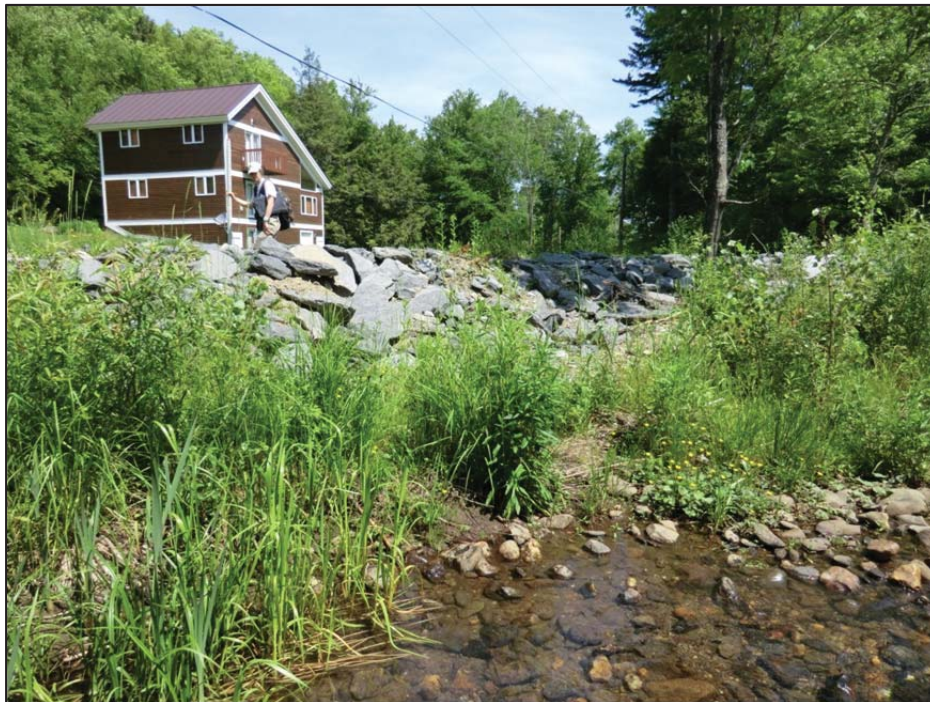
**Figure 5.20.** Large, recently constructed berm in T1.02-B.

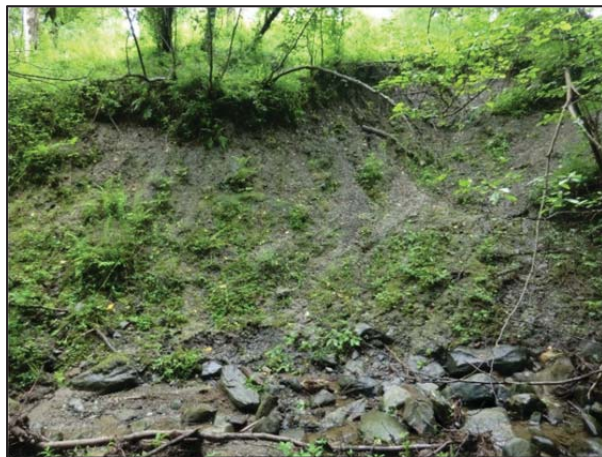
The upper segment on M04S1.02 is roughly 300 feet in length, beginning just downstream of the Bryce Road culvert and continuing downstream into the woods. The stream channel is steeper and more confined in this segment than the lower two segments. There is an extensive mass failure along the north bank in this segment, as well as abundant bank erosion. The banks are very steep and comprised of wet soils. No projects are recommended for this segment. Overtime, the mass failure and erosion should stabilize and revegetate on their own.

**Figure 5.24.** Photo of extensive mass failure along north bank in M04S1.02-C.

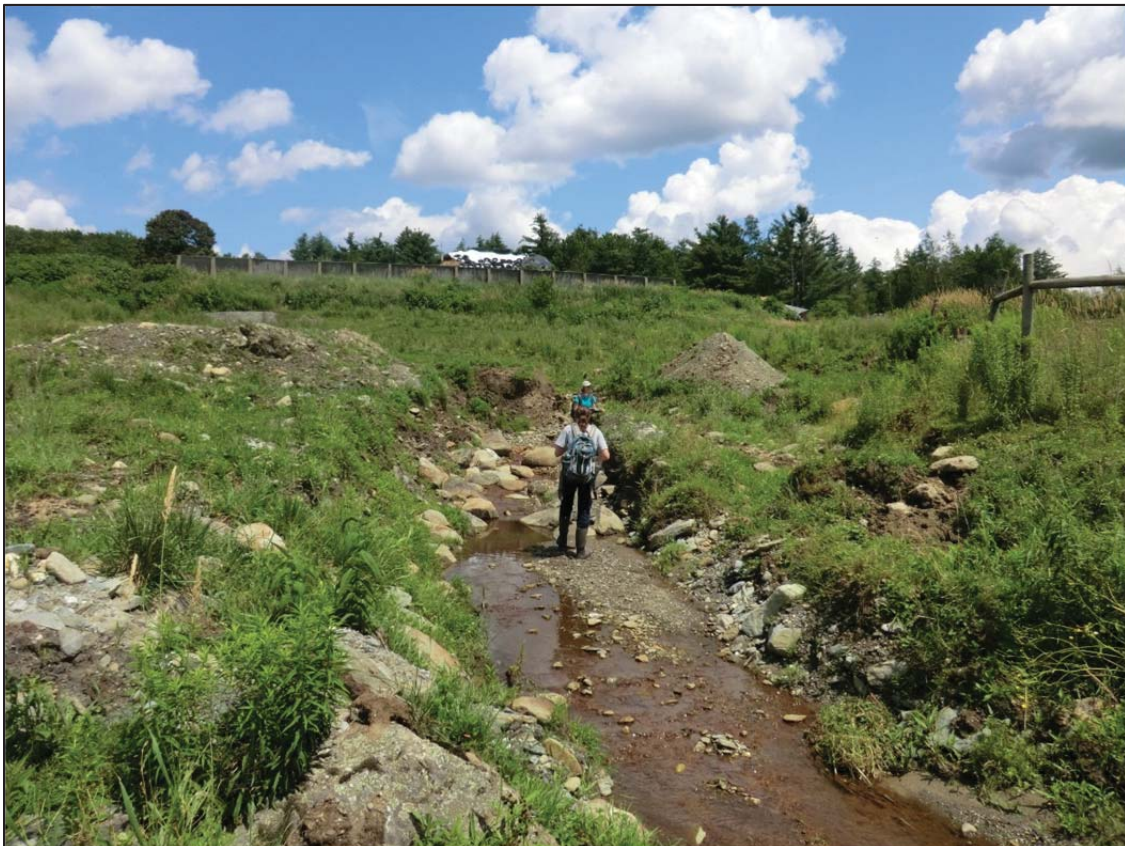
**Figure 5.28.** Windrowed section at upstream end of M06S1.02-C.

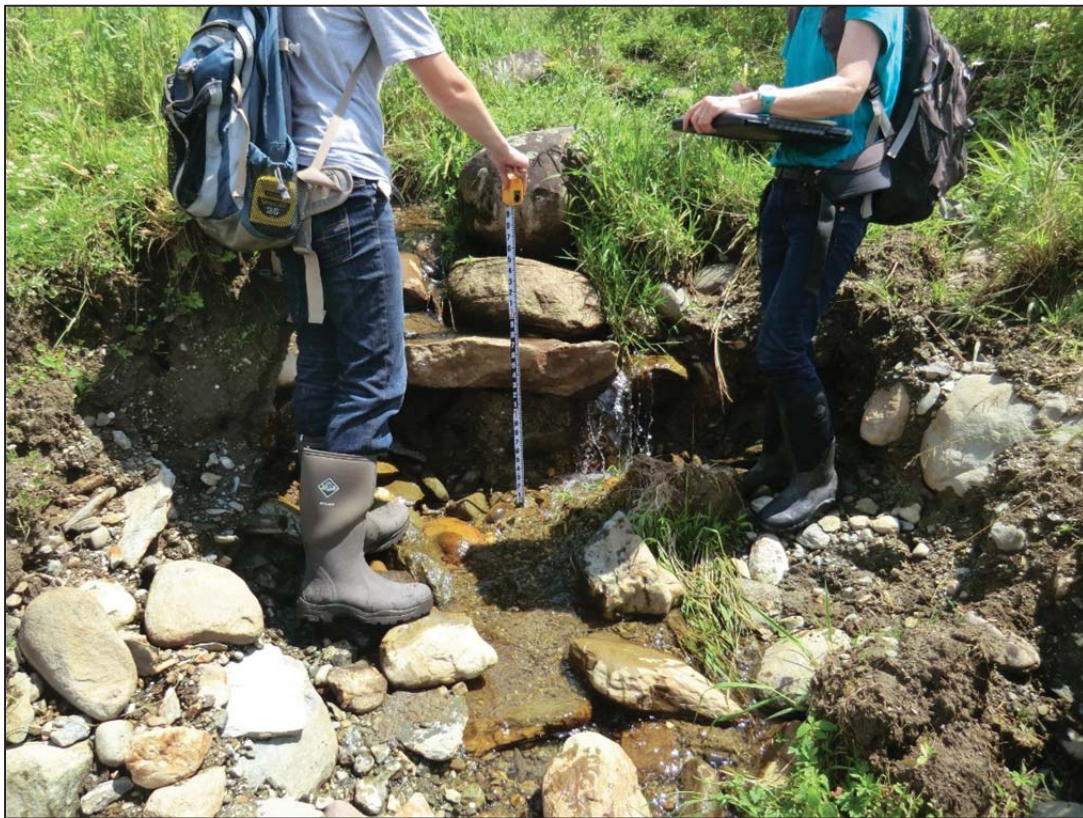
**Figure 5.29.** Headcut in M06S1.03.

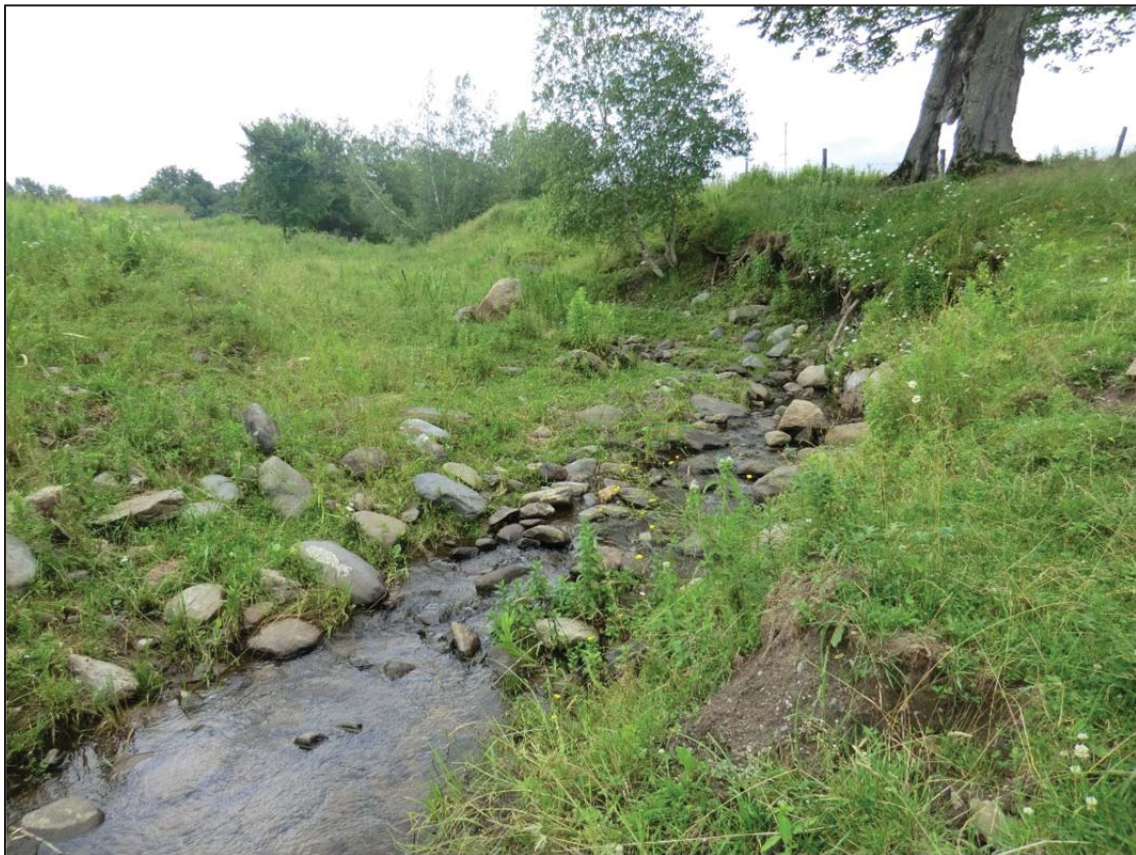
The second segment on reach two of tributary 2 to M06 is roughly 550 feet in length and flows through agricultural lands in a very broad valley. The entirety of the segment appears to have been historically straightened due to the adjacent pastures. Riparian buffers are lacking on both banks throughout the segment. One animal crossing was observed during the stream walkover.

**Figure 5.32.** M06S2.02-B flows through pastured land and is lacking riparian buffers.

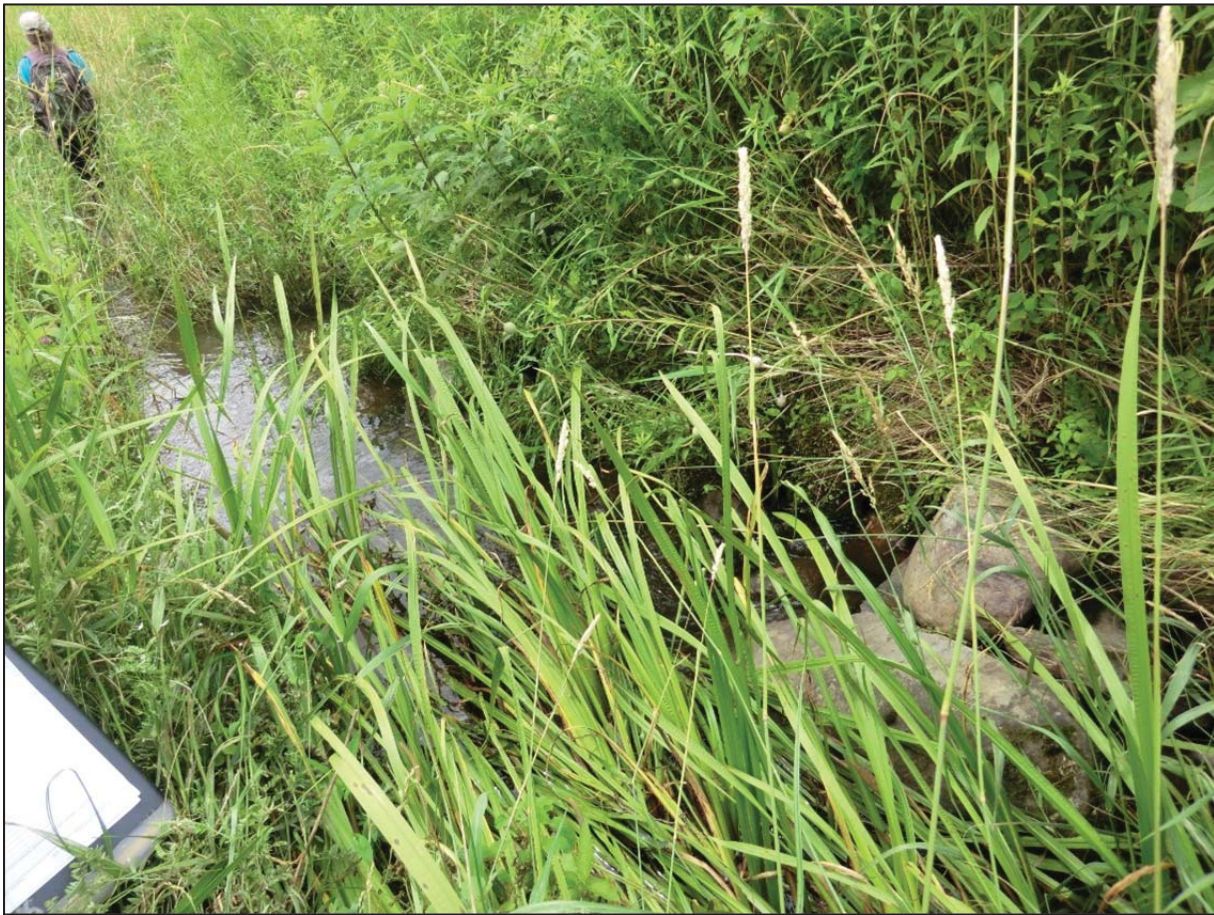
**Figure 5.33.** Old riprap in the channel in M06S2.02-C.

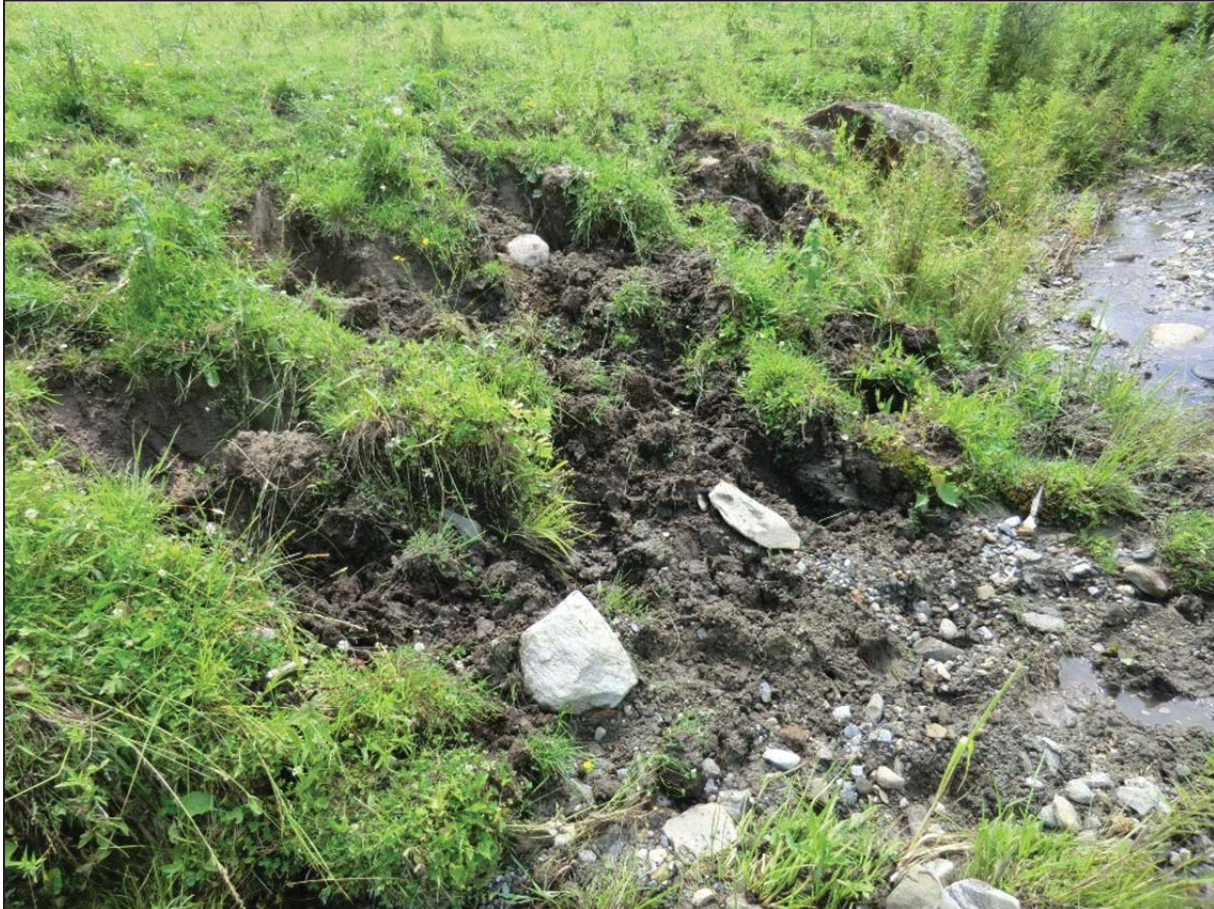
**Figure 5.37.** Animal access in M06S3.01-C is contributing to bank instability.
