Phase 2 Geomorphic Assessment of the Batten Kill, Vermont

Prepared by:
John J. Field
Field Geology Services
Farmington, ME

December 2005

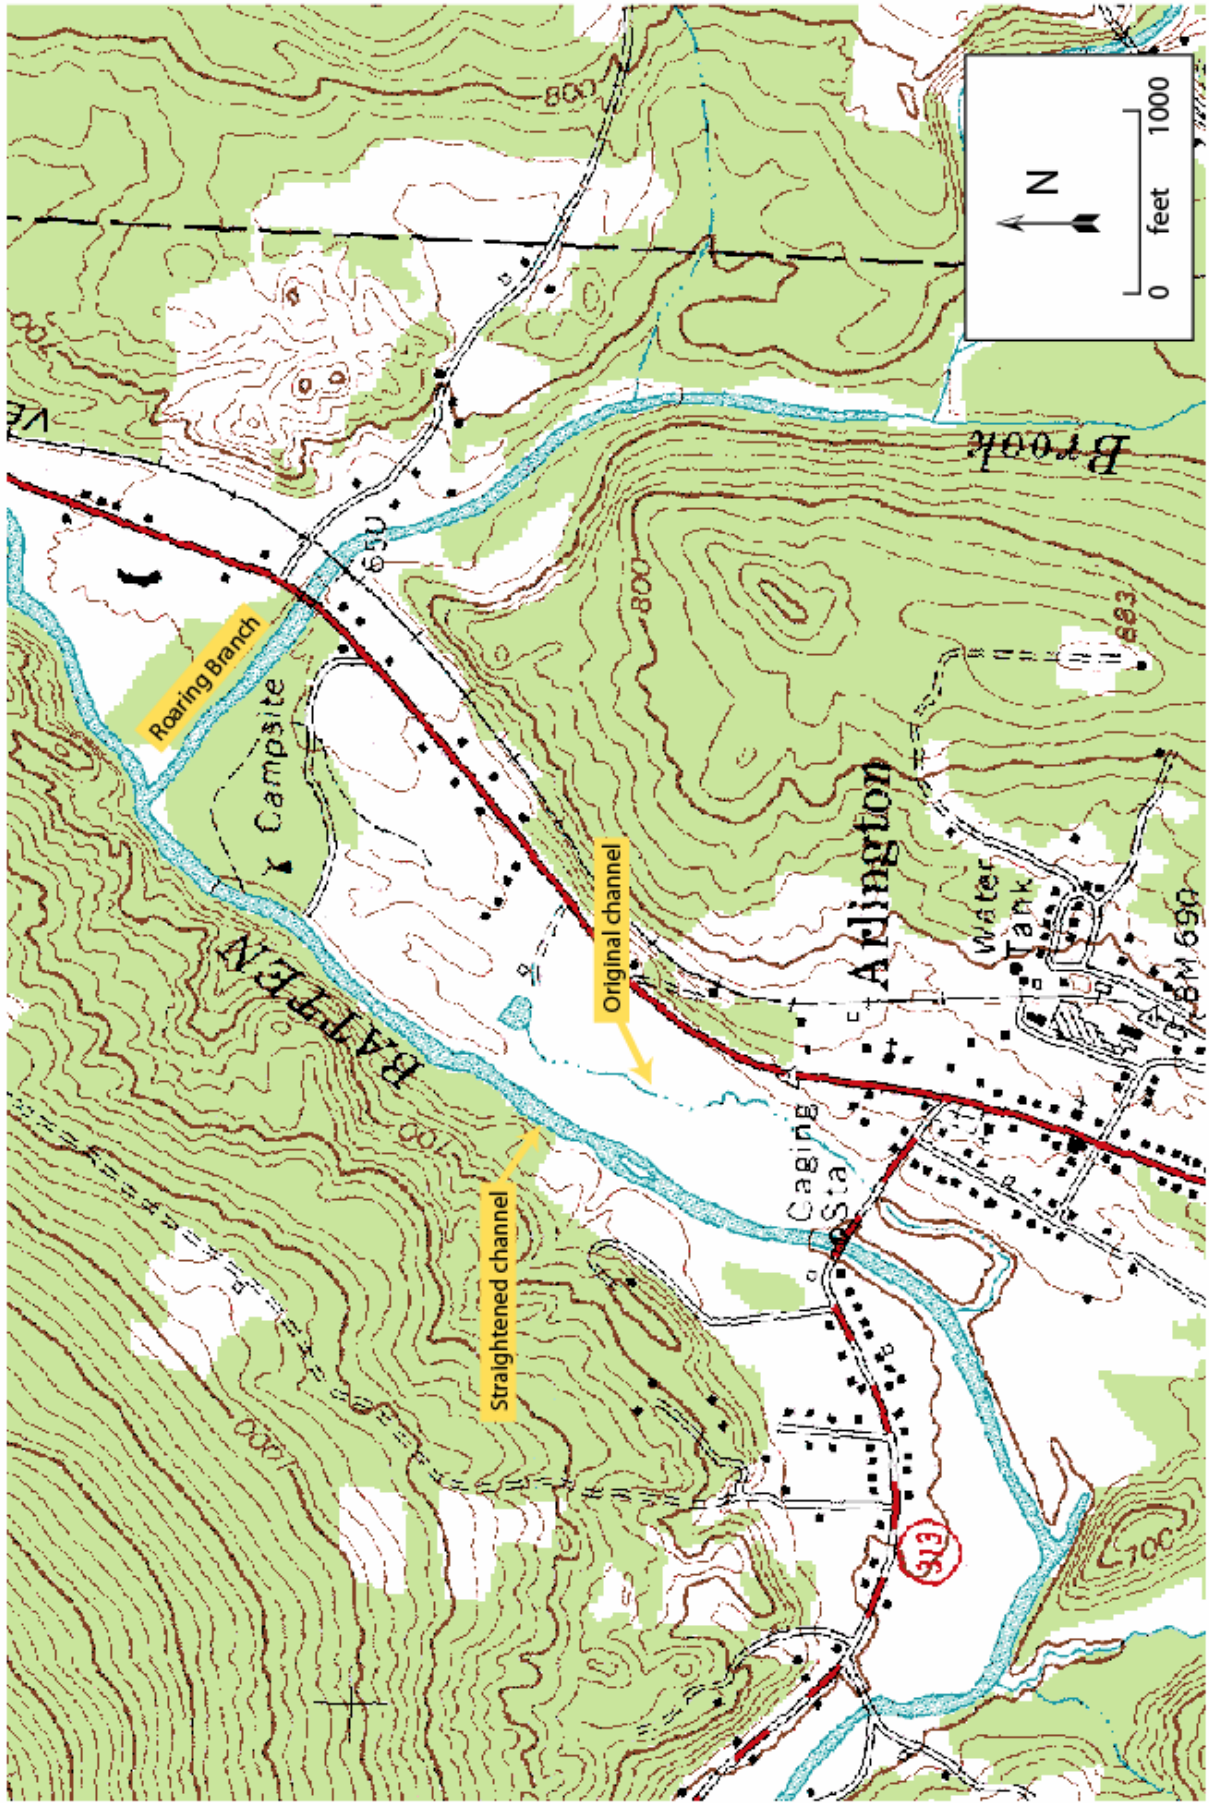
Batten Kill Phase 2 Assessment - Figure 4

The Phase 1 assessment documented significant channel straightening along all 4 reaches (>75% of total stream length) within this cell (Figure 4) and a long history of gravel mining/dredging into at least the 1980's is documented in Reach M4 near the Route 313 bridge in Arlington. Roads are present within the corridor of all 4 reaches with the river impinging against River Road and route 313 in M1-M3. While the river is causing erosion and maintenance problems along River Road at several locations, both roads closely follow the valley side slopes such that the roads are not causing a significant change in valley confinement. Land use in the river corridor is heavily agricultural and the riparian buffer is absent in many localities, particularly in Reach M3.

Straightened Channel Downstream of Roaring Branch

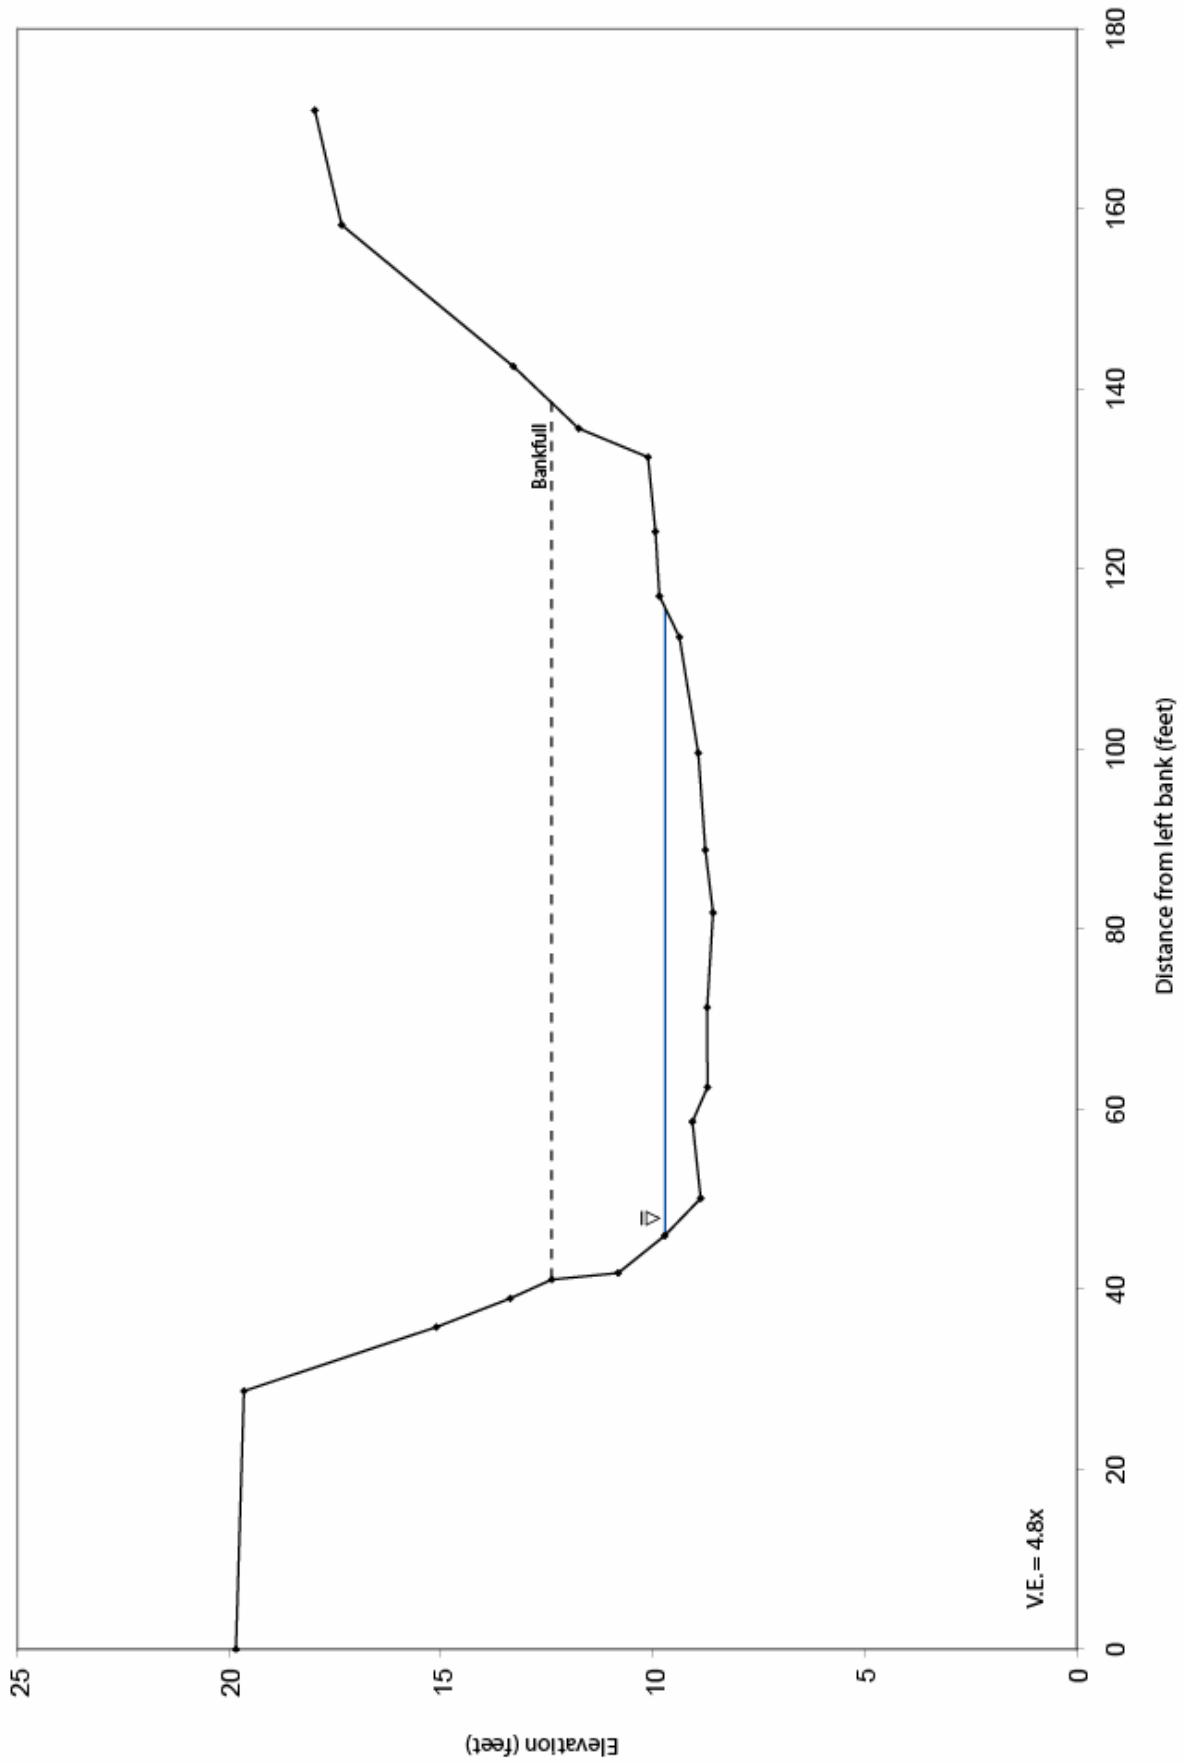
The impact of channel straightening on channel morphology was documented during the Phase 2 assessment. All 4 reaches have a nearly continuous plane bed morphology with deeper pools present only where the river flows against the higher banks of the valley side (or road embankments along the valley side), downstream of the Green River where sediment inputs from that tributary are constricting flow, and at bridges where flow is also constricted. Cross sections illustrate the generally wide, shallow, and incised morphology of the channel within this cell and absence of bar development (Figure 5). Despite the general lack of bar formation, sediment transport appears high through the reach because of upstream deposition and channel realignment upstream of the 2 bridges at the upstream and downstream end of River Road (Figure 6).

Cross Section of Straightened Channel in Reach M2

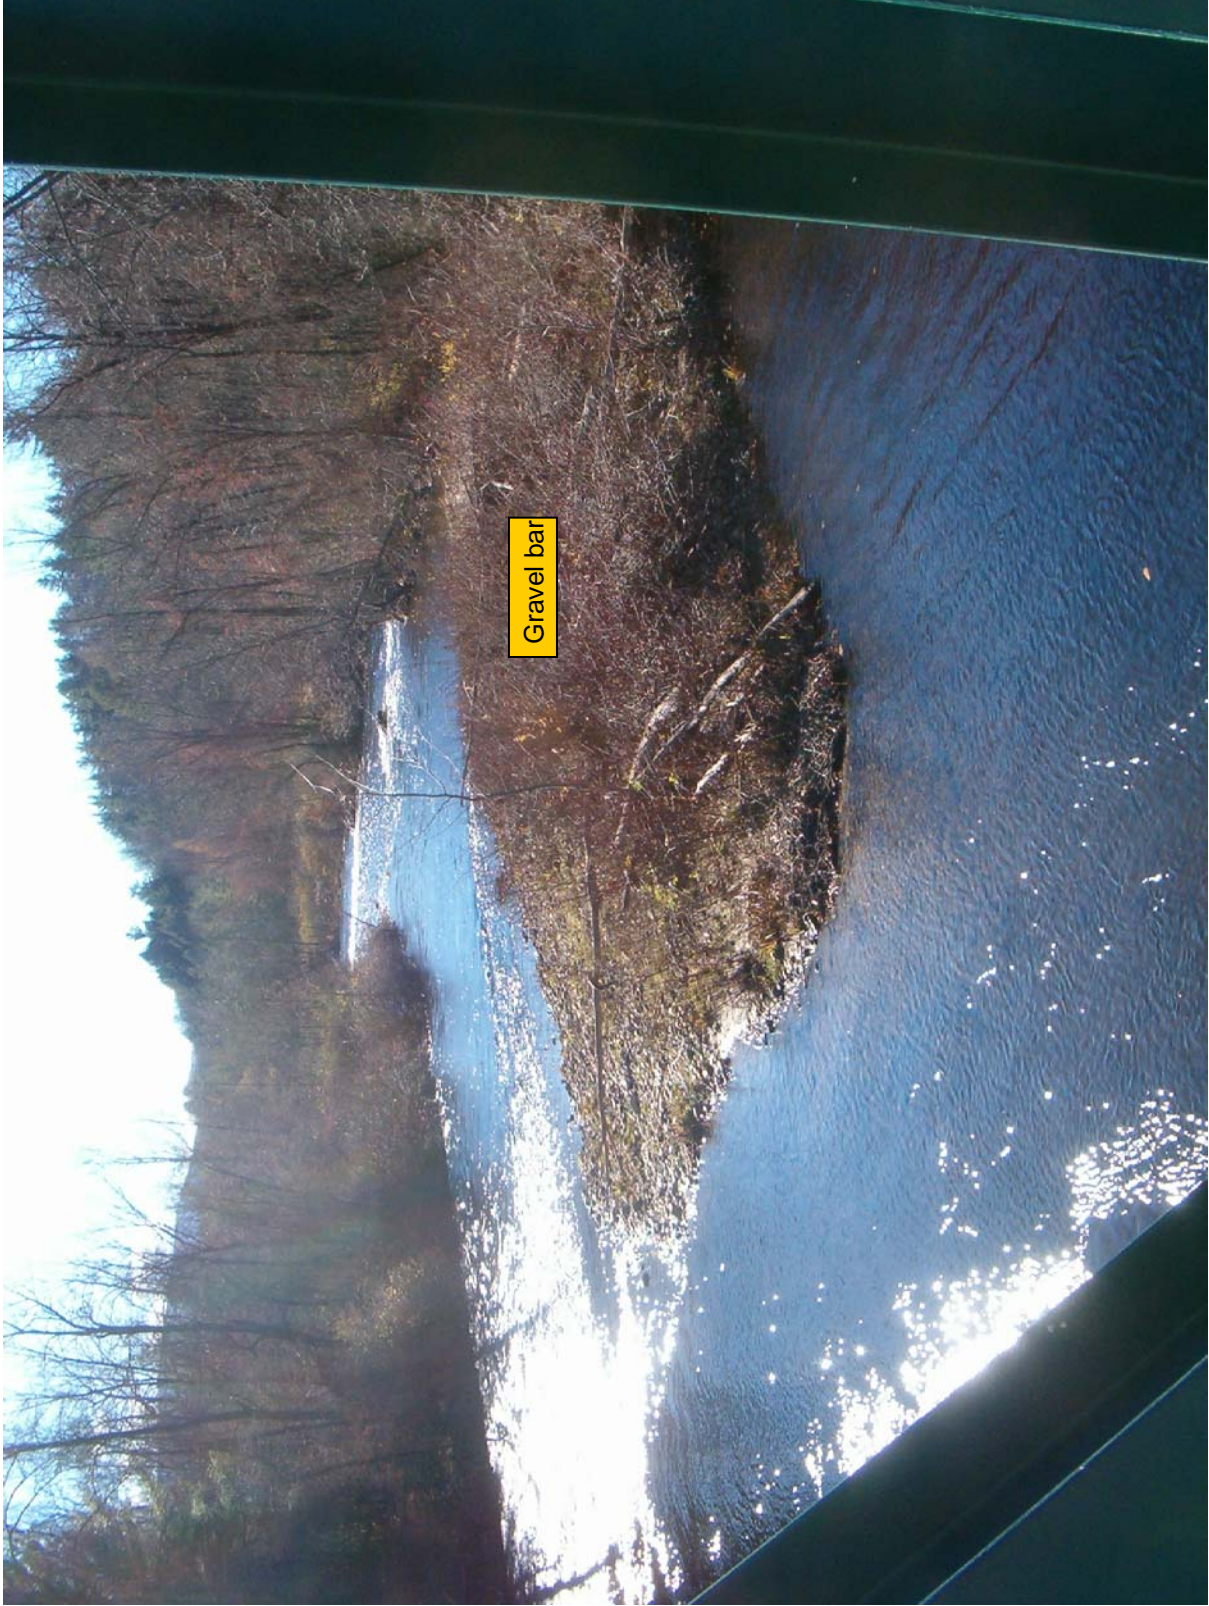
Batten Kill Phase 2 Assessment – Figure 6

Bar Deposition and Channel Realignment Upstream of Bridge in Reach M4

Note: View looking upstream from Rochester Bridge

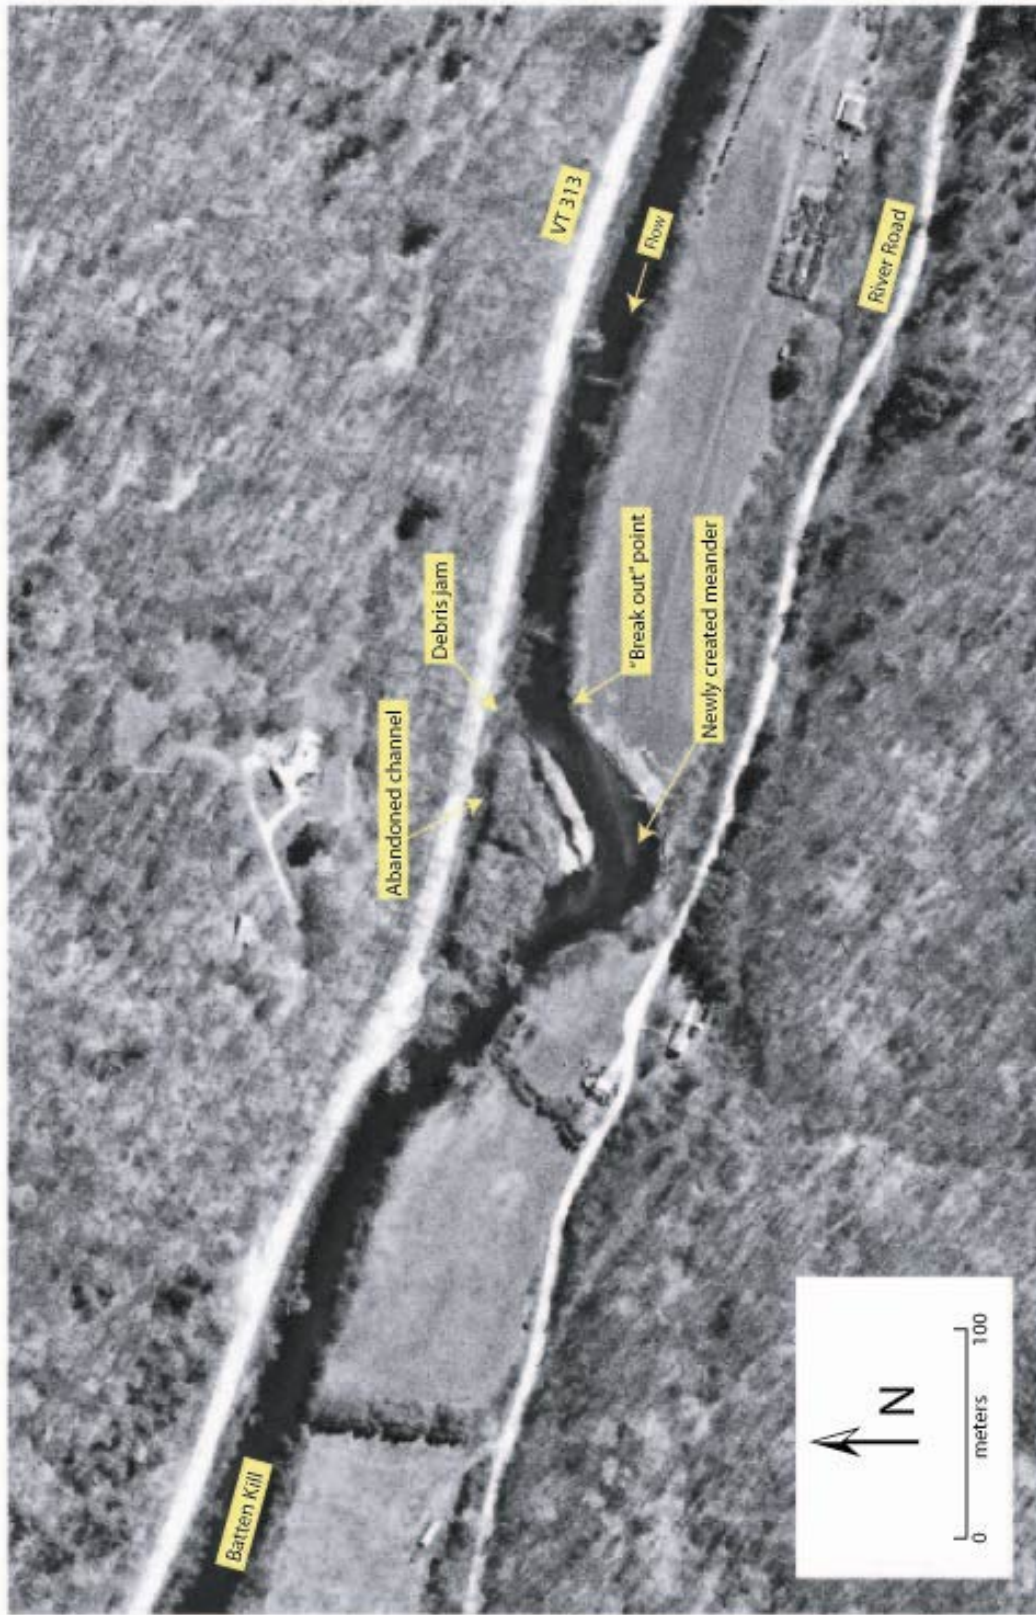
While the historic channel adjustments (e.g., incision and widening) in reaches M1-M4 resulting from channel straightening are largely complete, these reaches remain highly sensitive to future adjustments. Although portions of the straightened reaches have undergone a stream type departure from a "C" to an "F" type stream (Figure 5), these reaches are generally unchanging in their current late Phase II/early Phase III configuration (referring to Schumm's channel evolutionary model) under low to moderate flows. However, during large flows, debris jams can block the channel and flow can escape out on the floodplain at a low spot along the bank. Under these

conditions, channel aggradation and planform adjustments occur rapidly as new meanders form on the floodplain during Stage IV of the channel evolutionary process. The lack of a riparian buffer on the floodplain further increases the stream's sensitivity and susceptibility to these changes. The resulting flow and sediment attenuation across the floodplain at these "break out" points forms new meanders with large unvegetated point bars developing on the inside bend of the meanders (Figure 7). The resulting bankfull width in these attenuation zones (e.g., M3 Segment B) is similar to the straightened segments within the same reach (e.g., M3 Segment C)(Figure 8). Over time as fine sediment accretes on the point bar and vegetation becomes better established the bankfull width will ultimately become less than the straightened segments (i.e., as the channel evolves from a Stage IV to Stage V channel in the channel evolutionary model). Currently, even with a similar bankfull width, habitat conditions are better in the attenuation zones where there is a better segregation of particle sizes, greater variation in velocity-depth patterns, and deeper pools. The attenuation zones are areas of energy dissipation such that the reach as a whole becomes less sensitive to further "break outs" and channel adjustments.

New Meander Created at "Break Out" Point (Reach M3 Segment B)

Sinuosity is slowly returning to straightened reaches of the mainstem by forming new meanders at points of flow and sediment attenuation (“break outs”) where the flow has been diverted by debris or has overtopped its banks (Figure 7). Locating additional attenuation assets elsewhere where natural flow conditions can be restored will hasten the process by which the channel regains sinuosity after being artificially straightened in the past. Restoration and management efforts of this sort would improve habitat, allow the stream to expend energy in undeveloped areas, and, consequently, reduce the risk of flood damage to human infrastructure elsewhere.

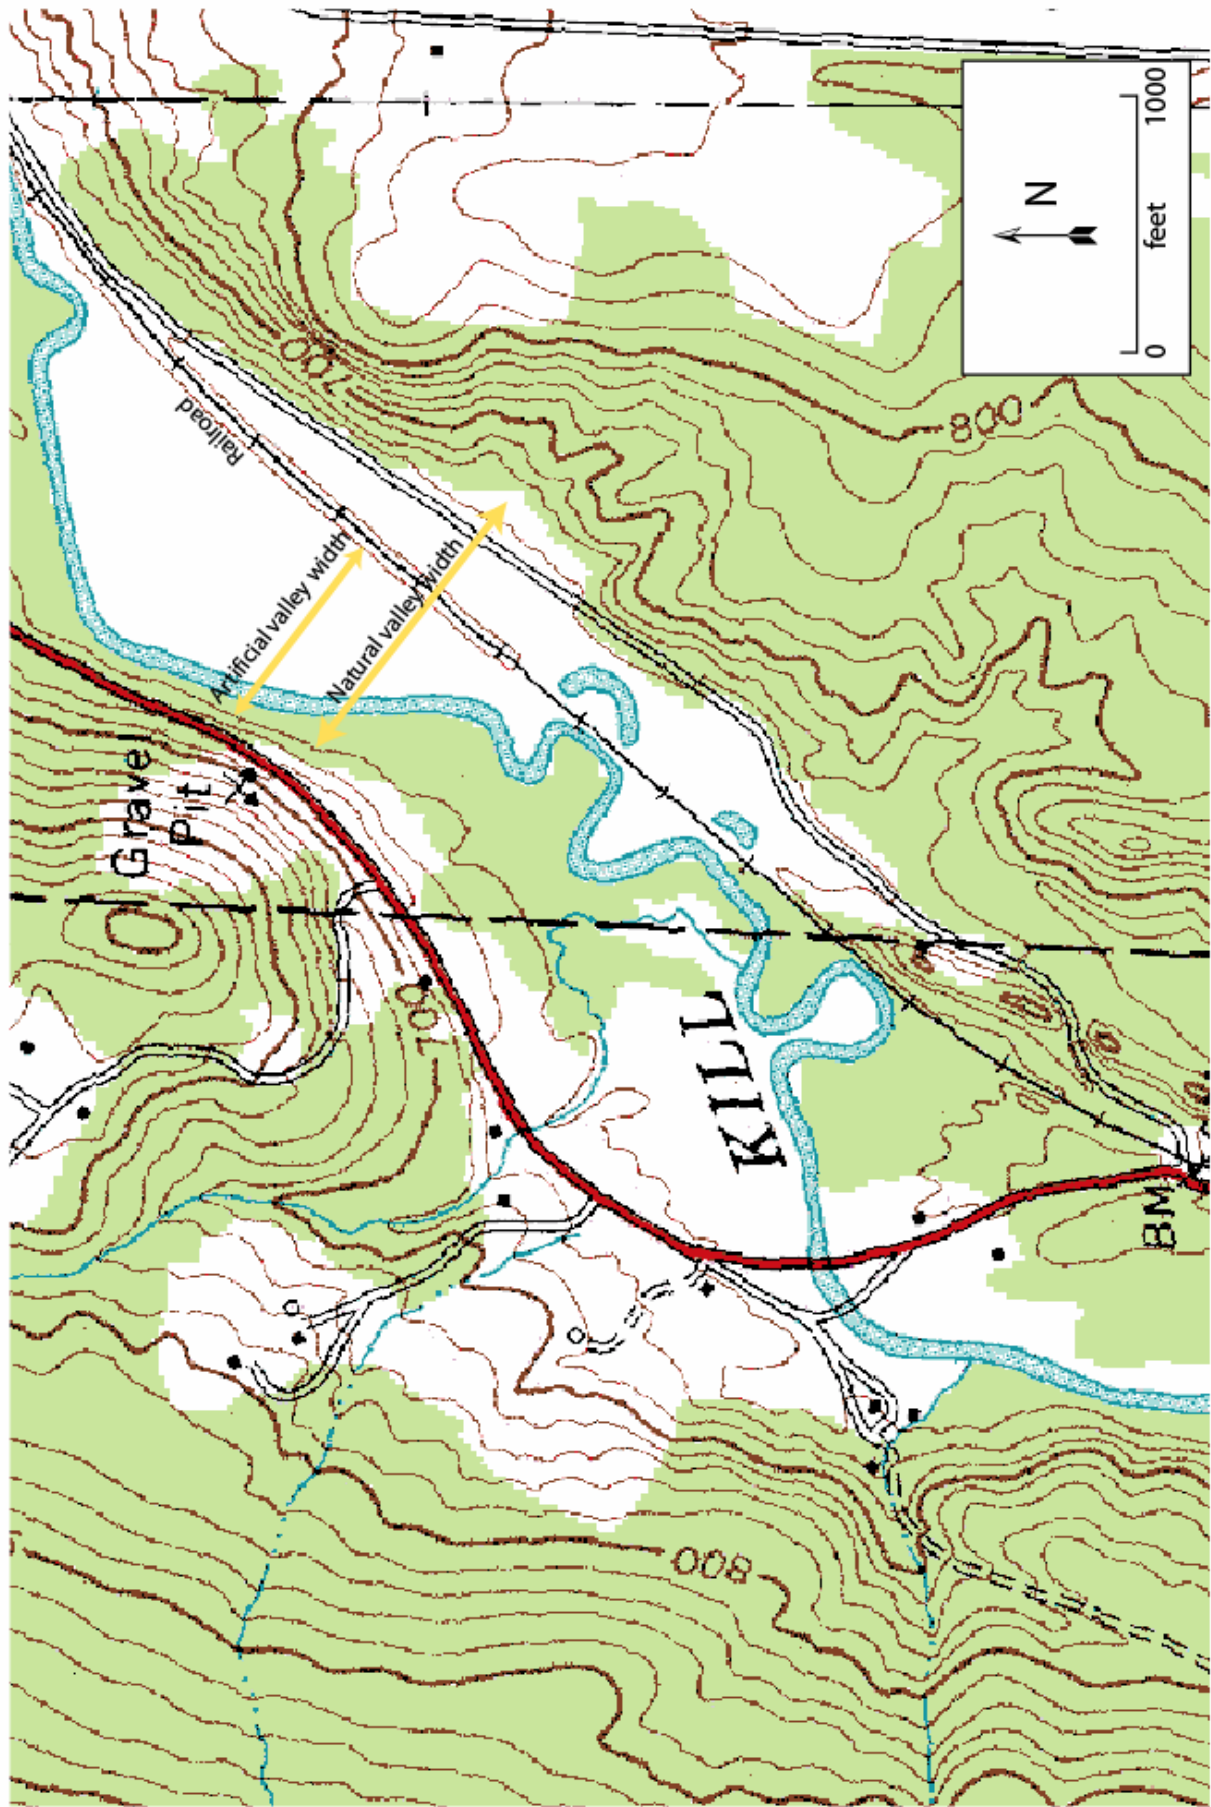
In addition to Reach M9, the Phase 1 assessment also documented significant channel straightening (i.e., high impact rating) in all of the other reaches in this cell. The straightening was likely completed to assist with draining wetlands that persist in portions of the very broad valleys within this cell. Land use within the river corridor is heavily agricultural but the riparian buffer is greater than 100 feet wide along 80 percent of all 5 reaches. In addition to the straightening, railroad construction resulted in meander cutoffs in Reach M5 and an artificial constriction of the valley in all 5 reaches of Cell 2 (Figure 9).

Railroad Impacts on Valley Width and Meander Geometry (Reach M5-B)

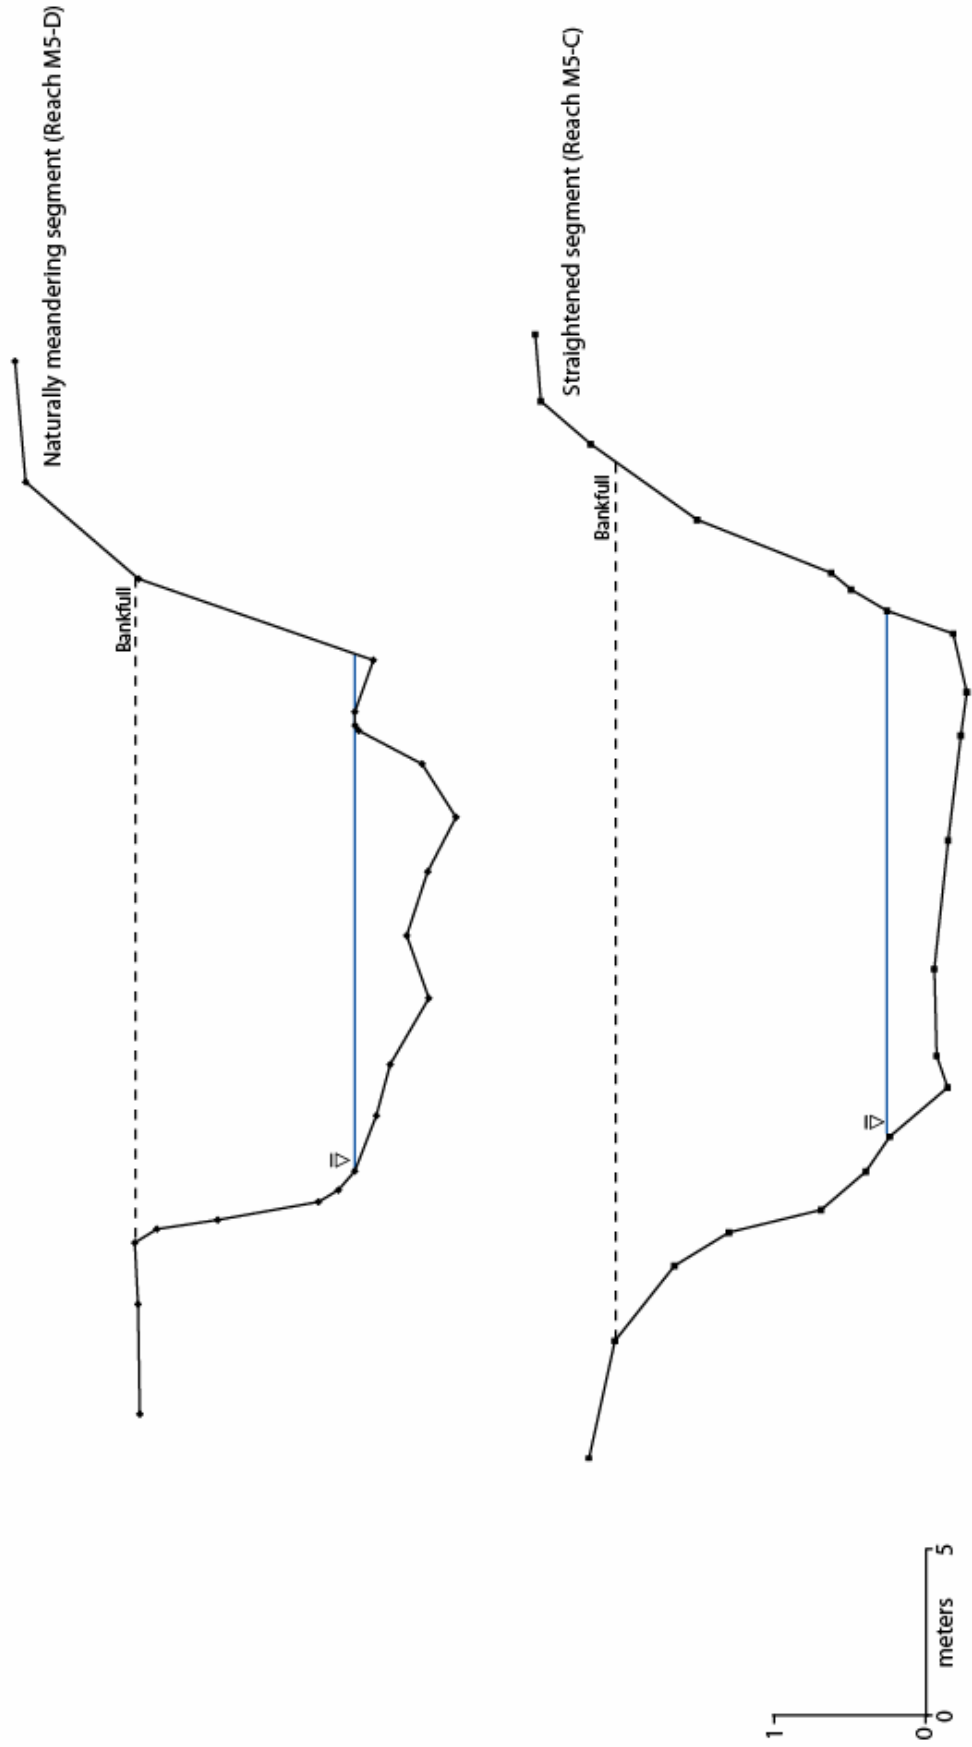
The impact of channel straightening on channel morphology was documented during the Phase 2 assessment and earlier Phase 3 assessments completed near the Ira Allen House in Reach M5 Segment C and D. Reach M5 was segmented into straightened portions (Segments A, C, and E) and portions where the original meanders are largely undisturbed (Segments B and D). The naturally meandering segments have a narrower bankfull width, shallower bankfull depth, lower width:depth ratio, and greater occurrence of point bars than adjacent straightened segments (Figure 10). Longitudinal profiles

Increased Bankfull Width in Straightened Channel

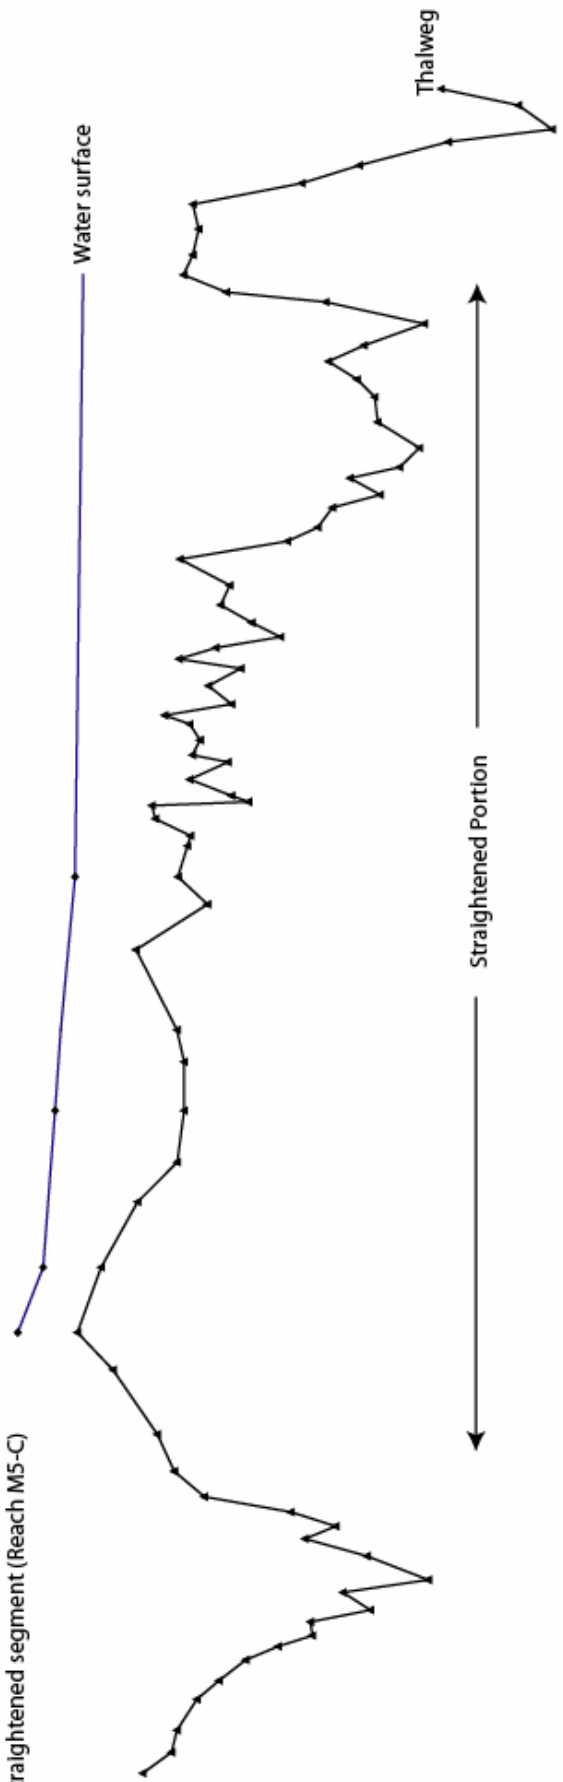
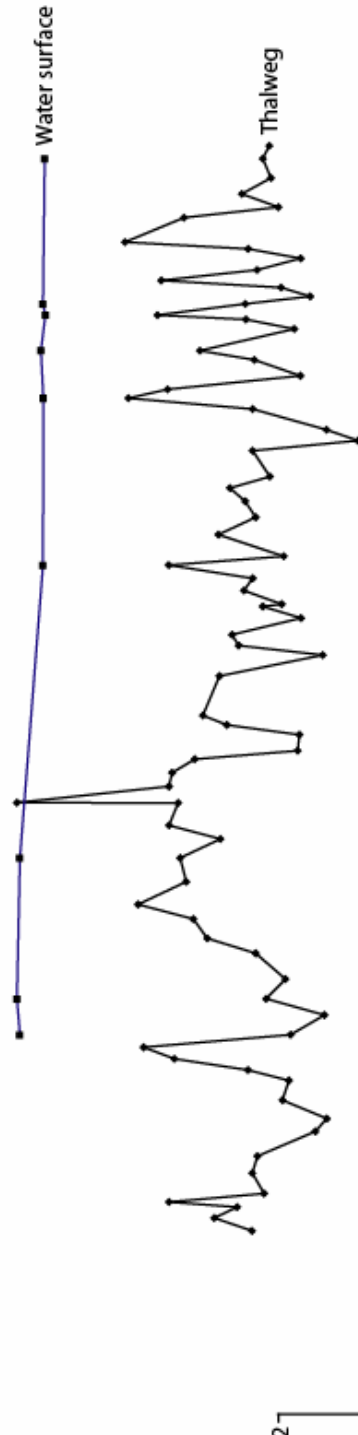
reveal that the well developed riffle-pool bed morphology in meandering areas is replaced by shallower and less numerous pools in straightened segments (Figure 11). These channel adjustments have resulted in degraded habitat conditions in the straightened segments with poorer pool development and less velocity-depth flow complexity. Sand substrate predominates in all segments of Reach M5 so particle size distribution is not altered by straightening.

Longitudinal Profile of Straightened and Meandering Channels

Straightened segment (Reach M5-C)

Naturally meandering segment (Reach M5-D)

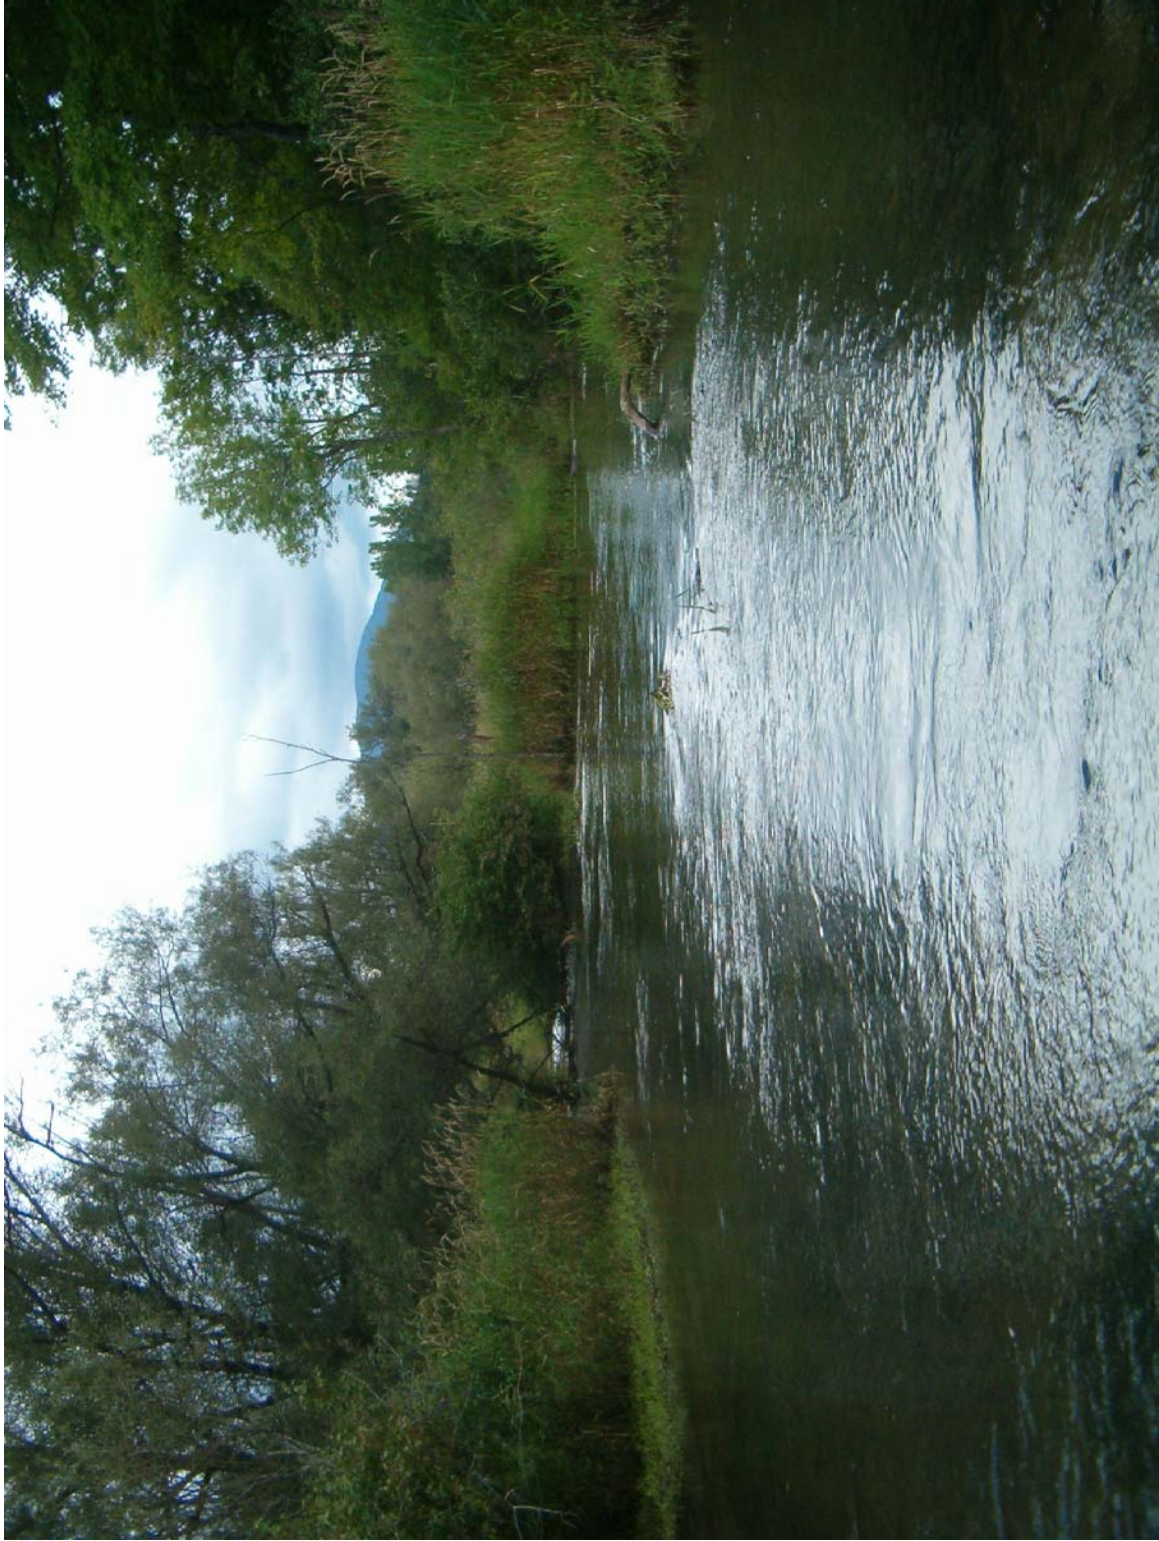
debris in the reach, effectively trap fine to coarse gravel sediment. Flow escapes over the banks in the backwater areas creating split flows and side channels (Figure 11). The creation of side channels, flow velocity variations, and gravel deposits results in improved habitat conditions. Although the creation of side channels may lead to occasional channel avulsions during large events, Reach M10 should be considered geomorphically stable and could serve as a reference condition for the downstream ends of other cells where human activities have depleted the availability of wood in the channel and on the banks.

Flow Splitting in to Side Channel (Reach M10)

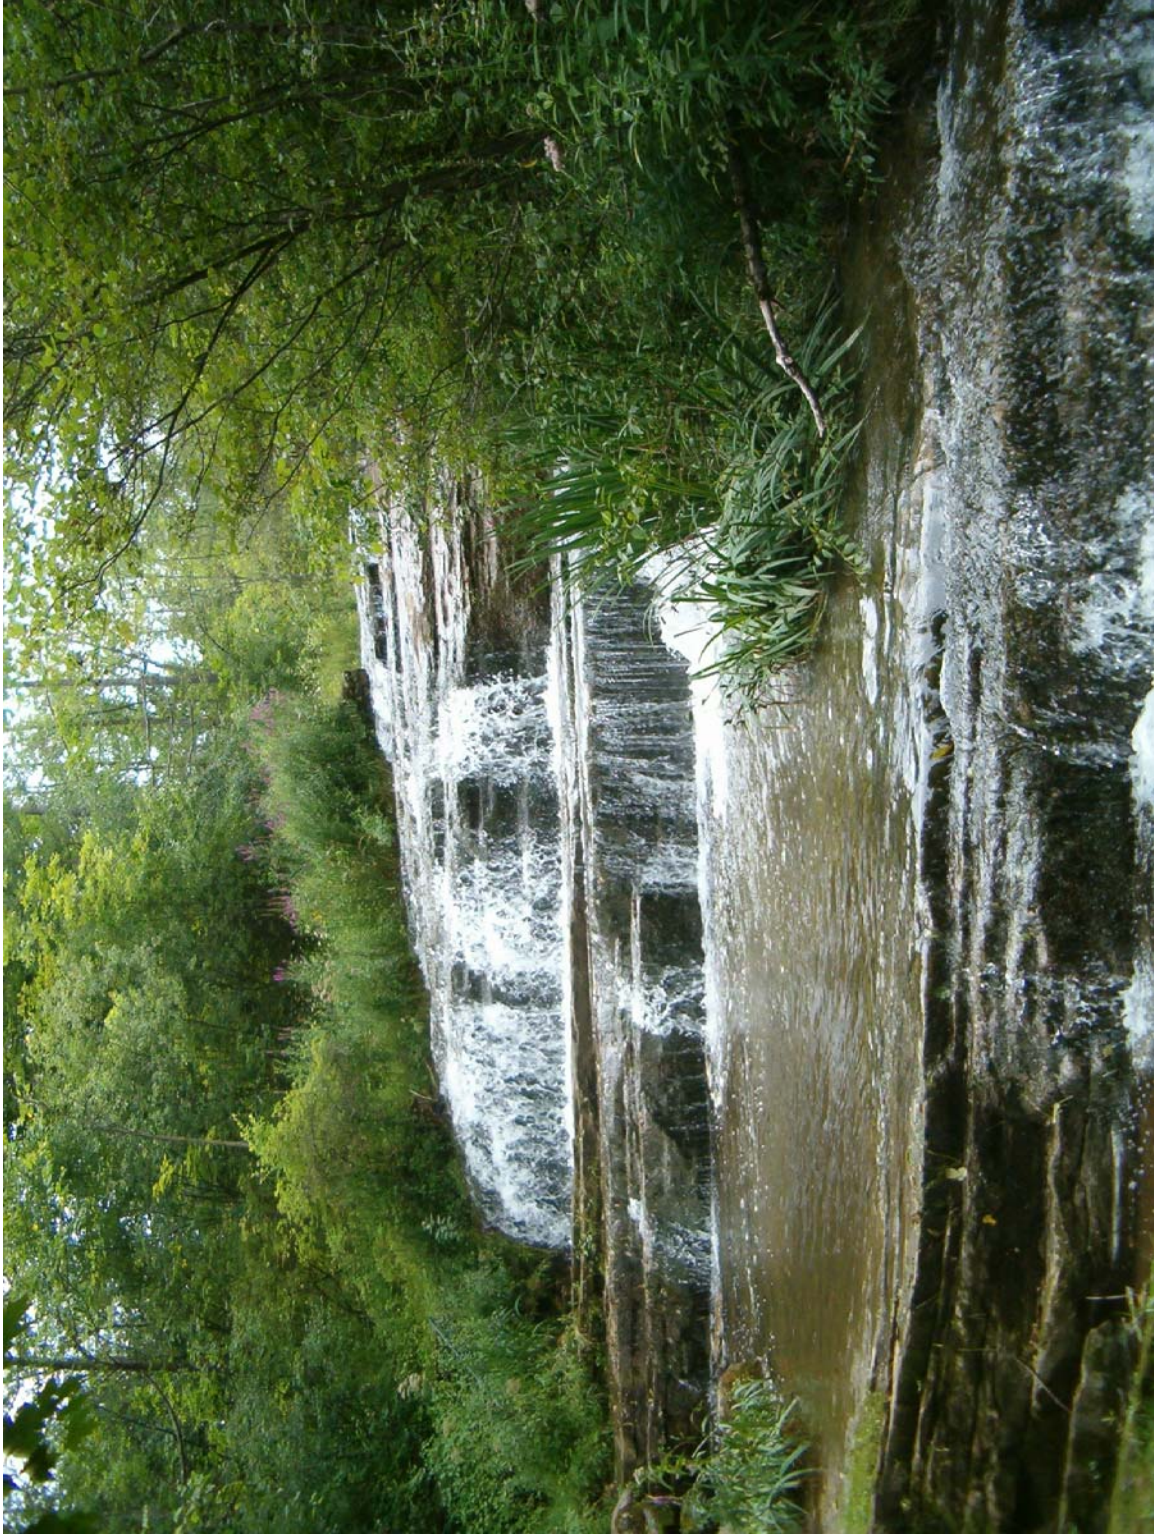
Both Munson Brook and West Branch have waterfalls near the confluence with the Batten Kill (Figure 13). Their presence might demarcate a geological fault line bounding the west side of the valley. The waterfall on West Branch is in the center of Manchester and a small dam and mill building is situated on the falls. The stream flows downstream through a heavily developed portion of Manchester before reaching a low gradient area dominated by beaver dams at the confluence with the Batten Kill. The West Branch flows into Reach M10, which is similarly characterized by beaver dams that divert flow into habitat enhancing side channels. Beaver dams are also present on the lowest end of Munson Brook. Immediately upstream of the waterfalls on Munson Brook and West Branch the streams have only narrow floodplains, if any, with glacial sediments constricting the valleys and the streams frequently flowing along these nonalluvial materials (T5.01-B and T6.02-A). Wetlands with poorly defined channels characterize the areas further upstream (T5.01-C and T6.02-B) and were not analyzed in detail as part of this study. Munson Brook eventually rises steeply as a small drainage near the Southern Vermont Arts Center that was not studied in detail (T5.01-D). Upstream of the wetland area on West Branch near the town park in Manchester, the stream channel again becomes well defined with a deep pool occurring where the left bank flows against bedrock (T6.03). The channel otherwise has a more plane bed morphology with a berm on the left bank extending 630 feet upstream of the bedrock exposure. A linear depression on the right bank floodplain parallels the stream channel and may be the remnants of an old diversion channel leading to a mill or some other structure no longer visible. While West Branch continues upstream to Dorset, the Phase 2 assessment terminated at Reach T6.03.

Waterfall on Munson Brook (Reach T5.01-A)

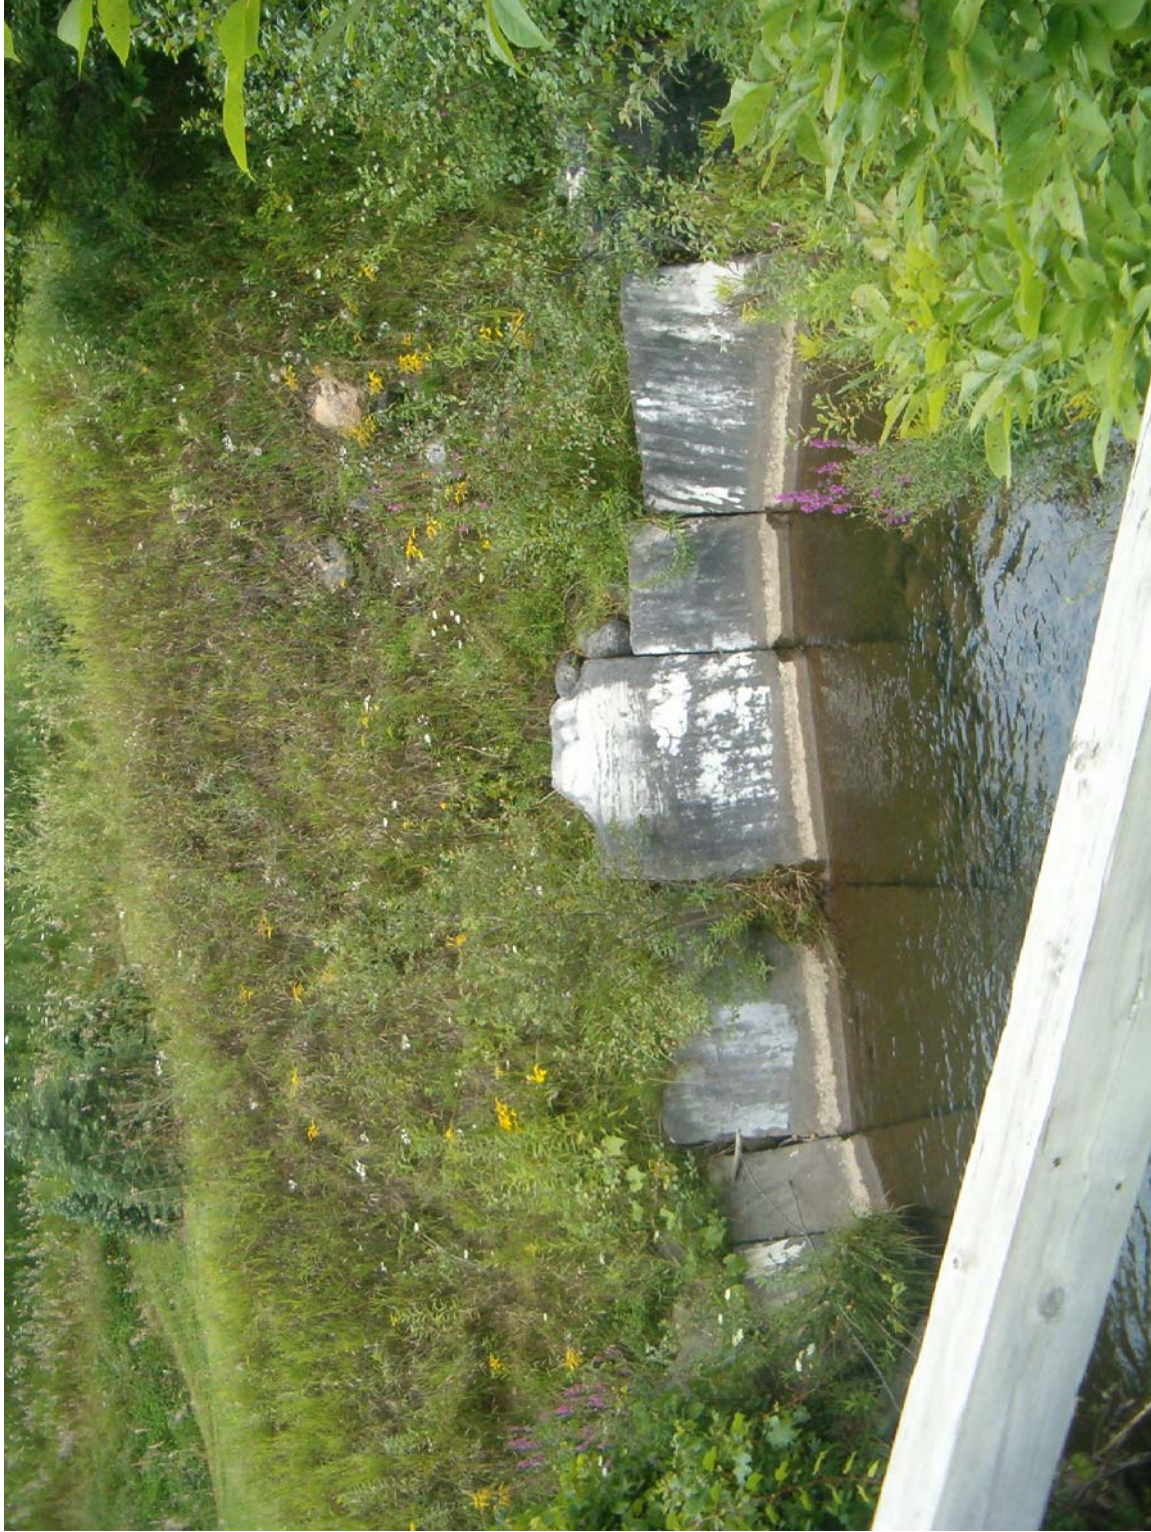
Bank Armoring Downstream of Culvert (Reach T5.01-B)
