Phase 2 Geomorphic Assessment of the Batten Kill, Vermont

Prepared by:
John J. Field
Field Geology Services
Farmington, ME

December 2005

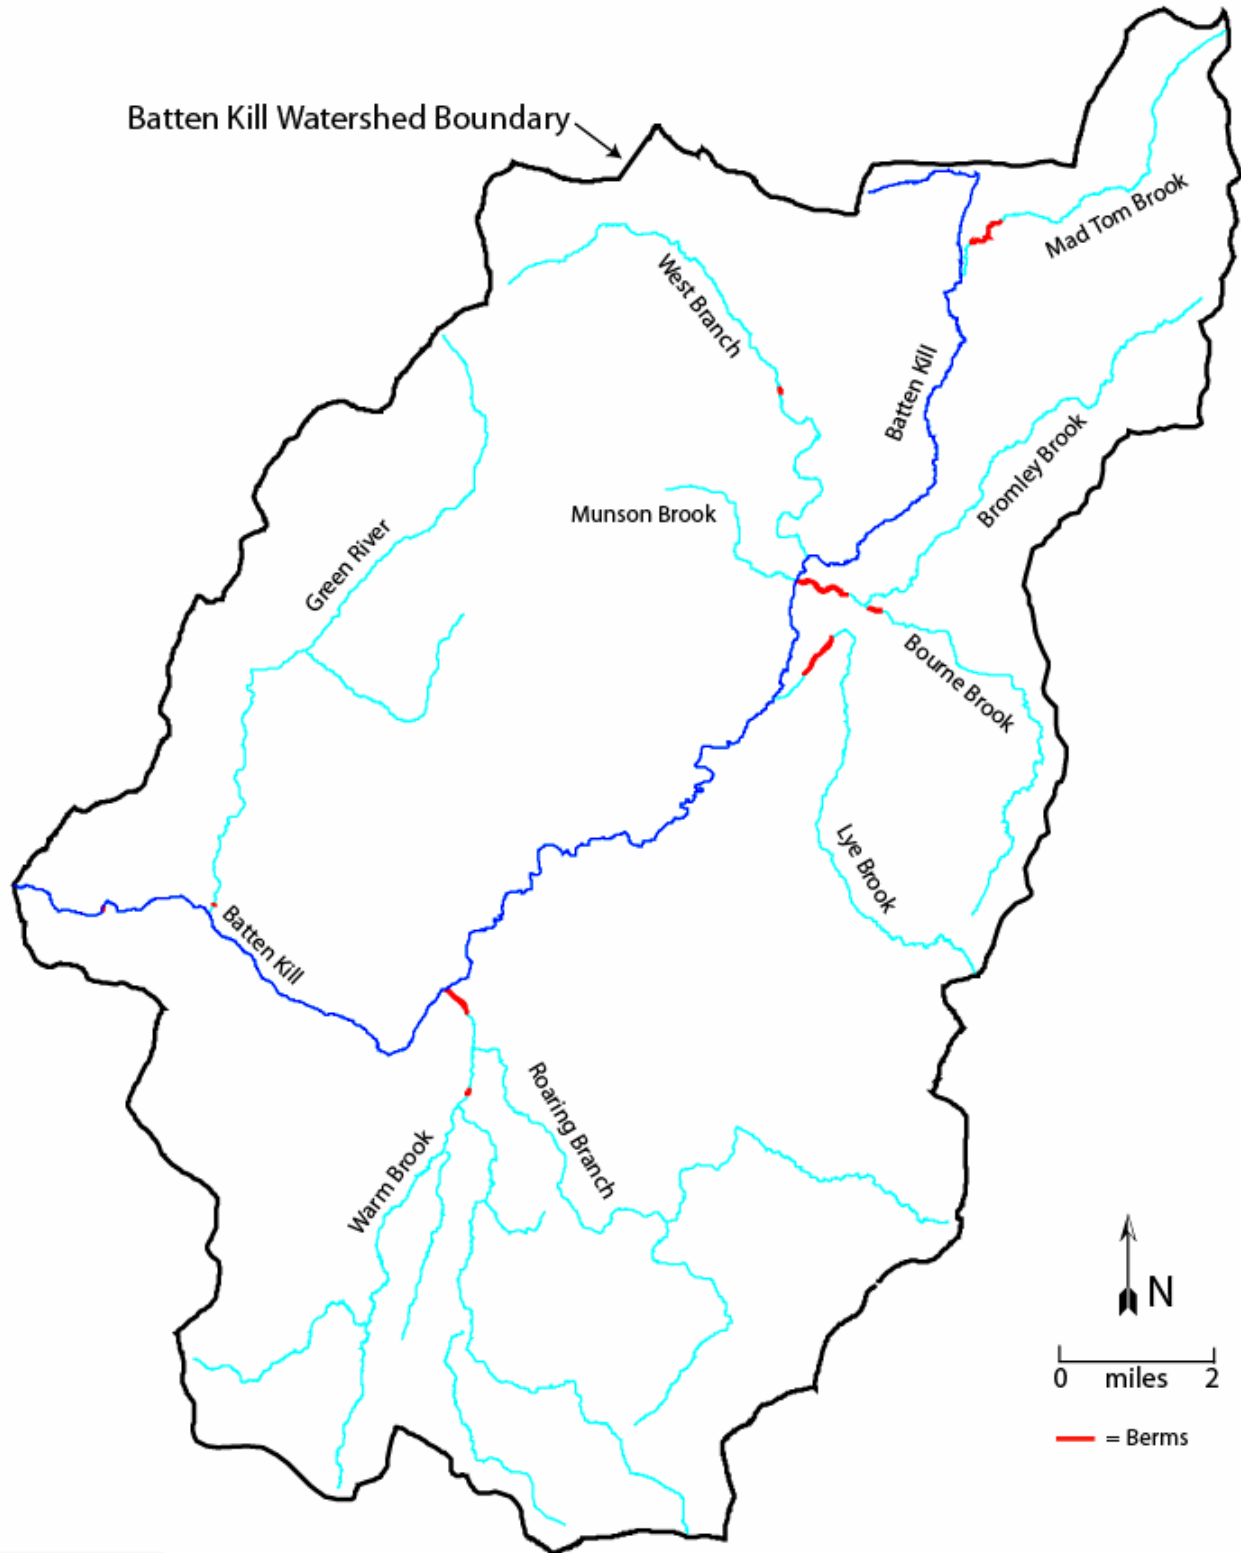
Nearly continuous berming is present along both banks on Bourn Brook, Lye Brook, and Roaring Branch and along the left bank of Mad Tom Brook (Figure 16). The berm on Lye Brook's left bank terminates where the channel has been placed along the bedrock valley side slopes. Only minor berming is present on the right bank of Warm Brook and no berms were observed on Bromley Brook. Numerous flood chutes are present at the termini of Warm Brook and Bromley Brook where they lose confinement and join Roaring Branch and Bourn Brook, respectively. An historical ground photograph found at the Arlington Public Library demonstrates that berming on Roaring Branch occurred shortly after the June 1973 flood, the largest flood on record since 1936 (Figure 17). The presence of double berms on Lye Brook (Figure 18) and patterns of vegetation growth on berms along Bourn Brook (Figure 19) suggest that widespread channelization occurred on all of the primary Green Mountain tributaries in response to the 1973 flood (Figure 18). The double berms on Lye Brook also indicate a prior history of channelization, perhaps related to the 1936 flood. In addition, a very large berm, protecting several homes, was more recently built on a short section of Lye Brook in conjunction with construction of the Route 7 bypass (Super 7).

Flow access to the alluvial fans at the lower ends of these tributaries is blocked by the berms, thereby increasing flow velocities and delivery of sediment to the Batten Kill mainstem while reducing the creation and maintenance of side channels on the alluvial fans. The lack of flow attenuation across the Roaring Branch alluvial fan is probably in part responsible for the severe erosion of a high bank of glacial deposits directly across from the Roaring Branch confluence (Figure 20). The integrity of the berms is sound in most locations and their height, more than or near twice the bankfull depth (Figure 18), mean that flow is confined at even large flows and the stream channel unable to adjust to smaller “bankfull” flows. Consequently, gravel bars remain unvegetated and the stream channel unable to completely “heal” (i.e., reach Stage V of Schumm’s Channel Evolution Model) from the 1973 flood, subsequent berming, and later floods (e.g., 1976). At the ends of berms (e.g., Bourn Brook) or where breaches are present in the berms (e.g., Lye Brook), flow escapes from the current channel and enters side channels that are being created in the surrounding forested areas. Habitat conditions are improved in these areas because deeper pools form where the escaping flow can scour around tree trunks and reduced flow velocities in the main channel can lead to revegetation of bars. While no breaches in the berms are currently present near human settlements, the presence of berms near settlements in other areas bespeaks to the potential hazards present on all of the Green Mountain tributaries if a berm was to fail during an extreme event.

Location of Tributary Berms on Assessed Reaches

The original process of berming along the Green Mountain tributaries in the early 1970’s, with heavy machinery in the channel, most likely had a direct, perhaps significant, watershed wide impact on instream habitat. Flow confinement by berms on the tributaries continues to prevent a full return to equilibrium conditions created when

flow crosses the alluvial fan surfaces found at the lower ends of the Green Mountain tributaries. Although removing berms in many localities would put property at greater risk, opportunities should be sought, far from any developments, where berm removal would allow flow to escape onto the alluvial fan surface. Restoration such as this would have several advantages: 1) create side channel habitat on the alluvial fans; 2) reduce peak flow velocities within the formerly confined tributary, thereby permitting revegetation of gravel bars; 3) reduce the risk of berms catastrophically failing in other areas where property might be damaged; 4) allow the stream to expend additional energy before entering the mainstem; and 5) return the stream to a more natural flow regime. The implementation of restoration strategies on the tributaries and mainstem that run counter to traditional river management techniques will require a concerted education effort throughout the watershed that increases public understanding and support for restoration plans that can potentially improve fish habitat, reduce risks to human infrastructure, and return streams to a natural equilibrium condition by hastening the natural channel evolutionary process.

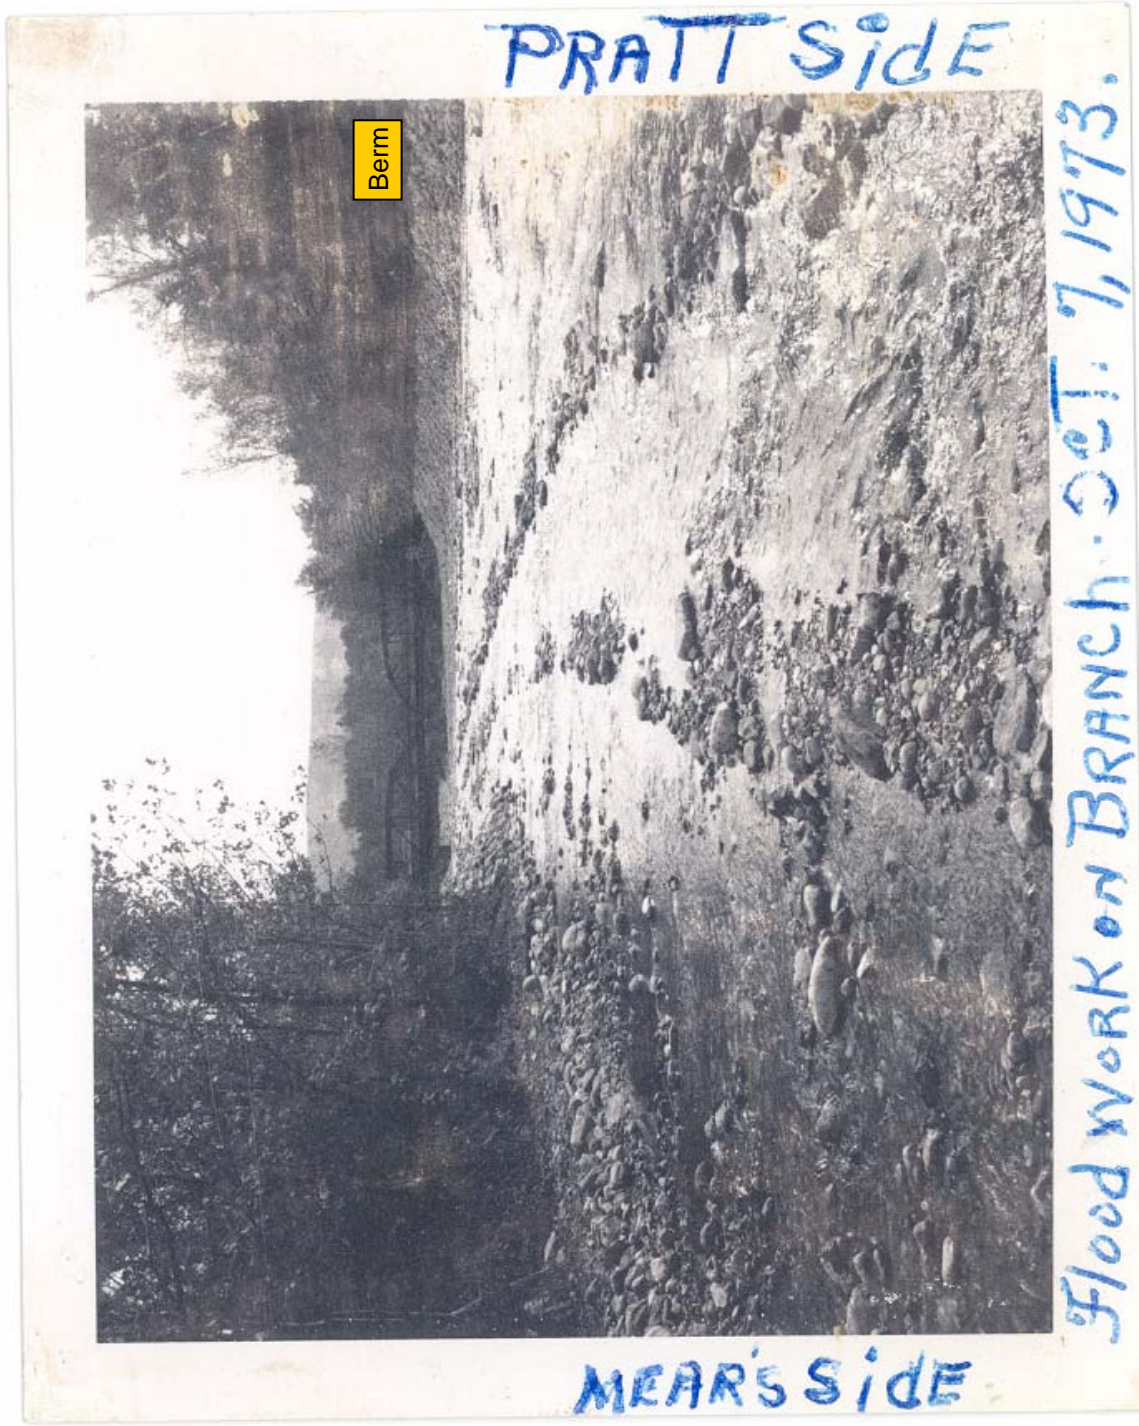
Berm Construction on Roaring Branch Following 1973 Flood

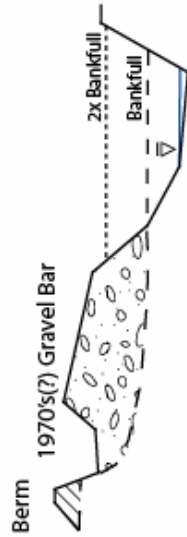
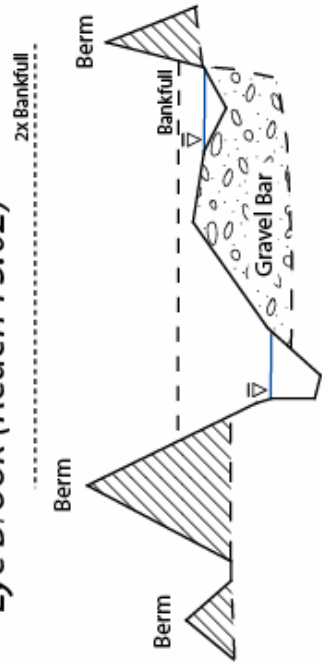
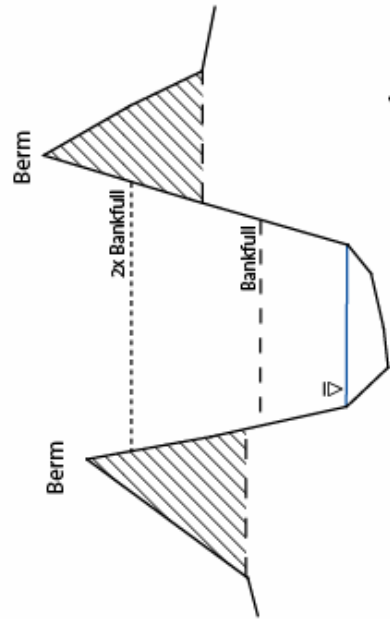
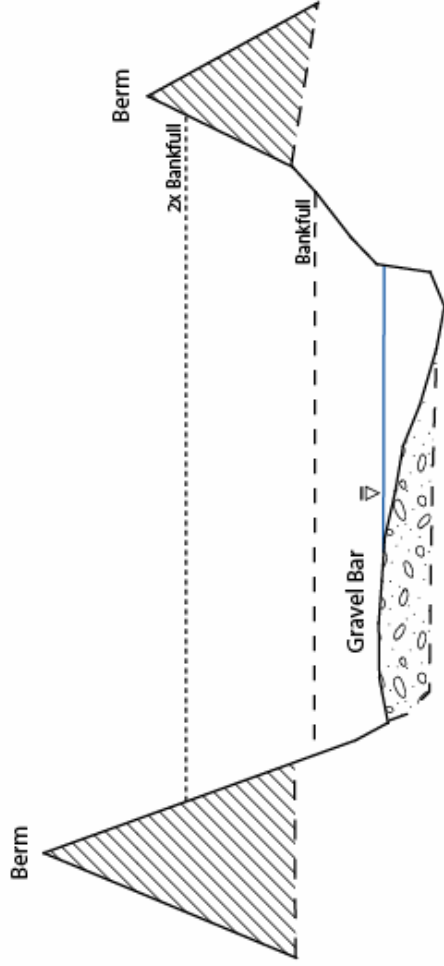
Cross Sections of Berms on Green Mountain Tributaries

Mad Tom Brook (Reach T7.01)

Lye Brook (Reach T3.02)

Bourn Brook (Reach T4S1.01)

Roaring Branch (Reach T2.01)

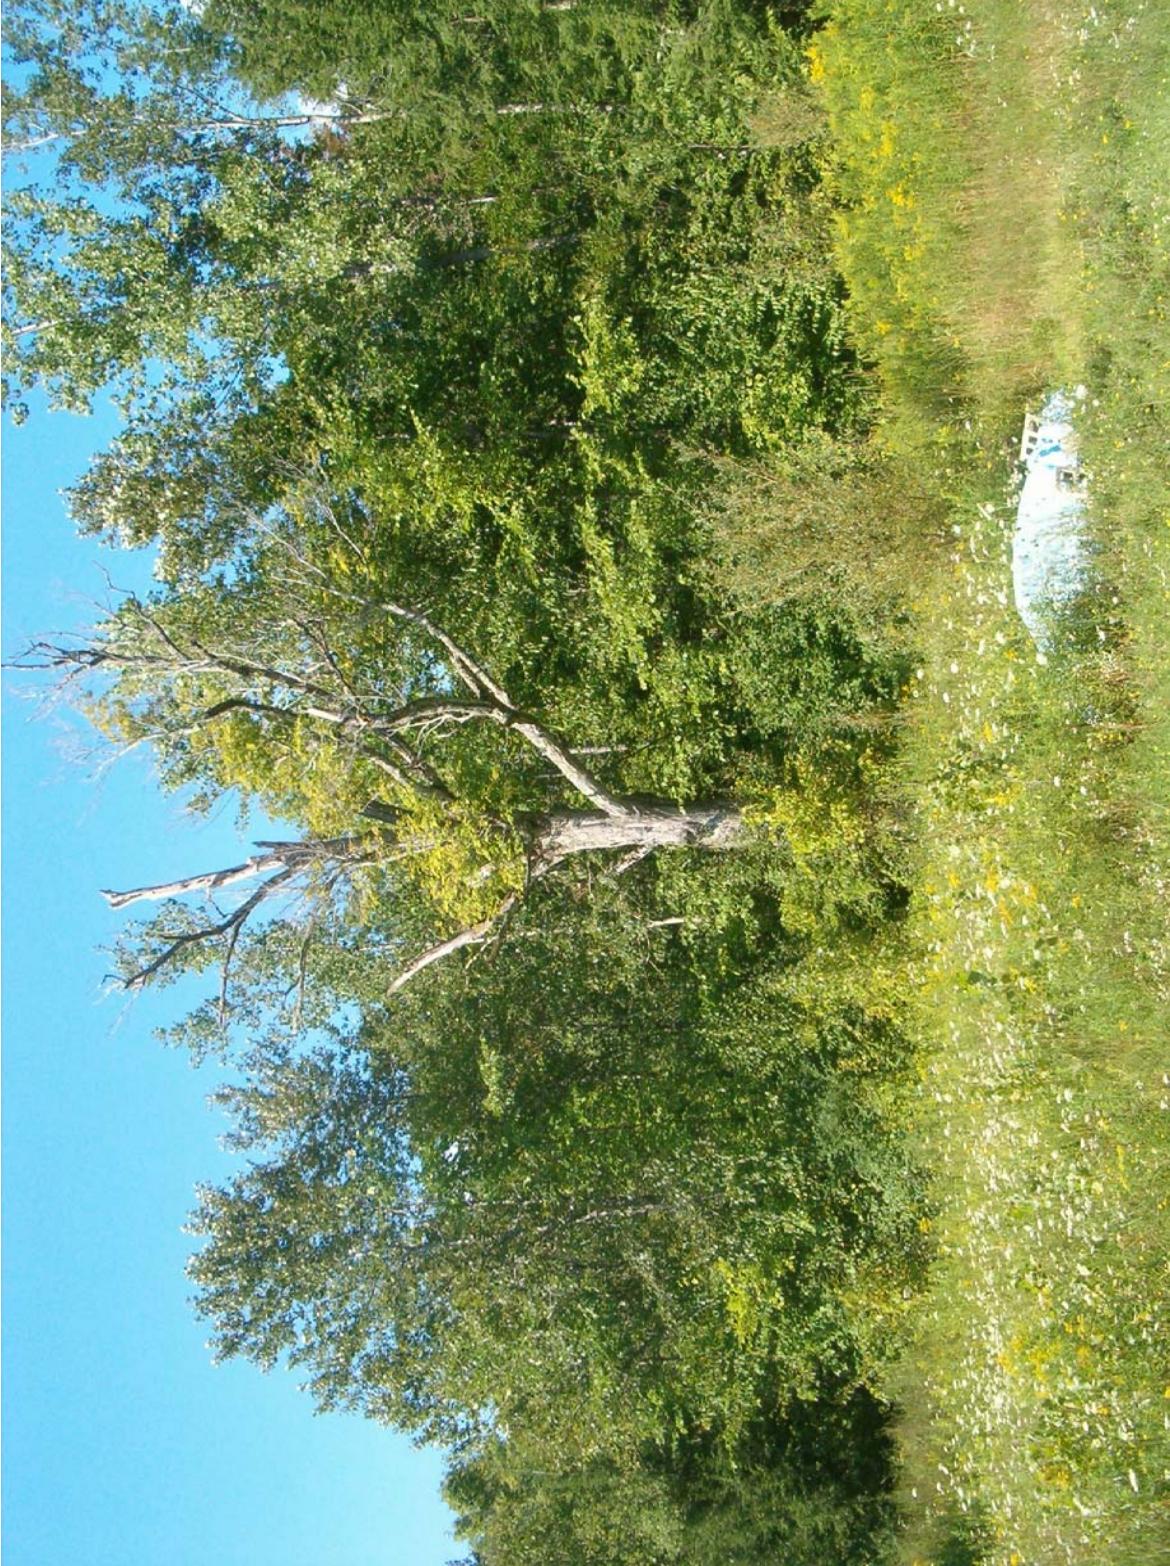
Patterns of Vegetation Growth on Bourn Brook Berm

Note: Old dying tree in center of photo was stressed when base was buried during berm construction. All healthy trees growing on berm are less than 30 years old.

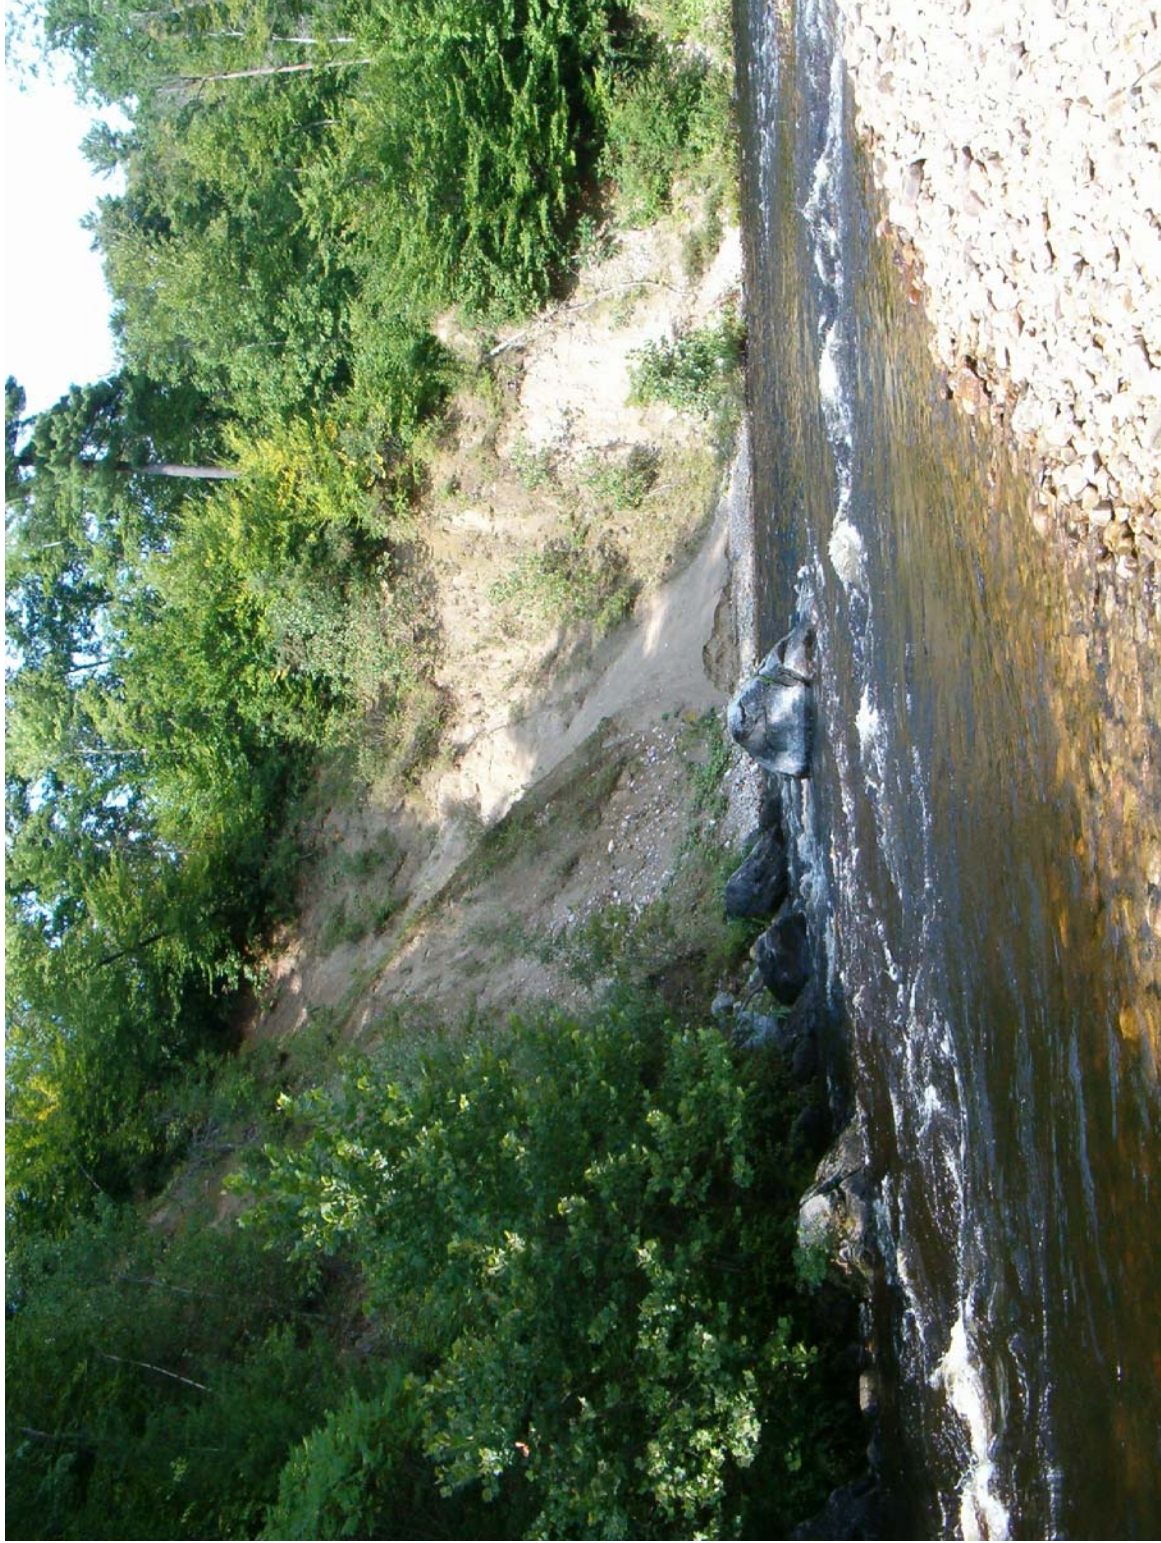
High Eroding Bank Across from Roaring Branch Confluence

Note: View looking upstream on Batten Kill
