# Upper Mad River Corridor Plan

January 31, 2008

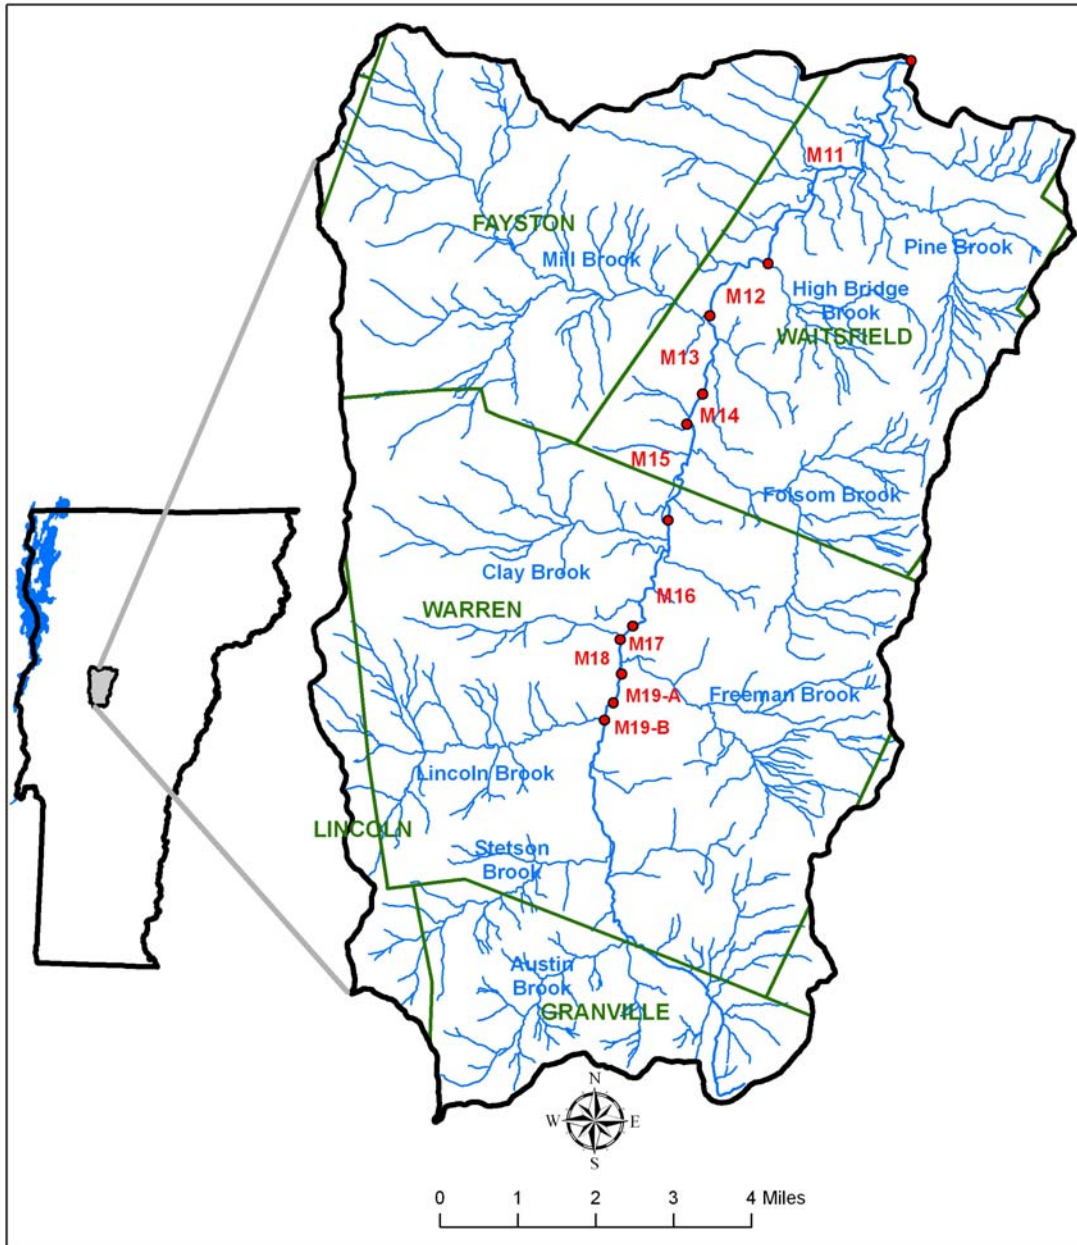
Figure 3.1. Upper Mad River watershed, town boundaries, and study reaches.

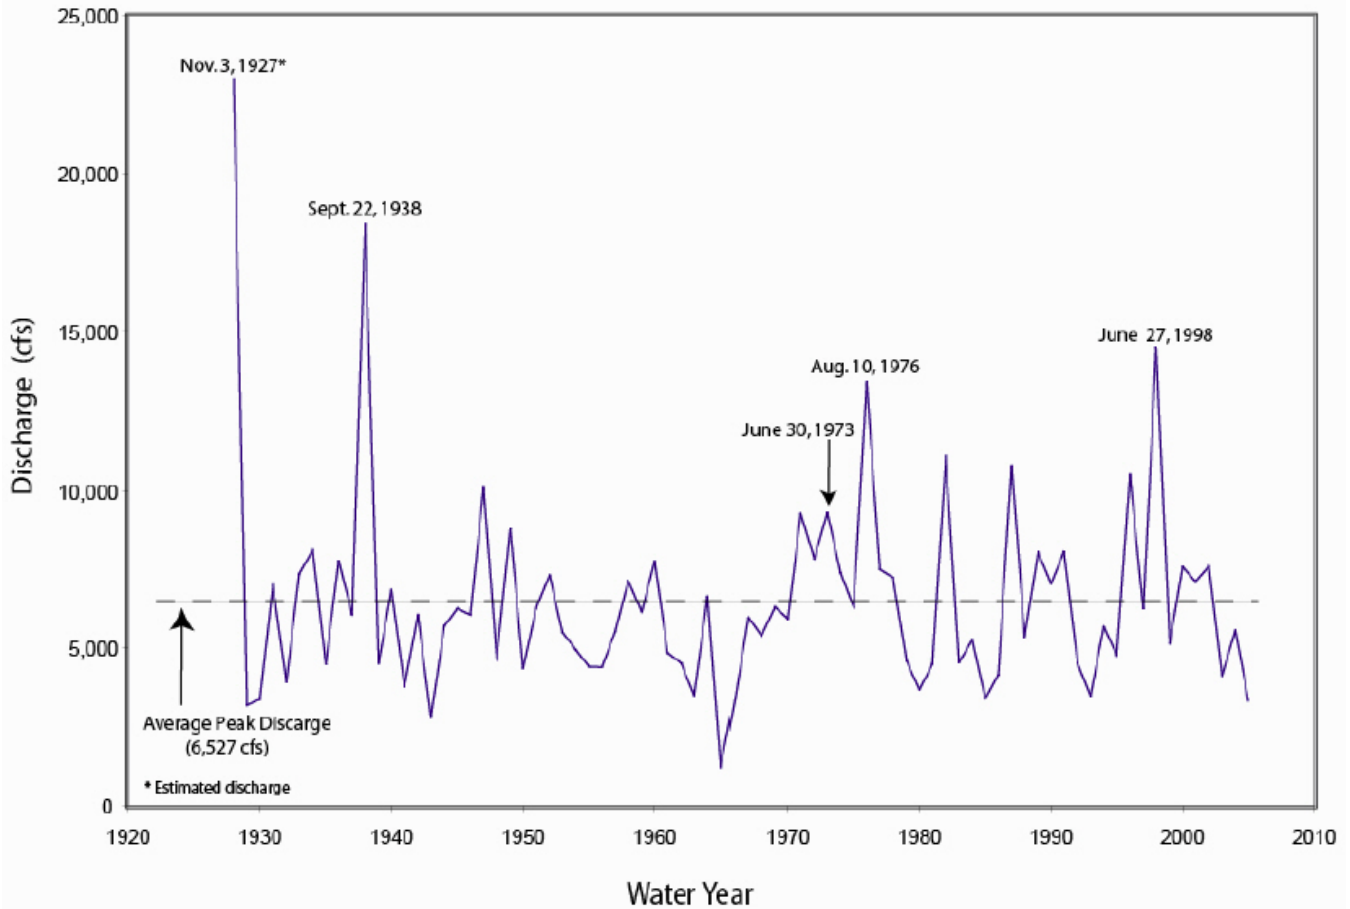
Figure 3.2 Annual Peak Discharges at USGS gauge from 1927 through 2005 (from Field, 2007)

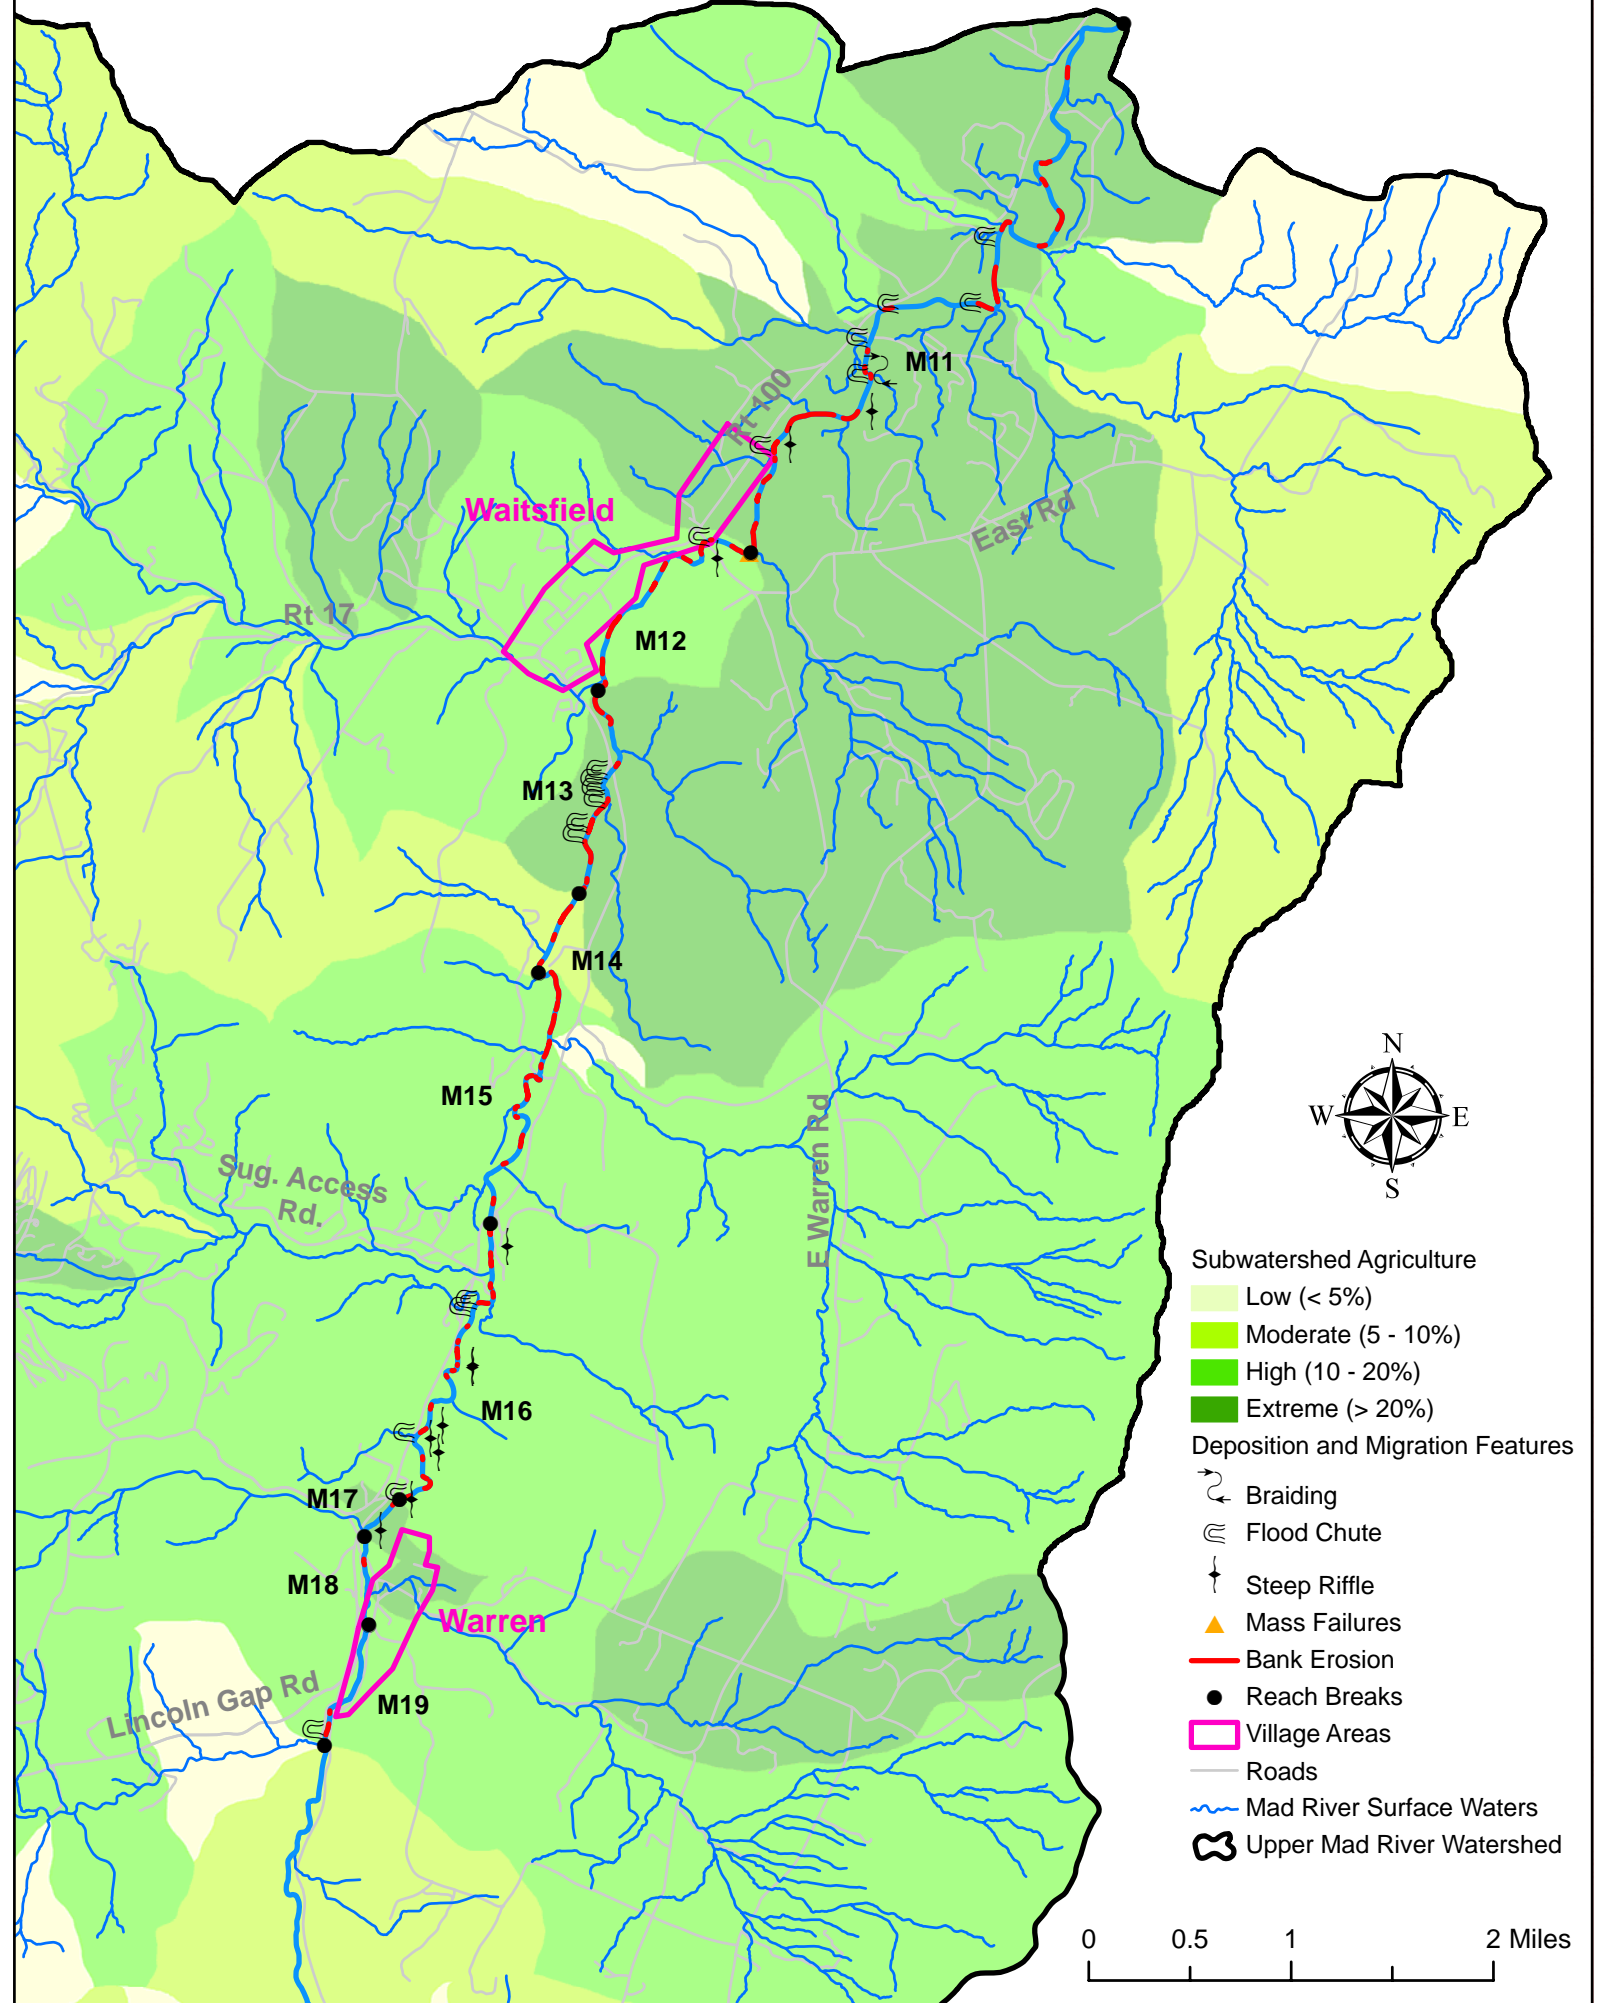
- Subwatershed Agriculture**
- Low (< 5%)
  - Moderate (5 - 10%)
  - High (10 - 20%)
  - Extreme (> 20%)
- Deposition and Migration Features**
- Braiding
  - Flood Chute
  - Steep Riffle
  - Mass Failures
  - Bank Erosion
  - Reach Breaks
  - Village Areas
  - Roads
  - Mad River Surface Waters
  - Upper Mad River Watershed

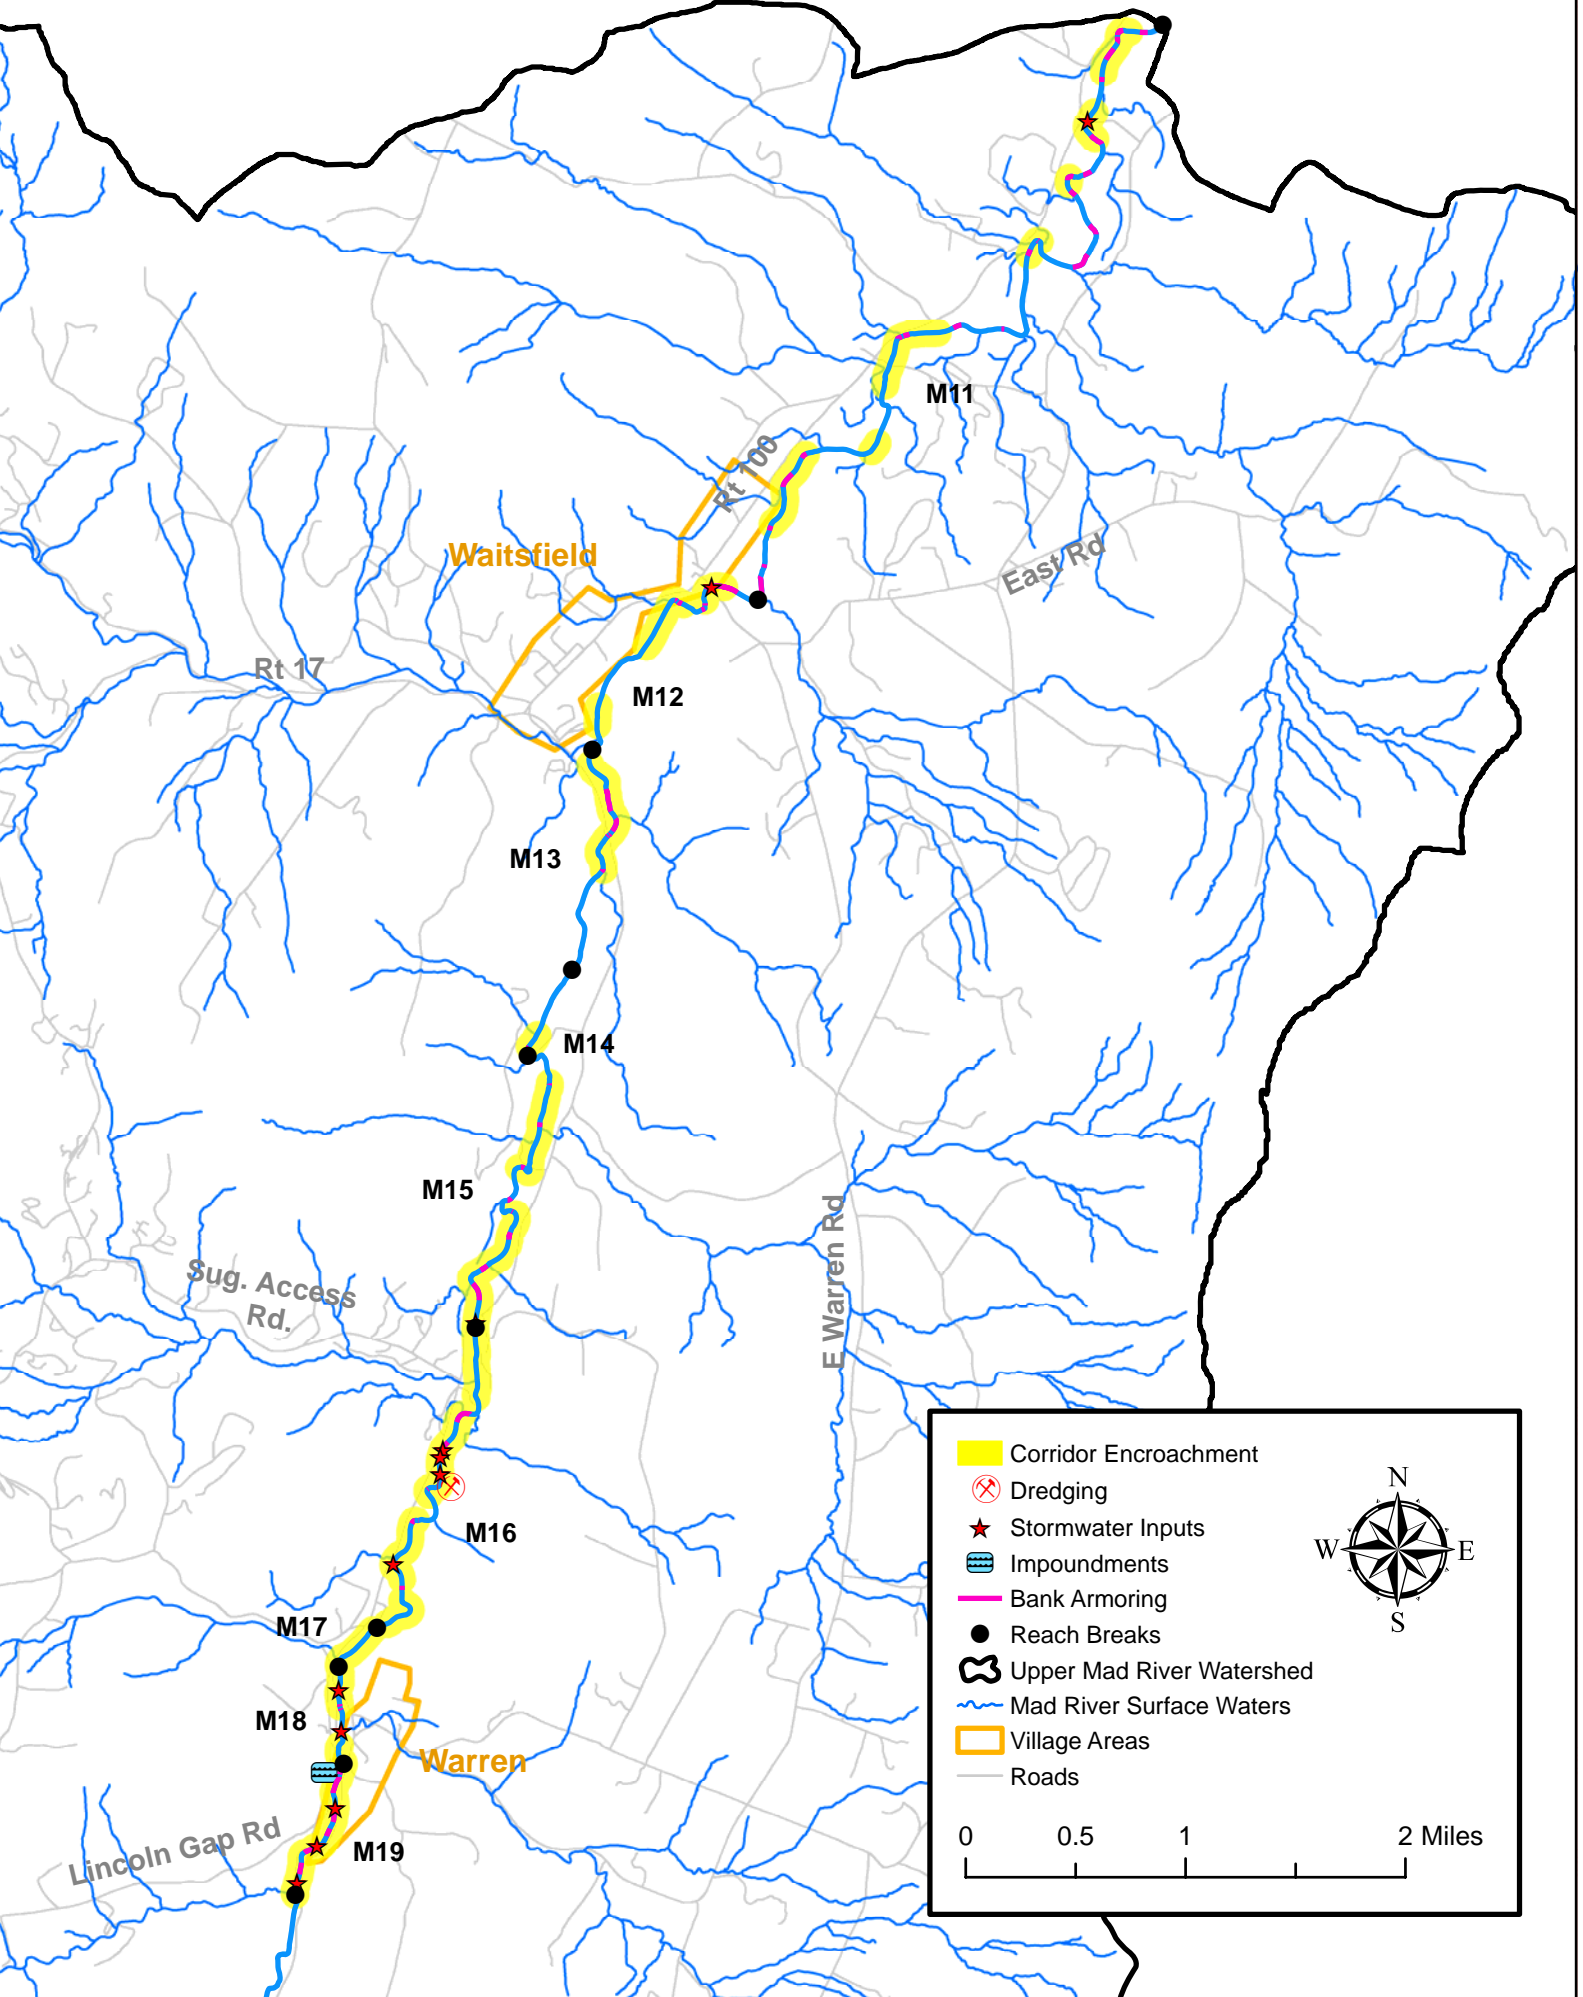
## 5.4 Modifications to Channel Boundary and Riparian Conditions

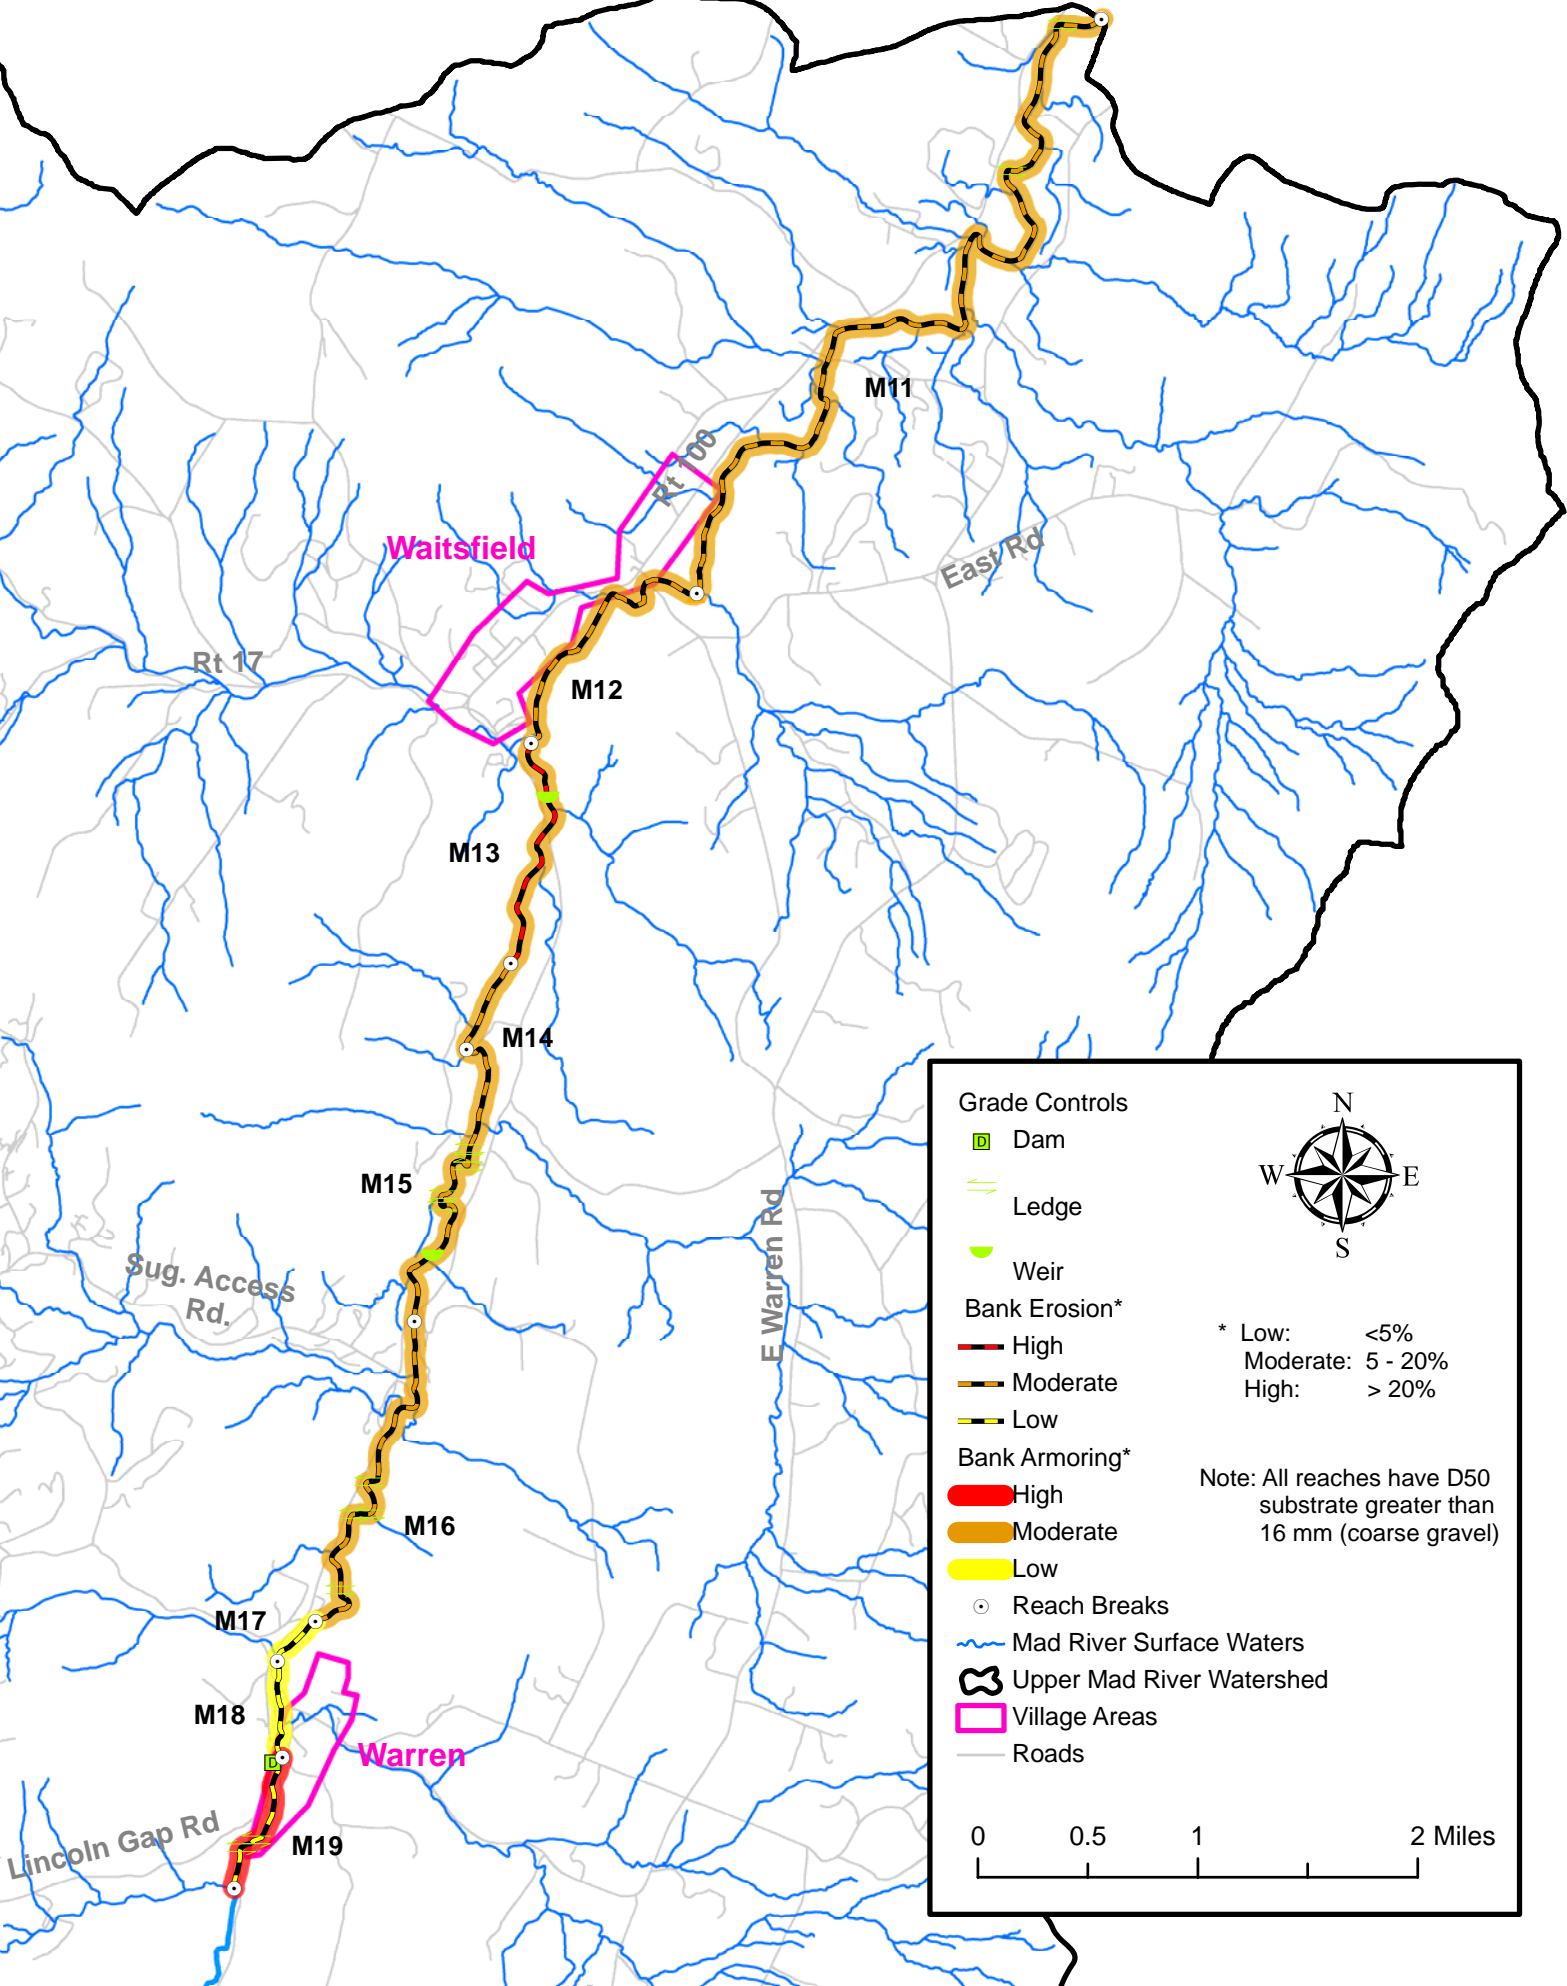
<b>Grade Controls</b>		
Dam		
Ledge		
Weir		
<b>Bank Erosion*</b>		
High		
Moderate		
Low		
<b>Bank Armoring*</b>		
High		
Moderate		
Low		
Reach Breaks		
Mad River Surface Waters		
Upper Mad River Watershed		
Village Areas		
Roads

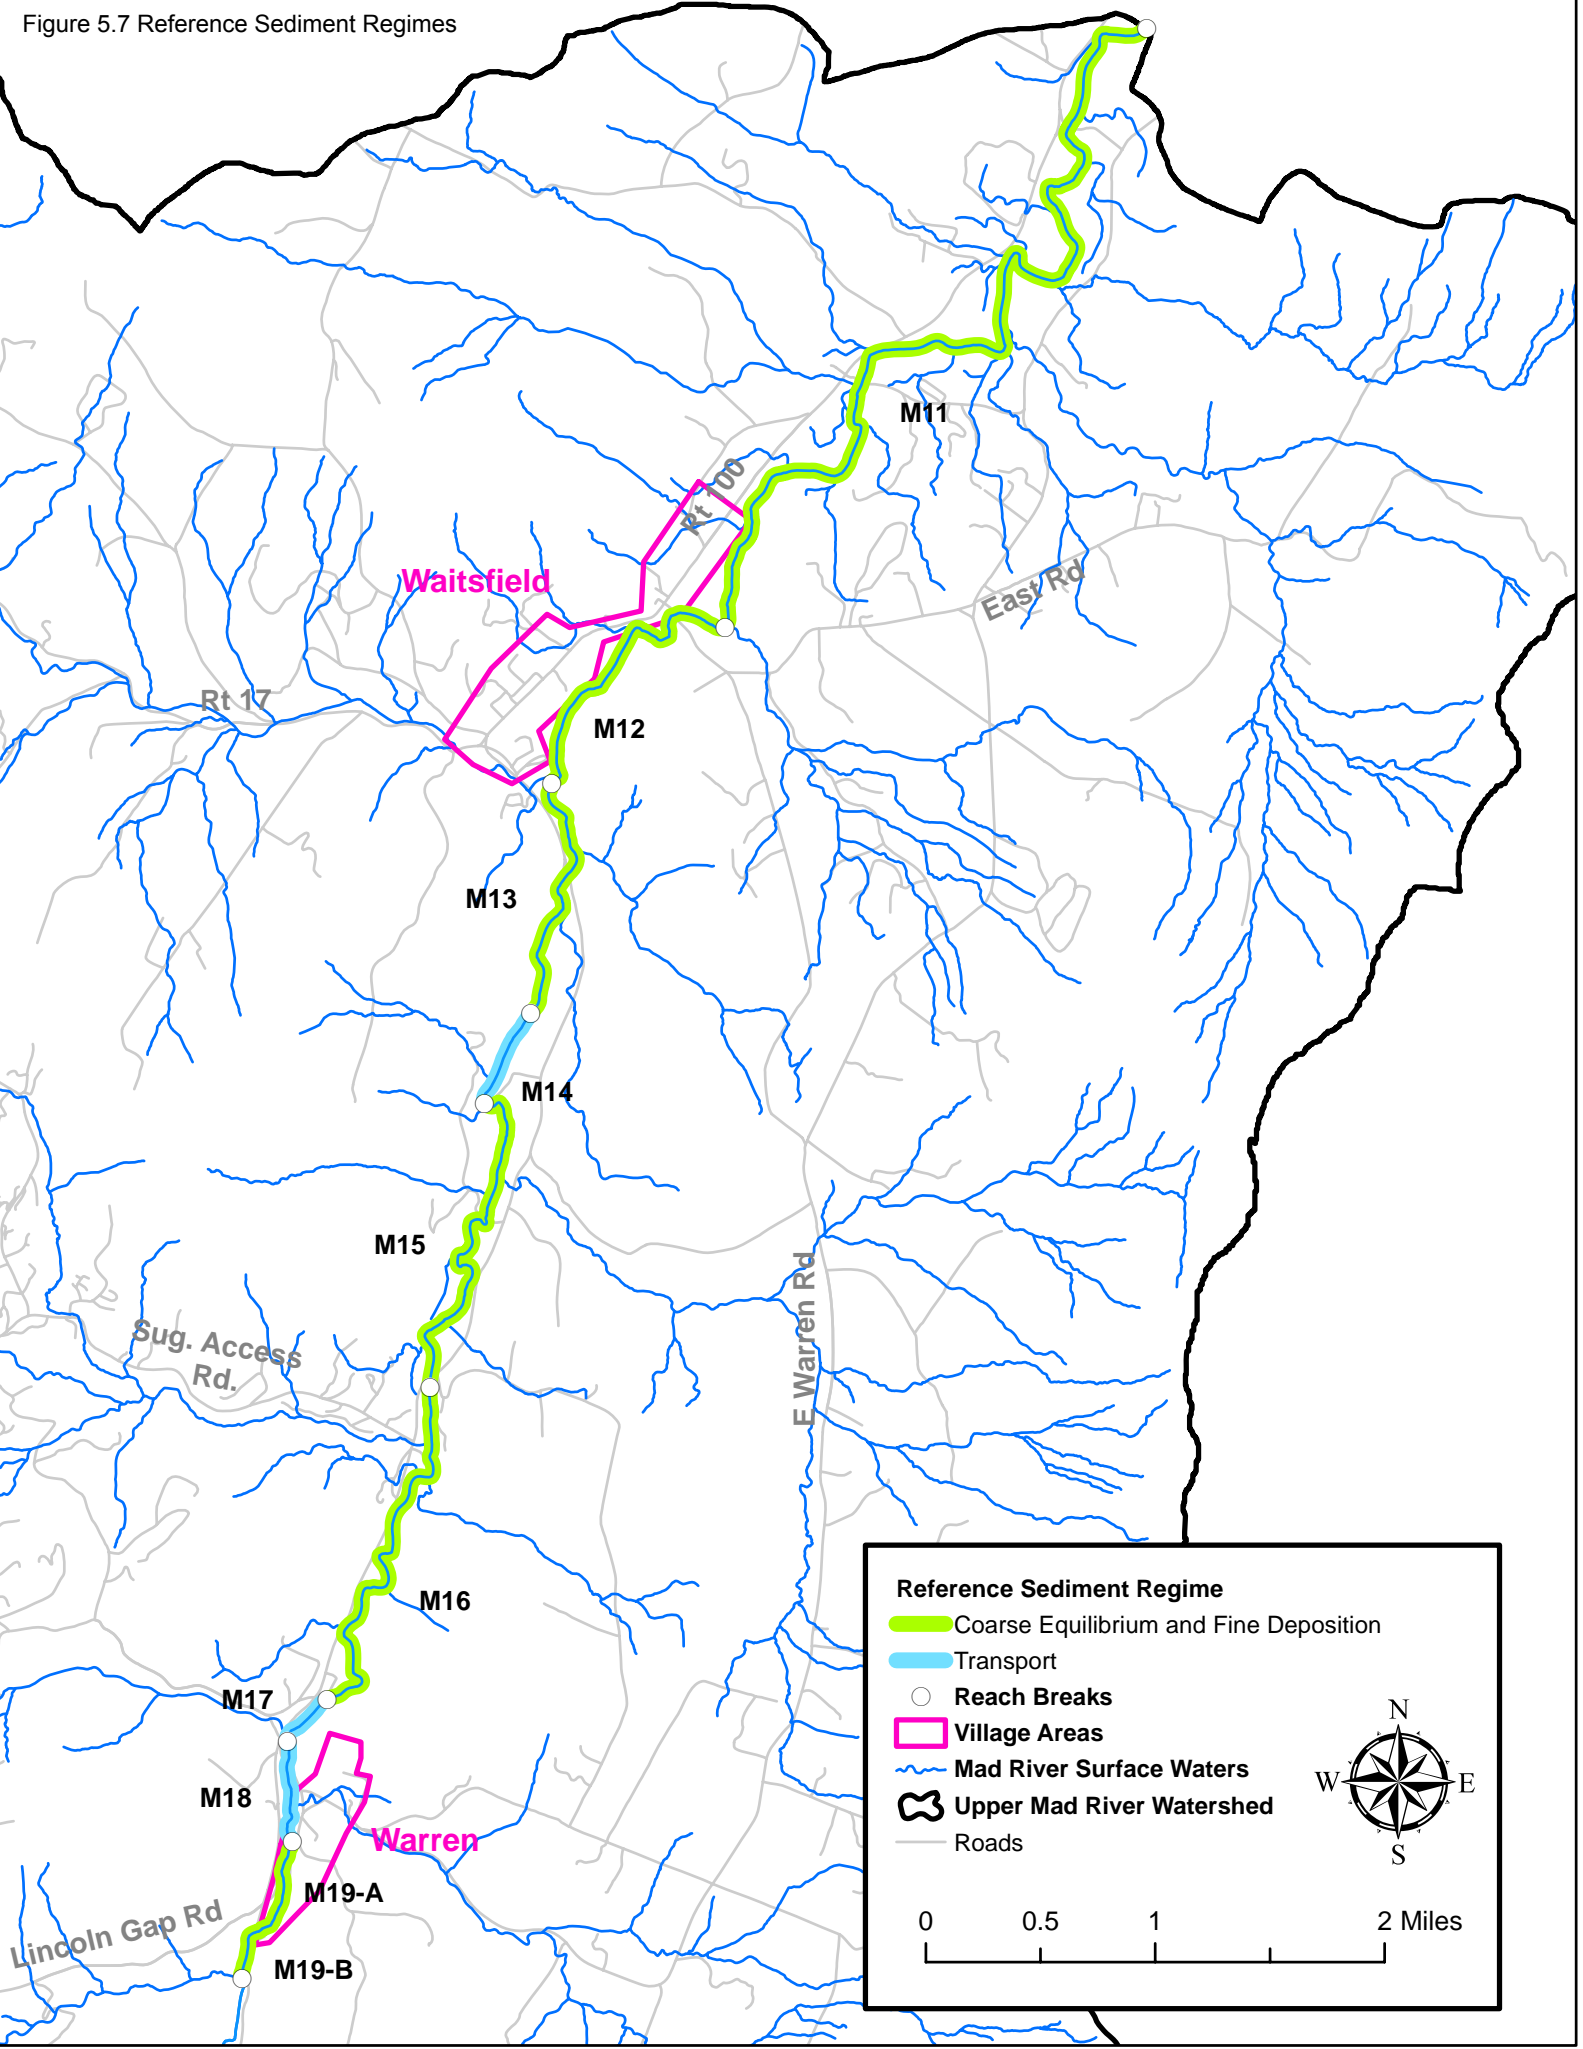
Figure 5.8 Existing Sediment Regimes

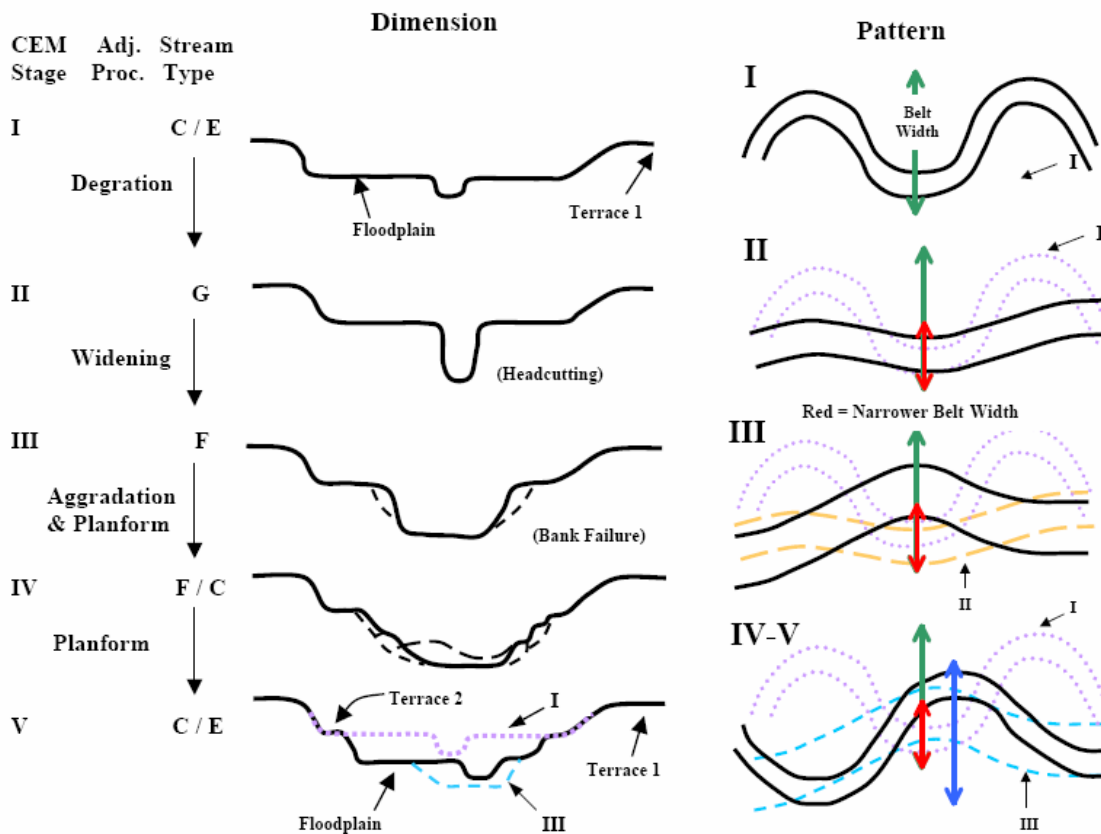
Figure 5.9 Typical channel evolution processes observed in rivers of VT (modified from Schumm, 1977)

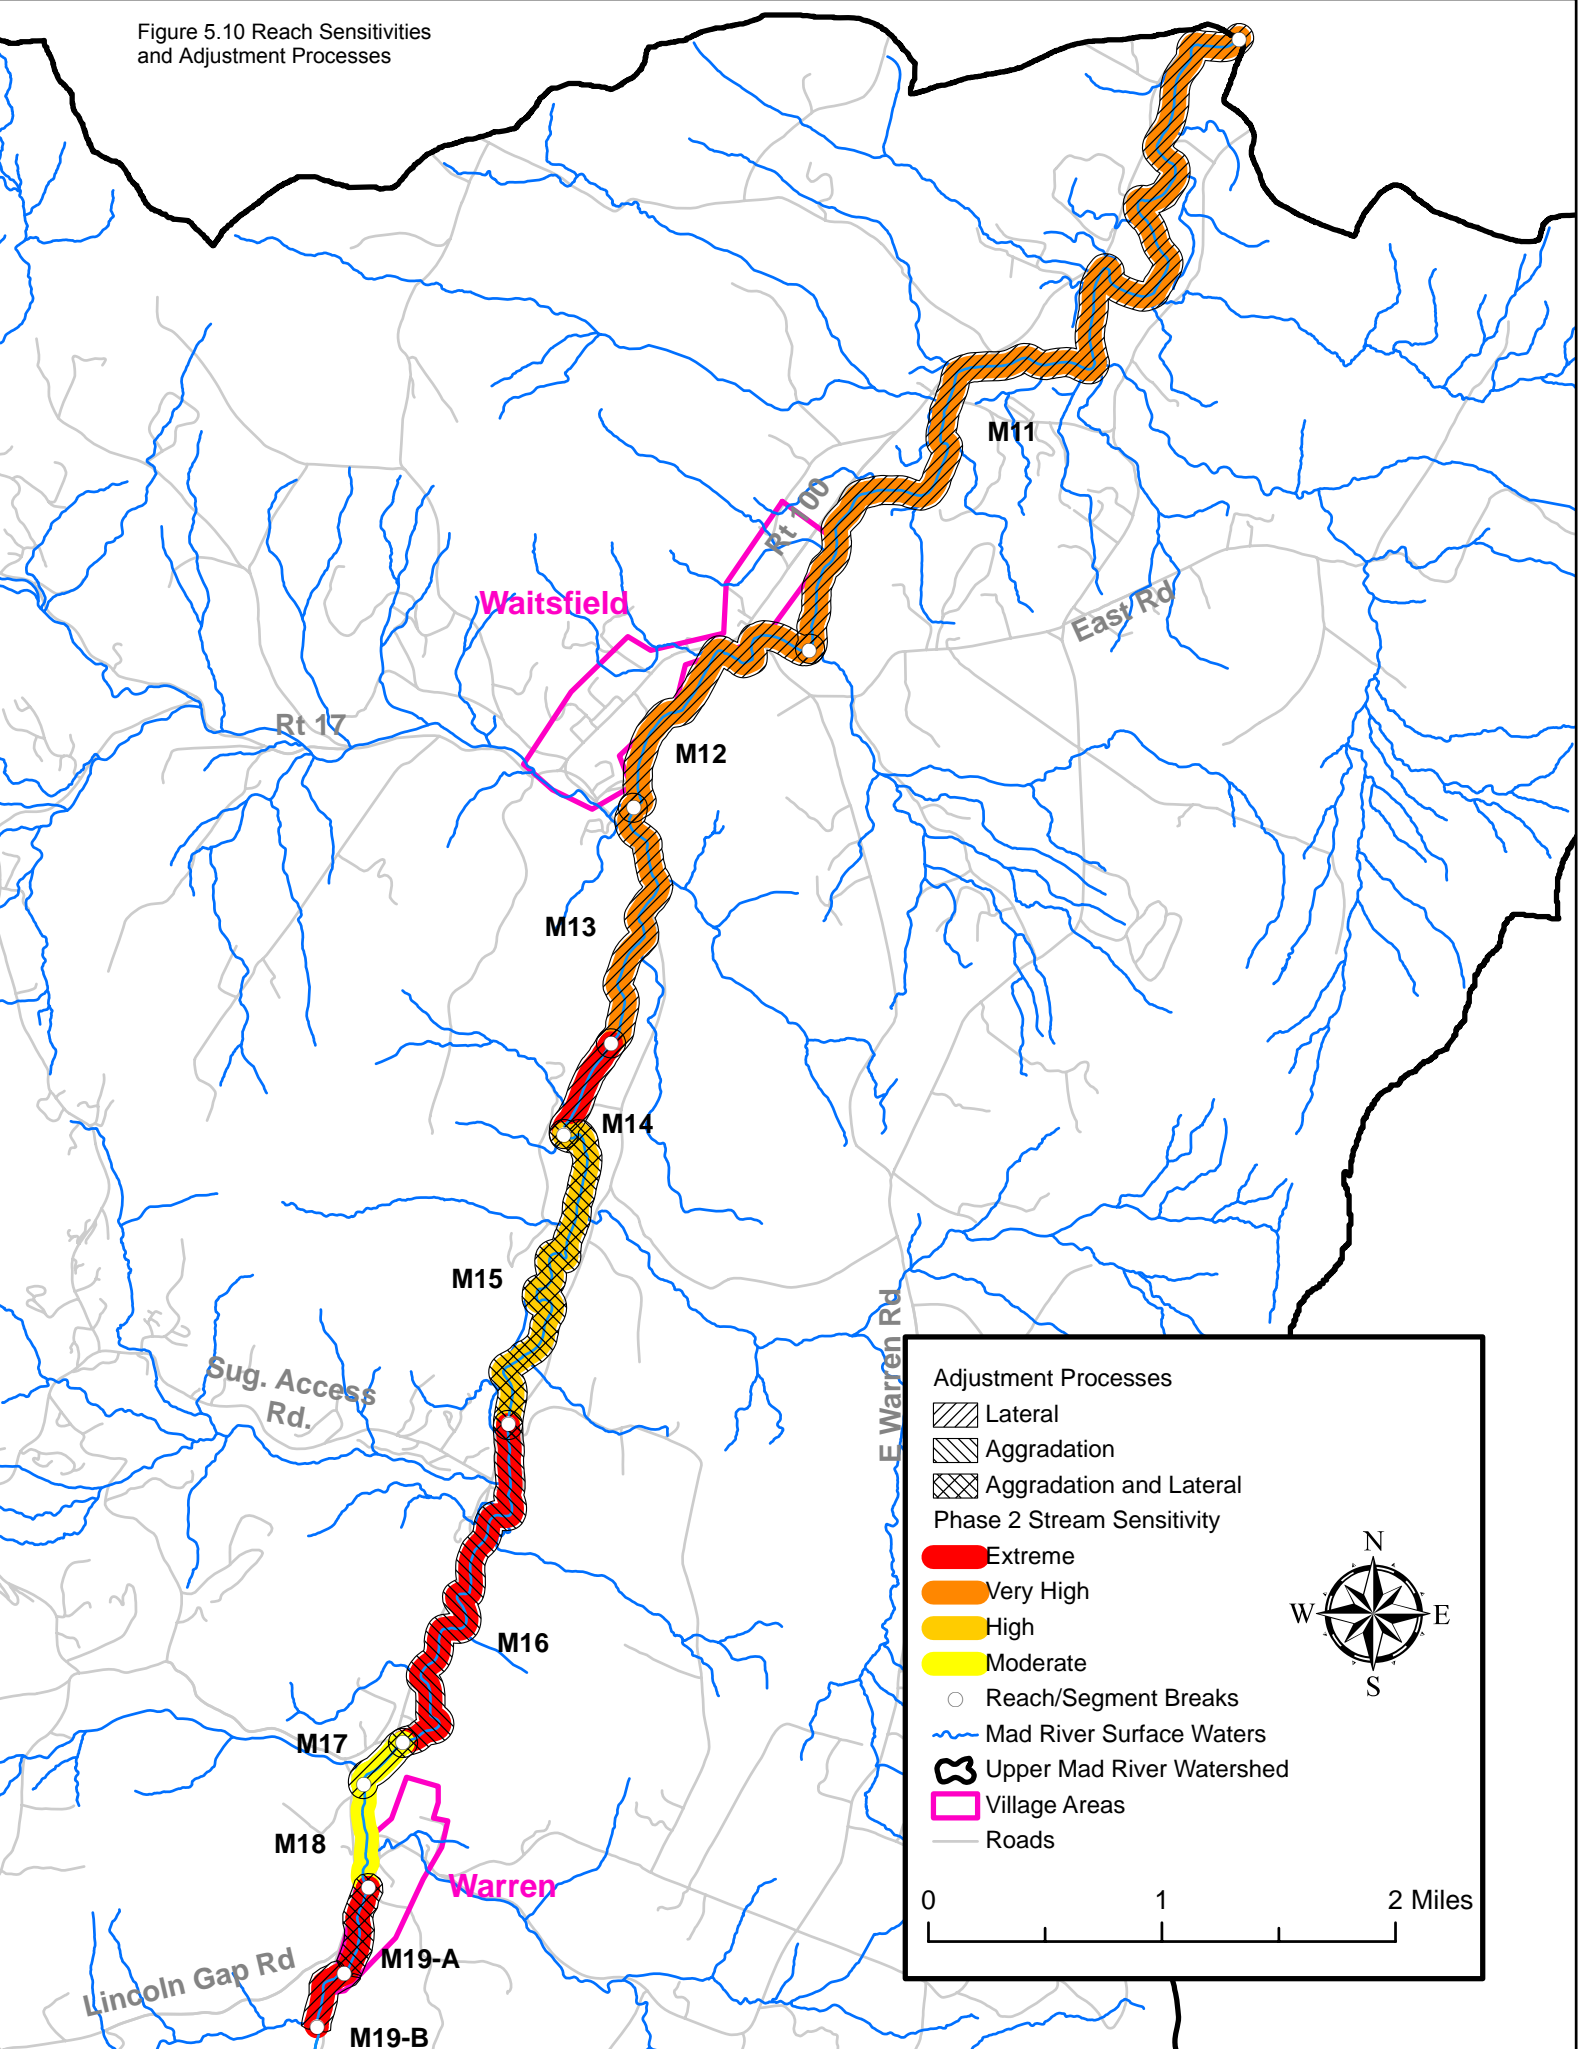
**Adjustment Processes**

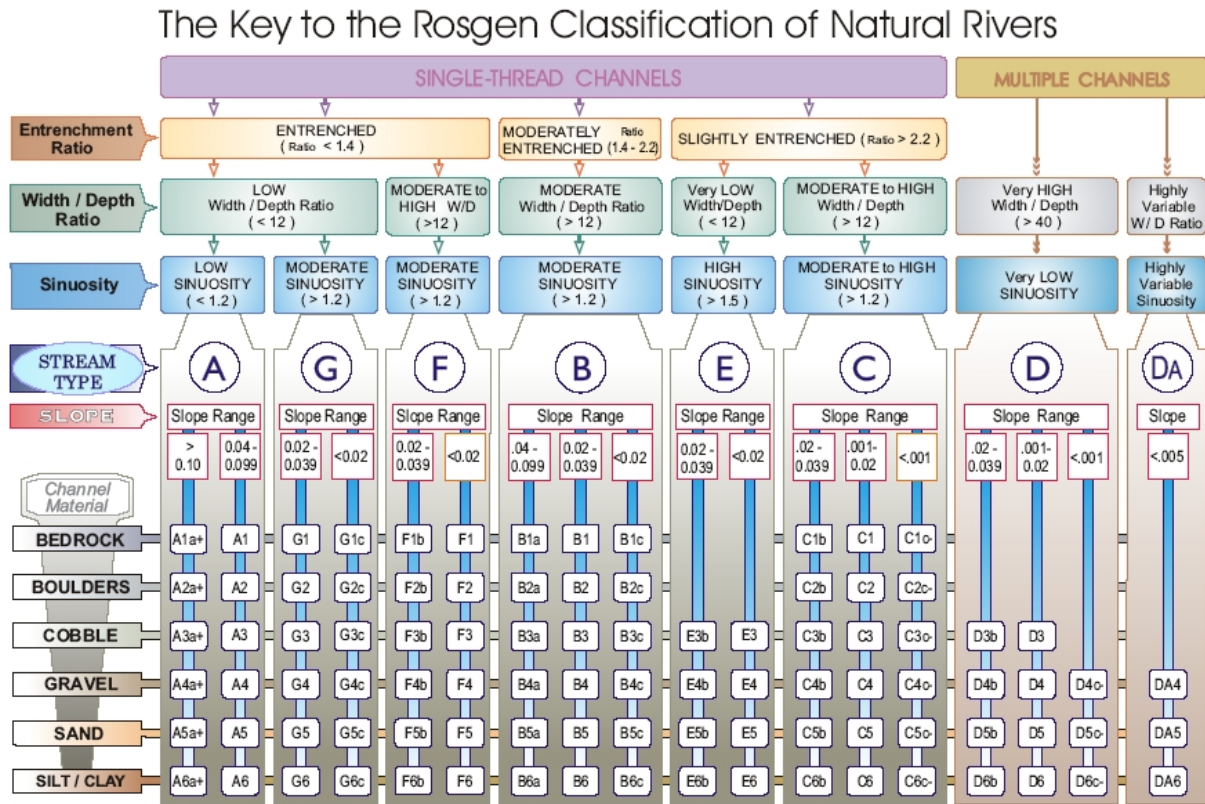
KEY to the ROSGEN CLASSIFICATION of NATURAL RIVERS. As a function of the "continuum of physical variables" within stream reaches, values of **Entrenchment** and **Sinuosity** ratios can vary by +/- 0.2 units; while values for **Width / Depth** ratios can vary by +/- 2.0 units.

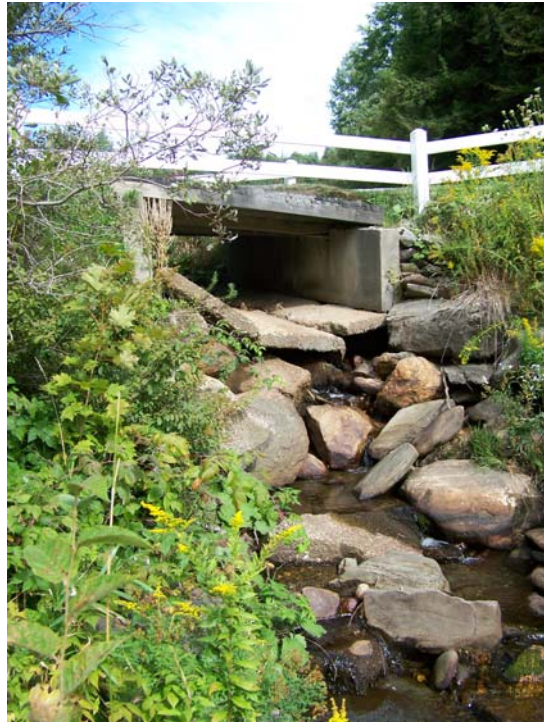
Figure 6.1 Concrete box culvert on T9.3S1.01 for a golf course path. The floor is broken and the stream flows through the cracks and emerges beneath the culvert.

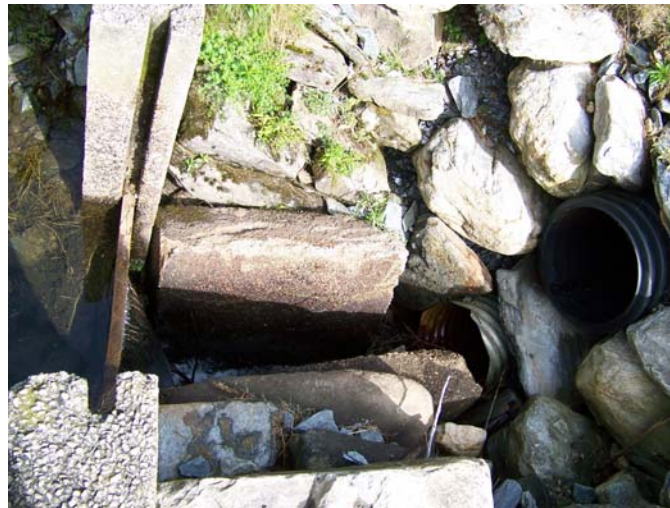
Figure 6.2 Culverts under part of the golf course on T9.3S1.01. A dam is seen on the left then 2 small culverts on right that travel under the golf course.

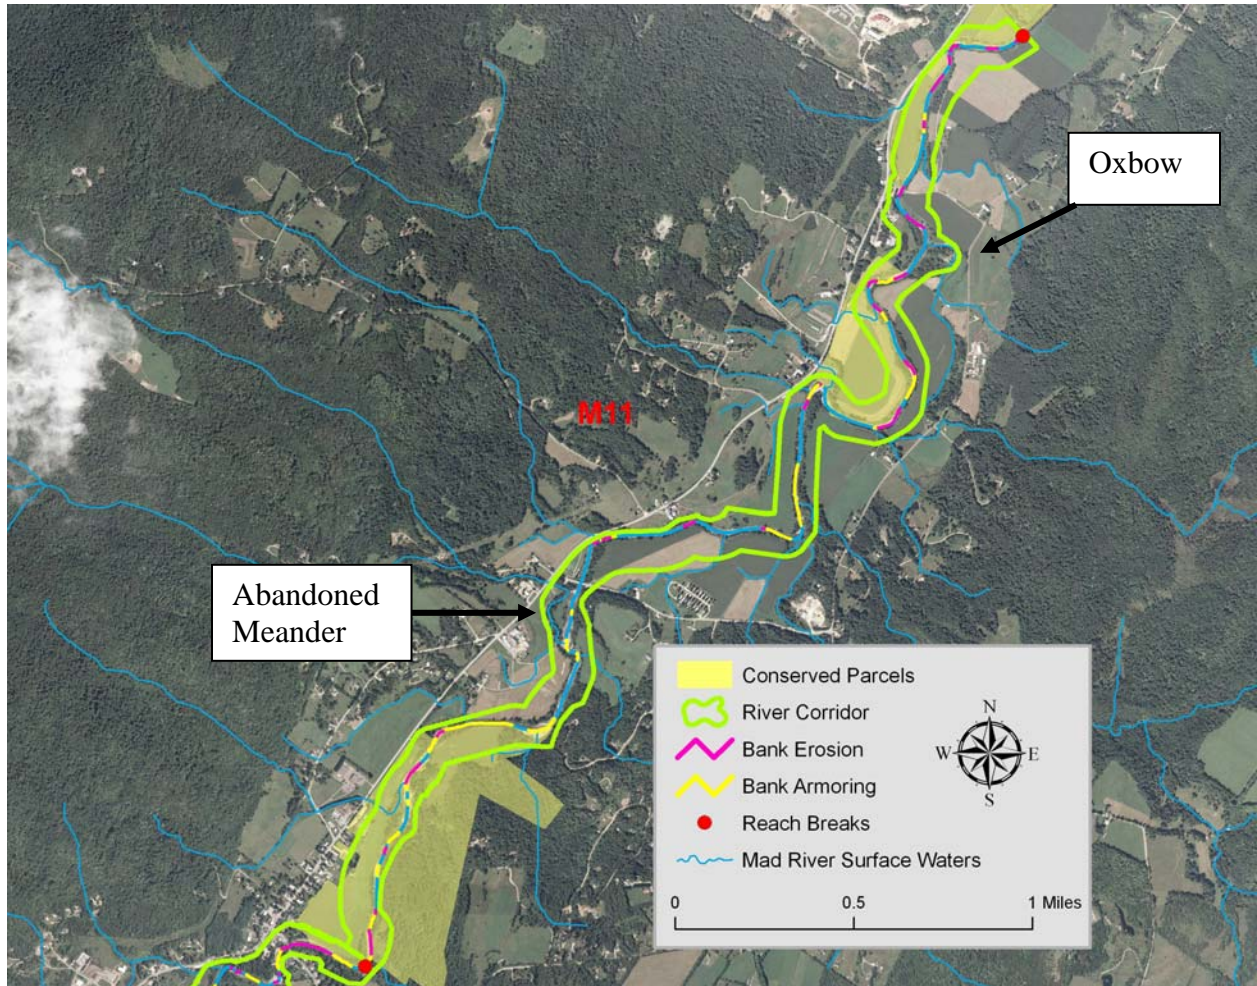
Figure 6.6 Map showing reach M11 with the corridor, areas of bank armoring and areas of bank erosion.
