# Upper Mad River Corridor Plan

January 31, 2008

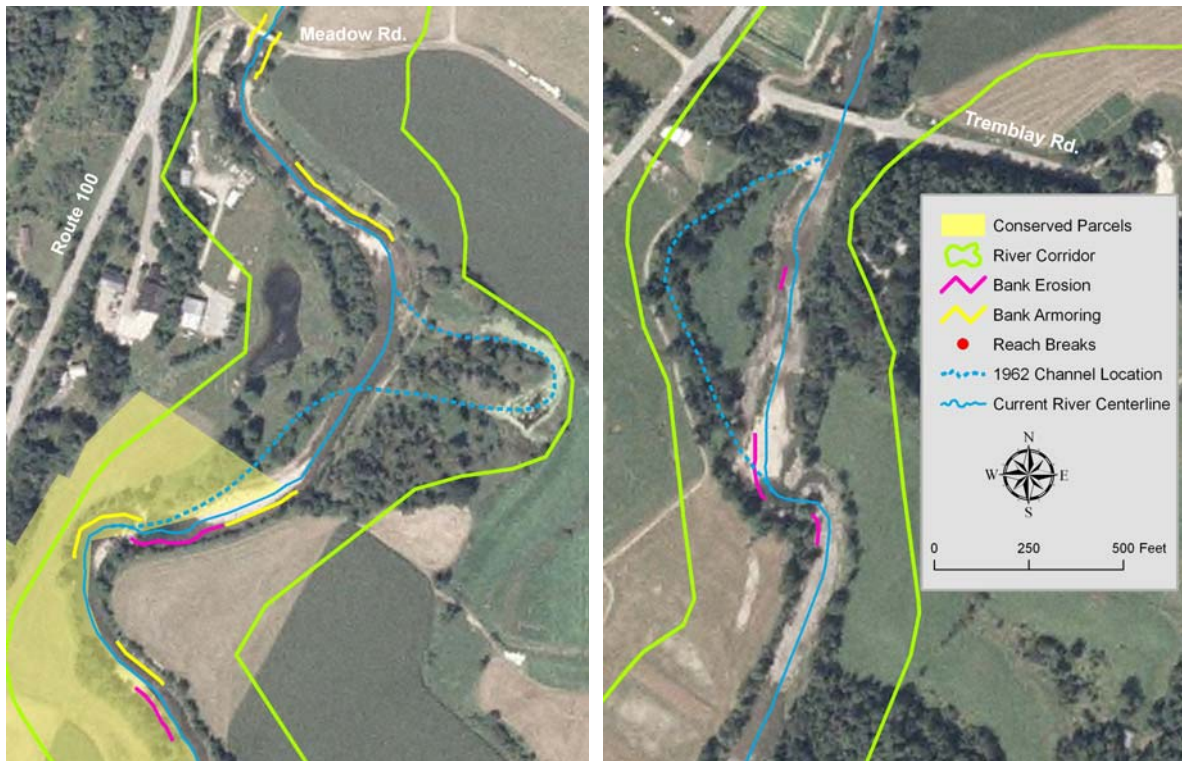
Figure 6.7 Oxbow area in Reach M11.

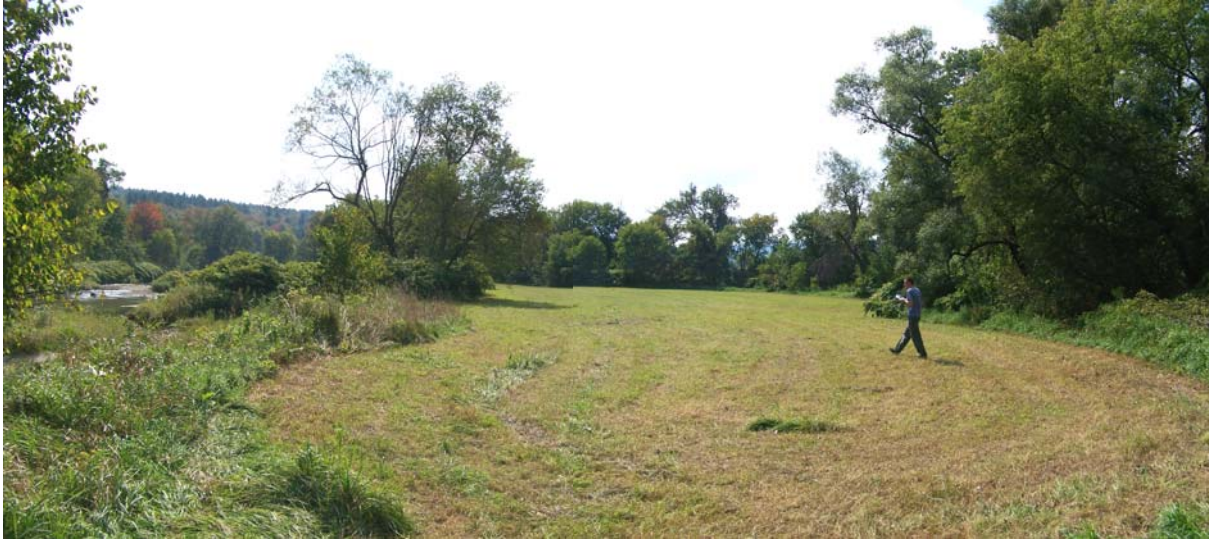
Figure 6.10 Looking upstream, the main channel is to the left with an abandoned meander on the far right, essentially following the tree line.

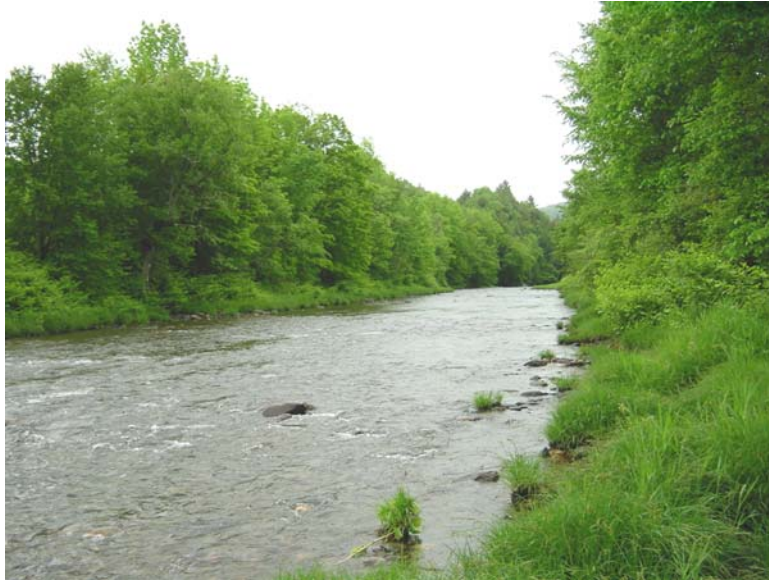
Figure 6.11 Straightened section of M12 between the ball field and Waitsfield Village.

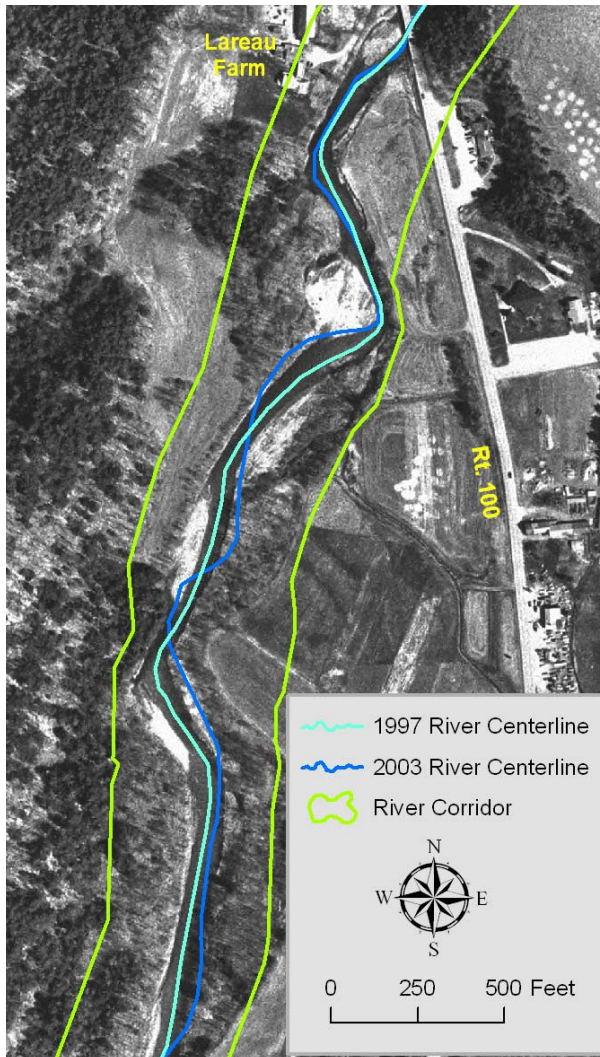
Figure 6.14 1997 orthophoto with stream centerlines.

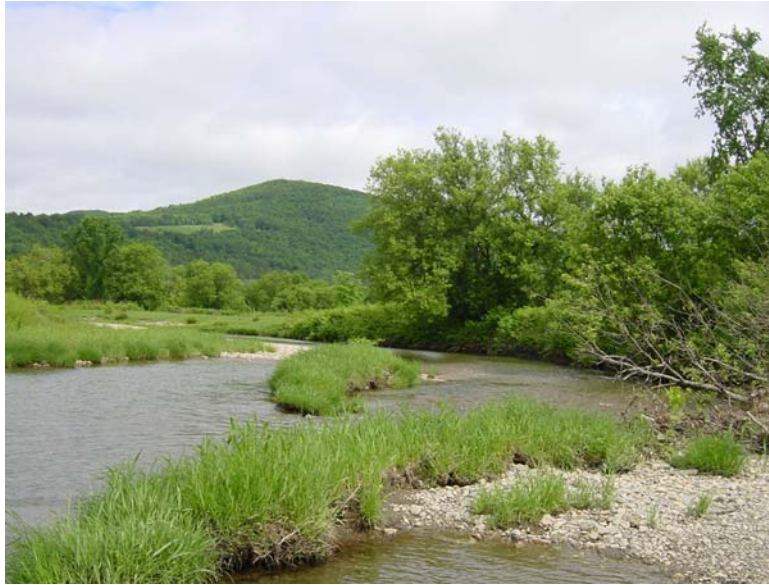
Figure 6.16 Bars and migration in reach M13 downstream of the Lareau Swim Hole.

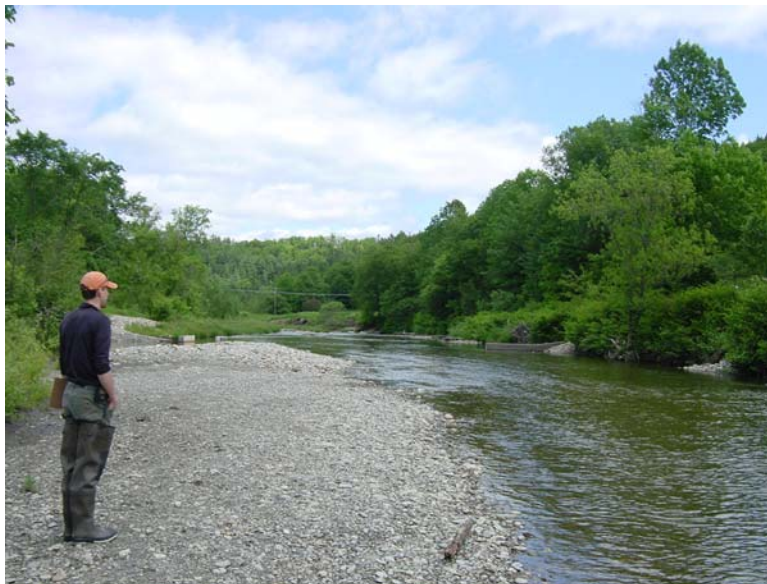
Figure 6.21 Bar forming adjacent to the snowmaking pond as the channel attempts to adjust. Dredging of the bar and sediment limit the adjustment ability of the channel here.

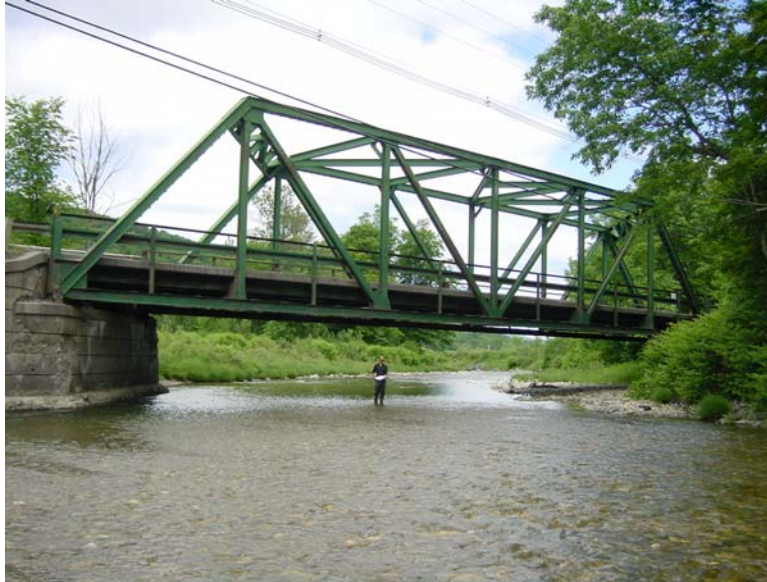
Figure 6.22 Warren Trestle Bridge

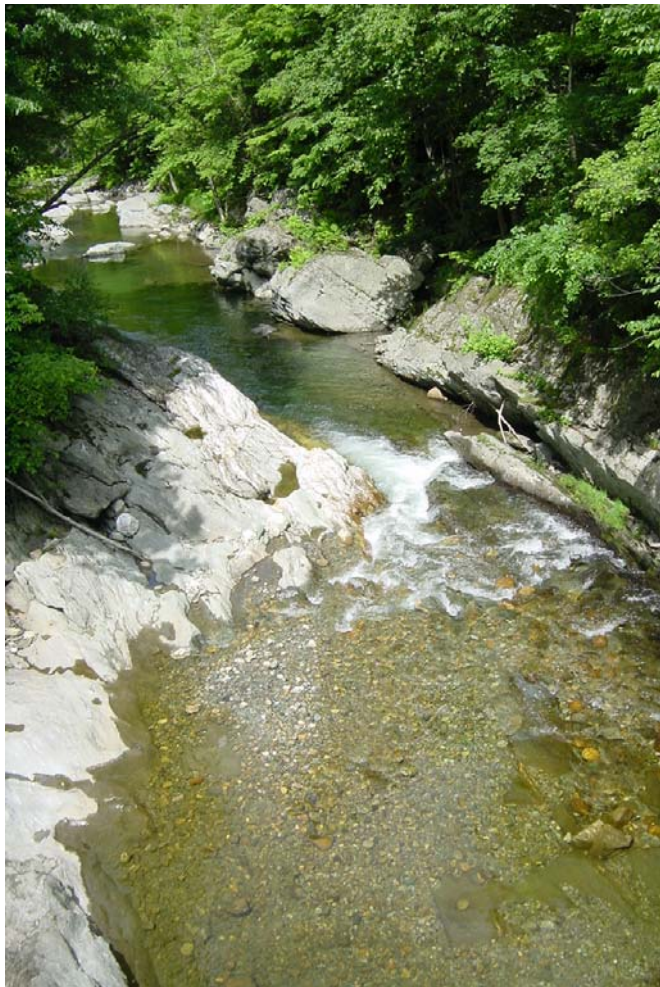
Figure 6.26 Bedrock gorge in lower M18.

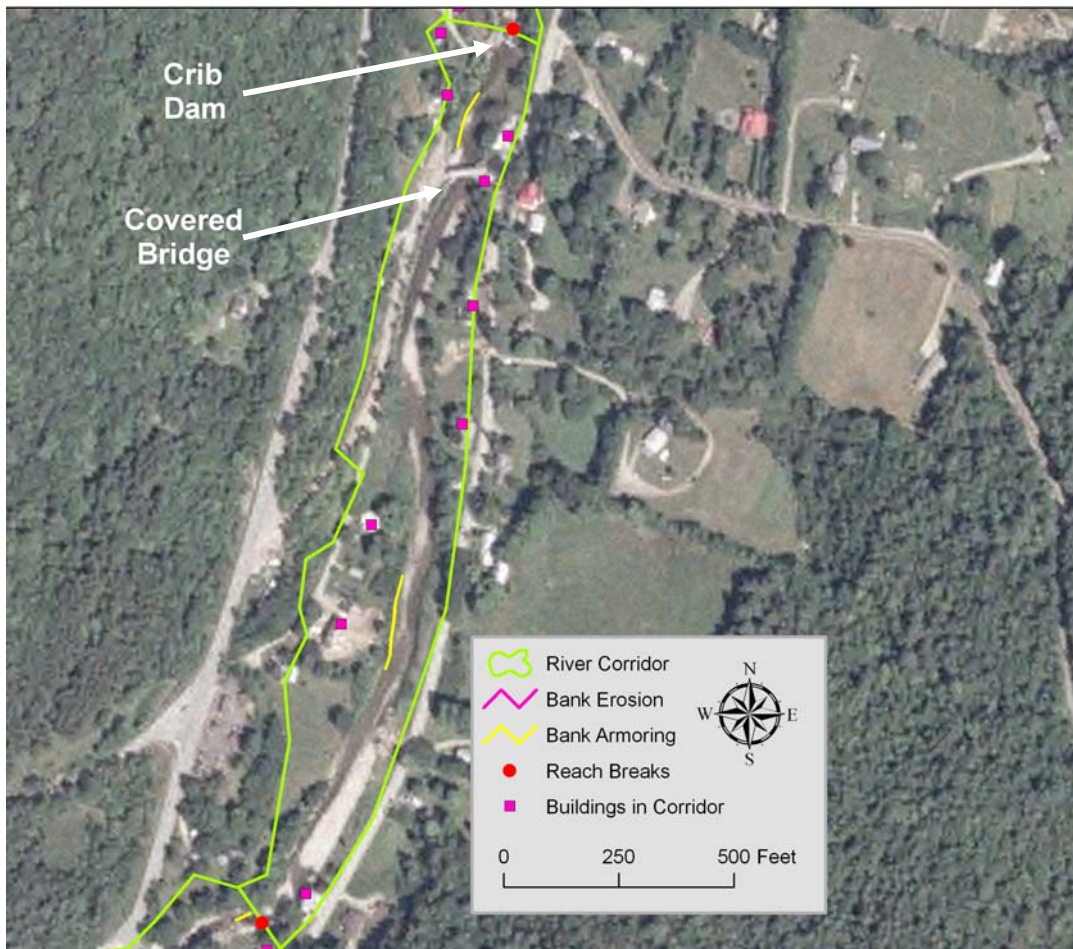
Figure 6.28 Site location map for Segment M19A.

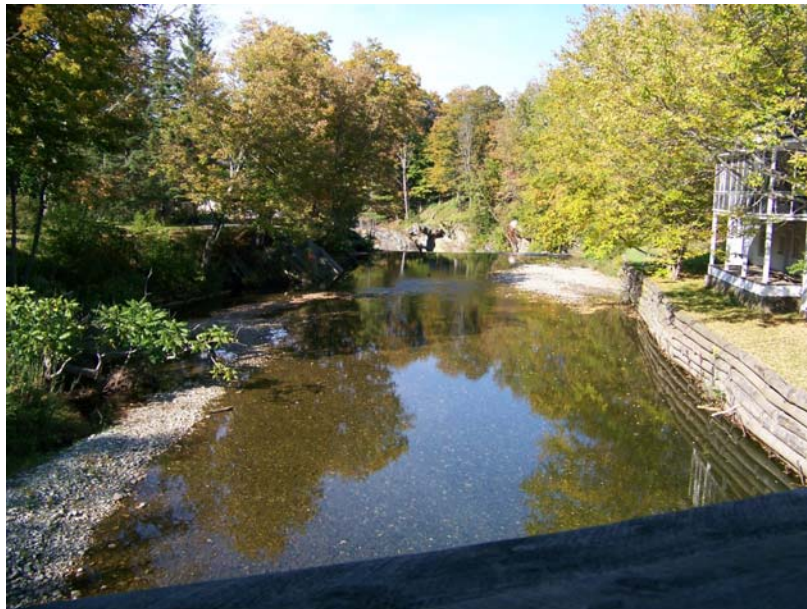
Figure 6.29 Aggradation of coarse gravel behind the Warren Crib Dam.

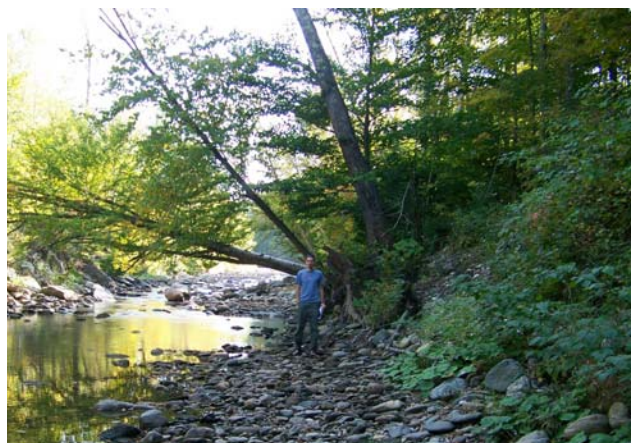
Figure 6.30 Bank erosion above Route 100 bridge.

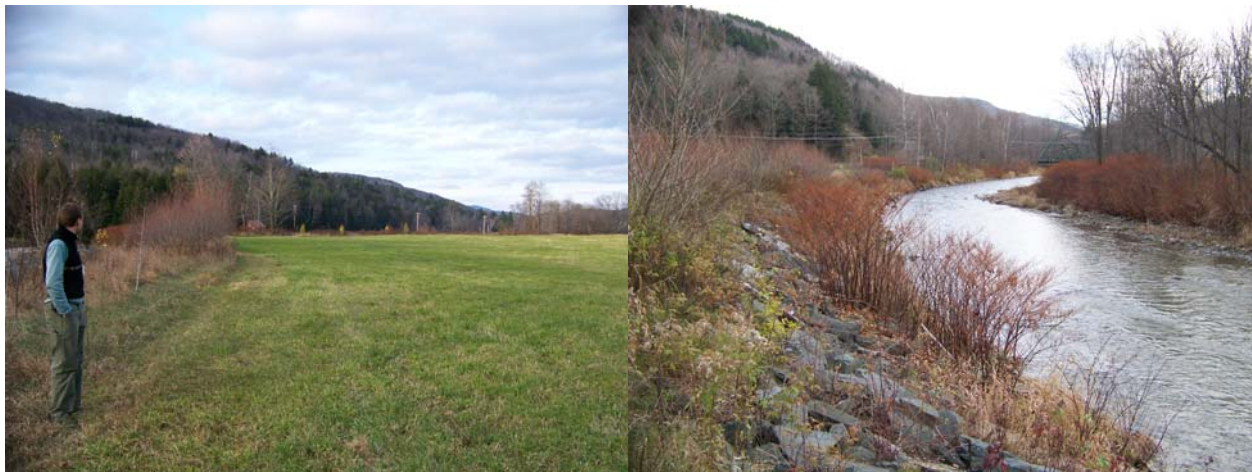
Photos showing thin buffer vegetation on left and extent of riprap on right at the Kingsbury property.

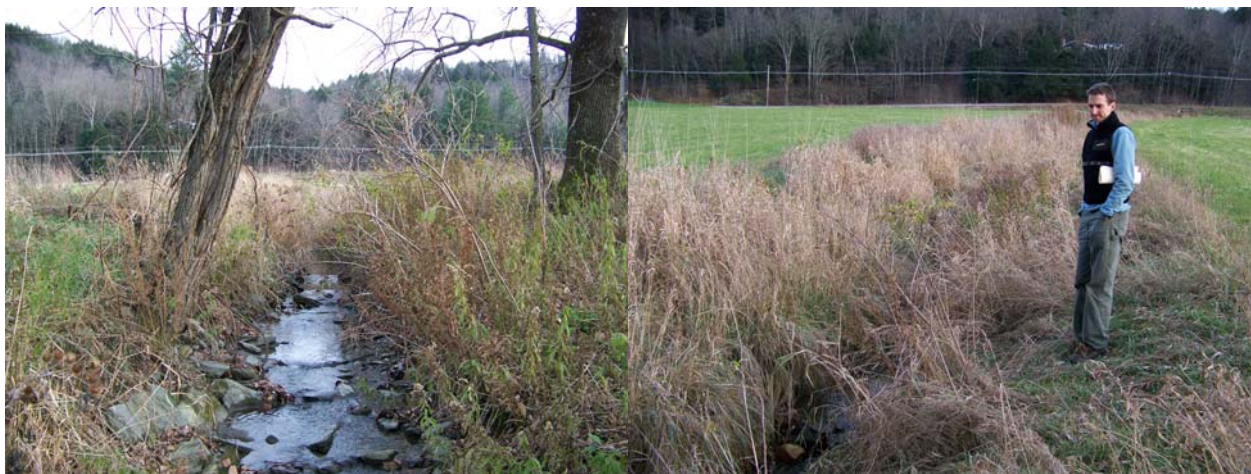
Photos showing the tributary incised on the left and lacking woody buffer vegetation on the right.

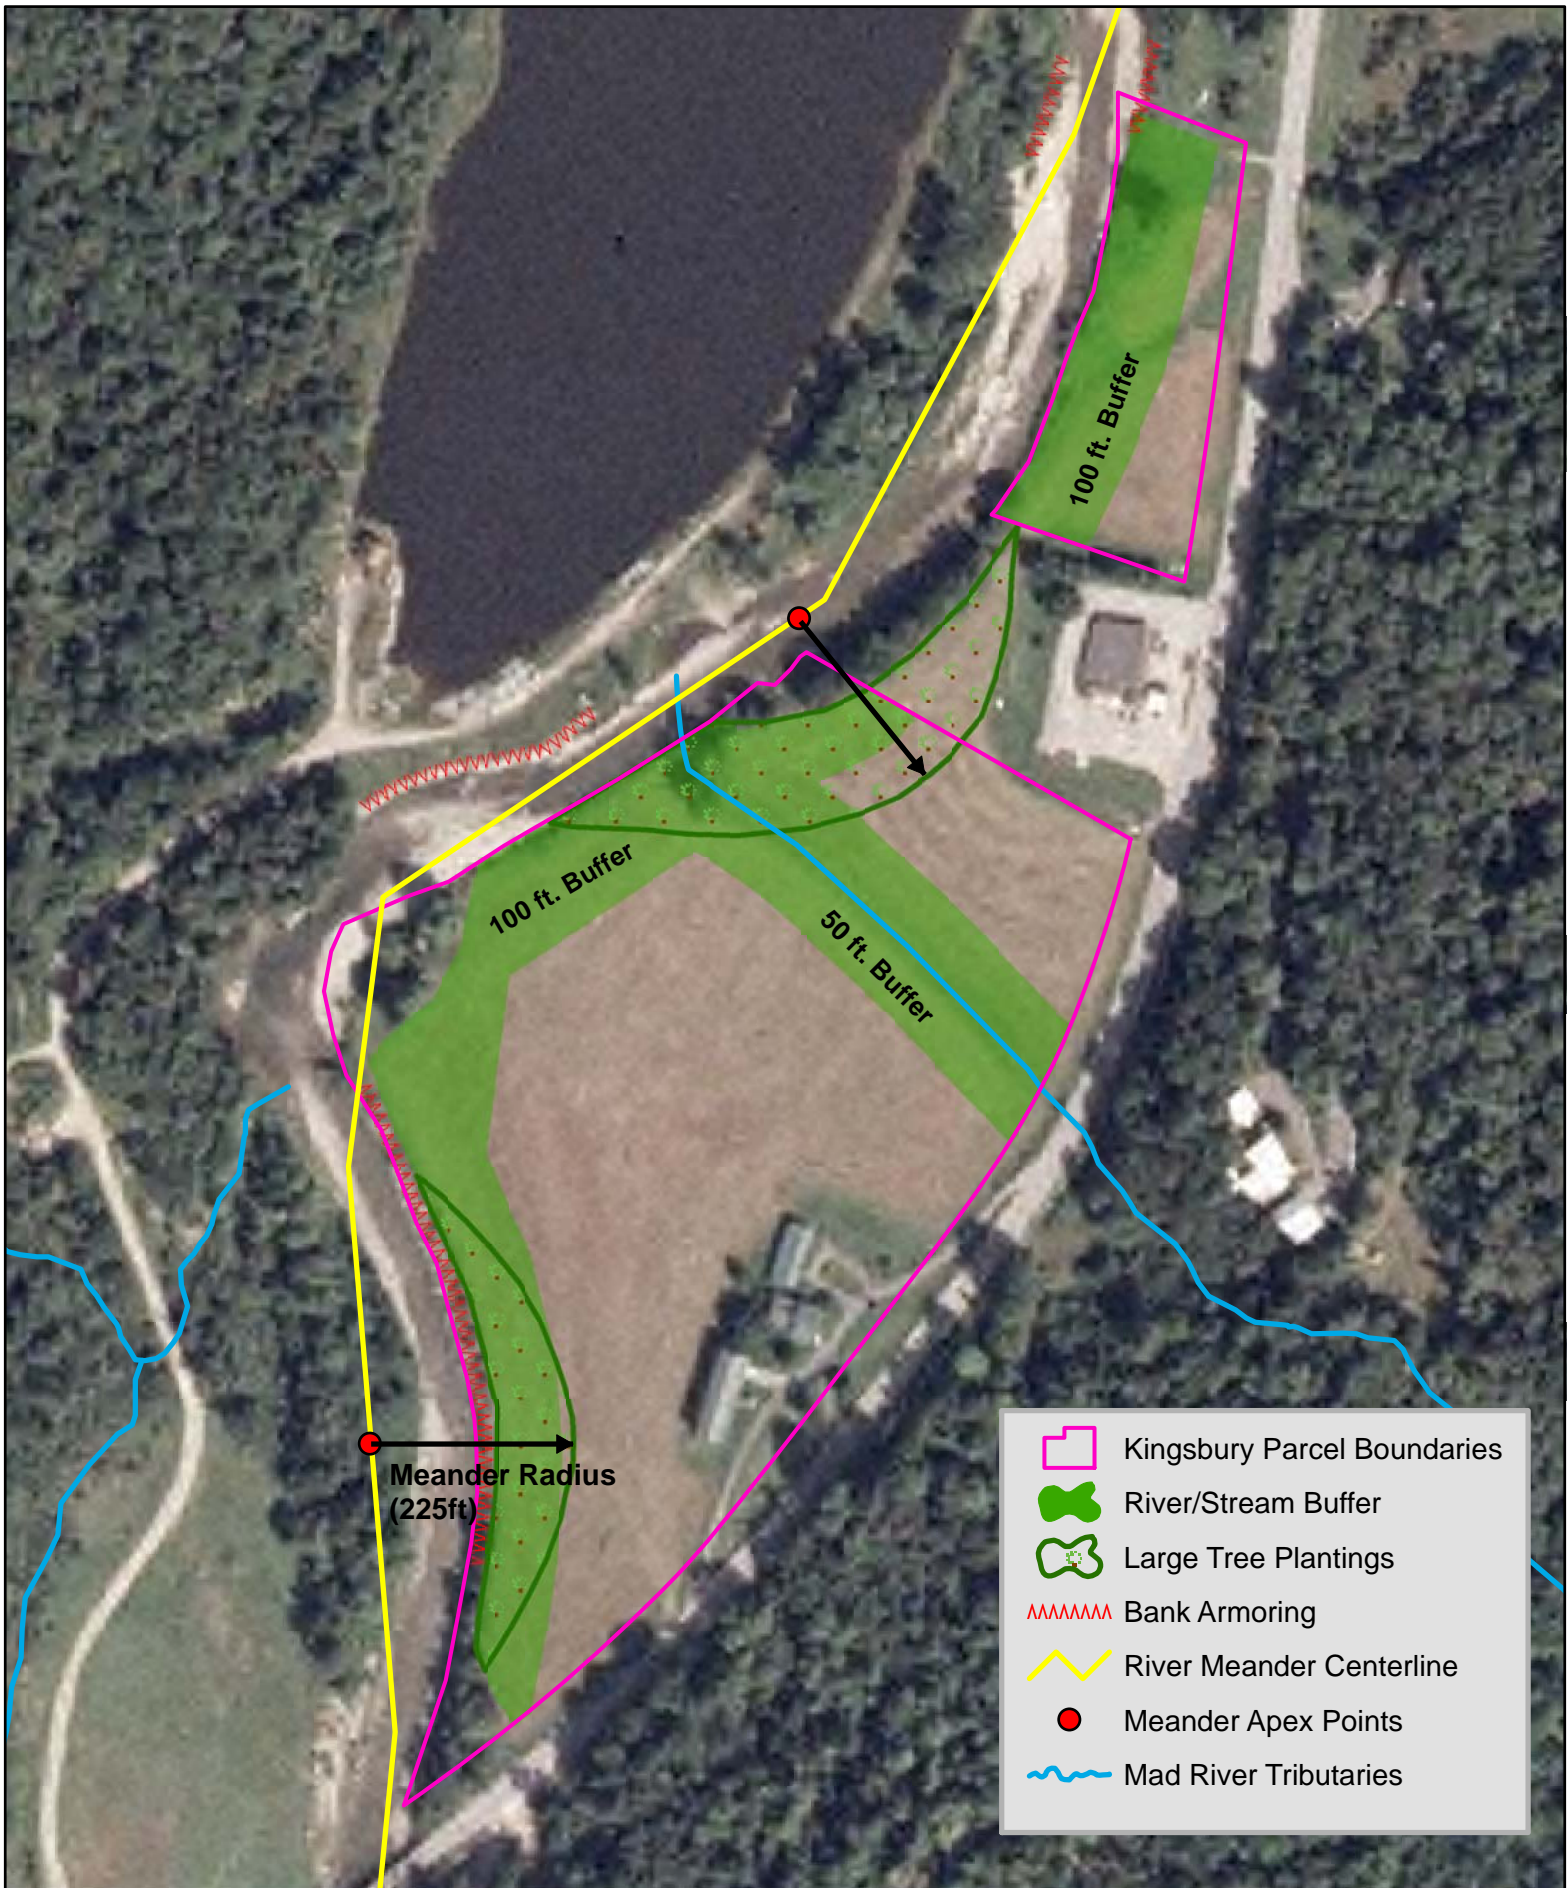
Due to the expanse of riprap along the mainstem at the southern end of the property, the trees will take decades before they are large enough to reach over and shade the channel. Additionally, it will be many years before the riprap fails and trees fall in to provide woody debris habitat. To improve the habitat along the barren stretch of riprap in the short-term, placing some habitat structures is also recommended. More specific project development for habitat enhancements could be pursued through a project development grant through the VTANR Clean and Clear Program.

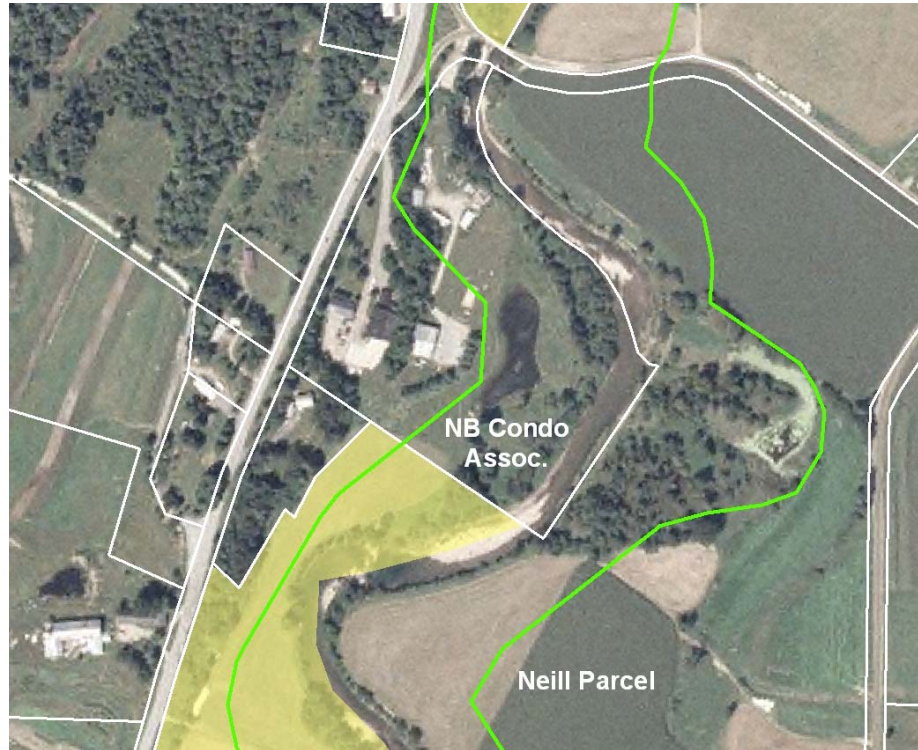
Figure 1. Parcels (white) found in FEH corridor (green), and conserved parcels (yellow) in lower Reach M11.

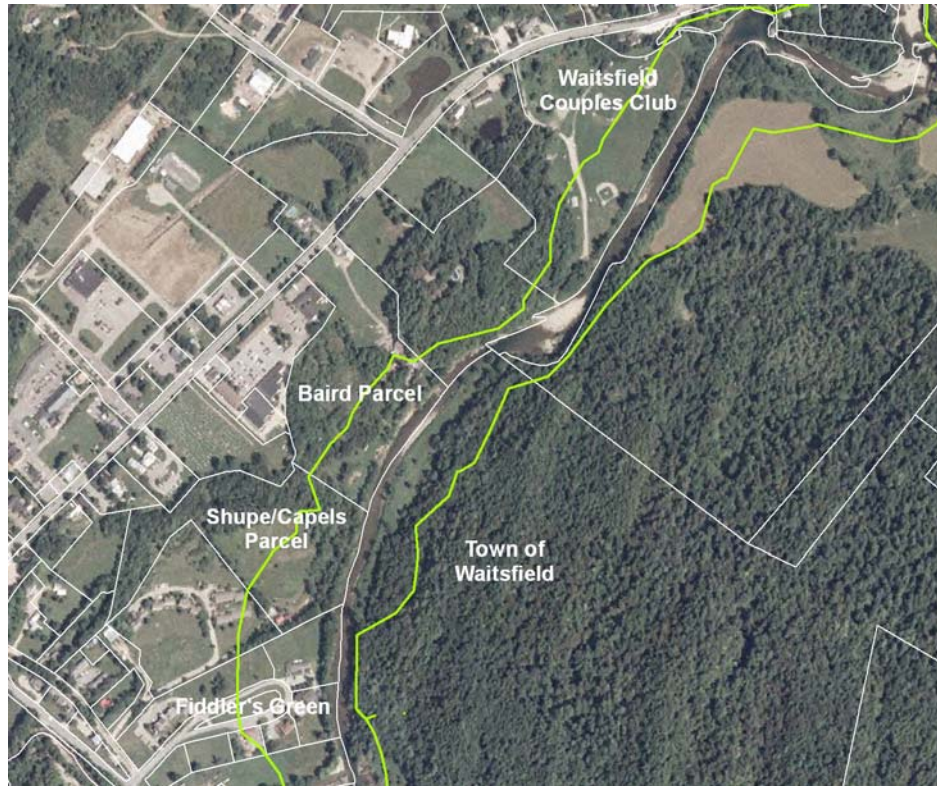
Figure 2. Parcels (white) found in FEH corridor (green) in upper Reach M12.

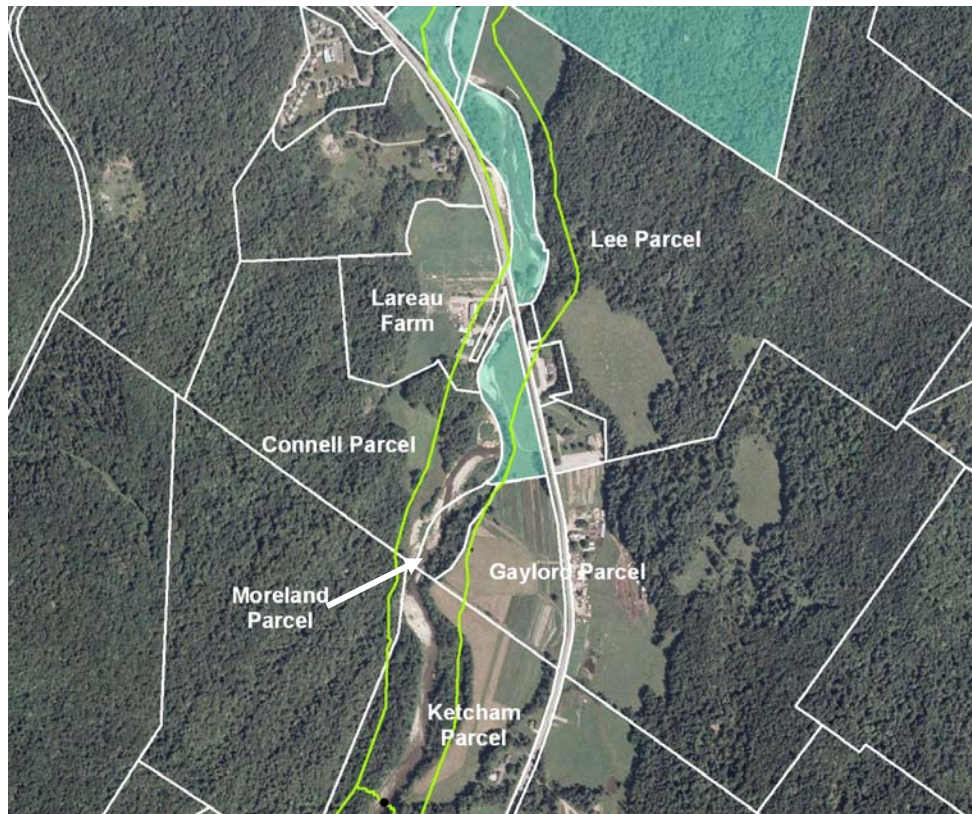
Figure 3. Private (white) and Town-owned or MRCP-conserved (blue shaded) parcels found in FEH corridor (green) for Reach M13.

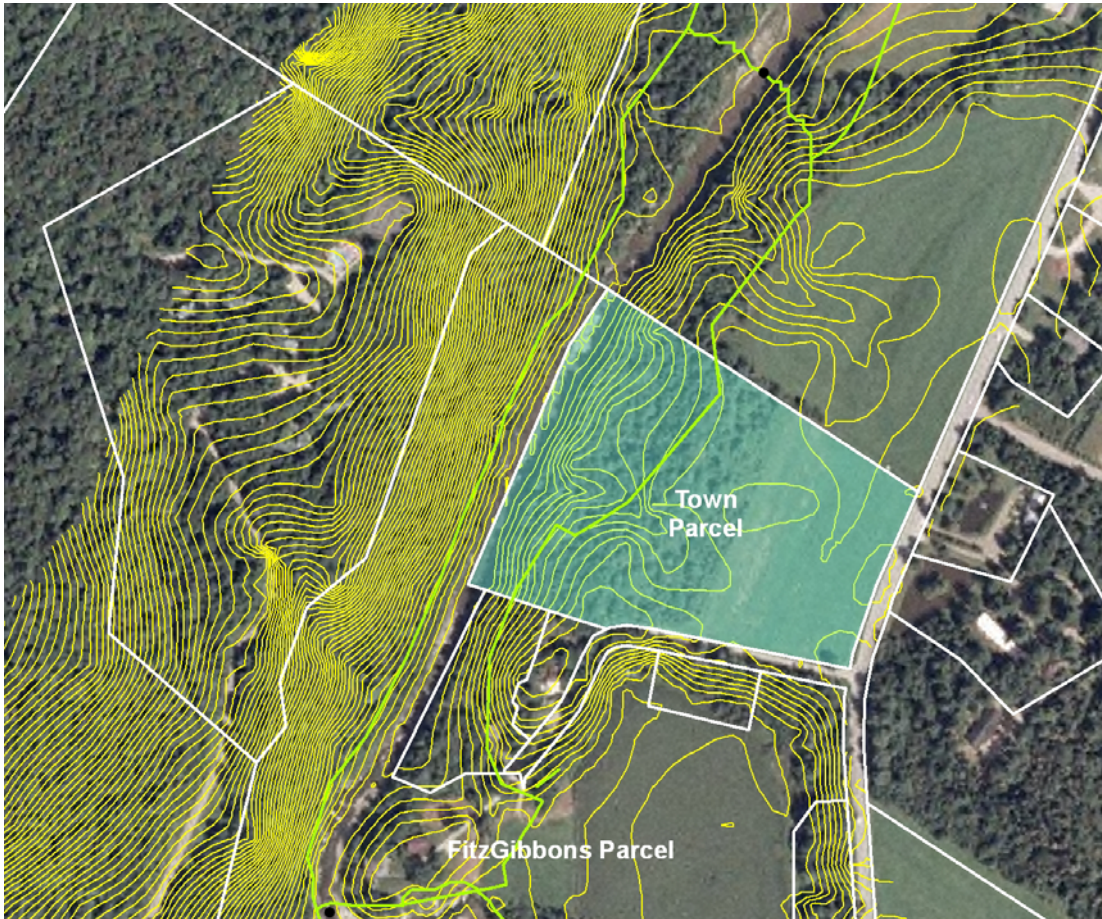
Figure 4. Private (white) and Town-owned (blue shaded) parcels found in the M14 FEH corridor (green). Note the steep valley side slopes as depicted by yellow 5 foot contour intervals.

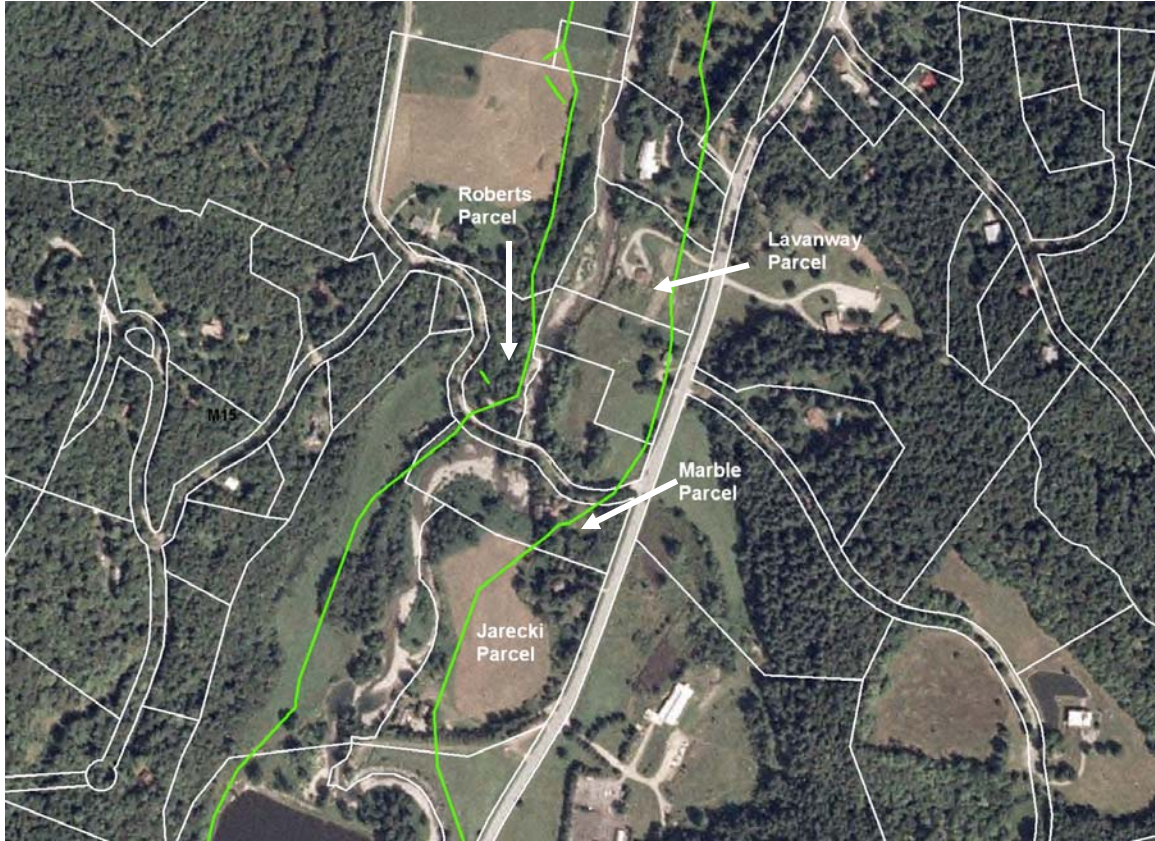
Figure 5. Private (white) parcels found in FEH corridor (green) for Reach M15.

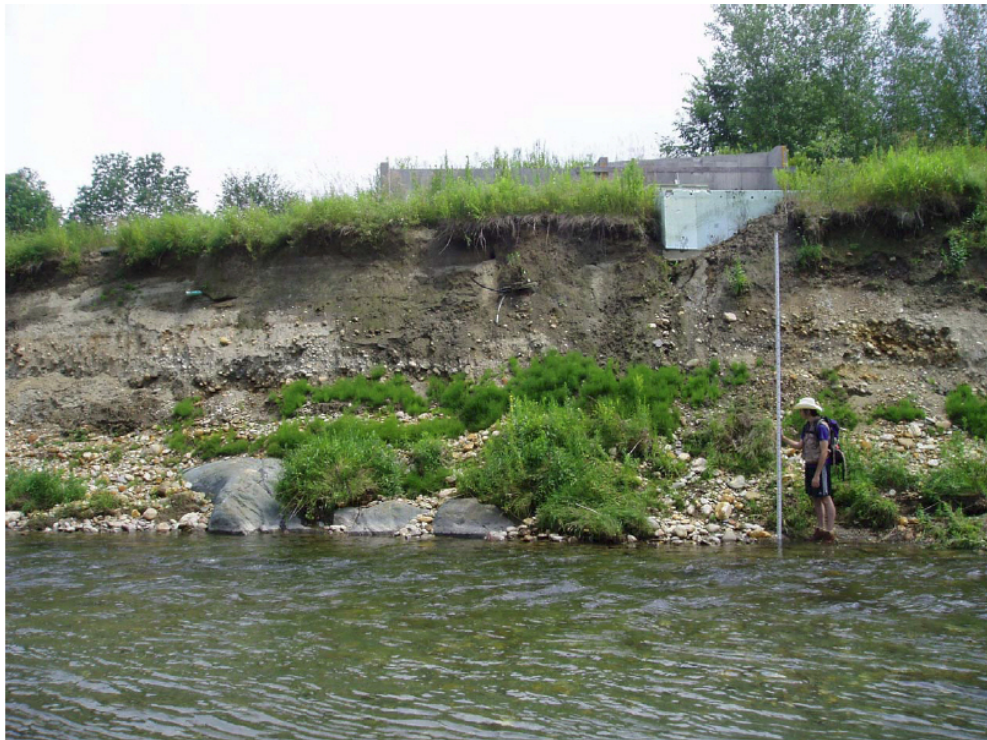
Figure 6. Eroding bank undermining foundation in Reach M15 (FGS, 2007).

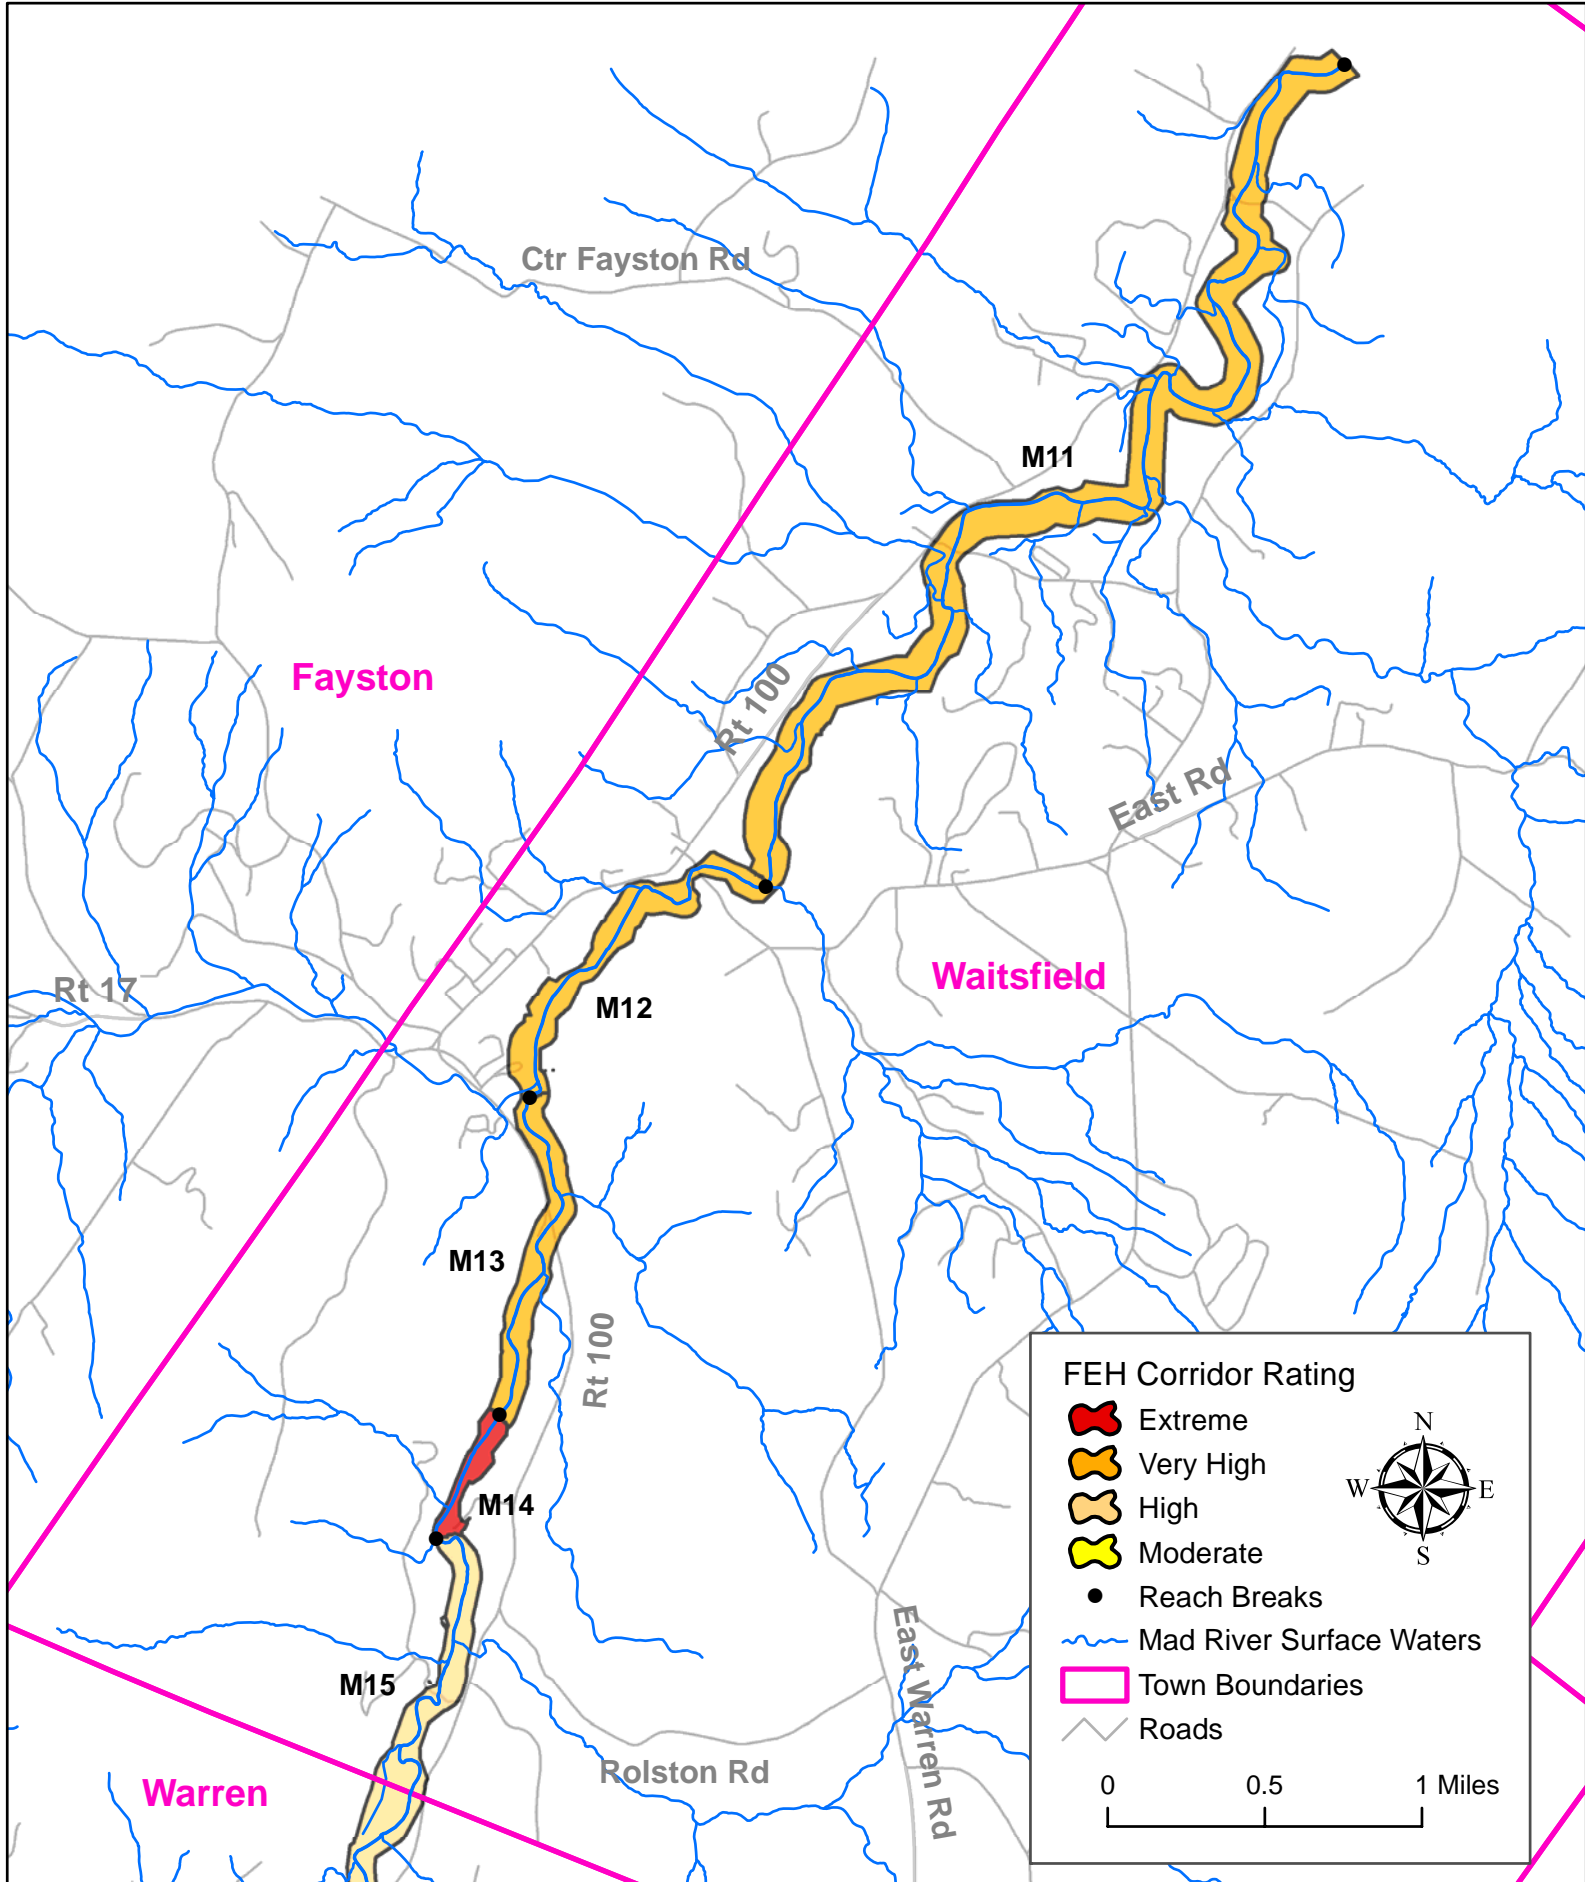
**Mad River Fluvial Erosion Hazard Zone (FEH)  
for the Town of Waitsfield, VT**

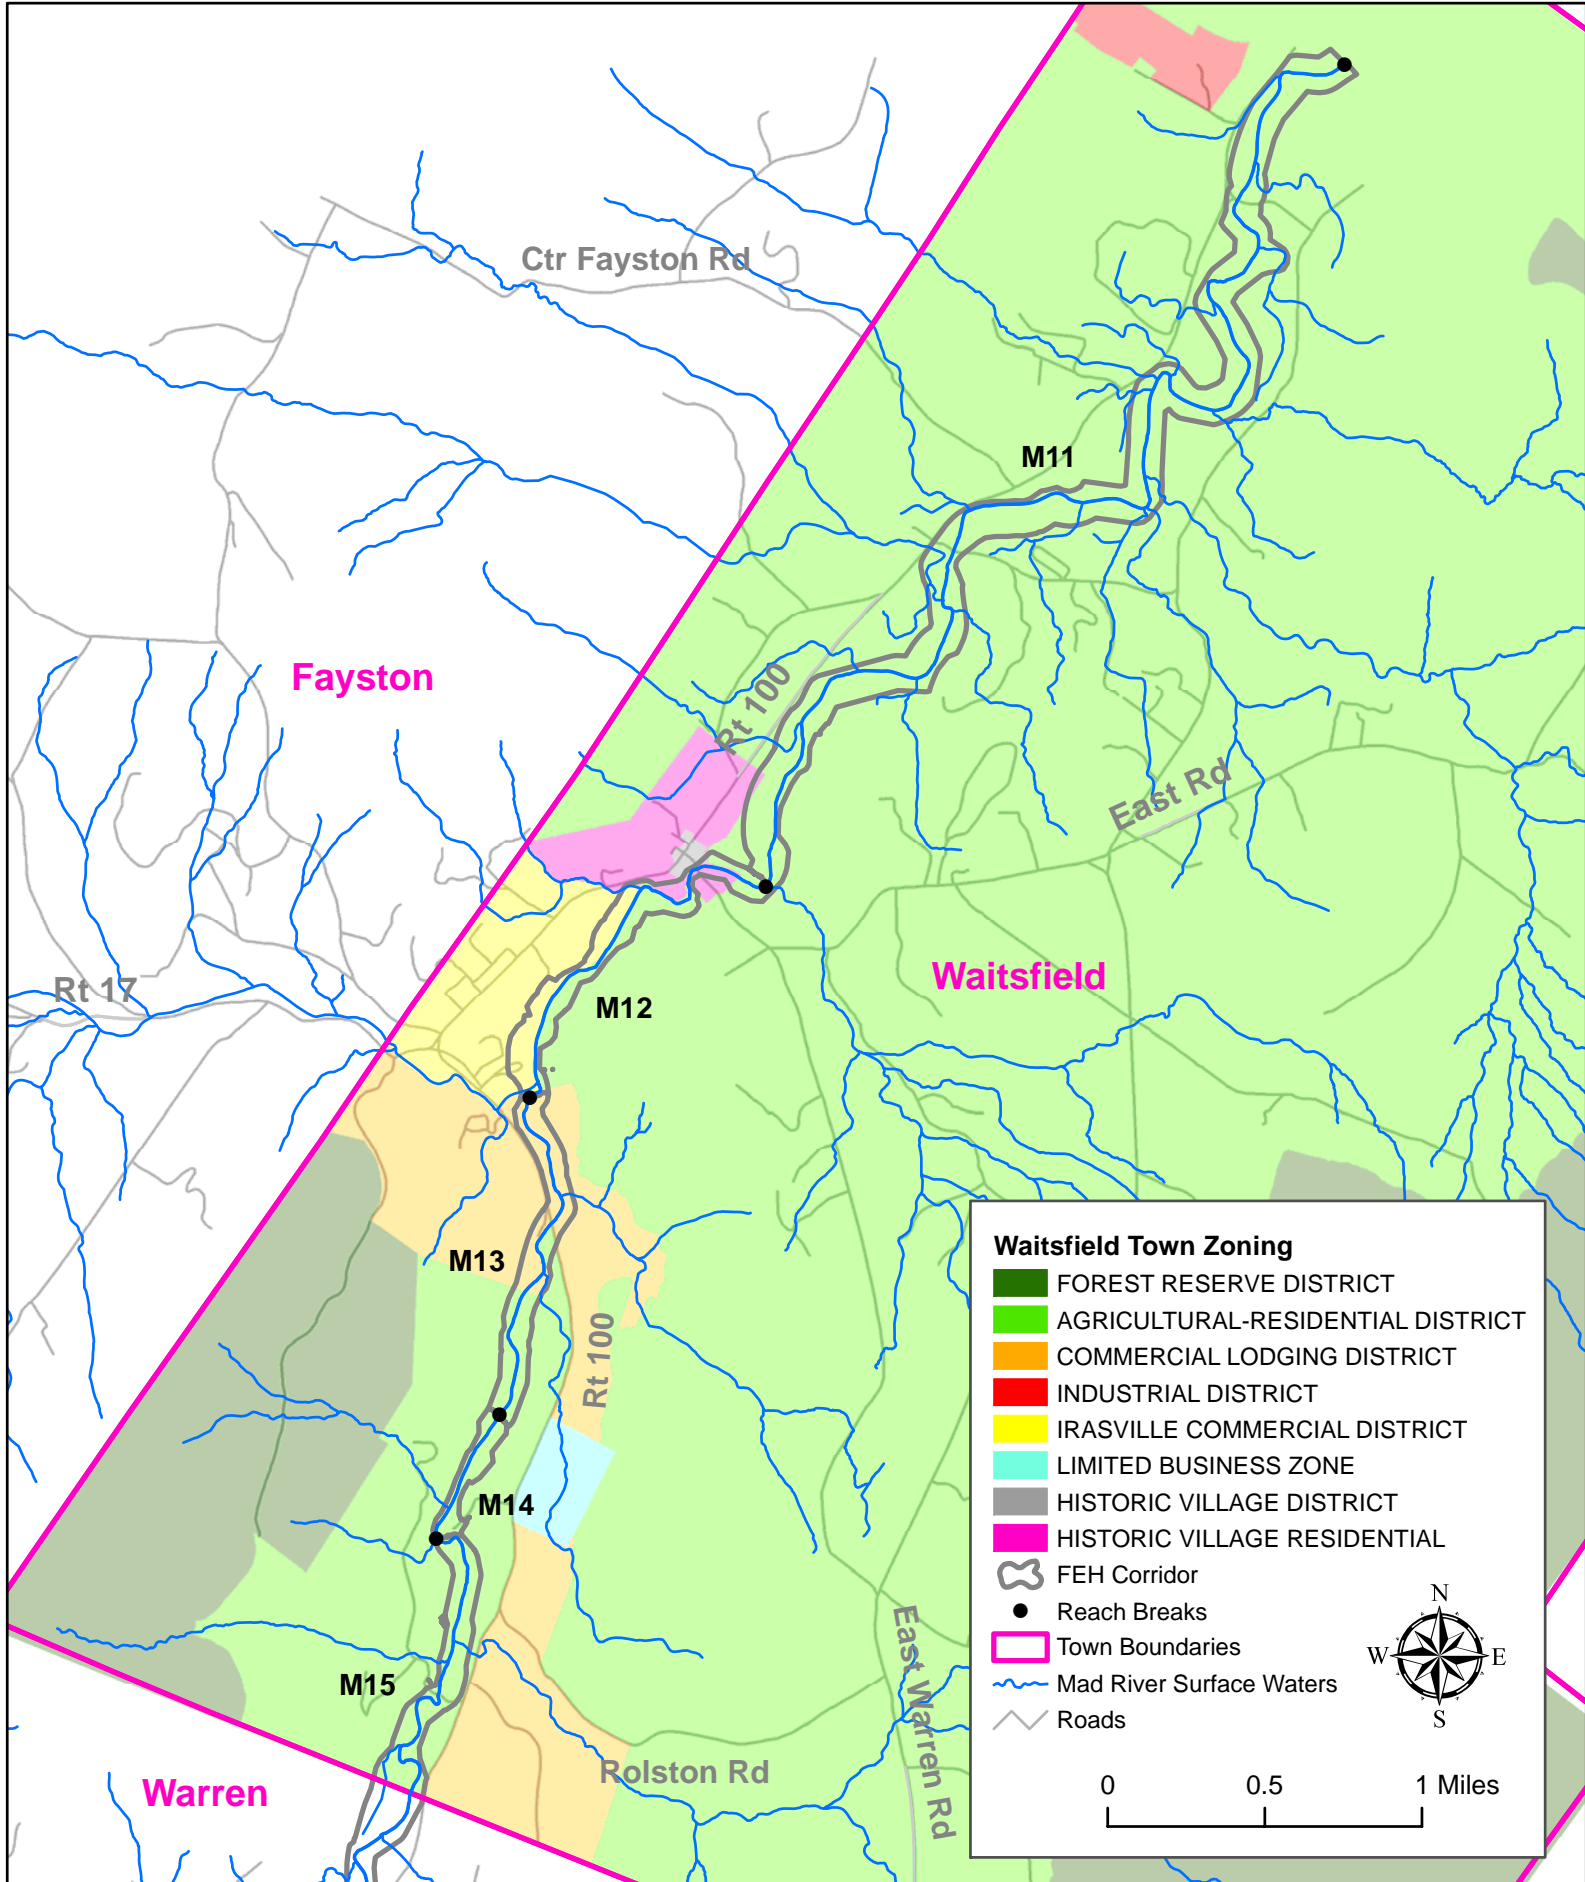
**Mad River Fluvial Erosion Hazard Zone (FEH)  
and Waitsfield Town Zoning**
