# Upper Mad River Corridor Plan

January 31, 2008

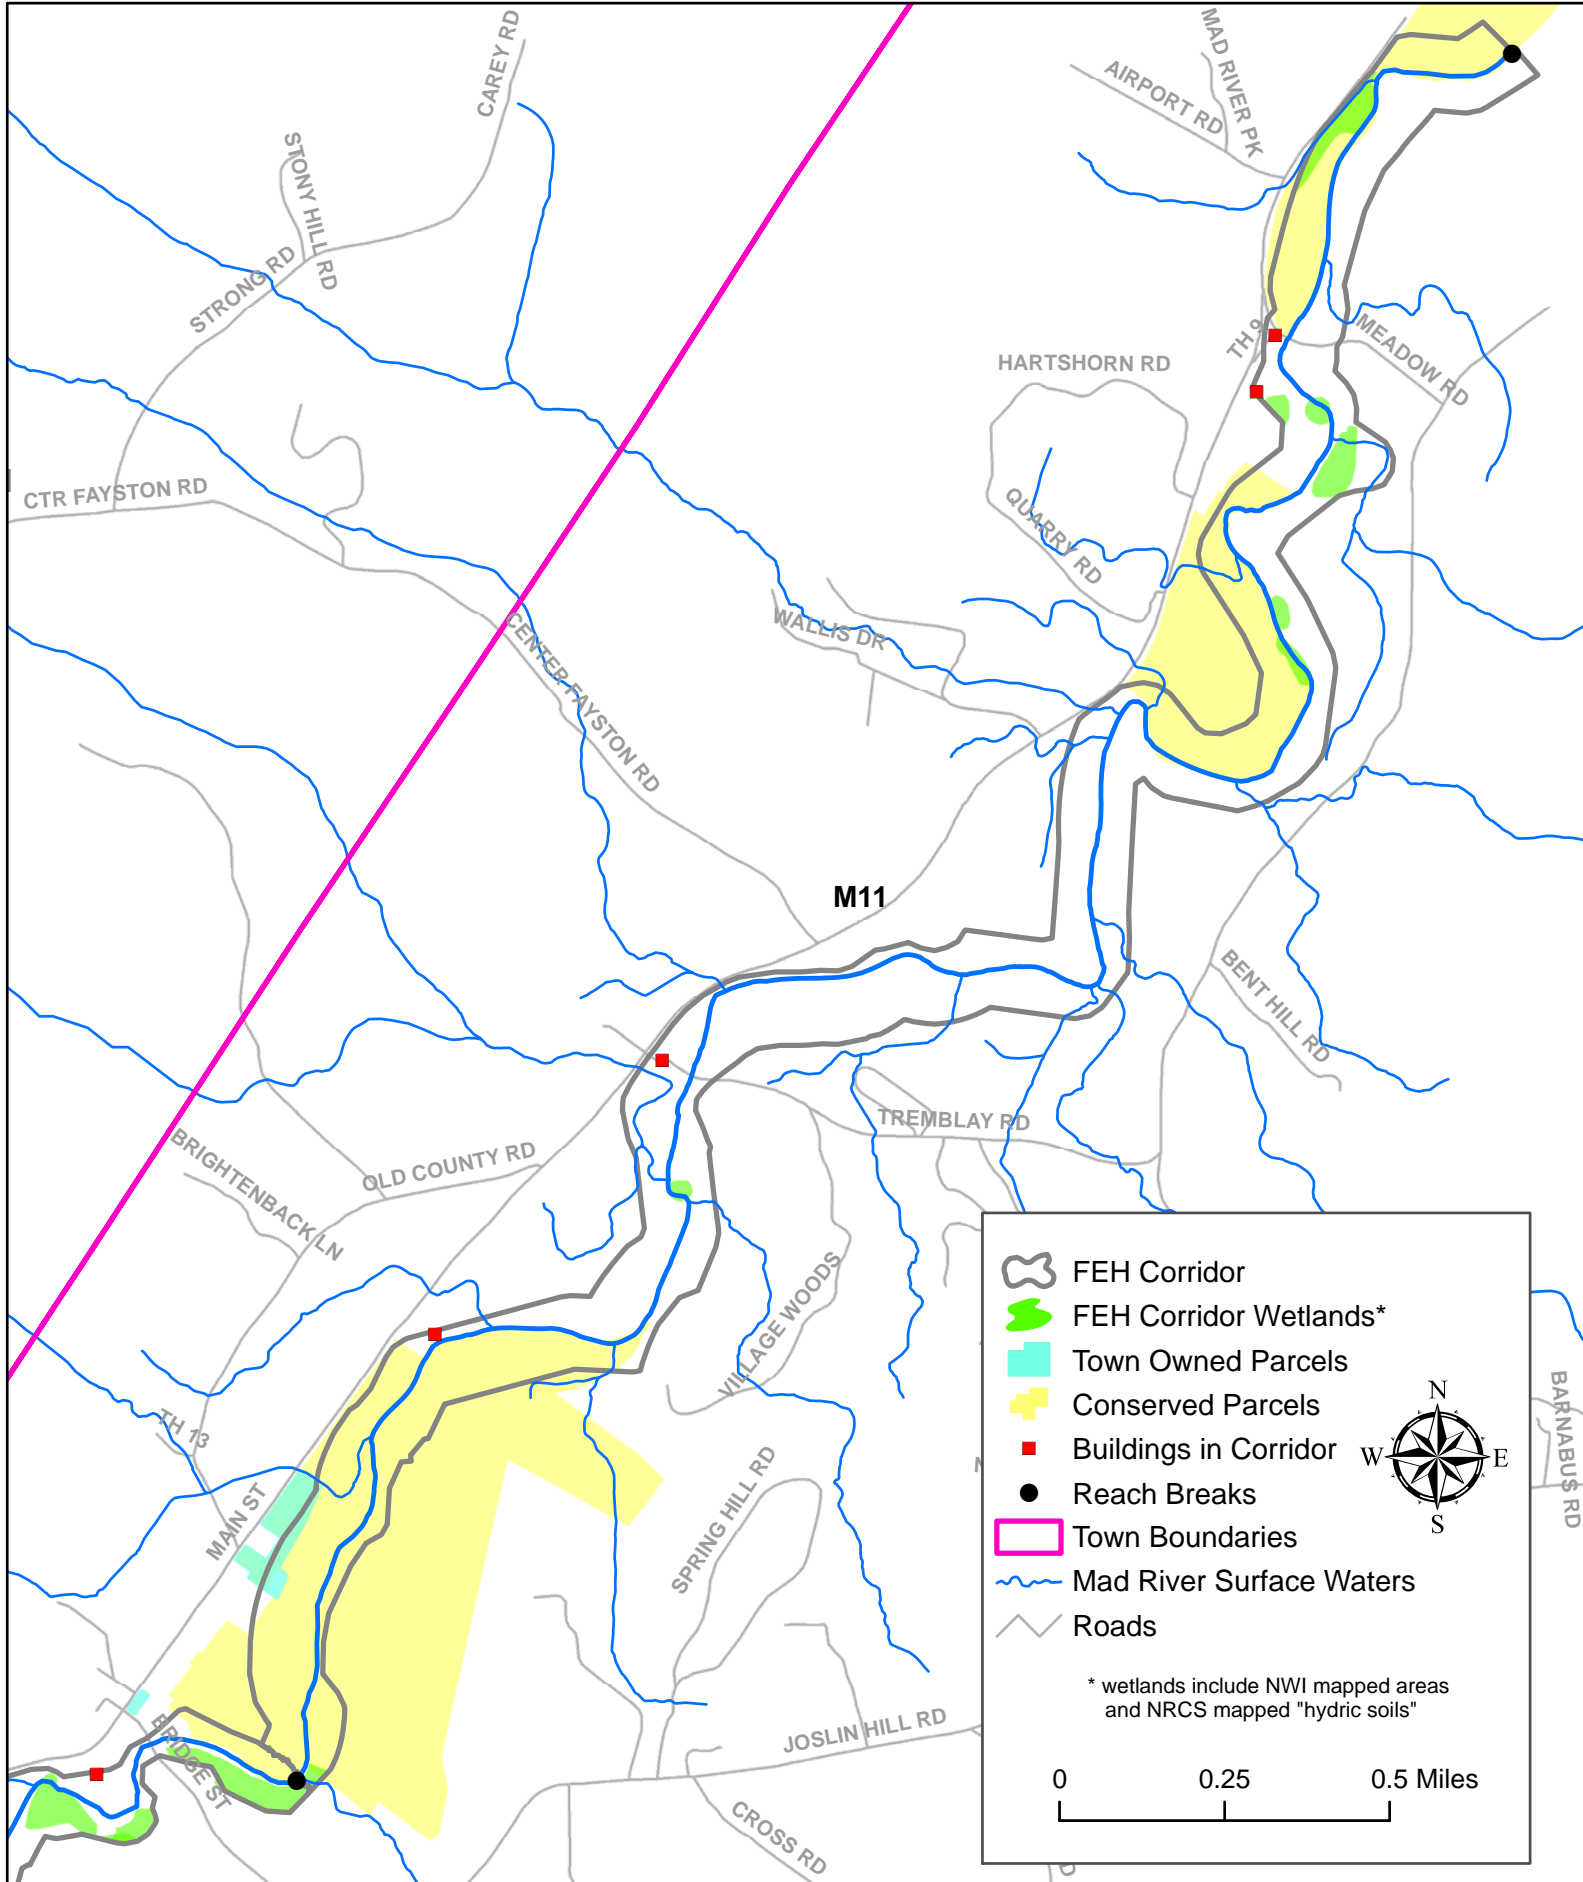
**Mad River Fluvial Erosion Hazard Zone (FEH)  
with Buildings, Wetlands & Conserved Lands  
(Reaches M11 & M12)**

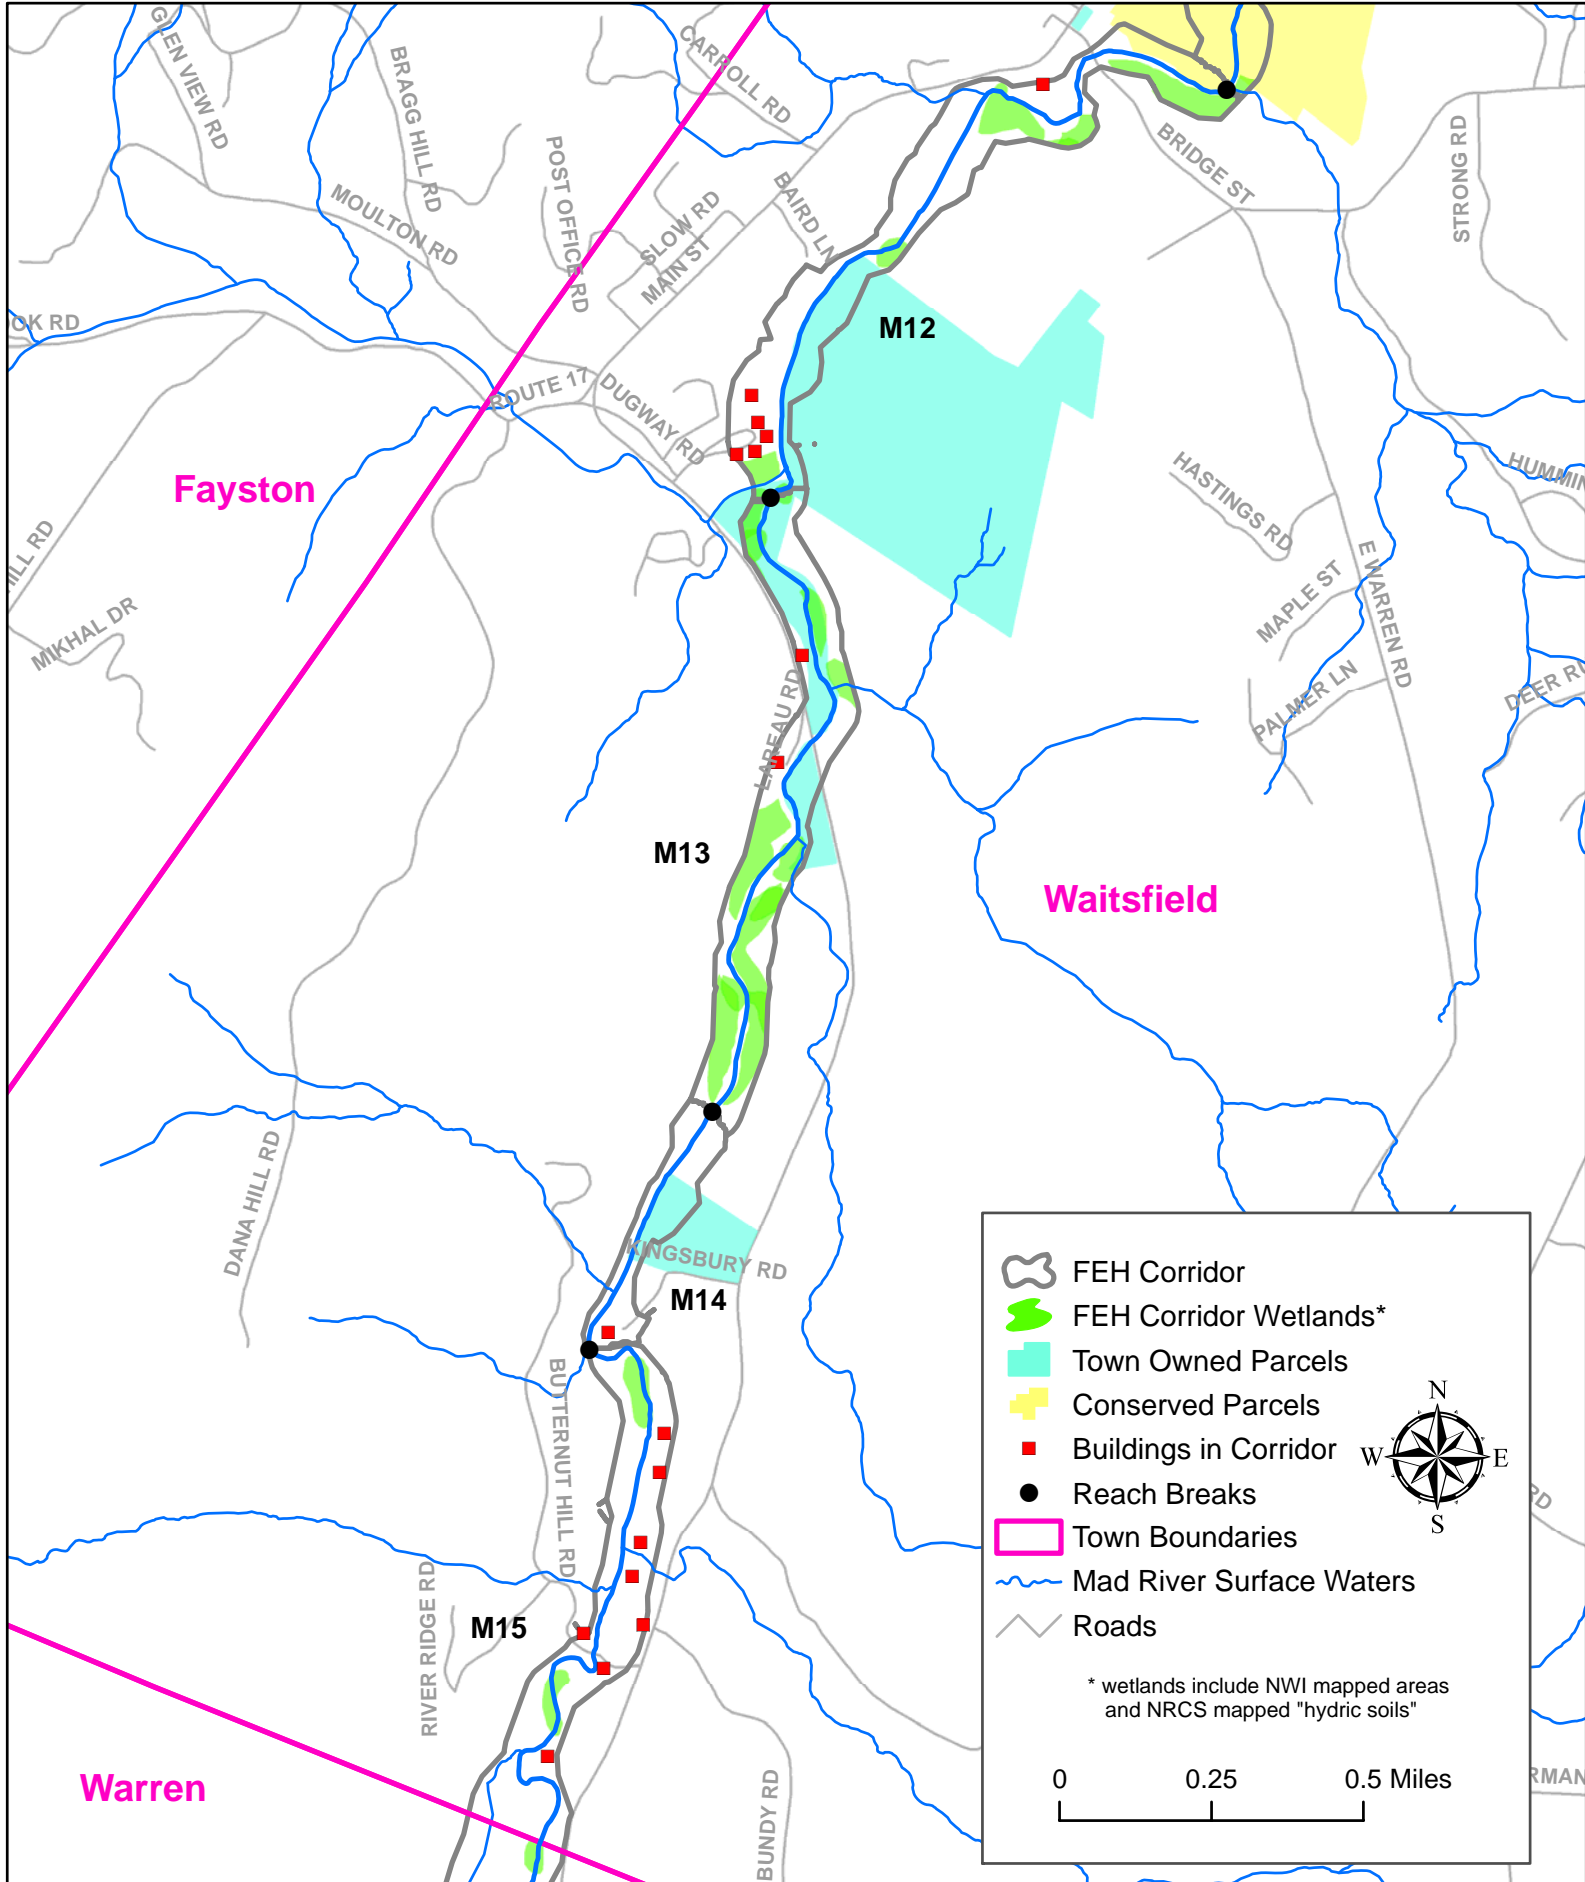
**Mad River Fluvial Erosion Hazard Zone (FEH) with Buildings, Wetlands & Conserved Lands (Reaches M12 - M15)**

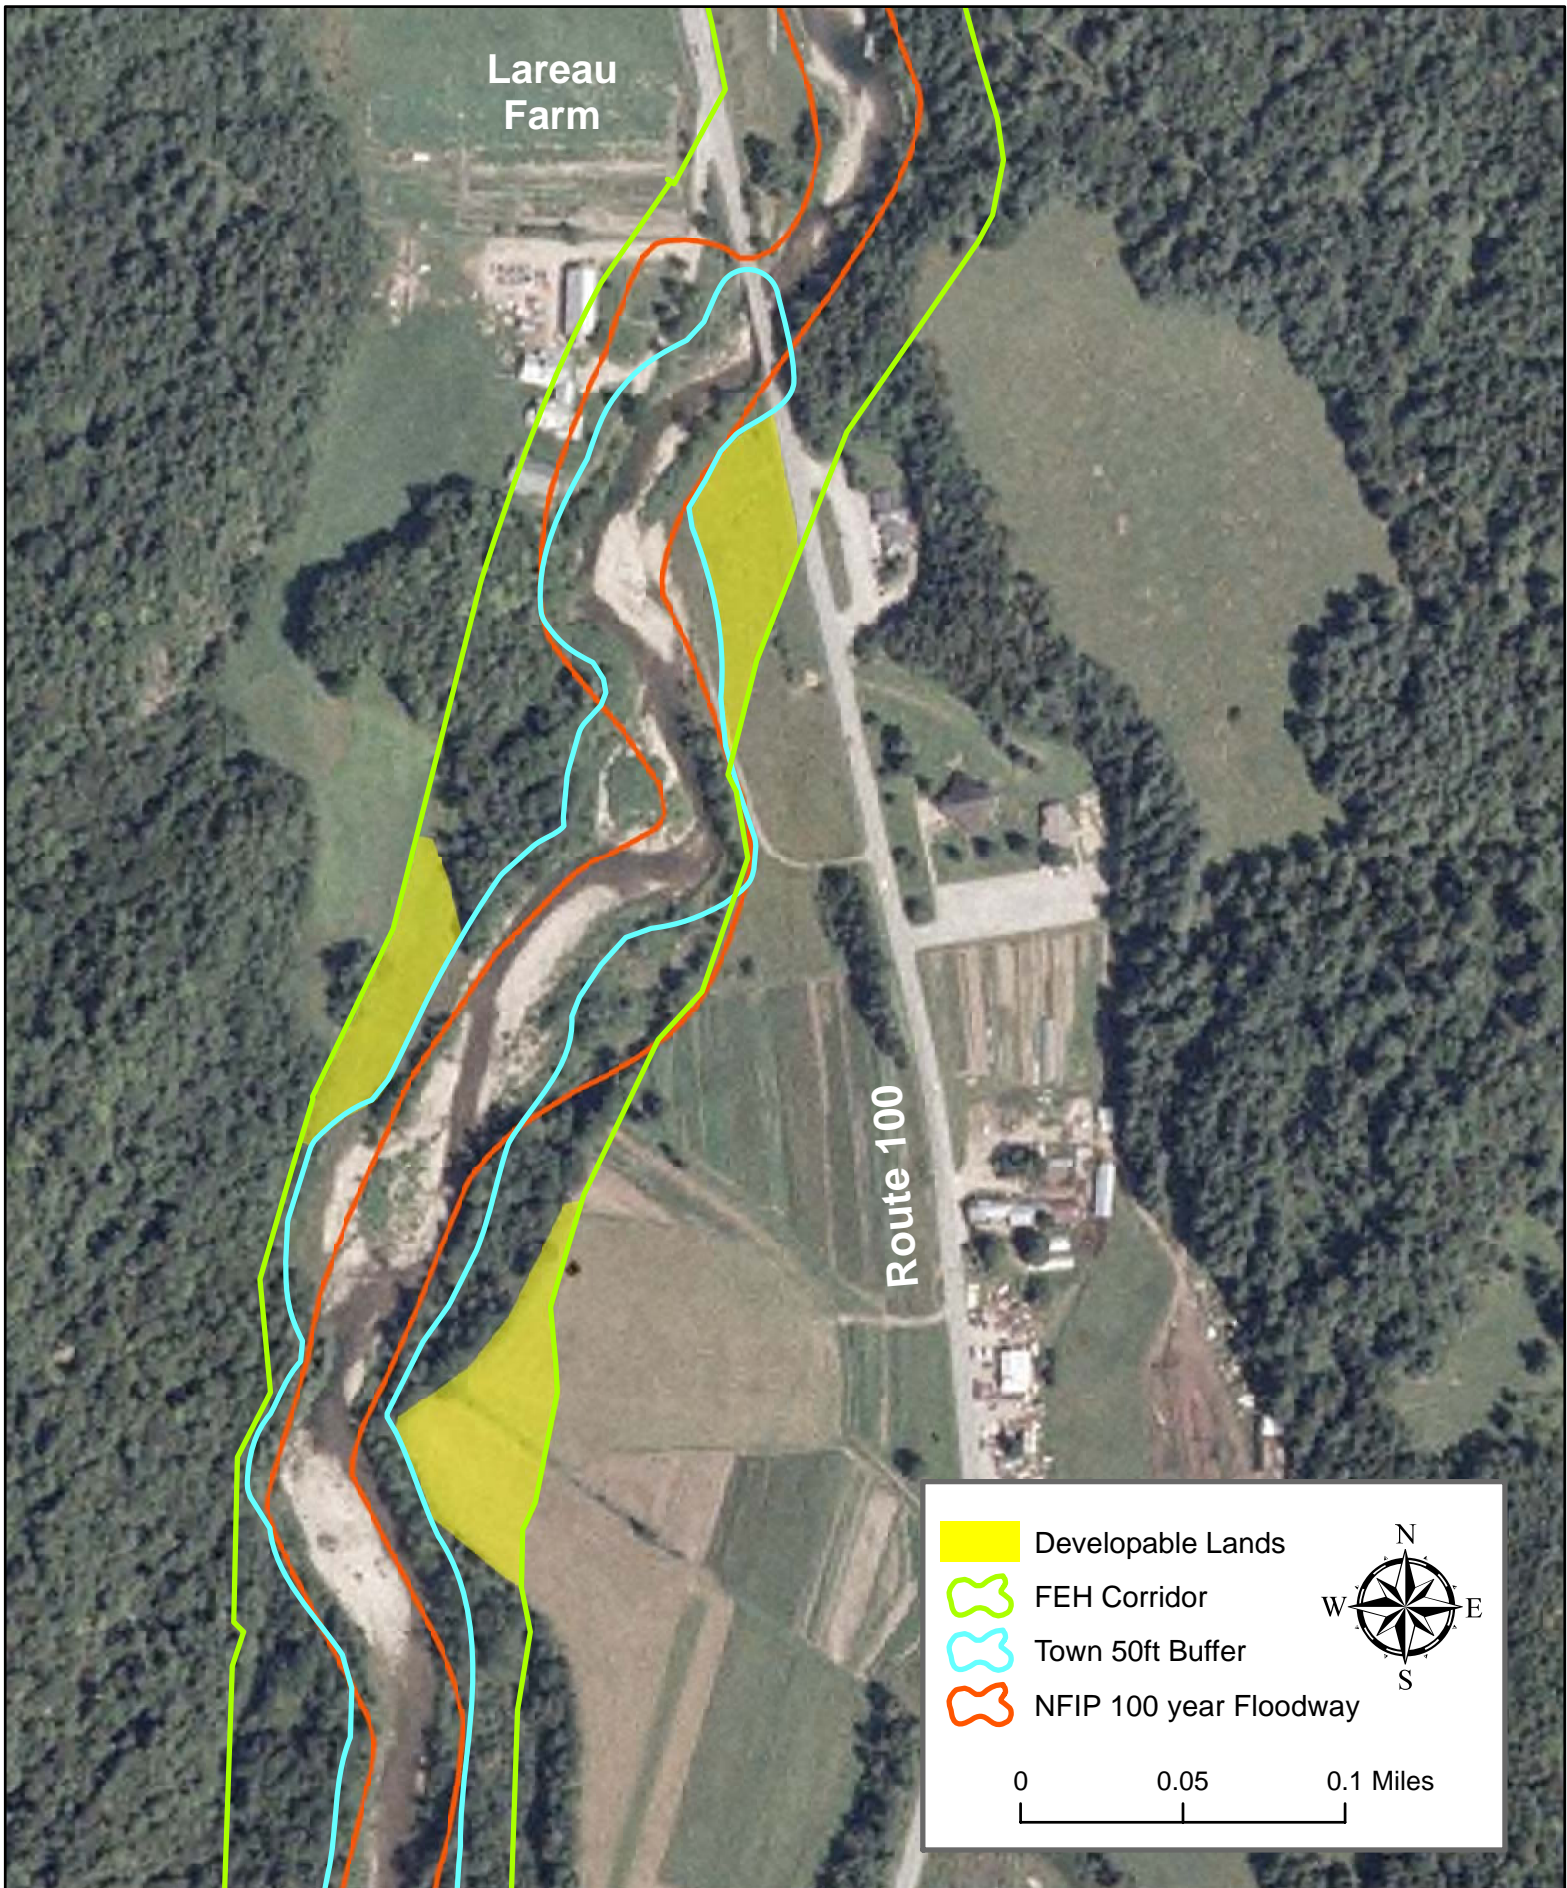
**Mad River Reach M13:  
Comparison of River Corridor and  
Buffer Protection Alternatives**
