North Branch of the Deerfield River River Corridor Management Plan Dover and Wilmington, Vermont July 28, 2013

North Branch of the Deerfield River River Corridor Management Plan for Dover and Wilmington, Vermont

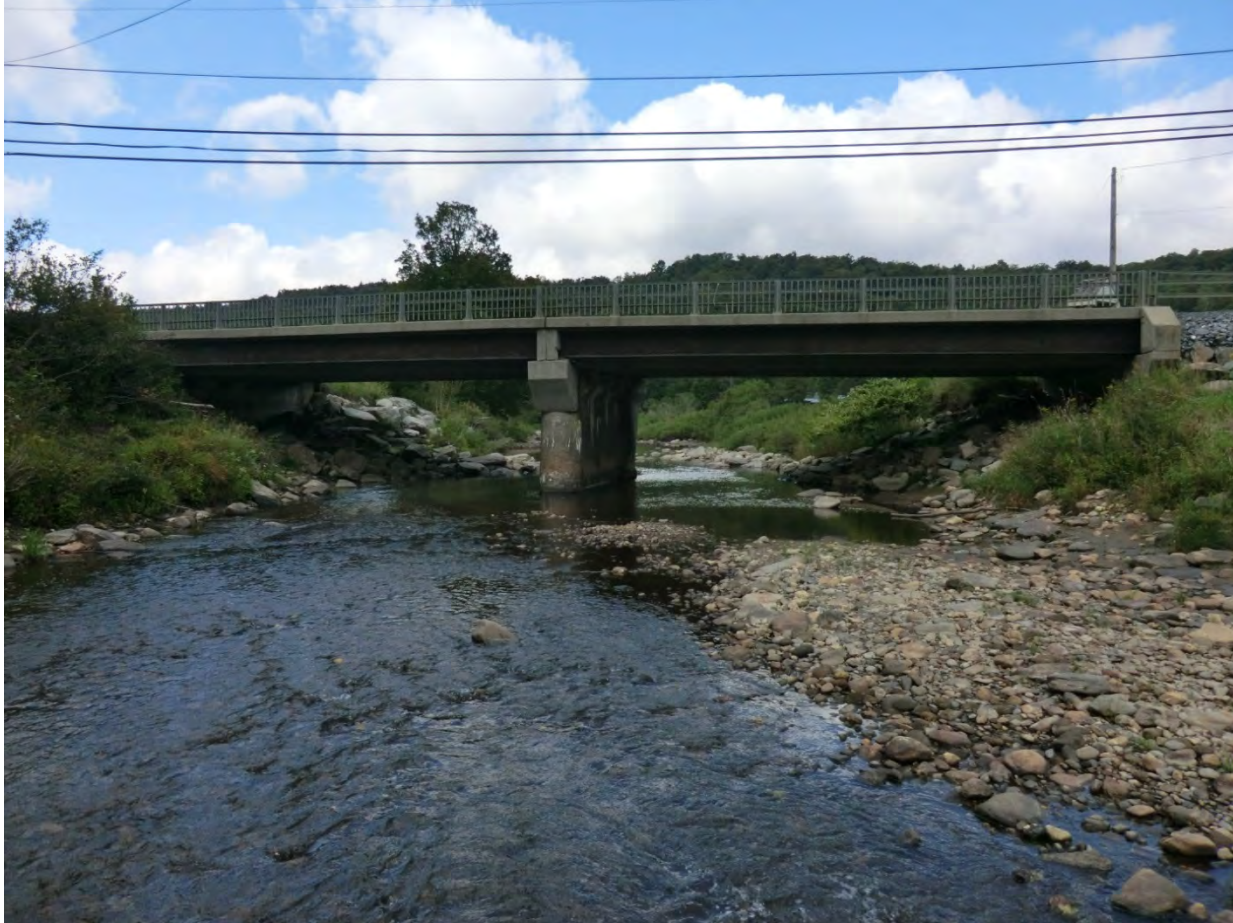
The Route 100N bridge in Wilmington has a pier that splits the stream channel in two. Streambed scour along the pier may lead to the undermining of the structure. As seen in Figure 5.1, the bridge is causing upstream *deposition* and is poorly aligned in relation to the stream channel.

Figure 5.1. The Route 100N bridge in Wilmington is poorly aligned and is causing geomorphic instability.

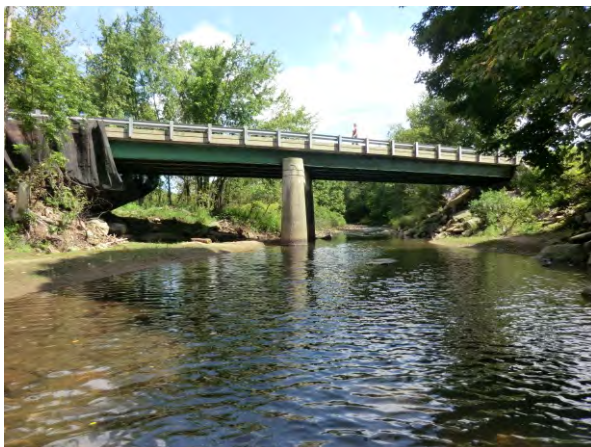
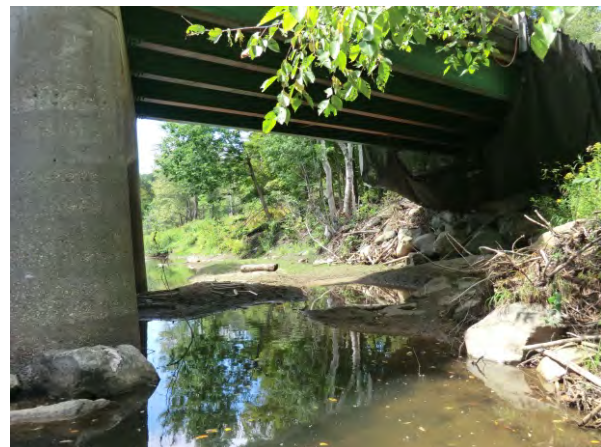
The Higley Hill Road Bridge in Wilmington also has a pier that splits the stream channel in two. One side is filling up with deposited sediment and is blocking lower flows (Figure 5.2). A deep scour *pool* has formed around the base of the pier that may lead to undermining of the structure. Figure 5.3 shows that the Route 100 bridge in Dover is poorly aligned in relation to stream flow and is causing sediment to deposit within the structure.

Figure 5.2. The stream channel is split by a pier under the Higley Hill Road bridge. Sediment is filling one side and blocking flow.

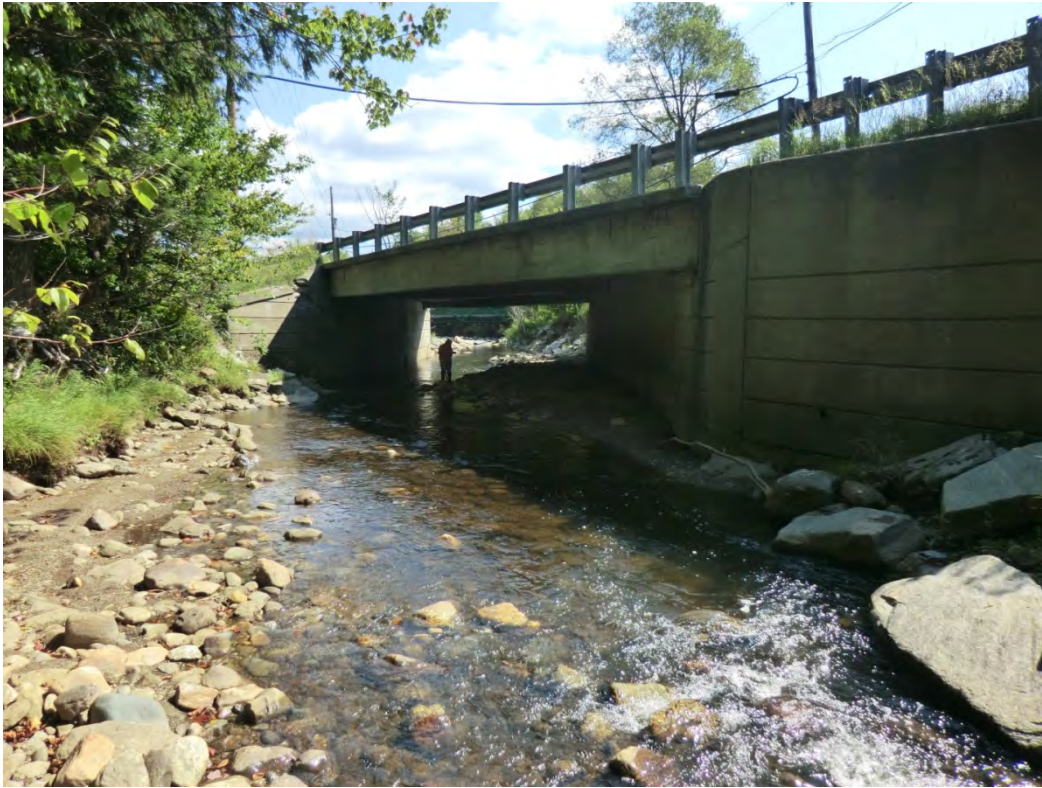
Figure 5.3. The Route 100 bridge in Dover (ID: 200013005813042) is poorly aligned and causing deposition.

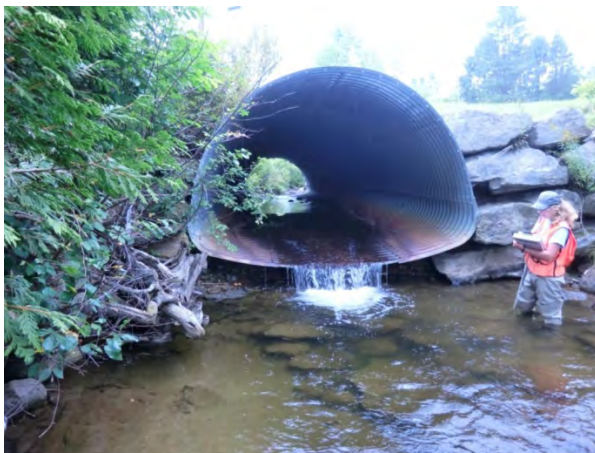
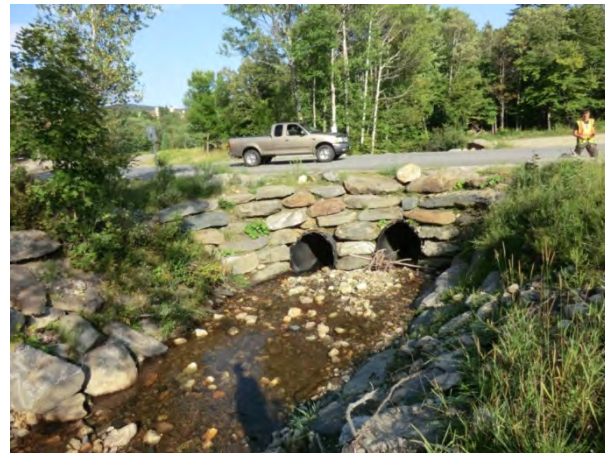
Both of the culverts that were assessed in 2012 were identified as high priority for replacement/retrofit and are included in Section 6.0 (Project Development) of this Plan. The Handle Road culvert in Dover is perched at least one foot above the water surface at the downstream end (See Figure 5.4). This culvert was found to be “mostly incompatible” with the lowest AOP rating, “No AOP including adult salmonids.” The North Access Road culvert consists of two culverts side by side. These culverts are both slightly perched above the water surface at the downstream end. The culverts are causing upstream deposition (Figure 5.5), which may lead to future blockage problems. The North Access Road culvert was determined to be “partially compatible” with an AOP rating of “No AOP except adult salmonids.”

Figure 5.4. The Handle Road culvert is perched. **Figure 5.5.** North Access Rd. culverts are causing deposition.

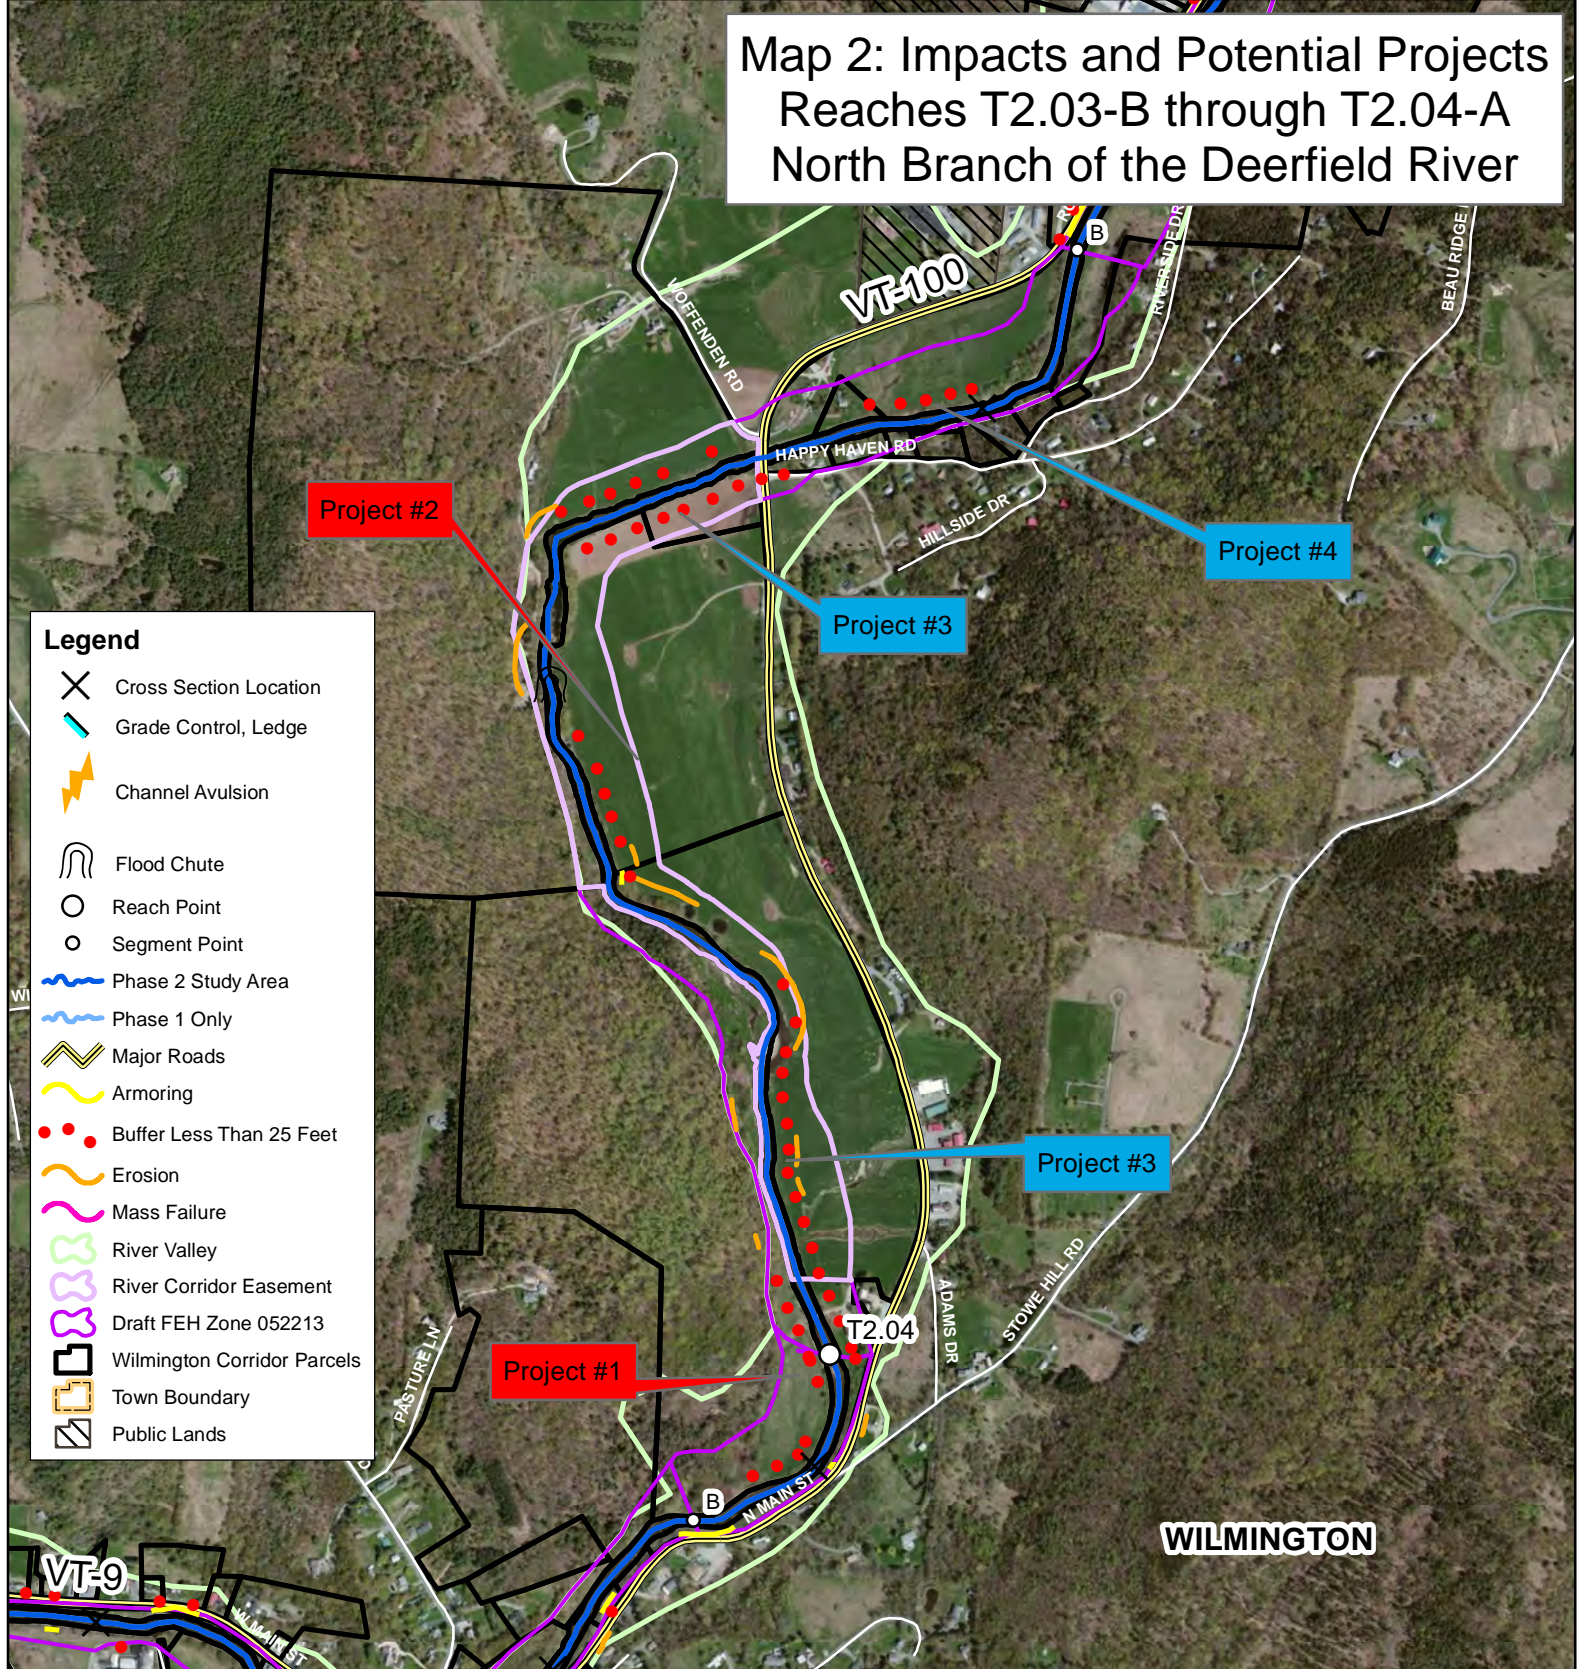
Map 2: Impacts and Potential Projects Reaches T2.03-B through T2.04-A North Branch of the Deerfield River

Project #4 T2.04-A	Passive Restoration	Northern bank along agricultural field lacks adequate buffer	Streamside plantings, plant away from channel – river is widening	Moderate Priority	Improved habitat and water quality	Cost of plantings	Landowner, Windham County NRCD, WRC, CRWC, VCF, VANR, Town of Wilmington CREP, TFS, WHIP

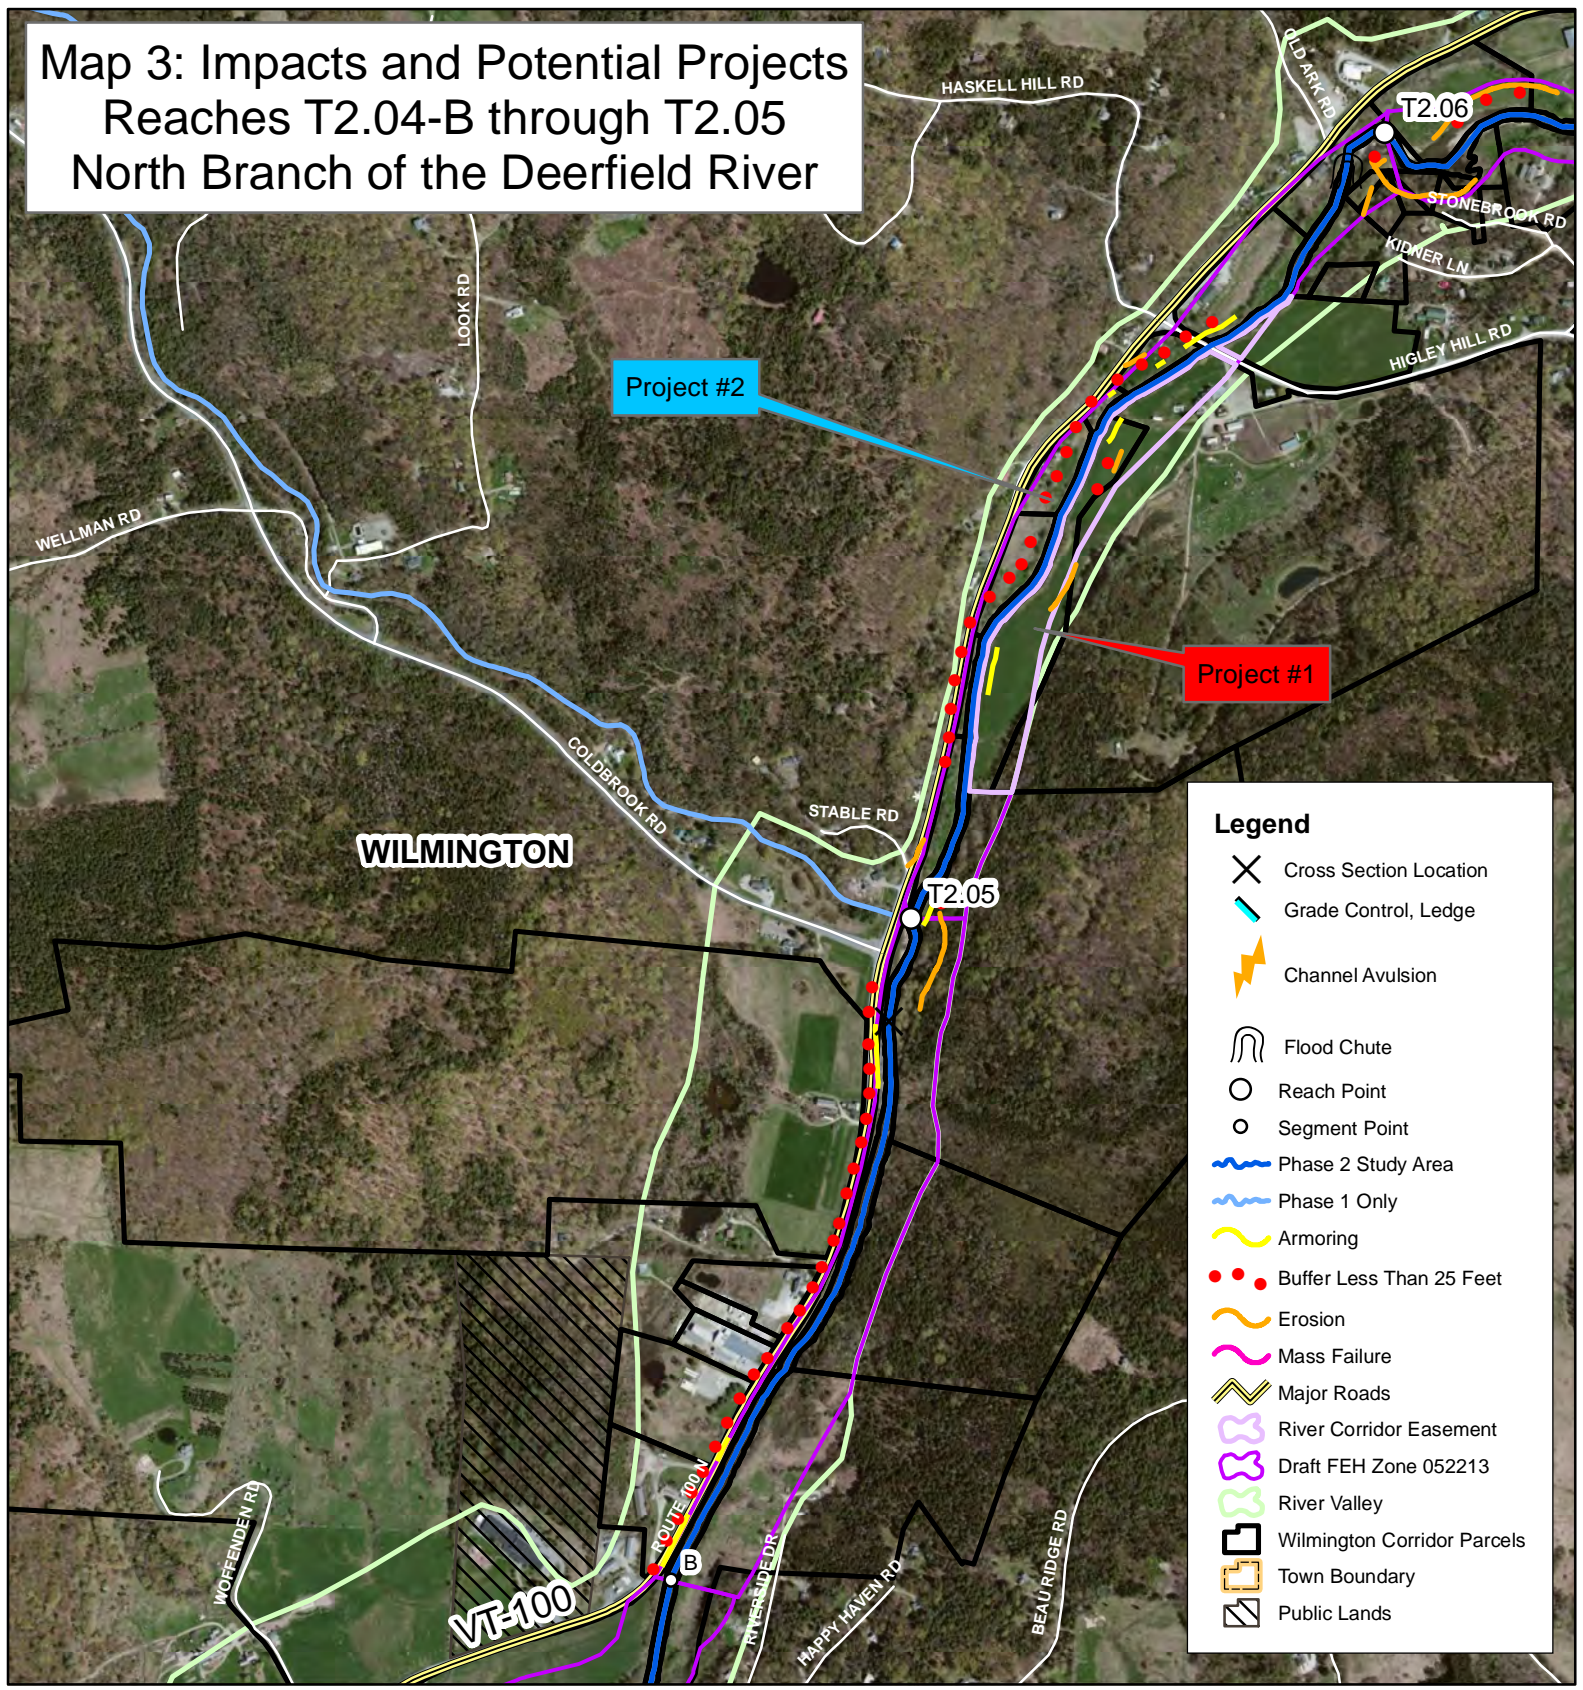
Map 3: Impacts and Potential Projects Reaches T2.04-B through T2.05 North Branch of the Deerfield River

Project # Segment	Type of Project	Site Description Including Stressors and Constraints	Project or Strategy Description	Technical Feasibility and Priority	Other Social Benefits	Costs	Potential Partners/Programs
Project #1 T2.05	Passive Restoration	Channel has fair floodplain access along agricultural fields	Protect river through corridor easement	High Priority	Flood resiliency; improved habitat, water quality, and geomorphic stability	Cost of easement	Landowners, WRC, VANR, Town of Wilmington RCE
Project #2 T2.05	Passive Restoration	Area along western bank that lacks adequate buffer	Streamside plantings, plant away from channel – river is widening	Moderate Priority	Improved habitat and water quality	Cost of plantings	Landowners, Windham County NRCD, WRC, CRWC, VCF, VANR, Town of Wilmington CREP, TFS, WHIP

- Projects:**
1. River Corridor Easement
 2. Streamside Plantings

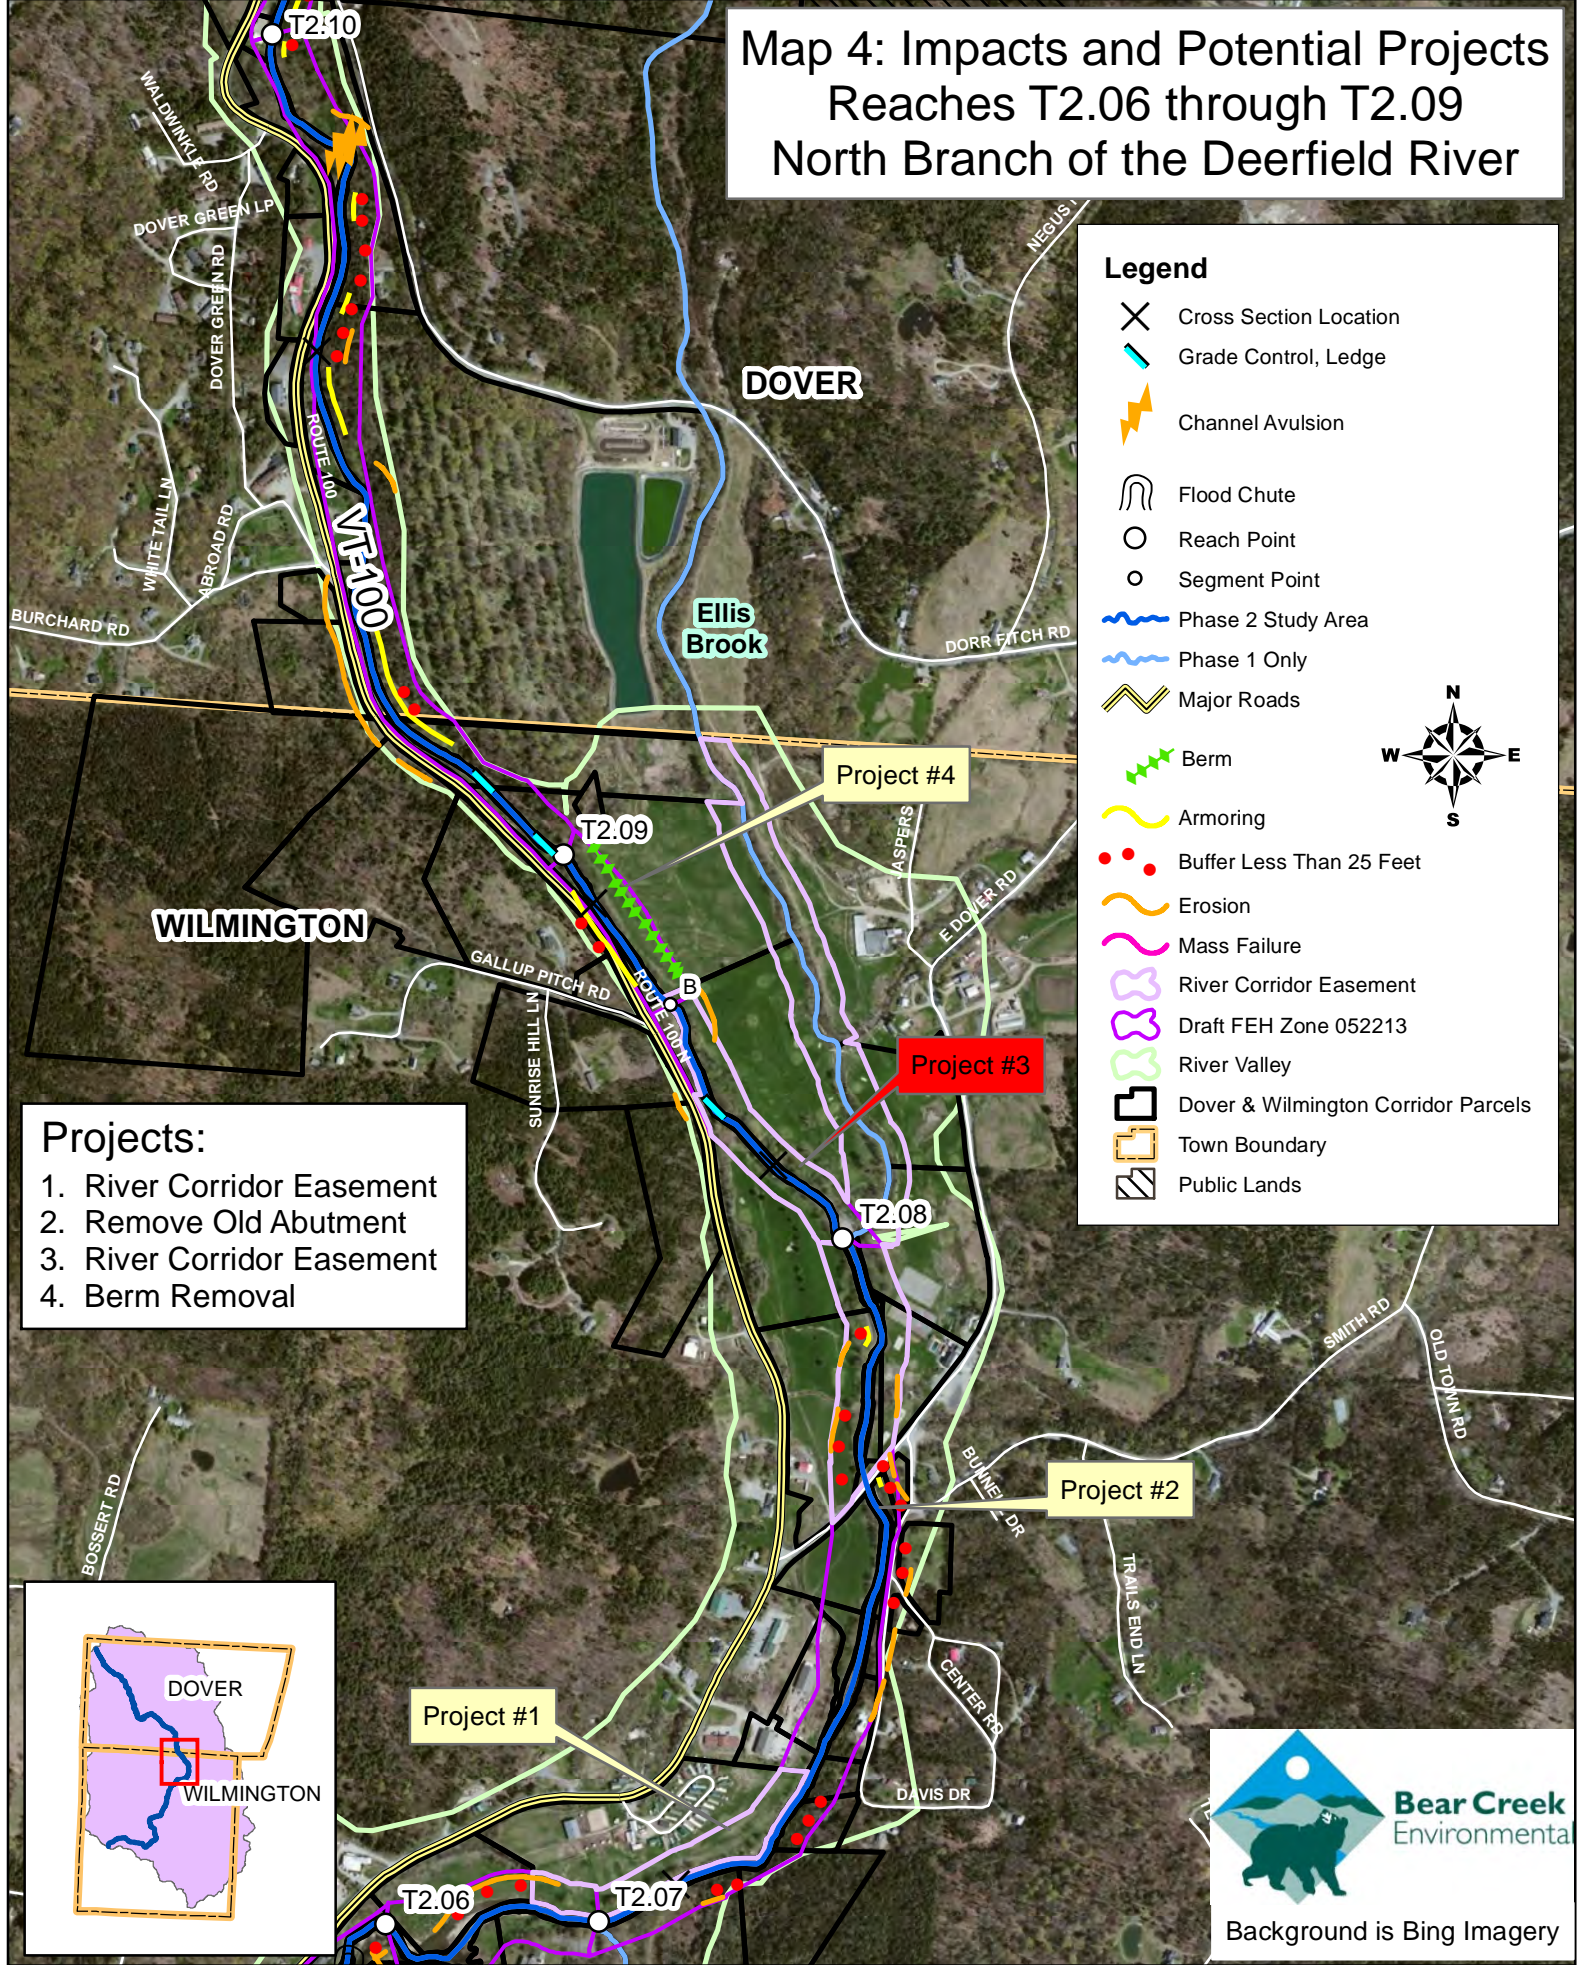
Map 4: Impacts and Potential Projects Reaches T2.06 through T2.09 North Branch of the Deerfield River

Project #4 T2.08-B	Active Restoration	A 900-foot long berm along the eastern bank is restricting floodplain access. Berm is preventing flooding of North Branch Fire District #1 spray disposal field. Recent site visit (May 2013) revealed that there is floodplain access upstream and downstream of the berm.	Berm removal	Low Priority (likely conflicts with land use, floodplain access above and below)	Improved geomorphic stability	Cost of berm removal	Landowners, WRC, CRWC, VCF, VANR, Town of Wilmington ERP

- Projects:**
1. River Corridor Easement
 2. Remove Old Abutment
 3. River Corridor Easement
 4. Berm Removal
