**West Branch of the Little River  
Corridor Management Plan  
Stowe, Vermont**

Prepared by:  
The Lamoille County Planning Commission

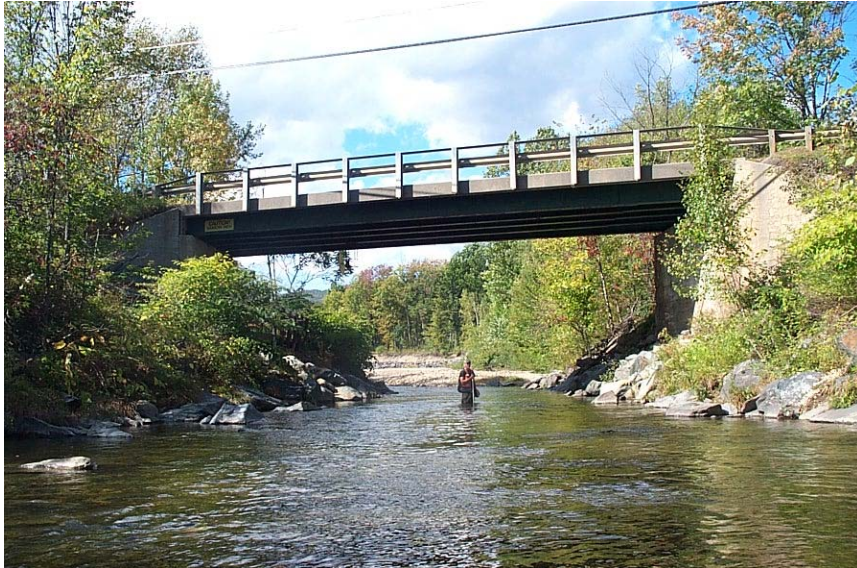
**Figure 4. Luce Hill Bridge**

Channel encroachment and adjacent land use have also led to extensive channel straightening and bank armoring (see Figure 5, page 18). Both of these activities tend to increase stream power and sediment transport and the vulnerability of downstream reaches to catastrophic erosion and deposition. An example of this is the erosion and deposition occurring upstream of the Luce Hill Bridge. The incised straightened and armored reaches upstream have the increased power to move a higher sediment load. When the flood water slows, due to backwater conditions above the bridge, the sediment drops out and the river pushes or erodes into adjacent lands.

This segment is also exhibiting signs of widening and creating a floodplain at a lower elevation, and is extensively armored with rip-rap, similar to reach 1. The Luce Hill Bridge is the cause of significant obstruction of sediment movement in this reach (see Figure 4, page 18). The riparian corridor in this segment is dominated by commercial and residential land uses.

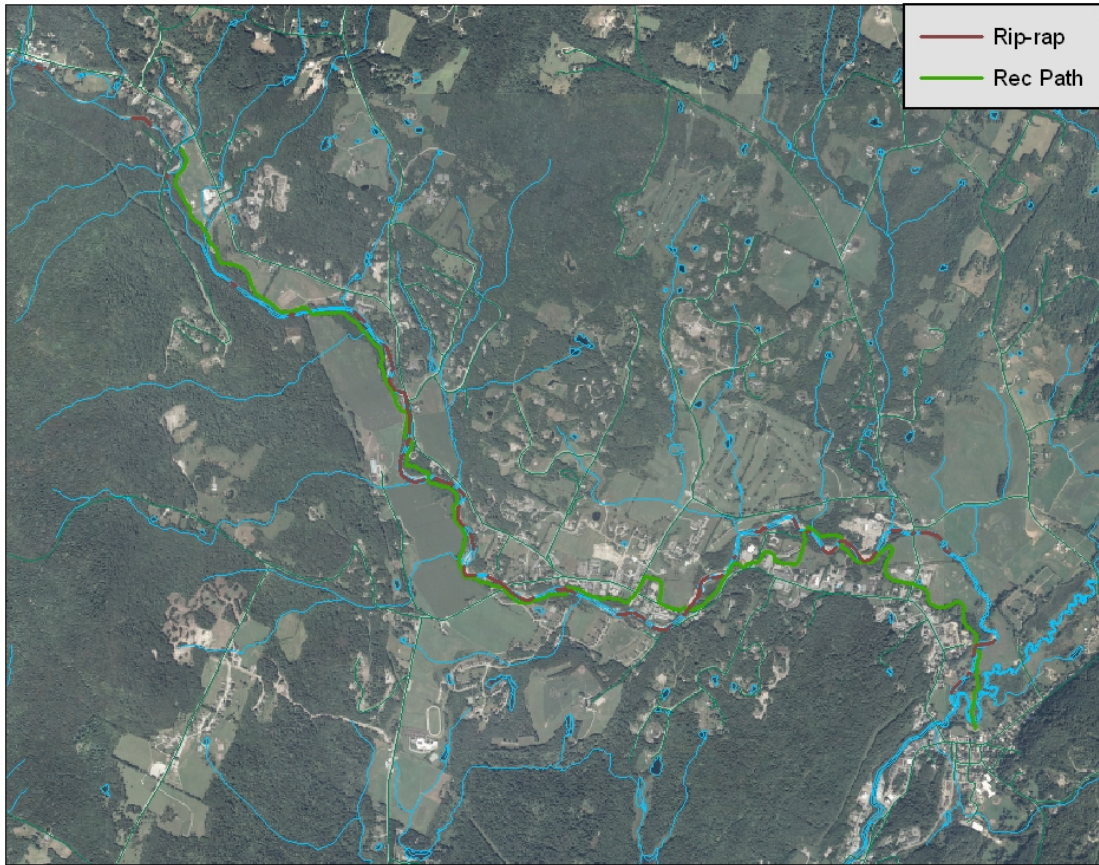
West Branch is armored on one side or the other; no other stream in Vermont has this amount of bank armoring. This practice is not cost effective as it perpetuates instability problems and inevitably fails and needs replacement. Barry Cahoon, River Management Program Director and civil engineer for the Vermont Agency of Natural Resources, says that some rip-rap has been replaced and rebuilt as much as four times (pers. comm. 2004). Due to the lack of bedrock grade control and proposed land use changes, it is likely that the West Branch will continue to lower its bed elevation. As the banks erode and the elevation of the bed lowers, the sediment load carried by the river increases.

**Figure 6. Stowe Bike Path and Rip-rap on the West Branch**

The bike path is an encroachment along much of the West Branch. In such places, consideration should be given to relocating the bike path to a site outside of the floodplain as not to encroach on the river corridor and cause maintenance issues, particularly bank armoring (see figure 6). It is recommended that the Town of Stowe revise its Recreation Plan and Recreation Lands Management Plan to place higher

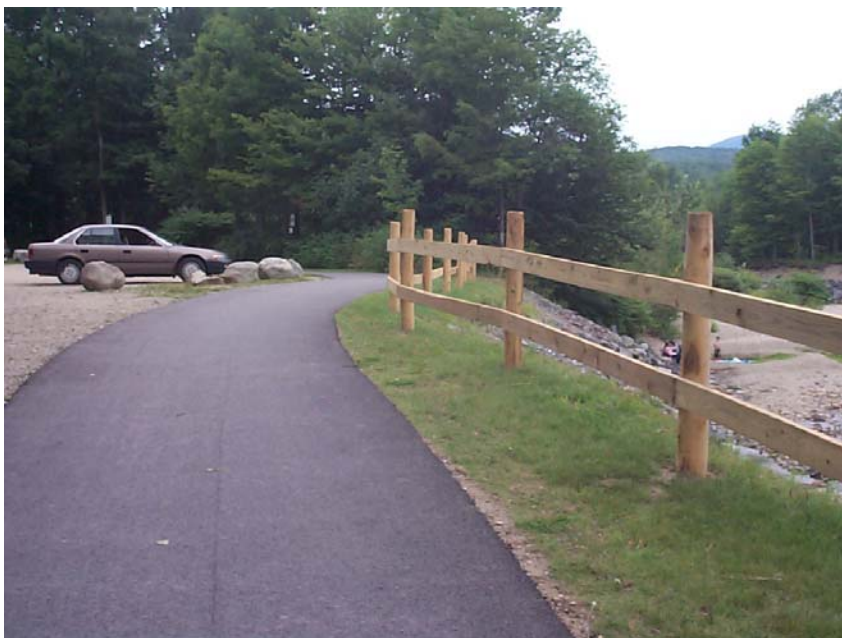
**Figure 7. Bike Path on bank of river**

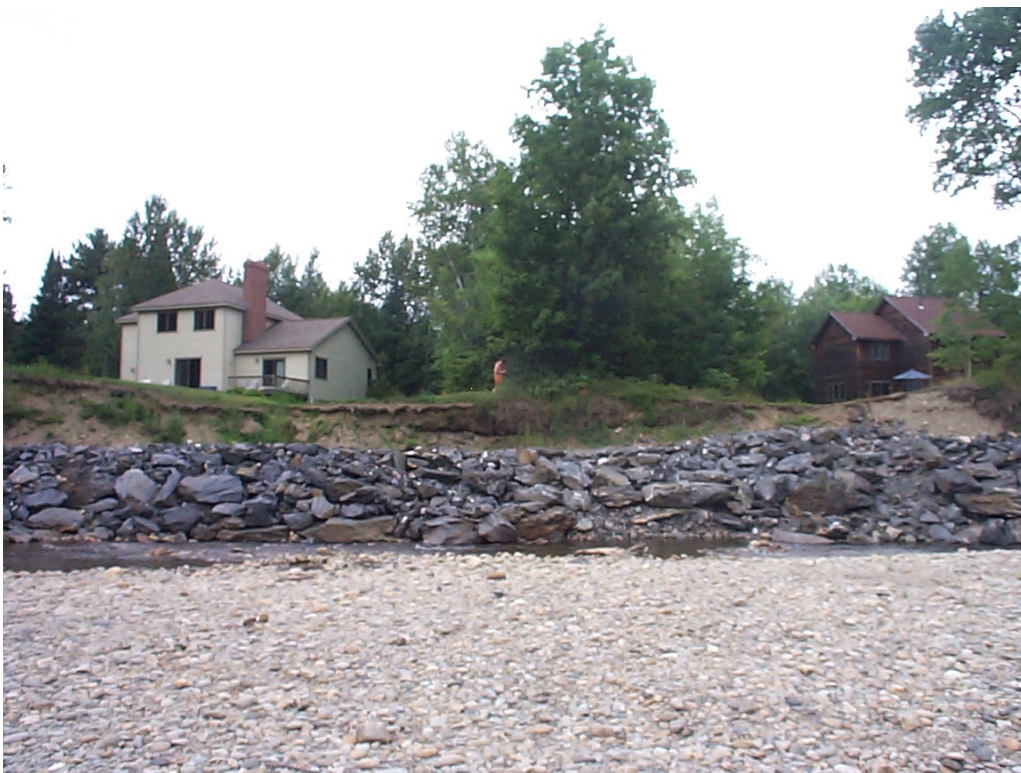
**Figure 9. Rip-rapped erosion threatening residential structures on the West Branch**

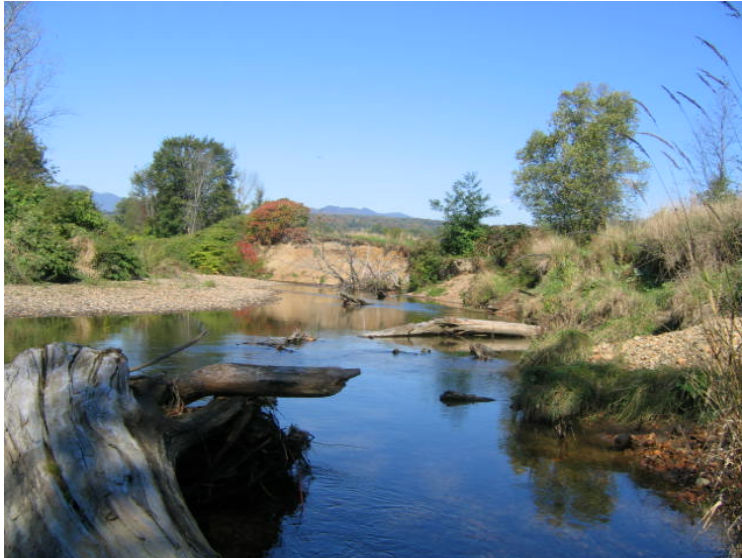
This segment has incised to the point that it has lost access to its historic floodplain. It is creating a new floodplain at a lower elevation by eroding its banks and widening. Approximately 50% of both banks were failing, and where active erosion was absent, riprap was generally present. Once the new flood bench is established, the channel will narrow and the banks will stabilize.

**Figure 11. Bank erosion on reach 1 as new floodplain develops**

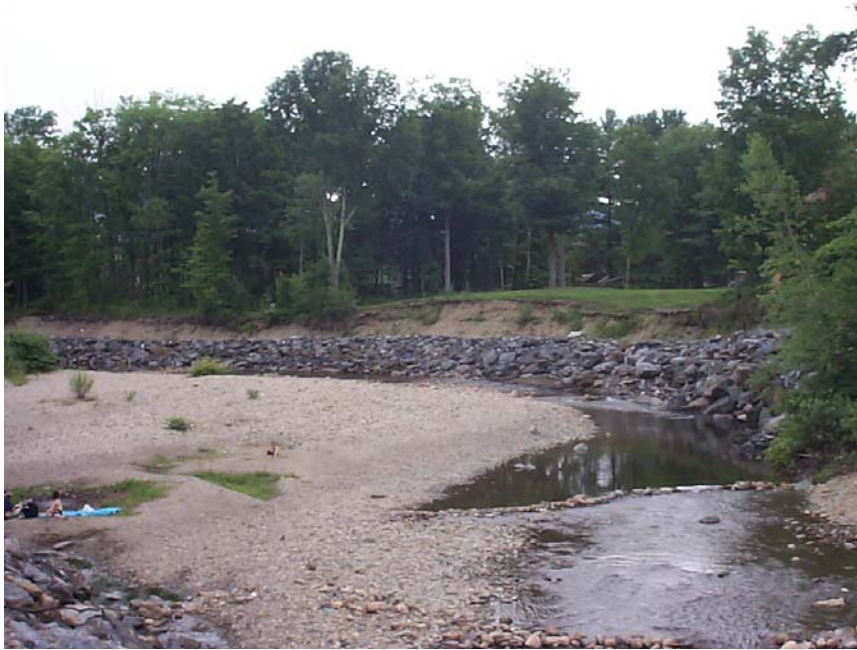
**Figure 12. Sediment upstream of Luce Hill Bridge**

This is another segment where erosion is currently widening the river and a new floodplain is being established at a lower elevation. This process should be allowed to proceed on its own wherever possible and may be encouraged through active floodplain creation where landowners are agreeable. However, in some areas, encroachments from the bike path, residential and commercial development, and transportation infrastructure will not allow the river to widen to achieve stability. Riparian plantings can provide stability on sections where further erosion is establishing a new floodplain. The right bank (right and left bank are always determined looking downstream) especially needs an enhanced riparian buffer, as it is currently less than 25 feet wide.

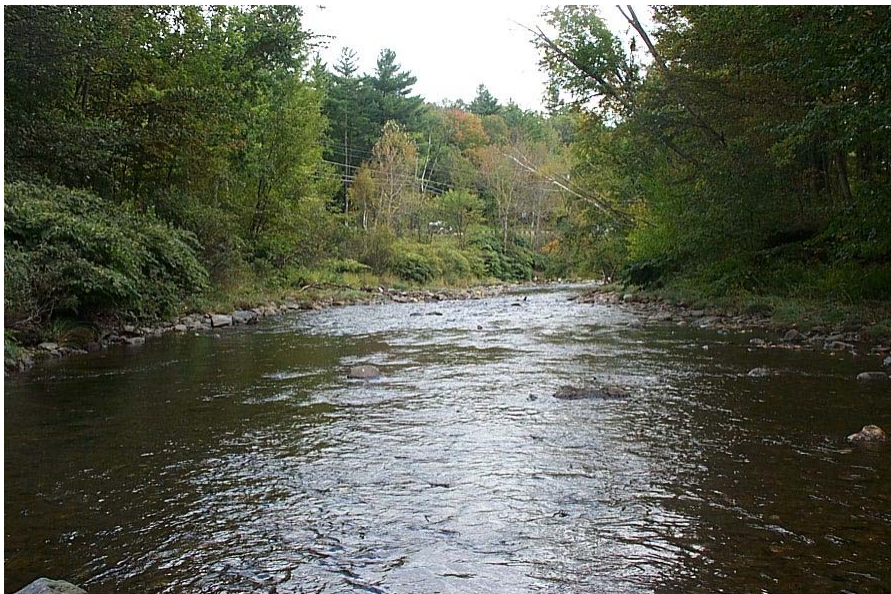
### **Figure 13. Reach 3**

This segment has reestablished a small floodplain and sediment is being stored in point bars. It is further along in channel evolution than the segment downstream, and is relatively wide and shallow.

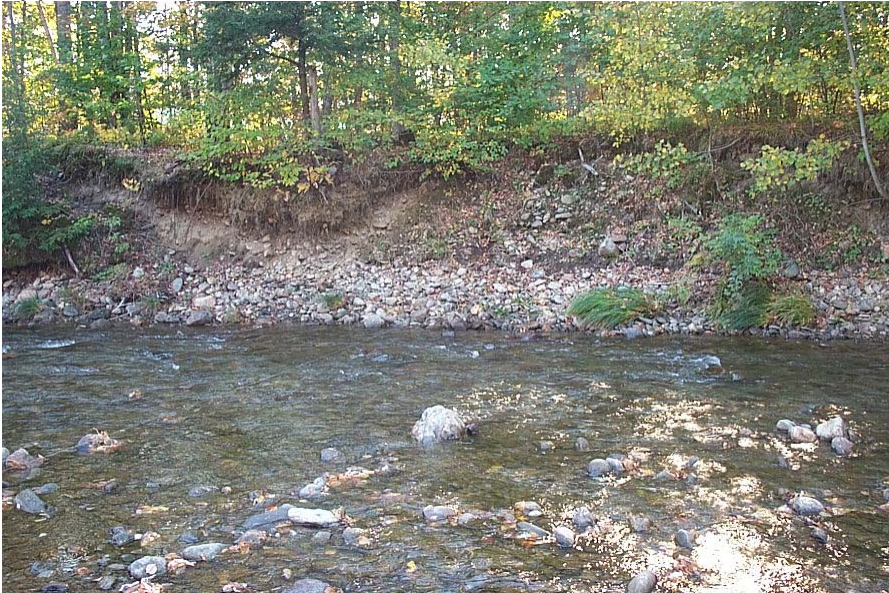
**Figure 14. Erosion on Reach 4**

This segment is highly entrenched. There is high bank erosion and very little sediment storage. This segment would benefit from the creation floodplain to help prevent further degradation and widening. Although many sections of this reach have a healthy riparian buffer that should be protected, continued erosion and loss of streambank trees can be expected unless a floodplain bench is created.

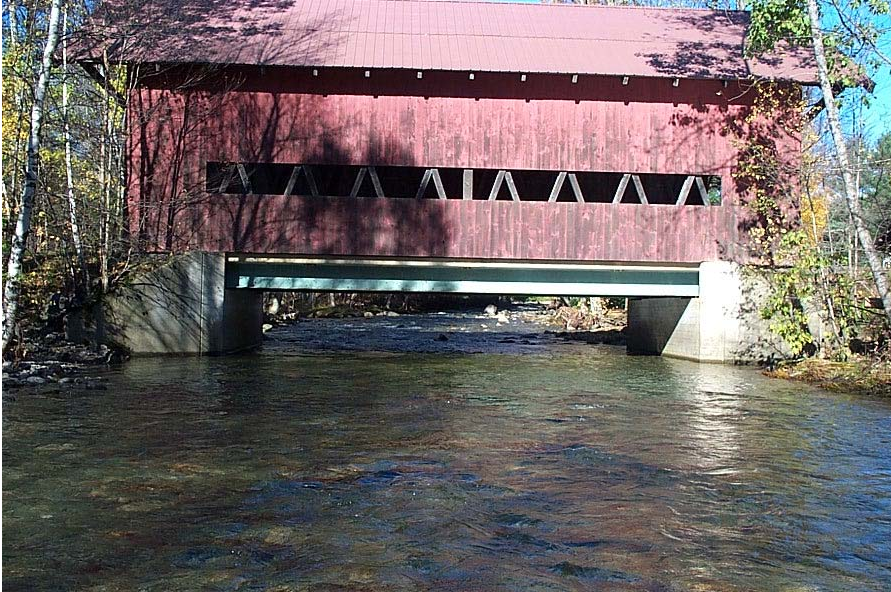
This segment generally had a healthy riparian forest of adequate width, despite a couple encroachments from Brook Road, Route 108, and some commercial and residential structures. This is another segment that still retains some riffle-pool characteristics and should be protected from further degradation. The areas with a healthy riparian buffer should be protected to make up for the few spots of encroachment by Brook Road and Route 108. Passive restoration approaches can be applied to this reach by protecting the assets through zoning.

**Figure 15. Undersized Brook Road Bridge**

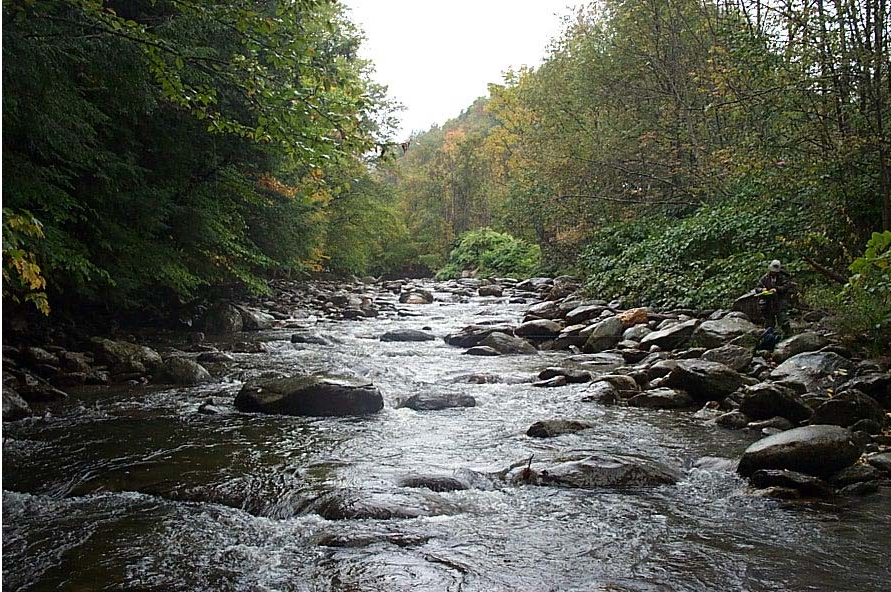
**Figure 16. Reach 6**

This segment has been affected by historic channel straightening and floodplain encroachment especially on the left bank. Opportunities for reducing these encroachments and reestablishing floodplain should be explored. Considering the amount of existing development in the left corridor, the right side of the corridor should be given higher priority for conservation to compensate for the lack of room on the left. Also, plantings should be a priority for the left bank to protect structures that are very close to the river.

This is a steep, bouldery, partially channelized reach that is providing no sediment storage and may even be producing sediment from active incision and bank erosion. It is very dynamic and has resulted in a number of significant erosion threats to developed property located within the corridor in the past. It is a high priority to avoid additional development within the undeveloped corridor.
