**Stream Corridor Plan
LaPlatte River and Tributaries
Town of Hinesburg, Vermont**

Prepared by the LaPlatte Watershed Partnership
June 2007

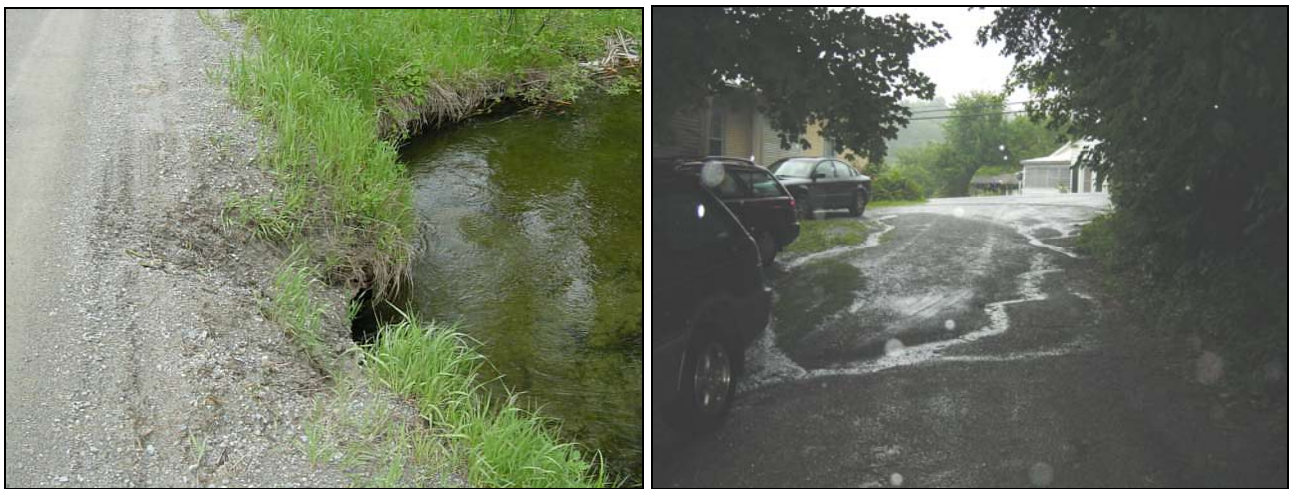
Runoff from roads, driveways, and road washouts during storms also appeared to be a source of increased sediment and increased runoff in the streams. Driveways and roads had essentially dammed floodplains and channeled runoff directly to streams, which was especially evident in hill reaches. Exposed soil from incremental development in the watershed was another source of sediment to stream channels.

Sand and gravel from roads and driveways washing into the channel.

Sediment from roads and driveways can be addressed with improved ditches, limiting future driveway lengths in sensitive areas, and other methods. The Better Back Roads program would be helpful.

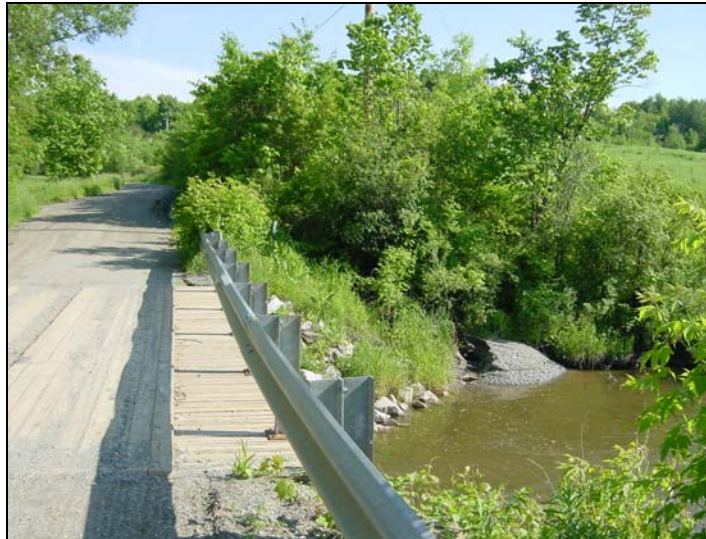
Leavensworth Road and bridge at M12 with large sediment deposit on the right where the road ditch meets the channel.

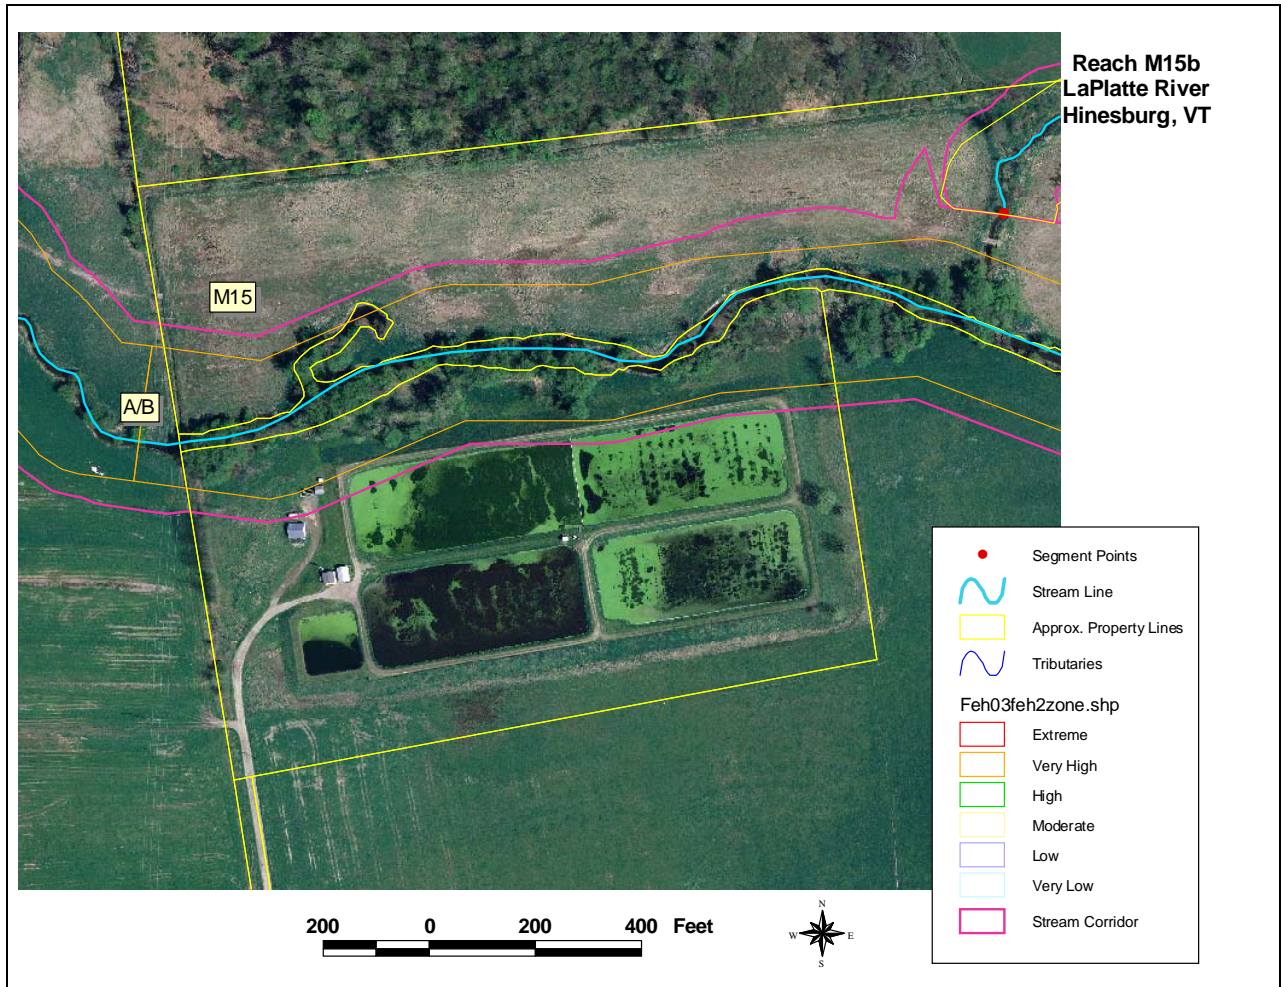
The channel was straightened and incised, resulting in greater stream power and increased sediment transport capacity. No recently abandoned channels were observed to capture as a restoration tool. The Hinesburg Sewage Treatment Plant is a permanent constraint within the corridor on the left bank. The LWP has been working with the Town of Hinesburg to plan future Plant expansions out of the stream corridor. Other than that, adjacent land use appeared to be fallow field and flow and sediment load alterations do not appear to be significant enough to inhibit the active geomorphic restoration of floodplain and meanders.

Downstream area of M15B with the STP on the left bank. The STP encroaches into both the FEH corridor and the Stream Corridor. The stream has begun to meander here and is migrating toward the berm of the lagoon.

Active restoration such as lowering of the floodplain may be preferable to a passive approach here due to the proximity of the Sewage Treatment Plant. The channel appeared to be adjusting and protection of the corridor could allow for passive geomorphic restoration, although an active approach near the STP might be preferable to provide protection and relief to that investment. Restoring the segment through a combination passive/active approach is a possibility as well.

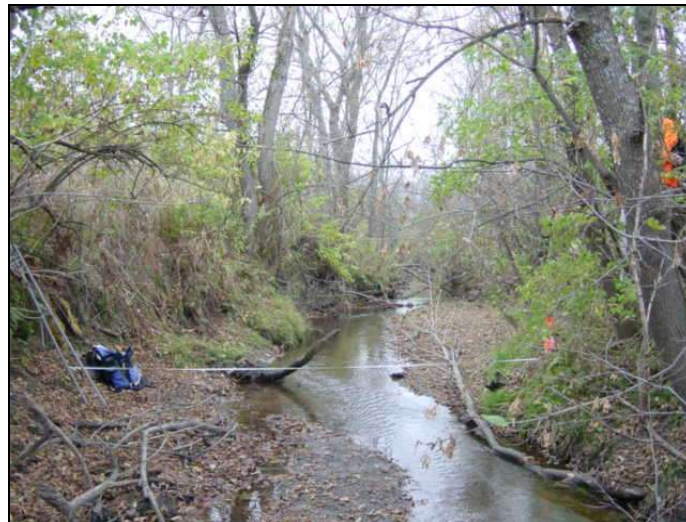
Reach M17 experienced a stream type departure (C to B) and currently appeared to be widening and aggrading, attempting to gain some floodplain and sinuosity in its incised and entrenched position.

Reach M17, entrenched and now widening and aggrading.

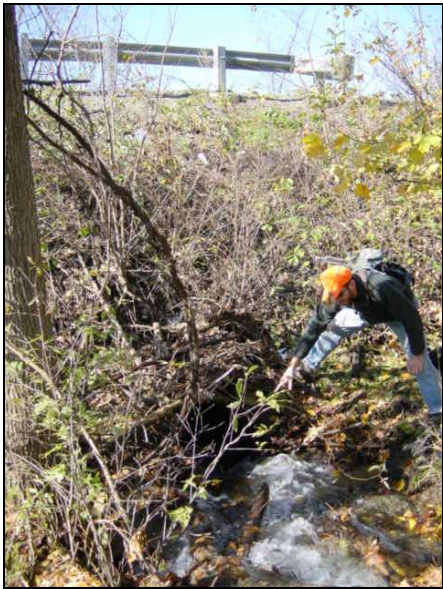
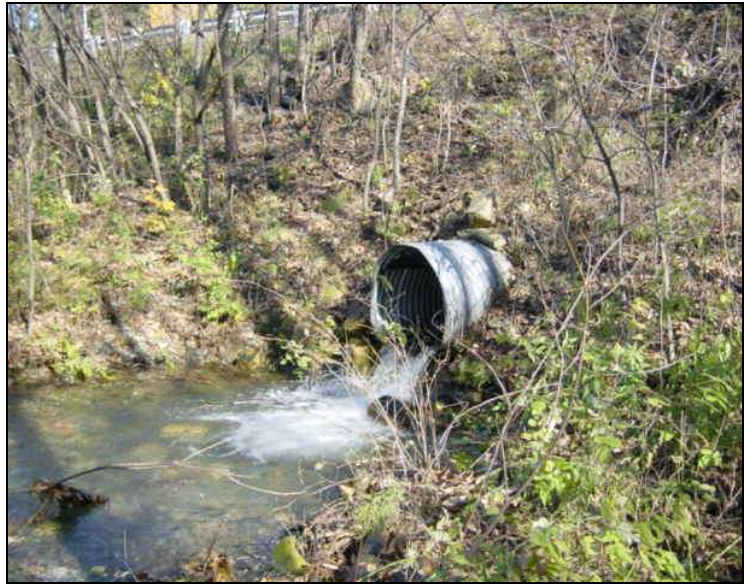
Culvert on segment M18B. The upstream end of the culvert was blocked by sediment and debris and was hardly visible (left). Extreme scour was apparent at the downstream end and beyond (right).

The river corridor is largely undeveloped except for one house on the left bank, but the channel is not likely to adjust to equilibrium due to the undersized culvert at Route 116. The streambed was actively eroding with active head cuts observed. The stream was deeply incised (1.9). The culvert should be replaced with protection provided to the house on the left bank if necessary. Sediment from upstream of the culvert would erode and enter the system, however that could aid adjustments underway downstream by slightly raising bed elevation and/or inducing meanders (such as in reach M17). If sediment introduction is undesirable from a water quality standpoint, structures could be placed to partially retain the sediment and encourage floodplain restoration or the sediment could be removed.

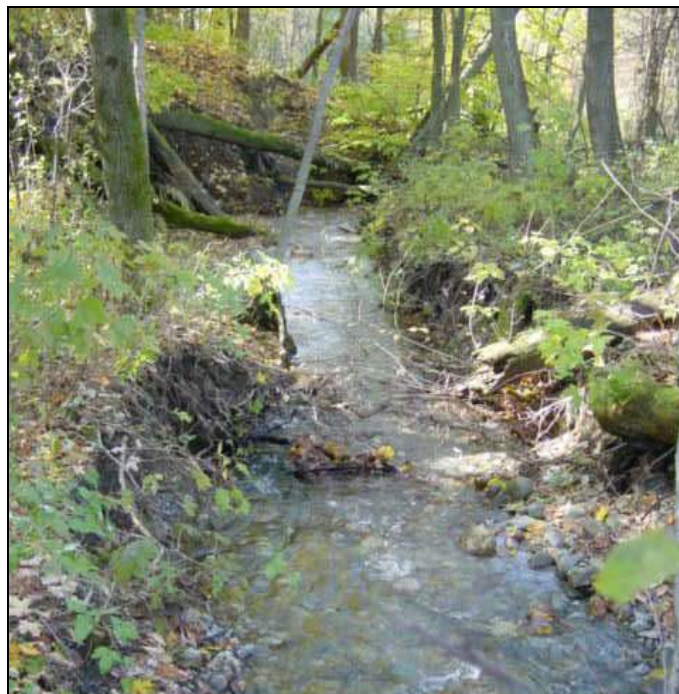
Extreme effects of constricting the channel and blocking flow of sediment has led to property damage with aggradation upstream and erosion downstream.

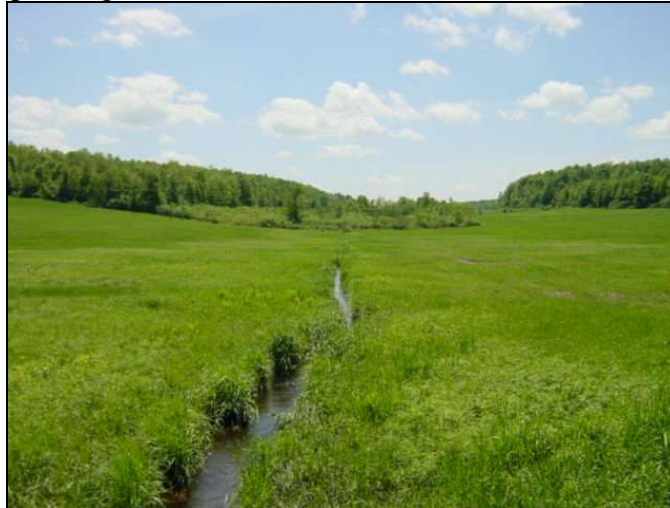
Channel and valley view. Note straightening and lack of woody riparian vegetation.

The river corridor is undeveloped and likely to adjust to equilibrium, although due to clay soils, may be in the long-term rather than the near-term. Protect the stream corridor to allow for adjustment to equilibrium. The landowner was working to fence the pasture and plant a 35-foot buffer (spring of 2007 planting).

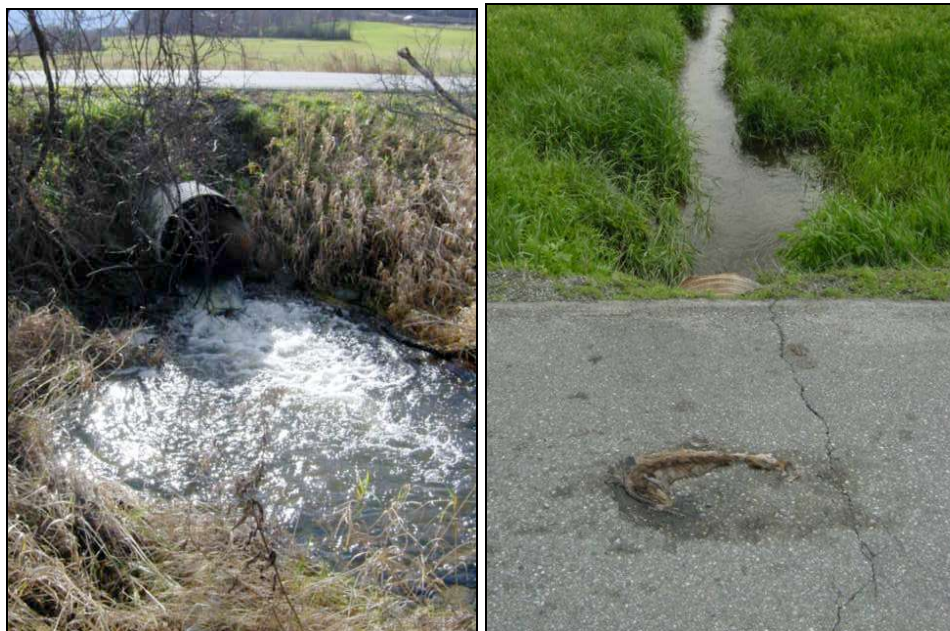
A culvert at Charlotte Road constricts the channel with sediment deposition upstream and scour downstream and a high incidence of road-killed wildlife. Sediment deposition is not likely to create a significant channel adjustment if it moves downstream, so replacing the structure with one of appropriate size is recommended.

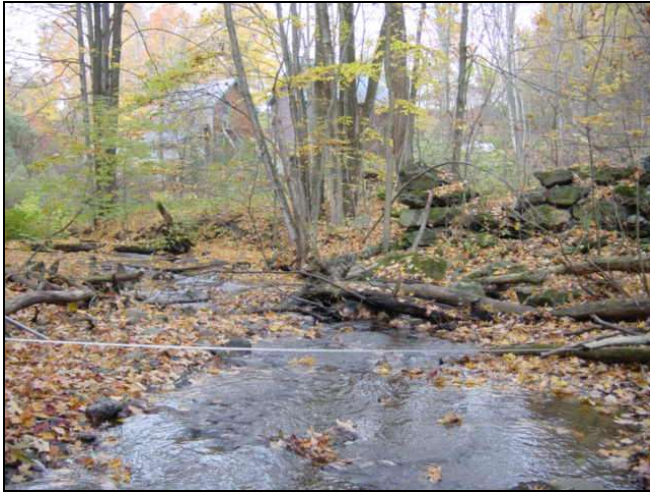
Reach view with old abutment.

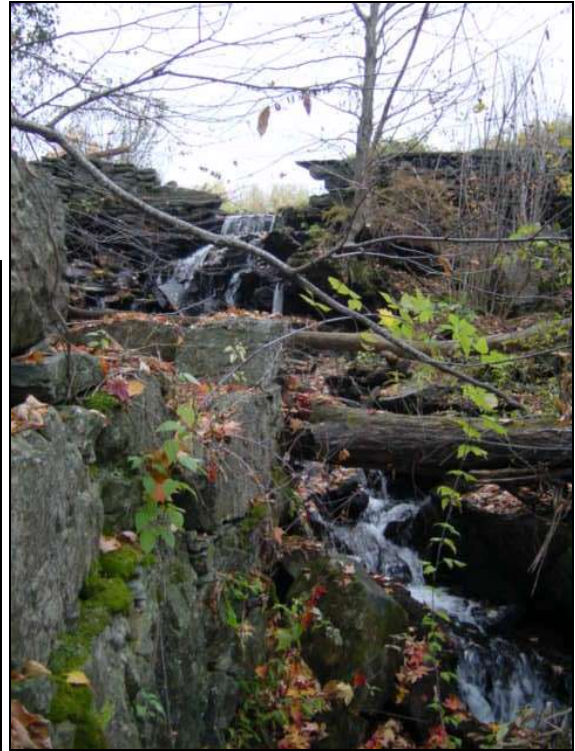
Old Mill dam near town cemetery.

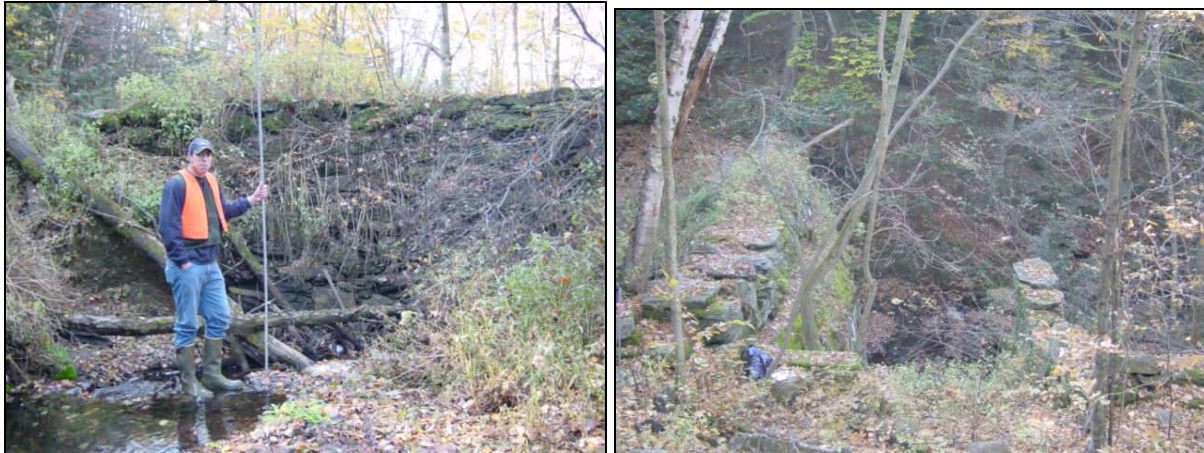
Old mill dam upstream and downstream photos.

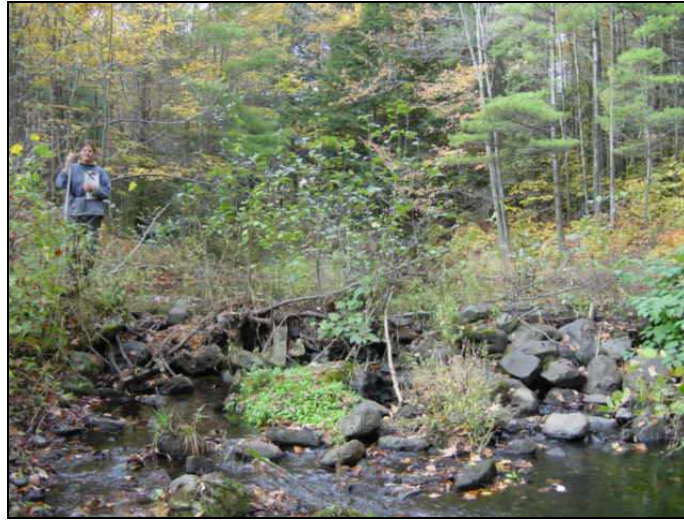
A dam was located in the reach and appeared to be non-functioning. Removal of this dam is recommended. A grade control structure may be necessary to prevent the channel from head cutting. Riprap and rock walls confine the channel toward the upstream end. Analysis of whether any of this could be removed without endangering infrastructure and homes is recommended.

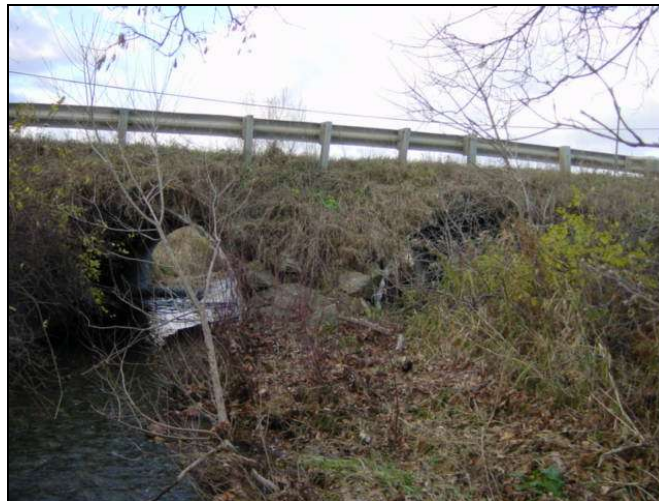
The double culvert at Route 116 constricts the channel and should be replaced with one of appropriate size. Route 116 also acts as a dam here. Sediment deposition has been a problem upstream of this culvert and has been cleaned out with riprap placed on the right bank.

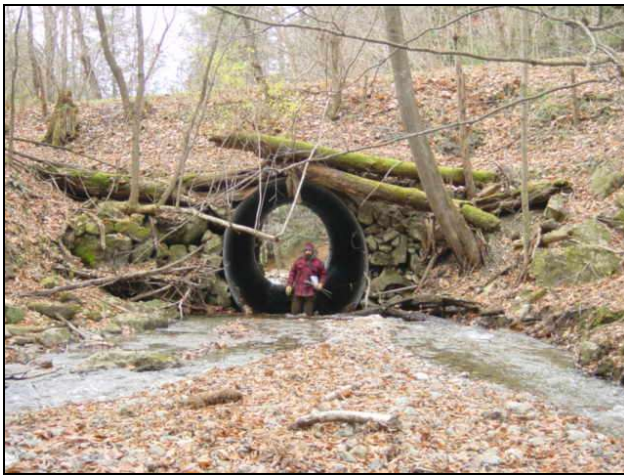
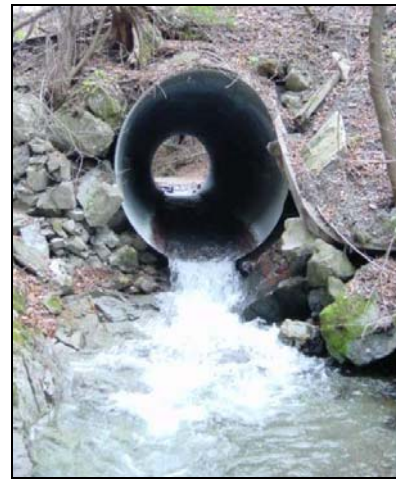
Beecher Hill Brook (T5.01B) culvert. Note aggradation forming bars and splitting flow upstream. Some erosion was noted downstream, although the downstream end falls onto ledge and boulders.

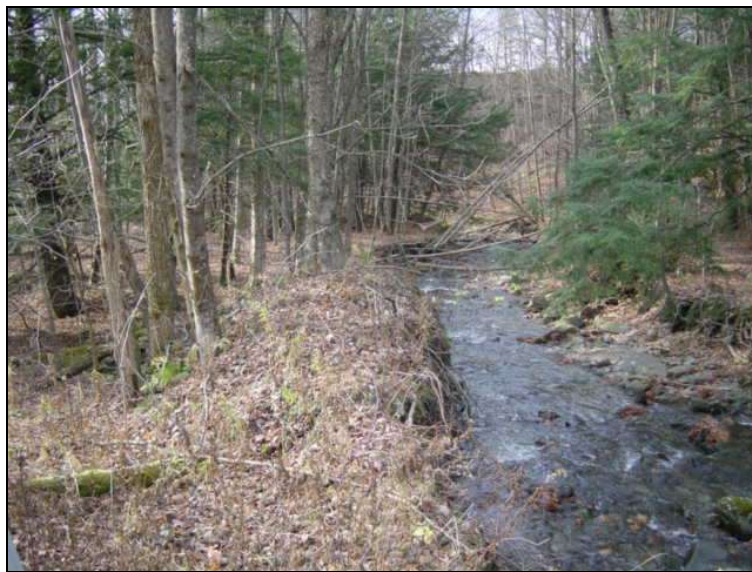
Segment T5.01D had been straightened, moved, and bermed historically, likely in conjunction with construction of North Road. Following the channel alteration, the stream had no access to floodplain and appears to have severely widened and incised. Continued incision and widening (channel enlargement) were evident in headcuts and scoured banks, leaving property at risk. This segment had ledge grade controls at both the upstream and downstream ends, helping confine these adjustments to this area.

Signs of an old channel were evident to the left of the photo. The channel appeared to have been moved to its current location and held in place by a berm, seen in the center of the photo.

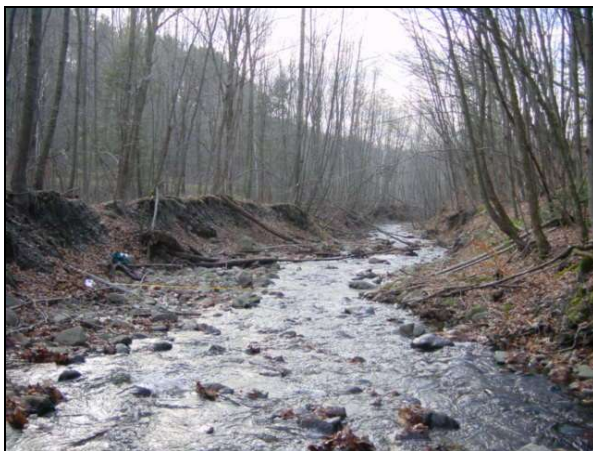
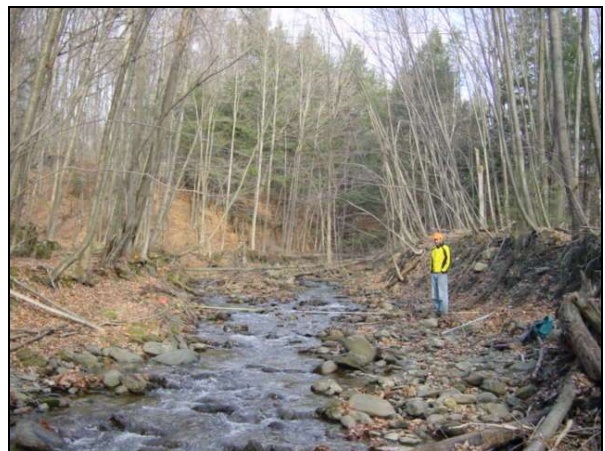
Significant channel enlargement following straightening and berming.

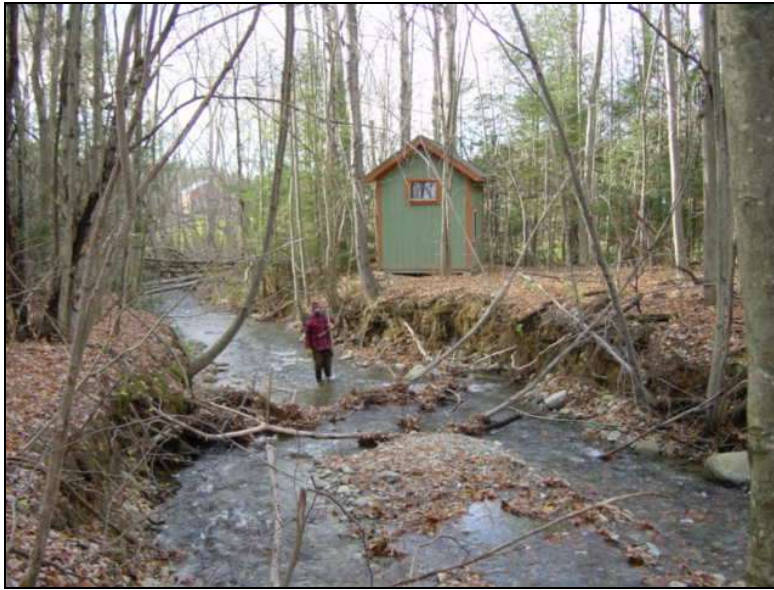
Channel enlargement further downstream leaving investments in danger.

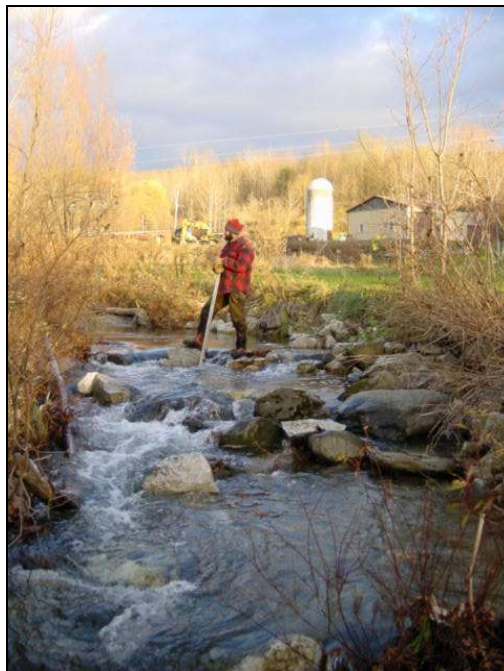
A head cut was identified downstream of the Beecher Hill Road bridge near North Road. This area has some floodplain access, so constructing a weir to arrest the head cut is recommended.

Headcut downstream of Beecher Hill Rd.

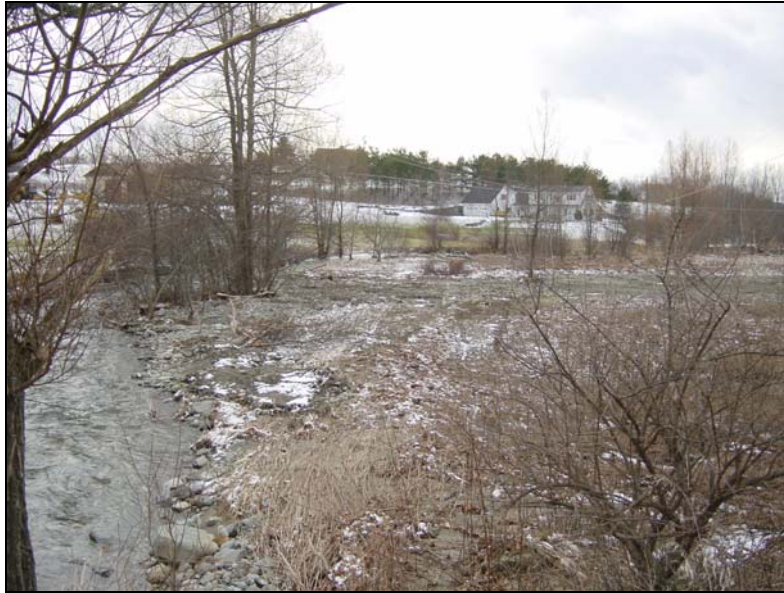
Floodplain fill replaced after January 18, 2006 storm flows, reducing sediment and flow attenuation in this area, which was between 2 degrading areas.

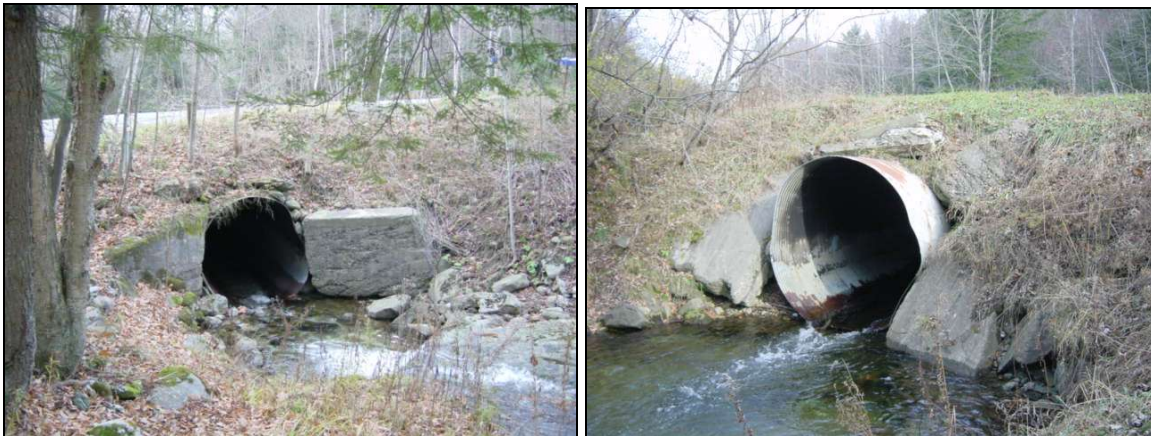
A bridge constricts the channel at Beecher Hill Road. Replacement with one of appropriate size is recommended. A culvert constricts the channel and has a significant downstream drop at the North Road. Grade controls upstream provide stability to this area. Replacement with one of appropriate size and orientation is recommended as a high priority to reduce erosion at the site. The segment is incised due to the berms. Parts of an abandoned channel exist that could be used for restoration. This should be examined in planning for restoration of the incised segment. The restoration may need to include bed forms and floodplain features in equilibrium with the higher stream power due to the North Road occupying some floodplain area.

Culvert at North Rd views: upstream end and downstream end.

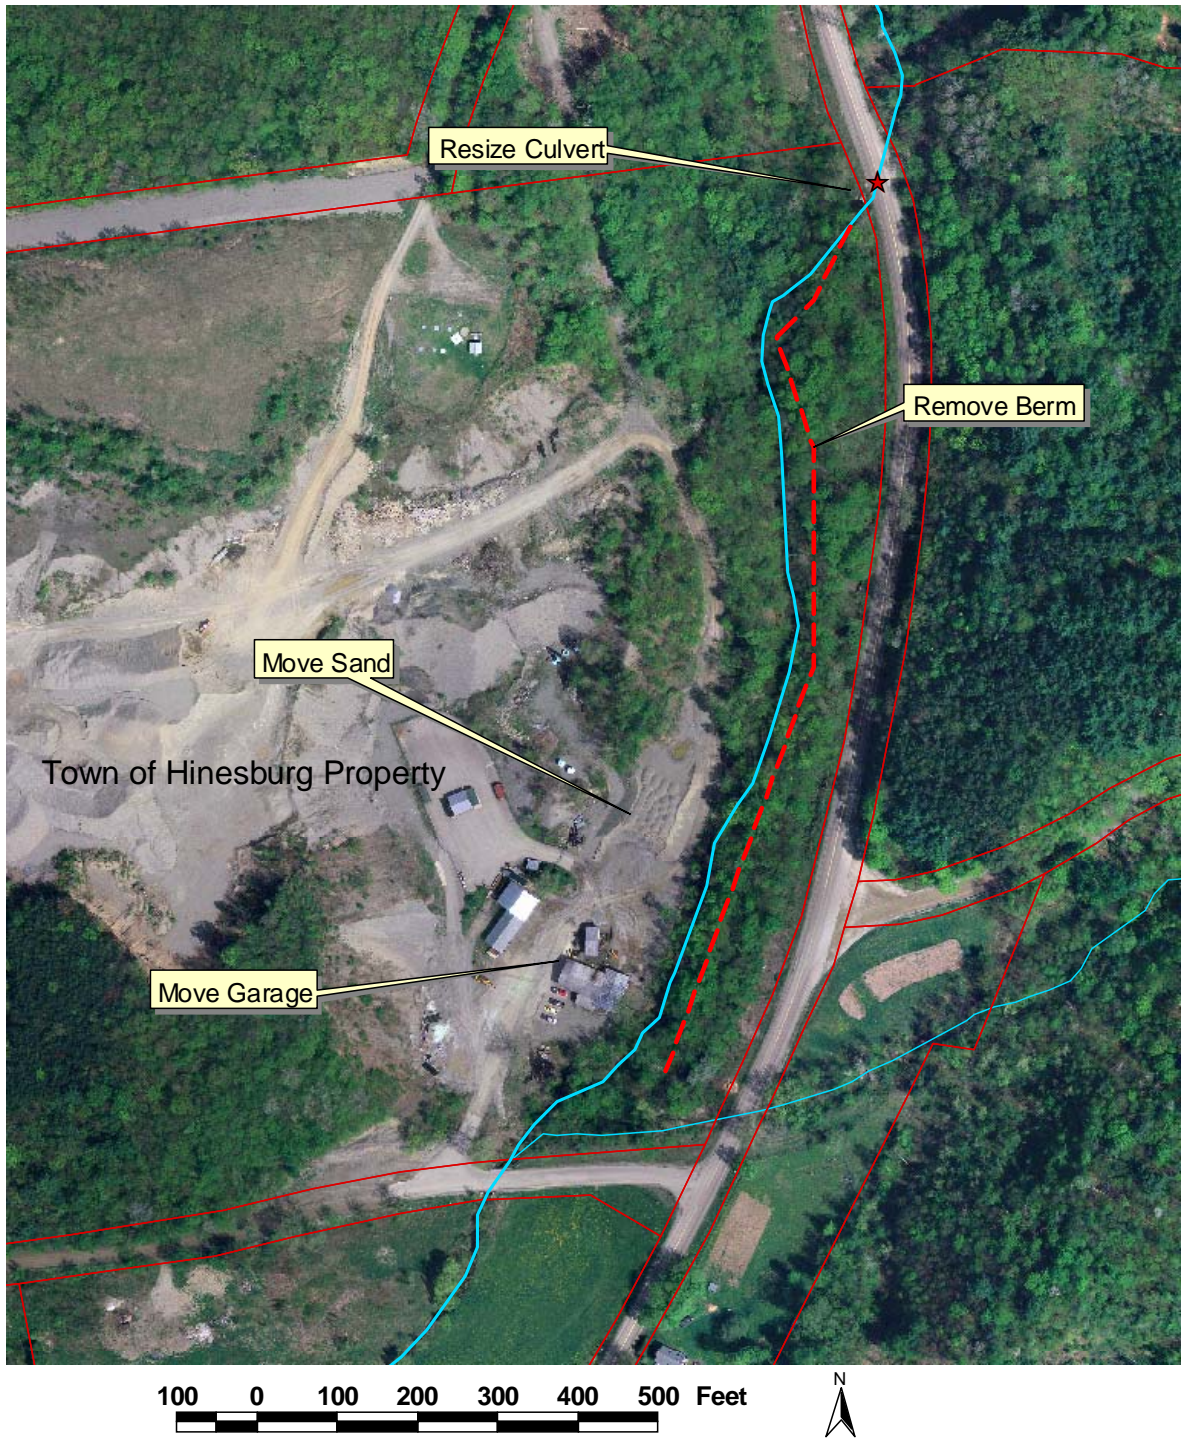
Town Garage site map showing berm highlighted in red, North Rd to the east, Beecher Hill Rd to the south, the town garage and sand pile, and the location of the undersized culvert.

- Concept project components include:
- Conserve corridor
 - Move Town Garage and sand pile
 - Remove berm
 - Resize culvert upstream
 - Stabilize North Rd if and where necessary
 - Recapture old channels

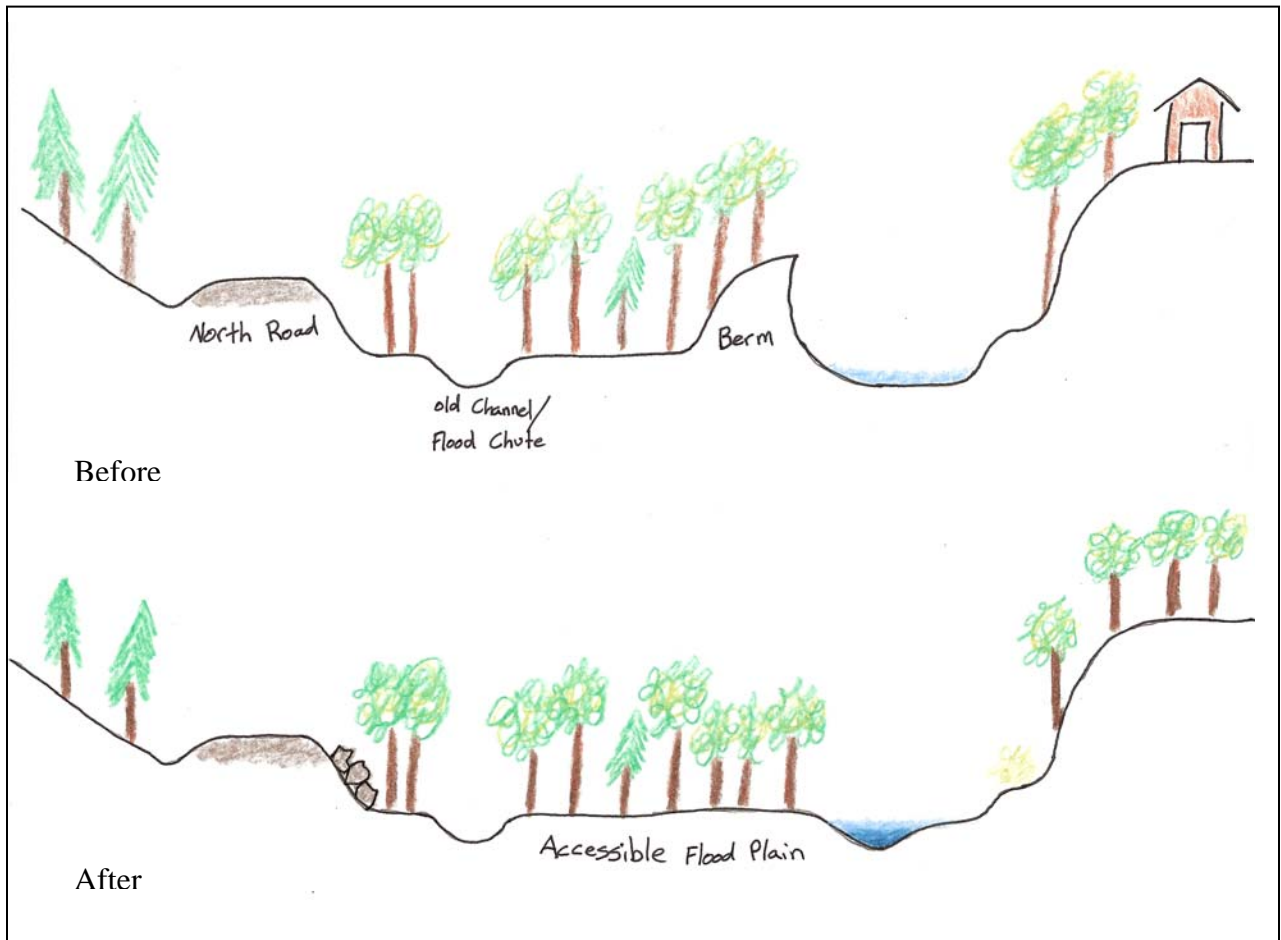
Conceptual cross sections to illustrate berm removal and relocation of garage and sand pile.
