Upper Missisquoi River Corridor Plan Missisquoi River Watershed Orleans County, Vermont

September 30, 2011

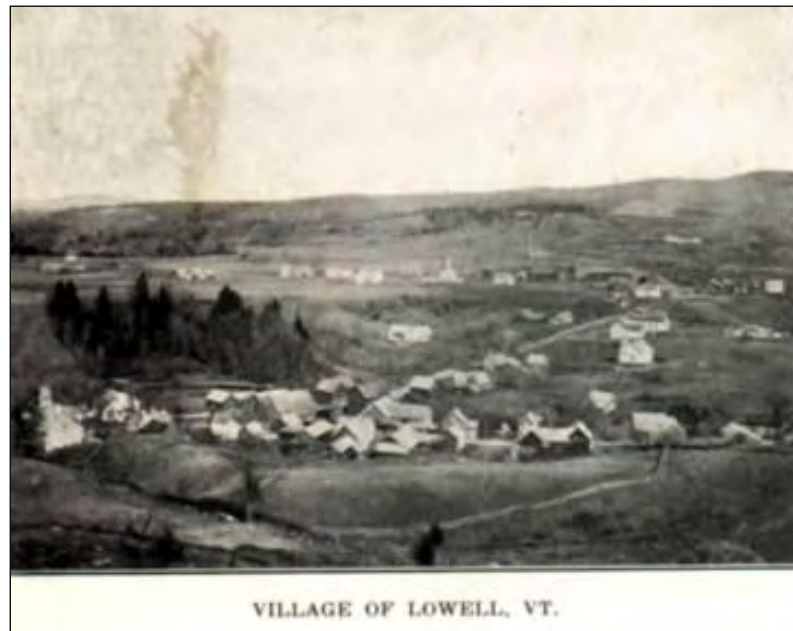
Figure 4. UVM Landscape Change Program, LS04376_000. Circa 1907. Postcards shows view of Lowell village

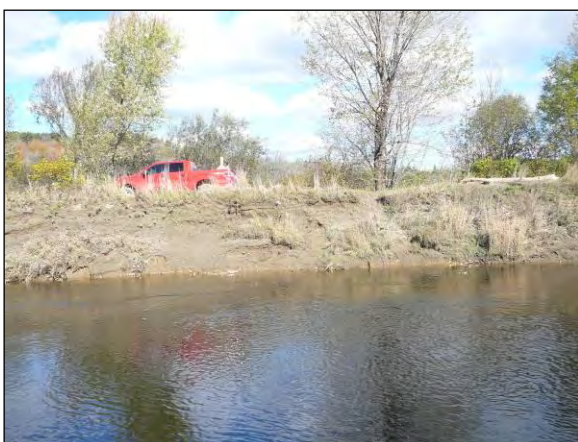
Figure 10. Erosion and poor buffers at the cross section

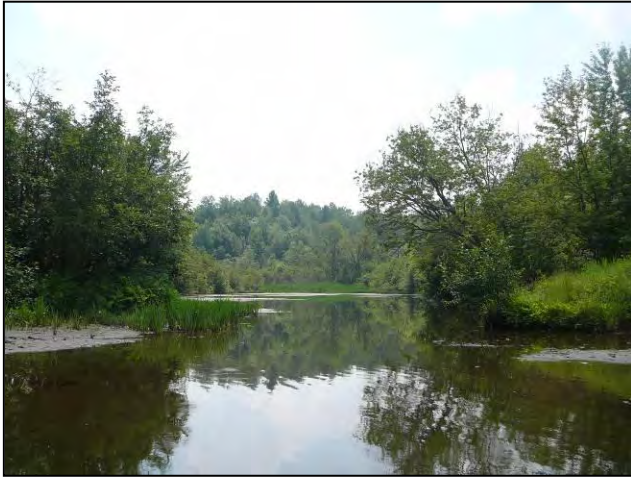
Figure 11. Nice oxbow wetland

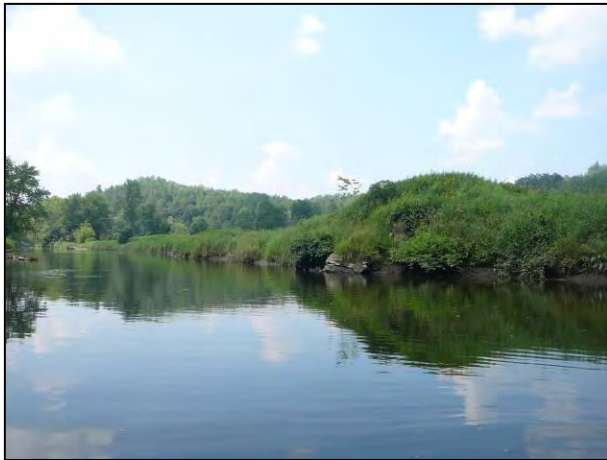
Figure 12. Old abutment

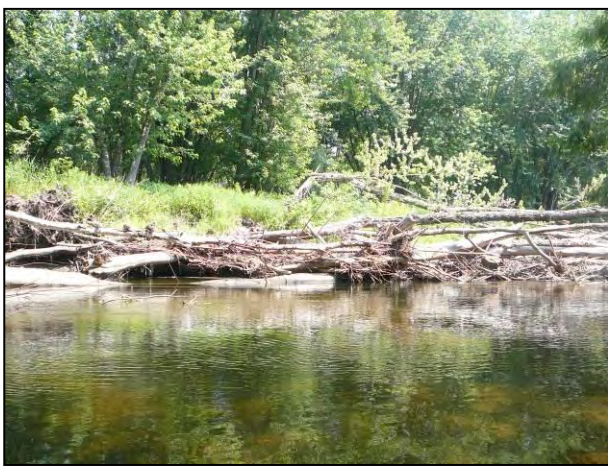
Figure 13. Large pool upstream of island

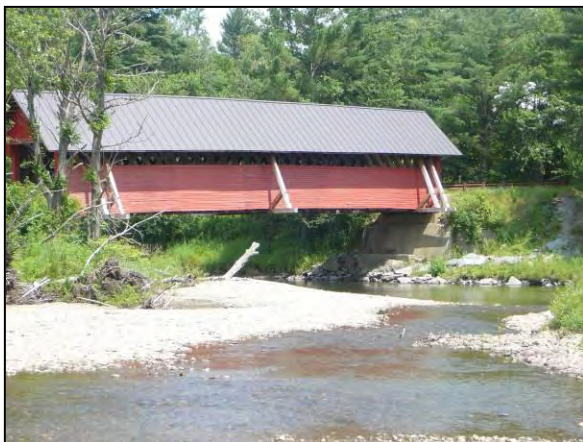
Figure 14. Covered bridge on Vielleux Road

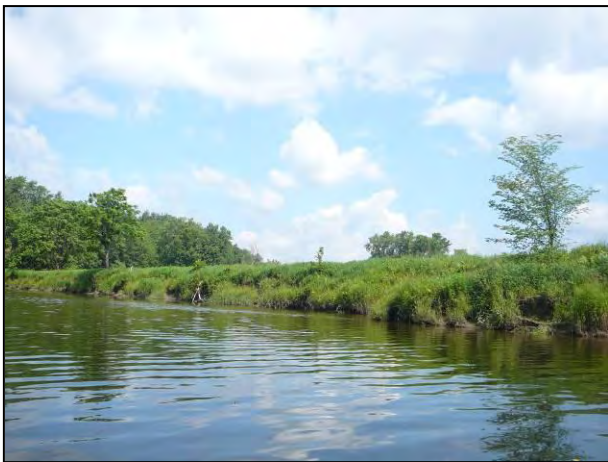
Figure 15. Erosion and poor buffers

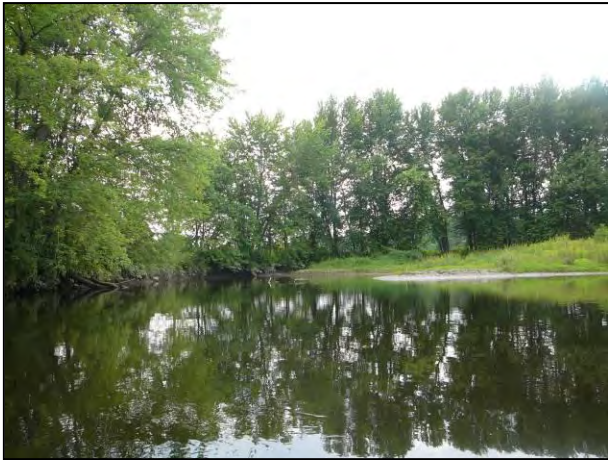
Figure 16. Refuge area with nice vegetation

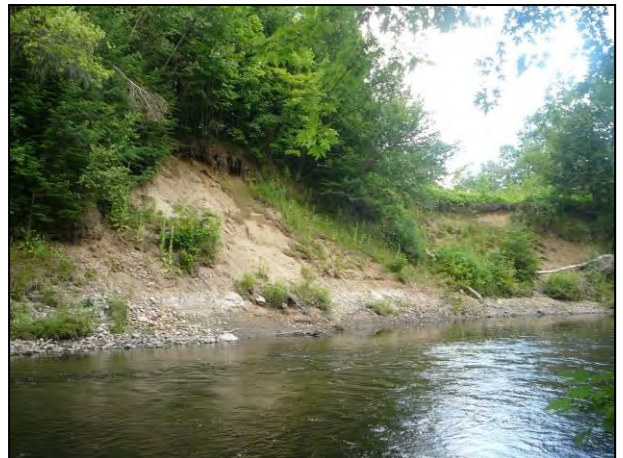
Figure 17. Mass failure

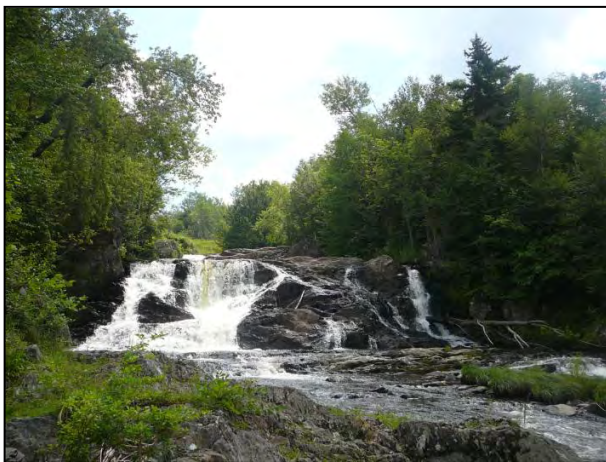
Figure 18. Bedrock falls

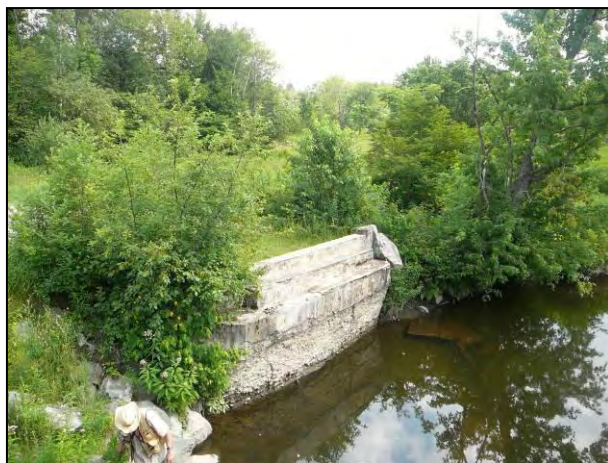
Figure 19. Old bridge abutment

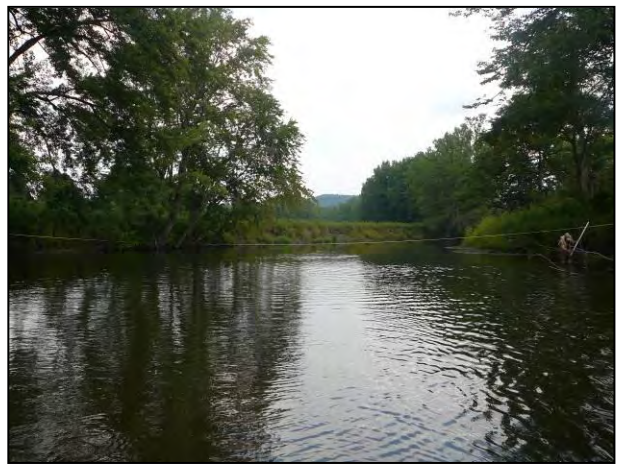
Figure 20. Channel at the cross section

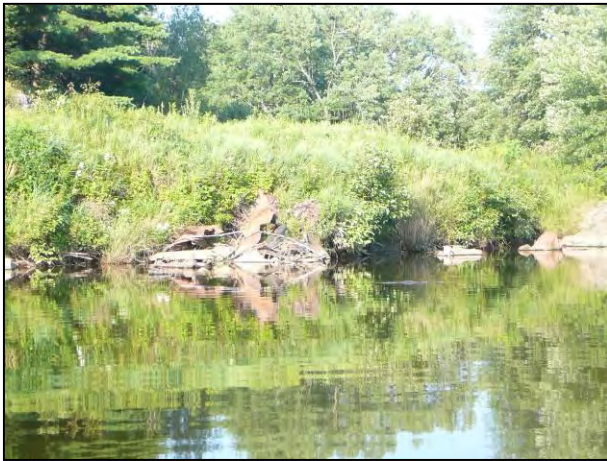
Figure 21. Dump site (Project #R35A-2)

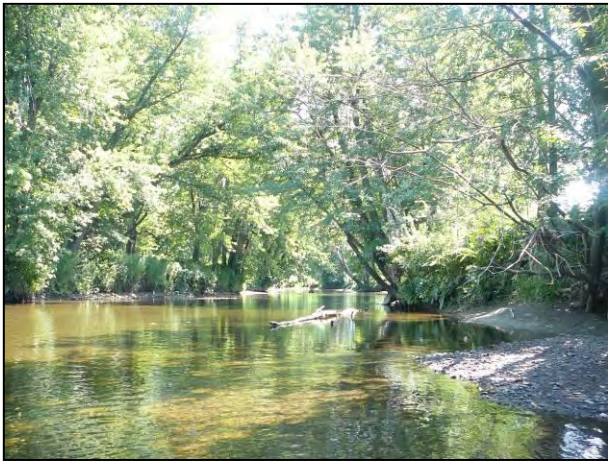
Figure 22. Channel at the cross section

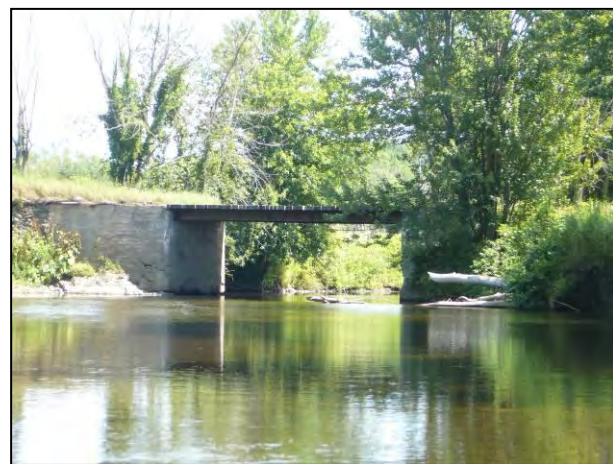
Figure 23. Undersized farm bridge

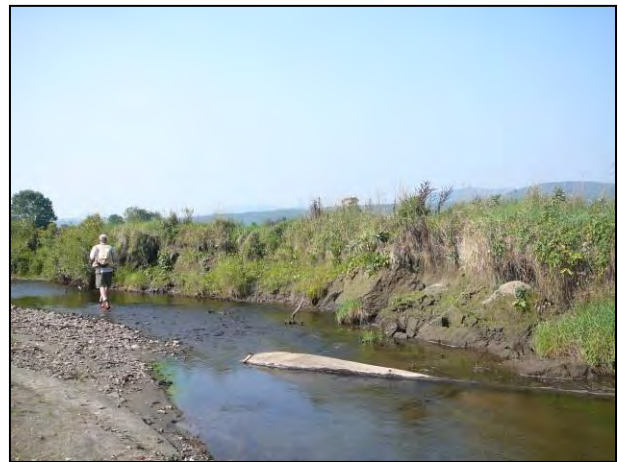
Figure 24. Erosion of outside meander bend

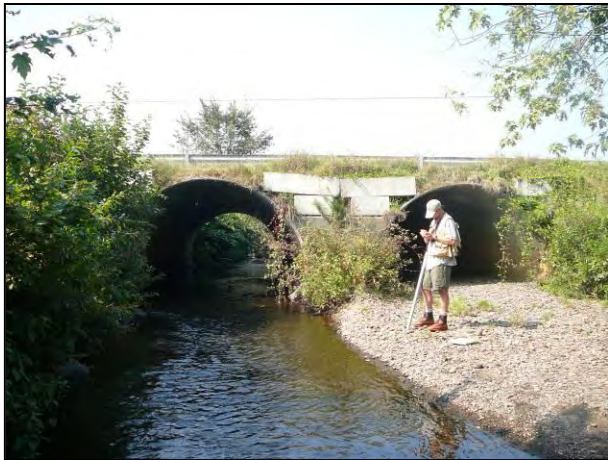
Figure 25. Double Culvert associated with Loop Road crossing

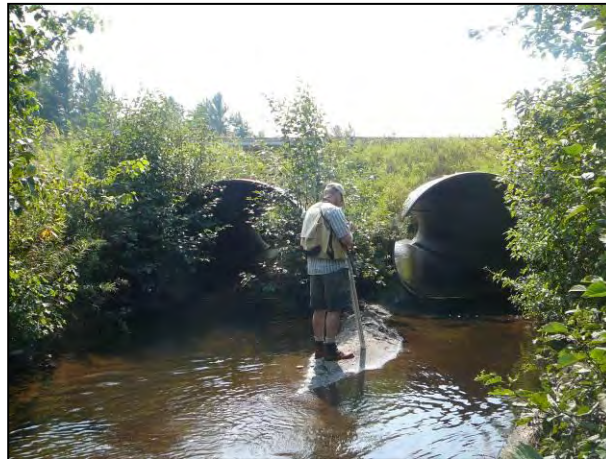
Figure 26. Undersized double culverts at Cemetery Road crossing

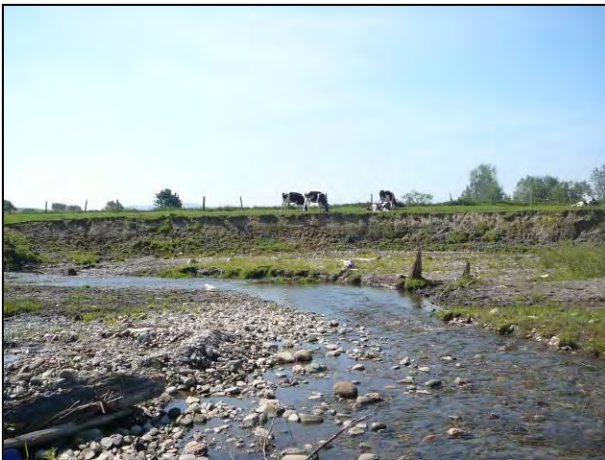
Figure 27. Erosion and Poor Buffers

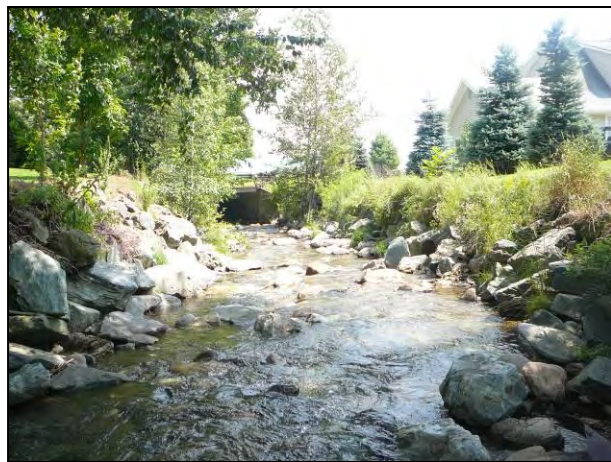
Figure 28. Channel management, corridor encroachments and channel constriction

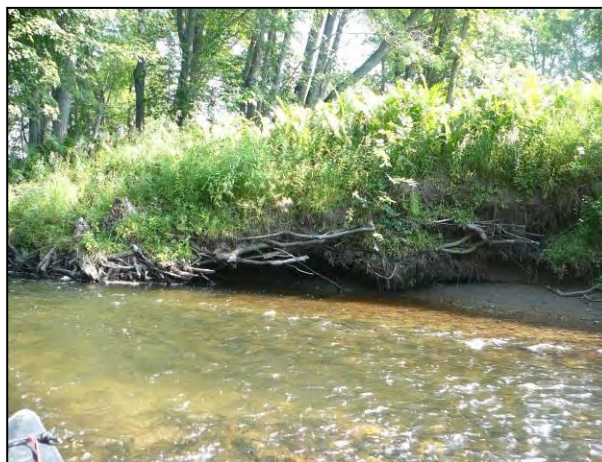
Figure 30. Nice undercut bank

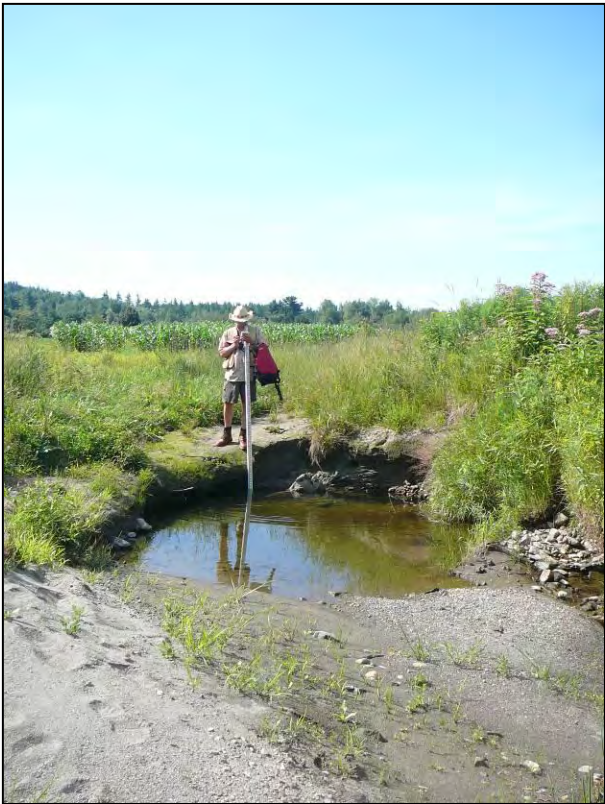
Figure 31. Active headcut on floodchute

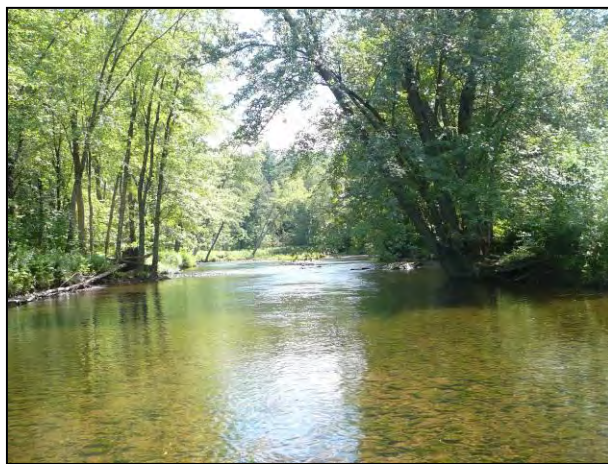
Figure 32. River channel at the cross section

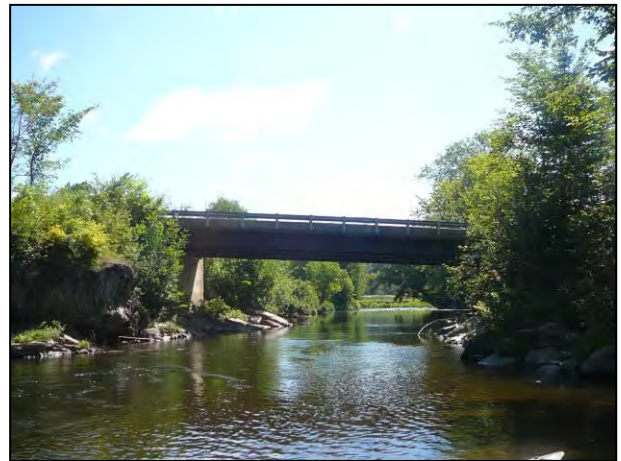
Figure 33. Undersized Loop Road Bridge

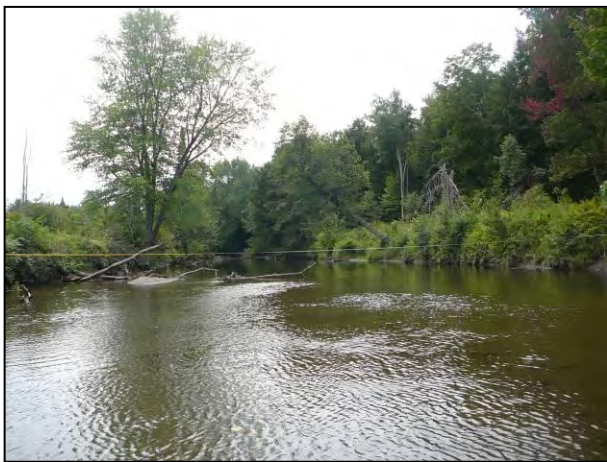
Figure 34. Channel at the cross section

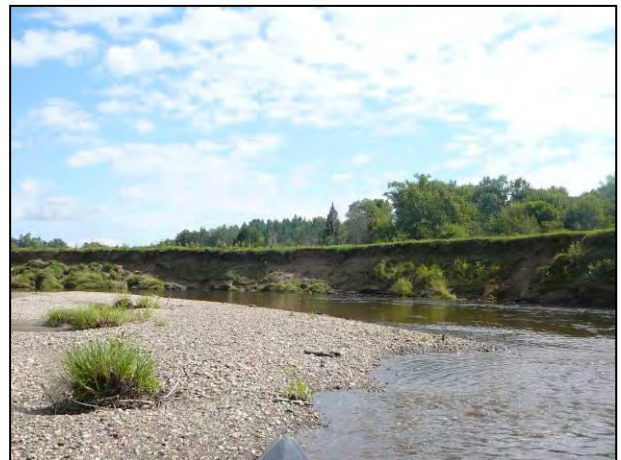
Figure 35. Erosion of an outside meander bend

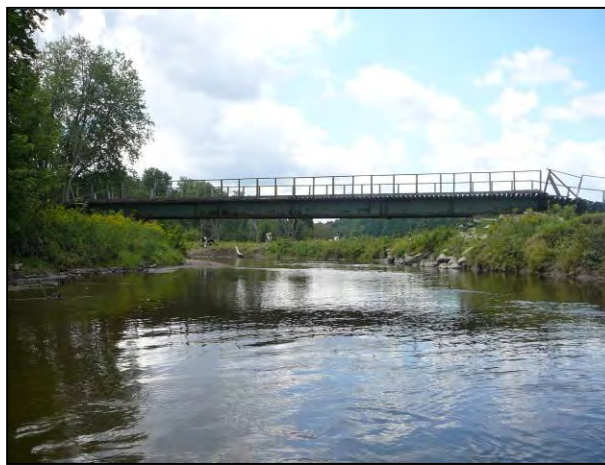
Figure 36. Undersized farm bridge

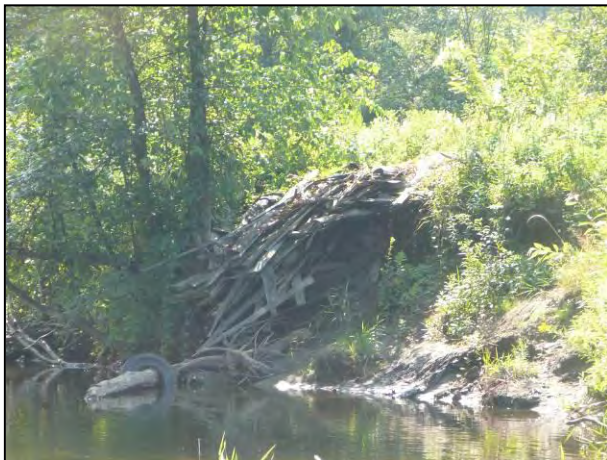
Figure 37. Dump site

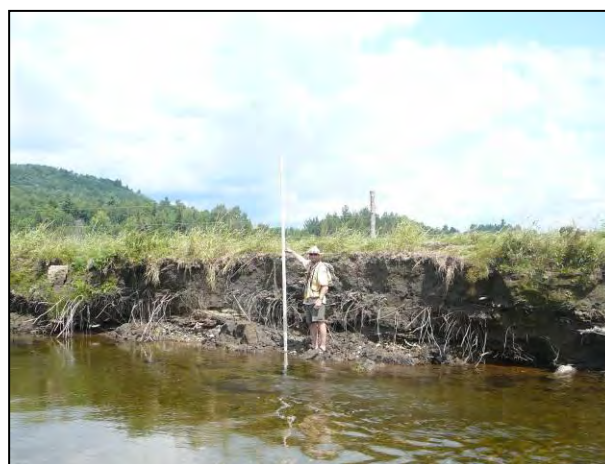
Figure 38. Erosion of outside meander bend and poor buffer condition

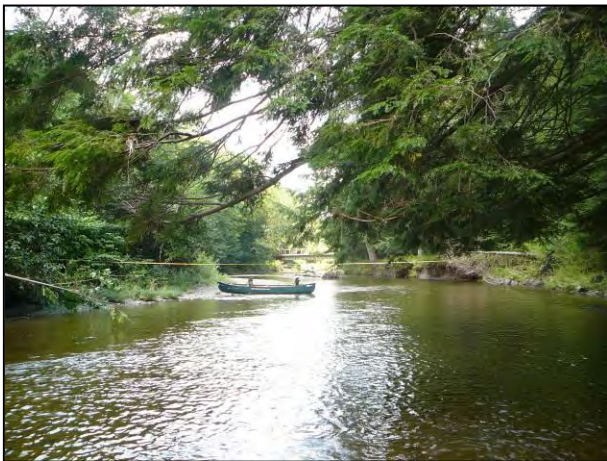
Figure 40. Channel at the cross section

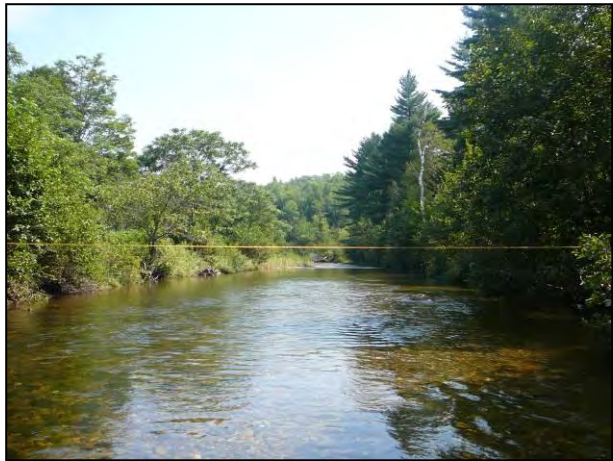
Figure 41. Channel at cross section

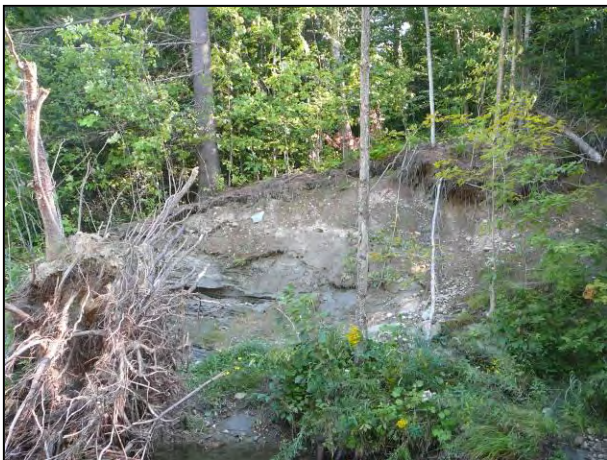
Figure 42. Mass Failure

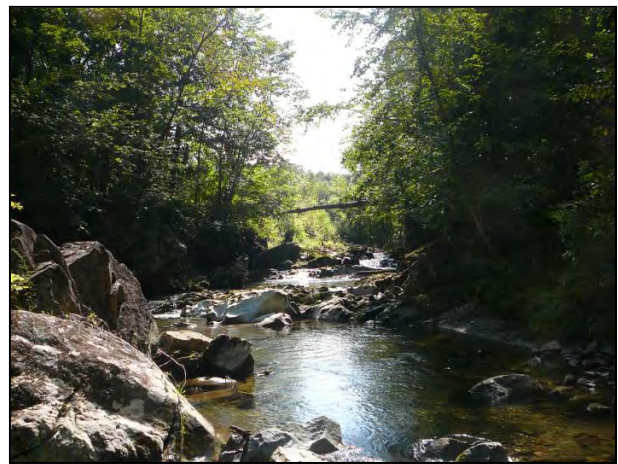
Figure 43. Nice step-pool sequence

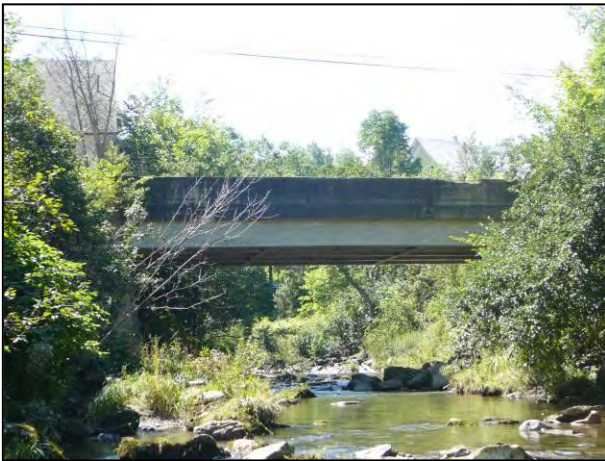
There is one undersized bridge serving as both a channel and floodprone constriction. The bridge is associated with the Hazen Notch Road crossing and is only wide enough to support 92 percent of the bankfull flow event. Deposition was observed above and scour above and below the structure.

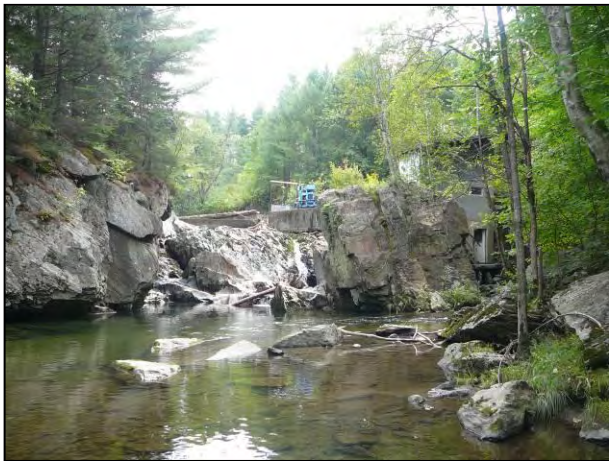
Figure 45. Large run-of-river dam

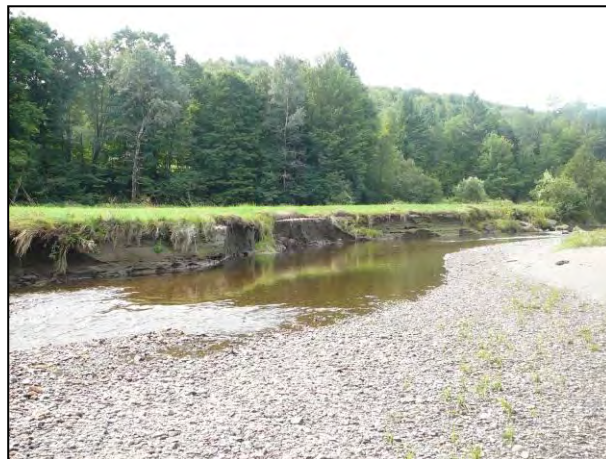
Figure 46. Bank erosion and poor buffer conditions

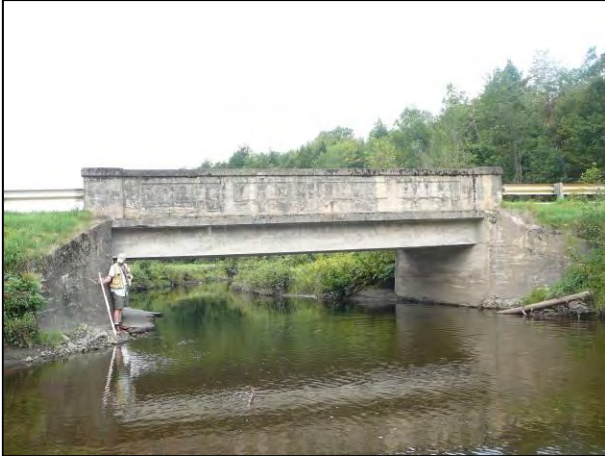
There is an undersized bridge acting as both a channel and floodprone constriction. The bridge is associated with the Hazen Notch Road crossing and is wide enough to support only 55 percent of the bankfull flow event. Deposition was observed above, and scour above and below the structure.

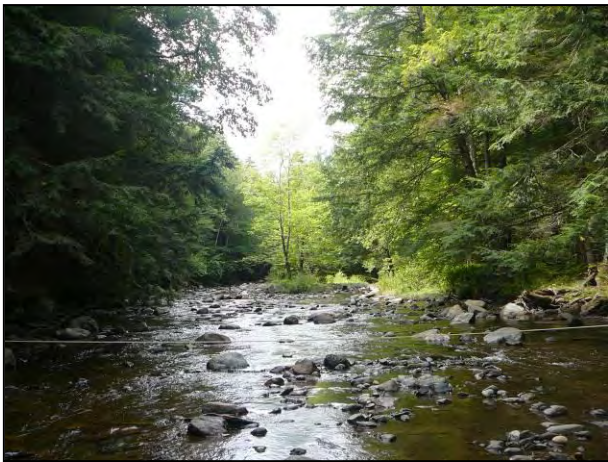
Figure 48. Channel at cross section

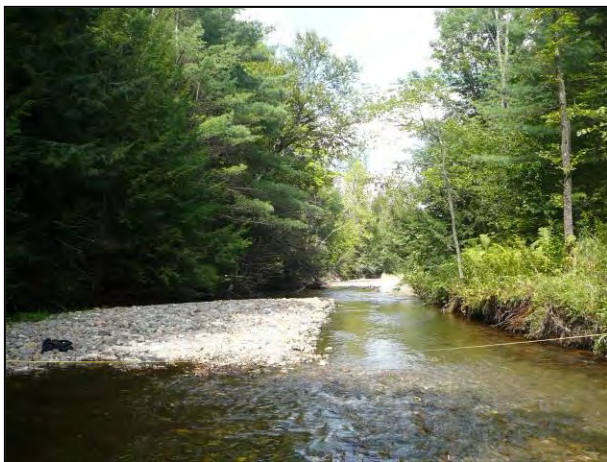
Figure 49. Channel at cross section

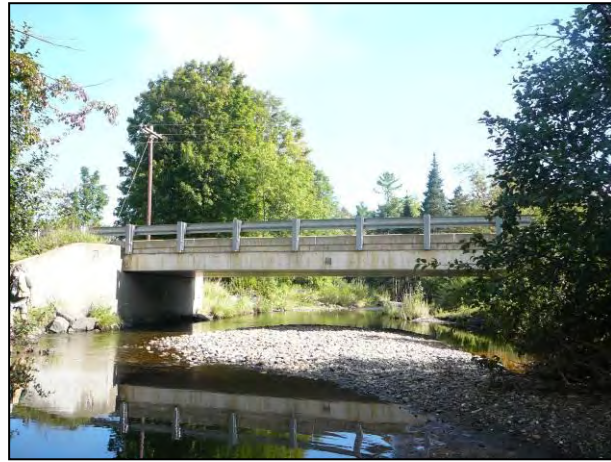
Figure 50. Undersized Lower Village Road bridge

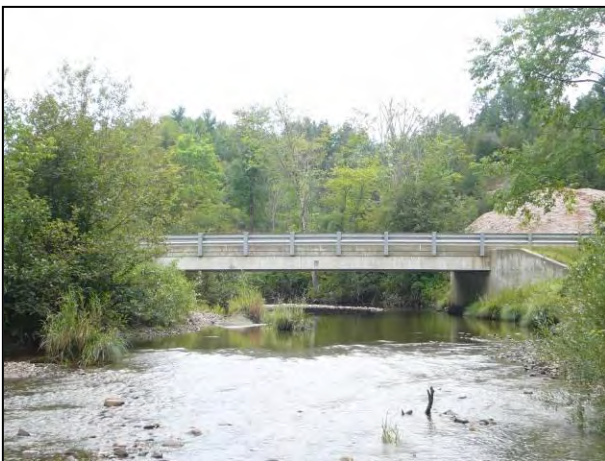
Figure 53. Undersized Route 100 bridge

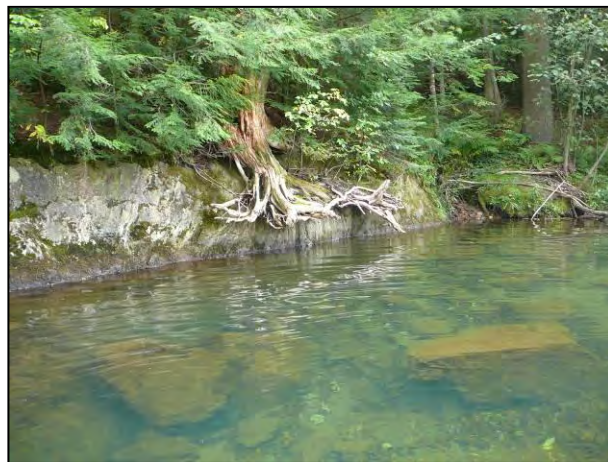
Figure 54. Nice deep pool

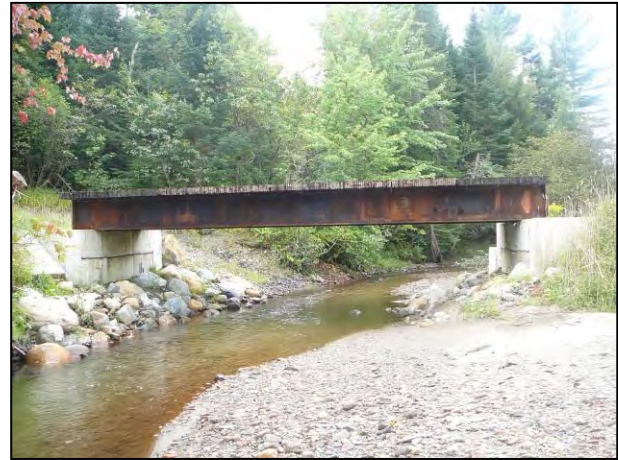
Figure 55. Undersized farm bridge

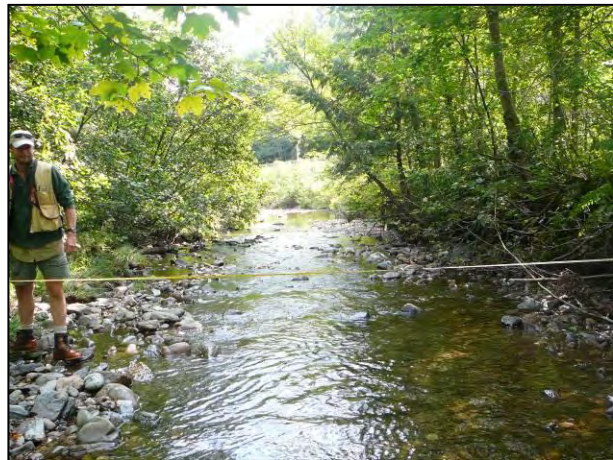
Figure 56. Channel at cross section

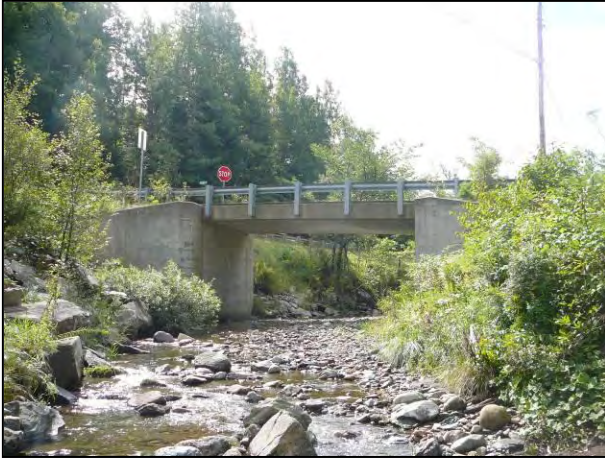
Figure 57. Undersized Rickaby Road bridge

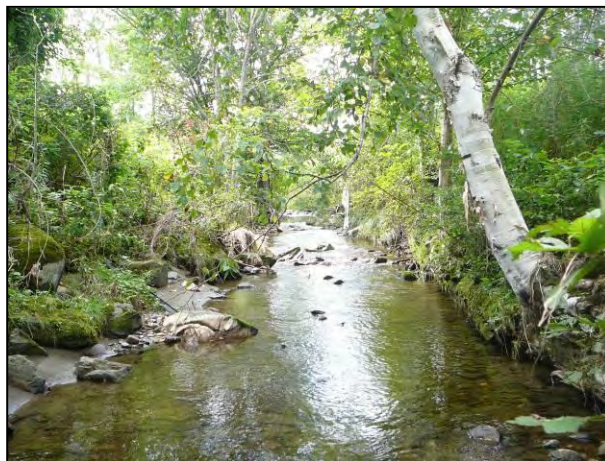
Figure 58. Historically straightened section of channel

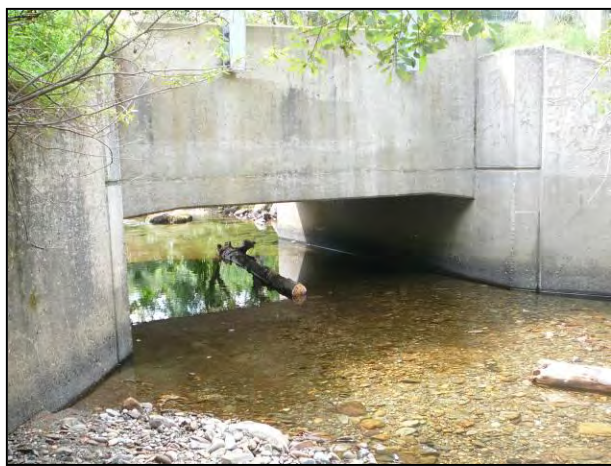
Figure 59. Undersized Private Bridge on Pierce Road

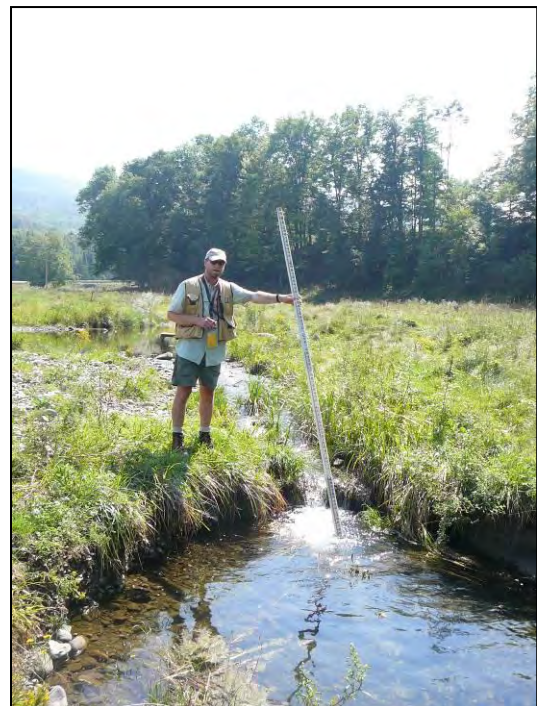
Figure 60. Excavated channel Resulting in a Headcut

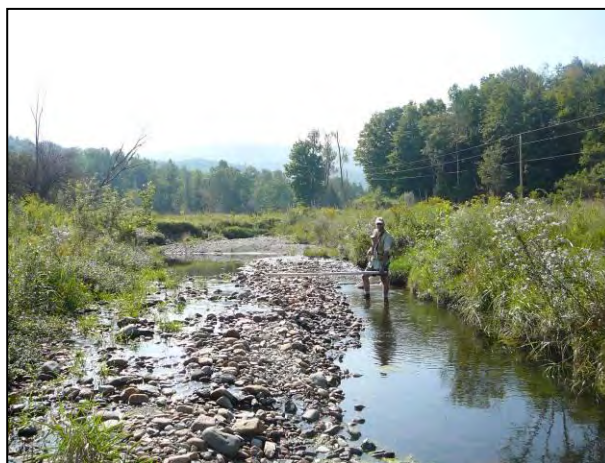
Figure 61. Channel at cross section

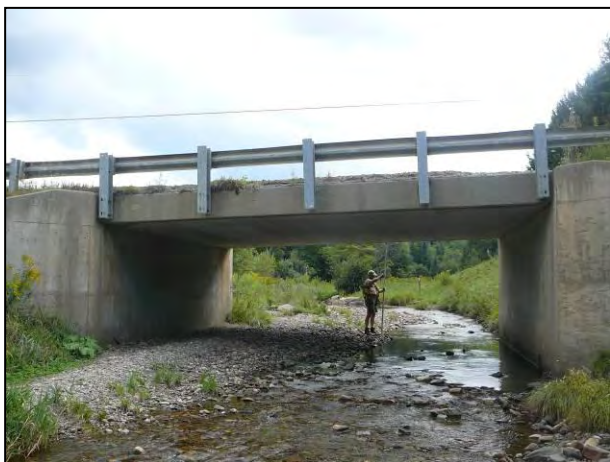
Figure 62. Undersized Cheney Road Bridge

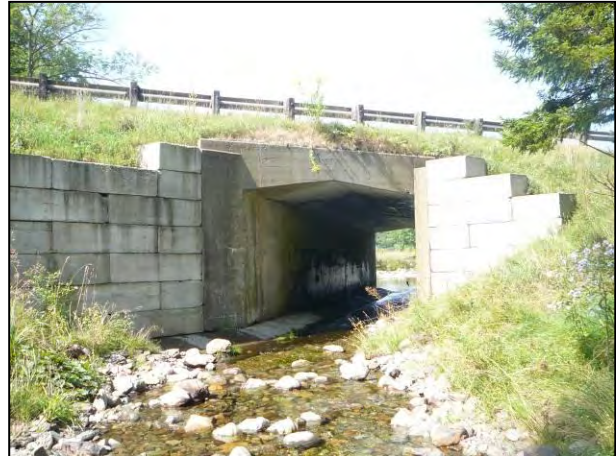
Figure 63. Undersized Rte 100 Box Culvert

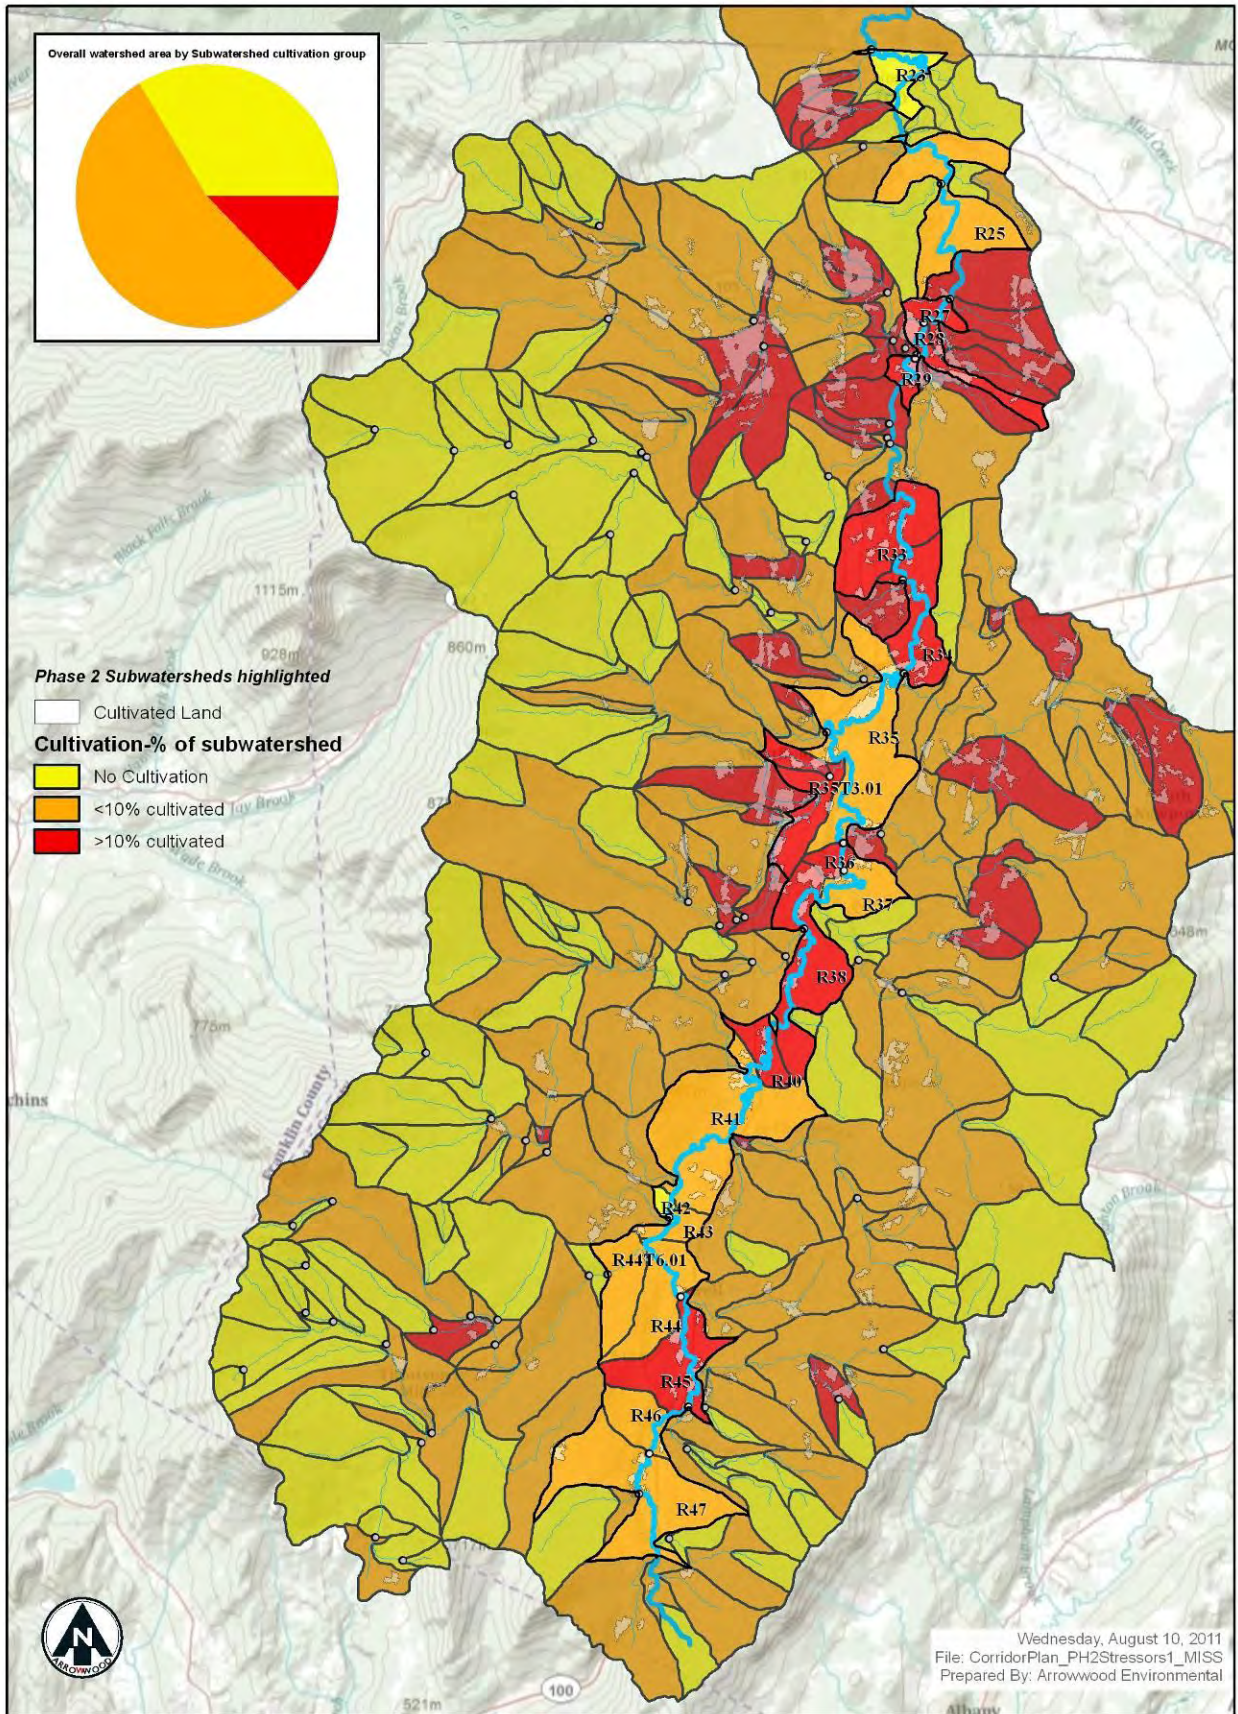
Figure 63. Cultivated Lands within the Upper Missisquoi River Watershed

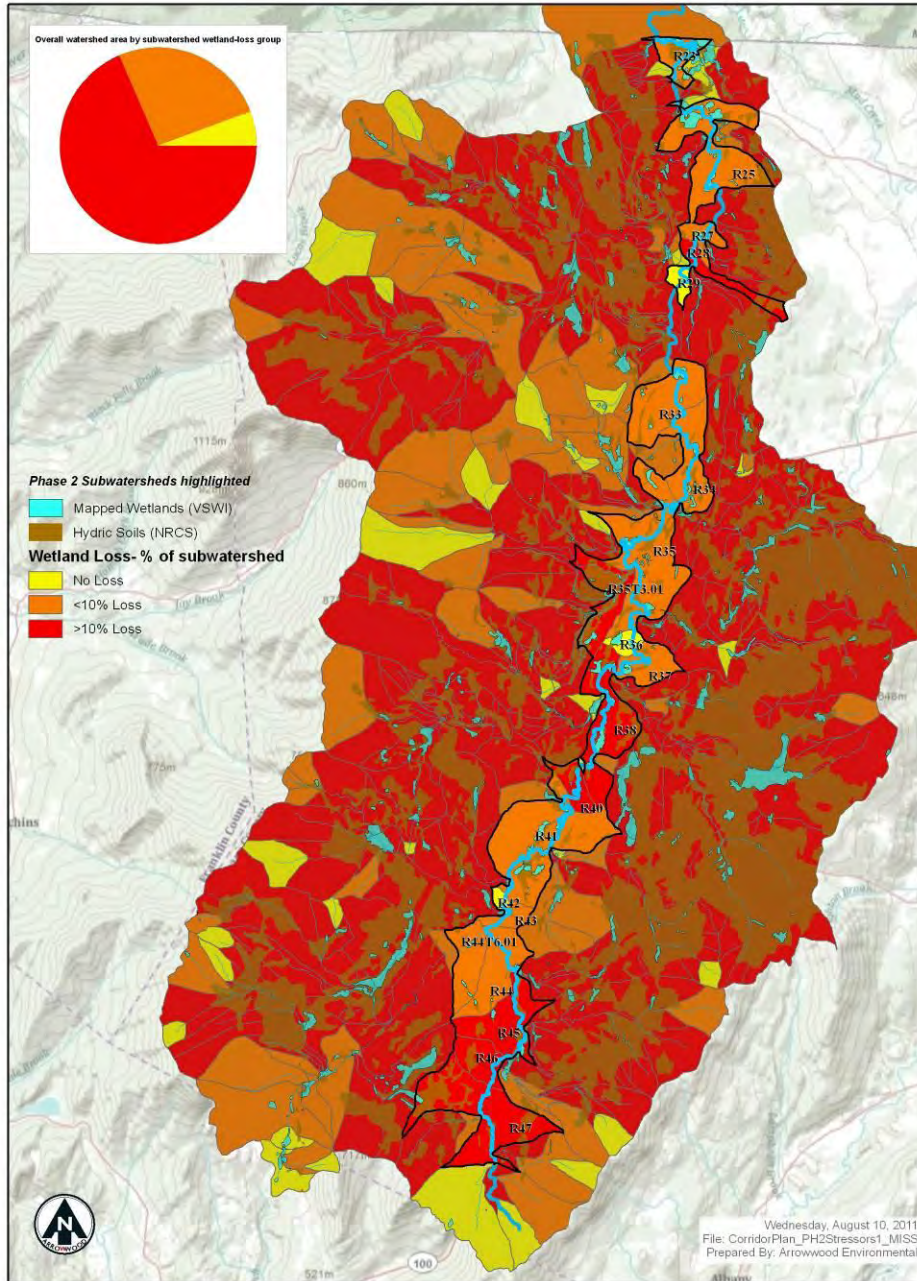
Analysis of hydric soils and existing agricultural and developed land uses indicates significant loss of wetland attenuation of precipitation inputs in the study watershed. Wetlands have been filled, ditched, diverted and otherwise manipulated resulting in a loss of hydrologic function.

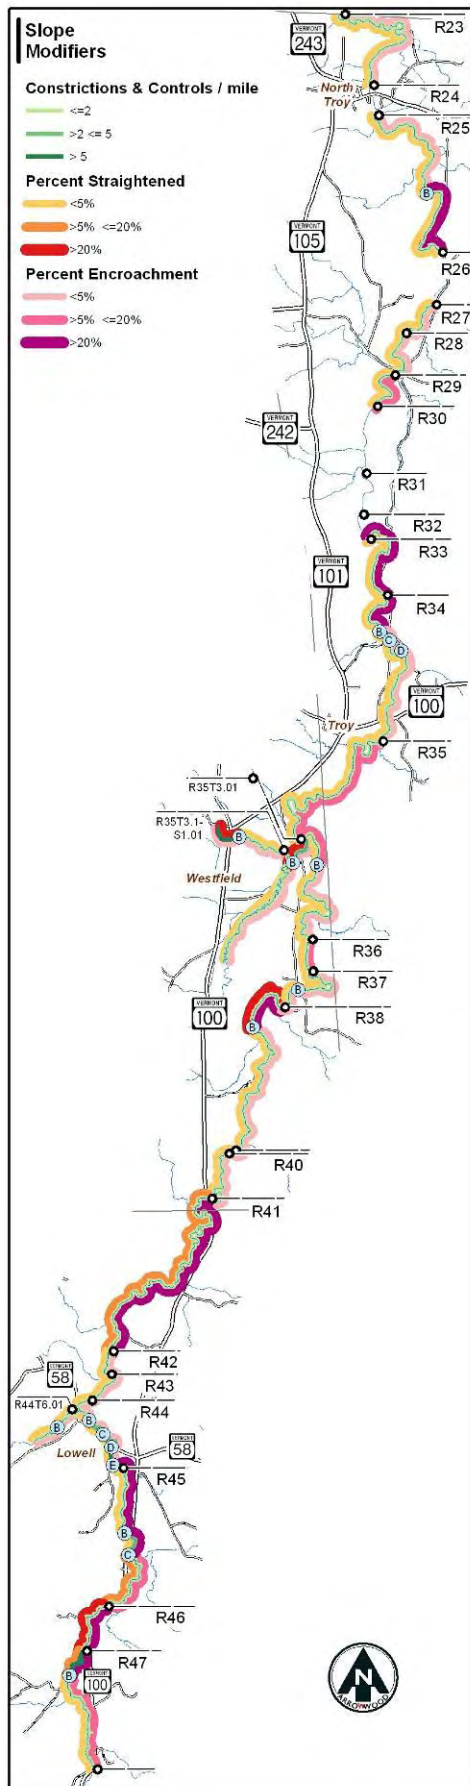
per mile on several of the study reaches is a combination of deposits and channel bifurcations, indicating that the sediment carrying capacity of the channel has been exceeded. The presence of the deposits and channel bifurcations do not explain the source of the sediment. The Sediment Load Stressors Map (above) presents both the deposition features and erosion ratings, as well as locations of mass failures to better complete the picture. The map shows that upstream and in reach sections with high erosion ratings and presence of mass failures are likely sources for high depositional zones. This pattern commences at the most upstream study reach R47 and continues for the majority of the main stem. The study tributaries evidence the same pattern of high deposition likely sourced by high levels of bank erosion upstream and/or within the same segment.

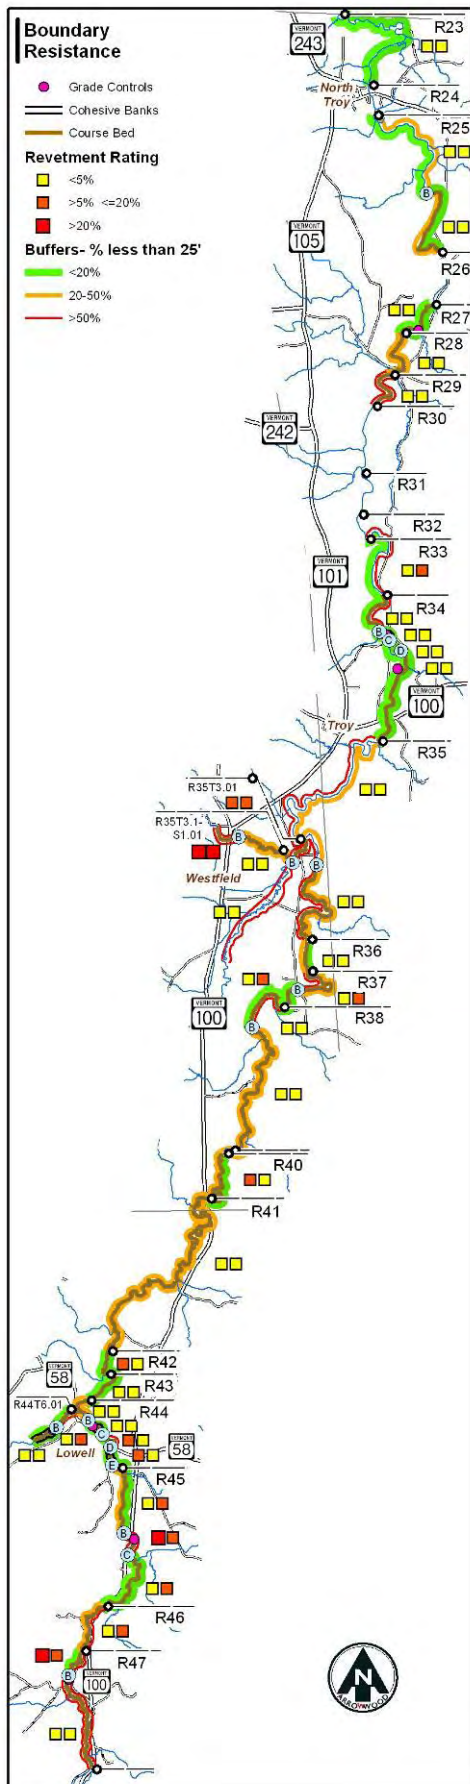
have gone through a similar evolution, including R47A and R46, currently in a relatively stable condition. Reaches R33 and R45B have not completed the process of channel evolution and are still in the process of developing a new floodplain. Reaches R25B, R34A, and R45A have not been stressed to a point of starting channel evolution, but again, their high levels of sensitivity may result in rapid changes with any increased stress.

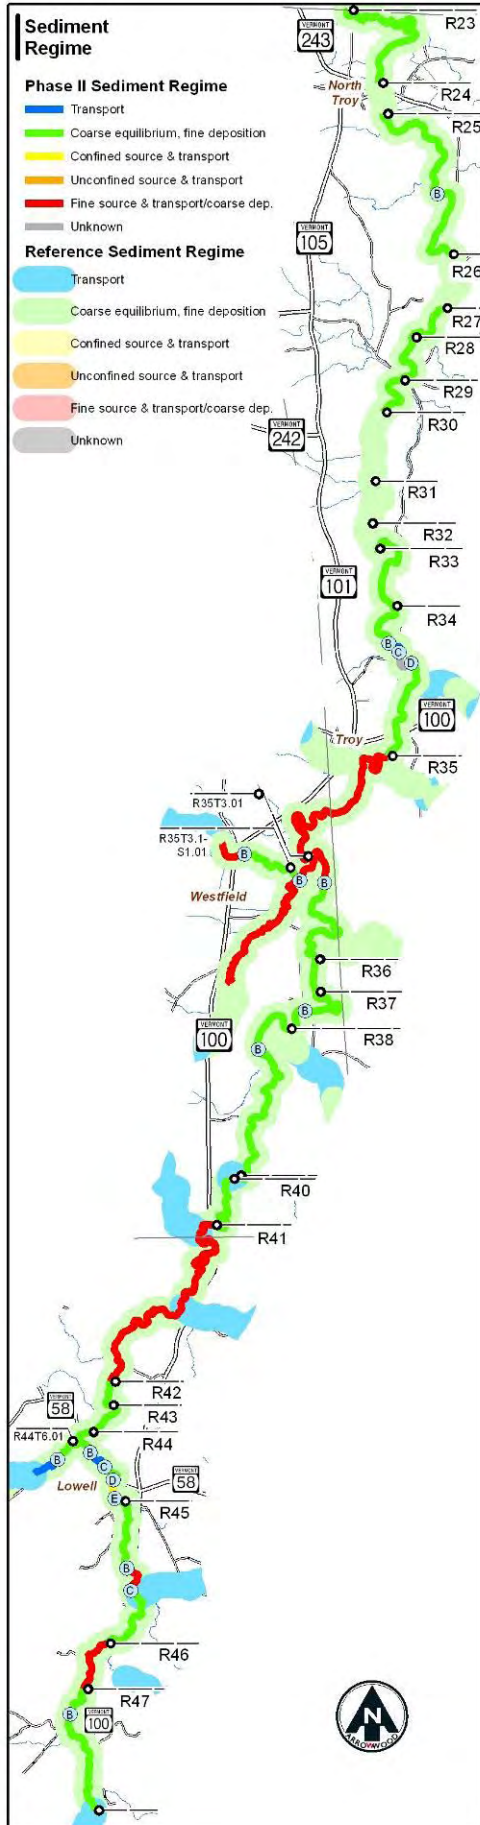
Sediment and nutrient attenuation is occurring in many of the study reaches (26 of the 37 assessed segments) because the channel has retained much of its floodplain access. It is critical to prevent the destabilization of the existing sediment regime in these segments so that sediments and nutrients continue to be retained in the watershed, and not carried downstream to Lake Champlain.

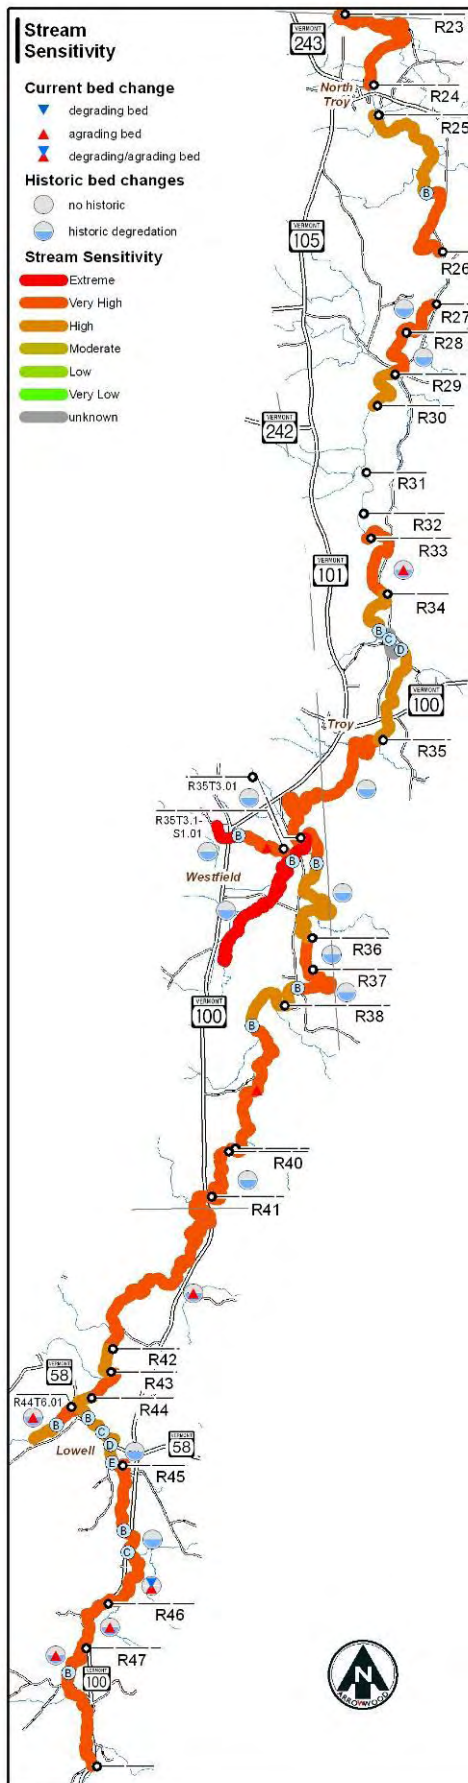
Figure 69. Stream Sensitivity Map
