Upper Missisquoi River Corridor Plan Missisquoi River Watershed Orleans County, Vermont

September 30, 2011

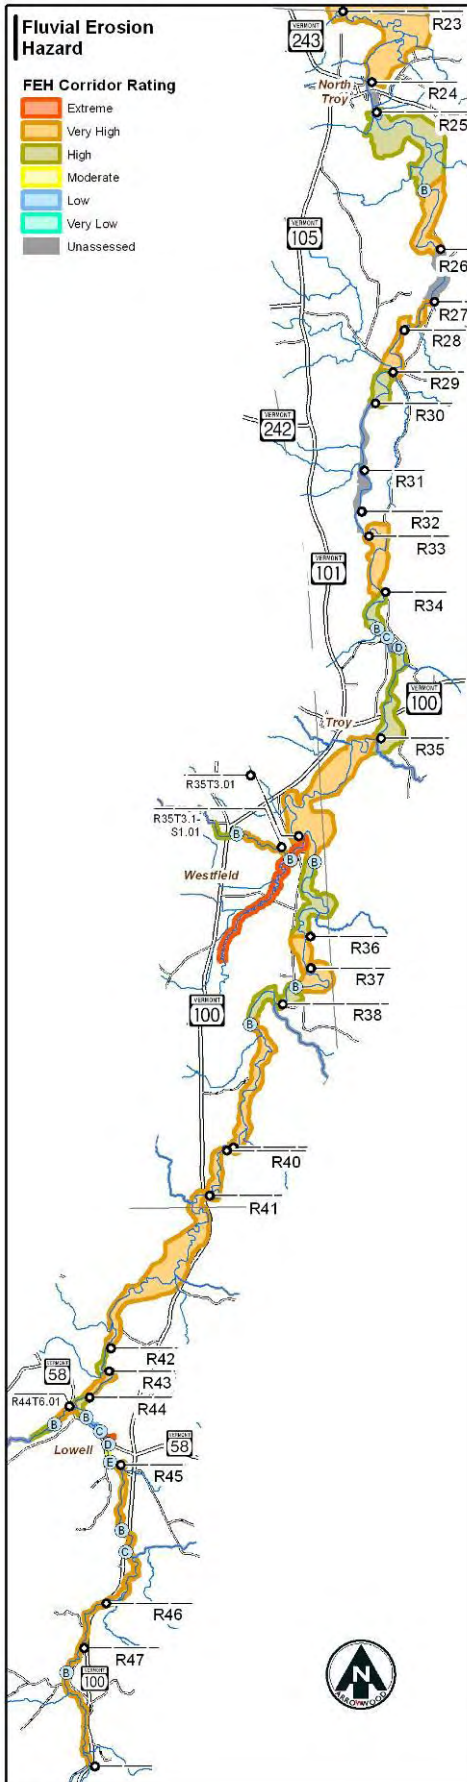
new construction in Special Flood Hazard Areas (SFHA). The SFHAs and other risk premium zones that affect participating communities are depicted on Flood Insurance Rate Maps. The Mitigation Division within the Federal Emergency Management Agency manages the NFIP, and oversees the floodplain management and mapping components of the Program (<http://www.fema.gov/business/nfip/>).
