# Centerville Brook Corridor Plan

Hyde Park, Vermont

February 10, 2010

# Centerville Brook Corridor Plan Hyde Park, Vermont

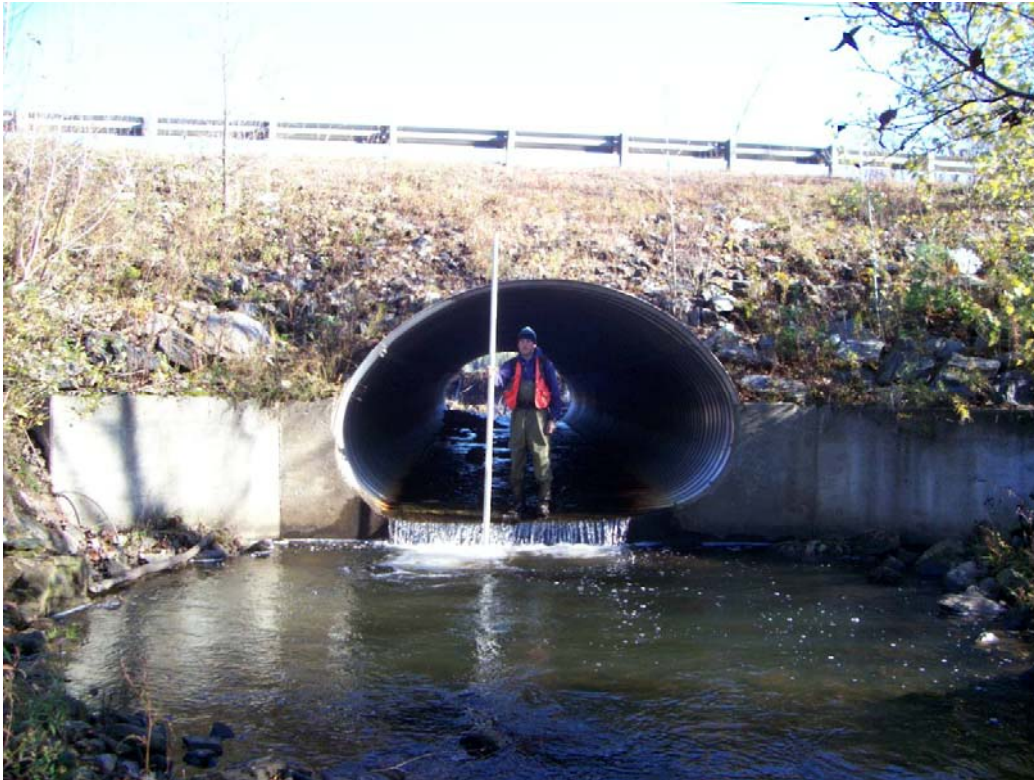
None of the culverts had sediment throughout the structure and were flagged as having reduced aquatic organism passage. The culvert crossing at Centerville Road in reach R1507-B is freefall with an outlet drop of 1 foot (see Figure 10). Using the VT Organism Passage Coarse Screen (Milone and MacBroom 2008) this culvert was flagged as no AOP for all aquatic organisms including adult salmonids. This structure is a high priority for replacement or retrofit.

**Figure 10. Culvert at Centerville Road in reach R15.07-B was flagged as “No Aquatic Organism Passage” using the Vermont Culvert Aquatic Organism Passage Screening Tool (Milone and MacBroom, Inc, 2008)**

R1505-D	Frost Road, Hyde Park	Bridge	Sharp bend	56% <sup>2</sup>	NA	Partially compatible	Moderate to high
R1507-B	Centerville Road, Hyde Park	Culvert	Free fall	57% <sup>3</sup>	No AOP <sup>6</sup>	Mostly compatible	High

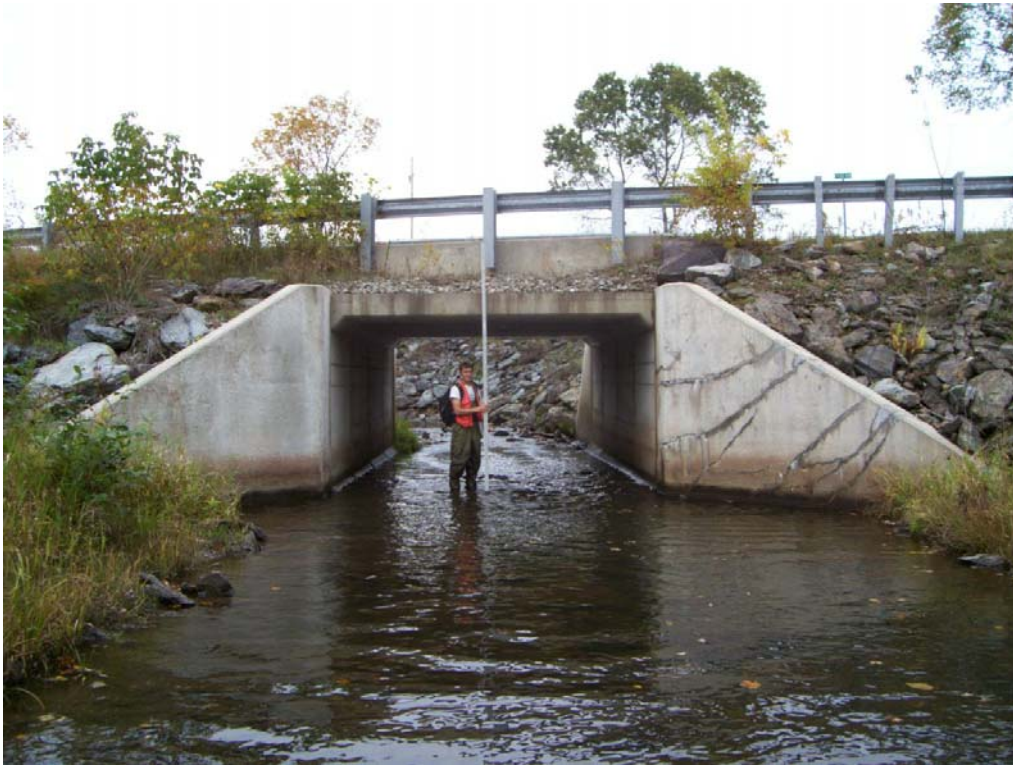
Seven of the eight structures in Table 5 were found to be fully or mostly compatible using the geomorphic screening tool. The bridge on Frost Road in Hyde Park (Figure 11) was found to be partially compatible using the Vermont Geomorphic Screening Tool (Milone & MacBroom, Inc., 2008). This structure is rated as moderate to high priority for replacement due to the sharp bend and scour above and below the structure. The alignment of this crossing should be reconsidered if the structure is replaced at some point in the future.

**Figure 11. Bridge crossing at Frost Road within segment R15.05D. Centerville Brook approaches this structure at a sharp bend.**

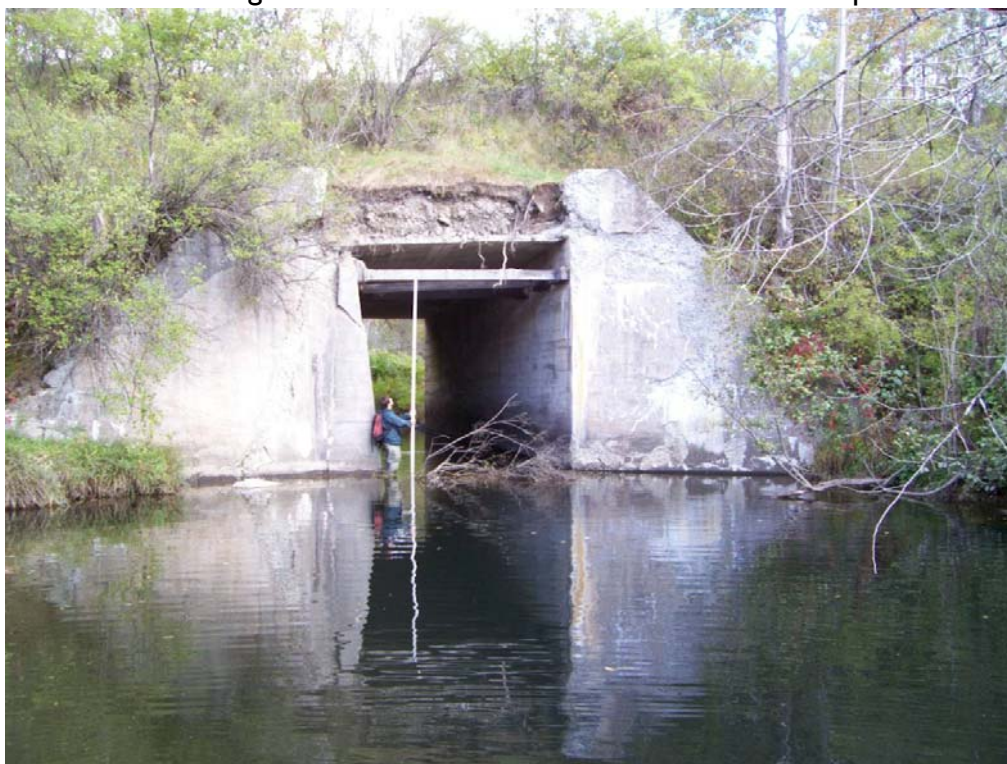
The bridge in reach R15.02, which crosses the Rail to Trail network, is undersized relative to the bankfull width and was noted to cause localized geomorphic instability due to sediment transport and alignment. As shown in Figure 12, the bank above the outlet of this structure is eroding. It is recommended that this structure be replaced.

**Figure 12. Rail to trail crossing in reach R15.02 has bank erosion above the outlet. This structure is undersized relative to the bankfull channel width and is recommended for replacement.**

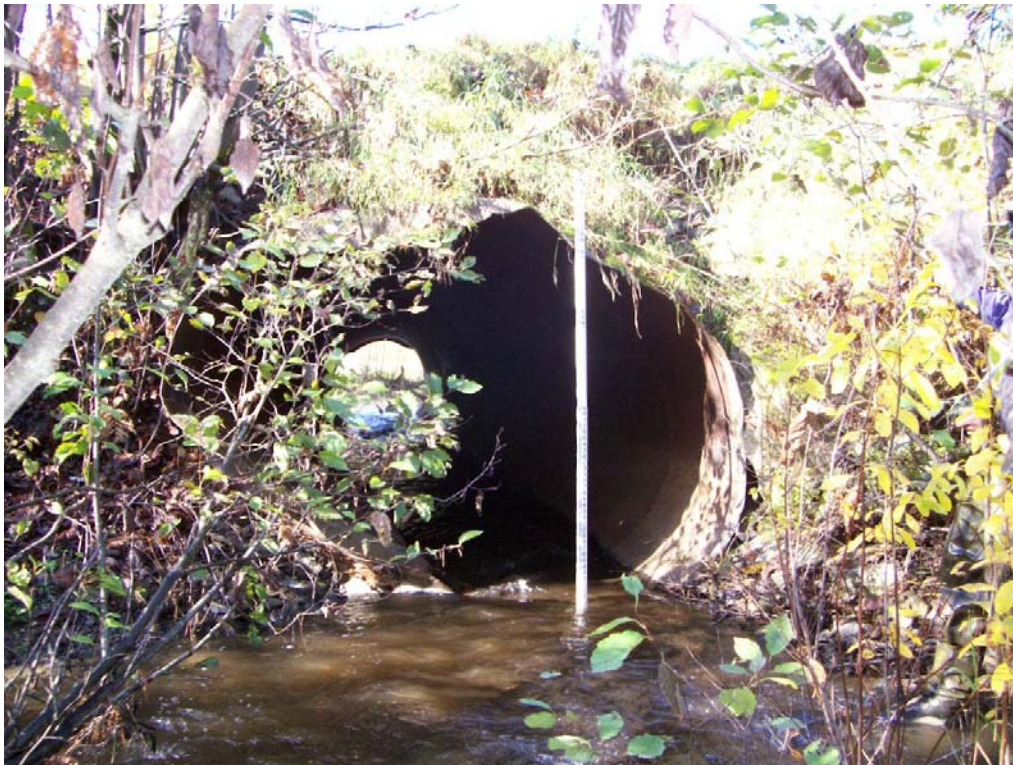
The farm crossing in reach R1506-A is also undersized, but is rated low priority for replacement at this time. The structure is located in a wetland and floodwaters have access to the floodplain. The culvert crossing at Brook Road (Figure 13) is undersized and was given a moderate to high priority to replacement due to sediment transport problems; reduced AOP and the poor condition of the culvert.

**Figure 13. Brook Road culvert crossing in reach R15.07-A is undersized and impeding sediment transport. The culvert is in poor condition and has the potential to reduce AOP.**

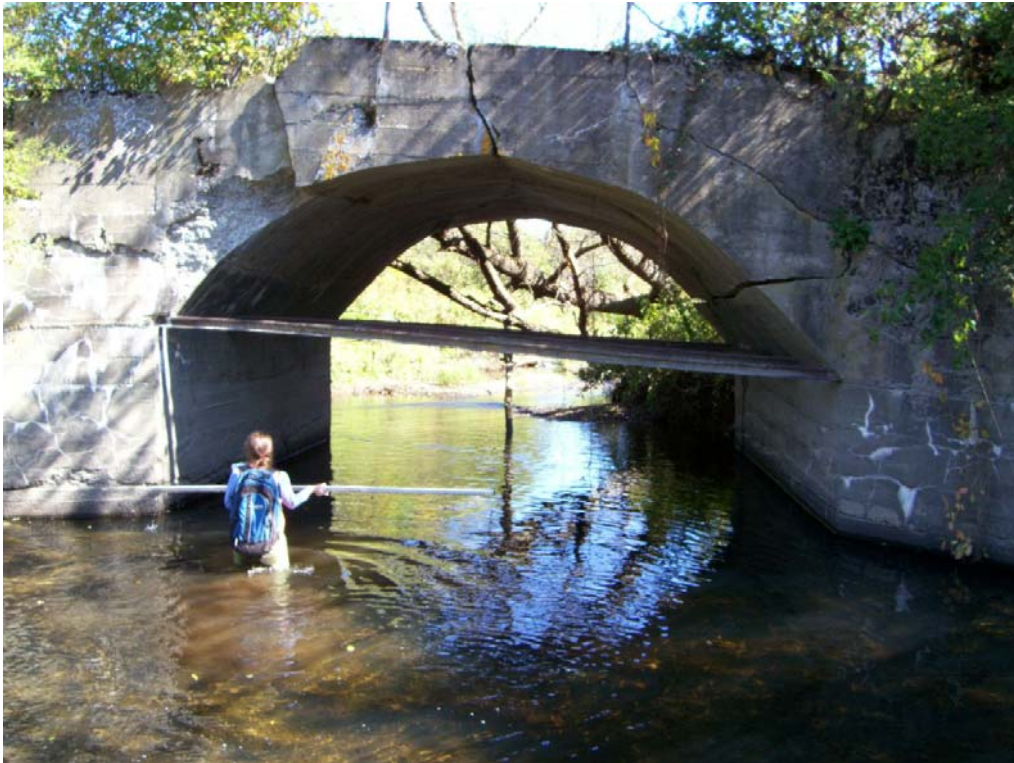
The farm bridge in reach R1501-A does not have a span which is less than 50% of the bankfull width, but was nonetheless rated as moderate to high priority for replacement. This span of this structure is 50% of the bankfull width and was noted to be causing sediment transport problems (deposition above, deposition below, score above, scour below) and was poorly aligned. The structure is in poor condition as shown in Figure 14.

**Figure 14. Farm bridge in reach R15.01-A that is structurally unsound and is causing localized geomorphic instability.**

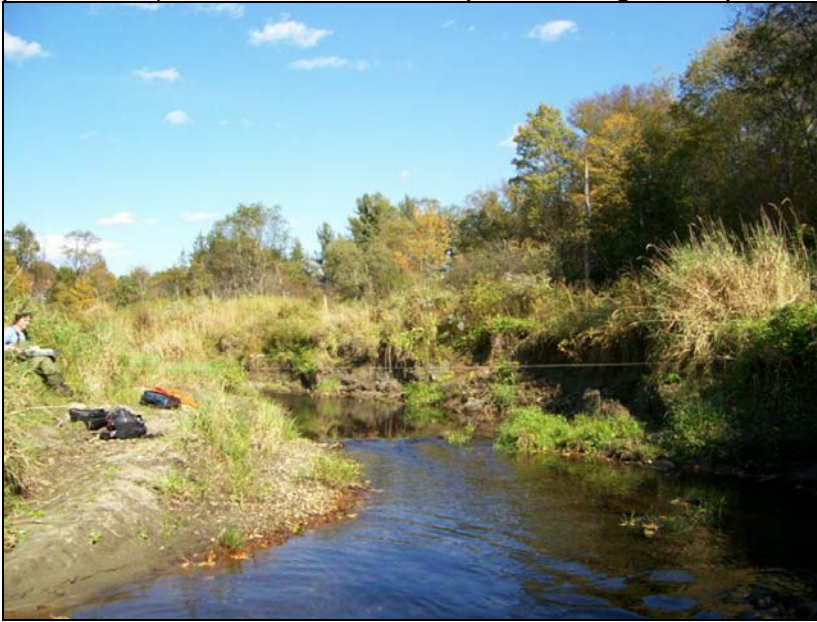
reach. The reference stream type is an “E” channel; however, due to major adjustment the channel is a “C” riffle-pool bedform undergoing major widening and extreme planform adjustment as a new floodplain is being developed.

**Centerville Brook segment R15.01-A is an “E” type channel that has undergone a stream type departure and major existing channel adjustment.**

##### **Passive Restoration: Corridor Easement and Improve Riparian Buffer Replace undersized farm bridge**

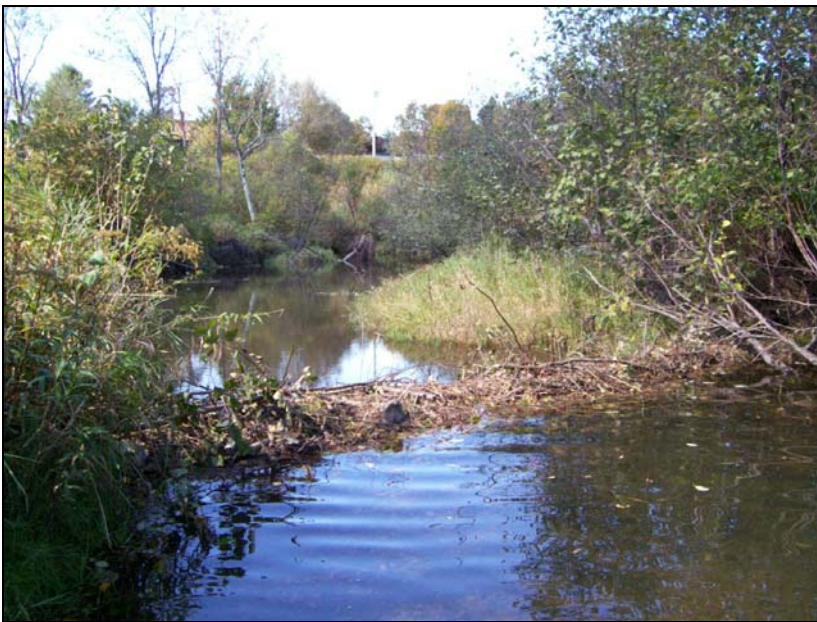
Centerville Brook segment R15.01-B flows through abandoned agricultural lands east of Hyde Park village. The stream in this reach has been impounded by several beaver dams. A complete geomorphic assessment was not conducted in this segment due to the influence of these dams.

**Centerville Brook R15.01-B has been dammed by beavers in numerous locations.**

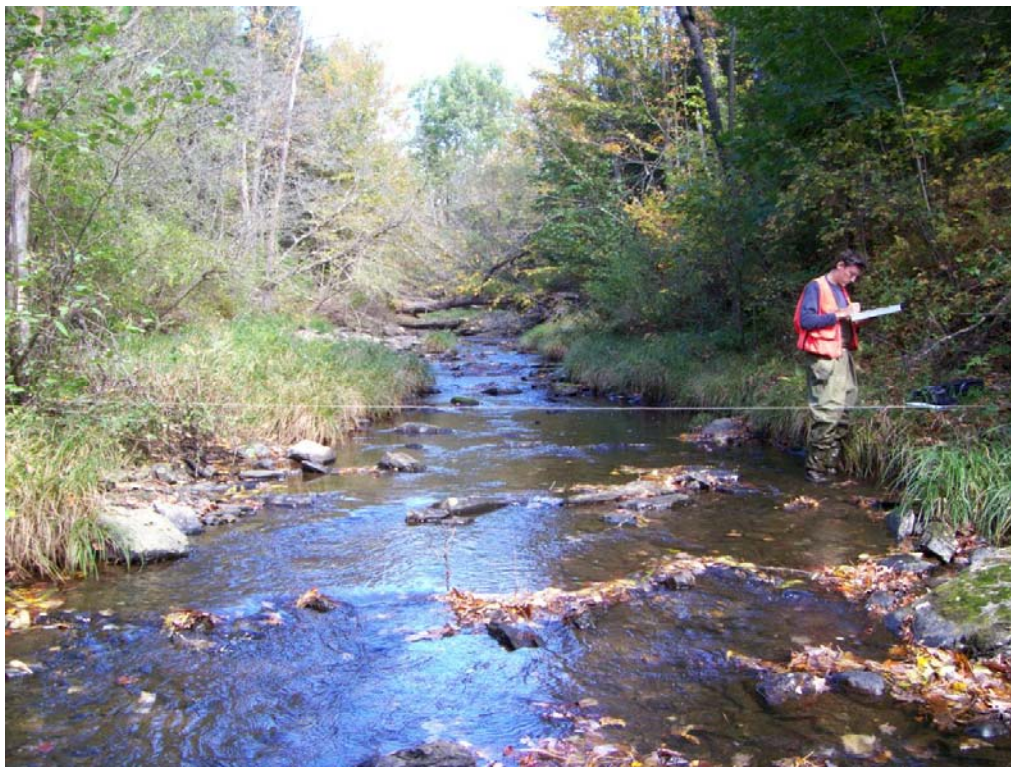
Centerville Brook reach R15.02 begins at the Main Street culvert and flows downstream for several hundred feet to the crossing of the old railway. The stream in this segment has some bedrock grade control. The lower two-thirds of the reach has enough floodplain access to make it a “C” type riffle-pool channel. The railroad crossing at the lower end of the stream reach is particularly narrow. The bridge on the rail to trail path is undersized and creating localized geomorphic instability.

**Centerville R15.02 is a “C” type channel.**

#### **Replace undersized bridge**

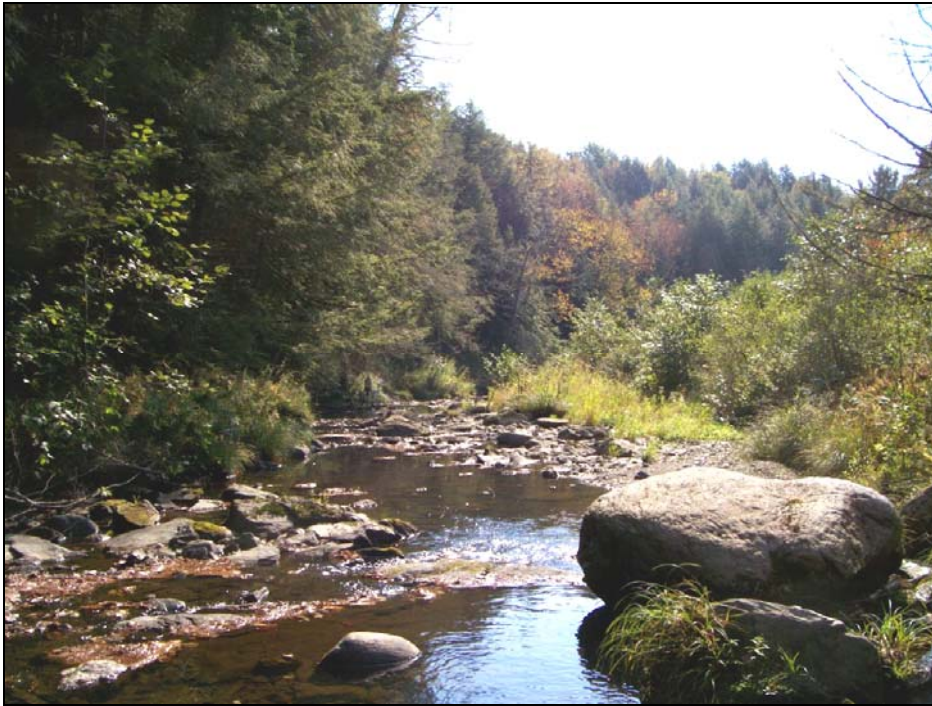
Centerville Brook segment R15.04-B is located in between two bedrock dominated segments. The valley walls in this segment broaden allowing for the deposition of sediments and a more active stream channel. Evidence of beaver damming was found near the downstream end. This damming in addition to the natural bedrock constriction found at the downstream end may account for some of the extensive sediment storage, incision, and planform adjustment that was observed in this reach. The stream is a “C” channel with a riffle-pool bedform through this segment.

**Centerville Brook segment R15.04-B appears to have historically incised.**

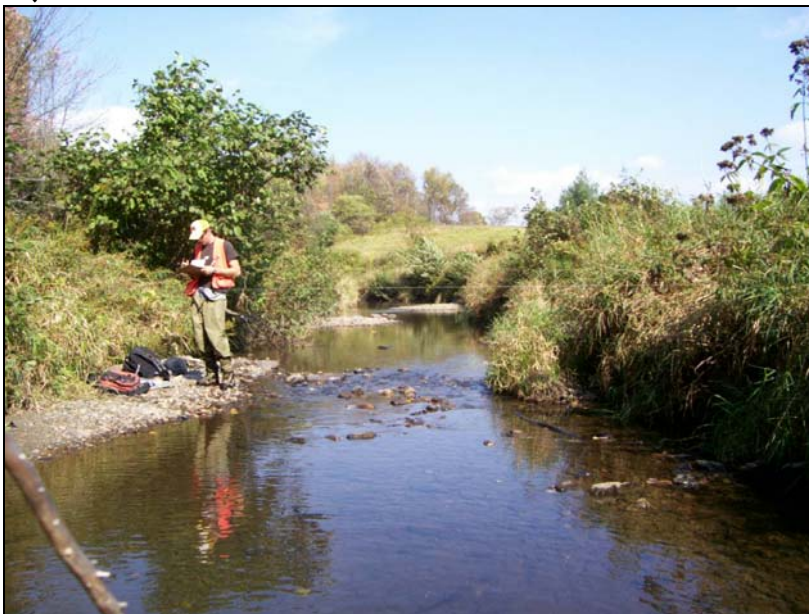
Centerville Brook R15.04-D is a short segment (850 ft.) which flows between two sections of bedrock gorge. The valley in this segment widens considerably and the streambed turns into an “E” stream type with a gravel riffle-pool bedform. The stream through this section appears to have been historically straightened and the buffer on the west bank seems to have been greatly altered. In response to these alterations, the channel was found to be undergoing minor aggradation, widening and planform adjustments.

**Centerville Brook segment R15.04-D is an “E” channel that has been historically straightened.**

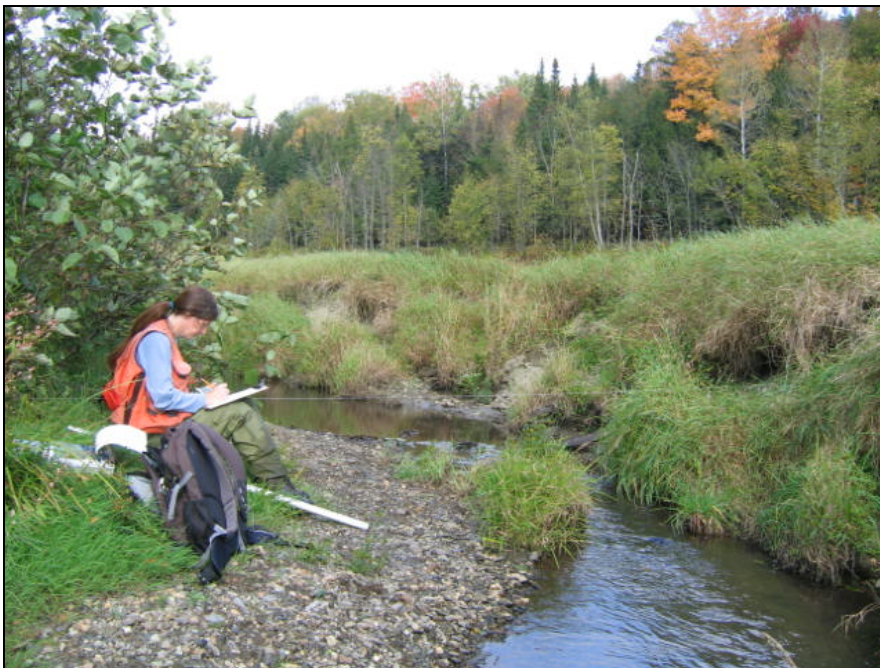
Segment R15.06-B begins just below the confluence with tributary R15T.07. The land use on both banks is pasture for a dairy operation. Brook Road borders the stream on the east bank.

**R15.06-B is a C channel that is widening and adjusting planform.**

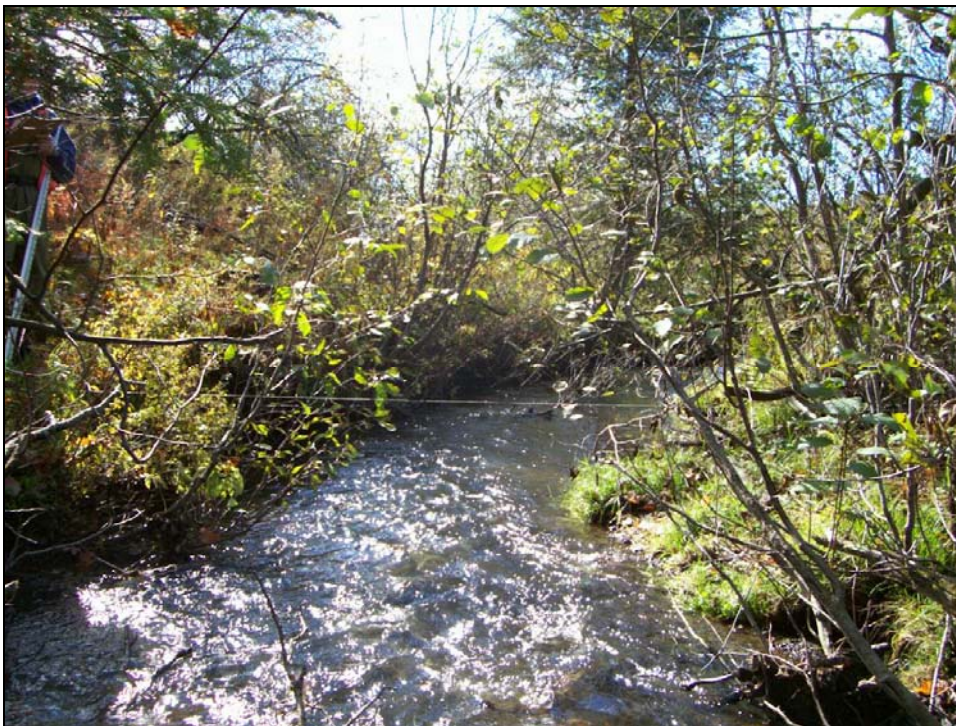
Centerville Brook segment R15.07-A is drastically different from its upstream segment. The segment begins at a small waterfall where the valley walls broaden and the slope of the channel decreases. This upper most area was historically an alder swamp until a landslide during the summer of 2006 occurred. Following the slide the material was allowed to be graded out at the site and the stream was locked into place with stone rip-rap for one hundred feet. There was excessive erosion, an active headcut, and very soft sediments in this upper portion of the reach. These sediments were found to be transporting downstream to a culvert under Brook Road. On the other side of the culvert the land use changes to pasture, however, the stream remains an “E” type channel with alder lining the banks except where cows have trampled the banks and vegetation for access to the stream. With the exception of the uppermost area where a small headcut is active, the channel does not appear to have incised recently, however there is evidence of minor widening, aggradation, and planform adjustment in response to changes in boundary conditions, heavy pasturing in the floodplain, a culvert, and the mass failure.

**R15.07-A is an “E” channel with alder vegetation and active pasture on both banks.**

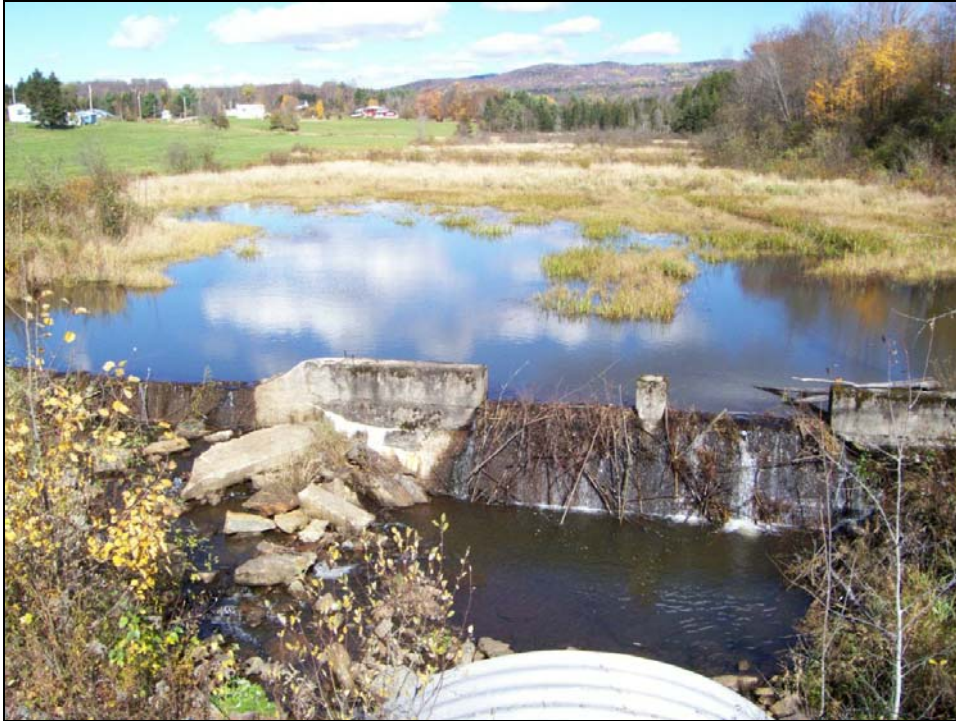
Centerville Brook reach R15.08 begins at a human-made dam just upstream from the crossing of Centerville Road. This dam, along with several beaver dams, creates a series of wetlands through most of this reach. Due to the impoundments a complete geomorphic assessment of the reach was not possible; however, field scientists walked the majority of the reach in order to evaluate some of the Phase 2 parameters. The dominant impact to this reach is the lack of a wide riparian buffer or filter strip along an active cow pasture.

**Reach R15.08 is a wetland system due to a human-made dam and several beaver dams.**

#15 Upstream of Centerville Road Crossing R1508	Active Restoration	Wetland channel due to concrete dam, which is 7.5 feet high.	Alternatives analysis for dam removal	High priority for dam removal	Restore aquatic organism passage and riverine habitat.	Very high construction and permitting costs for structure removal and channel restoration	Wetland to riverine habitat	ANR, LCPC, landowners
