Rodman Brook Corridor Plan

Morristown and Hyde Park, Vermont

March 22, 2011

Rodman Brook Corridor Plan
Morrystown and Hyde Park, Vermont

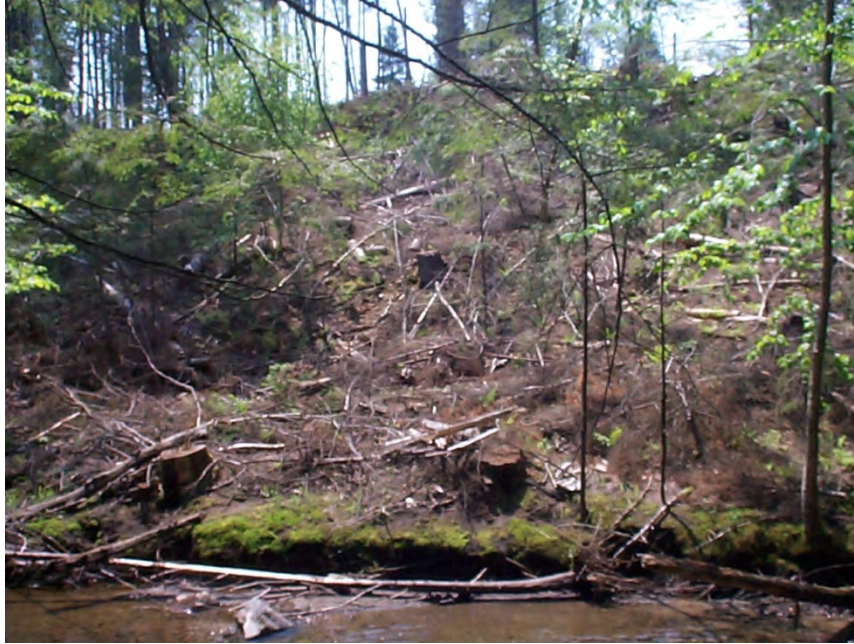
Figure 3. Trees cleared on river bank

As part of this assessment, land use, encroachments, and buffer condition were analyzed within 150 feet on each side of the river. The headwaters of the stream are located in land with sparse residential development adjacent to the steep McKinstrey Hill Road. There is a section that has been dammed by beavers at the upstream end of the stream. There are a few significant bedrock grade controlled sections of the river which will help maintain stability in those areas. There was one section along the river corridor where some logging activity has taken place very close to the channel (see Figure 3).

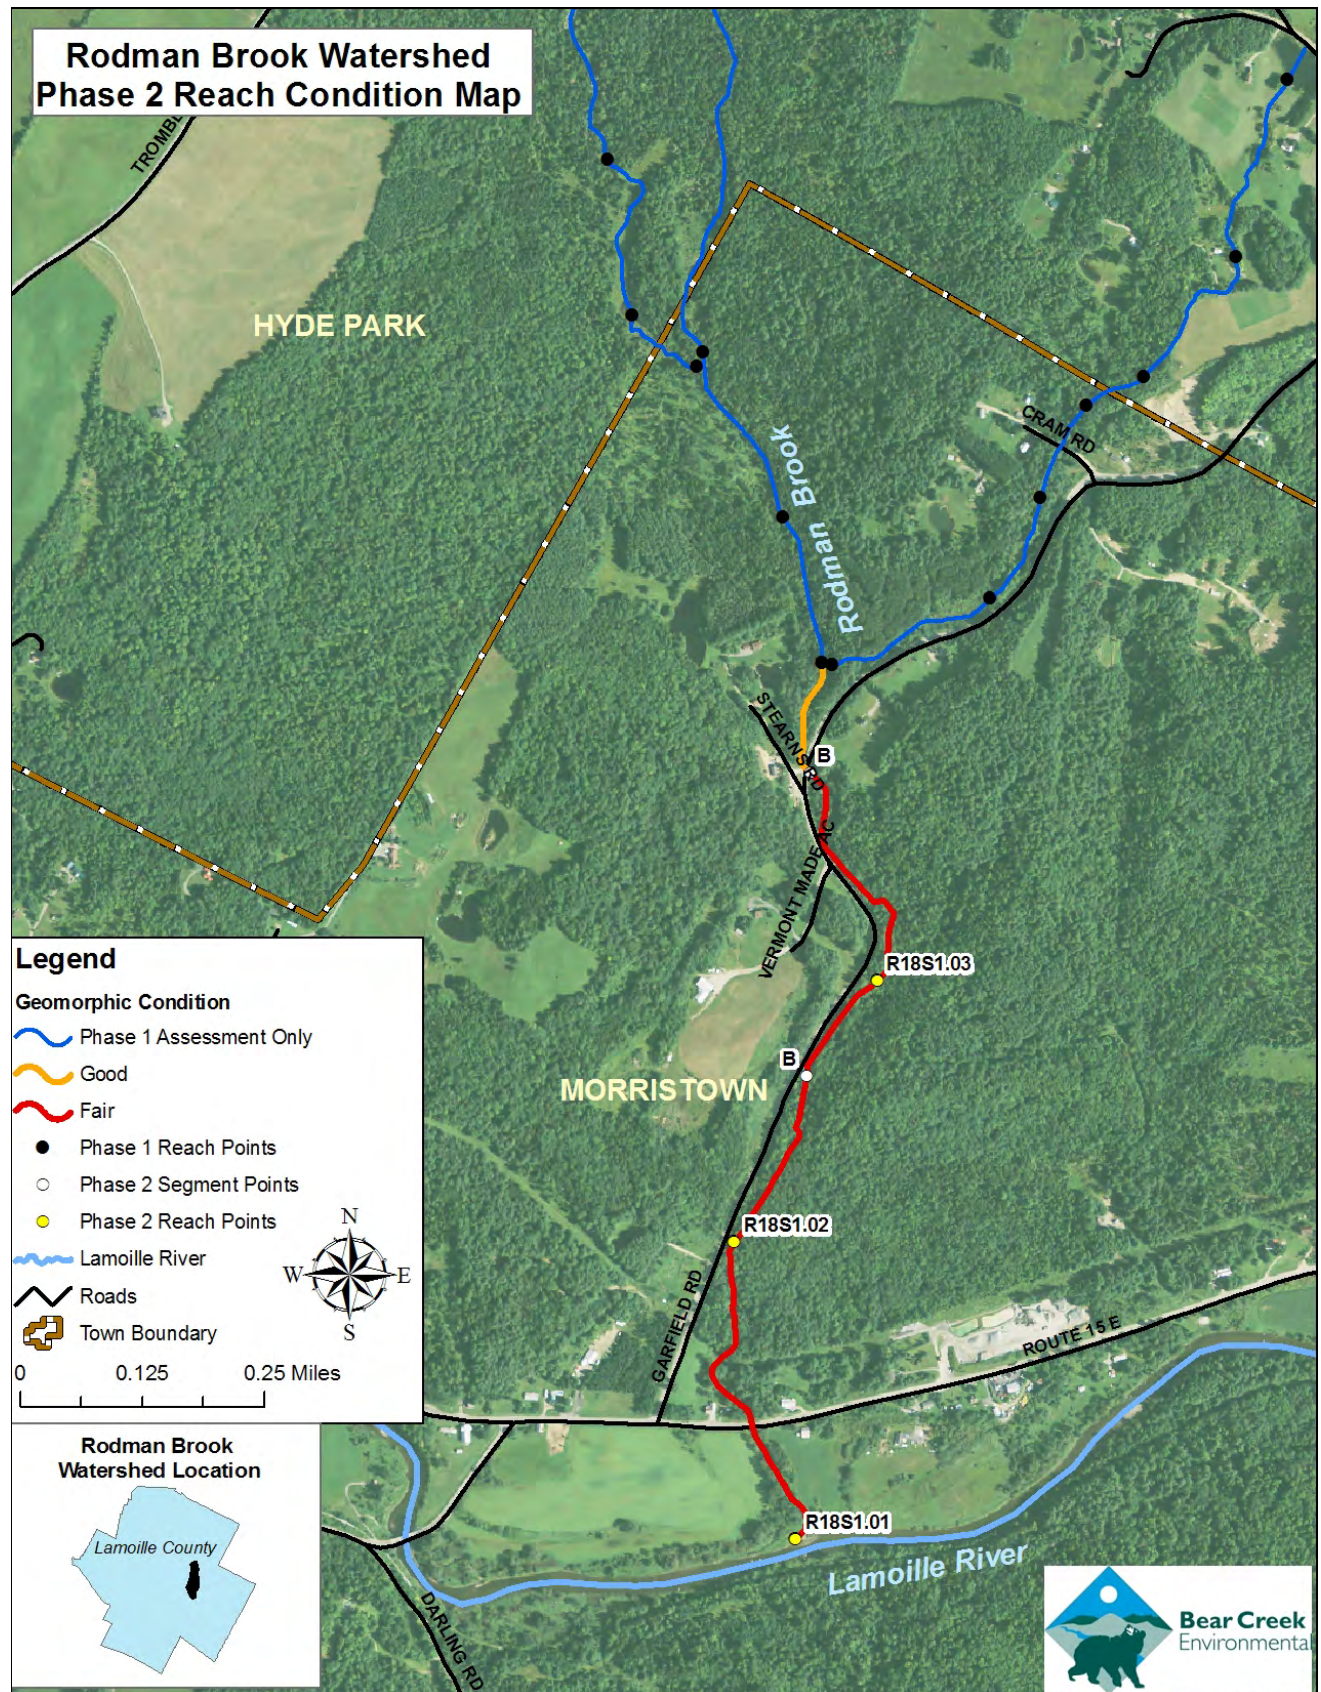
Figure 5. Rodman Brook Phase 2 Geomorphic Condition

The geomorphic condition for each Phase 2 reach is determined using the rapid geomorphic assessment (RGA) protocol, and is based on the degree of departure of the channel from its reference stream type (Vermont Agency of Natural Resources, 2005). As shown in Figure 5, four of the five assessed segments rated in the “fair” category for geomorphic condition. The most upstream segment (R18SI.03-B), which includes the Garfield Road crossing, is in “good” category. Detailed segment summary data are provided in Appendix B.

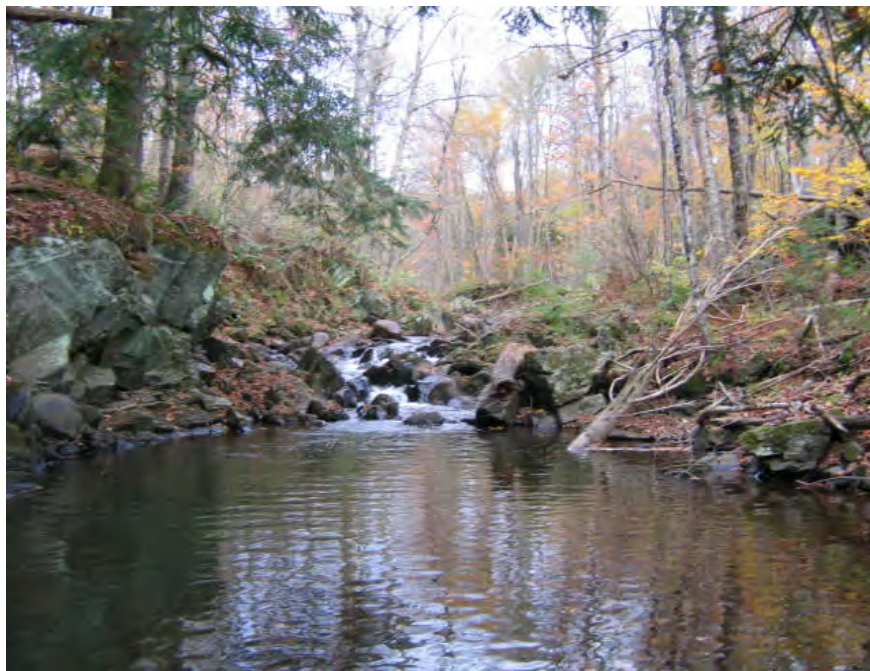
Figure 6. Bedrock grade control near former mill dam

The most downstream reach on Rodman Brook, RI8SI.01, starts at the confluence of the Lamoille River and extends upstream 1,878 feet. The top of the reach is approximately 1,100 feet upstream of the Route 15 crossing. Before Hyde Park was founded, this area adjacent to Rodman Brook and near the confluence with the Lamoille River was a mill town known as the Town of Garfield. Garfield was abandoned in the late 1800s, and berms adjacent to the Rodman Brook upstream of Route 15 are remnant of the old town. Also in the vicinity of the berms are two bedrock grade controls (see Figure 6) and what appears to be the foundation of an old mill.

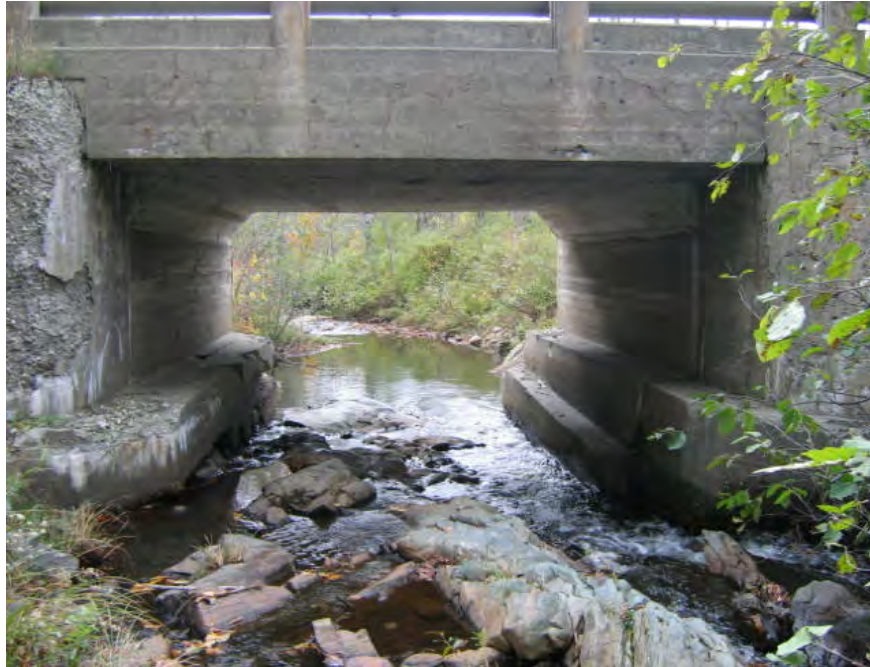
Figure 7. Bedrock grade control at Route 15 Crossing

Downstream of Route 15, Rodman Brook has been straightened with rock riprap. A third bedrock grade control is located at the Route 15 crossing. The span of the bridge is only 13 feet (Figure 7), making this structure a significant channel constriction as compared with the reference channel width of 24.8 feet. Major scour above and below this bridge were noted during the Phase 2 assessment.

R18S1.01	Active Restoration	The Route 15 Bridge is undersized relative to bankfull (span is 13 feet and is 50 percent of bankfull width) There is scour above and below the structure. The bridge sits on bedrock.	Bridge Replacement	Low priority – although the bridge is undersized, the bedrock bed under the bridge adds to geomorphic stability.	Improved geomorphic stability	High cost for replacement	Unknown	Town of Morristown VANR, LCPC

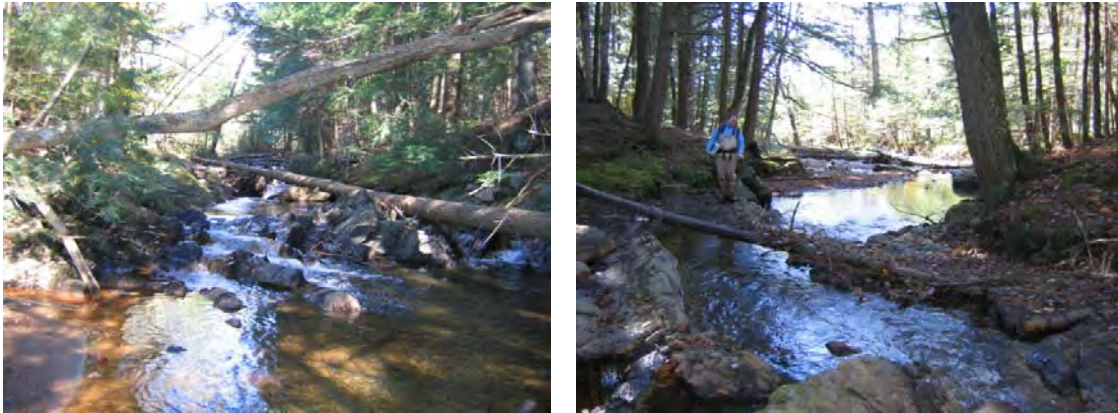
Figure 9. Bedrock grade controls in R18SI.02-A

R18SI.02-A is a “C” cobble dominated segment with a weak riffle-pool bedform in portions of the segment that have been straightened. In general, the stream channel is much more sinuous (i.e. meandering) in this segment than is evident on the Vermont Hydrography stream layer. Two bedrock grade controls are present within segment A (Figure 8).

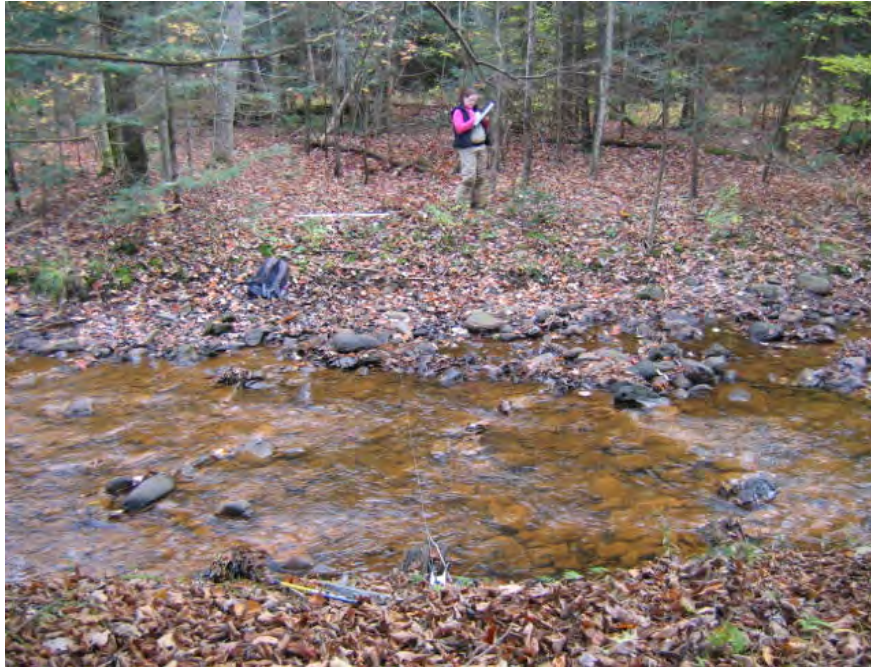
Figure 9. Heavy iron precipitate layer on substrate in R18SI.02-A

As shown in Figure 9, heavy iron precipitate was noted on the substrate. This heavy iron precipitate can result in a decrease in available food and loss of habitat for aquatic insects. Iron precipitate often occurs in areas where soil has been disturbed or iron rich soils used as fill is mobilized to the groundwater. In Vermont, water quality impairments from iron precipitate are common adjacent to road fill, landfills, and areas where structures, such as culverts, have been installed. According to Jim Ryan, Watershed Coordinator, with the Vermont Department of Water Resource, the Lamoille landfill, which has been capped and shut down for decades, is the cause of the water quality impairment. The impacted stretch of Rodman Brook was recommended for the draft State of Vermont 2010 303(d) list of impaired surface waters needing TMDL. (Personal communication with Jim Ryan, January 24, 2011).

<p>R18S1.02-A</p>	Active Restoration	There is an active iron seep at the upstream end of segment R18S1.02-A. Iron precipitate alters the food source for aquatic insects and also reduces available habitat by filling in the interstitial spaces of the substrate.	Remediate iron seep by using limestone to intercept the groundwater.	Moderate priority- The iron seep is not causing a geomorphic issue, but is likely impacting the available food source for aquatic insects in the immediate vicinity of the iron precipitate.	Improved aquatic habitat	Moderate cost for remediation design and construction	Unknown	VANR, LCPC, landowner, LNRCD
<p>#6 Downstream of intersection of Vermont Made AC and Garfield Road, where Rodman Brook is next to Garfield Road</p> <p>R18S1.02-B and R18S1.03-A</p>	Stormwater management	Rodman Brook runs next to Garfield Road and gravel and cobbles from the road base are falling down the bank into the channel. Stormwater from the road is flowing into road side ditches and directly into the brook.	Stabilize road base and treat stormwater prior to entering Rodman Brook. Possibly grade the road so stormwater flows away from brook.	High- The sediment is contributing to substrate embeddedness and is reducing aquatic habitat.	Improved aquatic habitat	Moderate cost for improved stormwater treatment and maintenance	Unknown	Town of Morrilltown, VANR, LCPC, LNRCD

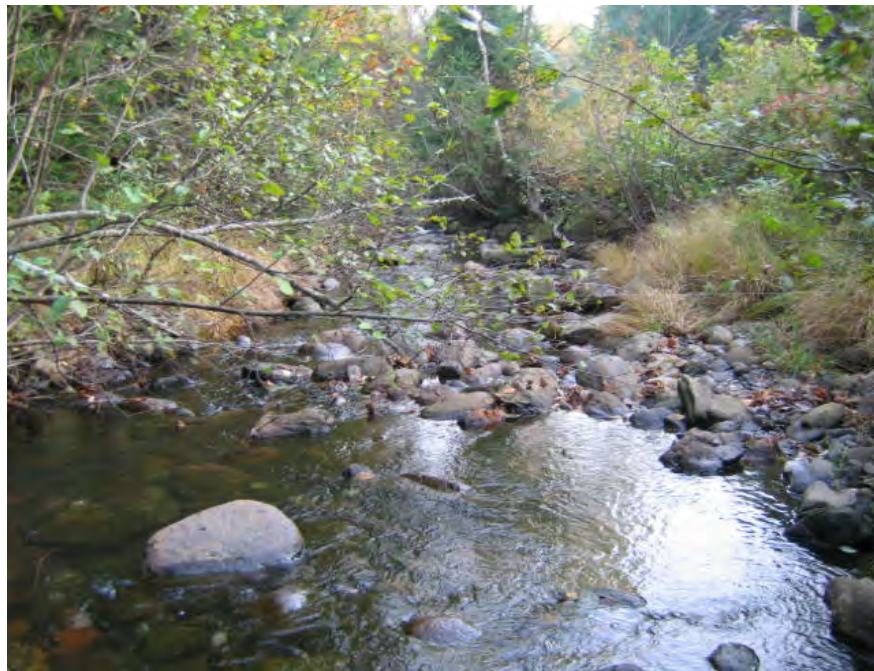
Figure 10. Cobble dominated substrate in RI8SI.03-A

Segment RI8SI.03-A is approximately 1,370 feet in length. Extreme historic incision has led to a stream type departure from a “C” channel to a “B” channel. This means the channel now has a narrow floodprone area rather than a wide floodplain that would be there by reference. The substrate is cobble dominated (Figure 10). The upper portion of RI8SI.03-A is acting as a sediment transport section where it is straightened along Garfield Road. There are more depositional features at the lower end of the segment as the stream moves away from the road.

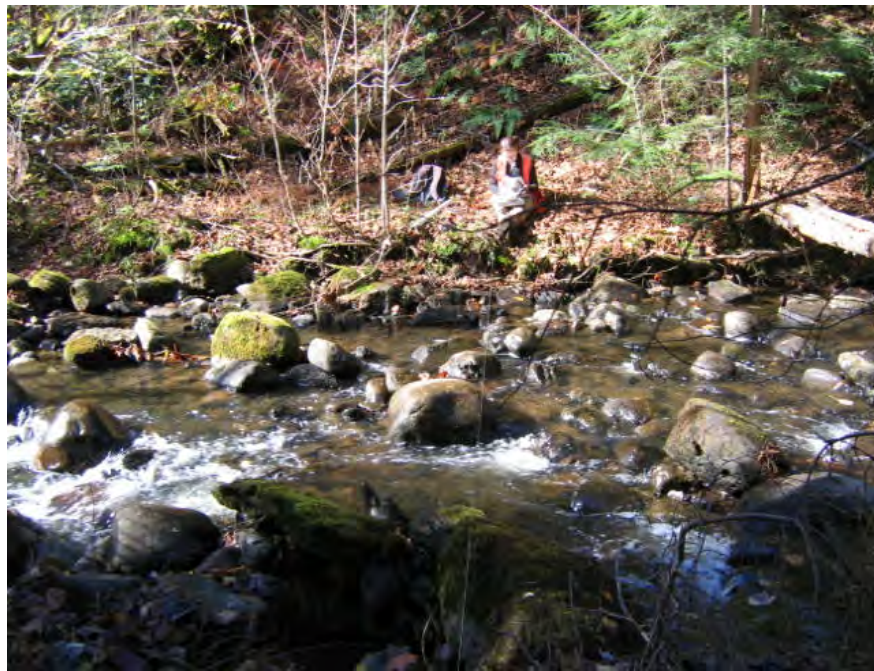
Figure 11. Representative cross section in R18SI.03-B

The valley wall narrows at the upper end of R18SI.03-A near the Garfield Road crossing. The valley confinement becomes semi-confined where R18SI.03-B begins. There are no grade controls in segment B, however, channel spanning ledge was noted at the lower end of R18SI.04 near the reach break. R18SI.03-B is a “B” channel by reference with a riffle-pool bedform and cobble dominated substrate (Figure 11).

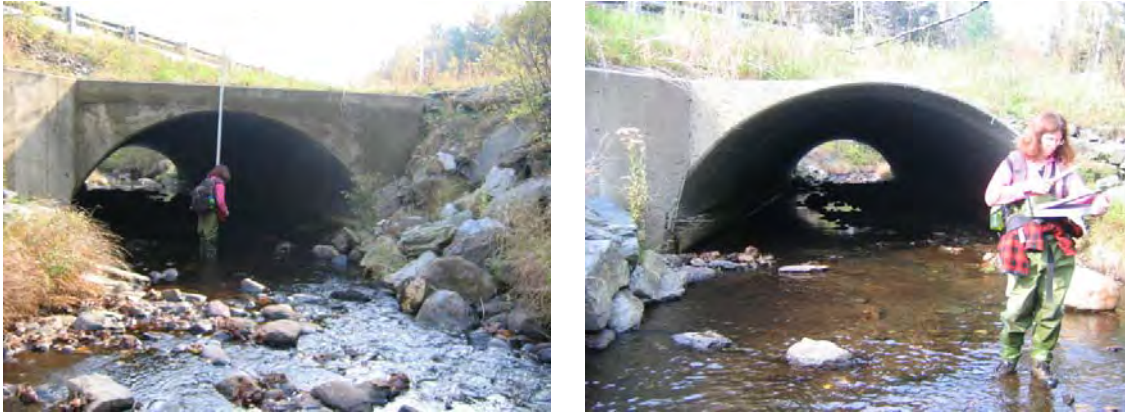
Figure 12. Inlet (top left) and outlet (top right) of Garfield Road arch

An arch at the Garfield Road crossing is creating a channel and floodprone constriction at the lower end of segment R18SI.03-B (Figure 12). The span of the structure is 18 feet compared with the reference channel width of 23.9 (75 percent of the bankfull channel width). Based on field observations by BCE during the phase 2 assessment in October 2007 and the bridge and culvert assessment conducted by LCPC in 2006, no obvious geomorphic issues were noted as a result of this stream crossing. There is a natural streambed at the arch, which is allowing fish to move through the structure.
