Rodman Brook Phase I Geomorphic Assessment Results

July 2010

Prepared by the Lamoille County Planning Commission

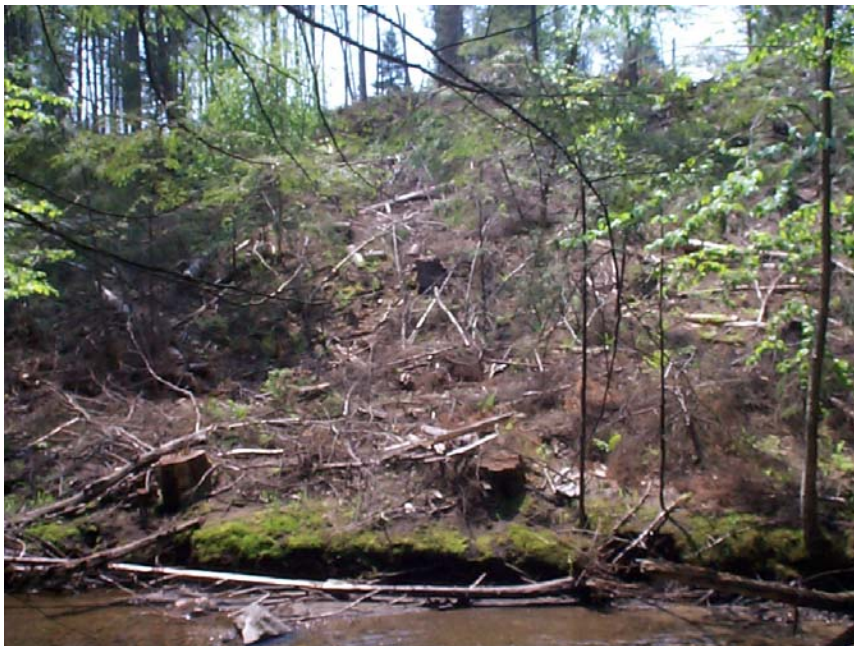
As part of this assessment, land use, encroachments, and buffer condition were analyzed within 150 feet on each side of the river. The headwaters of the stream are located in land with sparse residential development adjacent to the steep McKinstrey Hill Road. There is a section that has been dammed by beavers at the upstream end of the stream. There are a few significant bedrock grade controlled sections of the river which will help maintain stability in those areas. There was one section along the river corridor where some logging activity has taken place very close to the channel (see Figure 3).

Figure 3. Trees cleared on river bank
