Town of Colchester Phase I Stream Geomorphic Assessment Report

July 29, 2007

Chittenden County Regional Planning Commission South Burlington, Vermont

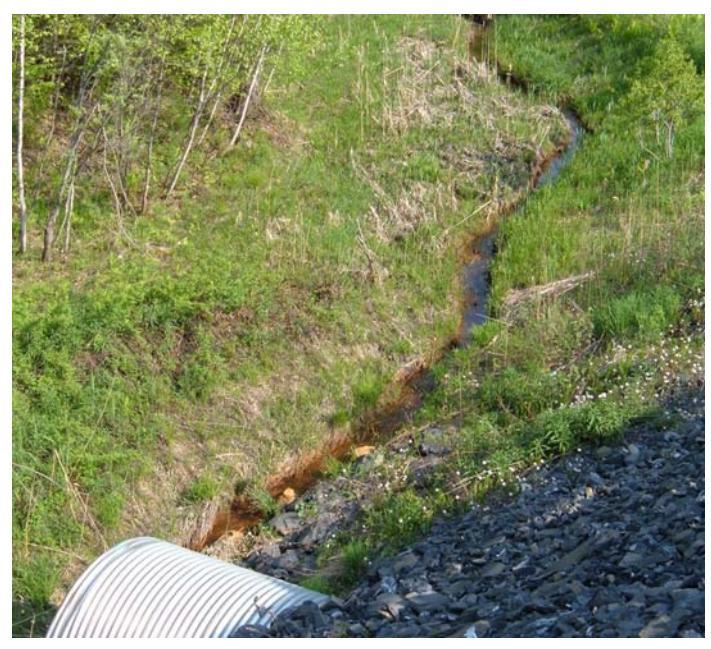
• **T1.04:** This reach is found on the southern tributary beginning at the road crossing associated with the industrial park (located across from Canyon Estates Rd; see map in Appendix A) and extending upstream to the crossing at Gentes Road. Under reference conditions we would expect to see a C-type channel with gravel substrate and a meandering planform. The lower section of the reach has been straightened and culverted (~25 % of entire reach length) beneath the industrial park, and nearly all of the natural channel sinuosity has been lost. Downstream of this area the channel shows some signs of historic incision (Figure 2). In addition, the high degree of urbanization in the immediate drainage area to the channel has likely altered the reach hydrology. Direct observations of the middle portion of the reach were not possible during the windshield survey due to limited property access. This reach is predicted to have significant changes in planform and a poor geomorphic condition (Appendix B; Table 3).

Figure 2. Channel immediately downstream of industrial park in T1.04

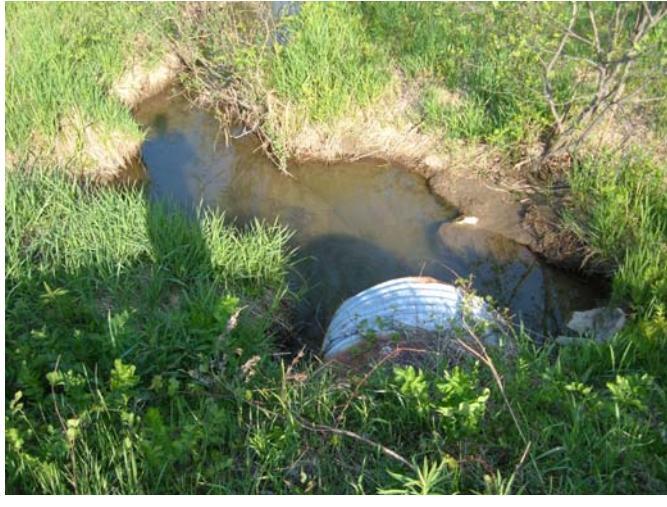
• **M06:** This mainstem reach is found from the confluence with the southern tributary up to a break in slope approximately 0.5 miles upstream of the East Road crossing. The channel is characterized by a low-gradient, sinuous form with many areas of meander migration resulting from beaver impacts to the floodplain. This reach has received a high impact rating due to the observed changes in planform, as well as the ice and debris jam potential at the East Road crossing. During an August 2004 runoff event, flooding occurred upstream of this road crossing, causing the road to be

temporarily closed. Debris and ice jams and future flooding will likely recur at this road crossing due to a combination of the following factors: 1) an undersized culvert (Figure 3); 2) limited relief of road from floodplain (less than 10 feet); 3) frequent beaver ponding above and below crossing.

Figure 3. 36" culvert constricting flow and debris beneath East Road

- **Reaches M05 and M06 (medium and high priority)** are priority reaches for assessment due to the high degree of lateral migration observed in both. In addition, the culvert beneath East Road should be evaluated in more detail to develop baseline information for the future replacement of this structure to reduce the risk of flooding along the road.
- Southern Tributary: Reaches T1.01 and T1.04 are recommended for further Phase 2 assessment.
 - Reach T1.01 (medium priority) should be investigated in further detail to determine the impacts of runoff associated with the surrounding lowdensity residential development. The windshield survey was limited to the East Road crossing and did not encompass the middle or lower section of the reach.
 - **Reaches T1.04 (high priority)** should also be assessed to determine the impacts of runoff associated with the surrounding industrial development.

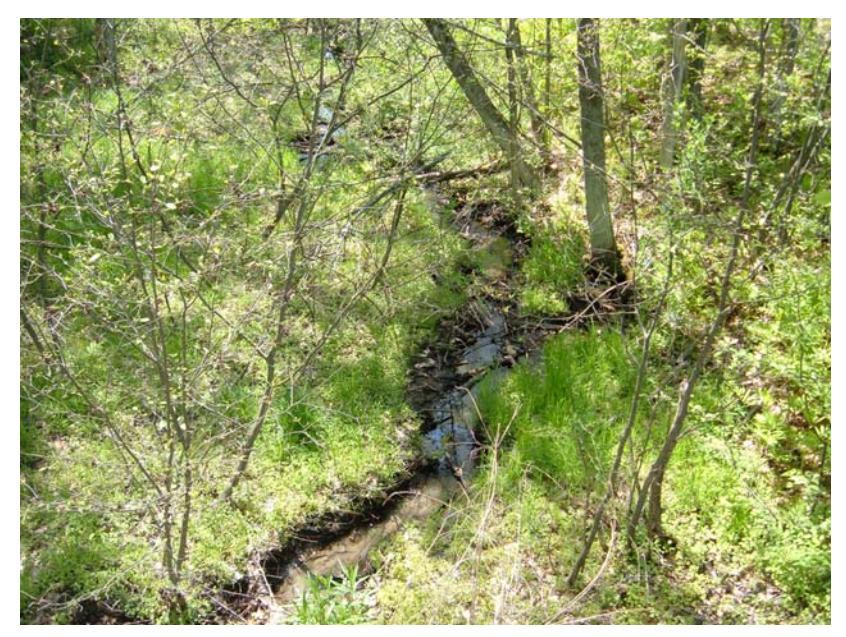
Figure 4. Small channel with adjacent wetlands in reach T2.01

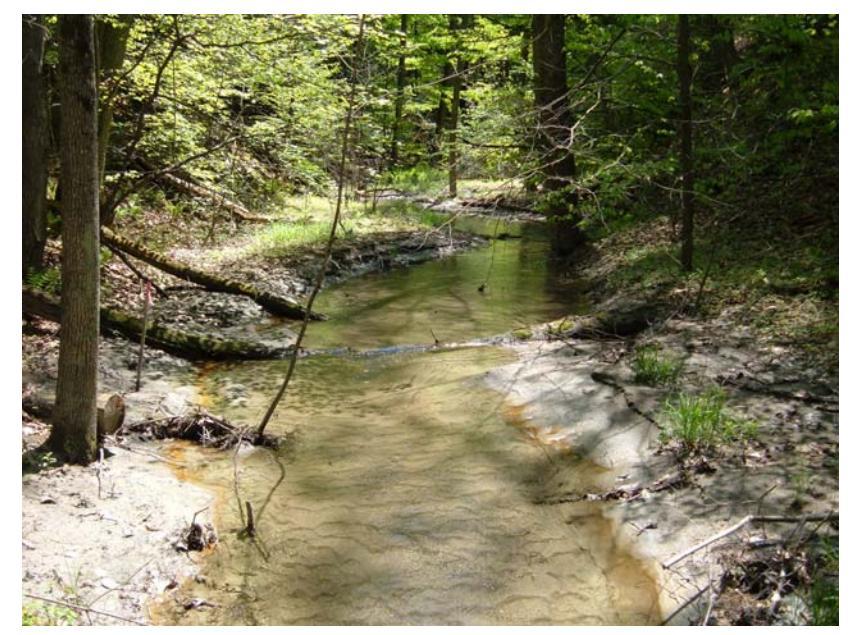
• **M01:** This reach is found from the outlet at Malletts Bay up to a change in valley confinement just east of the Colchester Junior High School recreation fields. This reach appears to have B-type geometry with a sand-bottomed channel (Figure 5). This reach has had severe impacts to the vertical stability due to impacts from upslope impervious cover. In a heavy rainfall event in August 2004, the culvert beneath East Lakeshore Drive was undermined and washed out, and has since been replaced. This reach is predicted to have significant channel aggradation (e.g., sediment deposition) and degradation (e.g., downcutting) and a fair geomorphic condition (Appendix B; Table 6).

Figure 5. Sand-bottomed channel in lower reach M01

- Mainstem: Reaches M01 through M04 are recommended for further Phase 2 assessment.
 - **Reaches M01 and M02 (high priority)** should be investigated in further detail to determine the impacts of upslope runoff from impervious surfaces. Given the erosion hazard noted with the washout of the culvert beneath East Lakeshore Drive in reach M01 (and the incision noted during the windshield surveys), further assessment of the upstream area is recommended. In addition, low-density development has recently been added to the area that drains directly to reach M02, and the impacts of this development are unknown.

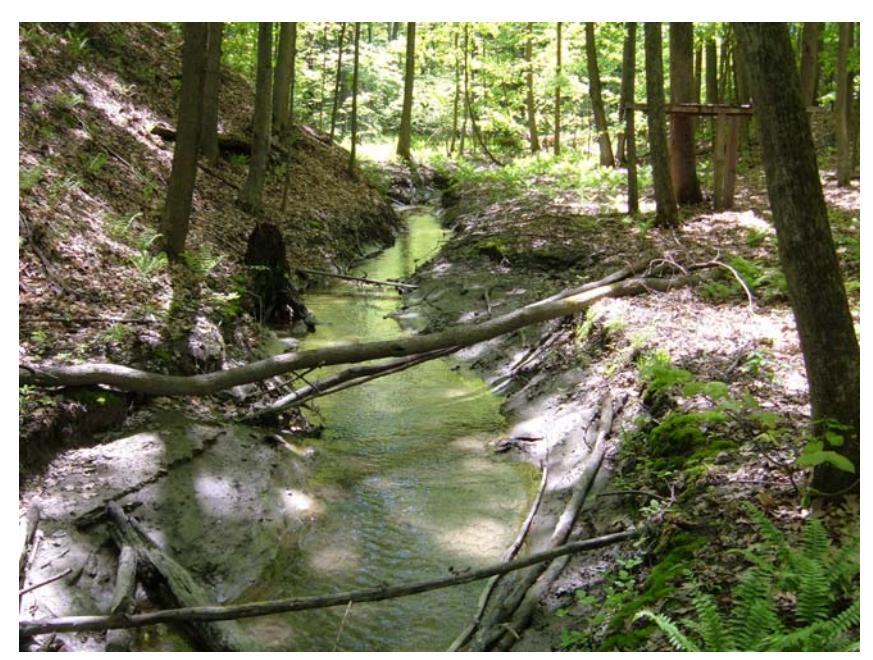
• **M02:** This reach is found from the reach break with M01 up to the Williams Road crossing. Many stormwater outfalls were noted along this reach, resulting in incision in the areas upstream of the bike path crossing (Figure 6). In addition, some scour and lateral migration was observed immediately below the Williams Road culvert. This reach is also predicted to have significant channel aggradation and degradation and a fair geomorphic condition (Appendix B; Table 6).

Figure 6. Incised channel in middle of reach M02
