Green River Corridor Plan

Guilford and Halifax, VT

November 1, 2014

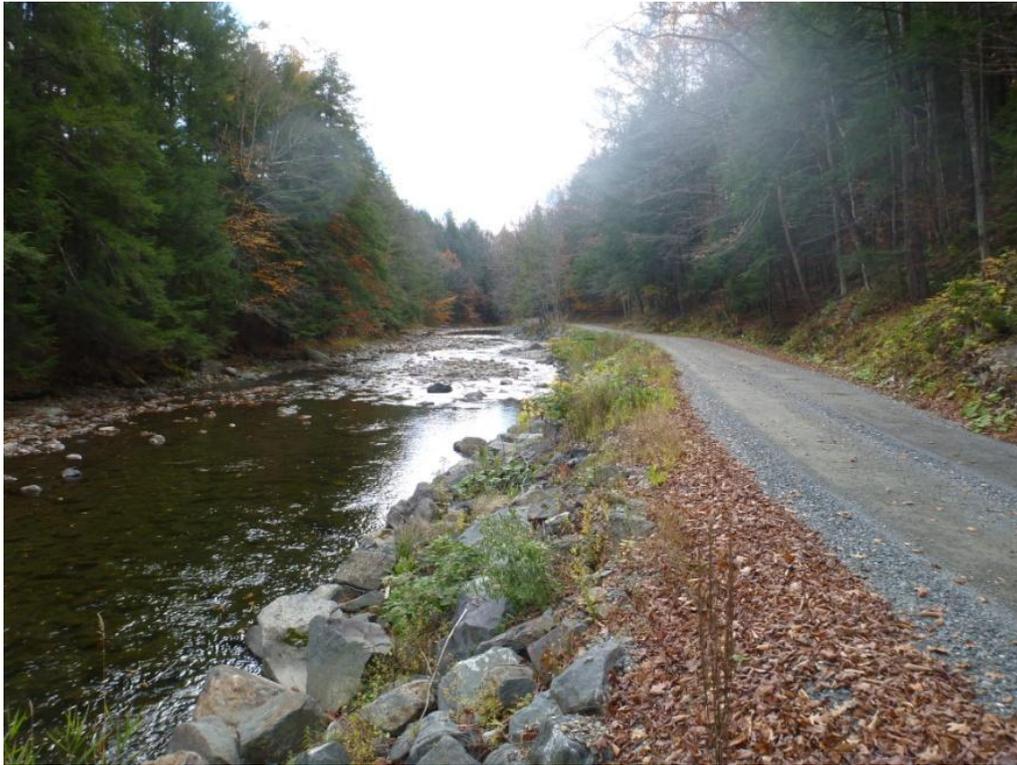
Figure 3.5: Looking downstream near the state line along Reach M01 with encroachment from River Road.

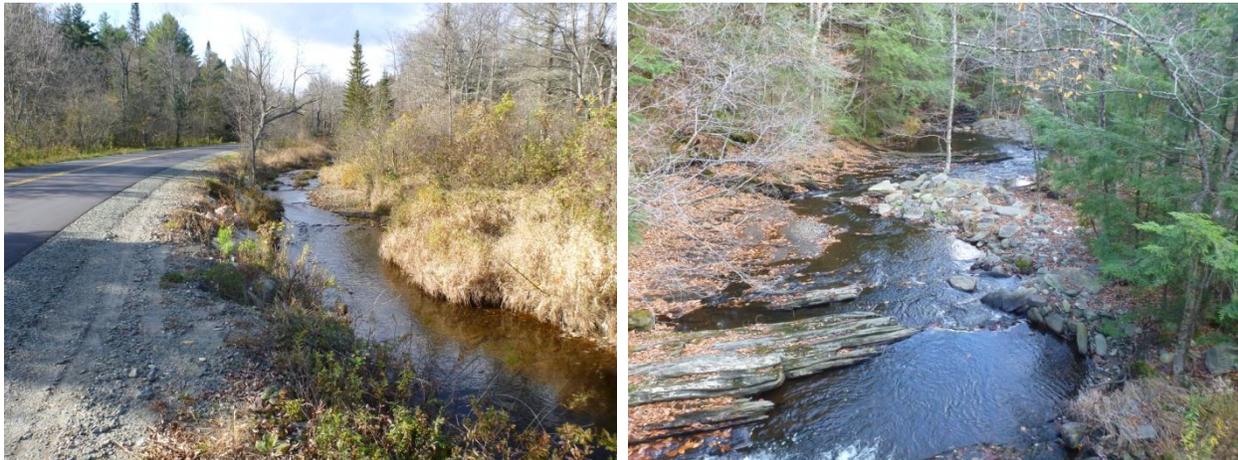
Figure 3.6: Road encroachment along M14 (left) and bedrock grade controls in upper M16 (right).

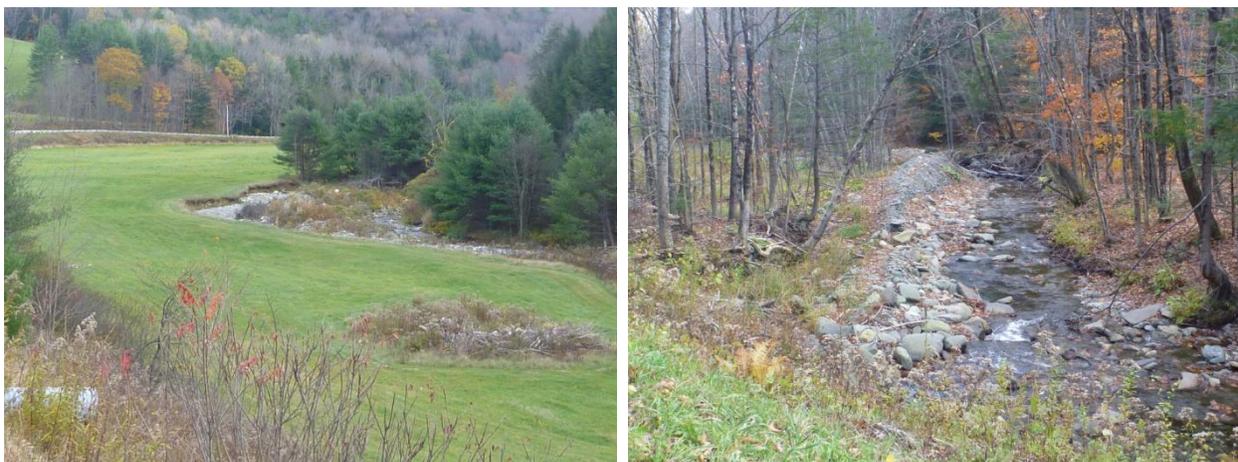
Figure 3.7: Berming and windrowing of TSI flood sediments in T3.01 (left) and T3.02 (right).

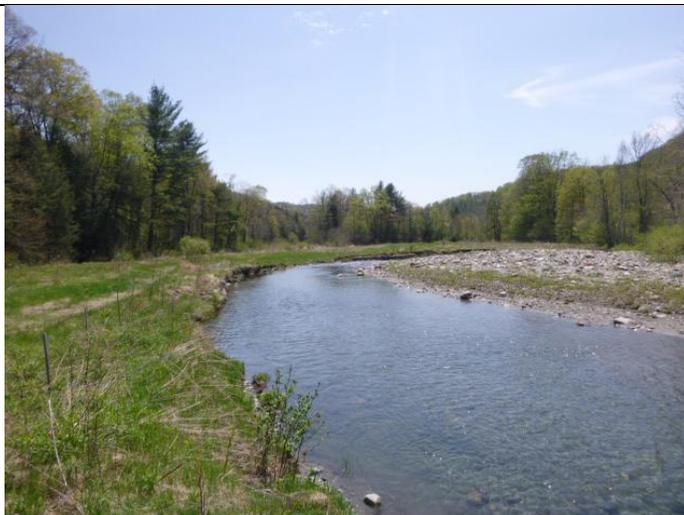
Ample flood storage, which was accessed during TSI leaving debris deposits along far tree line of field

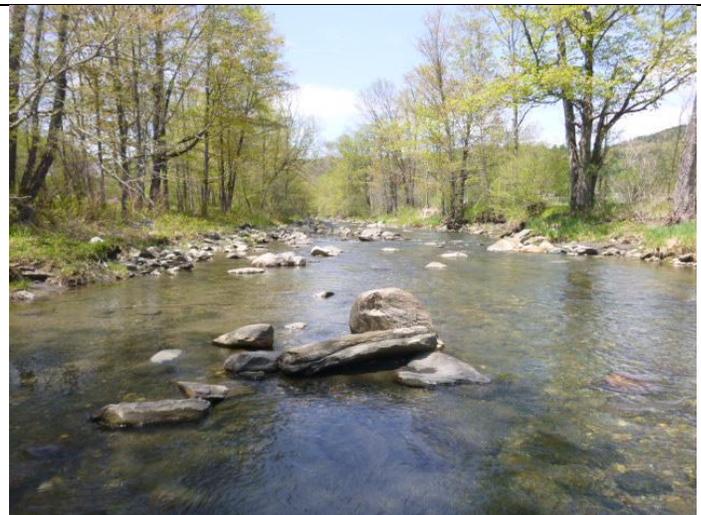
Typical over widened channel demonstrated by bank scouring

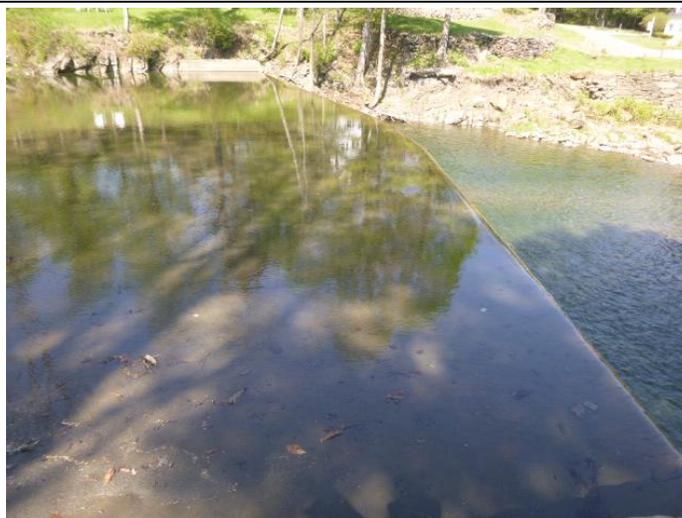
Sediment filling channel above dam

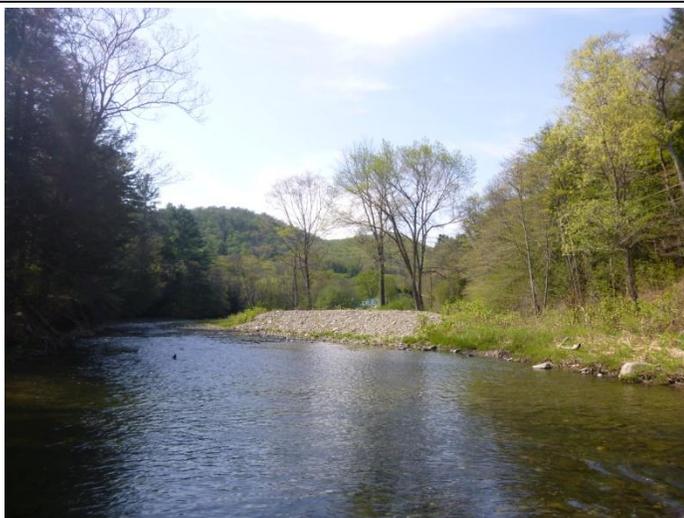
Berm on left bank from TSI sediment deposits removed from floodplain

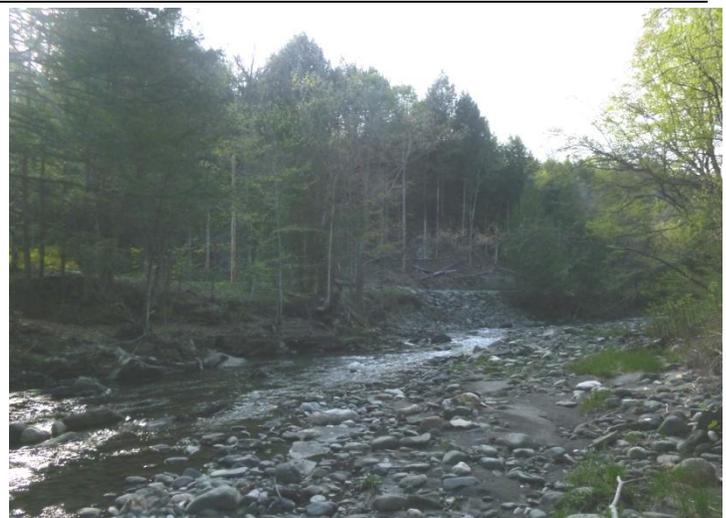
Road encroachment observed through most of reach resulting in degradation of the channel bed and erosion

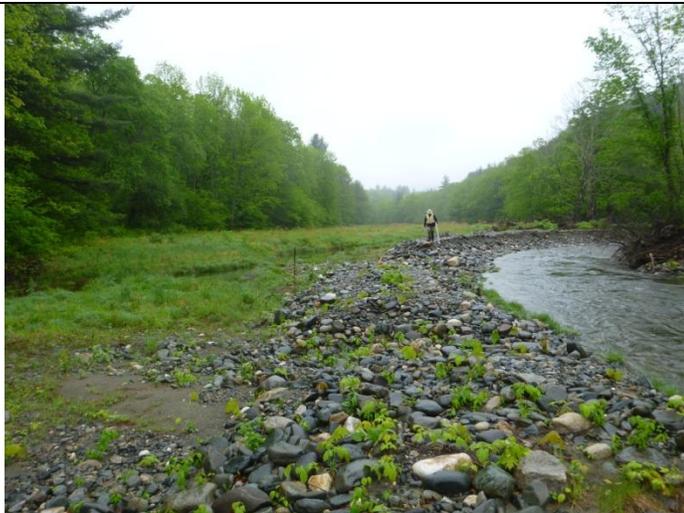
Berm greatly reduces access to a large left bank floodplain and straightens the channel

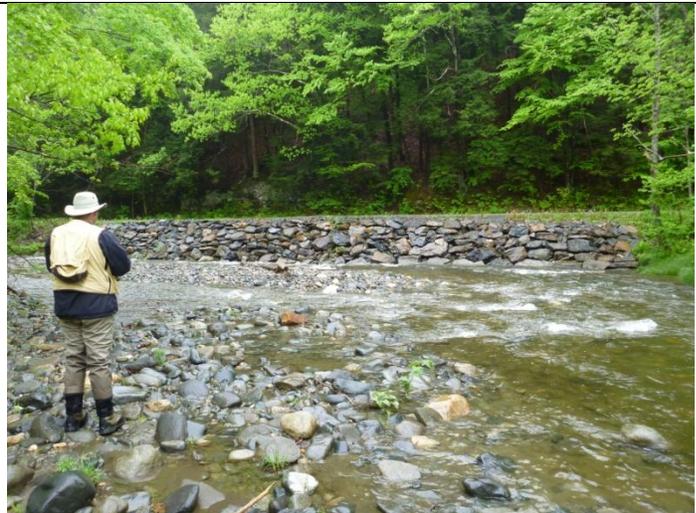
Bank armoring along road Green River Rd. at a sharp bend in the river

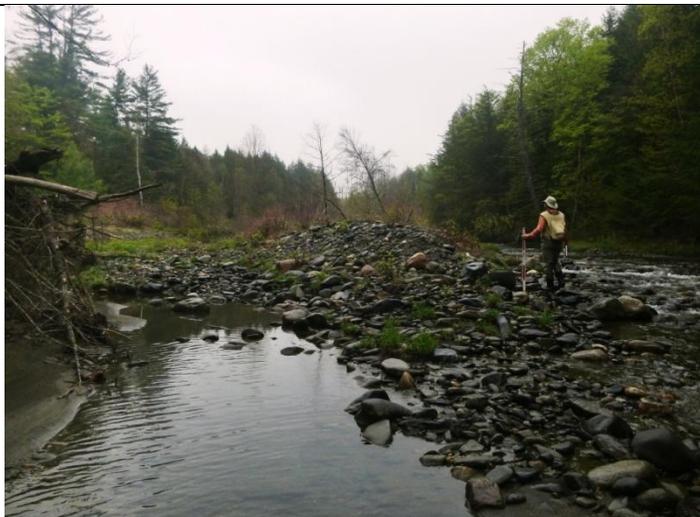
Channel migration resulting in large depositional features

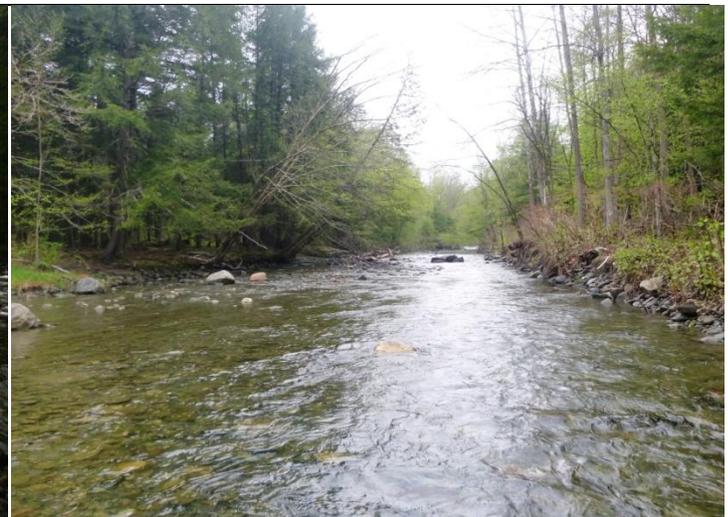
Channel has recently widened and still has accessible floodplain

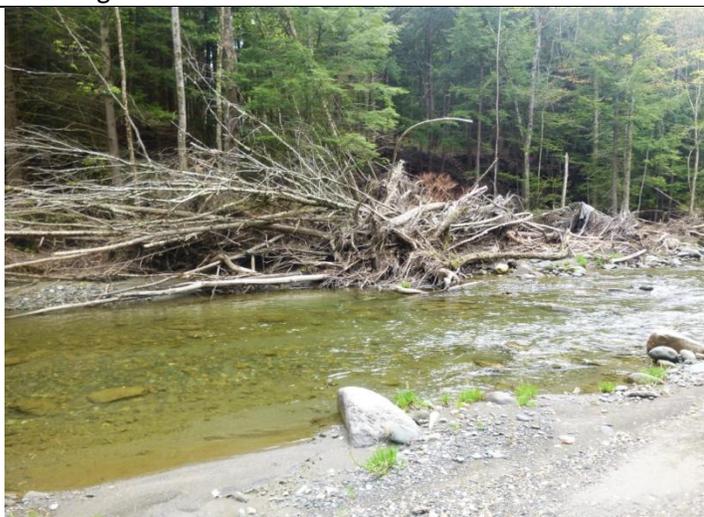
Large woody debris removed from channel following TSI

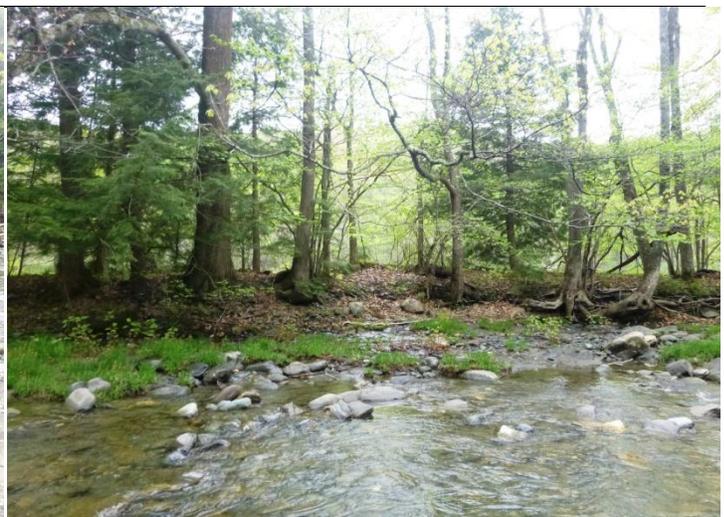
A historic berm creates a human elevated floodplain by eliminating access to the adjacent field

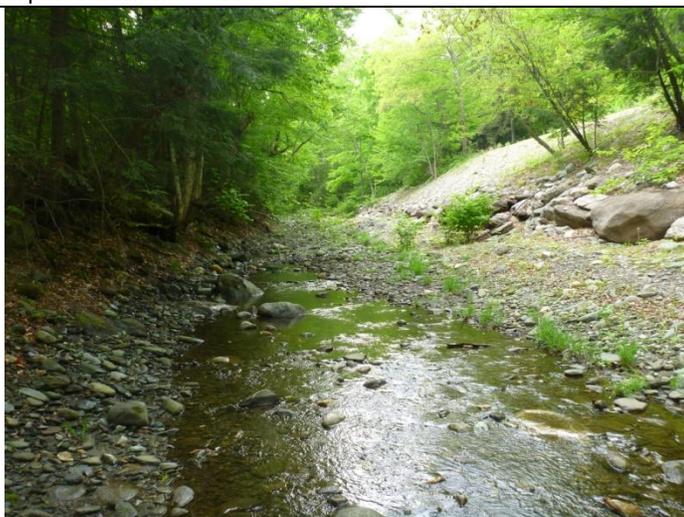
Recently abandoned historic channel

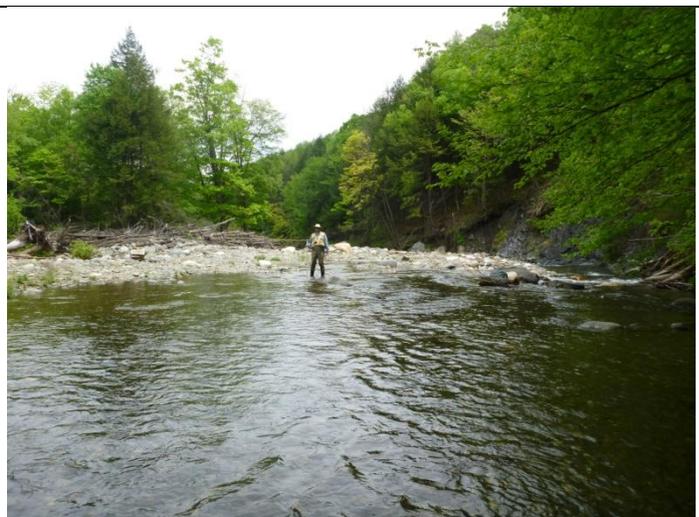
Overwidened new channel cutting down through TSI deposits

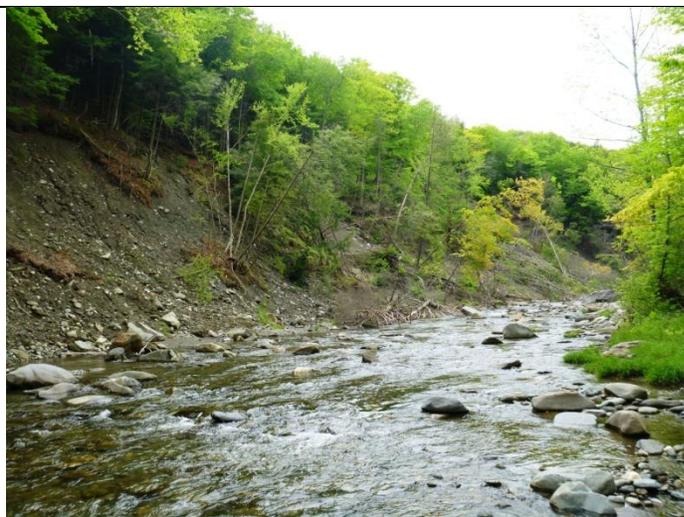
Large mass failure at upper reach break

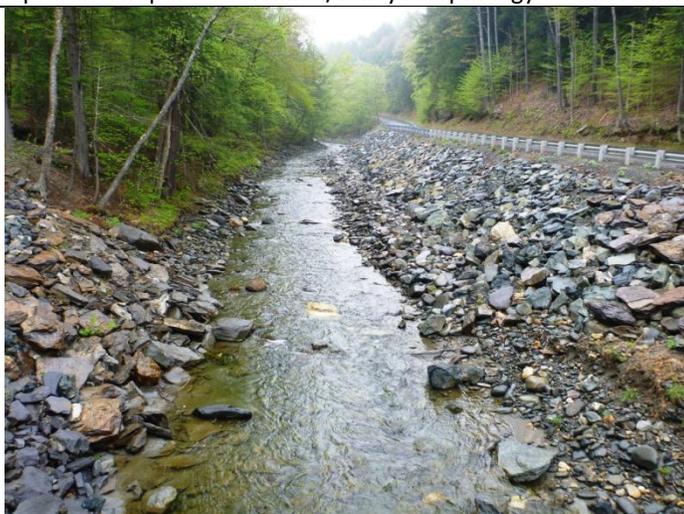
This reach was heavily armored along Green River Rd

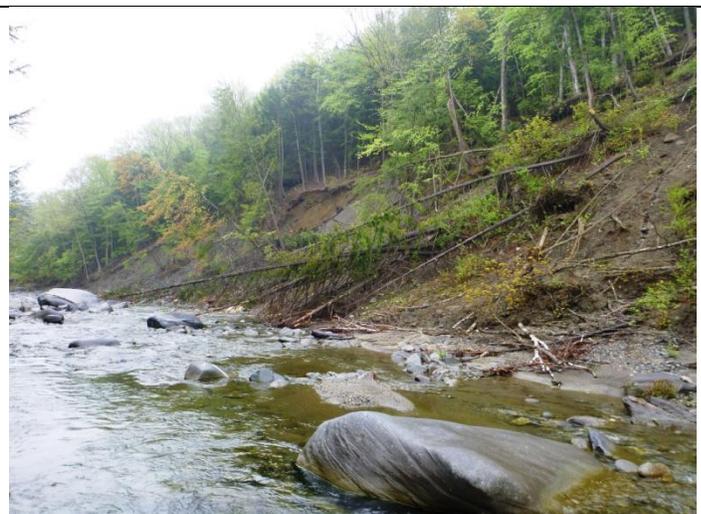
Road encroachment contributed to mass failures and bank erosion on opposite bank

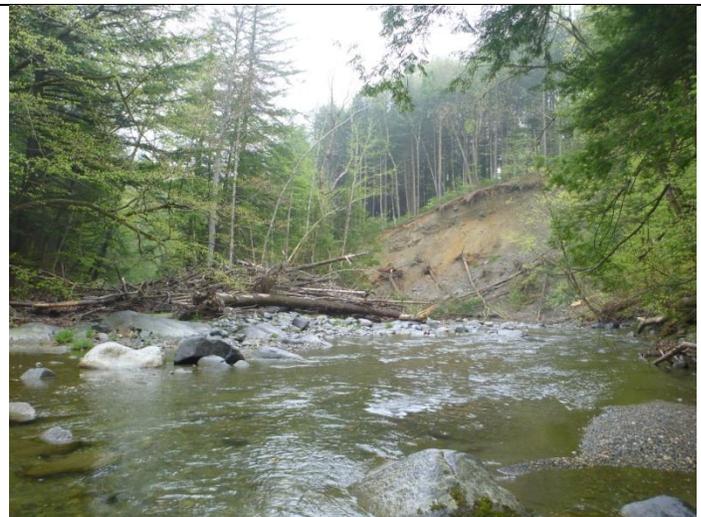
Debris blocking flood chute forcing flow against the far right bank resulting in a mass failure

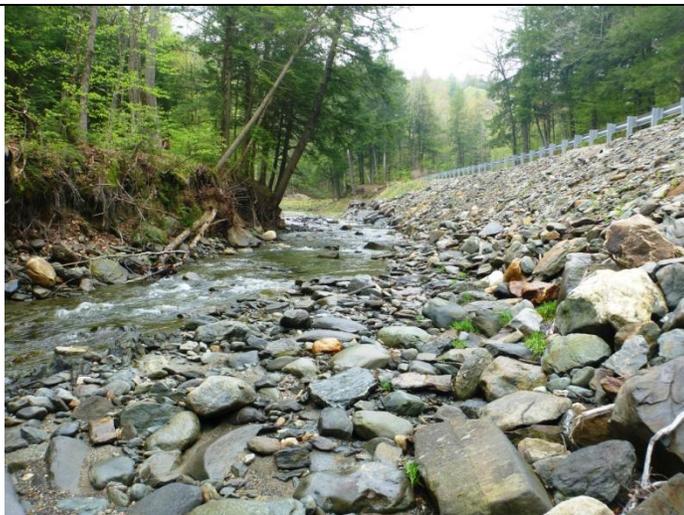
Bank armoring and road encroachment resulting in heavy bank scour and erosion on opposite bank

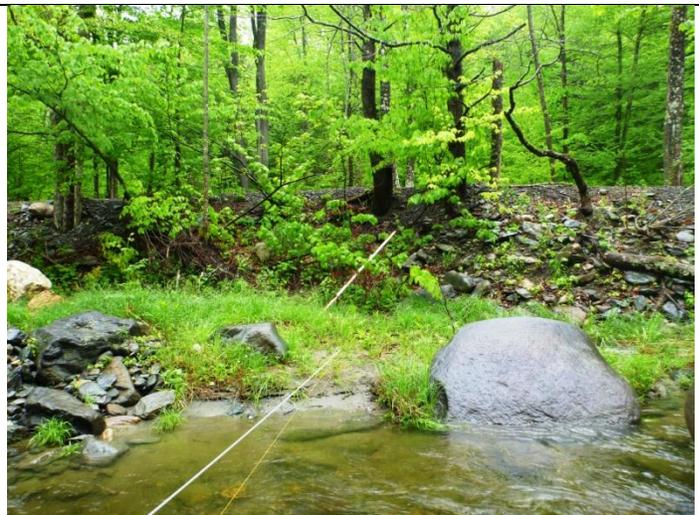
Limited floodplain storage on raised bench, which was consistent throughout the reach

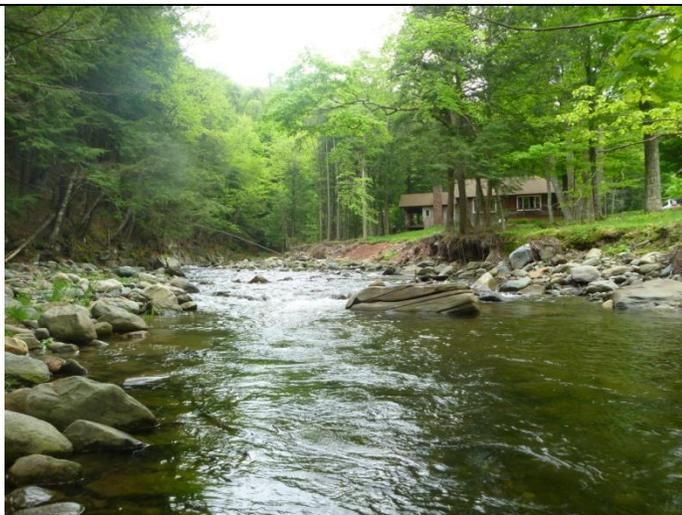
Bedrock forces flow against property causing bank erosion as channel widens

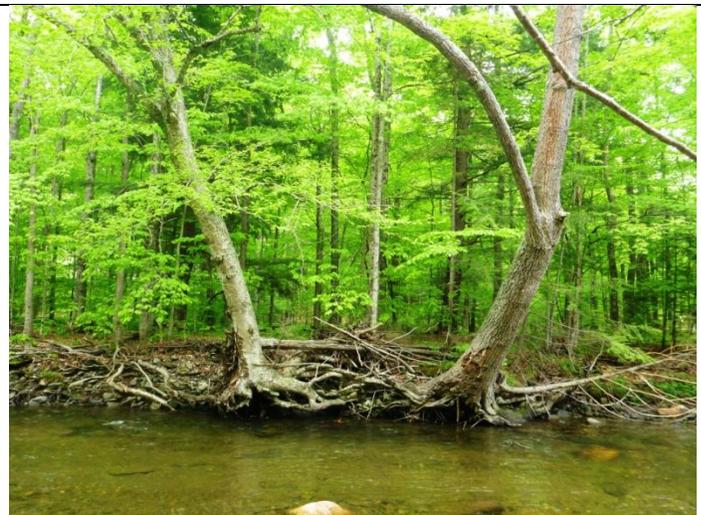
Bank scour observed through most of reach indicating recent widening

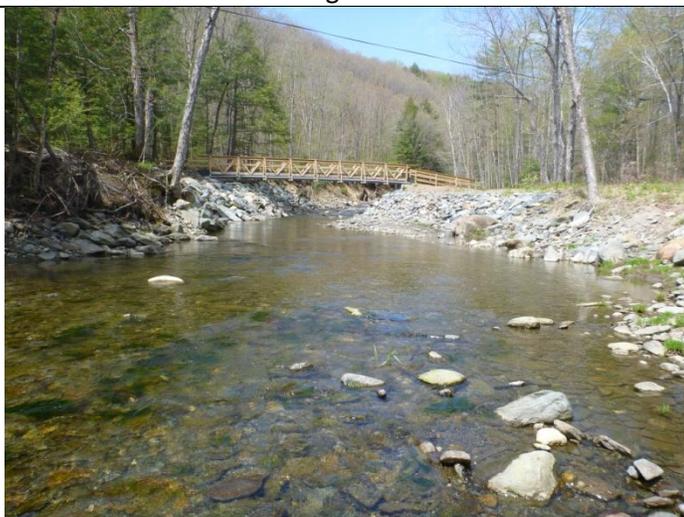
Bank armoring around foot bridge causes channel constriction

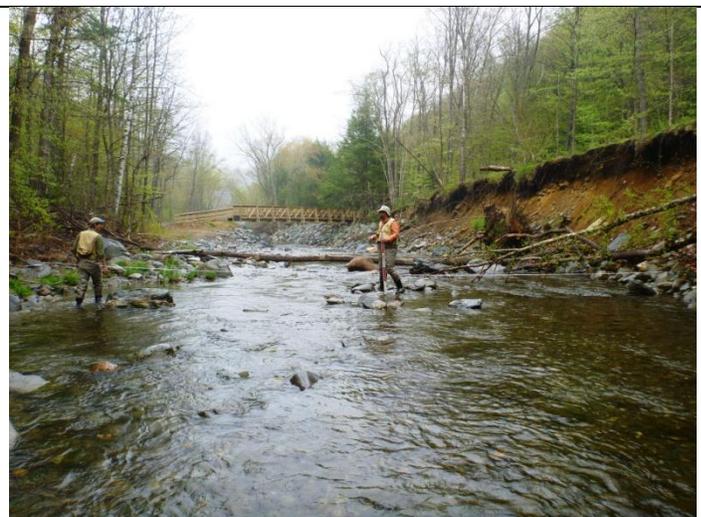
Bank erosion observed through much of the reach as a result of road encroachment and armoring

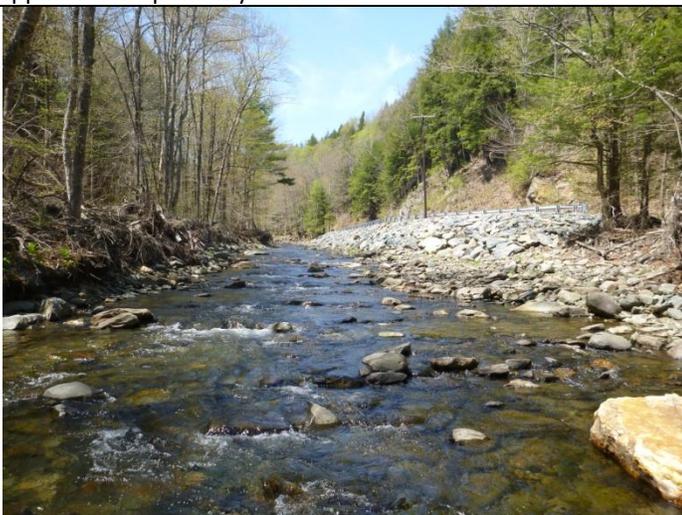
Bank armoring and road encroachment causes the channel to degrade as well as erode banks

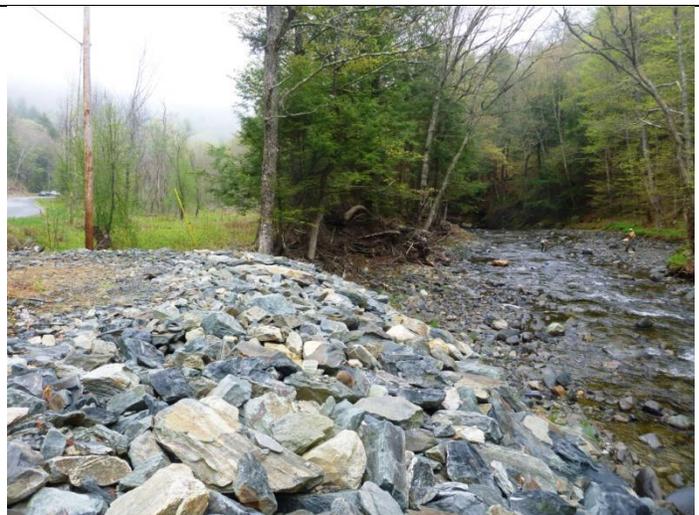
Bank armoring and berm that cuts off floodplain access

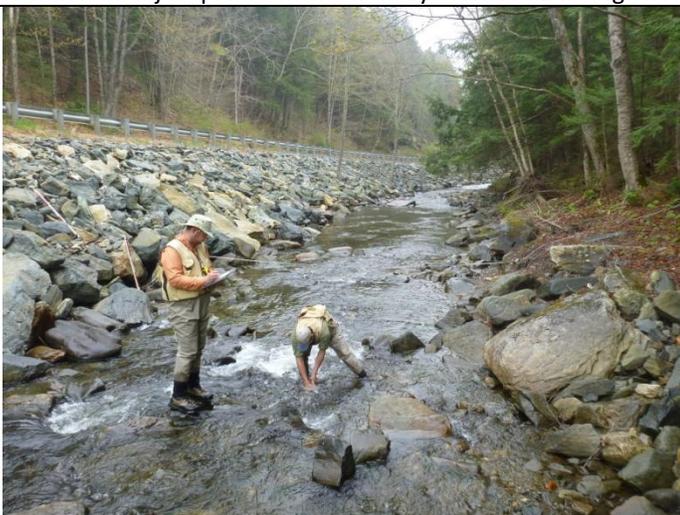
Reach is heavily impacted by bank armoring and road encroachment

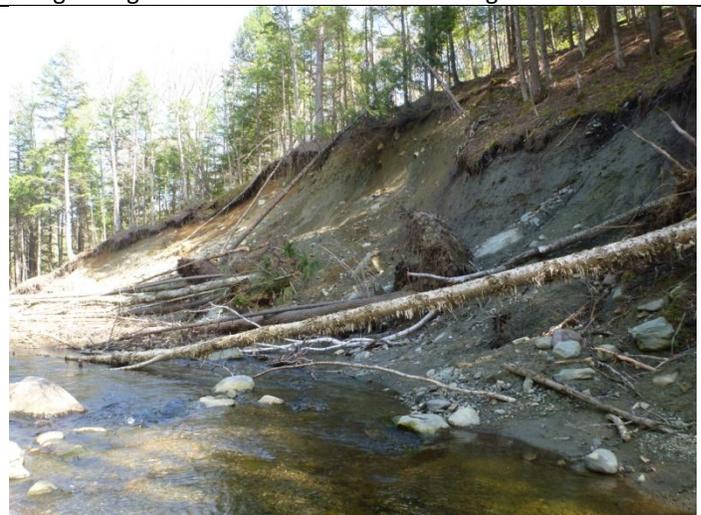
Mass failures result from armoring and encroachment as the bed degrades

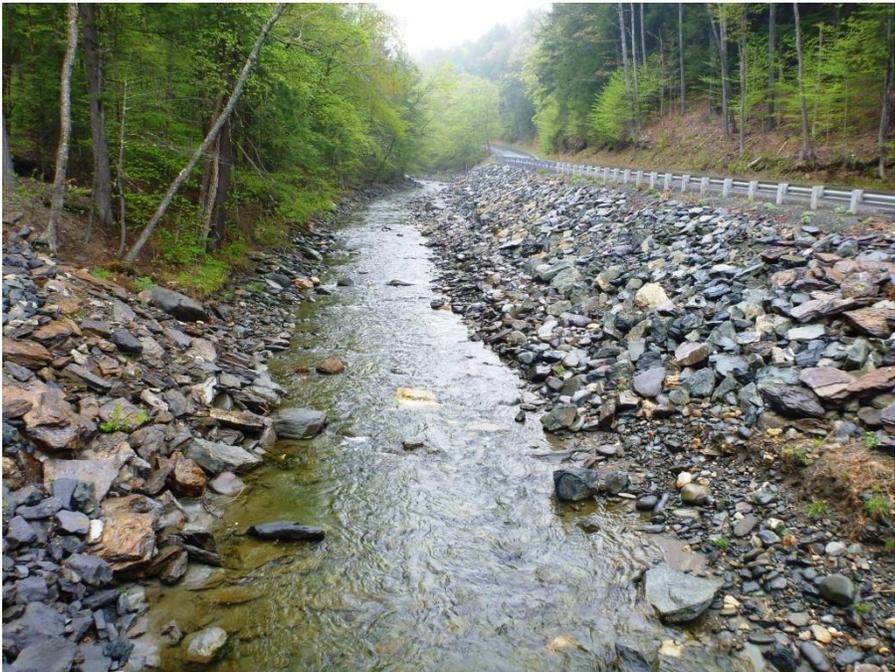
Figure 4.3: Extensive bank armoring on segment M09A.

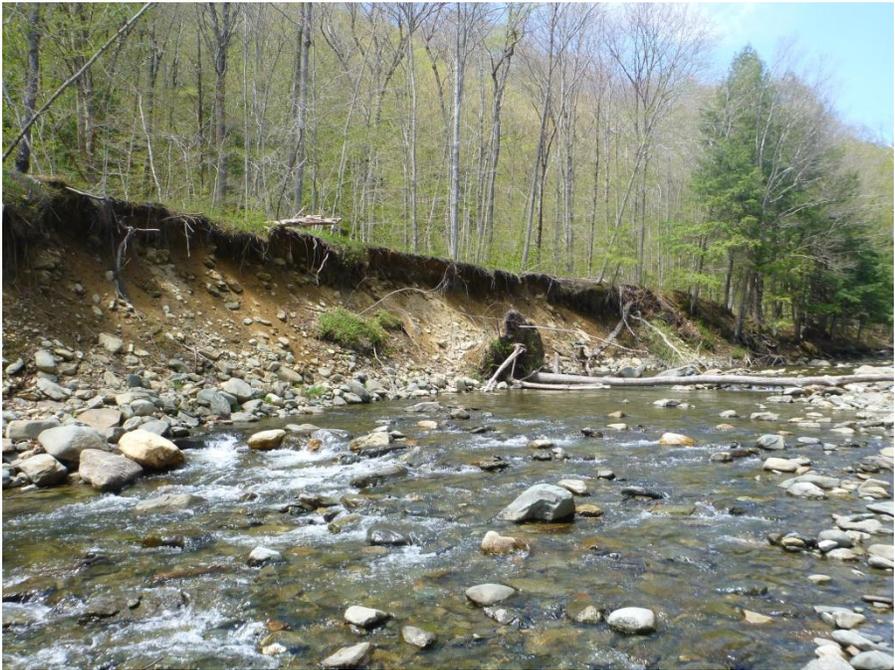
Figure 4.4: Bank erosion on reach M11.

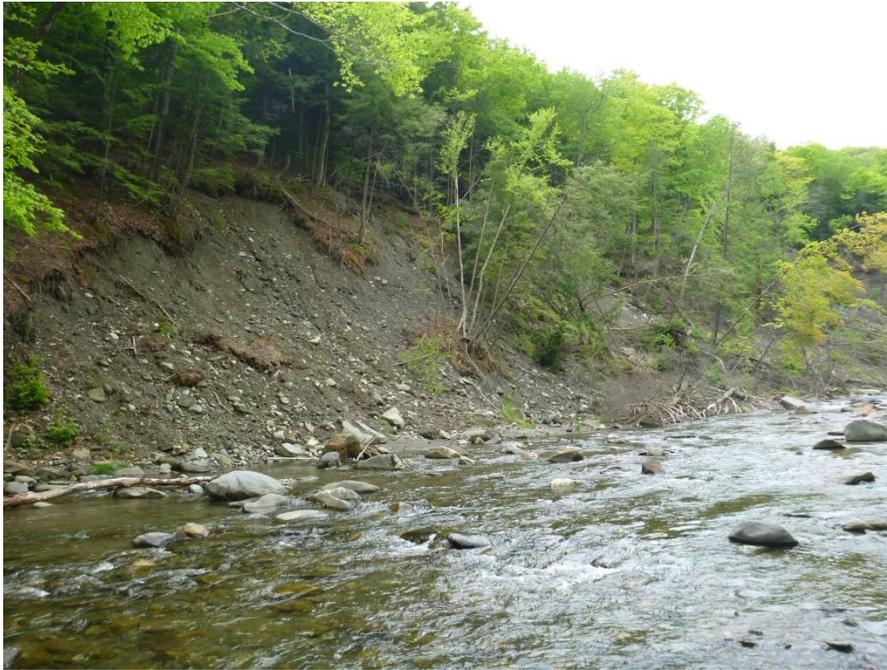
Figure 4.5: Large mass failure on segment M08B.

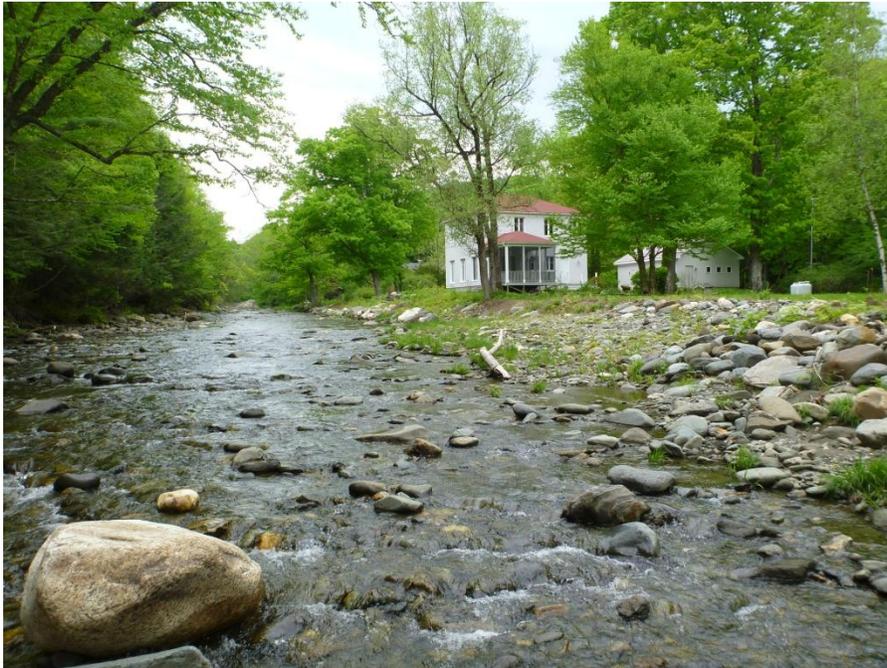
Figure 4.7: Historic straightening on segment M08B.

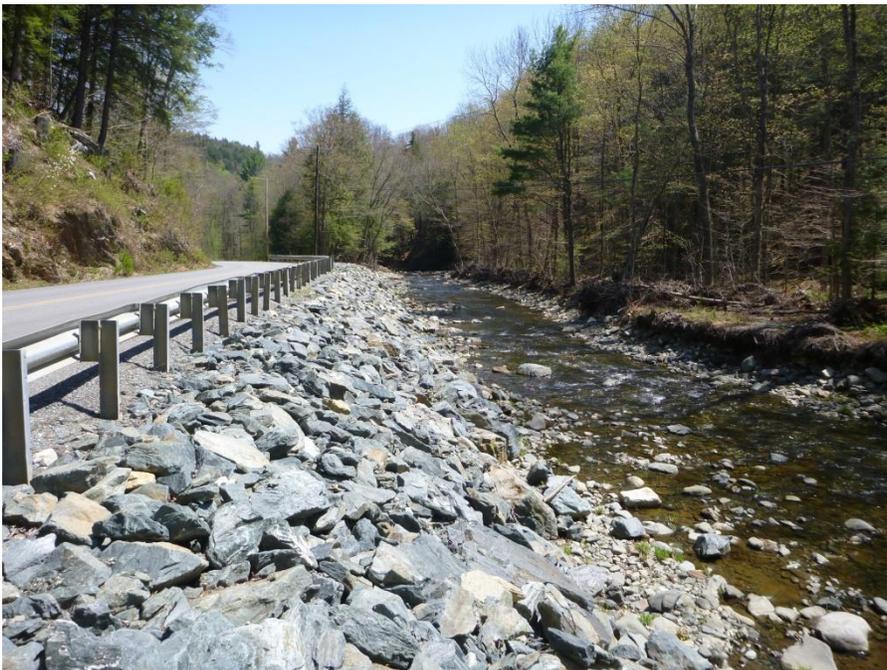
Figure 4.8: Road encroachment on reach M12.

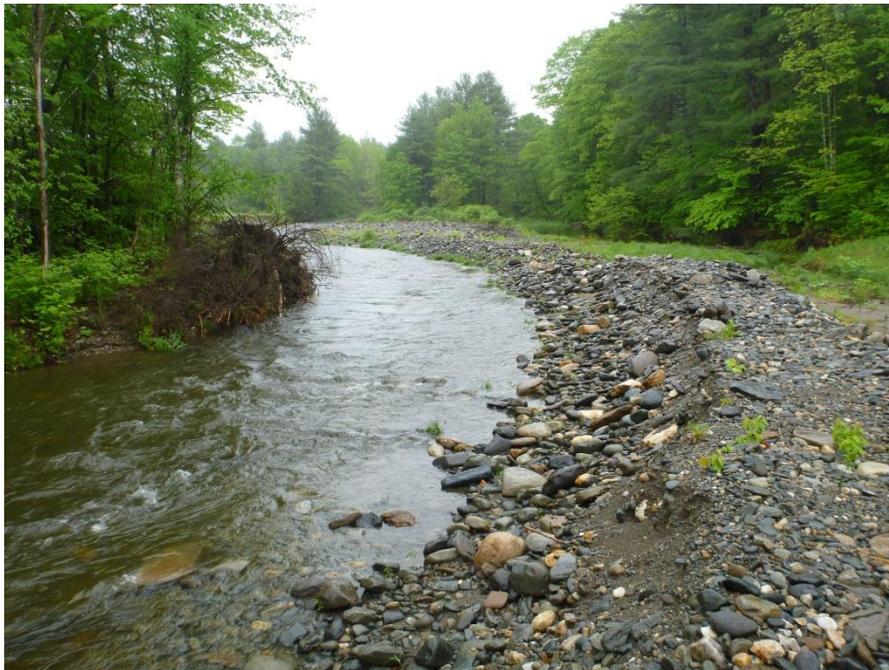
Figure 4.9: Recently constructed cobble berm on segment M06A

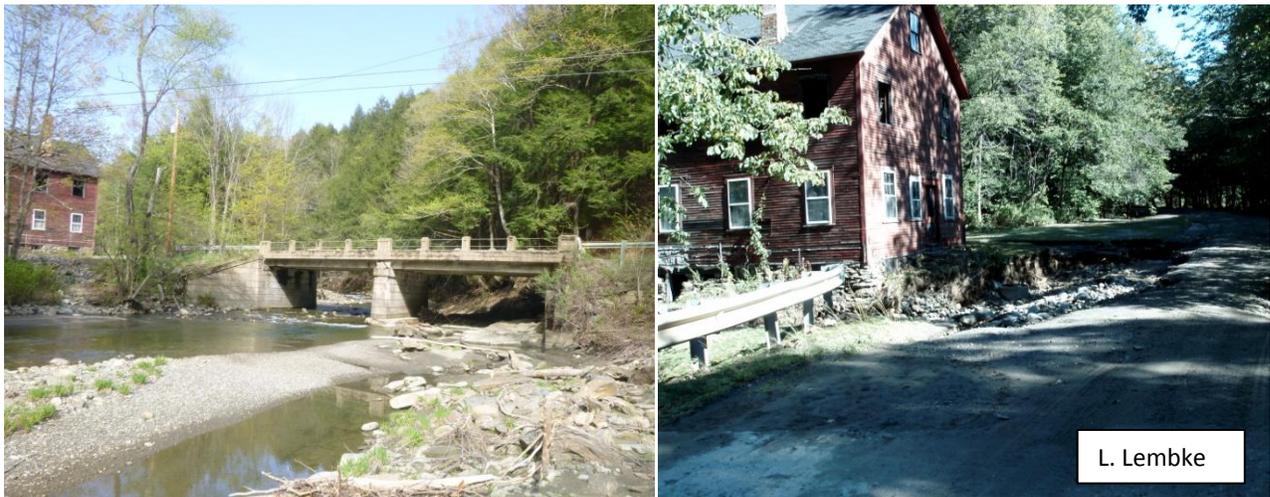
Figure 5.1: Green River Road crossing on M05 (left) which was overtopped severely damaging the road and an adjacent house during TSI (right).
