East Branch Passumpsic River Corridor Plan

Burke and Lyndon, Vermont January 2009

Prepared By: Kerry O'Brien, District Manager

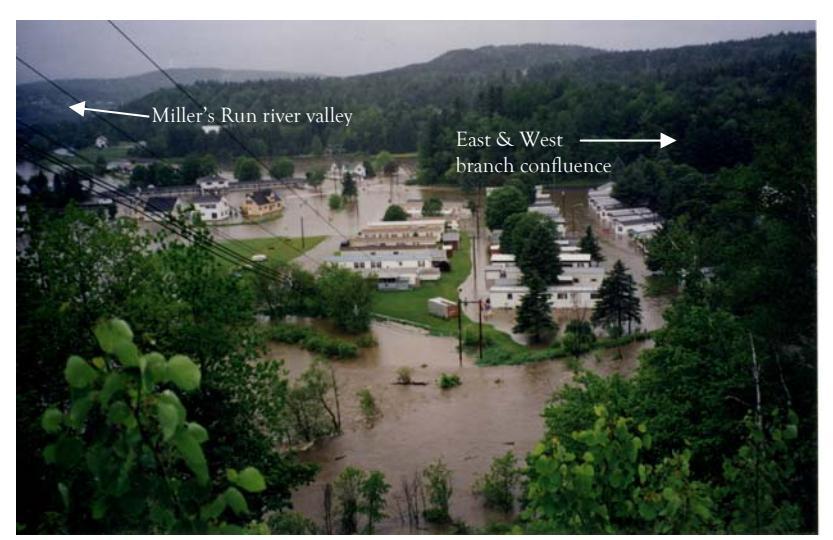
Figure 2: Photo by Kenneth Mason: 2002 Passumpsic River main stem flooding near junction of Rte 114 and Rte 5 in Lyndon and Miller's Run confluence

damage, power outages, as well as road and business closures. The photo on the left shows the Passumpsic River main stem near the confluence of the East and West Branches and the Miller's Run River. This is an area of frequent flooding and sediment accumulation, which is additionally challenged by development and transportation routes. As we examine the Upper Passumpsic watershed, it is clear that these three tributaries are critical components in the discussion of flood attenuation.

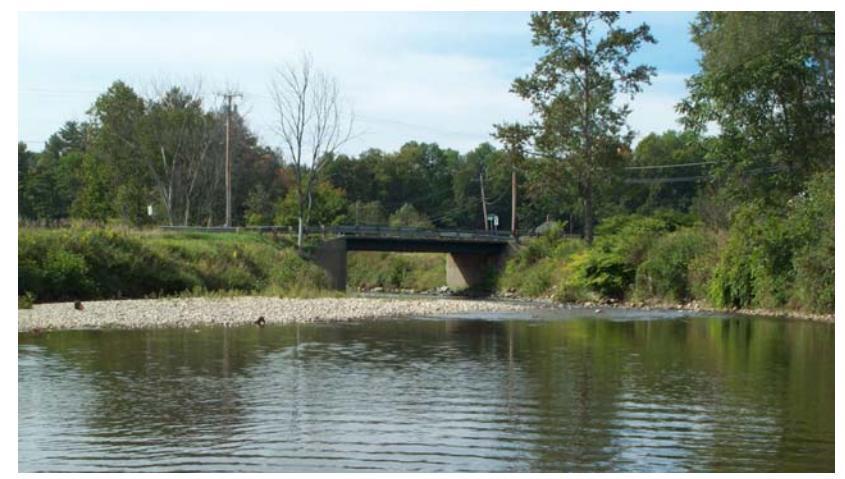
Figure 12: Photo taken in 2003, one year after flood, looking downstream towards Lily Pond Bridge on Reach T101A.Bridge is a channel constriction, showing sediment accumulations upstream, and was an area of conflict during flood.

Lily Pond Bridge Floodplain constriction and area of conflict Replacement should be considered

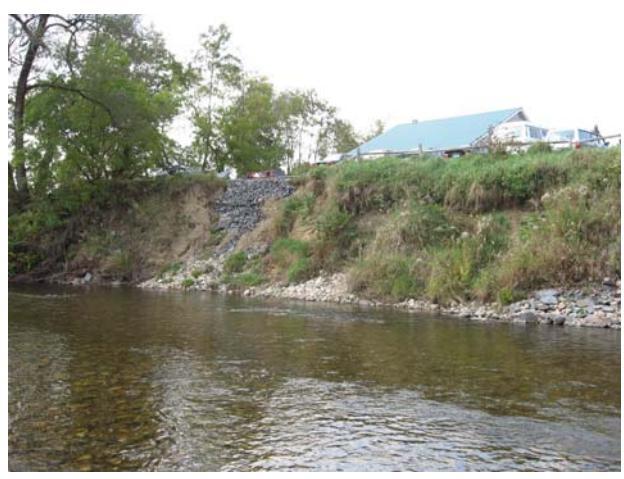
Figure 13: Right bank of Reach T101B showing streamside residence and business that could be impacted by fluvial erosion hazards. Tall eroding banks also observed showing poor access to floodplain.

Install/Enhanc e Buffers	High	Moderate	Yes	Buffers should continue to be installed and enhanced to help protect corridor and provide stability and habitat
	Examine conflict at residence/auto business	High	Low	Yes	Area should be monitored closely and landowner made aware of potential erosion hazards.

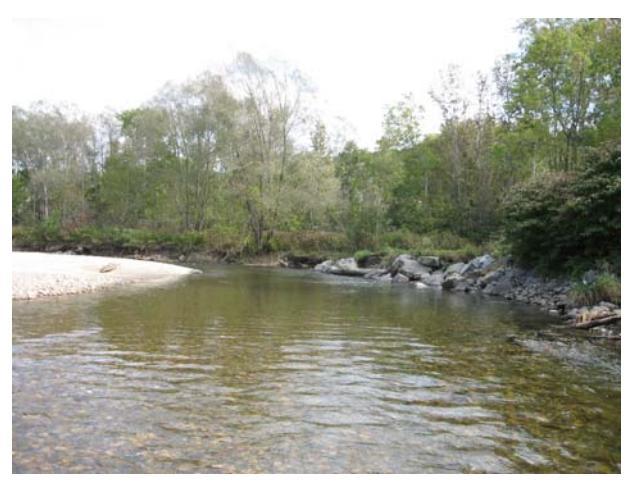
Figure 14: Reach T101B looking upstream showing new bank armoring protecting residential activities along left bank. Some new bar development on opposite bank

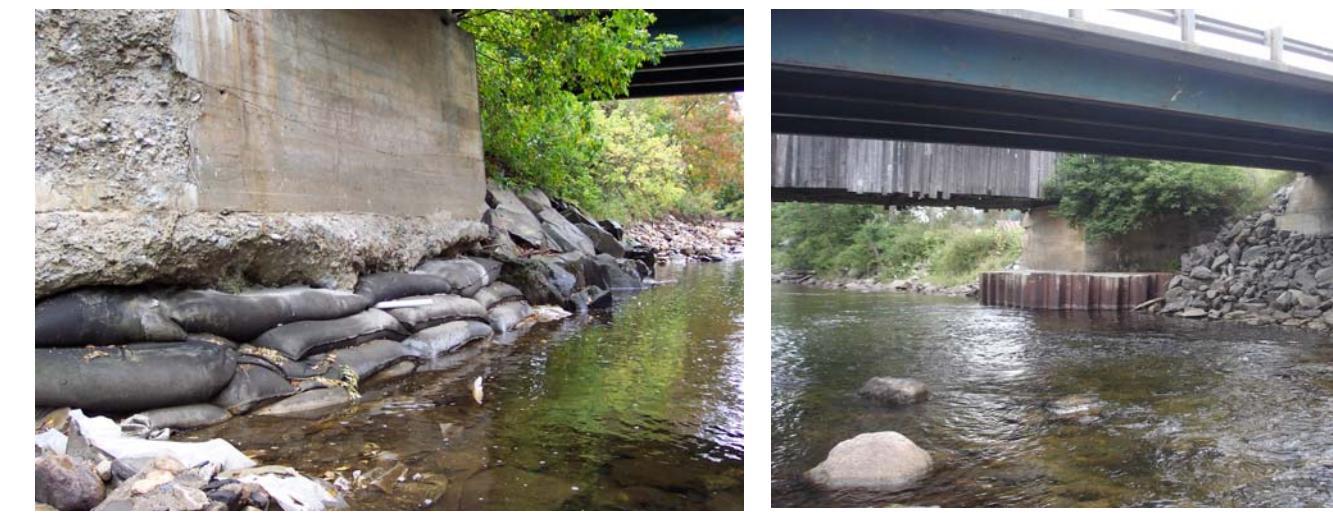
Figure 16: View looking upstream beneath Burrington Bridge (in background) and the covered bridge on Reach T102A taken in 2003. Channel degradation evident with reinforcements necessary beneath original footings. Stream level was formerly at base of concrete footing.

While the entire reach was classified as a C-type stream in Phase 1, this segment has departed to an Ftype stream with an incision ratio of 1.96. In reference condition the river would have access to its broad valley in flood conditions, but this segment currently has an entrenchment ratio of 1.14. T101A is slightly more naturally confined that the rest of the reach, however. In Stage II channel evolution, channel degradation is the current adjustment pattern taking place. Under flood conditions, floodwaters would be confined to the channel creating continued intense stream power, erosion hazards, channel degradation and increased water volume delivered downstream and to Lyndon. There is a conserved parcel along the right bank upstream of the bridges, and a gravel pit operation along the left corridor. The gravel pit and the stream are separated by a 30' tall stream bank that drops down approximately 10' to the gravel pit.

Project	Reach	Watershed	Completed	Next Steps and
River		Priority	Priority	Independen	other project notes
Segment				t of Other	
				Practices	
T102A	Protect River Corridor	High	High	Yes	Recommend a consideration of corridor protection through
					easements for all available
					undeveloped land in river corridor.
T102A	Examine	Moderate	Moderate	Yes	Some recent work was completed on
	Bridge				the bridge footings however both
	Structures				structures are still channel
					constrictions and causing channel
					bed scour. Bridges impact should
					be examined and replacement
					considered.
T102A	Restore	Low	Low		Explore excavation along right bank
	floodplain				to lower elevation of floodplain and
	access				help restore floodwater storage.
					Natural confinement may be
					prohibitive.
T102A	Restore	Low	Low	Yes	Explore potential of excavation
	floodplain				between gravel pit and stream which
	access				may offer additional floodwater

storage by terracing. Gravel
					operation could potentially benefit
					from additional material in
					exchange for corridor protection.

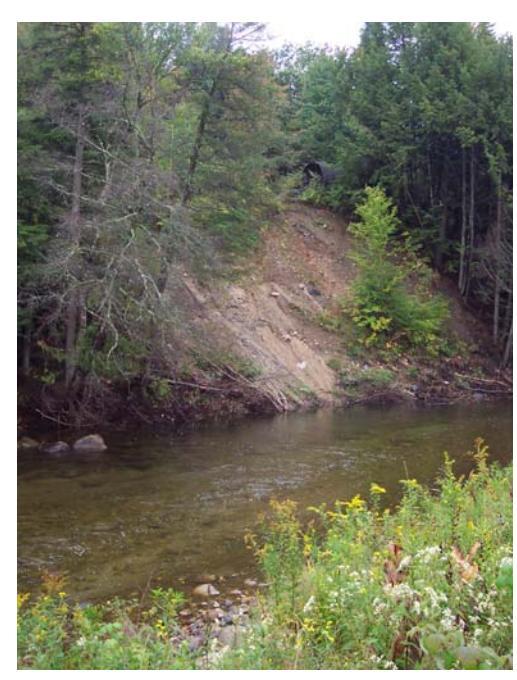
Figure 19: Mass failure on Reach T102B

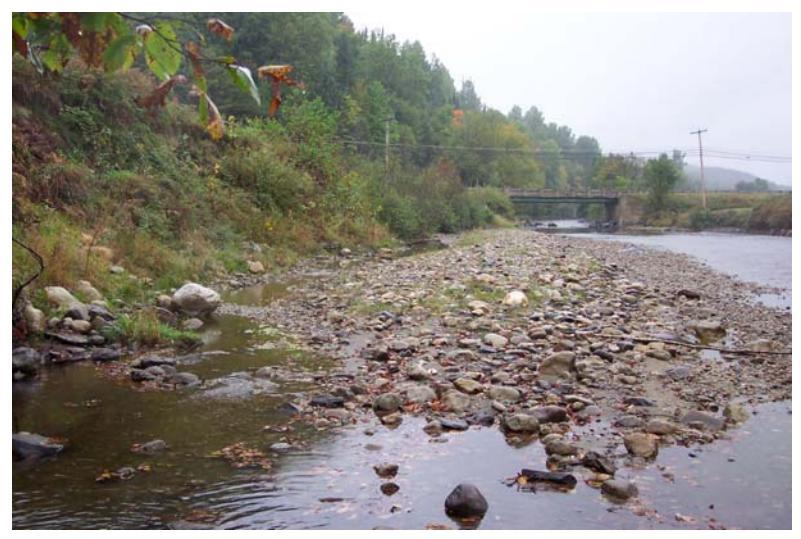
Figure 20: Looking upstream towards Route 114 Bridge on Reach T102B, Riverside Center on left. Sediment deposits and channel widening evident.

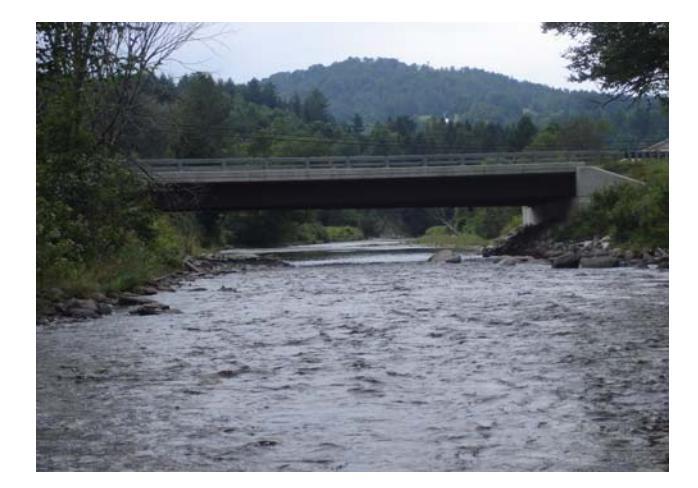
Figure 21: Looking upstream towards Route 114 Bridge on Reach T102B, Riverside Center on left. Sediment deposits and channel widening evident.

Project	Reach	Watershed	Completed	Next Steps and
River		Priority	Priority	Independen	other project notes
Segment				t of Other	
				Practices	
T102B	Protect River Corridor	High	High	Yes	Recommend a consideration of corridor protection through easements for all available undeveloped land in river corridor. River is adjusting and widening and it should be allowed to continue its natural processes. Riverside Life Center lower field very important floodplain.
T102B	Install buffers	High	Moderate	Yes	Eroding and unbuffered banks could be improved through installation of vegetated buffers.
T102B	Examine Bridge Structures	Moderate	Moderate	Yes	Some recent work was completed on the bridge footings however both structures are still channel constrictions and causing channel bed scour. Bridges impact should be examined and replacement considered.
T102B	Examine conflict at facility	Moderate	Low	Yes	Channel adjustments could impact land use at Riverside Enrichment Center. Bank erosion has subsided since 2003, but adjustments could occur at any time.

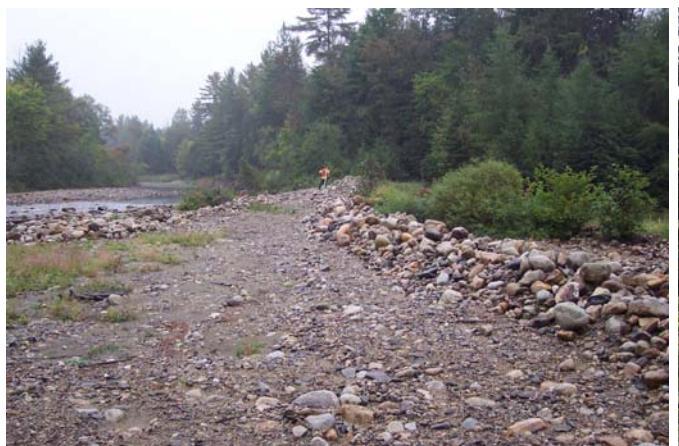
Figure 23: Looking upstream at berm on Reach T102C in 2003, one year after flood.

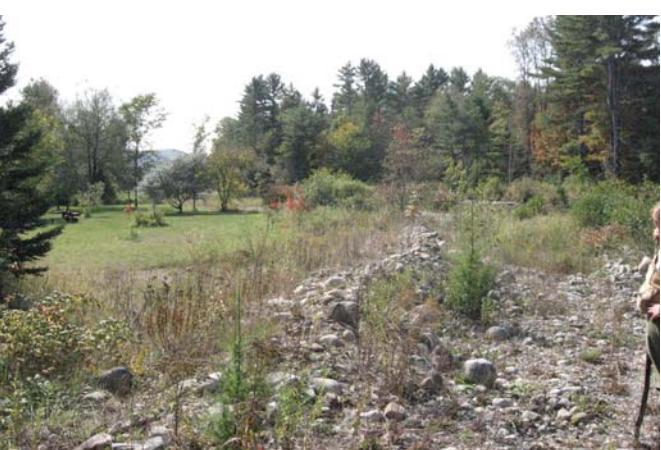
Figure 24: Looking downstream on the same berm in 2008. Floodplain is building.

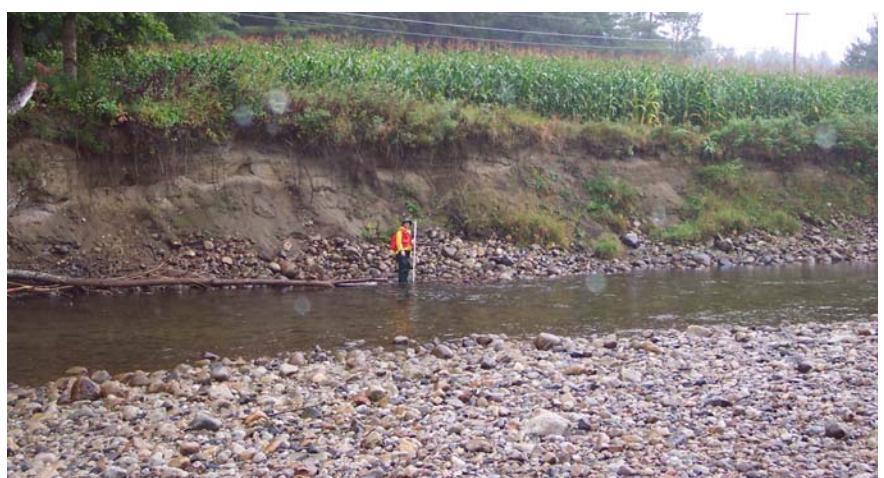
Figure 25: Upstream end of 12-acre cornfield on T102C. Tall eroding bank and no buffer. The majority of this large agricultural field is in Reach T102B

Project	Reach	Watershed	Completed	Next Steps and
River		Priority	Priority	Independen	other project notes
Segment				t of Other	
				Practices	
T102C	Protect River	High	Moderate	Yes	Residences along left bank corridor
	Corridor				are dependent on small pockets of
					floodplain along right bank and
					valley wall. Segment is undergoing a
					great deal of adjustment. Erosion
					and trees/debris adding to
					adjustment. Further development
					should be prohibited.
T102C	Landowner	High	Moderate	Yes	Recommend continued outreach to
	Outreach				landowners so they're made aware
					of potential conflicts.
T102C	Install buffers	Moderate	Moderate	Yes	Opportunity for buffer on 12-acre
					corn field.
T102C	Examine areas	Moderate	Moderate	Yes	Fluvial erosion hazards are evident
	of conflict				at lower residence. House was built
					on same location where former
					house fell into stream. Area should
					be monitored very closely.

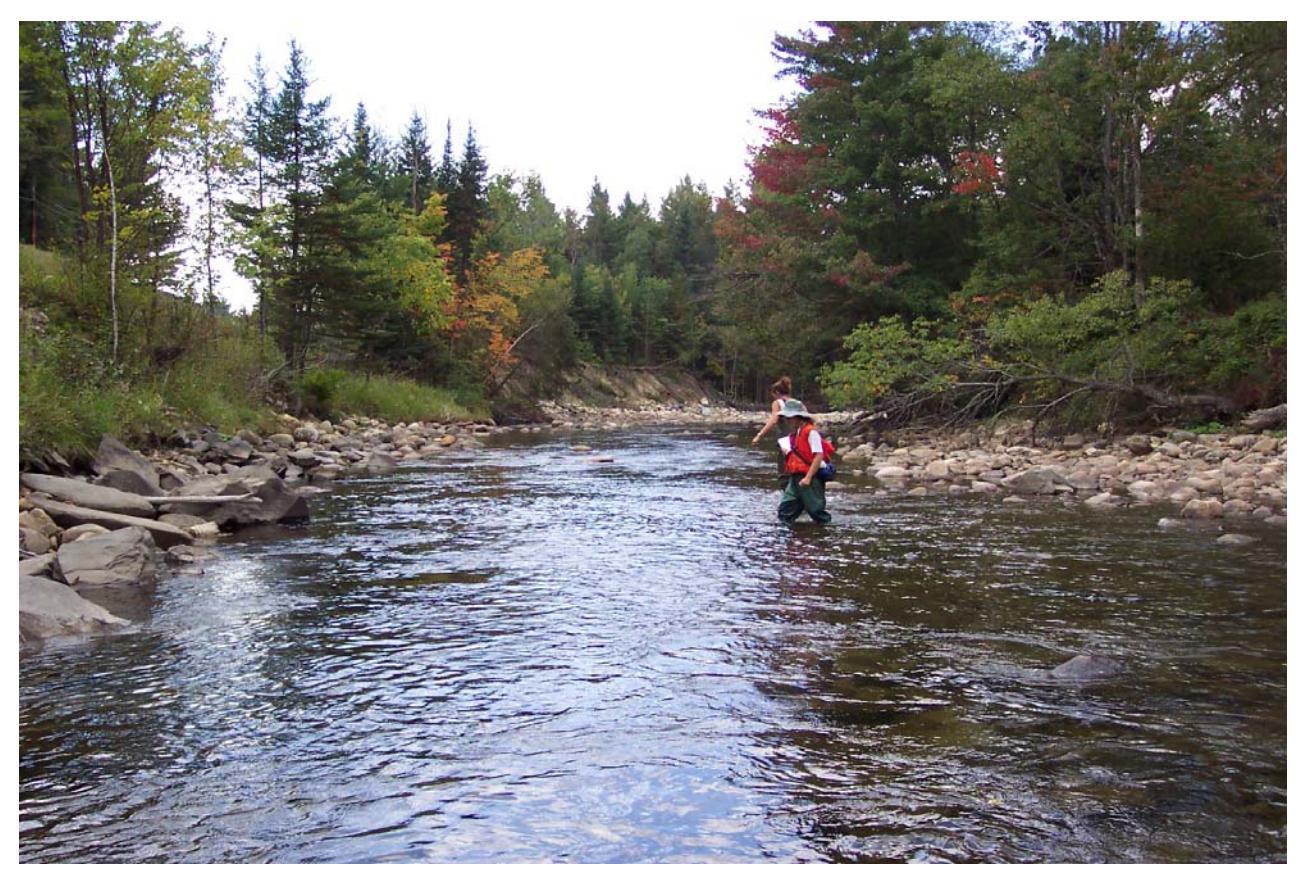
Reach T103 extends for 2086' and is flanked on its entire left bank corridor by Route 114. It pulls away from the road slightly towards the downstream end of the segment, where there is a mass failure and an old vehicle within the bank. The right bank is flanked by the valley wall with small pockets of floodplain at its base. There is evidence of straightening and dredging on this reach. The reach keys out to a C subclass b type stream with gravel dominated substrate and riffle pool bed form. While the reach seems confined and locked against the valley wall by the road, there is enough room largely due to the small floodplain pockets along the right bank for planform movement to occur. There are some recent deposits along the reach, likely from the 2002 flood, but it was determined that the reach is in an early stage II of channel evolution with an incision ratio of 1.1 and an entrenchment ratio of 2.7. Channel degradation that was observed was historic.

Figure 27: Reach T103 with Route 114 on left, mass failure downstream and floodplain pockets along right bank, photo taken in 2003 one year after flood

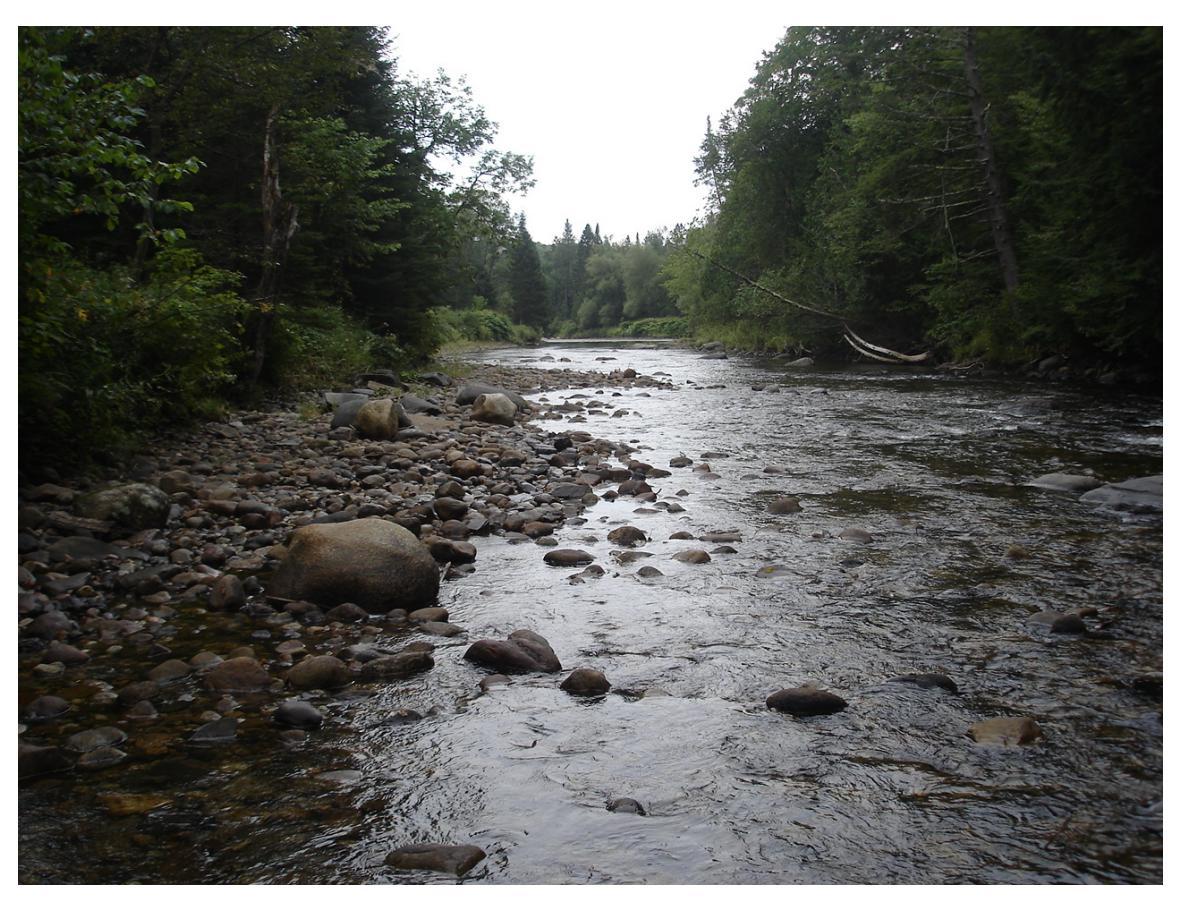
Figure 29: Reach T104 showing some bar formation

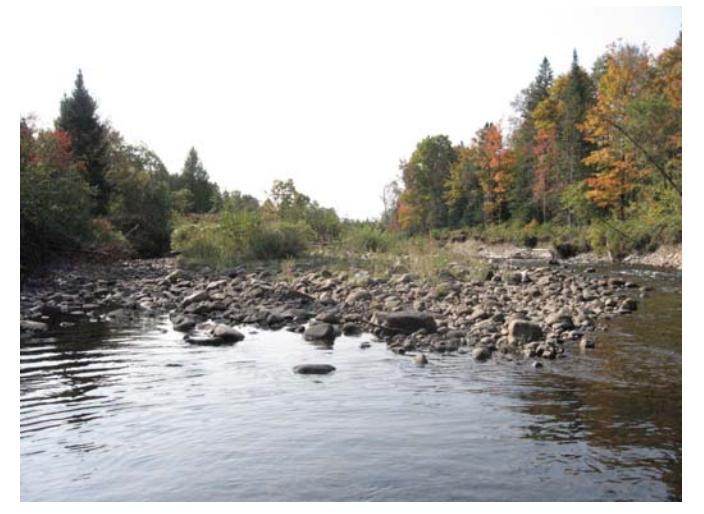
Figure 31: Reach T105A showing bank erosion supplying coarse sediment to segment and channel widening. First depositional features downstream of East Burke Dam.

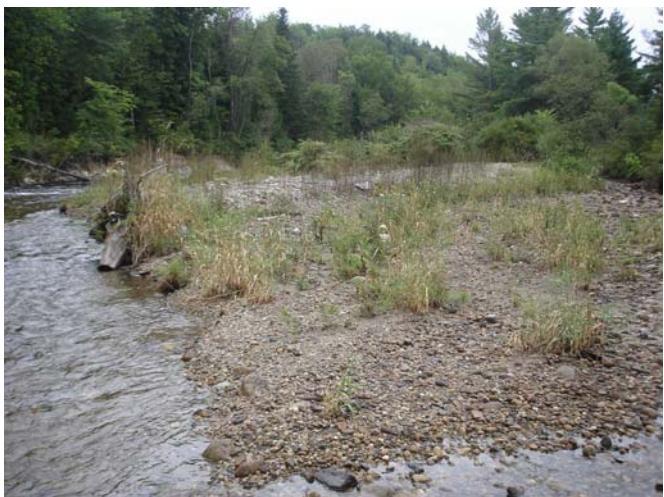
Figure 32: Reach T105A showing additional depositional features and bifurcated flow

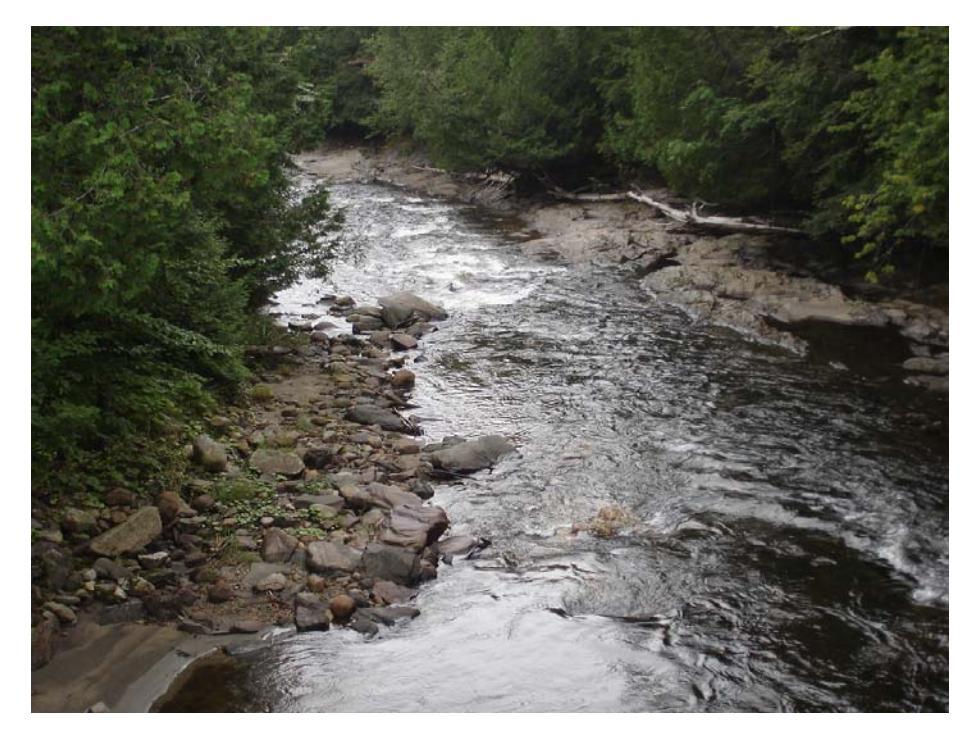
Figure 33: Looking downstream on Reach T105B. Segment is deprived of sediment due to upstream impoundment

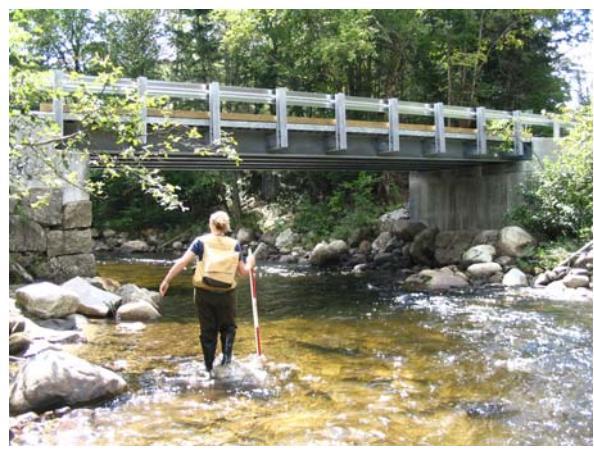
Figure 41: Reach T107B Worden Road Bridge

immediately downstream is 35'. The bankfull width is 87'. The bridge has alignment problems and together with the abutment the structures are acting as a channel constriction. The upstream bridge on Worden Road is 40' wide. The bank armoring recorded near the Worden Road bridge was noted as riprap but it is likely the result of windrowing after a flood event, with dredging also evident. And additional old abutment upstream measures 33' wide. There is just over 2000' of bank armoring which is located primarily where the stream abuts Route 114 or surrounding bridge structures. A natural gas pipeline crosses under the East Branch and a small rise in bed elevation is evident there.
