Evan P. Fitzgerald UVM/ANR Stream Geomorphic Assessment Project, Chittenden County, VT Bartlett Brook Phase II Documentation and QA/QC Notes July 26, 2006

Bartlett Brook Summary:

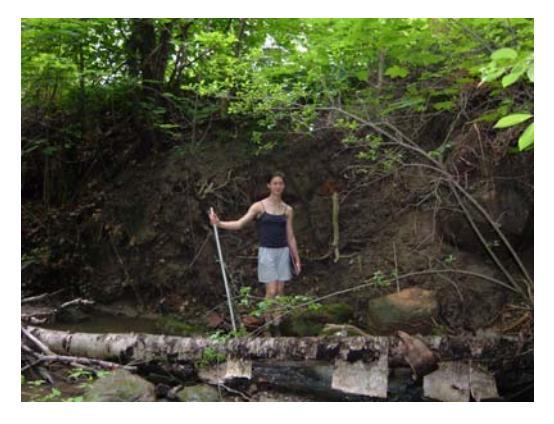
It can be clearly observed that the changes in watershed hydrology have affected the stability and habitat of reach M01. Bank erosion was observed in approximately 30% of the stream channel, and one large mass failure was noted (see photo to left). Local encroachments on the channel are also contributing to increased stream power and sediment transport capacity. Armoring appears to be holding a large area of the bank stable within the reach. Significant entrenchment and incision noted in channel geometry measurements will likely maintain transport regime (with degraded bed features) in perpetuity. Reach M02, located above and below Rt. 7, is a diverse reach with many different types of stream features. This diversity of stream geometry within M02 has been noted in Step 5 of the DMS, and should include further segmentation for any future geomorphic assessment work. In the lower part of M02, the channel has been completely redesigned and modified as part of a channel restoration effort by Pioneer Environmental Associates and the City of South Burlington. A cross-section plot of this redesigned channel is included in Appendix 2, and the entire length of this segment of the channel was observed to be stable with no significant signs of aggradation or degradation.

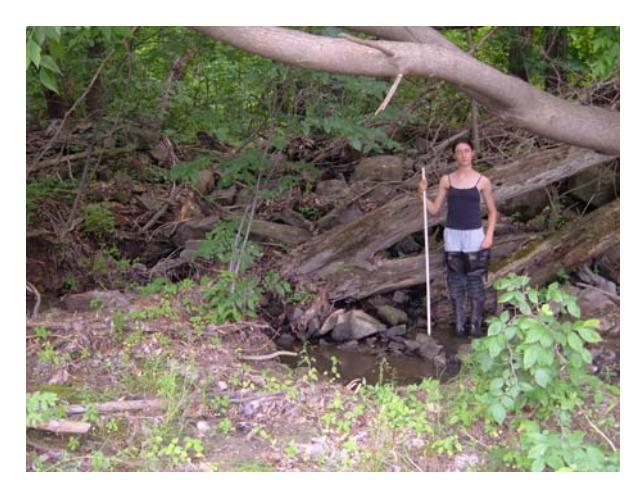
In reach M02 just above Rt. 7, there is an historic road crossing (old Rt. 7 location) that is a very large grade control and continues to affect the equilibrium condition of the channel network directly above it (see photo to left). In future assessment work, this segment should be typed as a "sub-reach" of M02, as its channel geometry resembles an E-type more than the B type referenced in the DMS. This grade control (approx. 10 ft) has caused significant aggradation in the channel directly upstream, and has likely caused a change in stream type since the crossing was established. Further discussion of this reach is also found in the STD section below.

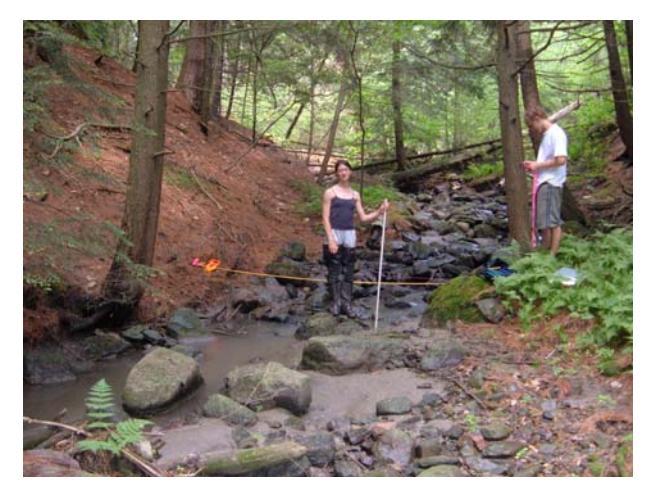
Above this zone of aggradation in M02, the channel slope increases and valley becomes more confined. Multiple, large mass failures are found in this small section of M02, and widening is occurring as a result (see photo to right). Dominant bed substrate was likely cobble under natural conditions, but aggradation of fine clay and sand material from the reach-wide mass failures has led to planebed features with a median substrate size of gravel. Although local encroachment is absent throughout this section, further incision and widening associated with upslope stormwater outfalls will likely continue to occur in this section of the reach, and habitat features associated with the natural step-pool system will continue to be lost.
