# <u>Fluvial Geomorphology Assessment of the</u> <u>Poultney River and Hubbardton River,</u> <u>Vermont</u>

## The Nature Conservancy Southern Lake Champlain Valley Program West Haven, VT

Field Geology Services Farmington, ME

March 2006

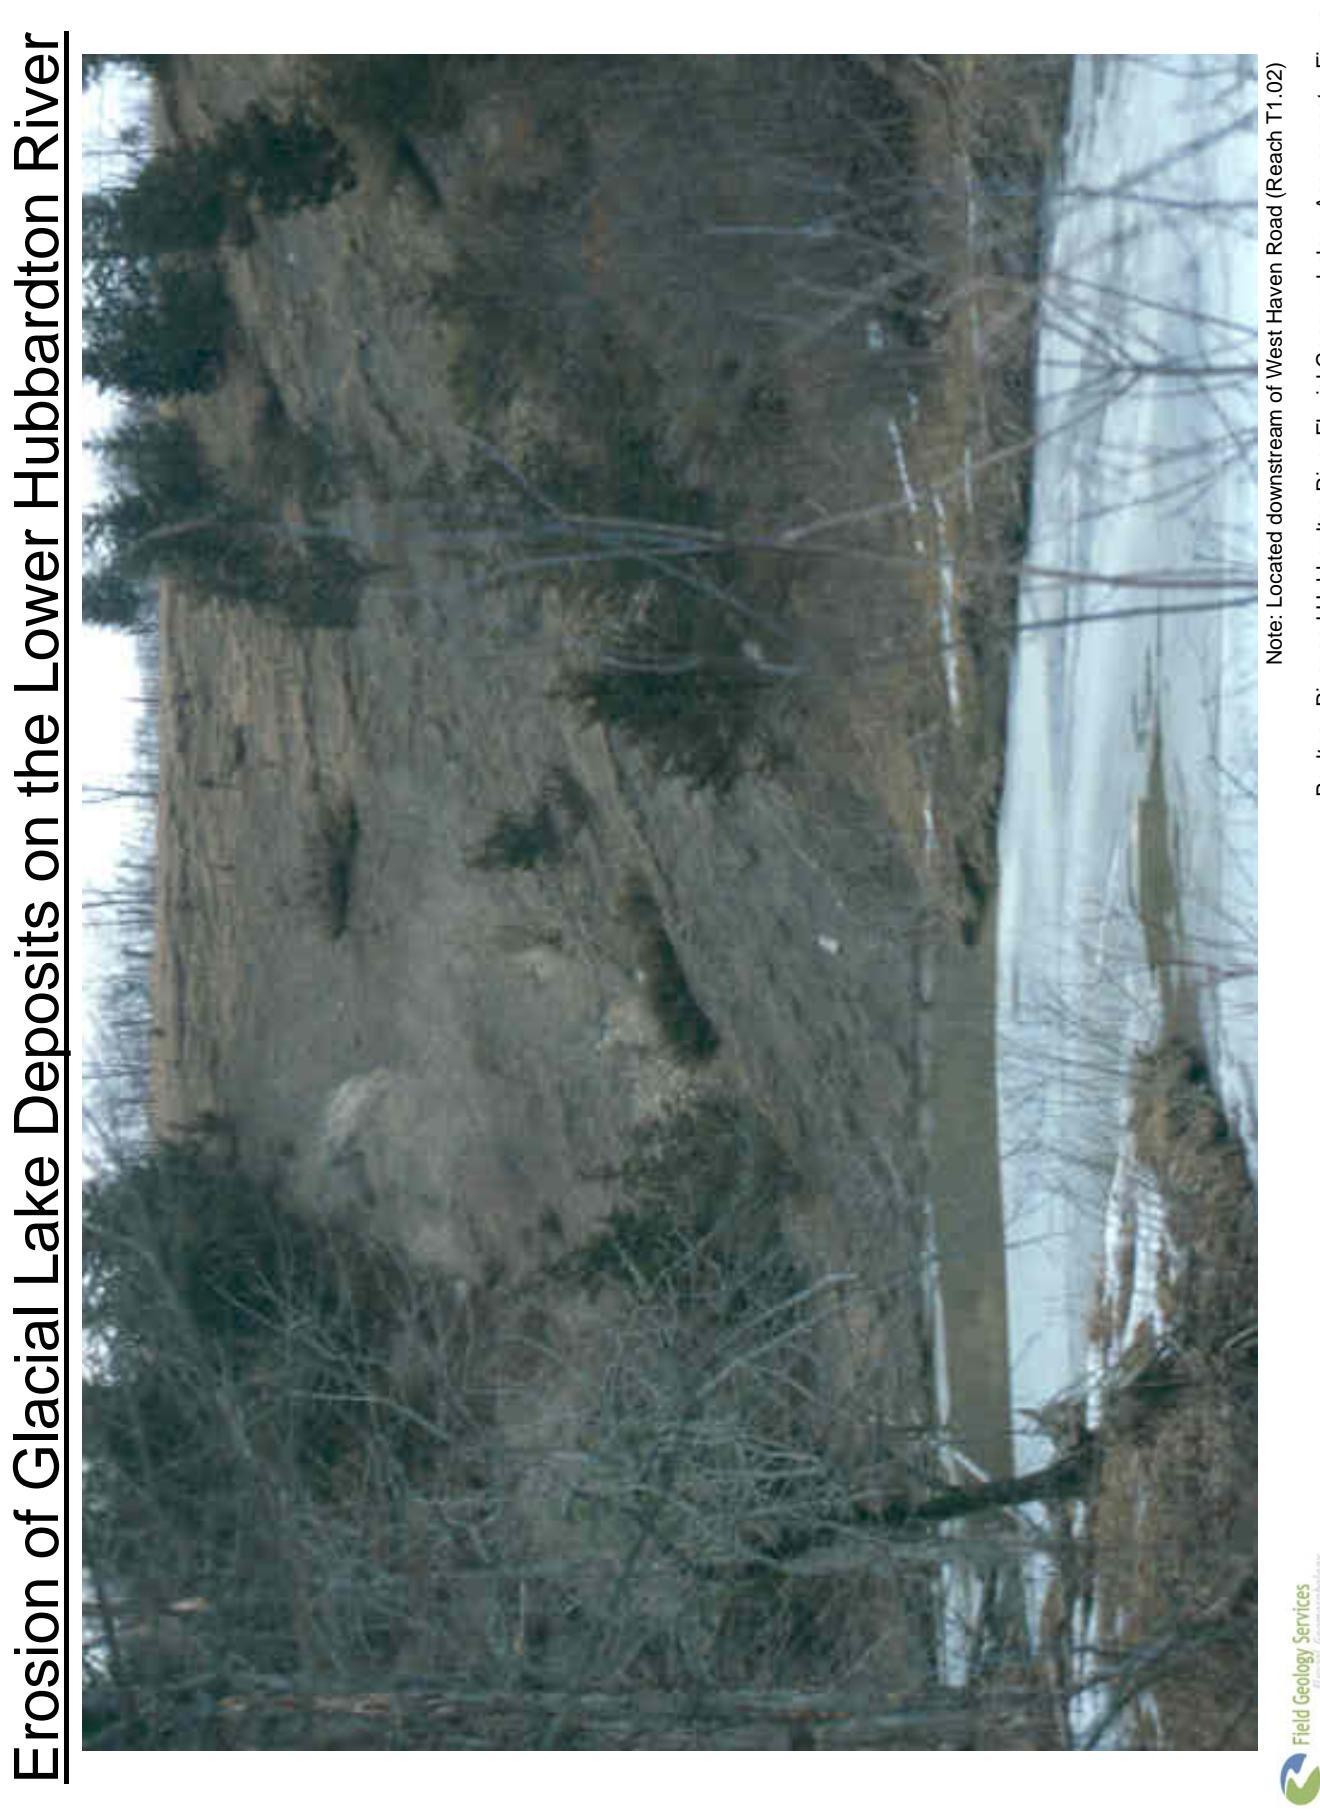
Poultney River and Hubbardton River Fluvial Geomorphology Assessment – Figure 4

- Figure 2: Eroding bank of glacial deposits on the upper Poultney River
- Figure 3: Large unvegetated gravel bar on the Poultney River
- Figure 4: High eroding bank of glacial lake deposits on the Hubbardton River

The Hubbardton River flows entirely within the Champlain Basin. The lowest reaches of the Hubbardton River (Reaches T1.01-T1.02) are incised over 100 feet into the glacial lake terrace. Channel sinuosity and channel migration values are low as the river is narrowly confined within nonalluvial slopes. Reach T1.02 is a "B" type stream by reference where the confinement is greatest. Although Reach T1.01 is a "C" stream by reference because valley widening has progressed sufficiently to create a narrow floodplain, the river frequently flows against the high banks, destabilizing the nonalluvial slopes (Figure 4). The Hubbardton River flows almost exclusively over clay soils deposited in a glacial lake or Champlain Sea that filled the Champlain Basin near the end of the last Ice Age (Figure 5). Both the low slopes and clay soils along the Hubbardton River promote the development of the highly sinuous channels and erodible banks observed in the middle reaches of the Hubbardton River (Reaches T1.03-T1.04)(Table 1). The occurrence of clay soils within the broad valley of the middle Poultney River (Reaches M7-M9) may also lead to the high channel sinuosity values observed in this area.

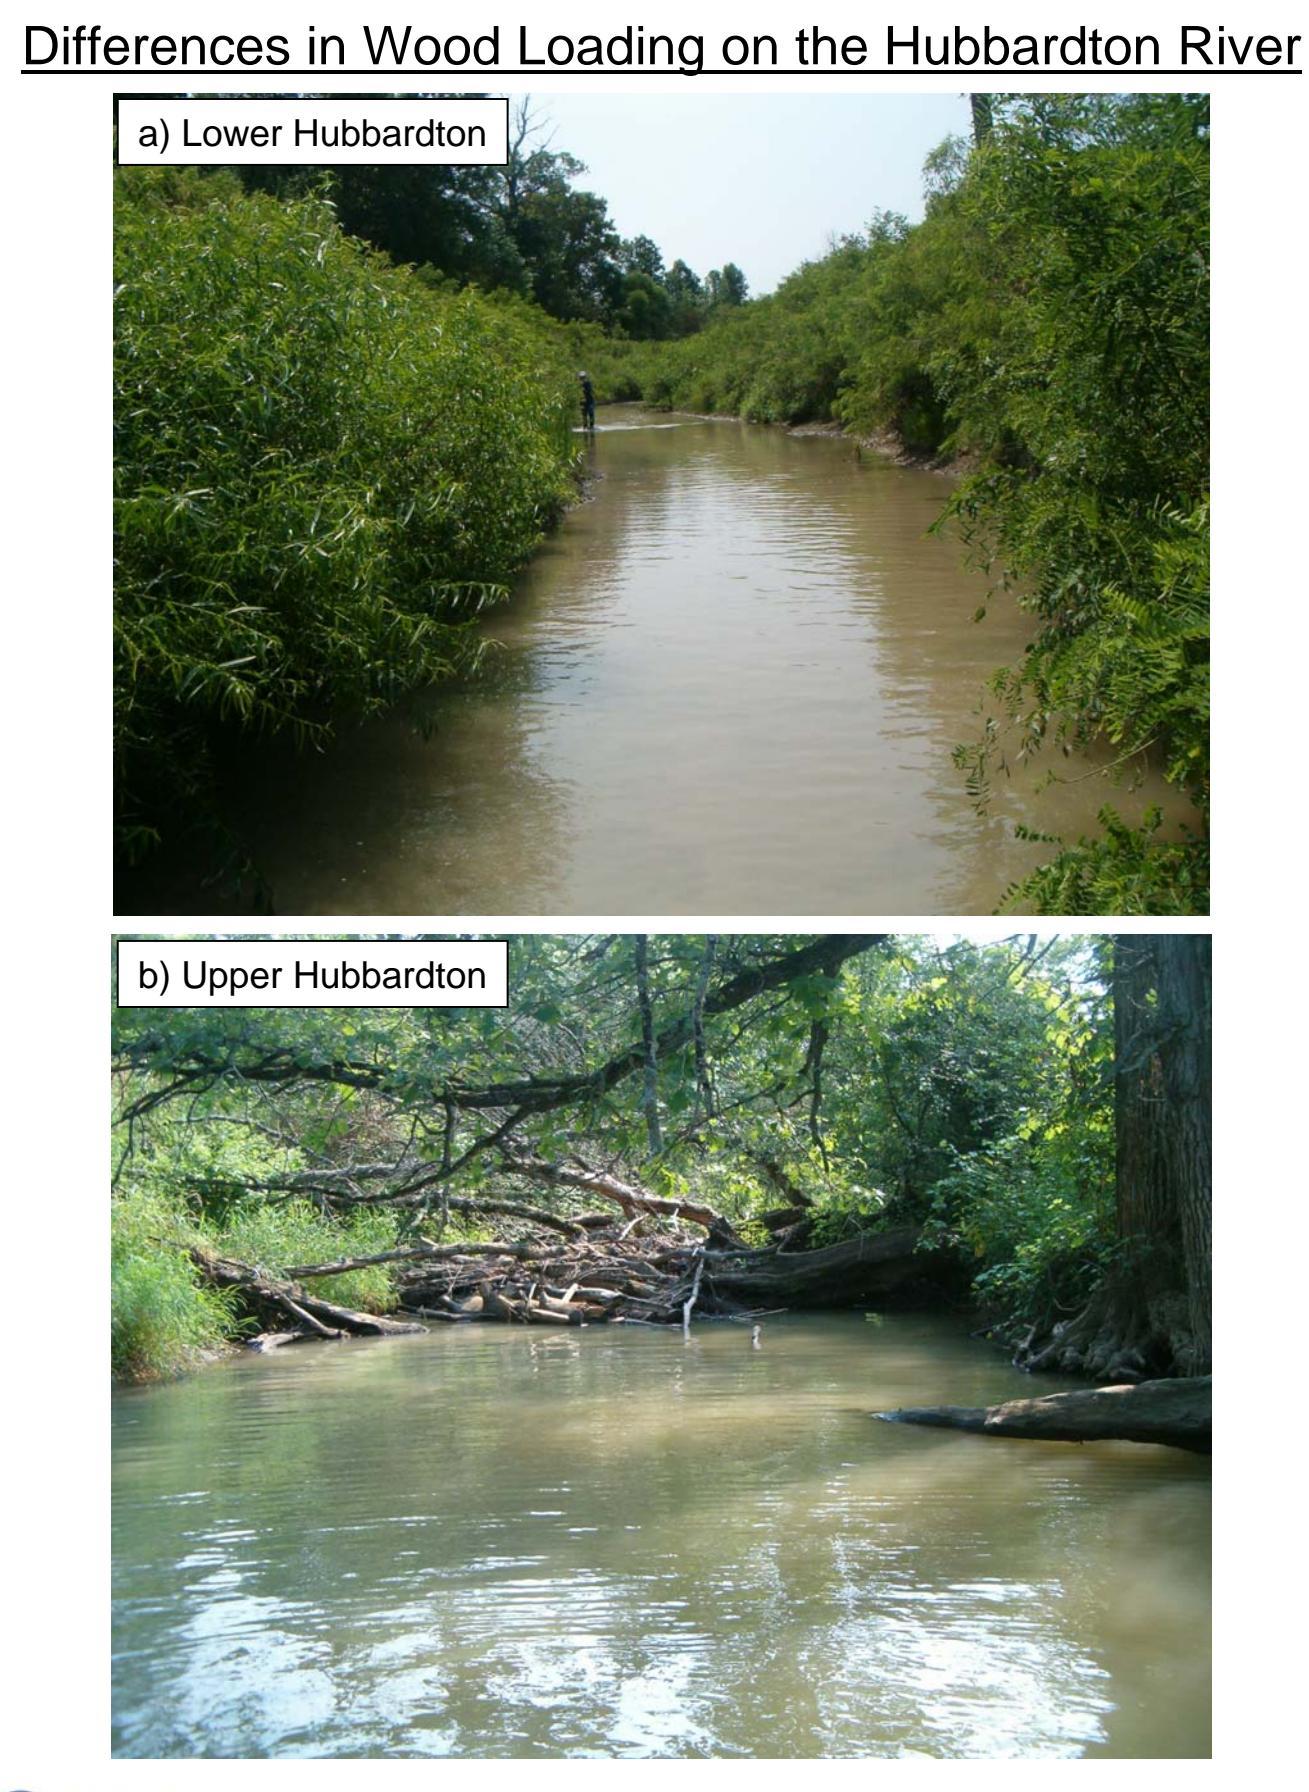
Poultney River and Hubbardton River Fluvial Geomorphology Assessment - Figure 8

- Figure 8: Portion of a) the lower Hubbardton River with no wood in the channel and high banks and b) the upper Hubbardton River with wood in the channel and low banks

Differences in channel morphology between the lower and upper Hubbardton River reflect the river's response to the 20<sup>th</sup> Century (and earlier) removal of wood from the channel. The wood removal was done to reduce flooding and improve drainage for agriculture but the resulting reduction in channel roughness caused channel incision. Incision on the lower Hubbardton River might be locally enhanced by the presence of Mill Pond Dam upstream (Reach T1.04) and tributary rejuvenation (Reach T1.01) in response to channel incision of the lower Poultney River. While wood has naturally reaccumulated along portions of the upper Hubbardton River (Figure 8b), the lower Hubbardton River is still largely devoid of wood (Figure 8a). Consequently, the upper Hubbardton River is reconnected to its floodplain (Figure 12b) and is no longer incised, as may have been the case several decades ago. An incised condition still persists on the lower Hubbardton River with widespread continuous bank erosion (Figure 14 and Appendix 2), high incision ratios (Figure 12a and Appendix 1), and reduced access to the floodplain and former channels (Figure 13).

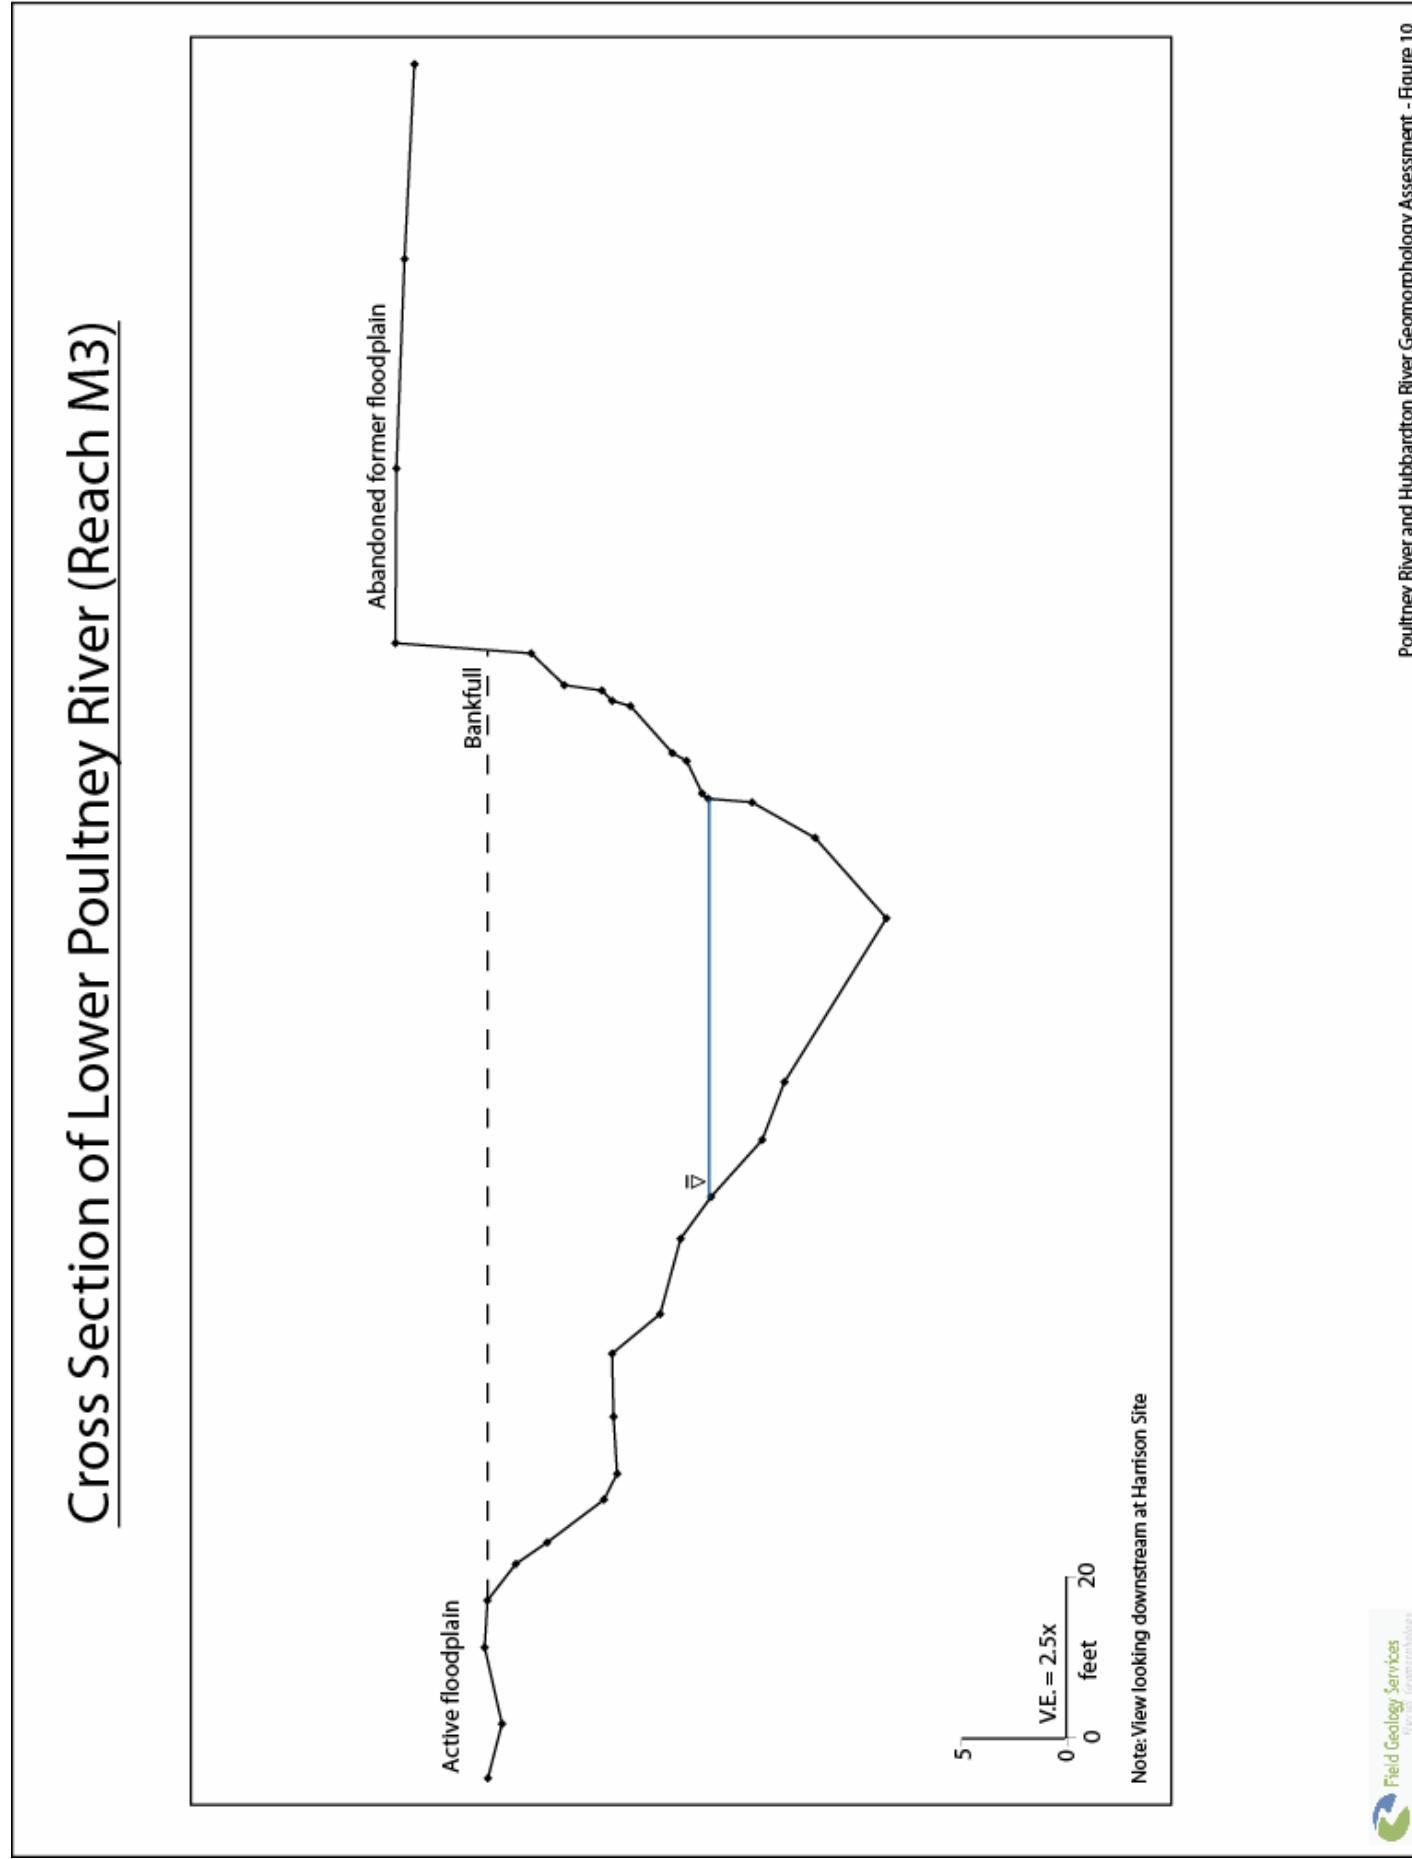
Poultney River and Hubbardton River Geomorphology Assessment - Hgure 10

- Figure 9: Comparison of cross sections along a) straightened and b) meandering channel segment on the Poultney River
- Figure 10: Cross section of lower Poultney River showing newly developed floodplain lower than older abandoned floodplain surface

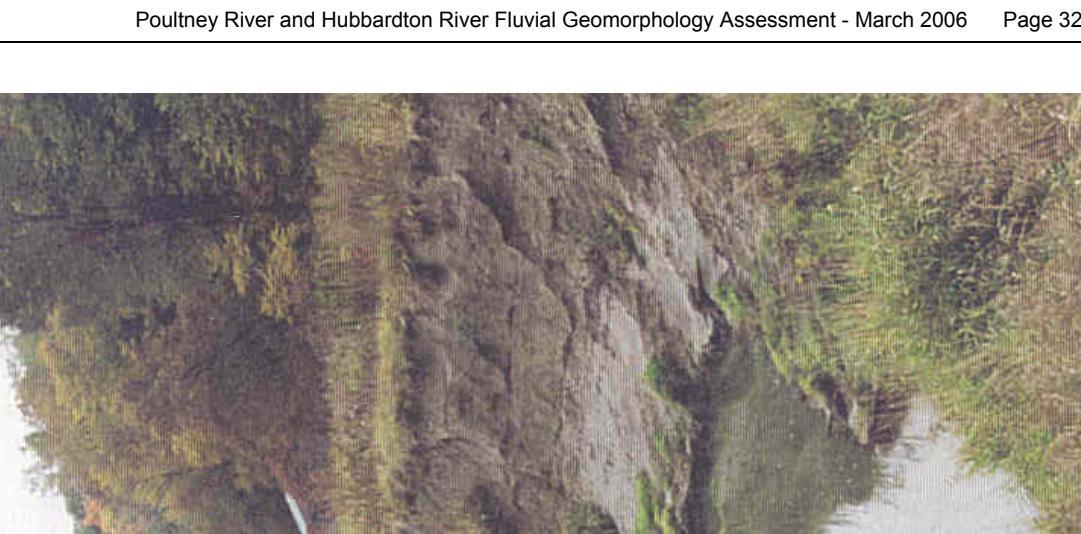
Poultney River and Hubbardton River Fluvial Geomorphology Assessment – Figure 11

- Figure 11: Photo of eroding bank on lower Poultney River exposing post-European settlement deposits
- Figure 12: Comparison of cross sections along an a) incised reach and b) unincised reach of the Hubbardton River
