LaPlatte River Corridor Plan

Reaches M6 – M11

Towns of Charlotte and Shelburne, Vermont

Prepared by the LaPlatte Watershed Partnership
April, 2008

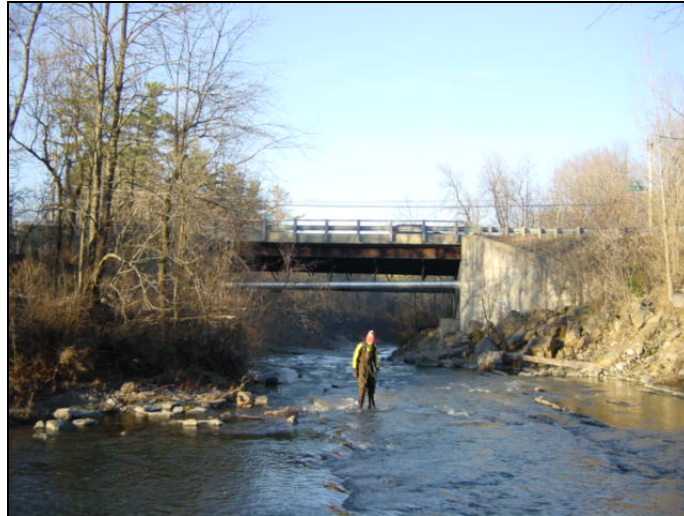
Figure 6.1. Shelburne Falls Road Bridge in M05.

The Shelburne Falls Road Bridge is equal to the channel width for reach M06 so was smaller than the recommended width. However, it is located just upstream of Shelburne Falls, a naturally constricted and bedrock controlled area. So although the bridge constricts and fills the floodplain in this area, the concern is less because of the natural constriction of the falls. Higher pressures would be exerted on the bridge abutments during floods, as it constricts the floodplain, so widening it could increase the lifespan of the structure.

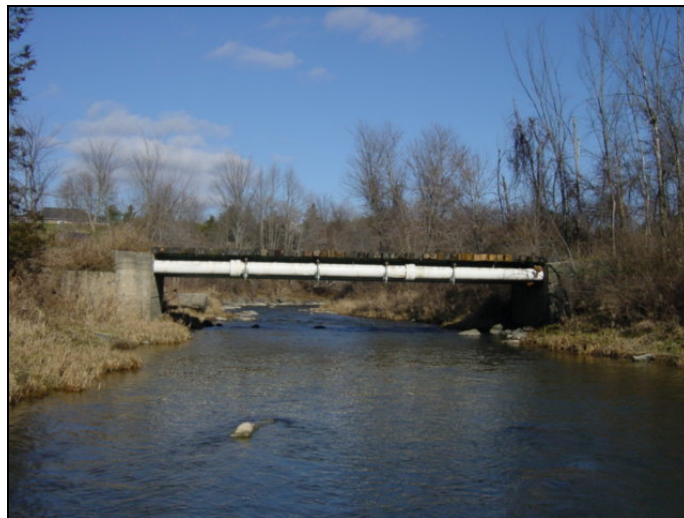
Figure 6.2. Farm access bridge in M06.

In reach M06, a farm access bridge constricts the channel width. Minor scouring of the channel bed was present downstream of the structure. Reach M06 did appear to be incised, so additional

pressure would be placed on the banks in higher than bankfull flows that are not high enough to reach the floodplain. This structure could be at risk of failure from erosion due to it constricting the channel, however, the floodplain did not appear to have been filled for the roadway or the approaches to the structure. Therefore flood flows that reach the floodplain could pass over the road and around the structure.

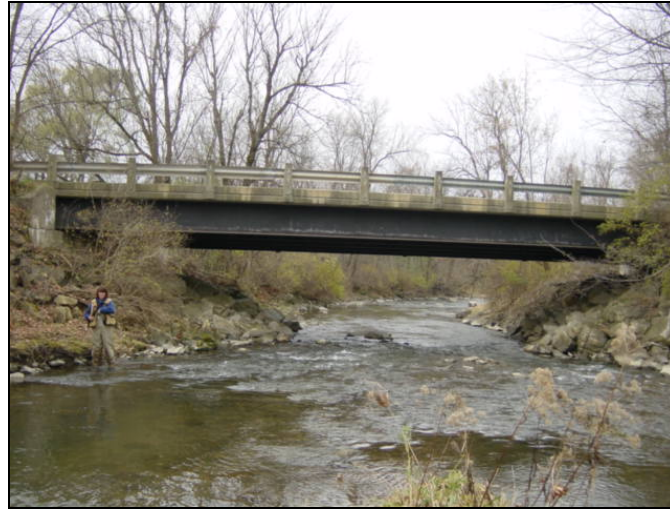
Figure 6.3. Spear Street Bridge in M09A.

The Spear Street Bridge in segment M09A did slightly constrict the channel width (88%) and had sediment deposition upstream and bank erosion present. Again, the floodplain was entirely filled by the road approaches, forcing all flood flows through this structure. Bank armoring was present as well, but resizing this structure could alleviate bank pressure and reduce erosion.

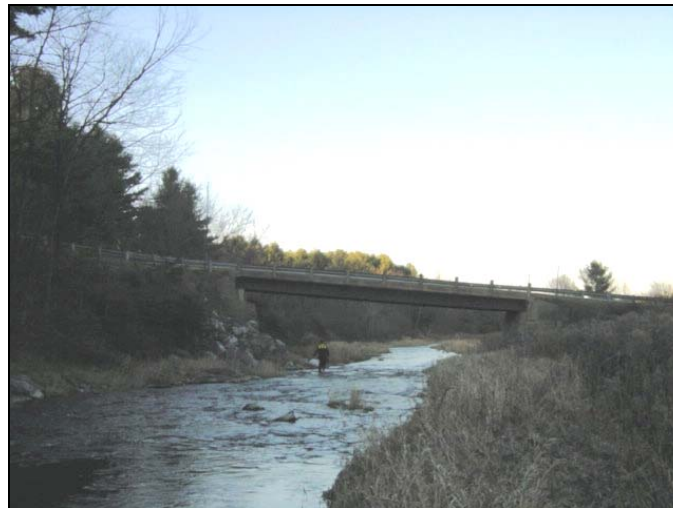
Figure 6.4. M10 Bridge at Carpenter Rd.

The Bridge at Carpenter Road in reach M10 meets the recommended width at 147% of stream width. Bedrock upstream of the structure helps control channel location in this area.

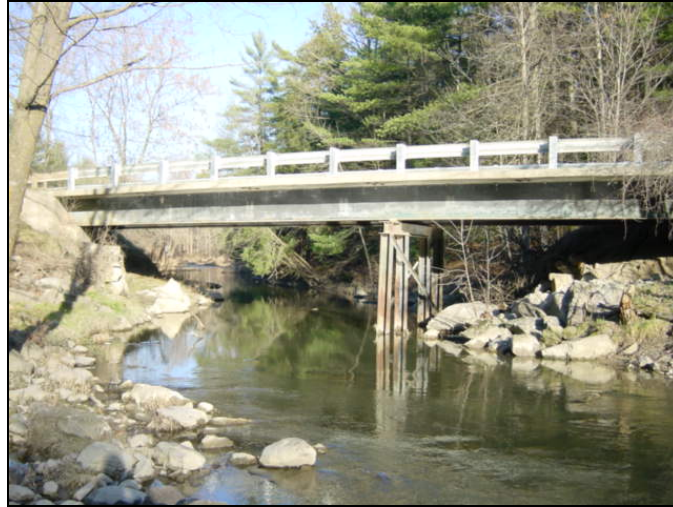
Figure 6.5. M11 Bridge at Dorset Street

The Dorset Street Bridge in M11 also meets the recommended structure width at 144% of stream width. An animal crossing at the bridge has led to bank trampling and erosion. Additional erosion and failing riprap are present. At the time of assessment, several deer carcasses had been dumped onto the bank from the bridge above as well as other trash. This dumping, as well as the animal crossing, compromise water quality. While the overall span of the bridge is large enough to meet RMP guidelines, the riprap at the base of the structure acts to constrict the channel. Widening this area by moving the riprap is recommended.

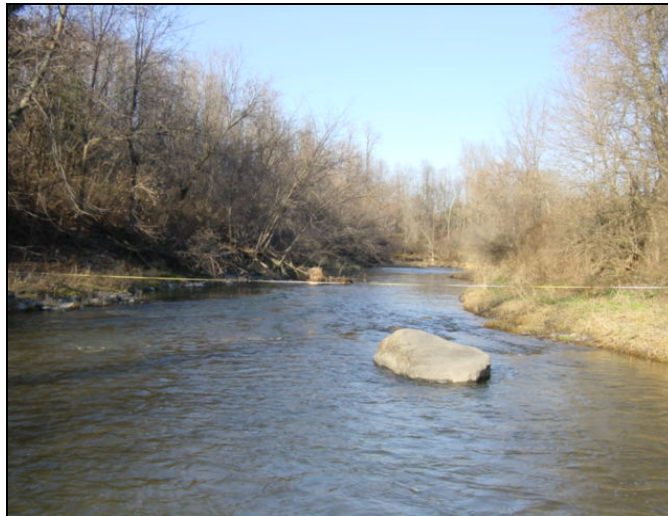
Figure 6.6. View of Reach M06.

The reference stream type for this reach appeared to be a meandering, gravel bed stream with Riffle-Pool features. However, due to channel incision (ratio 1.95), the reach experienced a stream type departure to a more incised, less meandering, Plane Bed type. Floodplain access was limited, although old channels and/or flood chutes on the upper terrace could provide additional floodplain access and relief from high flows. Incision appeared to be historical, as did channel widening. Current channel adjustments appeared to be aggradation and major planform. Bank erosion, islands, and multiple mass failures were indicators of these adjustments with significant contributions to sediment loads. Also contributing sediment were rejuvenating tributaries in the reach and gullies from stormwater inputs. Shelburne Falls at the downstream end of the reach provided grade control. The river corridor was largely undeveloped except for some short sections of road and some houses on the fringes.

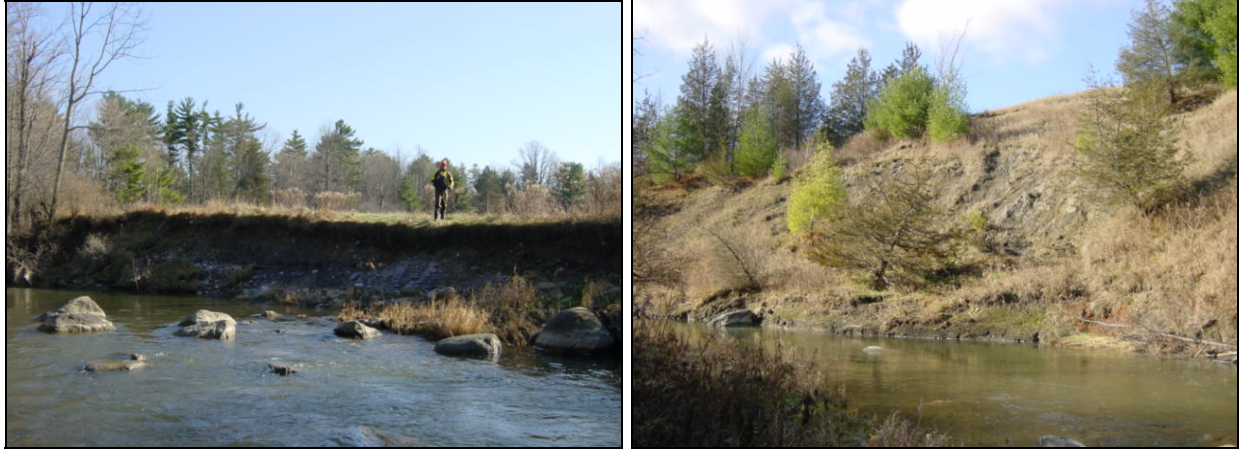
Figure 6.7. Bank erosion on an outside bend, contributing sediment (L) and one of many mass failures in M06 (R).

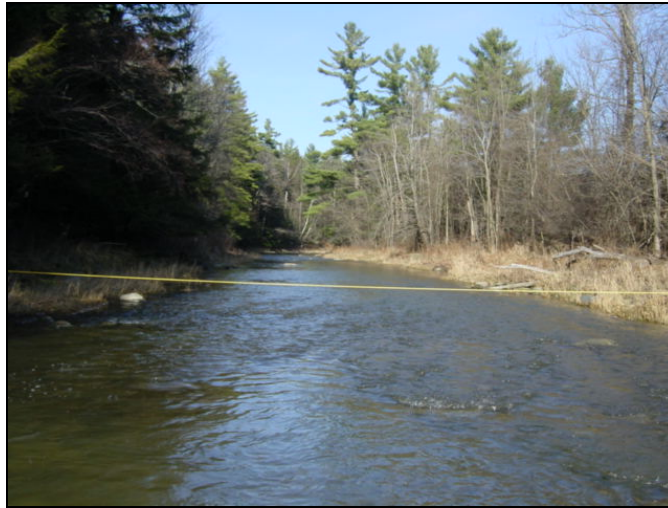
Figure 6.8. View of reach M7, appearing overwidened and with a plane bed form.

Reach M07 was fairly short, 2158 feet long, and appeared naturally straight. This section of the LaPlatte was in a narrowly confined, somewhat deep valley setting. Due to this narrow valley, there was very little floodplain adjacent to the channel. The “reference” stream would likely have been a step-pool type stream with cobble bed material. However, major sediment deposition filled the pools, leaving the stream with a Plane Bed stream type (no defined steps or pools) and more sand and fine gravel bed material. Overall, the stream geomorphic condition appeared “Good” with the channel widening historically and the current adjustment process being sediment deposition. Habitat condition in this section was “Good” but had a low mix of habitat types, no pools, incomplete riffles, and sediment deposition. Some hay fields on the right bank encroached into the otherwise forested corridor.

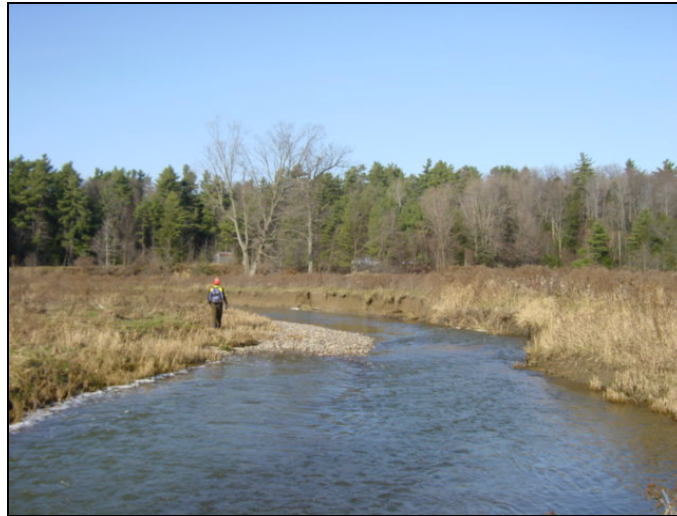
Figure 6.9. Right bank erosion and diagonal bar.

Reach M08 flowed through a broad valley dominated by herbaceous and shrub/sapling vegetation. The stream type appeared to be a meandering, riffle-pool type stream with mostly gravel bed material. Multiple sediment deposits (mid, point, side, and diagonal bars) were present. Many areas of bank erosion were observed as well as flood chutes (where high flows access chutes across the inside of a bend), signaling lateral channel migration.

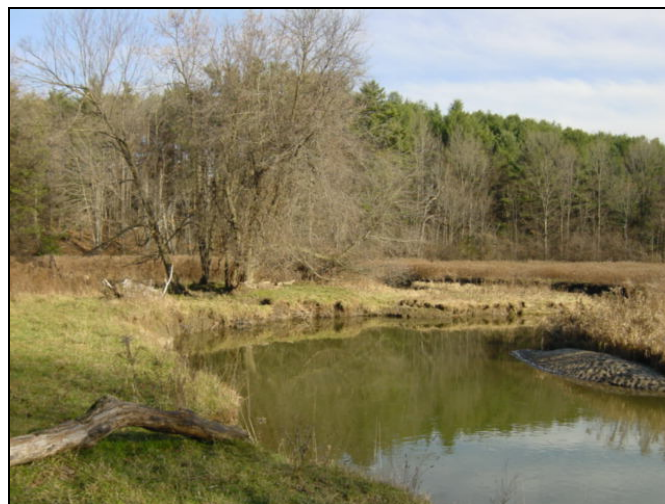
Figure 6.10. Channel meandering and varying terrace levels in reach M8, signaling lateral channel migration and slight incision with new bars forming.

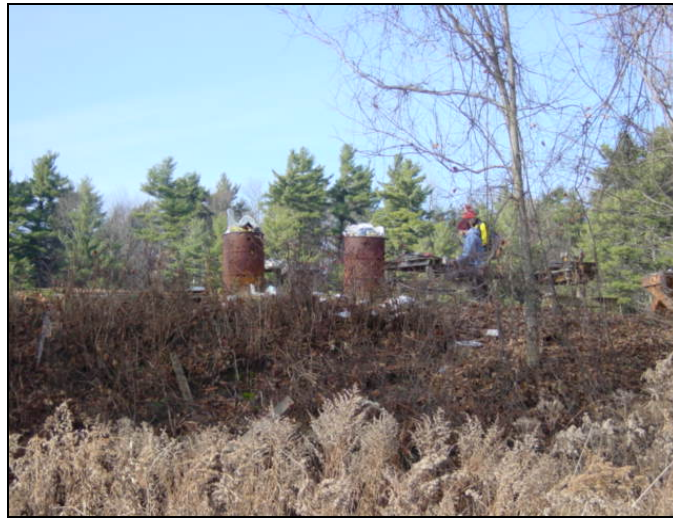
Figure 6.11. Trash close to the channel at the shooting range. Photo taken from the top of the left bank.

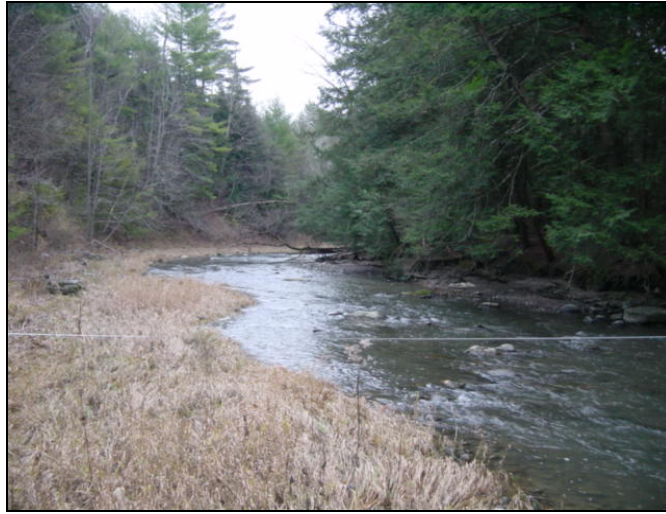
Figure 6.12. View of reach M9A upstream of Spear Street with small floodplain terrace developing.

Reach M09 was segmented into two segments due to varying planform and slope characteristics. Segment M09A (downstream segment) had a steeper slope and appeared to be a straighter stream with large gravel bed material and Plane Bed features by reference. Adjacent side slopes in the narrow valley were steep to very steep. The channel appeared to have eroded downward in the past, with evidence of an older, higher floodplain terrace adjacent to the stream. Current adjustment processes were minor sediment deposition, channel widening, and lateral channel migration. Overall stream condition appeared “Fair” and the channel in stage IV of evolution, no longer in reference condition but moving toward a new stage of balance.

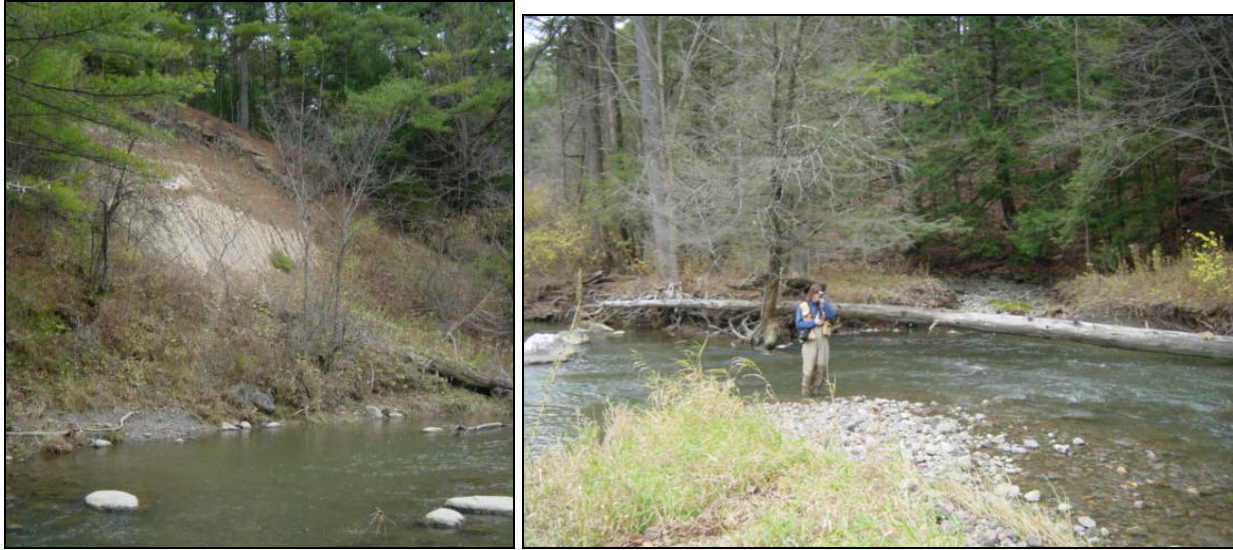
Figure 6.13. Mass Failure in M09A, a source of sediment to the system. Several flood chutes were seen in M09A, signaling planform adjustment.

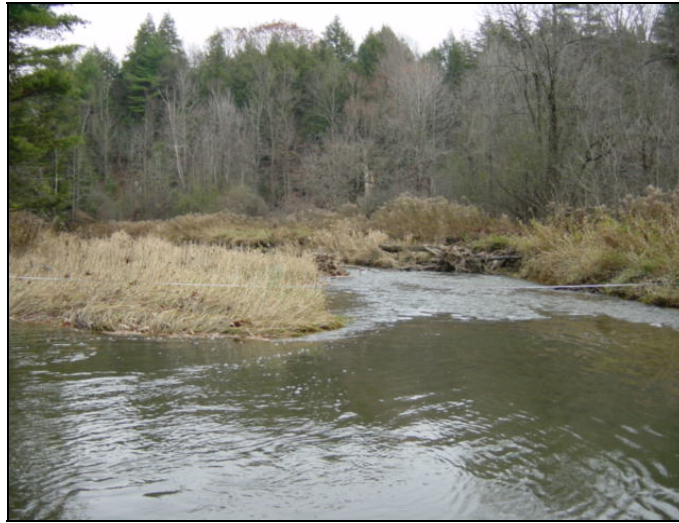
Figure 6.14. Migration in M09B.

Segment M09B appeared to be in a slightly shallower valley, although also narrow, with a meandering, mostly sandy, Riffle-Pool type. The riparian corridor was forested, with the same herbaceous bank vegetation as in M09A. This segment also appeared to have incised from an older terrace in the past, with current adjustment processes being planform with minor aggradation (stage IV of evolution). Overall stream condition appeared “Fair.” RHA condition appeared ‘Good’ with bank instability and sediment deposition being the main factors affecting habitat. Some signs of beaver activity were observed in the segment.

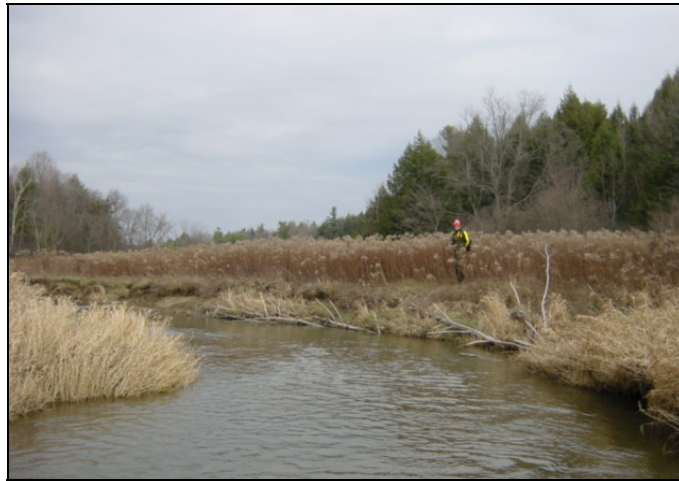
Figure 6.15. Tree Revetments in M10.

Reach M10 appeared to be a meandering, sandy bed, Riffle-Pool stream type in a broad valley setting with steep adjacent hill slopes. Bank vegetation was herbaceous, as was the majority of the corridor vegetation with some saplings and forested areas. Many wetland areas were near the channel, which could account for some of the herbaceous vegetation. Many sediment deposition types (mid, point, side, diagonal bars) were noted in the reach along with two islands. Much bank erosion and several mass failures were present in the reach, contributing sediment. Current adjustments were major planform and minor aggradation and widening. The channel did not appear incised. Overall RGA condition was “Fair” and the channel appeared to be in stage IV of channel evolution. RHA condition appeared “Fair” with sediment deposition, embeddedness, and bank instability the main factors affecting habitat scores. Some ledges provide grade control in the reach, and one bridge constricts the flood prone width.

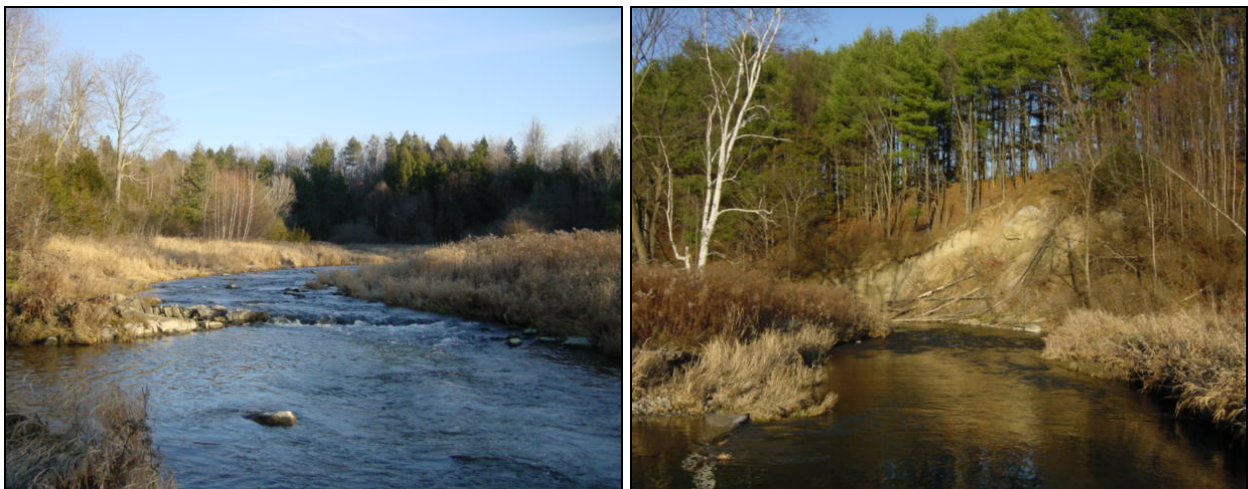
Figure 6.16. Ledge grade control and herbaceous bank vegetation (L), and one of several mass failures in the reach (R).

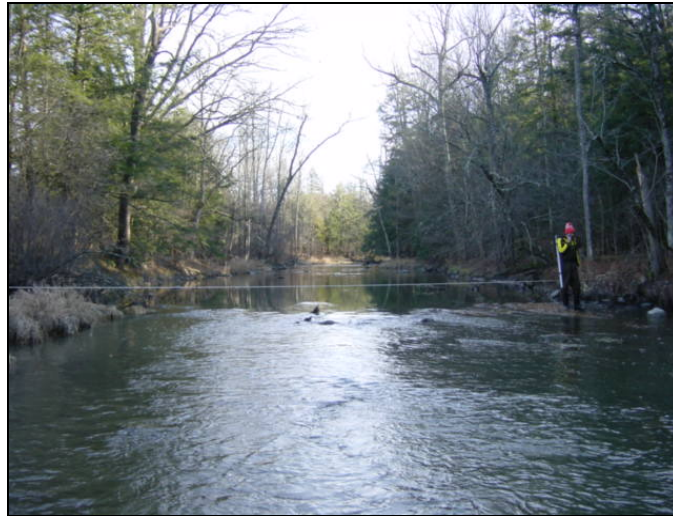
Figure 6.17. Cross section view of M11.

Reach M11 had a fairly shallow slope for its confined valley setting. The stream type appeared to be an somewhat incised, Dune-Ripple type having a fairly shallow slope. Beaver activity increased toward the upstream end of the reach, with a large dam and pond on a tributary. The riparian corridor was forested, however downstream of the bridge, cows had free access to the channel and many crossing areas and areas where banks were trampled noted. The channel did not appear incised, however tributary erosion was noted, possibly due to beaver activity in the upstream areas, and land use at the downstream end as well as possible channel adjustment in the tributary itself. One bridge constricted the floodprone width and had scour downstream. Trash and deer carcasses were seen dumped on the banks at the bridge. Trash and old farm equipment were dumped on the right bank roughly in the middle of the reach. RGA condition appeared “Good” with only minor aggradation observed. The reach was considered “in regime.” RHA condition was also “Good.” Few substrates for food and cover were present. Riffles and diversity of velocity/depth patterns were infrequent.

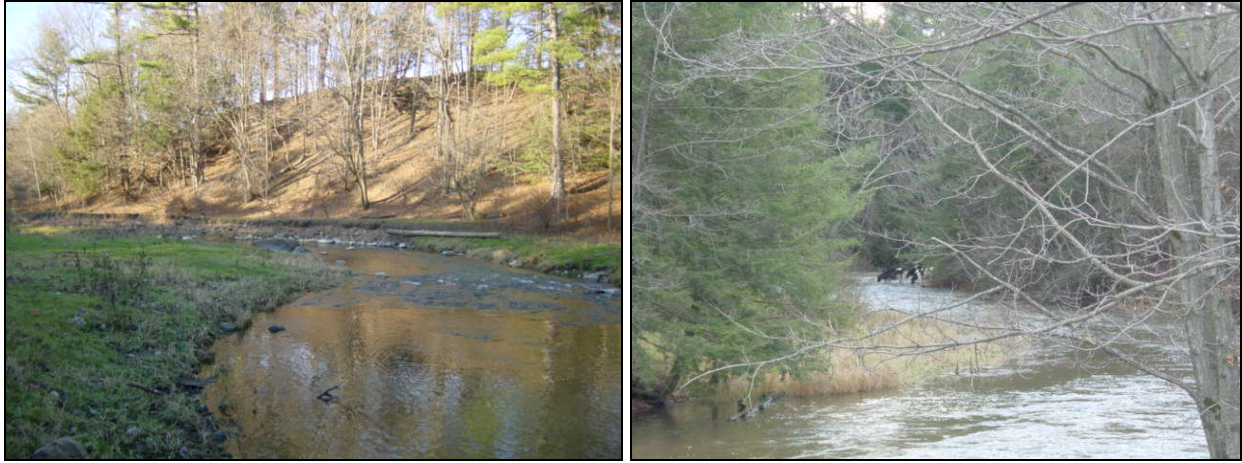
Figure 6.19. Animal access to channel and bank trampling (L) and cows with full access to the channel (R) in M11.
