Stormwater Master Plan Lake Bomoseen Watershed, Castleton and Hubbardton, Vermont

December 15, 2016

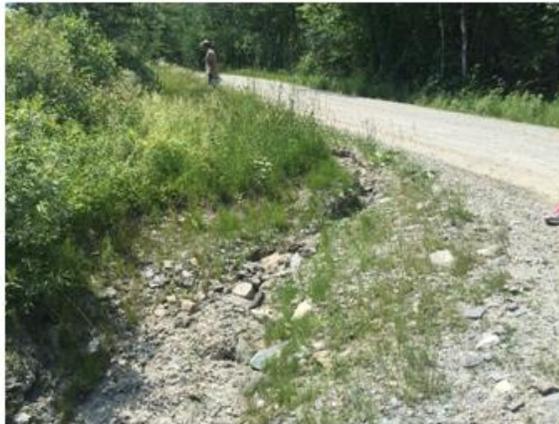
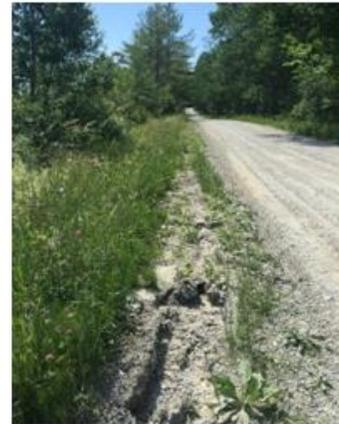
LAKE BOMOSEEN #3		PROBLEM AREA SUMMARY
Site ID: Map3	Design: No	
Date Observed	6/20/2016	
Location	St John Road near Frog Hollow Road	
Waterbody	Sucker Brook	
SGA Reach	N/A	
Latitude	43.6956N	
Longitude	73.15934W	
Land Ownership	Road ROW	
Site Ranking	High

Site Description: Moderate erosion in ditch along south side of Saint John Road; regrade road shoulder to get water in vegetated ditch and prevent rilling. The road and ditch have an 8% slope with 0.25 acre of gravel road draining to the ditches.

Photo 1: Erosion and road runoff runs to Sucker Brook. Photo from top of culvert

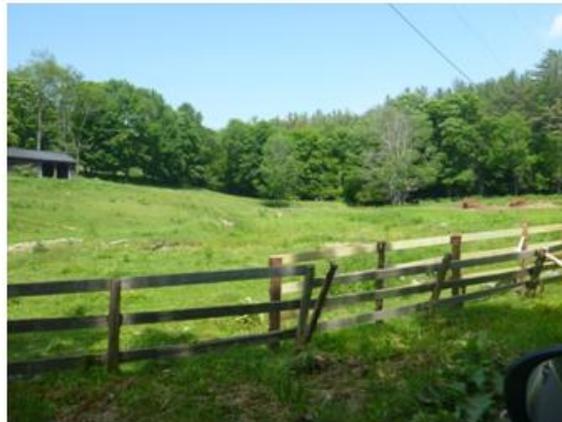
LAKE BOMOSEEN #4		PROBLEM AREA SUMMARY
Site ID: Map4	Design: No

Site Description: Livestock exclusion fencing opportunities in three sections of Sucker Brook near St. John Road. The first at the SJR crossing is 500 LF, at the next farm 1550 LF, and at Biddie Knob Rd 700 LF, for a total of 2750 LF feet of fencing opportunities.

Photo 1: Grazing pasture with Sucker brook running through middle and no fencing to keep animals out of stream.

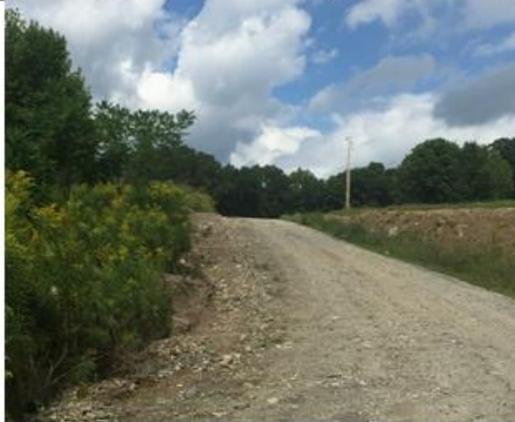
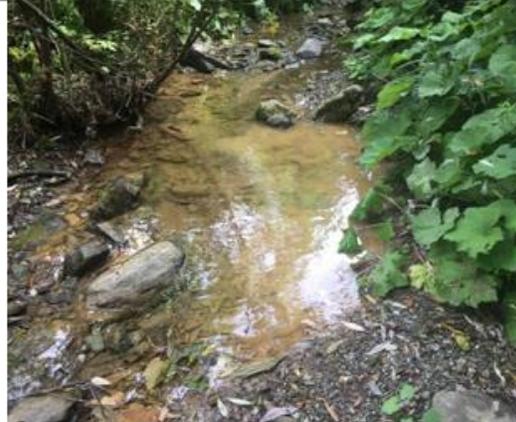
LAKE BOMOSEEN #8		PROBLEM AREA SUMMARY
Site ID: Map8	Design: No

Site Description: Private Driveway off Stables Road with large area of exposed earth on slopes exceeding 10%. This site contributes a significant source of fine sediment entering the tributary at the driveway bridge, as observed in field. Gravel drive and ditch exceeds 10% slope. Nearly an acre of unpaved surfaces drain to this area from upslope in addition to large house/rooftop.

Photo 1: Erosion from driveway, cleared area, and ditch drains to Sucker Brook.

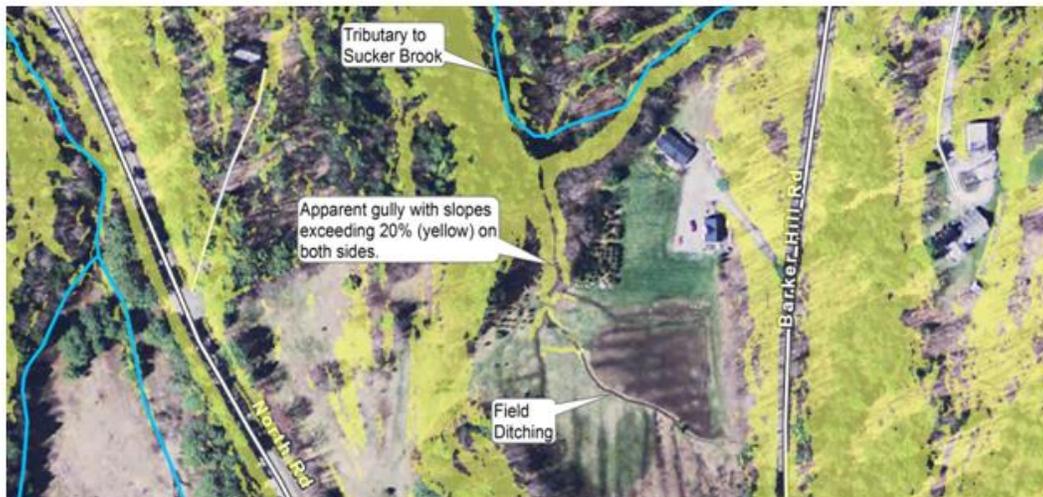
LAKE BOMOSEEN #9		PROBLEM AREA SUMMARY
Site ID: Map9	Design: No

Site Description: Likely gully site visible in aerial photos and with LiDAR. Field to south appears to be ditched leading to potential gully location. Field access difficult - need landowner permission (tried to visit on 8-18, but no one home); can see tall erosion along creek banks from the yard.

Photo 1: Aerial photo of site with steep slopes (>20%) highlighted in yellow from LiDAR.

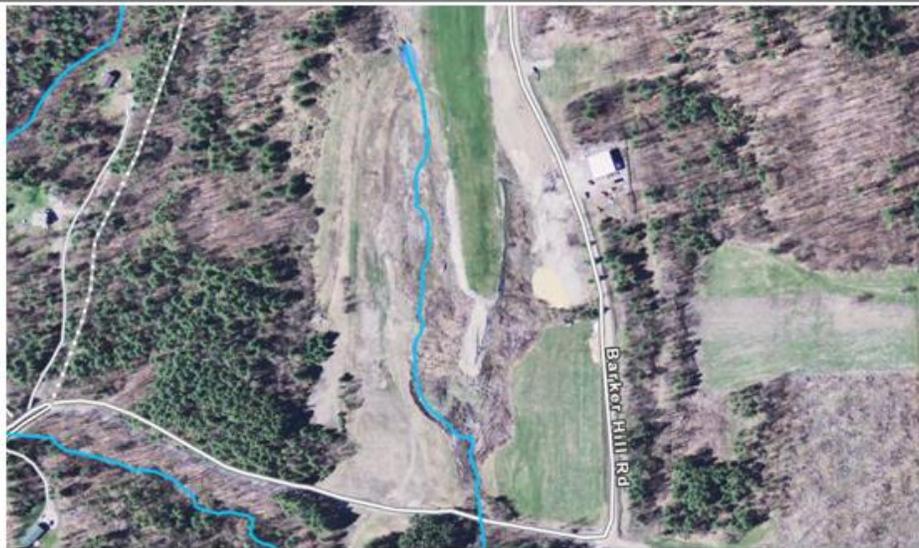
LAKE BOMOSEEN #12		PROBLEM AREA SUMMARY
Site ID: Map12	Design: No

Site Description: Cleared areas of steep land at end of Barker Hill Road associated with the Mortimer Brown Landing Strip. Channel and bank erosion noted on aerial photos. Approximately 6 acres of recently cleared land along a perennial tributary. Approx. 5 acres of impervious surfaces including gravel areas and buildings draining into a pond with sediment seen on aerial photo. Need property permission to access.

Photo 1: Aerial photo of clearing adjacent stream along upper Barker Hill Road.

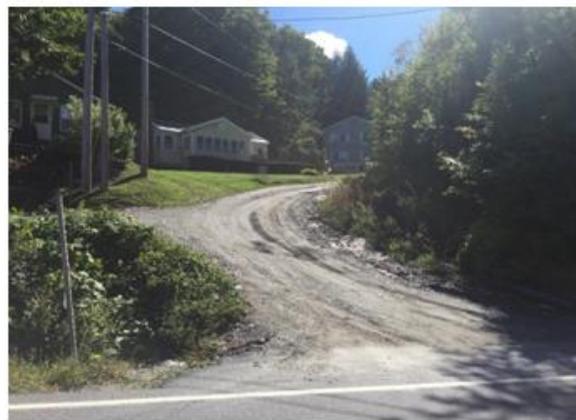
Site Description: Cliff Dwellers Road with 5-6 homes draining to the west down very steep (10-20%) gravel drive. Fine sedimentation likely in culvert at intersection with Route 30. Needs field follow-up for additional assessment. Road and ditch has slopes >10% with 0.25 acre gravel road draining to ditches, plus the drainage from short driveways serving the homes.

Photo 1: From Route 30, Cliff Dwellers Road with driveway spurs drains and erodes along the south side of the driveway.

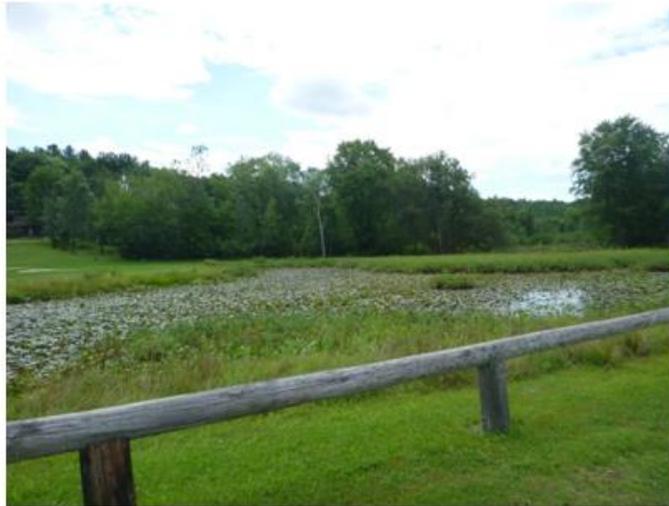
LAKE BOMOSEEN #15		PROBLEM AREA SUMMARY
Site ID: Map15	Design: No	
Date Observed	8/18/16	
Location	Prospect Point Golf Club	
Waterbody	Lake Bomoseen	
SGA Reach	N/A	
Latitude	43.64359N	
Longitude	73.20043W	
Land Ownership	Private	
Site Ranking	Moderate

Site Description: Upslope runoff into eutrophied pond at the Prospect Point Golf Club; Confirmed no P used in golf course fertilizer; Potential in-pond aeration treatment or retrofit to improve nutrient retention/cycling. Two phosphorus samples collected at this site over the summer (2016).

Photo 1: Pond at the Prospect Point Golf Course.

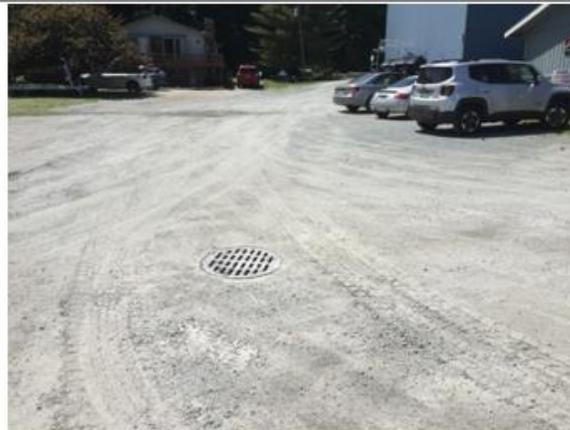
LAKE BOMOSEEN #20		PROBLEM AREA SUMMARY
Site ID: Map20	Design: Yes

Site Description: New catch basin installed by Town in Woodard Marina parking lot. Potential location for Vortechs swirl unit or other enhanced catch basin.

Photo 1: Storm drain in the Woodard Marina parking lot.

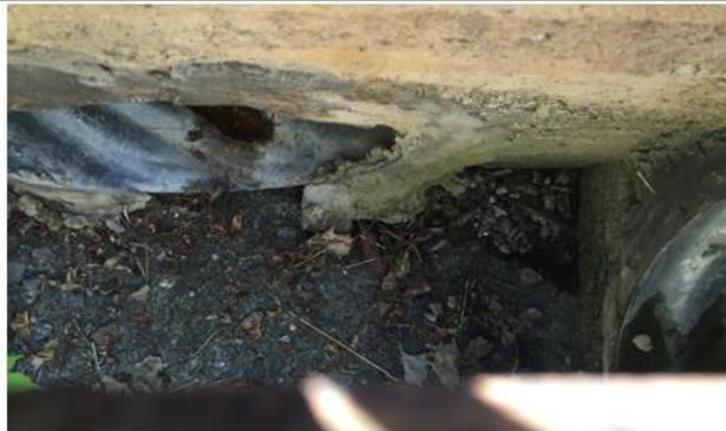
LAKE BOMOSEEN #27		PROBLEM AREA SUMMARY
Site ID: Map27	Design: No

Site Description: Drop inlet with catch basin just north of Creek Road and Point of Pines intersection. Catch basin takes runoff from ditch upslope. Very little sediment storage in basin due to limited sump. Upslope road and ditch has 5-10% slope with 0.25 acre gravel road draining to ditches

Photo 1: Sump needs to be cleaned out.

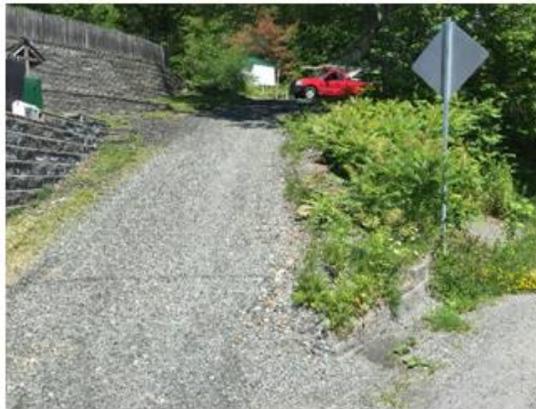
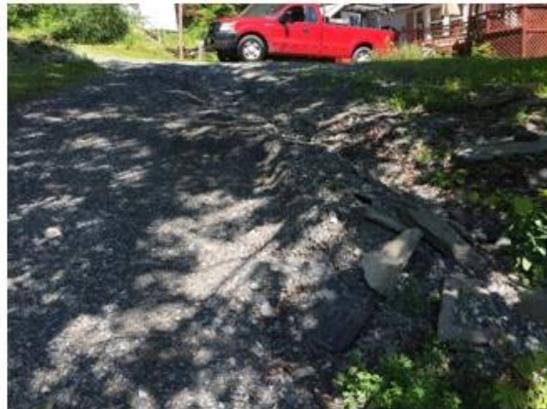
Site ID: Map28	Design: No

Site Description: Shared driveways west of Creek Road, located 300 feet north of Point of Pines Road, drains to a catch basin on Creek Road. Very tight site, probably limited space for new stormwater BMPs. The site needs a larger catch basin with a sump along Creek Road. The houses and gravel surfaces cover 0.25 acre and sections of the gravel drive leading to Creek Road are >20% slope.

Photo 1: Steep driveway drains to Lake Road and the lake. Existing catch basin located behind road sign.

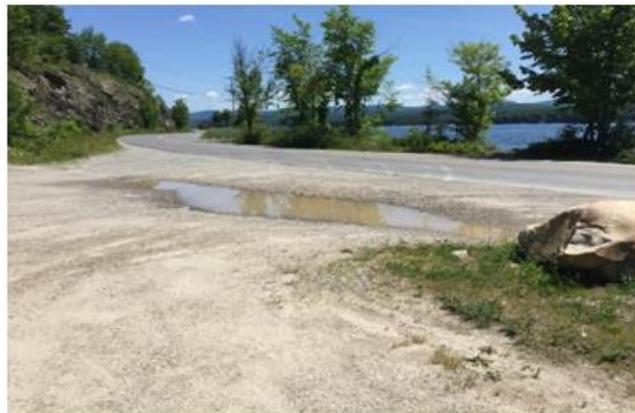
LAKE BOMOSEEN #29		PROBLEM AREA SUMMARY
Site ID: Map29	Design: Yes

Site Description: Green Dump fishing access has 2 locations where stormwater drains to low points and treatment of runoff could be enhanced with an engineered infiltration area. Highly visible public location. Gravel parking area approx 0.5ac draining directly to lake.

Photo 1: Possible infiltration area to capture runoff during storm events.

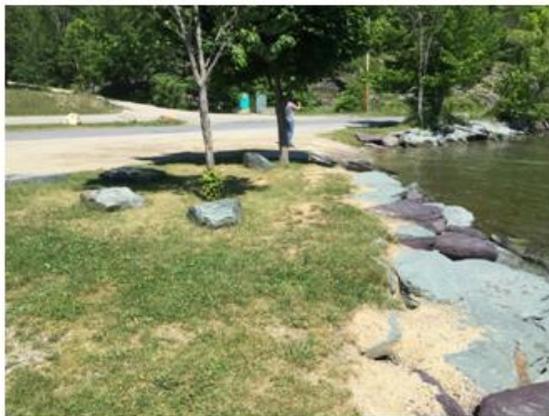
LAKE BOMOSEEN #31		PROBLEM AREA SUMMARY
Site ID: Map31	Design: Yes

Site Description: Public beach known as Green Dump. Consider planting plan for shade and stormwater improvements.

Photo 1: Location to create an improved, landscaped buffer and walkway to provide shade, capture nutrients and sediment from the parking lot, and create a safe attractive area to walk and sit.

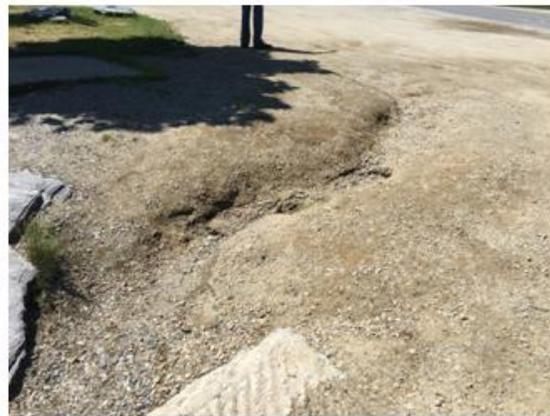
Photo 2: Possible infiltration area to capture runoff during storm events.

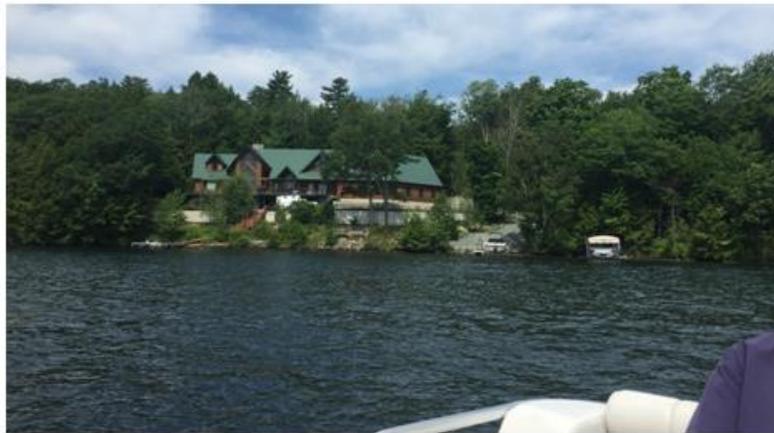
Site ID: Map34	Design: No

Site Description: Large, new house on Avalon Beach Road with steep gravel driveway and boat launch down to the lake. Houses and gravel surfaces cover 0.4 acre; Portions of gravel driveway leading down to lake have >15% slope and rilling erosion was noted in field.

Photo 1: View of new home from lake with driveway and boat launch leading down to lake edge.

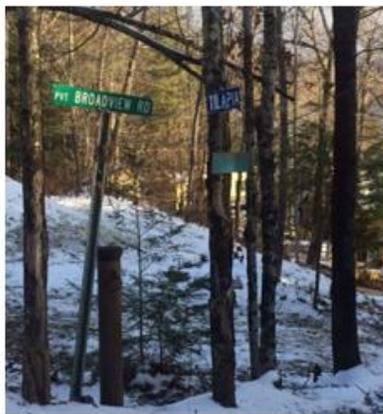
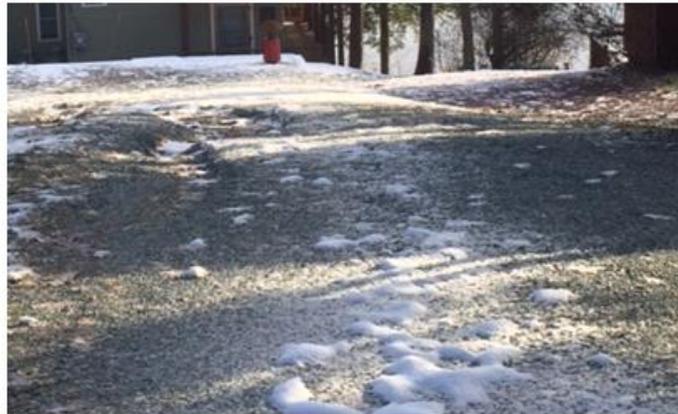
Site ID: Map35/36	Design: No

Site Description: Avalon Beach Road has several steep driveways down to lake; Some driveways are gravel and some paved. Several new mound systems noted in field on west side of road. Avalon neighborhood stormwater project - rooftop disconnects, driveway erosion, septic systems. Houses and gravel surfaces cover 0.4 acre; Portions of gravel driveway leading down to lake have >15% slope and rilling erosion was noted in field.

Photo 1: Septic mound systems near Broadview Road .

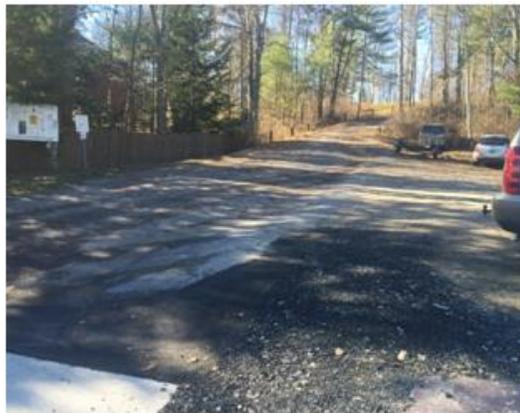
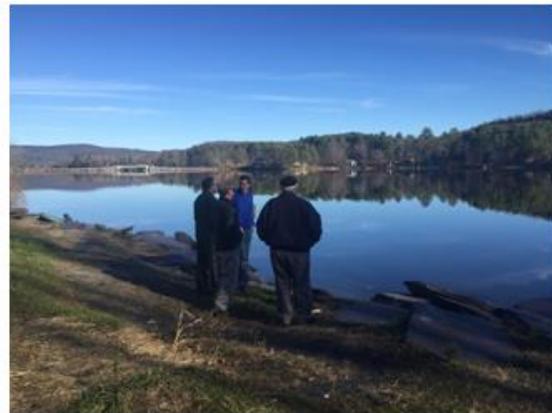
LAKE BOMOSEEN #38		PROBLEM AREA SUMMARY	
Site ID: Map38	Design: Yes

Site Description: Runoff from a steep fishing access off of Johnson Spooner Rd is entering the lake. There is some space in the parking area (west / north near the lakeshore to implement at potential BMP along west/north side of parking lot. Space is tight. Approximately 0.25acre impervious surfaces with slopes >10% on access road.

Photo 1: Erosion and stormwater from the access road and boat launch drains to Lake Bomoseen.

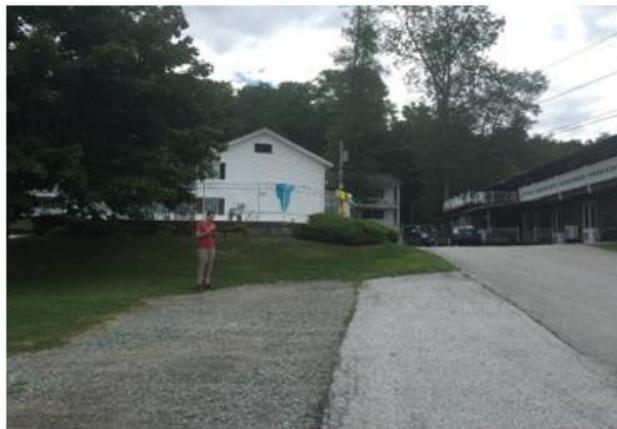
LAKE BOMOSEEN #41		PROBLEM AREA SUMMARY
Site ID: Map41	Design: Yes

Site Description: Edgewater Resort on Route 30. Many stormwater retrofit opportunities including rooftop disconnects, small infiltration/detention basins, and re-routing of stormwater down to network along Rt 30. Approx 2.5ac of impervious surface with many areas having slopes 5-10%.

Photo 1: Area for possible infiltration retrofit to capture runoff during storm events prior to entering lake via storm sewer system along Route 30.

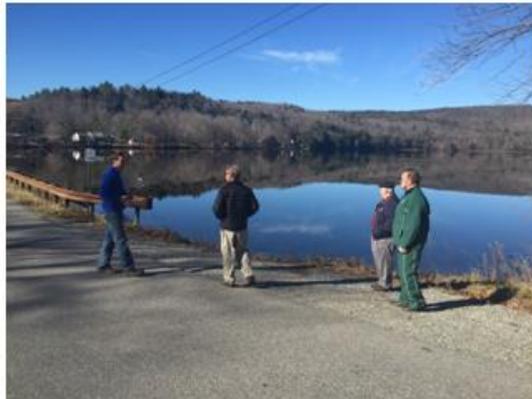
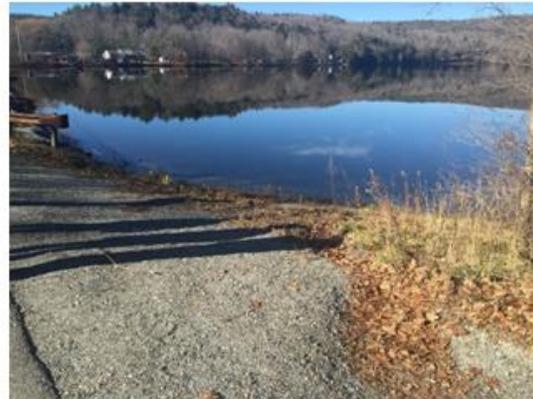
LAKE BOMOSEEN #42		PROBLEM AREA SUMMARY
Site ID: Map42	Design: Yes	
Date Observed	11/17/16	
Location	Float Bridge	
Waterbody	Lake Bomoseen	
SGA Reach	N/A	
Latitude	43.67756N	
Longitude	73.19682W	
Land Ownership	Public	
Site Ranking	High

Site Description: The steep ditch along the north side of Float Bridge Rd is eroding and delivering fine sediment and nutrients to the Lake. A water bar along Campbell Rd is directing additional runoff to the ditch. Approximately 0.3ac impervious with slopes 5-10%

Photo 1: View of fishing access from Float Bridge Road on eastern shore.

Photo 2: Close up view of fishing access.

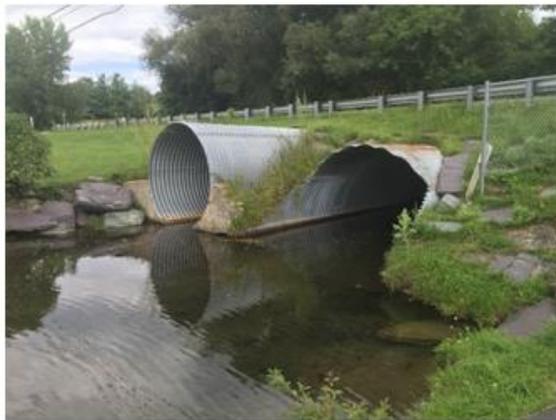
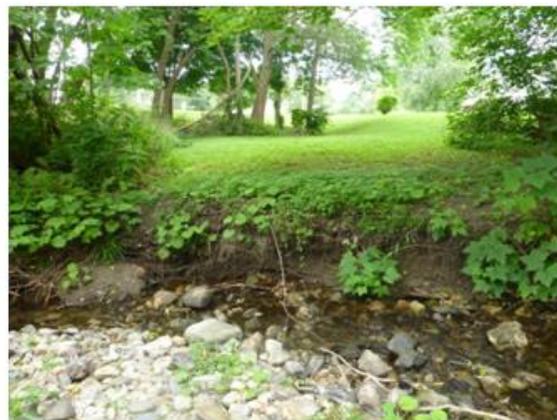
LAKE BOMOSEEN #44		PROBLEM AREA SUMMARY
Site ID: Map44	Design: Yes

Site Description: Multiple areas of bank erosion on Sucker Brook in between Route 30 and North Road. Some areas are moderate sources of sediment to channel and lack buffer. Approximately 300 ft of bank erosion with height 4-5ft upstream of Route 30. Channel is moderately incised and is actively widening in areas where post-irene sediment deposits are large.

Photo 1: Culvert carrying Sucker Brook beneath VT Route 30.

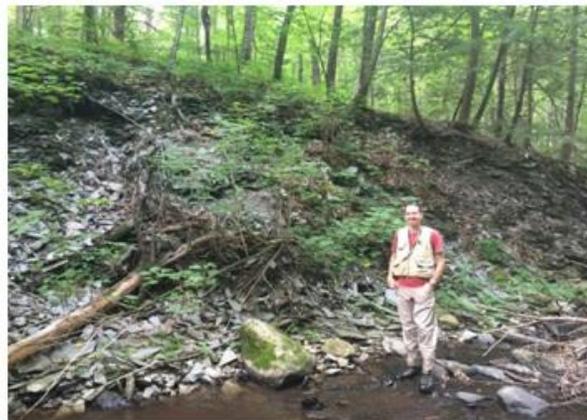
LAKE BOMOSEEN #46		PROBLEM AREA SUMMARY
Site ID: Map46	Design: Yes

Site Description: Multiple areas of bank erosion and mass wasting on valley side slopes on Sucker Brook upstream of Stables Road. Some slopes are major sources of coarse and fine sediment. Abandoned slate quarry. Approximately 300 ft of bank erosion and mass failures with height 6-12ft upstream of Stables Road crossing. Site is an abandoned slate quarry and sediment is mobilized downstream in moderate/large floods.

Photo 1: Old slate piles from the pencil mill.

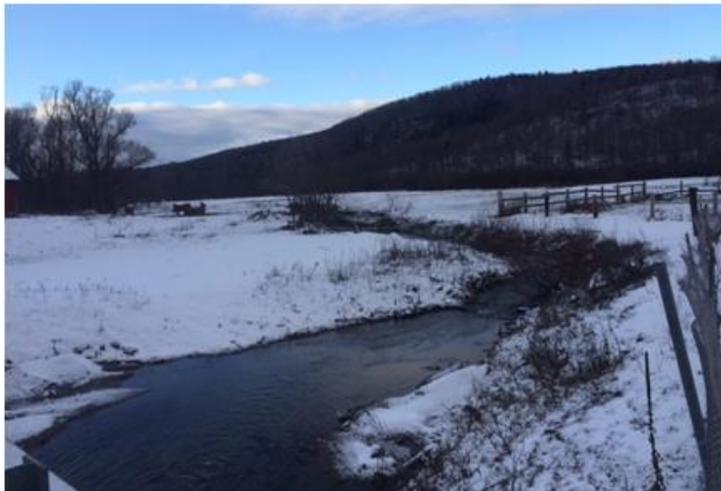
LAKE BOMOSEEN #48		PROBLEM AREA SUMMARY
Site ID: Map48	Design: No

Site Description: Fencing and buffer needed along horse pasture on Giddings Brook, southwest of the intersection with Monument Hill Road and Route 30 in Hubbardton.

Photo 1: Horse pasture needs exclusion fencing.
