Lamoille River Corridor Plan
Hardwick to Johnson
Lamoille County, Vermont
December 15, 2010

Bear Creek Environmental, LLC
297 East Bear Swamp Road
Middlesex, Vermont 05602

The Lamoille County Planning Commission
632 LaPorte Road
Morrisville, VT 05661

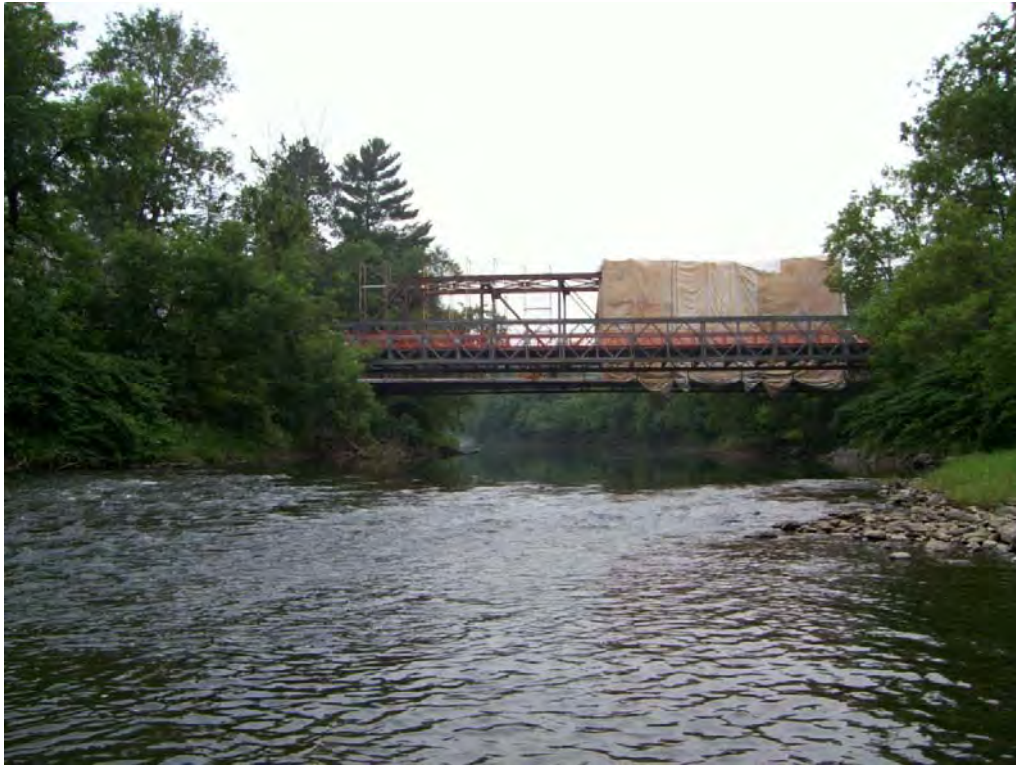
R15	700000000008073	Bridge	River Ridge Road	47	Deposition below, scour above	High
R15	700000000108063	Bridge	Railroad	98	Deposition above and below, scour above and below	Low
R14-A	100806000608061	Bridge	Railroad Street	79	Deposition below, scour above and below; old steel truss bridge	NR ¹ – being replaced at time of assessment

Figure 9: Railroad Street Bridge in Reach 14-A under construction.

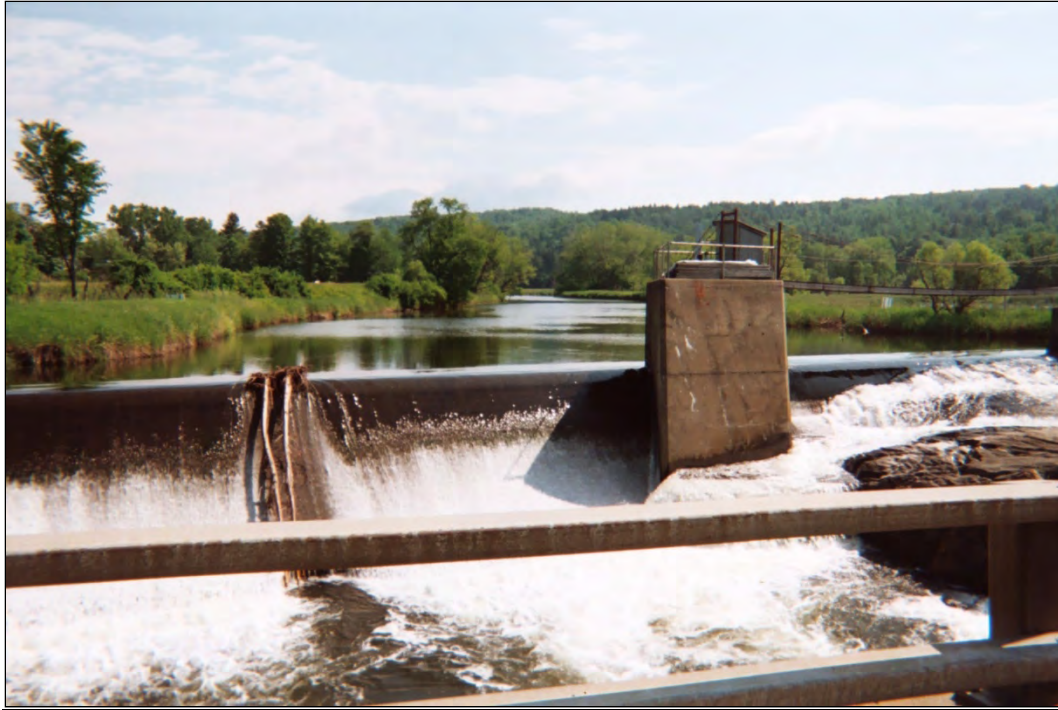
The most upstream segment of the Lamoille River Phase 2 geomorphic assessment, segment R23-B, received only a partial assessment due to the influence of the run-of-river dam at Hardwick Lake which impounds the Lamoille River (Figure 13).

Figure 13. R23-B is affected by the impoundment of water behind the Hardwick Lake dam.

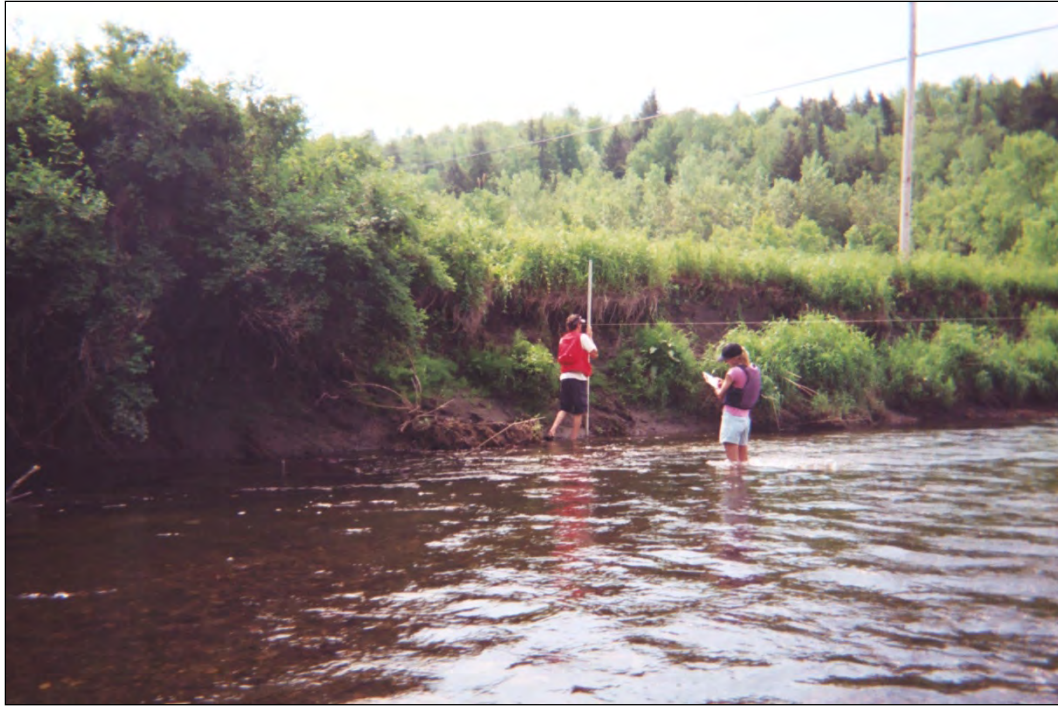
Figure 14. R23-A has undergone historic channel degradation. The incision ratio, illustrated in this photograph, was recorded at 1.5. Major disturbance of the riparian buffer is also evident in this photograph.

A site (Hardwick_I), located to the east of the Wolcott/Hardwick town line was selected by Milone and MacBroom as a possible floodplain restoration project on the Lamoille Valley Rail Trail. Floodplain mitigation would benefit the Lamoille River within R23-A by providing locations where flood and sediment attenuation could occur.

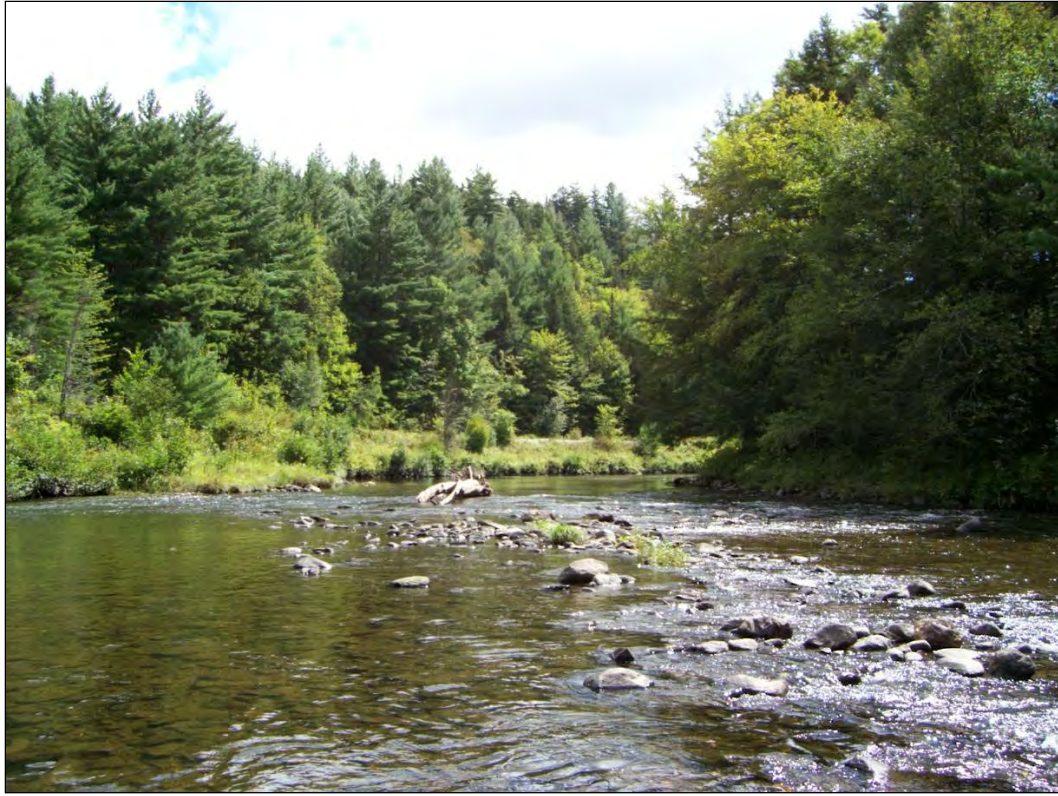
Lamoille River segment R22-D begins just above a Route 15 bridge in Wolcott and flows downstream for 3,519 feet before the hydropower dam changes the water surface slope of the river. This segment flows through predominately forested land and is bordered by the old Lamoille Valley railroad line on the east bank. The fill of the rail bed has altered the floodprone width of the river. There is a lack of buffer on both sides due to the encroachment of the road and railroad and agricultural fields (Figure 15). Riverside plantings are recommended for this segment to improve the riparian buffer. A river corridor easement would allow room in the west corridor for the river to adjust.

Figure 15. Lack of buffer on eastern bank due to encroachment in R22-D.

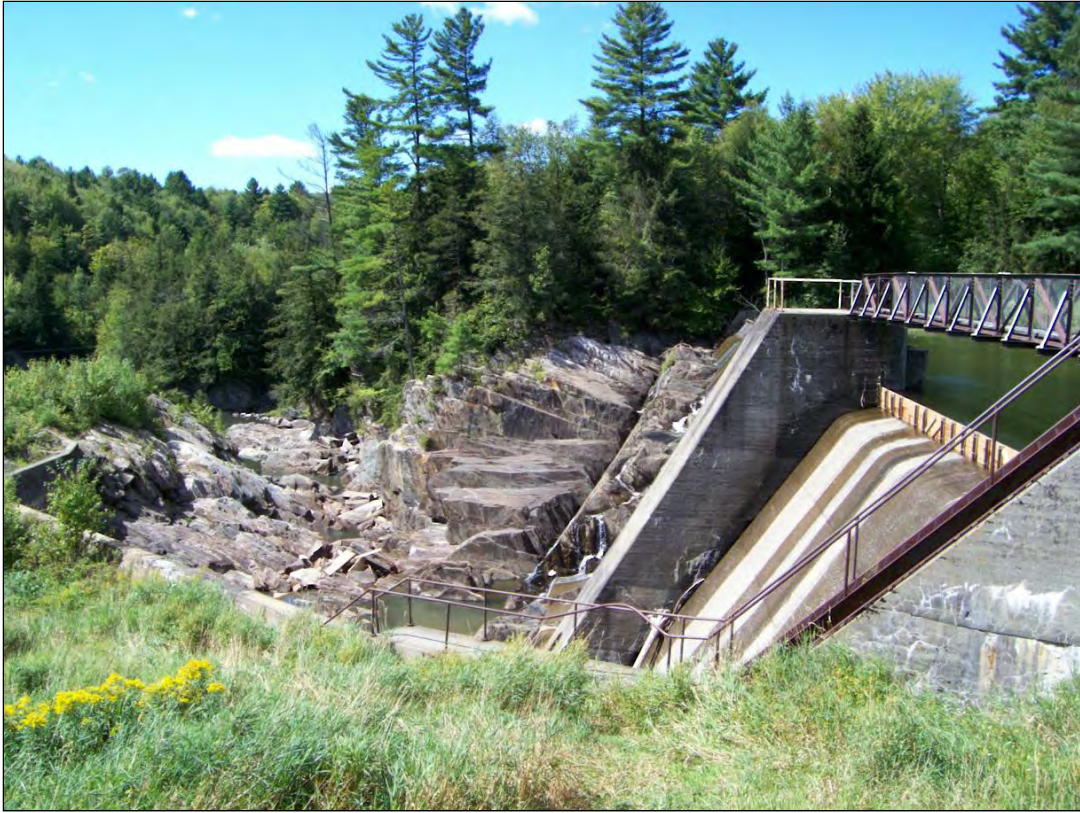
Lamoille River segment R22-C was created to capture the influence of a hydropower dam on the stream channel (Figure 16). The segment begins just upstream from the hydropower dam east of Wolcott and continues to the powerhouse location for the dam where the flow of the Lamoille is again moving at its full capacity. Due to the extreme influence of the dam on the flow of water and sediment, this segment was only partially assessed.

Figure 16. The hydropower dam east of Wolcott village alters the flow of sediment and water in segment R22-C.

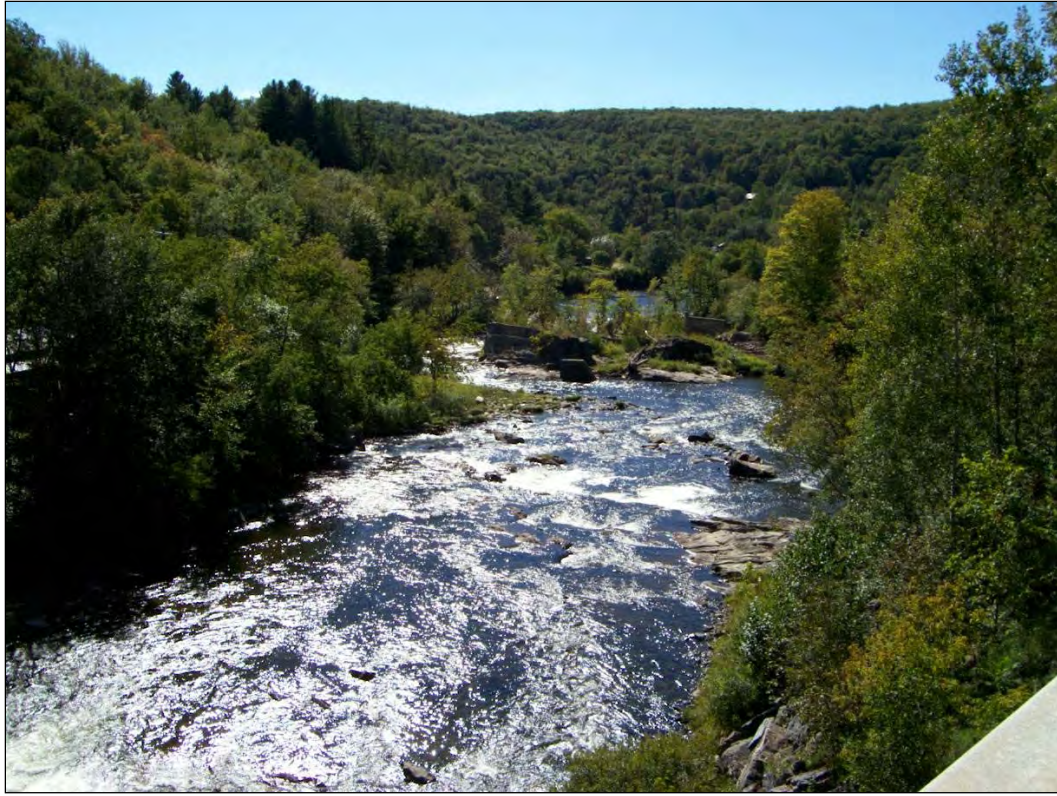
The extensive presence of bedrock (Figure 17) and absence of floodplain essentially make this segment a bedrock gorge that transports sediment and water. Segment R22-B was only given a partial assessment because of the abundant bedrock in the channel and stable nature of the system.

Figure 17. Abundant bedrock grade controls within R22-B.

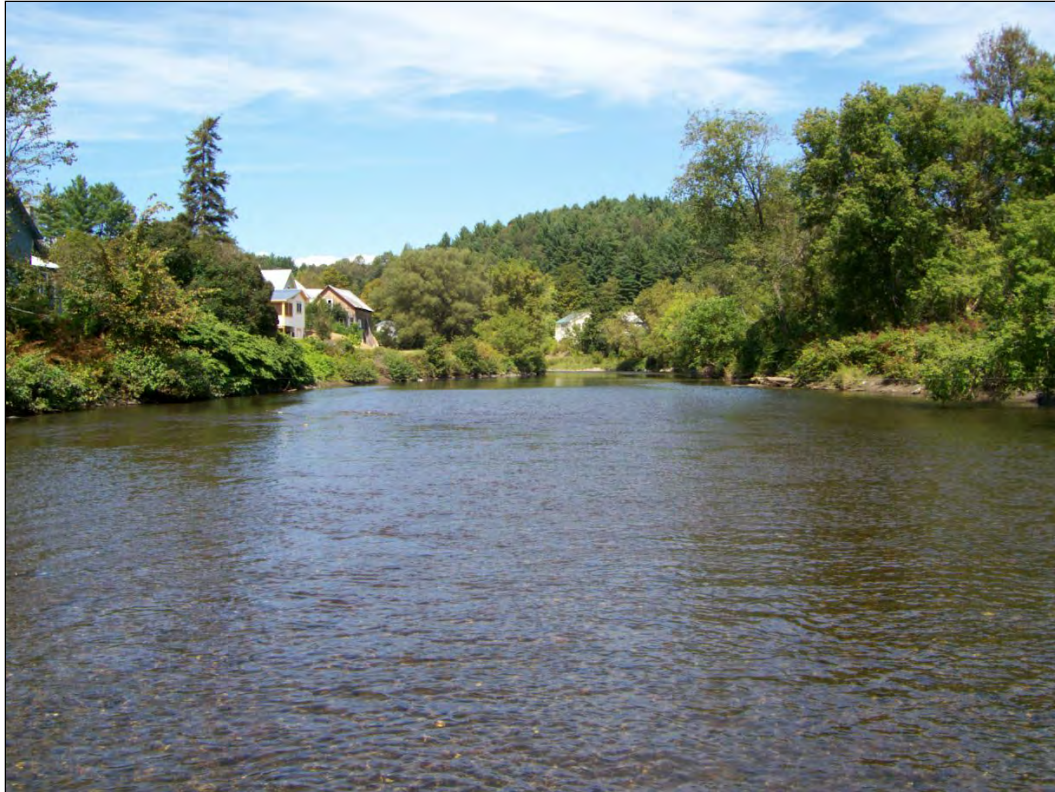
Influences of the village on segment R22-A are significant. There is little to no riparian buffer throughout much of the segment. Several stormwater inputs were recorded, as was an abundance of channel straightening, rock armoring, and floodplain encroachment. The reference stream type is “B”, however, in response to the extensive manipulation the river has become an “F” type stream channel with almost no floodplain access (Figure 18). Plantings in segment R22-A are recommended to improve the riparian buffer. However, given the extreme historic incision and active major widening, plantings along the near bank are not recommended. Rather, plantings should take place back from the river bank and should be in areas that are not prone to active erosion.

Figure 18. R22-A has been historically straightened and managed causing extensive floodplain loss.

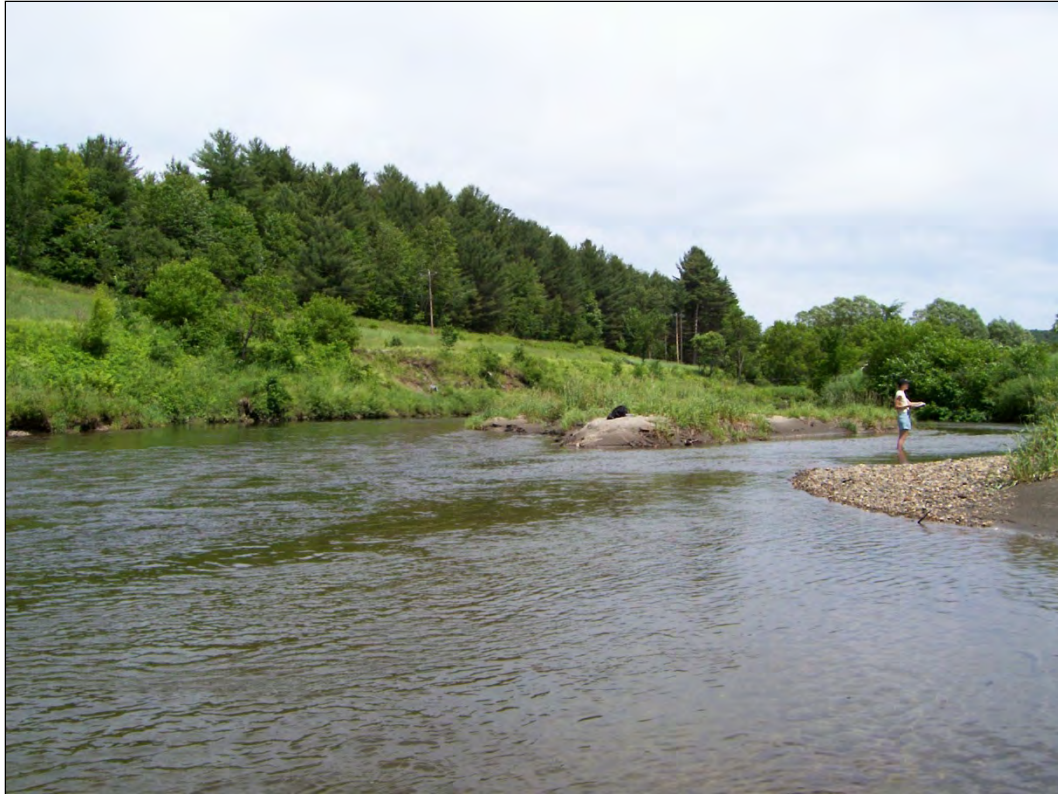
Lamoille River reach R2I begins below Wolcott Village and continues downstream to where the Wild Branch, a major tributary, enters on the north bank. The reach flows through hay fields, forest, and residential lands in a very broad valley that has been narrowed by Vermont Route 15 and the Lamoille Valley rail bed. Historic degradation within the reach has led to active widening and planform adjustment (Figure 19). Many of the side and point bars observed are being outflanked by the river indicating active planform adjustment. Riparian vegetation is absent or minimal along much of the reach and is dominated by herbaceous plants. CREP or other programs, such as the U.S. Fish and Wildlife Service Partners for Wildlife Program, are recommended to improve the riparian corridor in Reach 2I.

Figure 19. Lamoille reach R21 is undergoing major planform adjustment and widening.

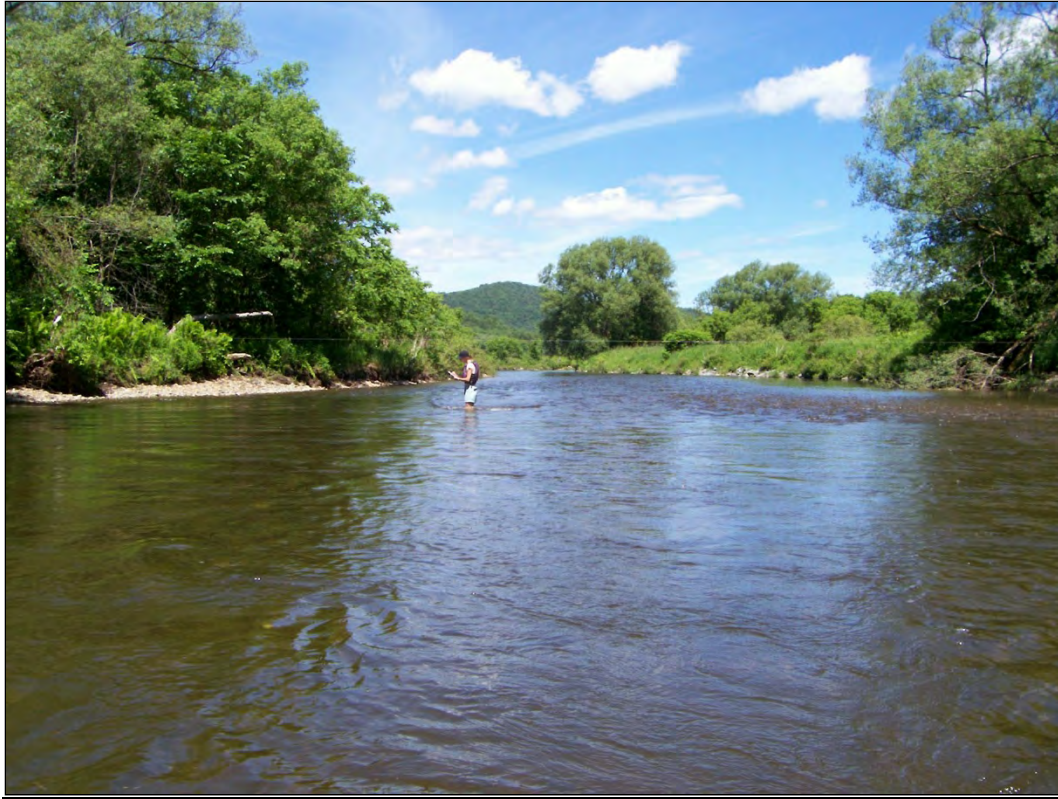
Reach R20 begins below the Wild Branch and flows through a very broad valley for 8,215 feet to the confluence with Jones Brook and a change in reference valley confinement. Similar to the upstream reach, R21, this reach flows through hay fields and forest and past residential properties. The reach appears to have been extensively historically straightened (Figure 20). The low incision ratio of 1.14 makes reach R20 a high priority for streamside plantings. Widening was only a minor process in this reach and trees planted along the bank are at lower risk of being uprooted due to channel adjustment.

Figure 20. Lamoille River reach R20 is straightened and flows through a broad valley.

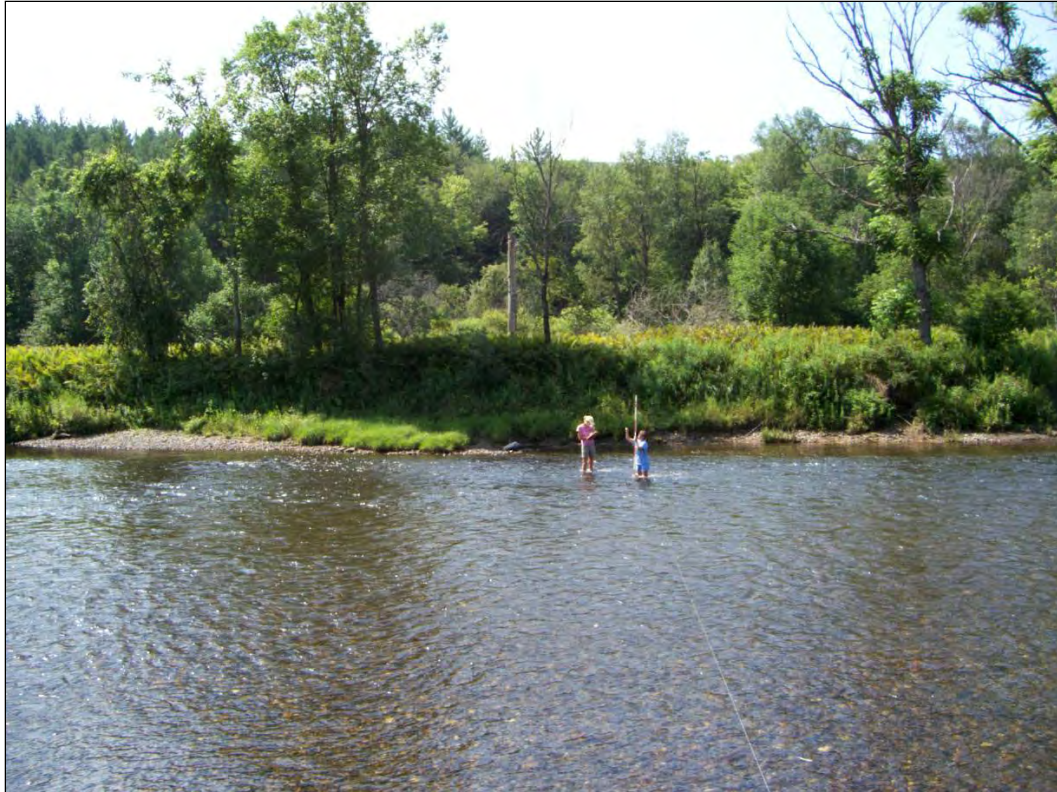
The south side of the river channel is dominated by forested lands with a wide buffer over 100 feet. On the north side of the channel, the riparian vegetation has been significantly removed to less than 5 feet in width as it flows through industrial land and hay fields. Streamside plantings on the north side of the channel are of lower priority given the major historic incision and major active widening that was noted in this reach.

Figure 21. Lamoille River reach R19 with a narrow floodplain visible in the background.

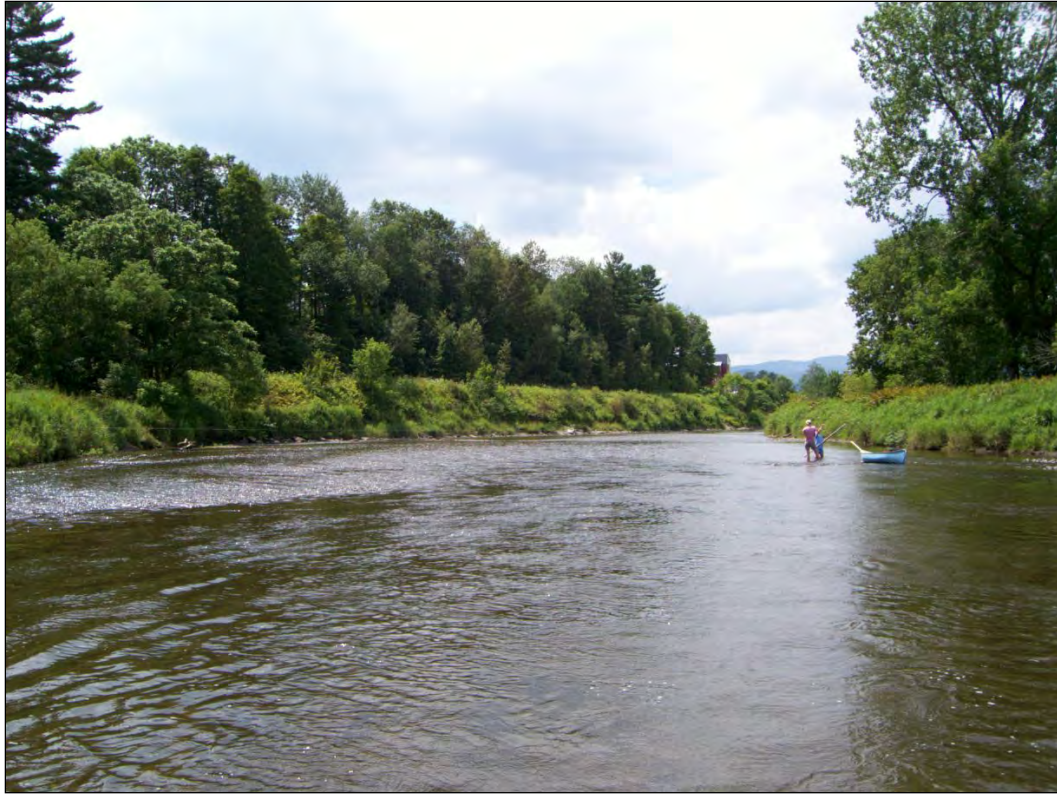
Plantings are recommended in reach 18 to improve the riparian buffer. Due to the moderate incision, the plantings were given a moderate priority in the project identification table (see Table 9). There is active major widening and planform adjustment in R18, and plantings should take place back from the river bank and should be in areas that are not prone to active erosion. River corridor protection through a corridor easement is a lower priority because of the current encroachment within the river corridor by Route 15 and the railroad bed.

Figure 22. Lamoille River reach R18 has been historically straightened and is incised.

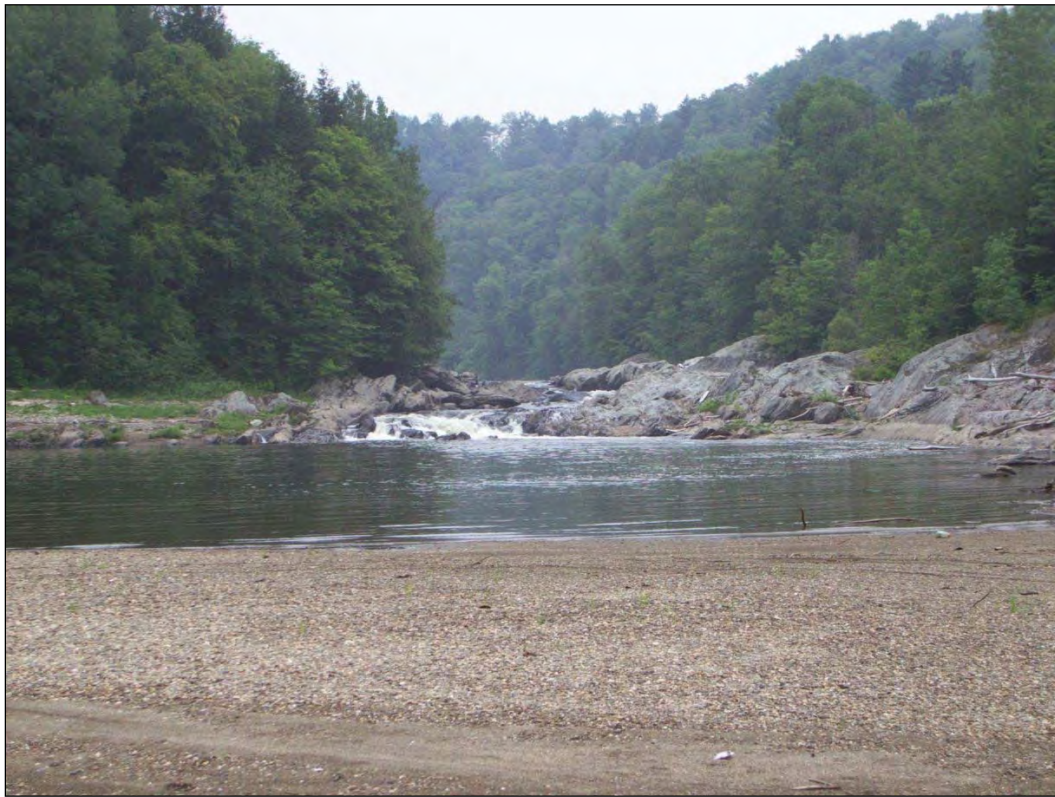
Lamoille River segment R14-B begins at Dog Head Falls, a bedrock waterfall east of Johnson Village. The segment continues downstream to Slide Falls (Figure 23), another large bedrock drop on the mainstem of the Lamoille River. Due to the influence of bedrock on the stream channel this segment received only a partial geomorphic assessment.

Figure 23. The stream channel of segment R14-B is heavily influenced by bedrock ledges such as this one, known as Slide Falls.

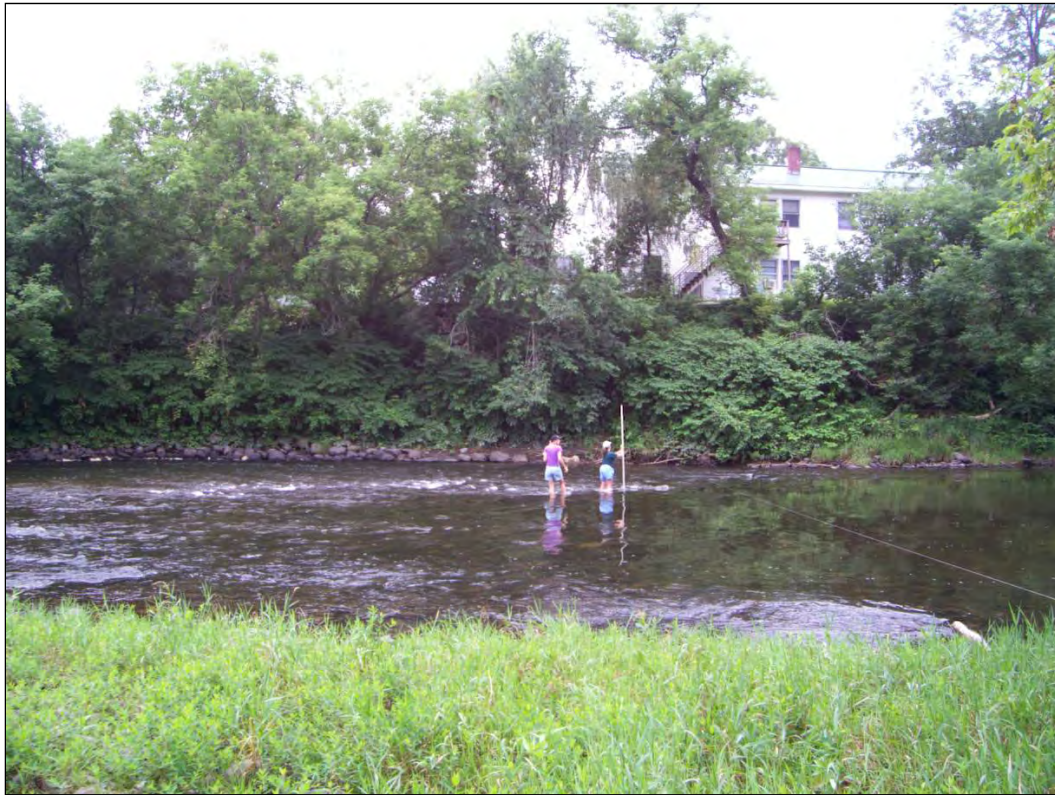
Lamoille River segment R14-A begins below Slide Falls, east of Johnson village, and continues to the mouth of the Gihon River. Historic floodplain encroachment, fill, and channel straightening within the Village of Johnson have significantly altered the floodplain within segment I4-A. The alteration has caused major historic incision, which has resulted in a loss of floodplain access (Figure 24). Widening and planform adjustment are expected, but the extensive armoring along the banks has limited these processes. The removal of riparian vegetation has impacted both banks. There has been a stream type departure from a “C” to an “F” channel due to the extensive disturbance.

Figure 24. R14-A flows through Johnson Village. Historic channel straightening and floodplain encroachment have resulted in loss of floodplain access.
