Coleman and Trailside Brooks, Ludlow, Vermont

30% Conceptual Design
Project LT-06
Ludlow SWMP

Stormwater Master Plan - Town of Ludlow
Unified Prioritization Project Table
May 19, 2021

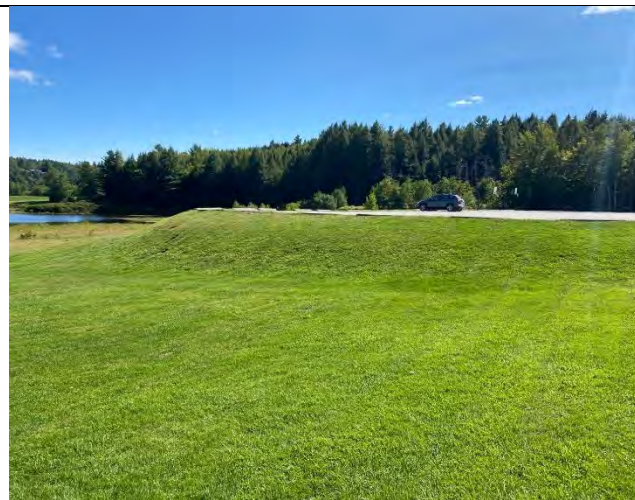
Site Description: Existing stormwater treatment system along parking lot does not receive any runoff due to grading. Green space north of parking lot receives runoff from portion of parking lot, gravel road, and building

Photo 1: Open space along runoff flow path suitable for rain garden installation.

BMP Description: Direct drainage into a rain garden or bioretention swale

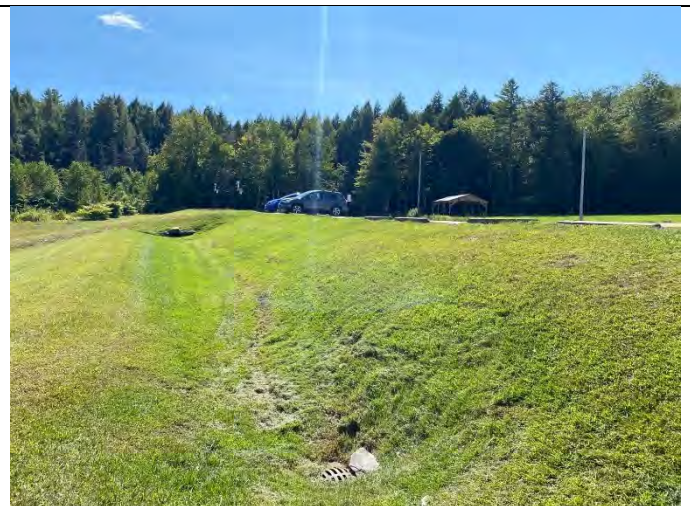
Photo 2: Swale along east side of parking lot that does not receive runoff due to poor site grading

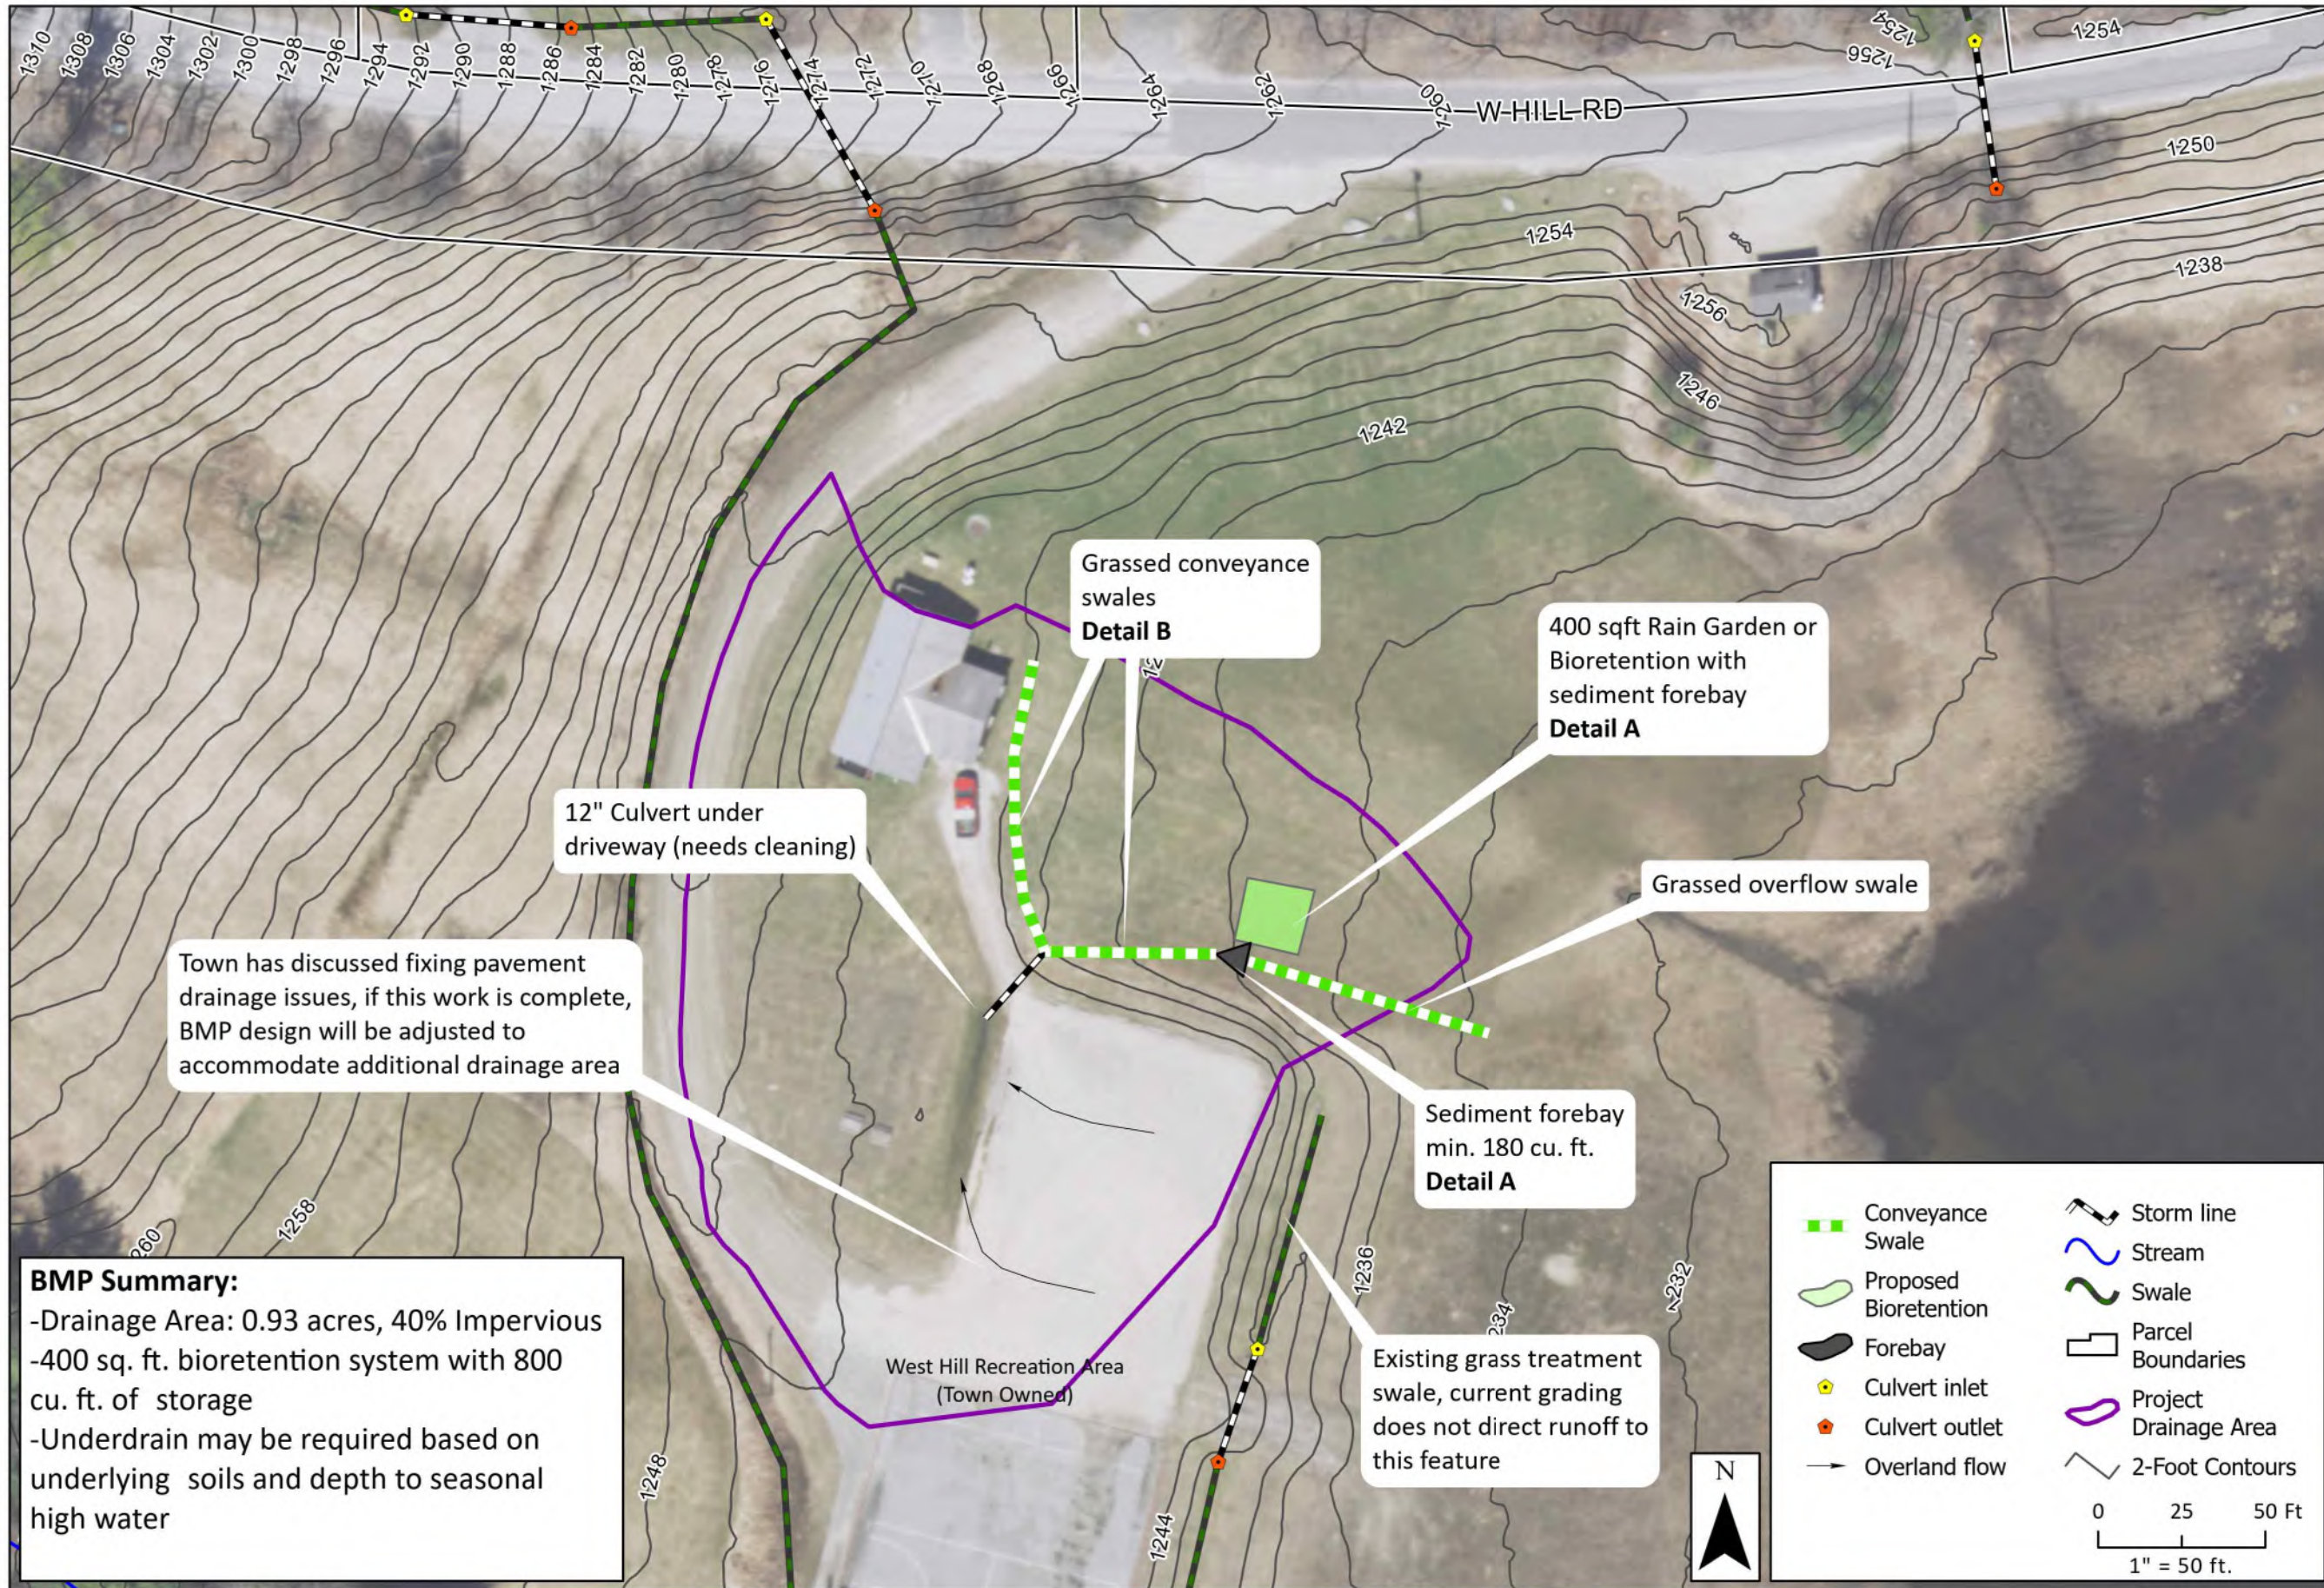
Town has discussed fixing pavement drainage issues, if this work is complete, BMP design will be adjusted to accommodate additional drainage area

12" Culvert under driveway (needs cleaning)

Existing grass treatment swale, current grading does not direct runoff to this feature

BMP Summary:
 -Drainage Area: 0.93 acres, 40% Impervious
 -400 sq. ft. bioretention system with 800 cu. ft. of storage
 -Underdrain may be required based on underlying soils and depth to seasonal high water

400 sqft Rain Garden or Bioretention with sediment forebay
Detail A

Sediment forebay min. 180 cu. ft.
Detail A
