Stormwater Master Plan Town of St. Johnsbury, Vermont

15-215

Stormwater Master Plan

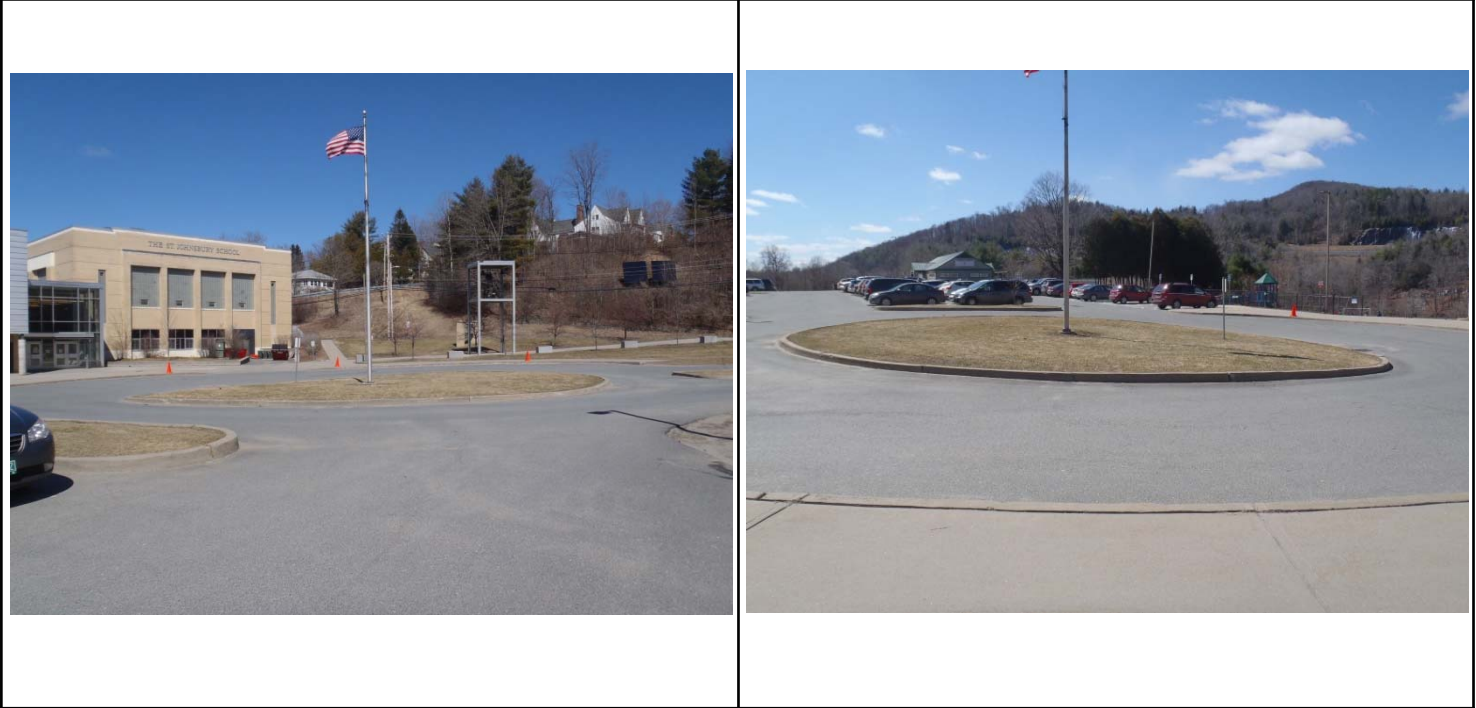
Description of Observed Conditions:
Retrofit opportunity; Take advantage of existing green around perimeter of upper parking lot and flag circle at School to provide treatment for runoff from the parking lot. There are existing sewer lines in the vicinity of this retrofit opportunity and care will need to be take to avoid potential conflicts.

Photo 1. Flag circle and green space in upper parking lot	Photo 2. Flag circle
---	----------------------

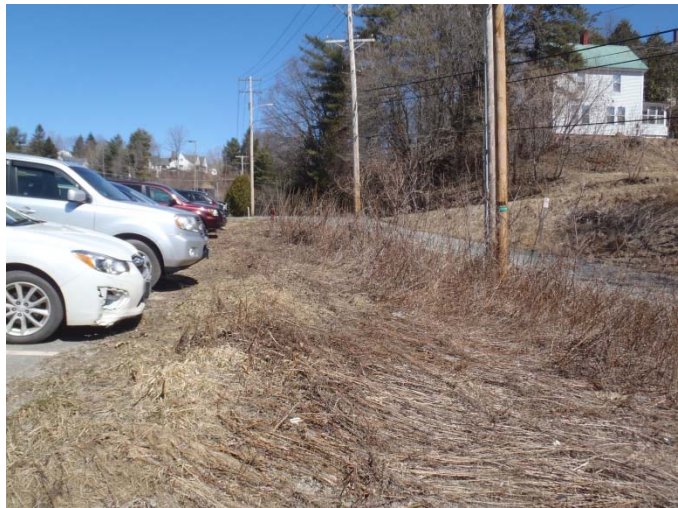
Photo 2. Possible retrofit area east of parking area

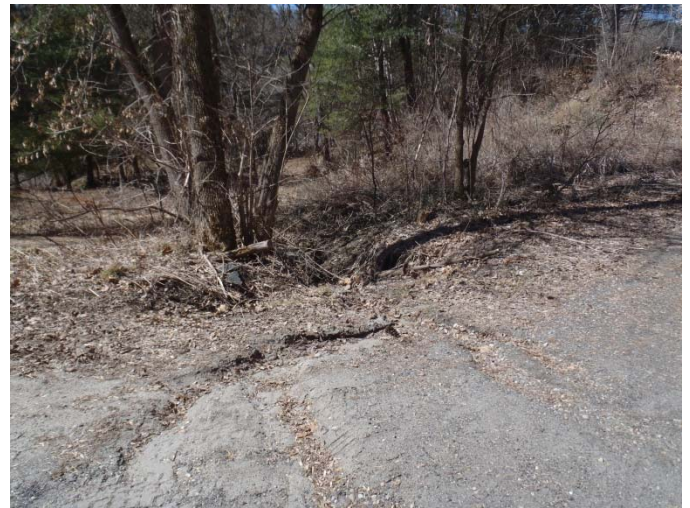
Photo 2. Gully caused by stormwater runoff from SR-03

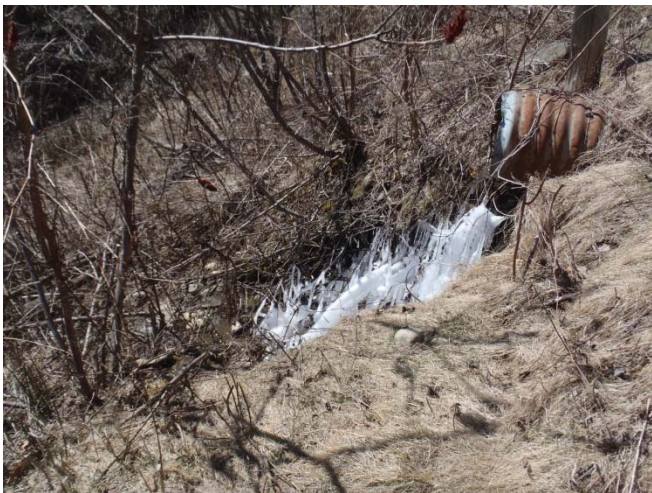
Description of Observed Conditions:
Visible erosion along the shoulder of the access road; currently at least a portion of runoff from the road and parking area contributes to the problems observed at the Town Garage.

Photo 1. Stormwater outfall from Municipal Forest parking area

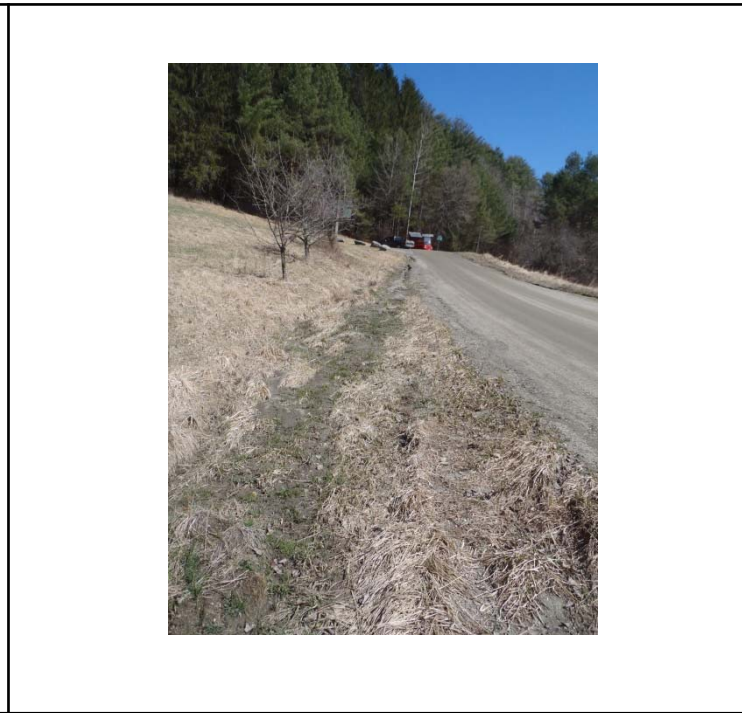
Photo 2. Municipal forest access road

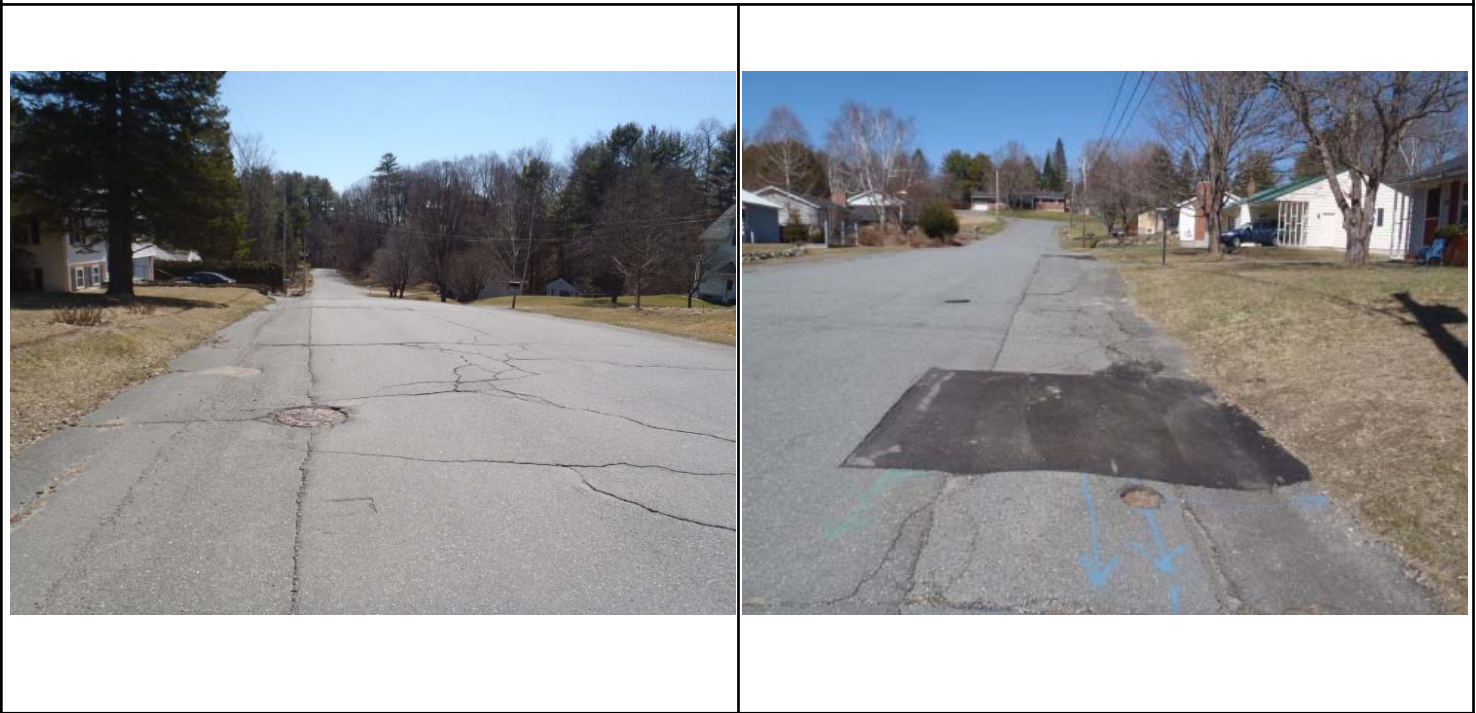
Photo 1. Looking south down Gilman Ave toward Concord Ave	Photo 2. Looking north up Gilman Ave toward Waterman Circ
---	---

Description of Observed Conditions:
 Bring overly-wide section of road back to standard width, establishing a grassed channel with check dams, as needed, on both sides of the road to convey stormwater runoff.

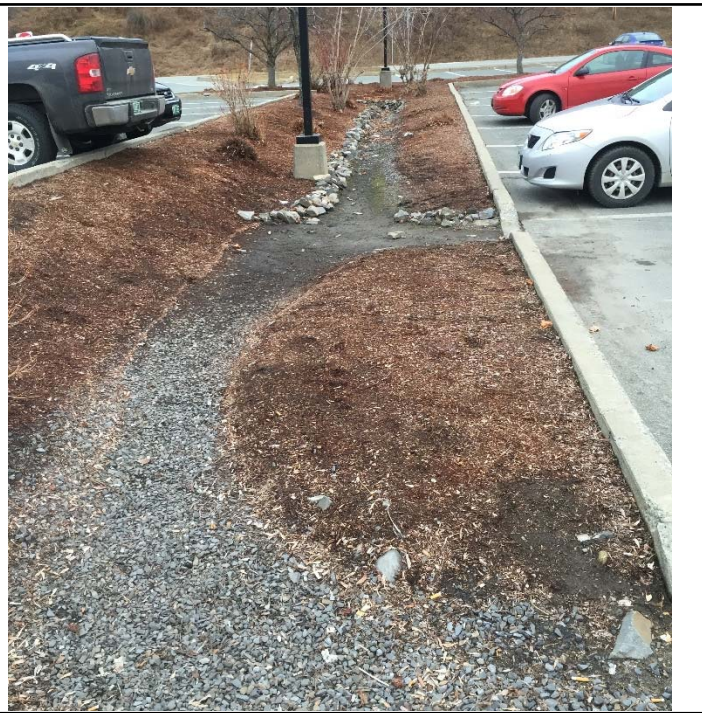
Photo 2. Underutilized, existing island in Price Chopper parking lot
