Neshobe River in Rutland County Corridor Plan

**Brandon, Vermont
September 12, 2011**

Prepared by:
Bear Creek Environmental, LLC
297 East Bear Swamp Road
Middlesex, Vermont 05602

Prepared for:
The Rutland Natural Resources Conservation District
170 Main Street
Rutland, VT

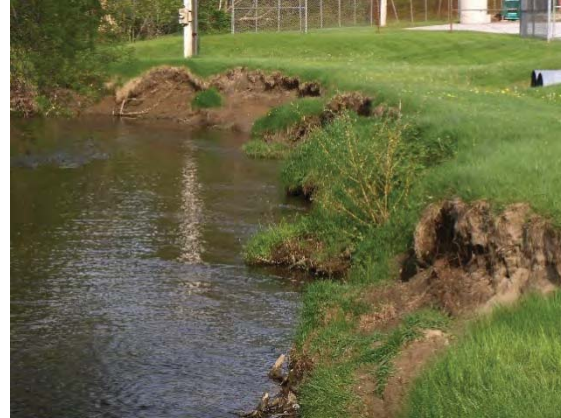
Approximately 30 percent of Reach M02 is influenced by road encroachment and development. The dominant buffer on both sides is greater than 100 feet, but there are areas where the buffer width is less than 25 feet. In many of the areas that lack a high quality buffer, bank erosion is resulting in widening of the stream channel. The area adjacent to the Brandon wastewater treatment facility (Figure 7.3) is an example of an area that is experiencing significant erosion and lacks woody vegetation in the buffer.

Figure 7.3. Lack of buffer and bank erosion in the vicinity of the wastewater treatment plant (BCE, 5/7/2010)

Potential Project #2 – Alternatives Analysis near Wastewater Treatment Facility (WWTF) Within Reach M02. The stream bank along the Neshobe River at the WWTF off of Union Street is actively eroding and lacks vegetation. The property is owned by the Town of Brandon. The channel is currently locked in place in this location with the Union Street Bridge at the upper end of the site, Barlow Avenue to the north, and the WWTF and access drive to the south. In addition, residential lots along Barlow Avenue and an access drive to the east of the WWTF on property owned by OMYA may pose additional lateral constraints. During late 2010, the Town of Brandon moved forward with the temporary action of armoring the streambank to protect the WWTF power pole. An alternatives analysis is recommended for this area adjacent to the WWTF to consider possibilities for channel and/or floodplain management in this area. The project could range from a community planting project to providing ways for the river to have additional space to migrate.

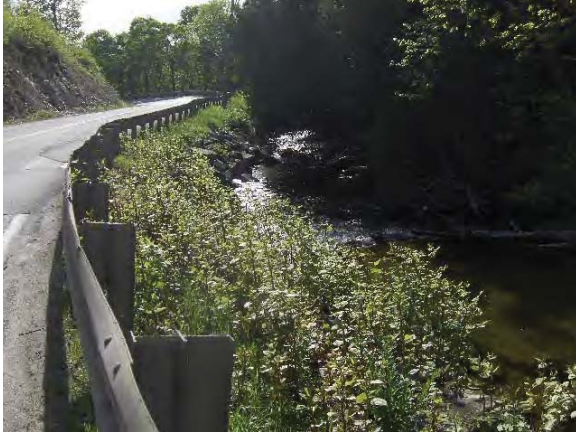
Reach M04 begins at the Stone Mill Dam Road crossing and continues through the Neshobe Golf Club for approximately one mile. Significant historic channel straightening has occurred in Reach M04 along Forest Dale Road and the golf course (Figures 7.5 and 7.6). The stream type of Reach M04 is “E” that was gravel dominated by reference but is now sand dominated. The greens-keeper at the golf course informed Round River Design personnel that the river floods onto the golf course approximately 2 to 3 times each year. The buffer along the east bank has been radically altered due to the golf course with 50 percent of the length having a buffer less than 25 feet. Forty percent of the east bank is also armored with riprap, thereby decreasing the streambank’s ability to absorb energy and causing increased stream power. The increased stream power can cause more pronounced downstream erosion.

Figure 7.5. Encroachment of Forest Dale Road and channel straightening in Reach M04 (BCE, 5/7/2010)

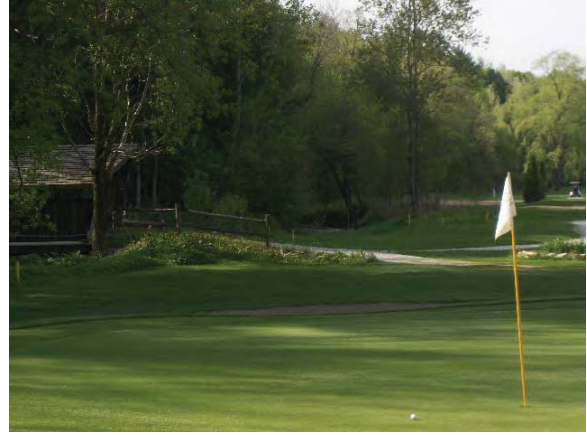
Figure 7.6. Neshobe Golf Club within river corridor in Reach M04 (BCE, 5/7/2010)

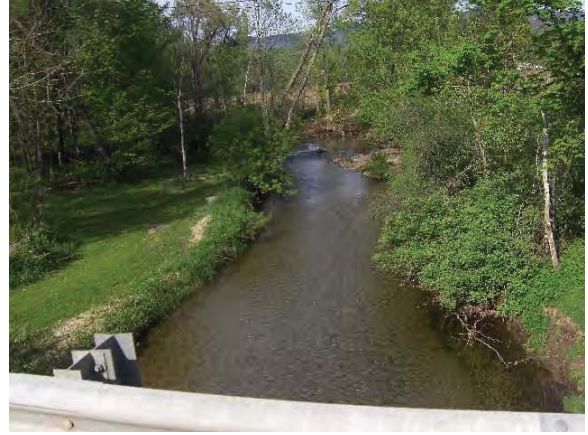
Figure 7.8. No buffer near Town Farm Road Bridge in Reach M05 (BCE, 5/7/10)

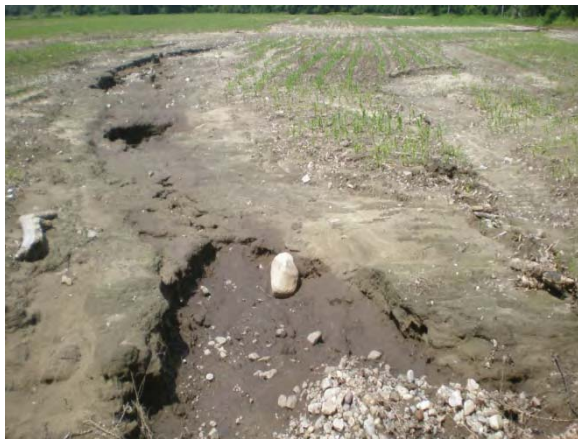
The dominant buffer width on the south side is less than 25 feet. On the north side, the dominant buffer width is 51-100 feet and subdominant is less than 25 feet. There are some agricultural fields bordering Reach M06 and recent flood waters have scoured the fields in some locations (Figure 7.10).

Figure 7.10. Drainage off of agricultural field to Reach M06 (Round River Design, 6/17/09)

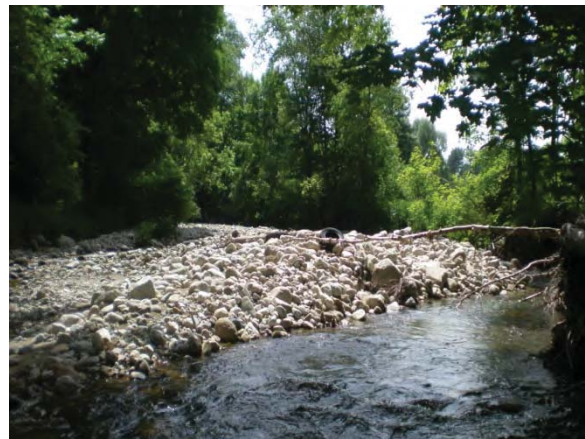
Figure 7.11. Large point bar in Reach M06 (Round River Design, 6/17/09)

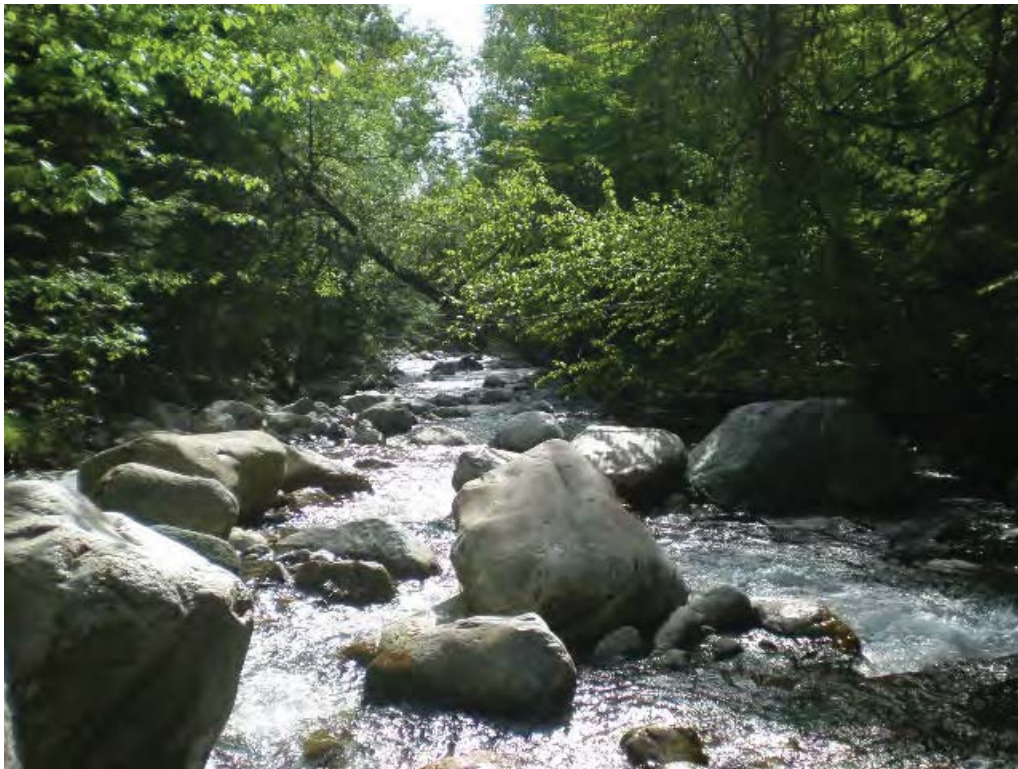
**Figure 7.12. Cobble dominated
straightened “B” channel of Reach M07
(Round River Design, 6/8/09)**

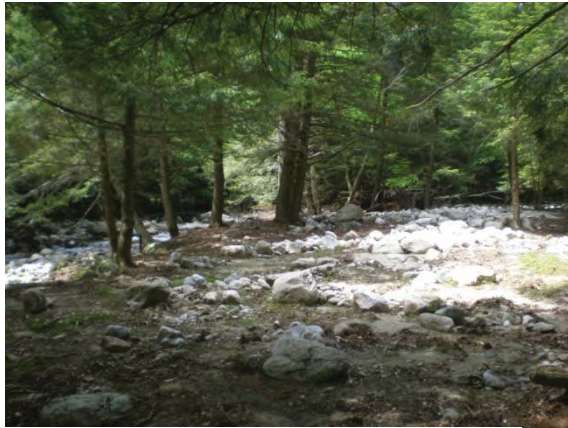
Figure 7.15. Historic aggradation on floodplain of M08-C (Round River Design, 6/8/09)

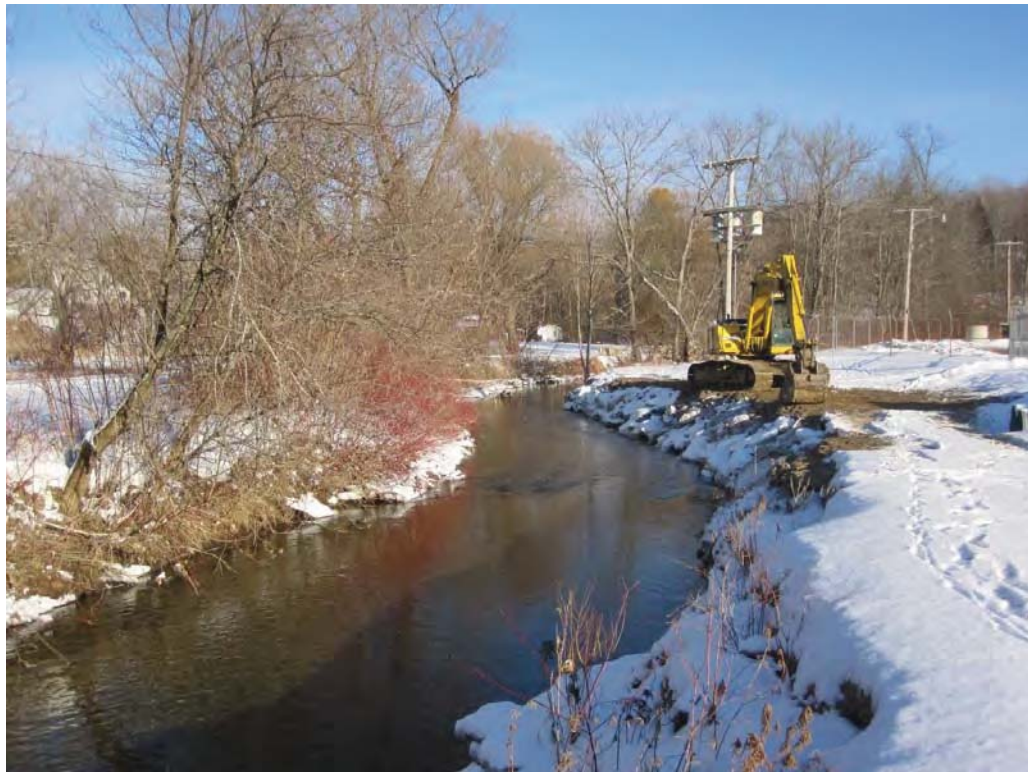
**Figure 7.20. Newly riprapped section of Neshobe River adjacent to WWTF
(Photo by Ethan Swift)**

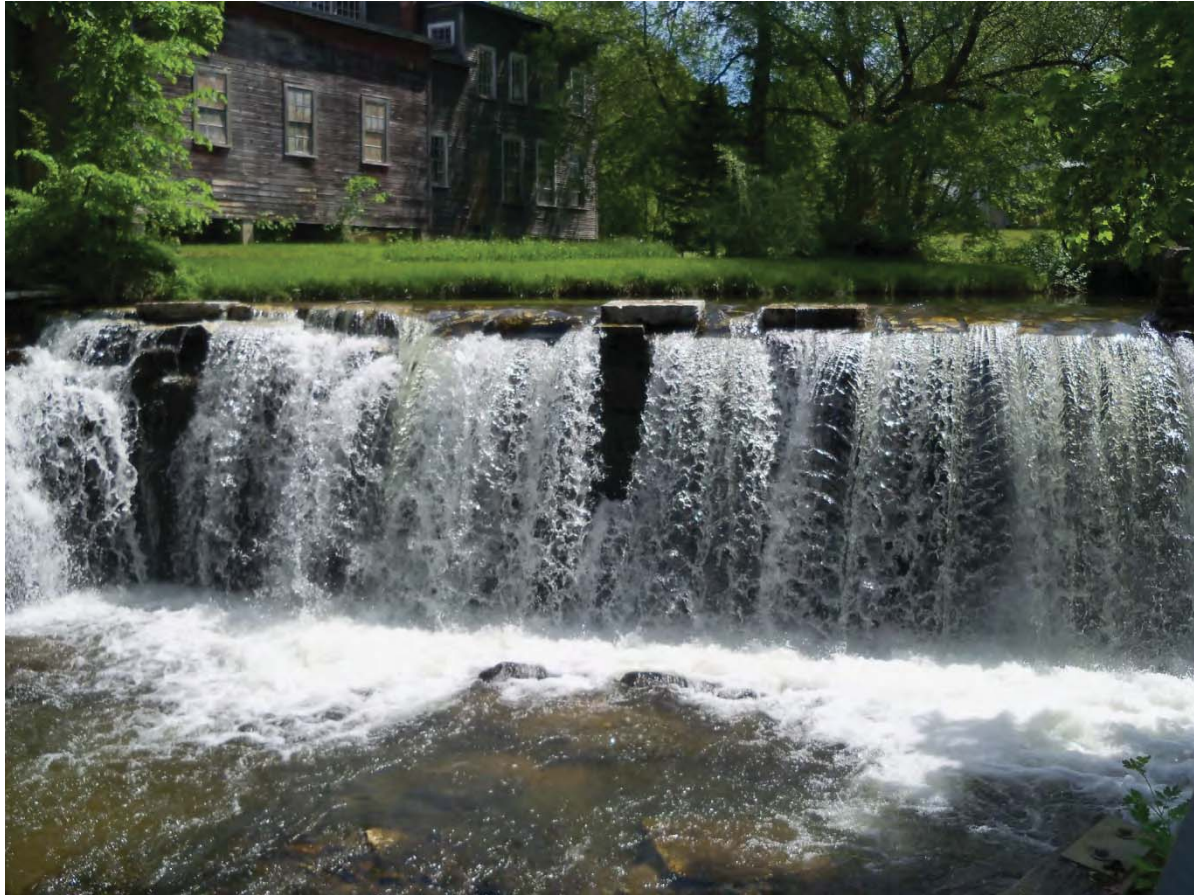
masonry structure founded on ledge. The remains of a sloping plank facing are visible on the upstream side. A masonry and concrete intake structure is located at the left end. The pond is mostly silted in and has little effective storage.

**Figure 7.21. Dam on Neshobe River in downtown Brandon
(BCE, 5/25/2011)**

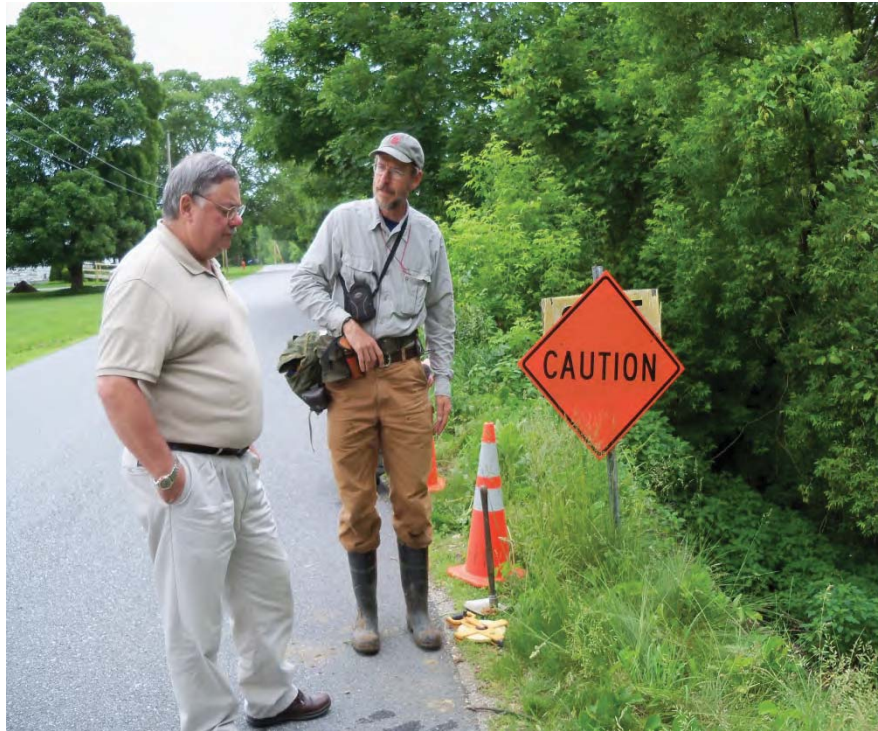
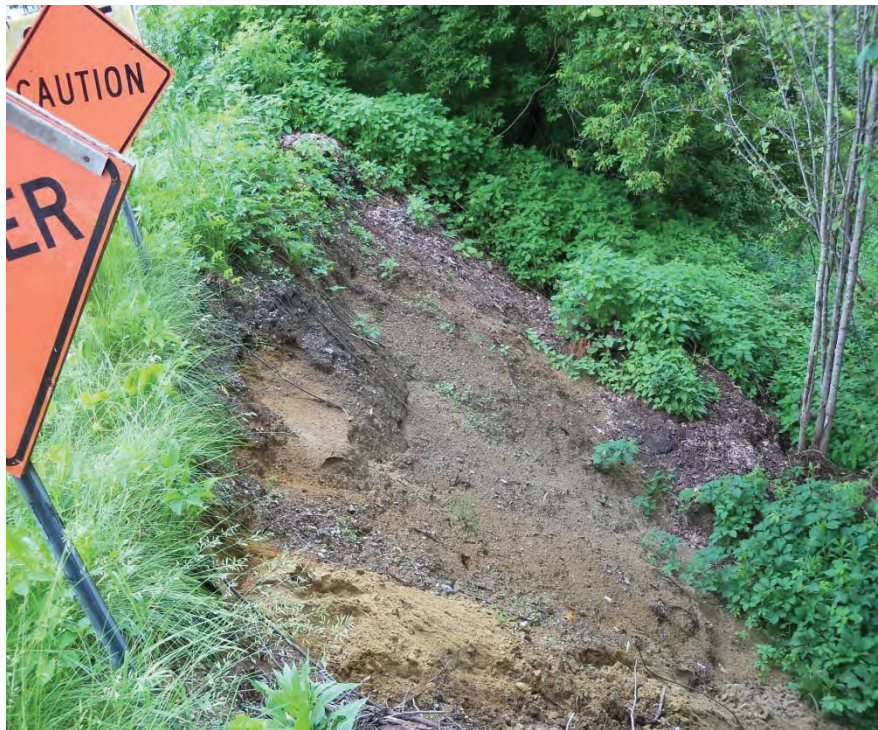
Figure 7.22. George Springston (Vermont Geological Survey) and Keith Arlund (Brandon Town Manger) examine the mass failure on Wheeler Rd (BCE, 5/25/2011)

Figure 7.23. Mass Failure (unstable valley wall of the Neshobe River) located adjacent to Wheeler Rd (BCE, 5/25/2011)

Potential Project #6- Remediate Mass Failure in Reach M03. A mass failure located on the west bank adjacent to Wheeler Road is contributing sediment to the Neshobe River and is undermining Wheeler Road (Figures 7.22 and 7.23). A project to divert the flow away from the mass failure or improve the stability of the mass failure is recommended.

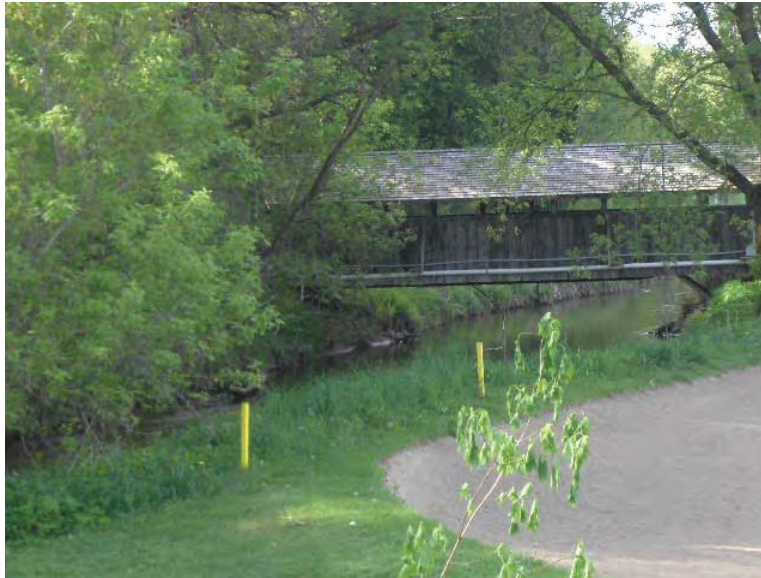
Figure 7.24. Lack of buffer along Neshobe River at Neshobe Golf Club (BCE, 5/7/10)

Potential Project #7 – Riparian Buffer Improvements in Neshobe Golf Club in Reach M04. The buffer along the east bank of the Neshobe Golf Club property has been significantly disturbed (Figure 7.24). Buffer restoration is recommended for this stretch of river, recognizing there will be land use constraints.

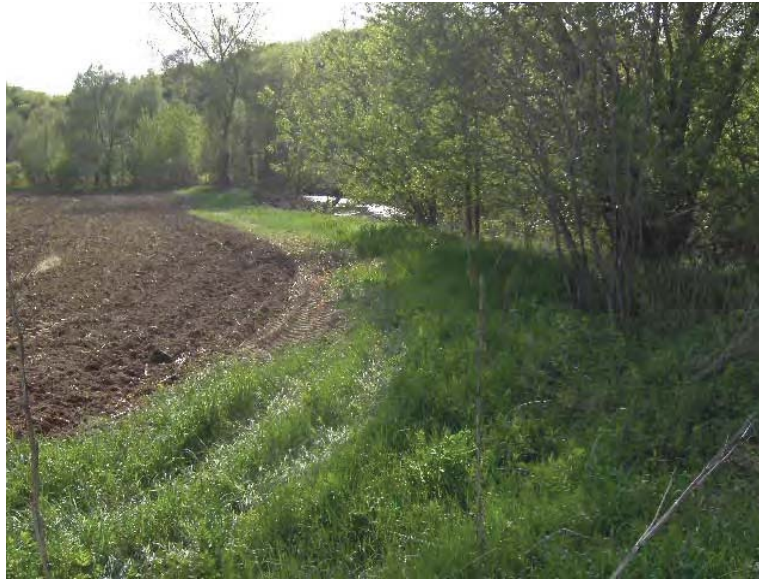
Figure 7.25. Lack of buffer along agricultural fields in Reach M05 (BCE, 5/7/10)

Potential Project #8 – River Corridor and Wetland Protection and Streamside Plantings in M04 through M06. Reaches M04, M05 and M06 offer a myriad of river restoration and protection opportunities with all riparian properties being at least 15 acres in size. There is also a significant wetland that is at the top of Reach M05 and at the bottom of Reach M06 that warrants consideration for additional protection beyond federal and state regulations. There are a number of farms in this stretch of the river along Town Farm Road that may qualify for CREP. Corridor easements are an additional option for corridor protection. Riparian buffers are lacking along much of Reach M05 on both sides (Figure 7.25). Phase 2 data indicates this reach is not incised. For this reason, buffer plantings within this reach are a high priority. There are some agricultural fields bordering Reach M06 and recent flood waters have scoured the fields in some locations causing sediment from farm fields to enter the channel (Figure 7.26). It is recommended that an analysis for reducing farm runoff to Reach M06 be conducted. CREP is one possible program that could be used to increase buffer widths to reduce runoff and sedimentation along Newton Road.

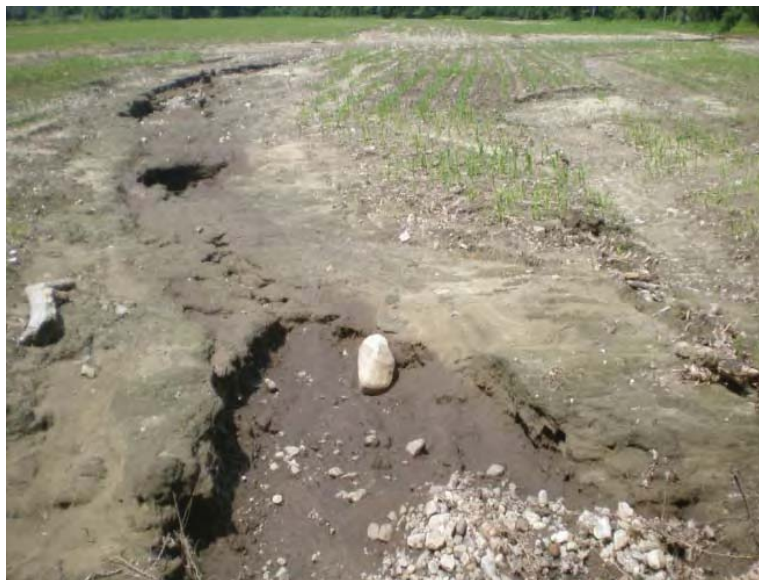
Figure 7.26. Drainage off of agricultural field to Reach M06 (Round River Design, 6/17/09)
