Crosby Brook Watershed Stream Corridor Restoration Plan

June 1, 2009

Fitzgerald Environmental Associates, LLC. 316 River Road

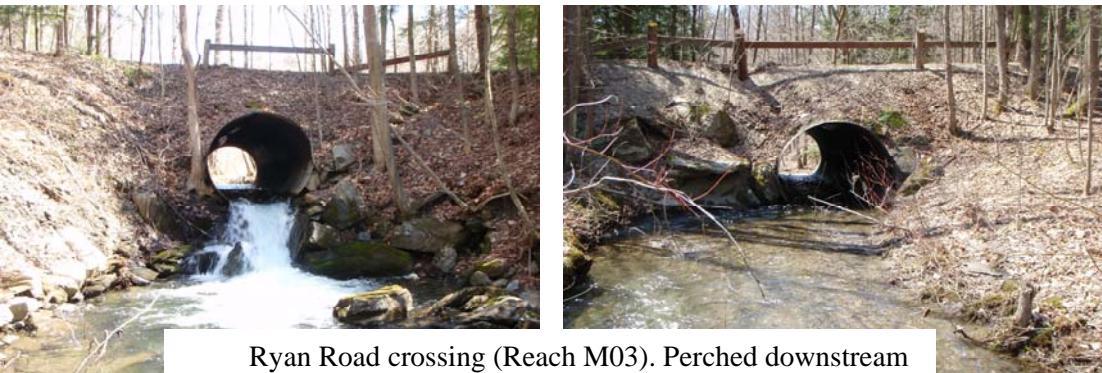
end (left) and inlet (right).

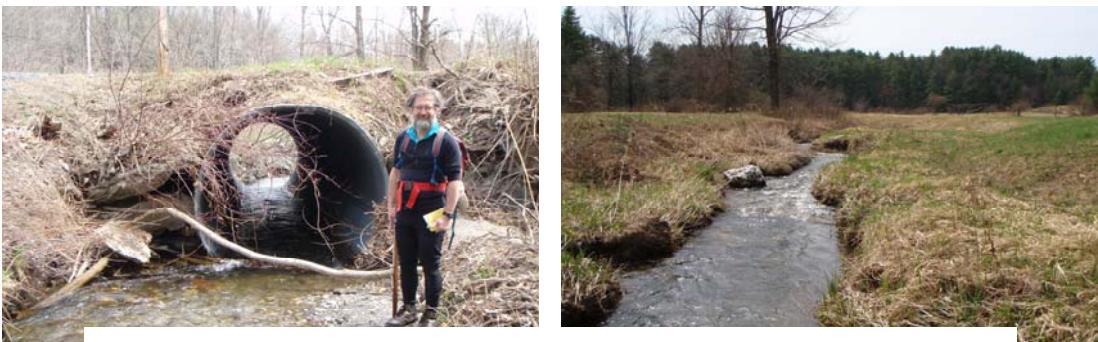
Upper Middle Road crossing (Segment M06-A). Upstream end (left) and lack of riparian buffer downstream (right).

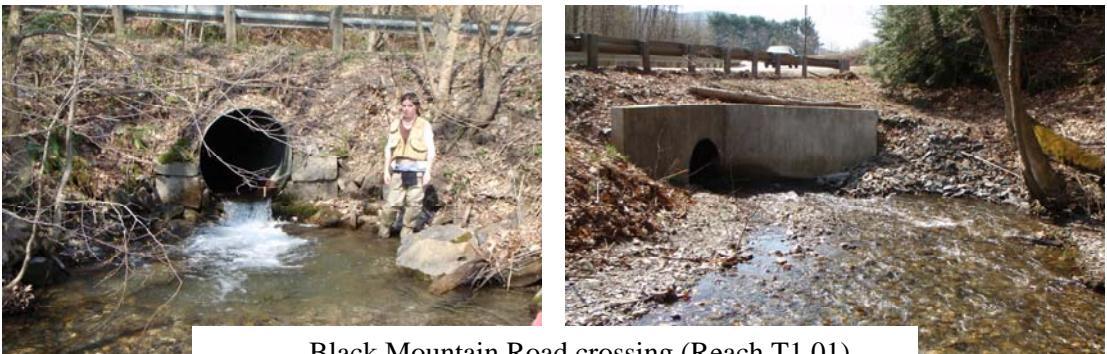
Black Mountain Road crossing (Reach T1.01). Perched outlet (left) and headwall at inlet (right).

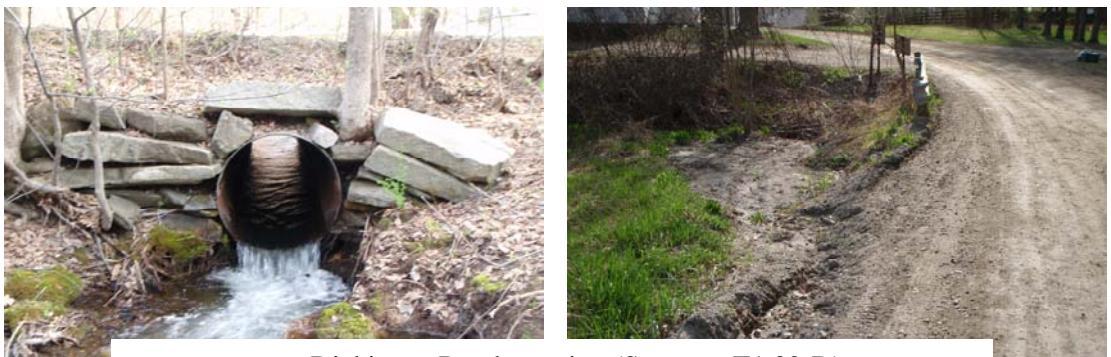
Dickinson Road crossing (Segment T1.02-D). Downstream end (left) and road runoff into upstream end (right).

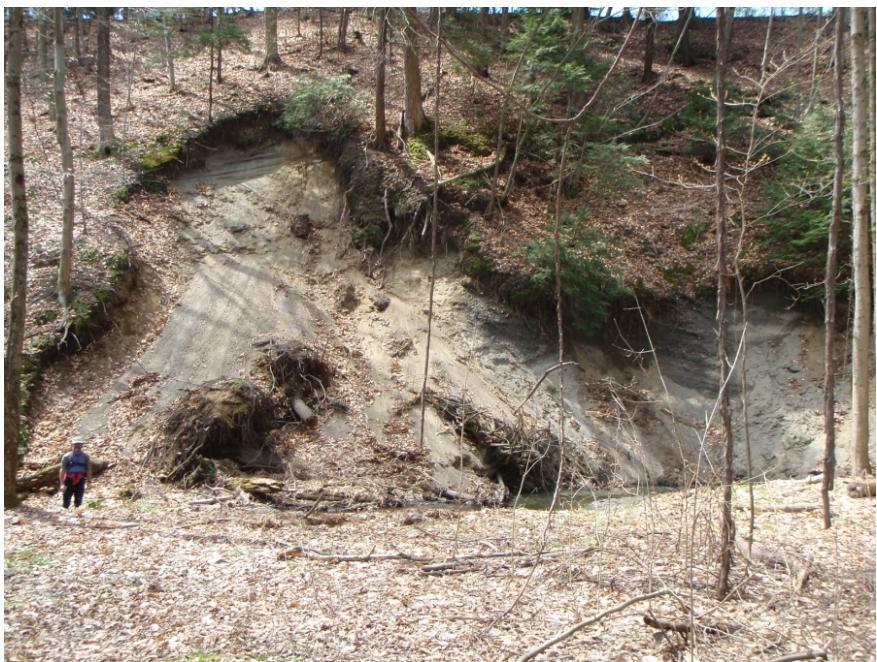
Figure 13. Large mass failure in upper segment.

The large mass failure is found along the right bank, and measures approximately 90 feet in length by 35 feet in height. Based on observations by Brattleboro Town officials, the slope failure has become worse in recent years. A review of historical photography from 1962 suggests that the failure did not exist at that time, and has perhaps developed as a result of increased incision at the site since that time period. Due to the channel incision and adjustment features, this segment is considered highly sensitive to further human impacts (RGA condition "Fair", CEM stage II). The habitat diversity is compromised by aggradation of fine sediments from the slope failure, and a loss of bed features due to the channel incision (RHA condition "Fair").

2) Sheer at toe of failure: Ongoing sheer at toe of failure will continue to undercut and aggravate the failure. A combination of "soft" and "hard" armoring could reduce the stress at the toe. An approach using a log deflector in combination with rock rip-rap is one possibility.

1) Top-down slope failure: Due to the steep slope of the valley wall, the failure is now active in a top-down direction. One option to address this (described further below) is the use of root wads with boles anchored into stream bed edge (above the bankfull elevation) would address the long term instability of the slope by mimicking and enhancing the natural process of fallen trees stabilizing the structure-less soil. Future plantings along the slope would add further stability and reduce sediment loading directly to channel.

Given the active nature of the channel and slope adjustments, conceptual designs for the stabilization of the slope have been developed. Initial plans for dealing with the mass failure have been re-evaluated and a new design is proposed. The new conceptual design proposes to address the three adjustment processes outlined in the stressors section above.

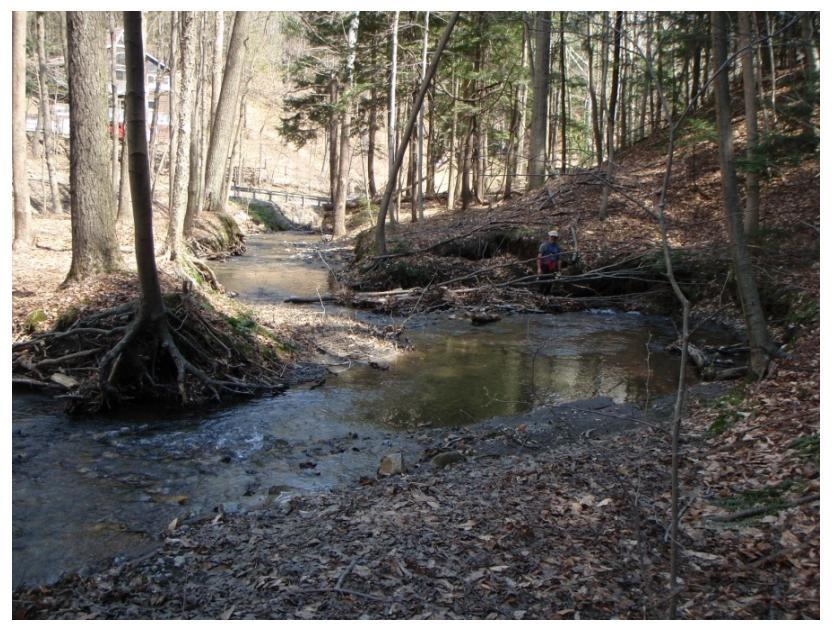
Figure 15. Nickpoint in lower segment.

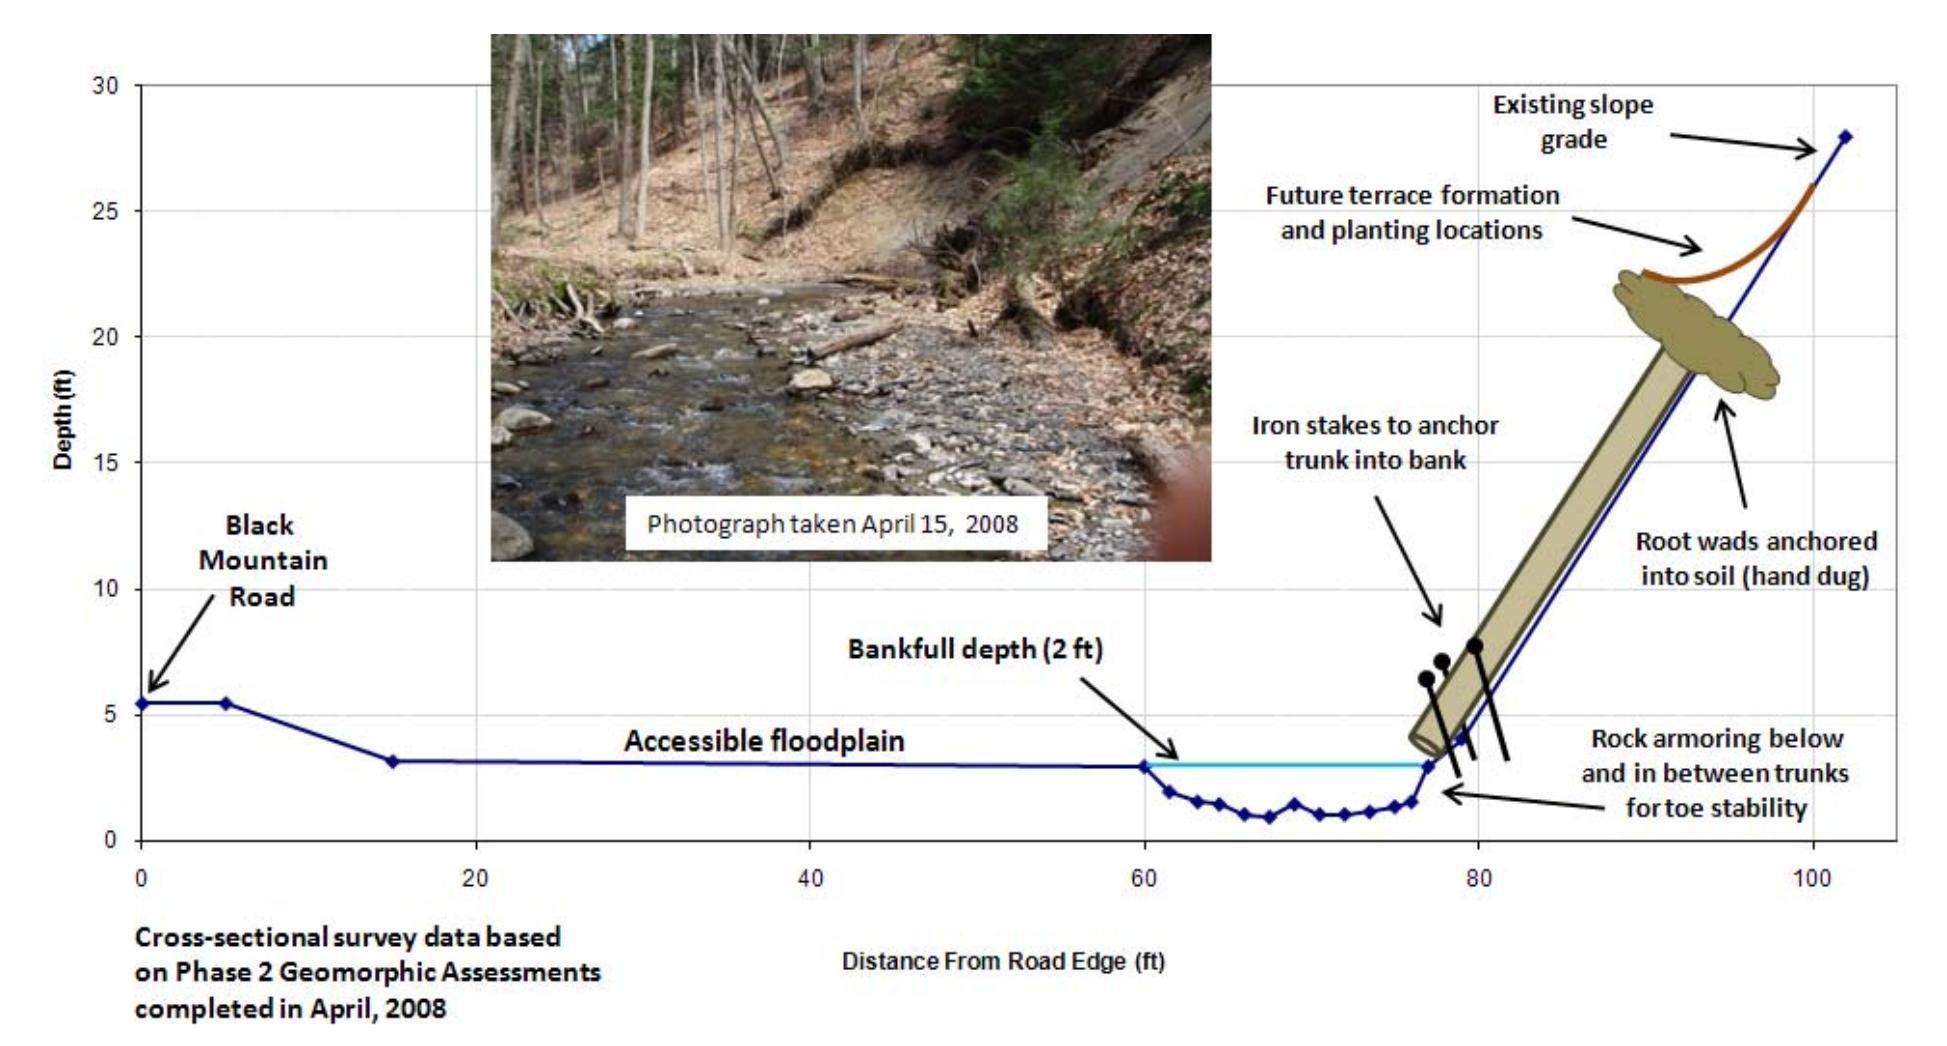
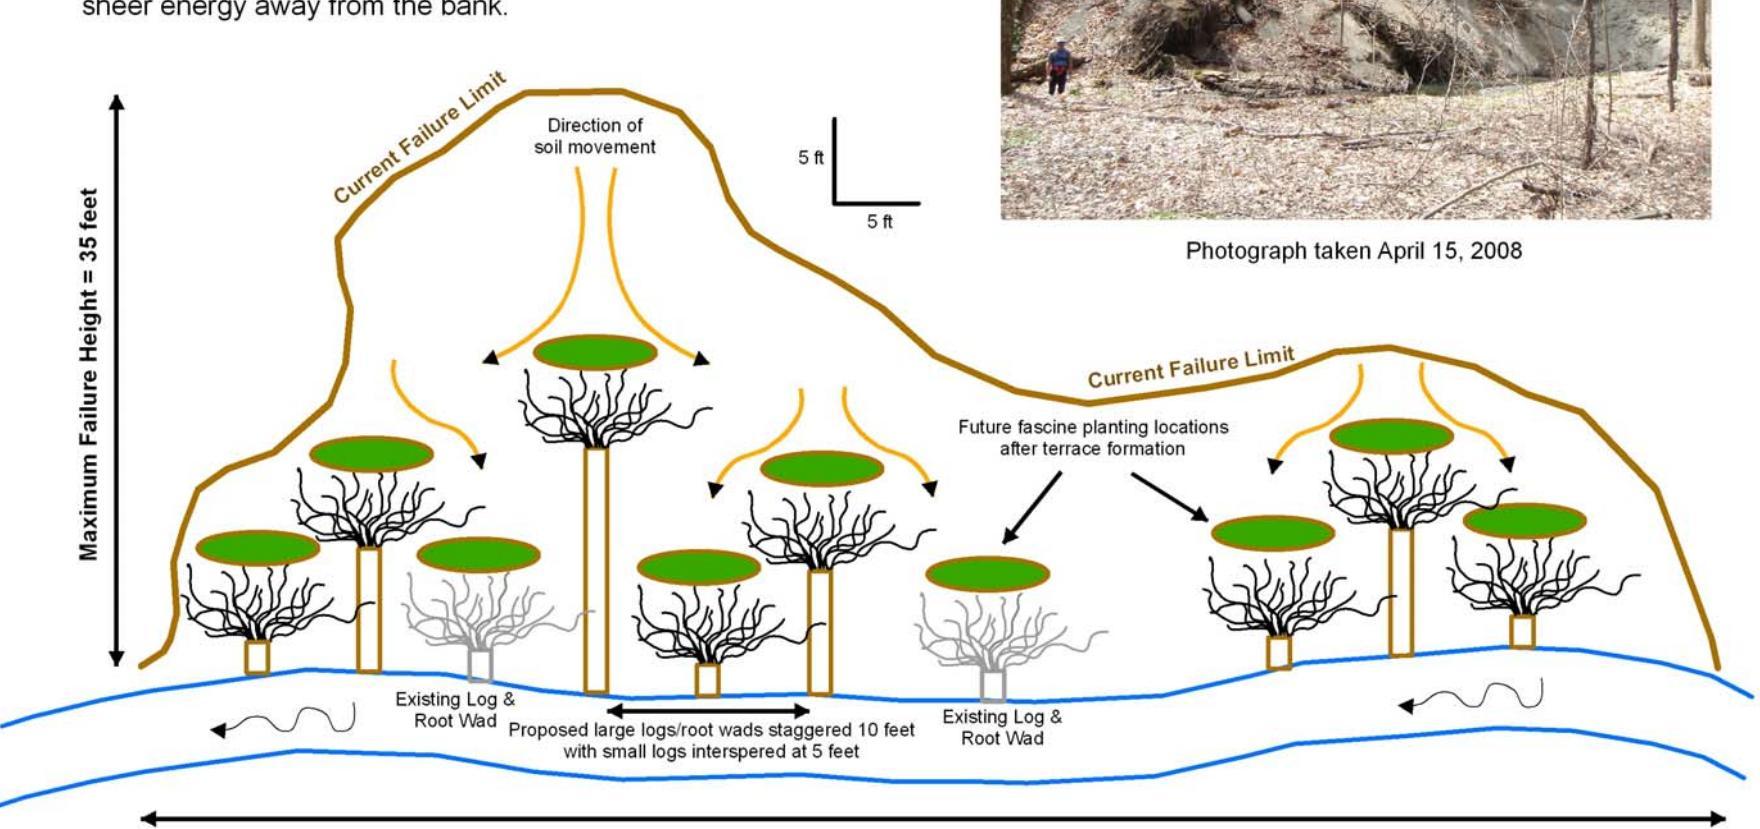
Figure 16. Concept sketch (in cross-section) to address slope failure.

Total Failure Length = 90 feet

Use of logs & root wads anchored into slope to promote terrace formation and prevent fine sediment from entering channel. Terraces could be planted with willow fascines in future to ensure long term stability and revegetation.

Rock armoring and/or tree revetments would also be used to stabilize the toe of the slope and deflect sheer energy away from the bank.

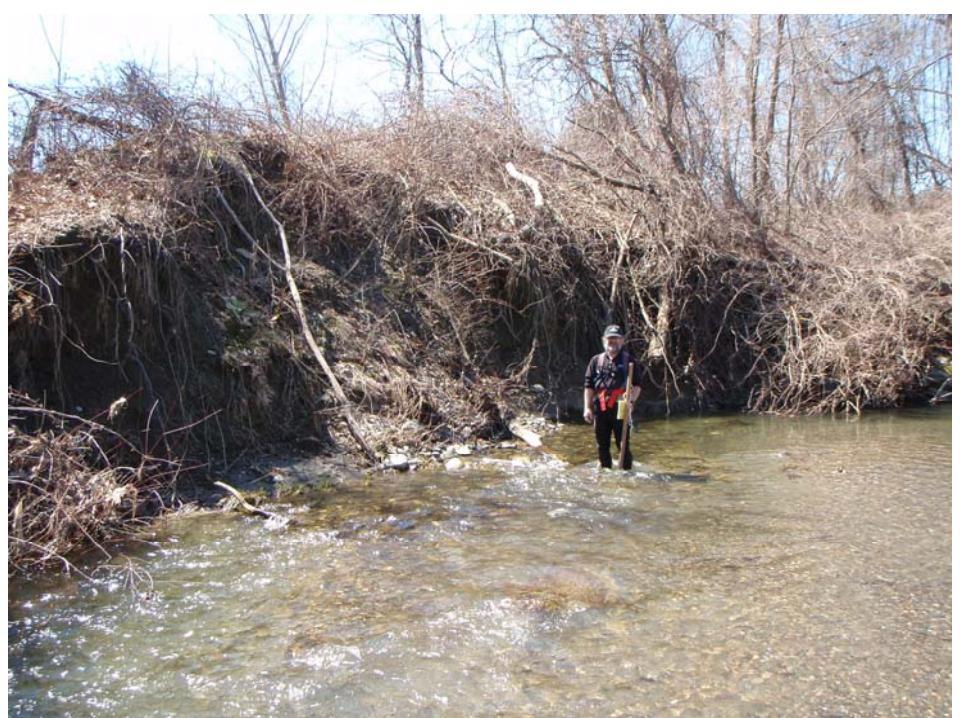
Segment M01-B is found from a break in slope near the railroad tracks up to the confluence with the South Branch at the Exit 3 ramp (see Figure 19). The segment is approximately 1,500 feet long and has an overall channel slope of approximately 0.5%. Under reference conditions we would expect this segment to be found in a broad, alluvial valley. Gravel stream channels in this setting and watershed zone typically have a meandering profile with riffle-pool bed features. However, encroachments on the channel from the railroad, Route 9, and commercial development have reduced the available floodplain area. As a result, the channel is found in an altered (semi-confined) valley setting with a lower than expected entrenchment ratio (ER = 2.8). Due to the diminished floodplain access, greater stream power is concentrated in the channel and has led to incision and numerous bank failures. Large failures were noted along the south bank of the segment, some reaching heights of 12 feet (Figure 18).

Figure 18. Bank failure in fill soils along south bank.

The failures along the south bank are caused by channel adjustments and a lack of structure and vegetative protection in the fill soils. Compared to the Black Mountain Road failure site, there is a greater amount of space to work within at these failure sites beyond the banks; therefore a wider range of stabilization techniques can be considered. A soft engineering approach using natural materials in combination with some rock armoring could be applicable. In addition, the steep banks of the fill soils could be peeled back, with the final bank profile taking on a moderated slope that would allow planted vegetation to become established. Examples of combinations of rock riprap with wood and/or tree revetments are provided below (Figure 21) from the Federal Interagency Stream Restoration Working Group's publication on Stream Corridor Restoration (FISRG, 2001).

Due to the active nature of the channel and slope adjustments, a bank restoration approach with floodplain re-grading should be considered for this site. Conceptual designs used from other stream stabilization projects have been compiled below to illustrate the range of techniques available for this site. In addition, a typical channel cross-section from the Phase 2 surveys illustrates the degree of channel incision, and how floodplain re-grading could increase floodplain function.

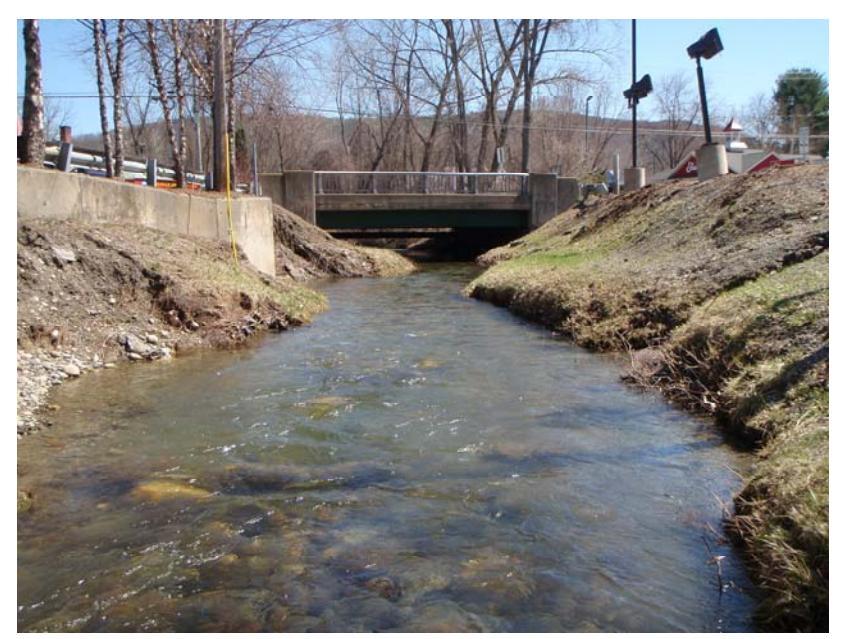
Figure 20. Lack of healthy buffer west of Route 5.

3) Riparian Buffer: Lack of riparian vegetation is contributing to elevated stream temperatures in the lower reaches. Among other impacts, lack of tree cover leads to greater sunlight reaching the

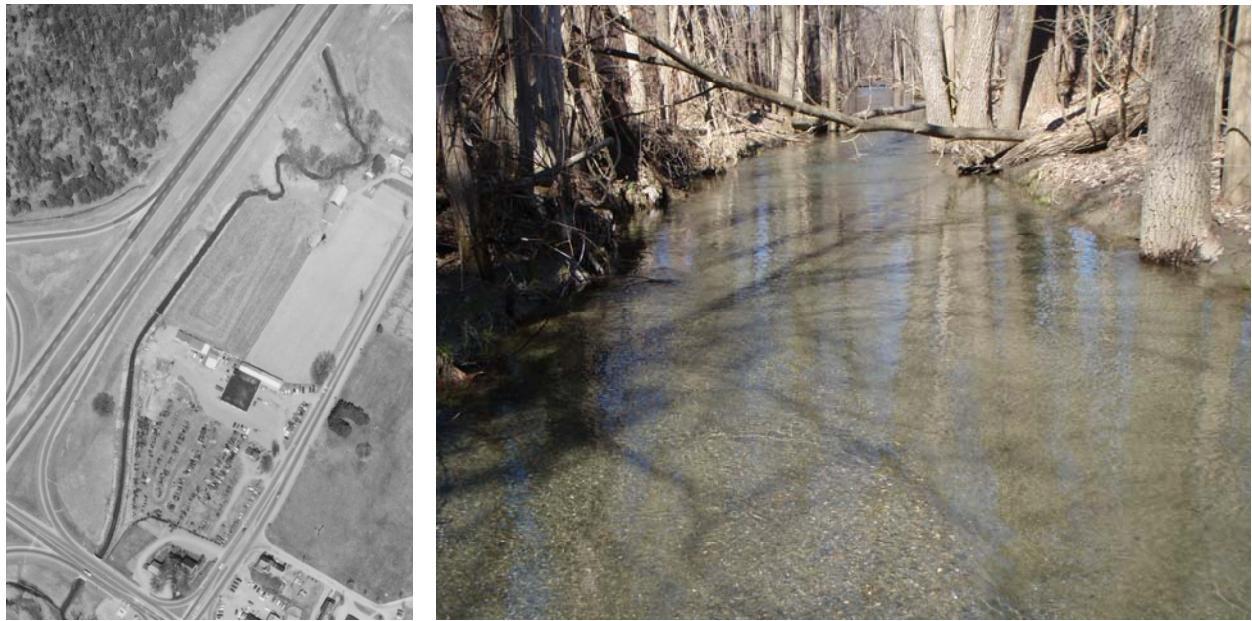
Figure 23. Historical channel straightening during construction of I-91 (left), and resulting plane bed morphology in the lower reach (right)

Due to the departure in valley and channel morphology and the high channel incision, the segment is considered extremely sensitive to further human impacts (RGA condition "Poor", CEM stage II). There is very limited habitat diversity due to extensive straightening, increase in fine sediments, and limited buffer and corridor protection (RHA condition "Poor"). VTDEC sampling data indicate that the fish and macroinvertebrate communities have been highly impacted, supporting fair to poor conditions. The LWD density for this reach was the lowest for any of the main stem reaches (30 pieces/mile).

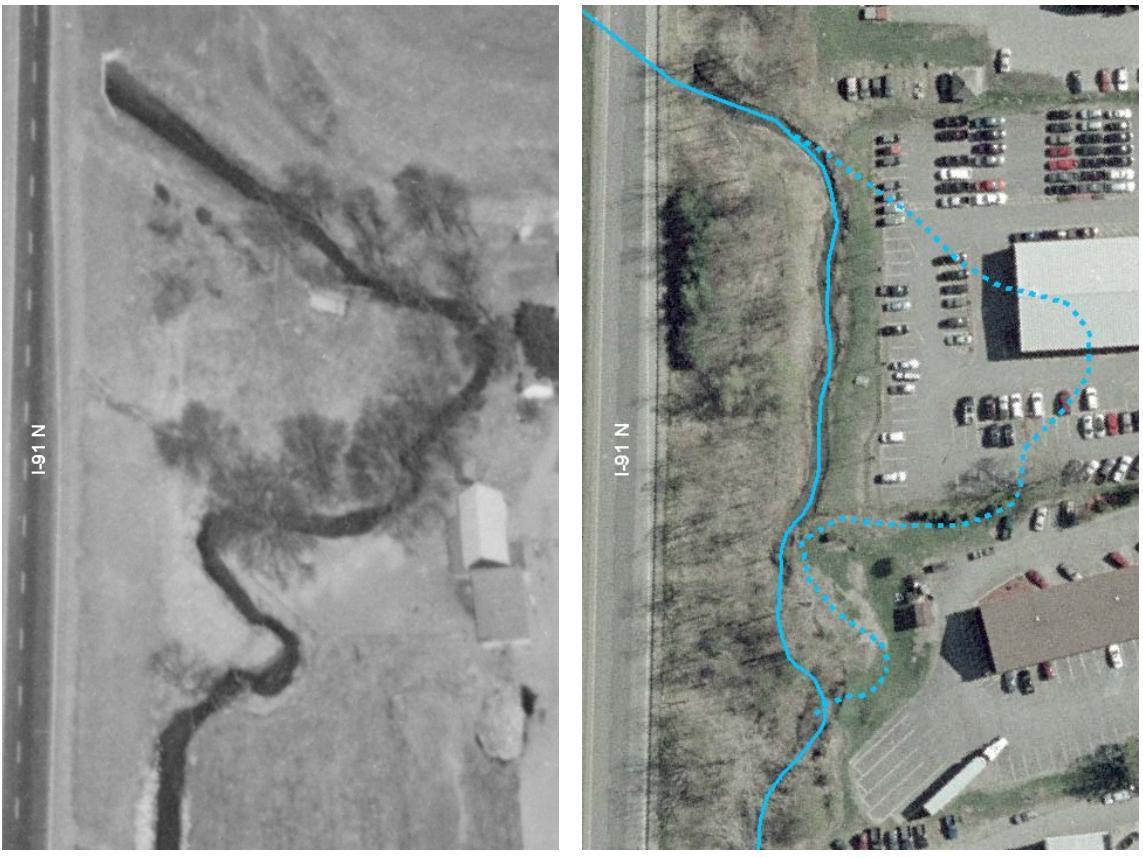
1) Channel adjustments: Channel straightening and encroachment has led increased stream power due to loss of floodplain along both banks, and a much simplified channel form. Historical aerial photographs indicate that the channel had an extensive, meandering form and flowed across the wide valley that is now occupied to the west by I-91 and to the east by commercial development along Route 5. Significant amounts of fill were placed in the floodplain to serve adjacent commercial building lots as early as the 1960's around the time that I-91 was constructed. Since that time, there has been additional development within the stream corridor, and the channel has been further straightened to allow for adjacent development (Figure 25). In addition, increasing adjacent development has led to greater stormwater discharges directly to this section of Crosby Brook. The loss of channel meanders from recent development has also led to decreased storage capacity of sediment coming down the channel from upslope. The sediment originating from the gully upstream of I-91 appears to be overwhelming the storage capacity of the channel south of this project site. While there is some channel incision and entrenchment due to floodplain encroachment, there are also areas of severe aggradation. This has led to very poor habitat conditions in this reach. Due to severity of floodplain encroachment in this reach, there is little hope for recovery of reference channel geometry.

Figure 25. Channel straightening and floodplain encroachment. 1962 aerial photograph (left), and 2008 (right). Note location of historic meanders (dashed blue) and current straight channel (solid blue).

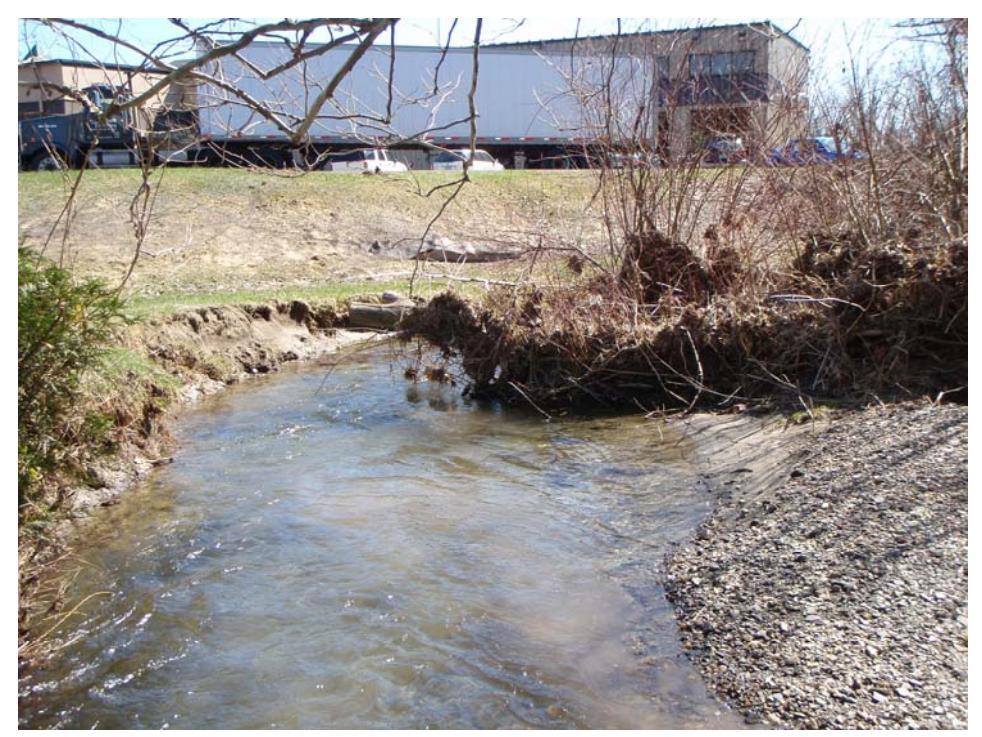
Figure 26. Lack of buffer and bank erosion behind Motel 6.

3) Riparian Buffer: Lack of riparian vegetation in this reach is contributing to elevated stream temperatures downstream. Lack of tree cover leads to greater sunlight reaching the water's surface and increases in water temperature. VTDEC monitoring has shown that stream temperatures in the lowest reach (M01) upstream of the Connecticut River exceed 20°C for several days in succession. Brook trout will generally not survive in streams with temperatures above this level. In the lower reaches such as M02, any and all opportunities for re-planting the buffer with native woody vegetation should be explored. At this project site (Figure 26), approximately 400 linear feet of bank is recommended for buffer planting to increase shading of the stream channel and promote long term bank stability.
