**Lamoille River Corridor Plan**  
**Hardwick to Johnson**  
**Lamoille County, Vermont**  
**December 15, 2010**

# Lamoille River Corridor Plan

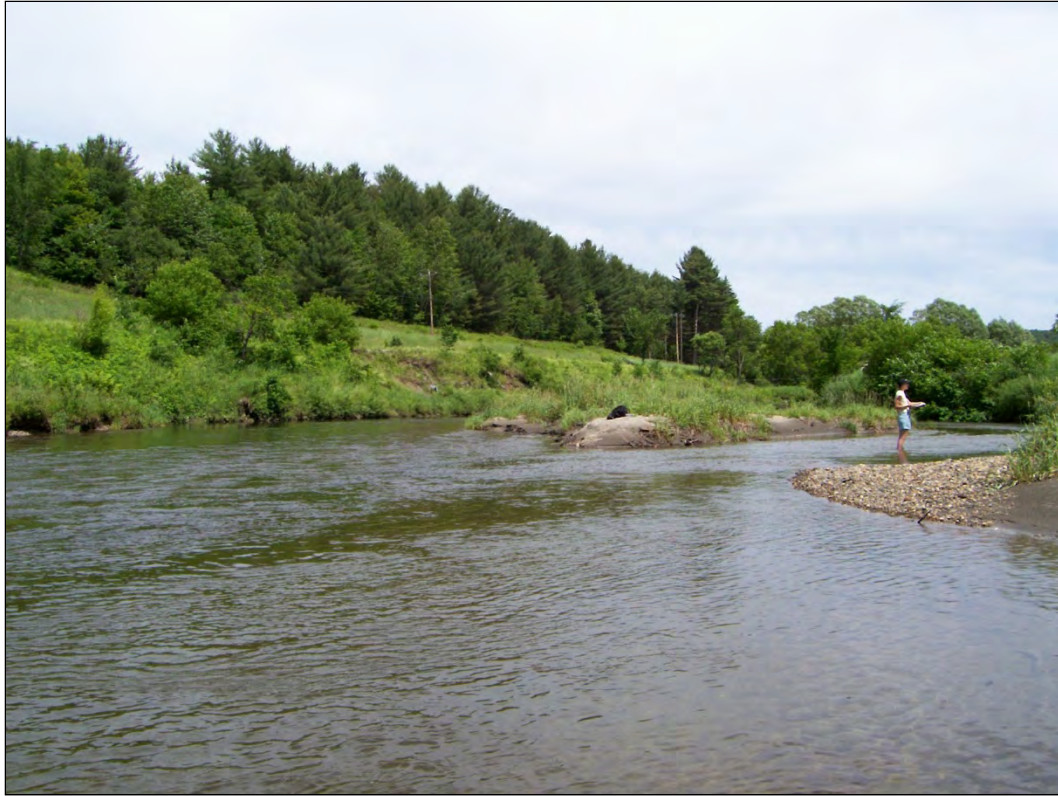
Lamoille River reach R2I begins below Wolcott Village and continues downstream to where the Wild Branch, a major tributary, enters on the north bank. The reach flows through hay fields, forest, and residential lands in a very broad valley that has been narrowed by Vermont Route 15 and the Lamoille Valley rail bed. Historic degradation within the reach has led to active widening and planform adjustment (Figure 19). Many of the side and point bars observed are being outflanked by the river indicating active planform adjustment. Riparian vegetation is absent or minimal along much of the reach and is dominated by herbaceous plants. CREP or other programs, such as the U.S. Fish and Wildlife Service Partners for Wildlife Program, are recommended to improve the riparian corridor in Reach 2I.

**Figure 19. Lamoille reach R21 is undergoing major planform adjustment and widening.**
