Stormwater Master Plan City of Montpelier, Vermont

15-097

Stormwater Master Plan

City of Montpelier, Vermont

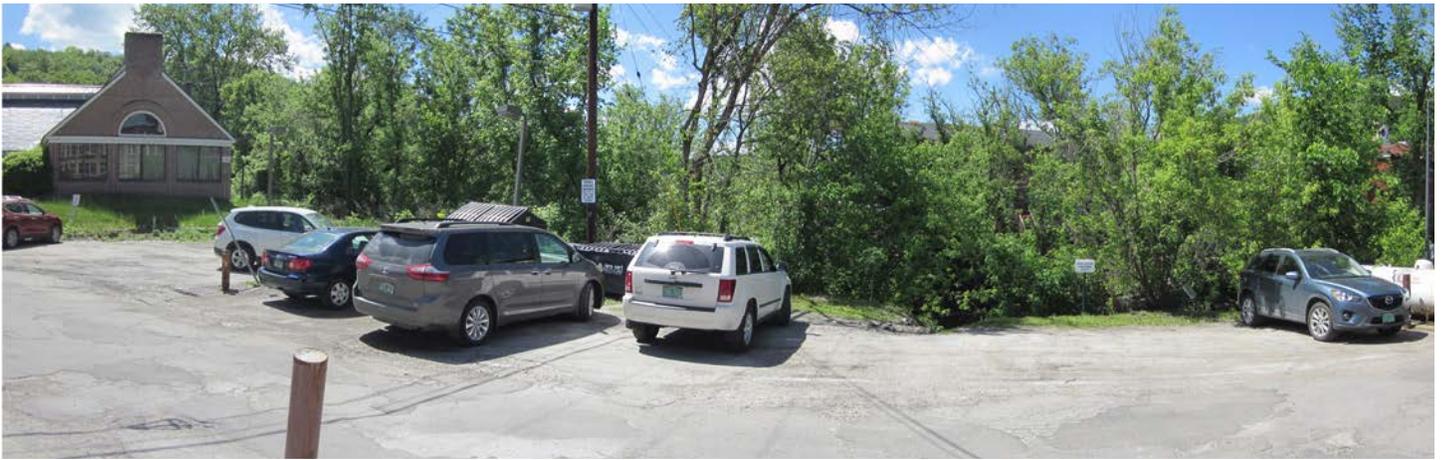
Existing Condition. The existing parking lot behind Main Street at the river’s edge. The parking lot drains into the river and there is significant erosion at the low spot where the water drains into the river (see photos below).

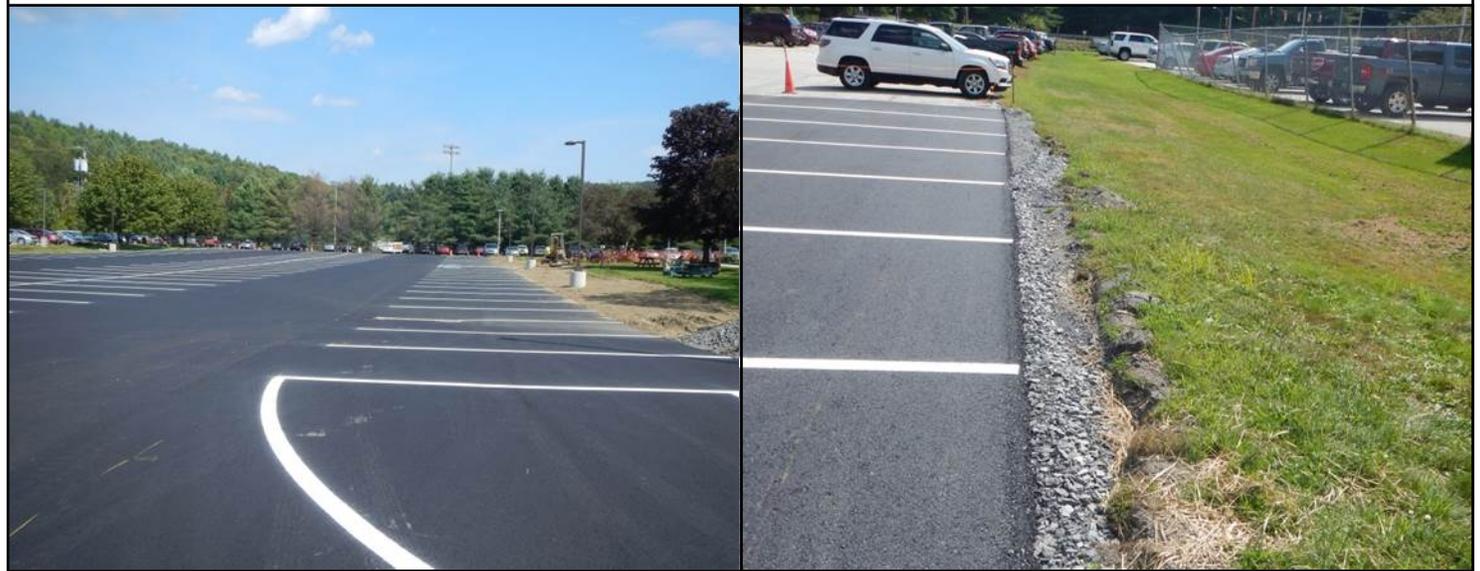
Photo 1. New paved area (previously green space) Photo 2. West edge of new parking area

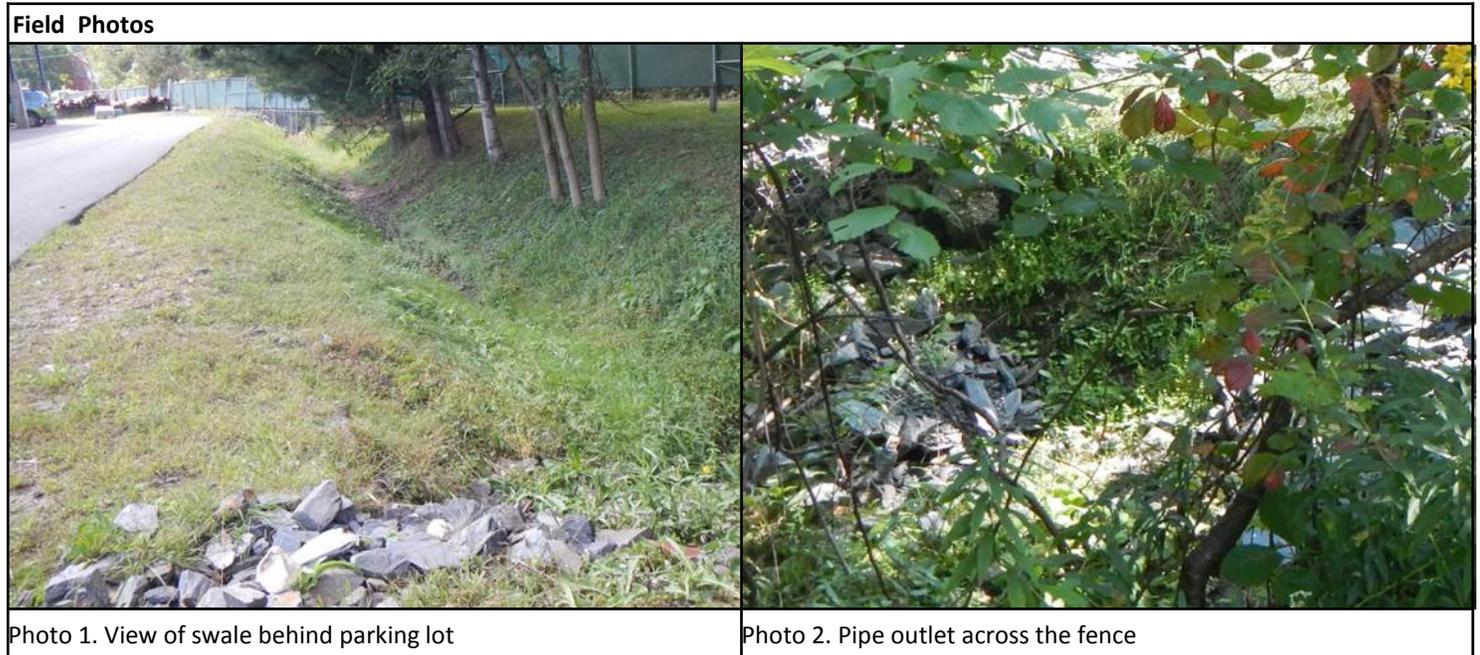
Description of Observed Conditions:
Stormwater is directed into a steep-sided, eroded swale. VT DEC retrofit concept for an infiltration basin in this area appears to be a viable option.

Prioritization Ranking Factors							
Relative Impact	Frequency	Current Condition	Urgency	Impact to public infrastructure?	Realistic to fix?	Impacts beyond water resources?	Part of a larger or systemic problem?
2	2	2	2	N	Y	N	N

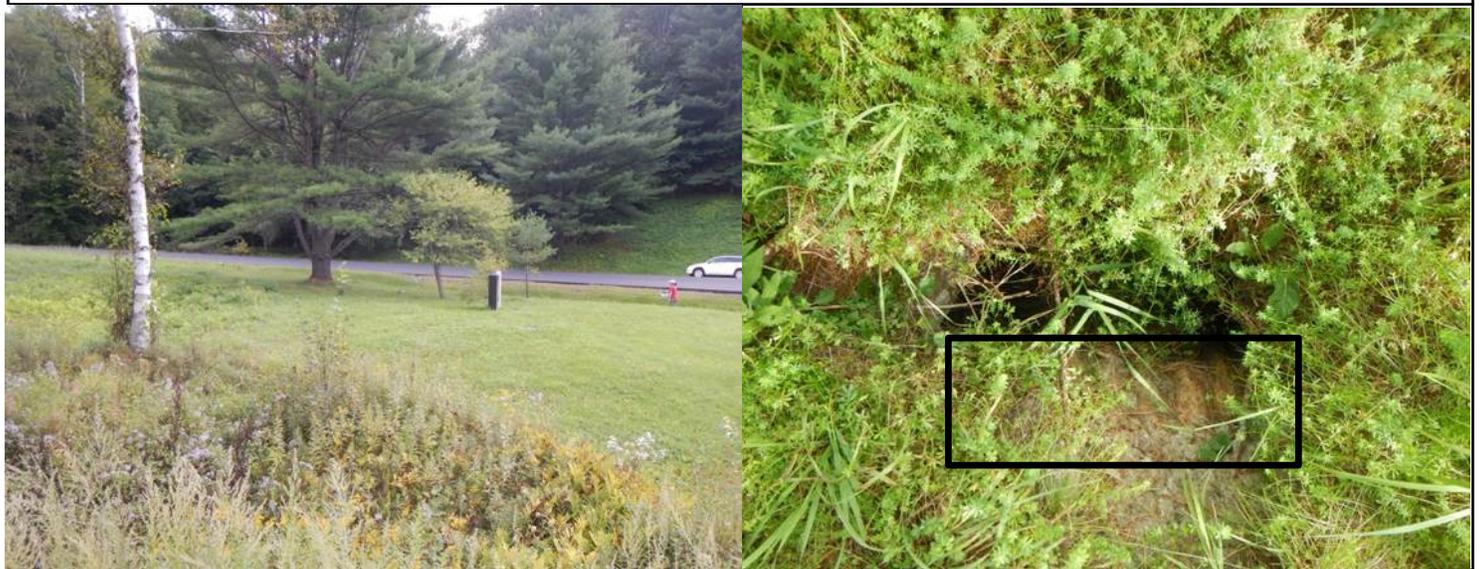
Photo 1. View of green space. Pipe runs to the left of the birch tree. Photo 2. Exposed pipe (in box) and eroded area

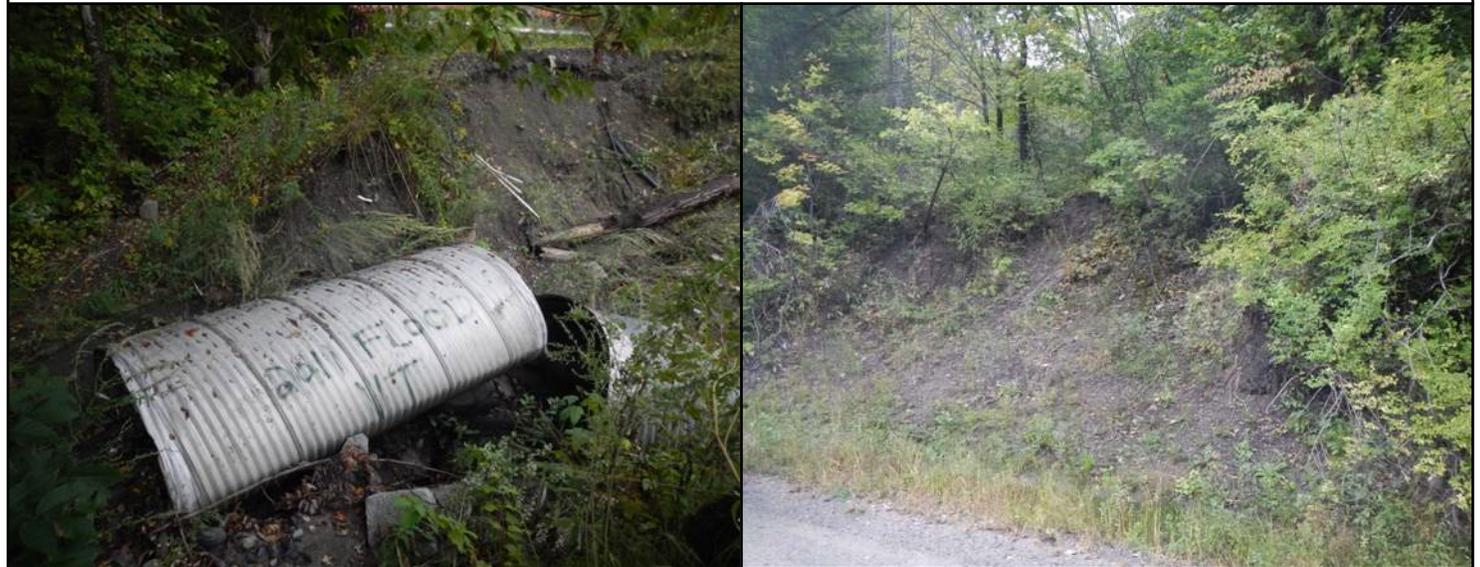
Photo 1. Damaged culvert and severe storm damage. Photo 2. Erosion of area draining into the ditch on side of the road.

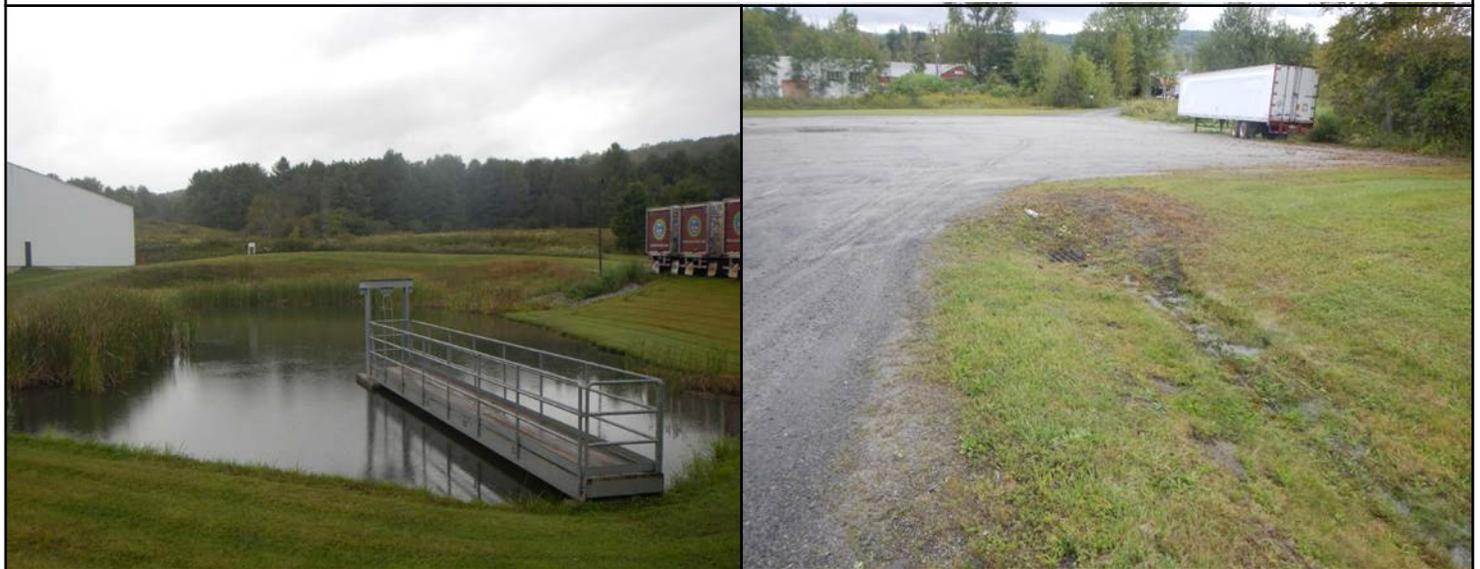
Photo 1. Pond between the two building complexes
 Photo 2. Ditch that could be reshaped and stabilized to provide better treatment for storm water before it reaches the pond.

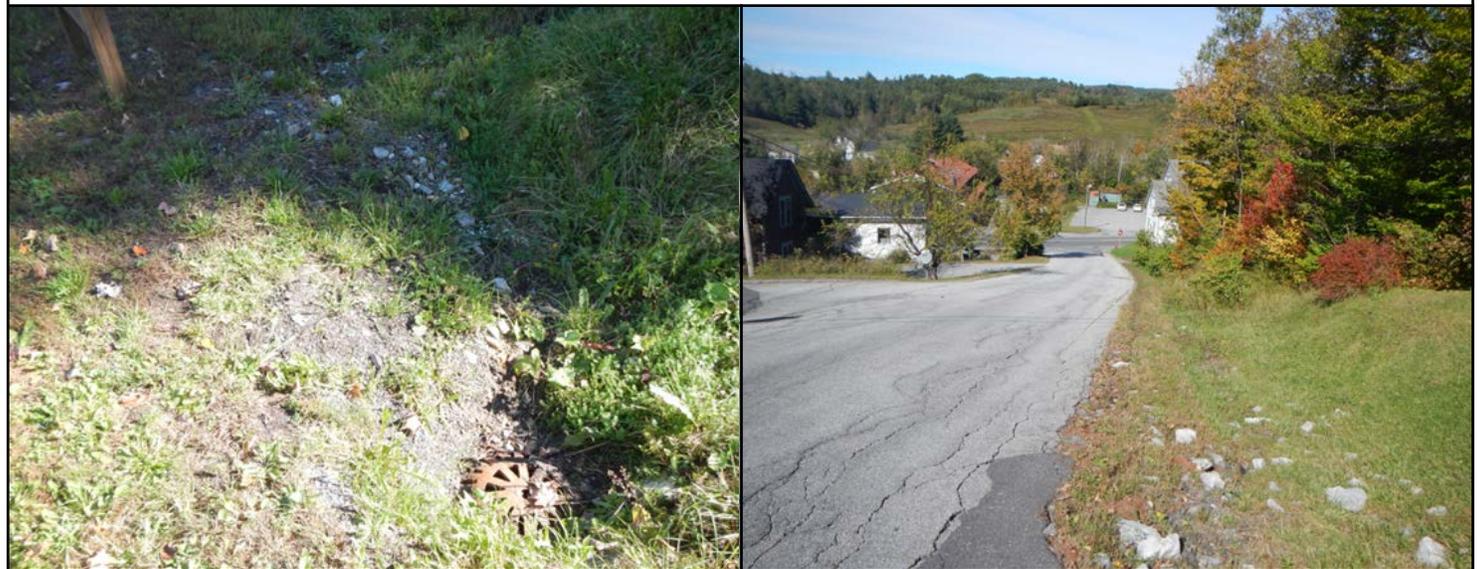
Photo 1. Catch basin and ditch could be improved. Photo 2. The road is steep but has vegetation on either side.

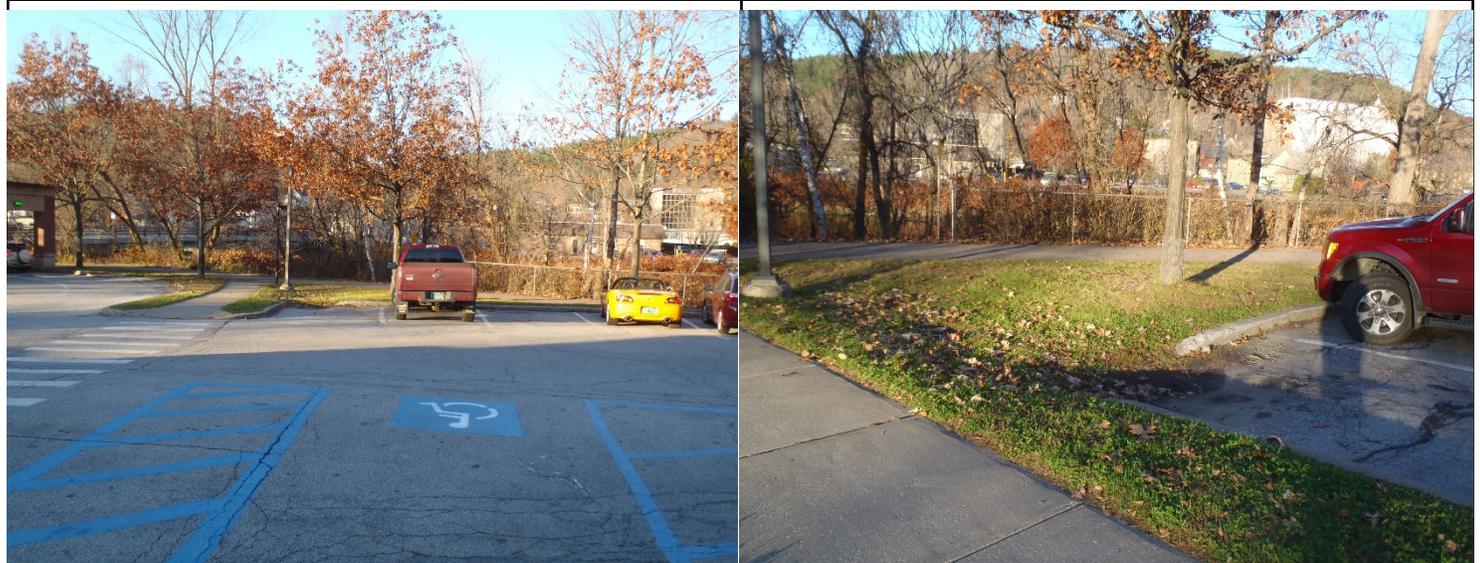
Photo 1. Parking lot is graded to drain toward existing green space | Photo 2: Sediment accumulation notes at corner of parking lot

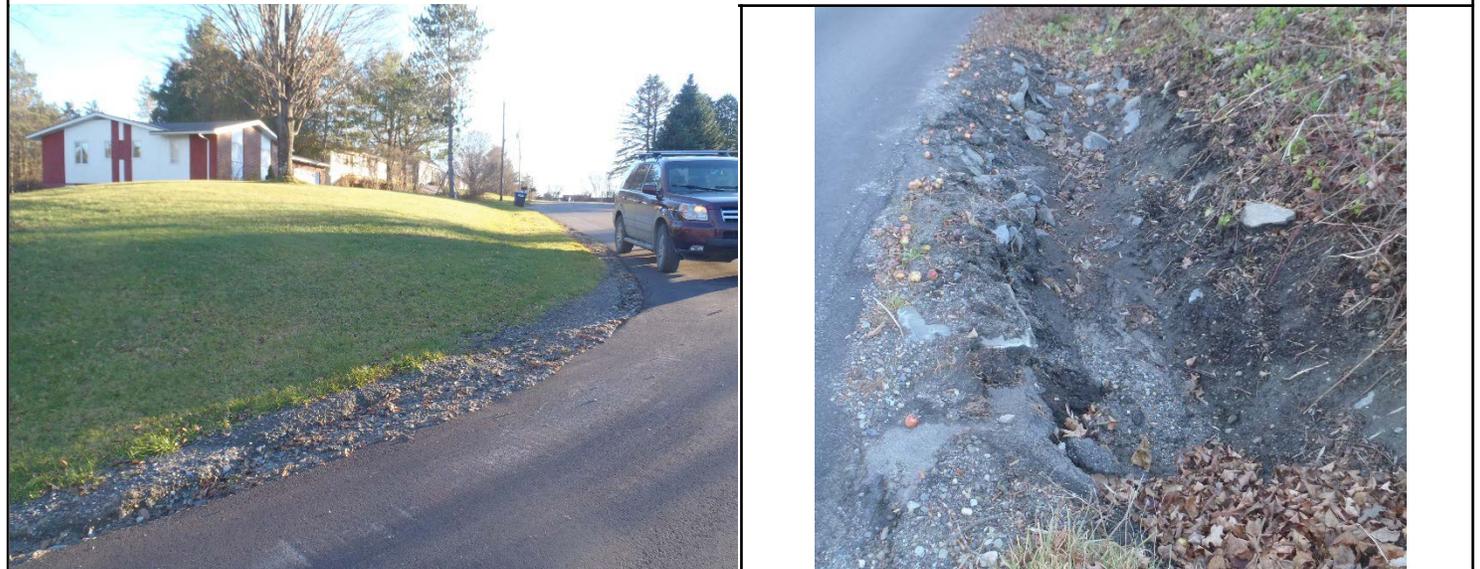
Photo 1. Erosion along the road shoulder Photo 2. Sediment accumulation in drainage ditch

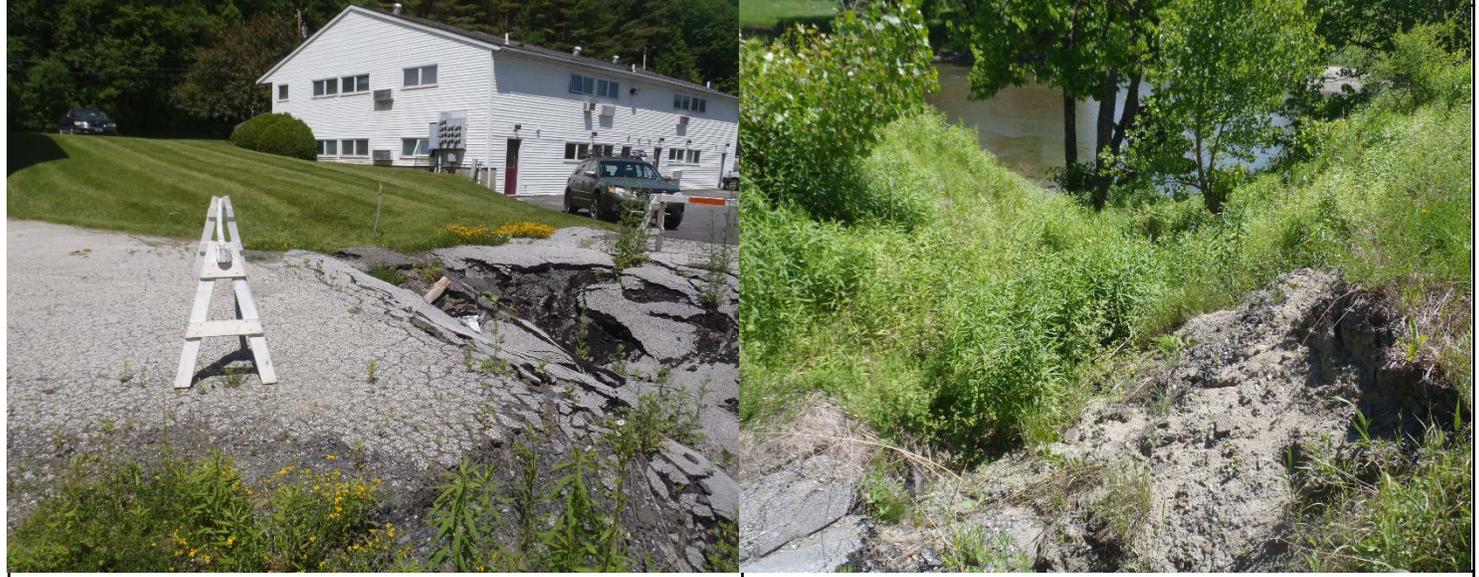
Photo 1. Damaged area where culvert used to be. Photo 2. Visible evidence of active erosion.

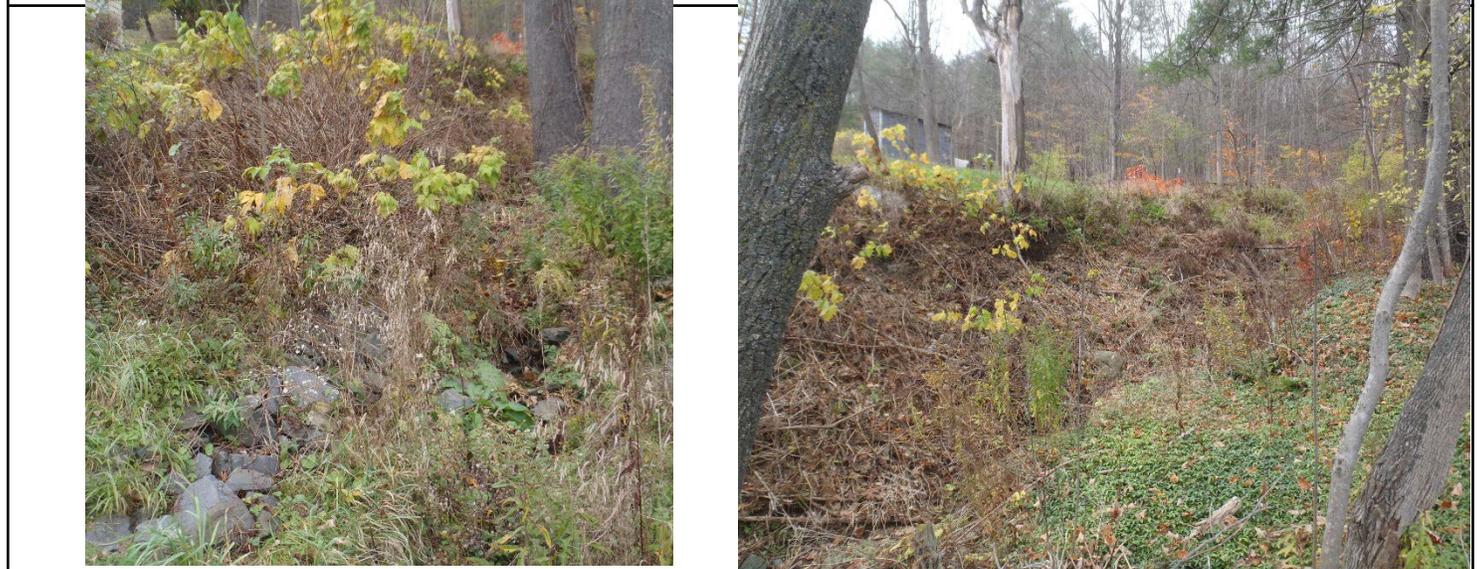
Photo 1. Base of gully at River St. Photo 2. Evidence of slope failure along western embankment of gully.

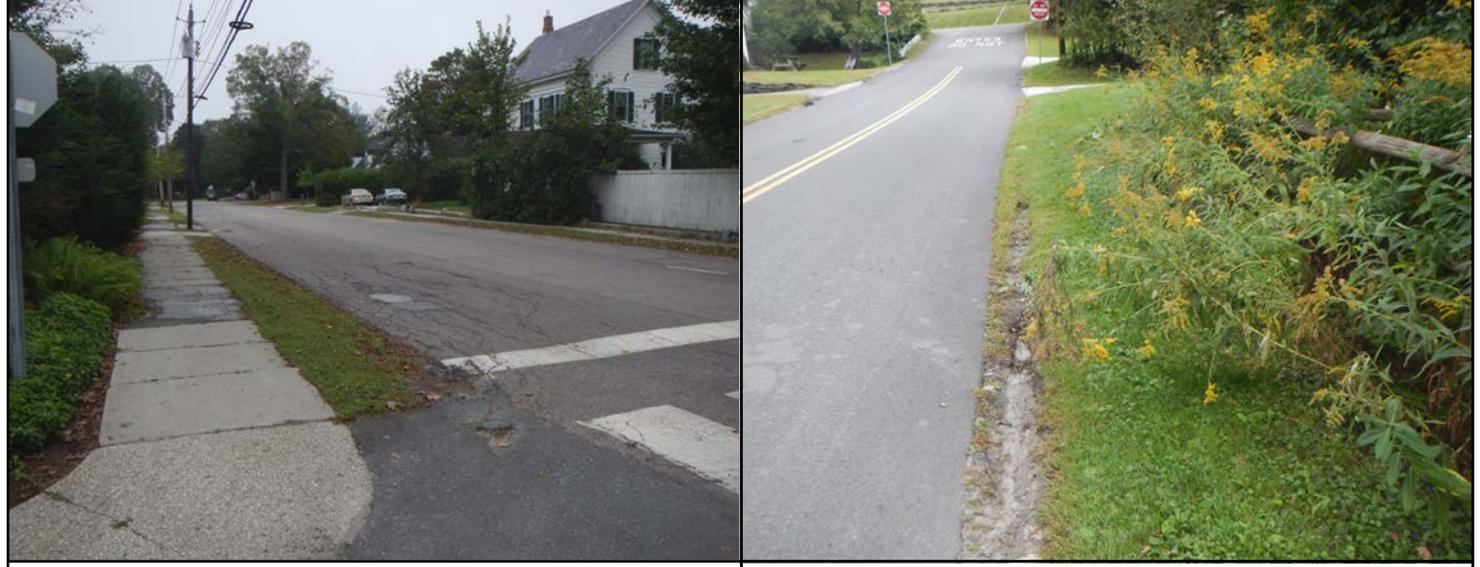
Photo 1. North side of College St. Photo 2. Minor erosion along Woodrow Ave.

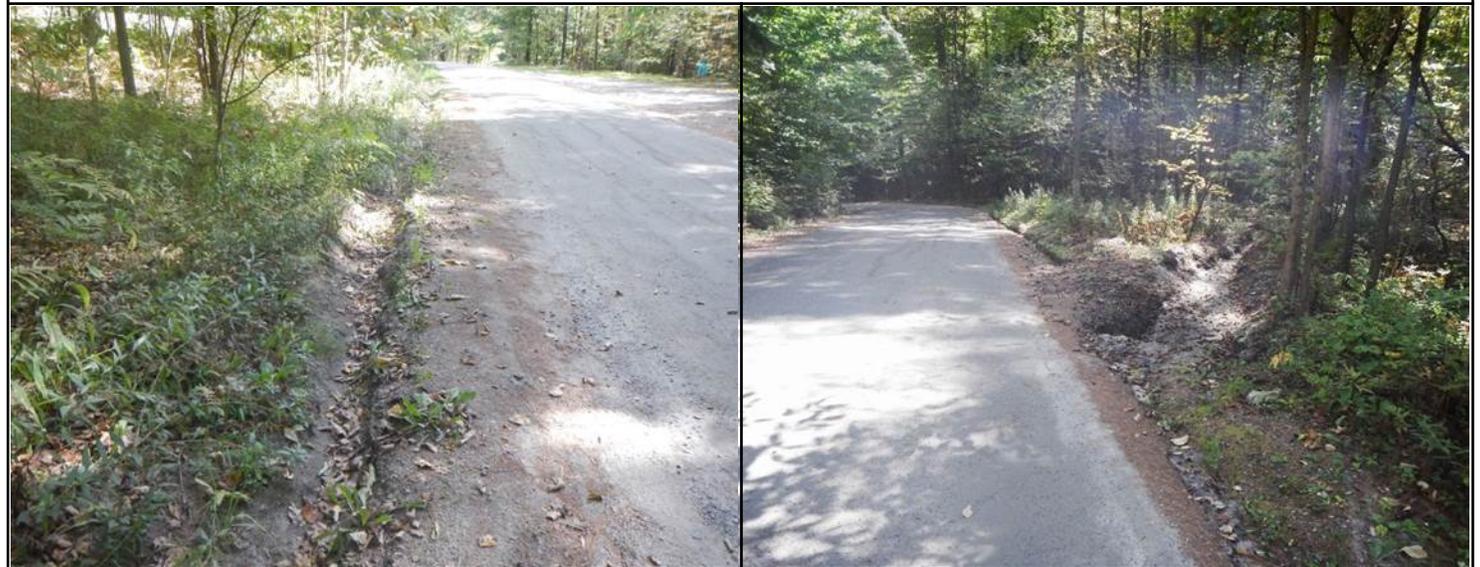
Photo 1. Roadside erosion in Hubbard Park Photo 2. Roadside erosion in Hubbard Park

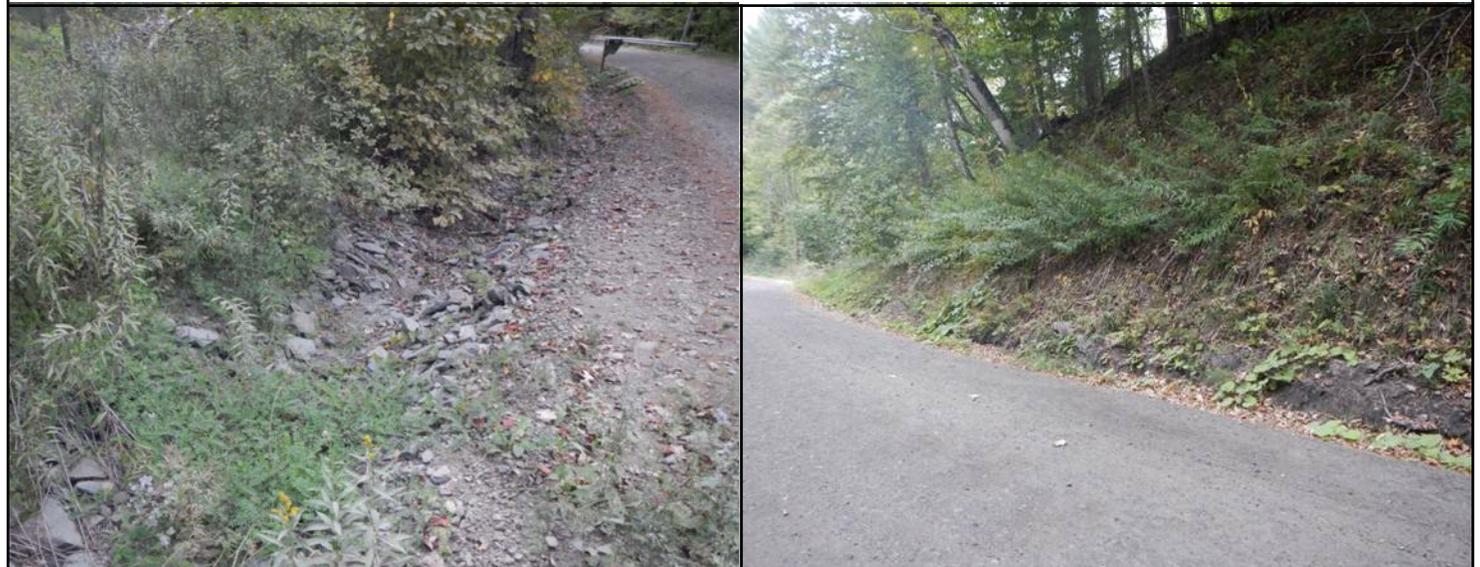
Photo 1. Rock-lined ditch in need of improvement. Photo 2. Erosion along the road.

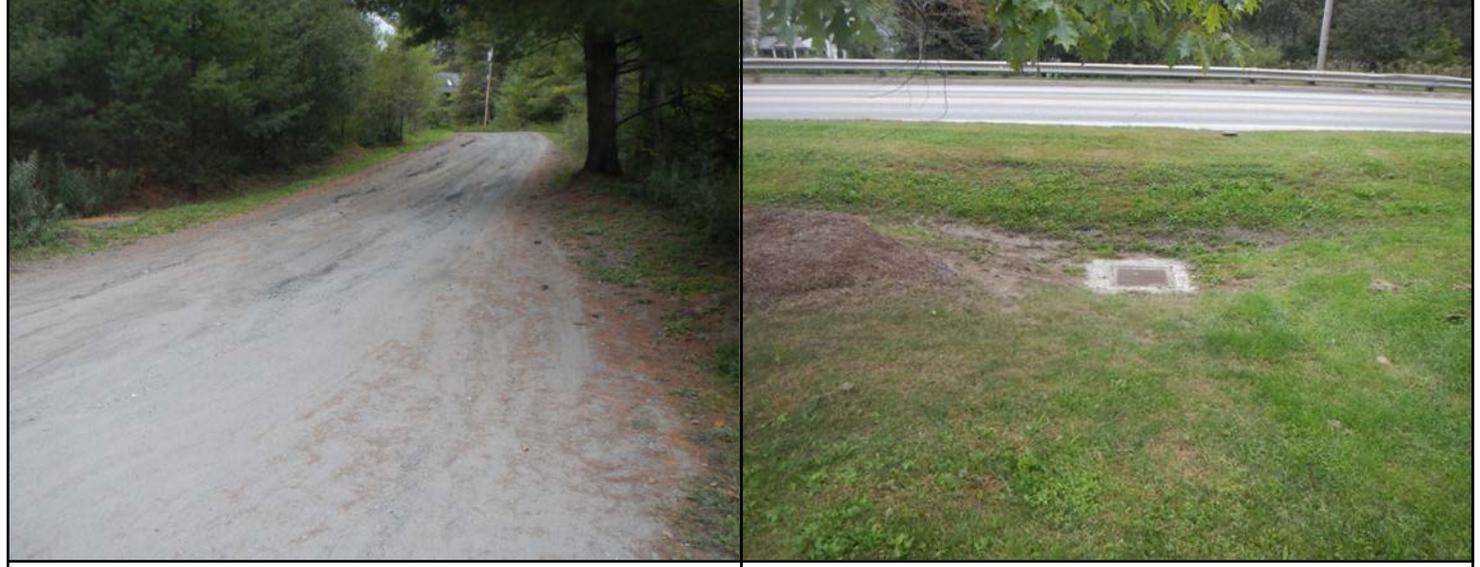
Photo 1. Eroded road	Photo 2. Catch basin that needs to be raised
----------------------	--

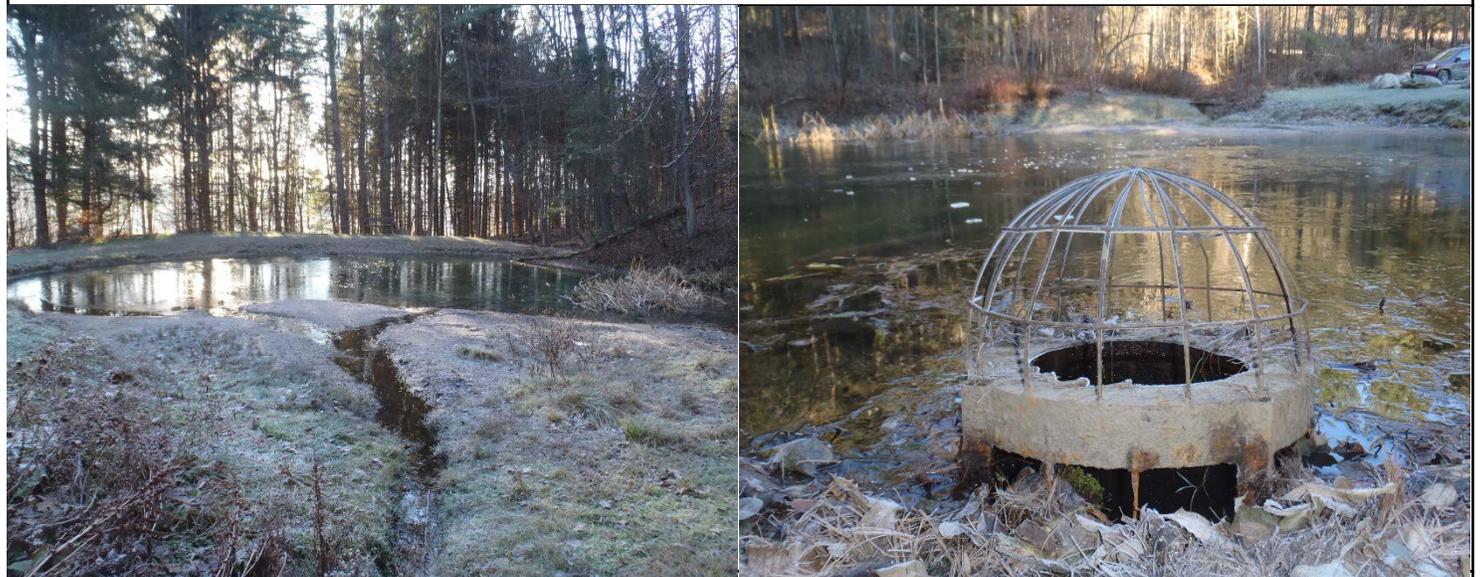
Photo 1. Sediment accumulation at pond inlet Photo 2. Existing pond outlet structure

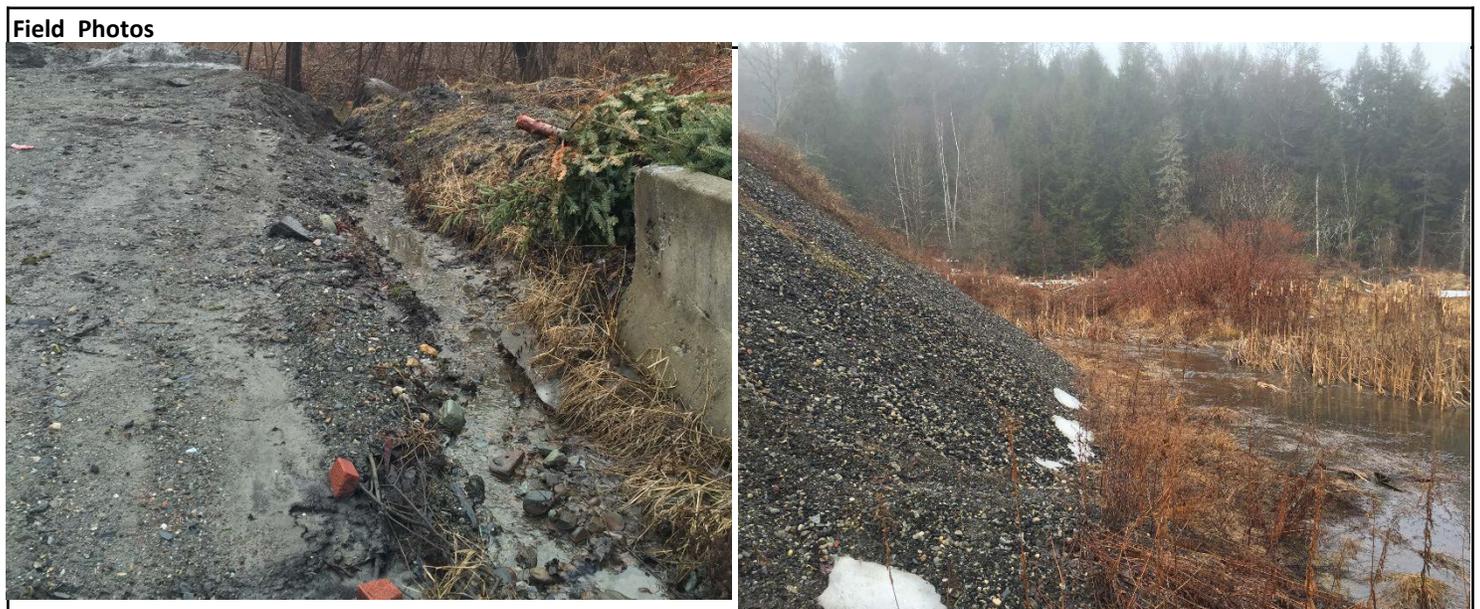
Description of Observed Conditions:
 The City's "stump dump" is a location where stockpiles of gravel and road sand area stored, as well as miscellaneous construction materials. In addition, residents are able bring Christmas trees and other organic yards wastes for disposal and/or reuse. Small watercourses surround the stump dump on all sides, and sideslopes between the working area and these watercourses are generally over-steepened and subject to erosion. In addition, unmanaged road runoff concentrates along road shoulders, causing erosion.

Photo 1. Erosion along haul road shoulder. Photo 2. Material stockpile slumping into watercourse.

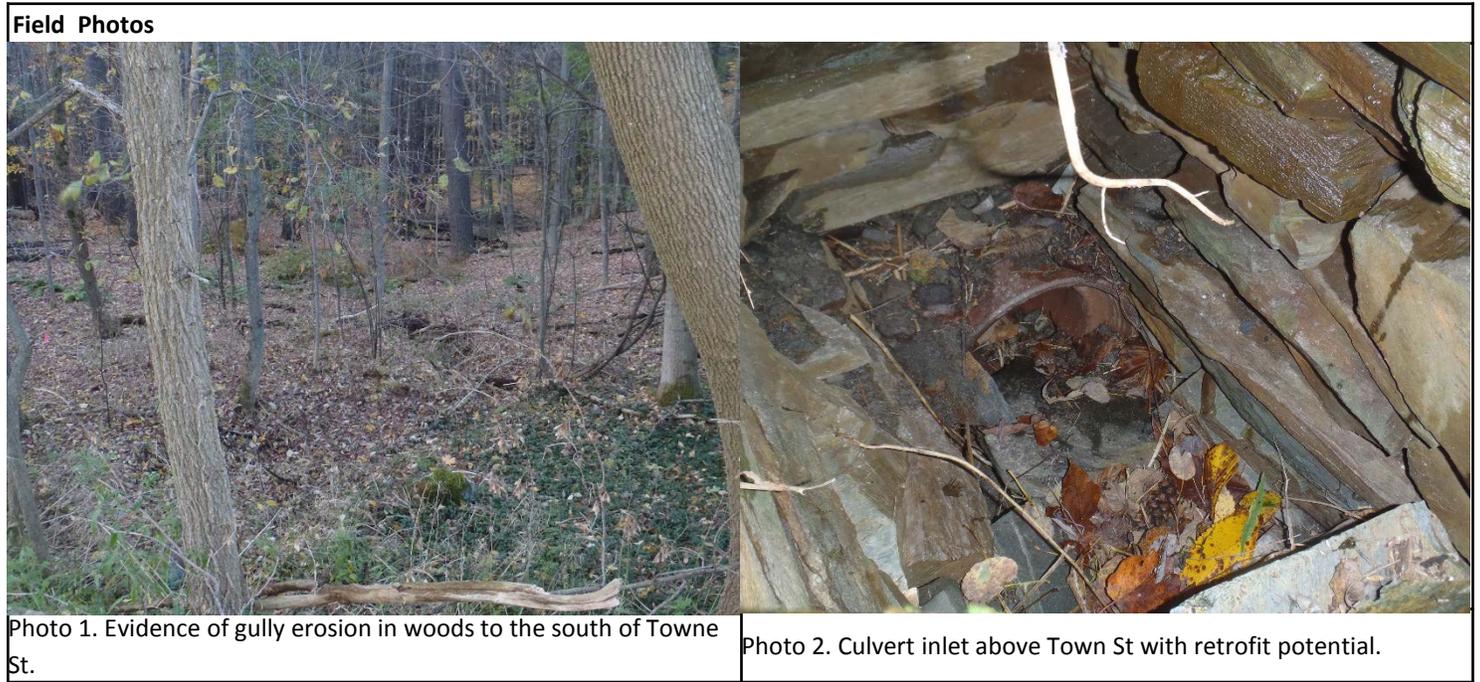
Description of Observed Conditions:
 Stormwater runoff from above Towne Rd crosses through a culvert under Towne Rd and has formed a gully in the woods between Towne Rd and Main St. There is a catch basin in the woods, about 2/3s of the way down the slope which takes some of this flow but is also connected to the combined sewer system. There is an opportunity to temporarily retain some of the stormwater above Towne Rd by installing an upturned elbow on the culvert.

Prioritization Ranking Factors							
Relative Impact	Frequency	Current Condition	Urgency	Impact to public infrastructure?	Realistic to fix?	Impacts beyond water resources?	Part of a larger or systemic problem?
3	2	2	1	Y	Y	Y	Y

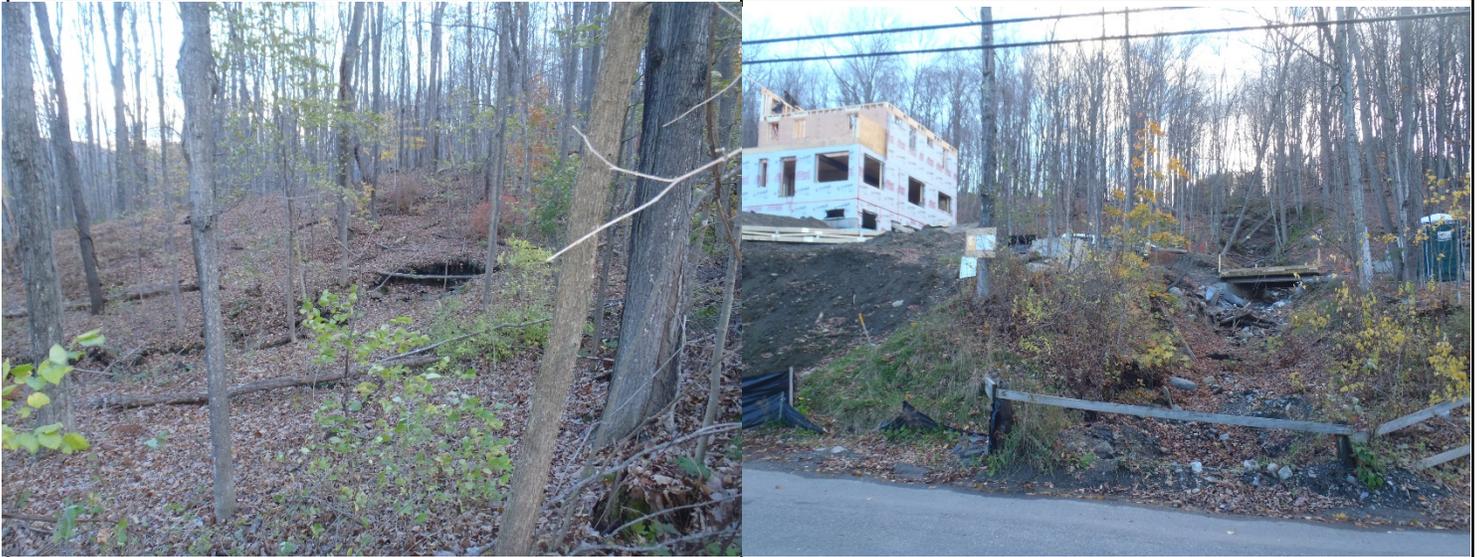
Photo 1. Evidence of gully erosion in woods between Murray Hill and North St.

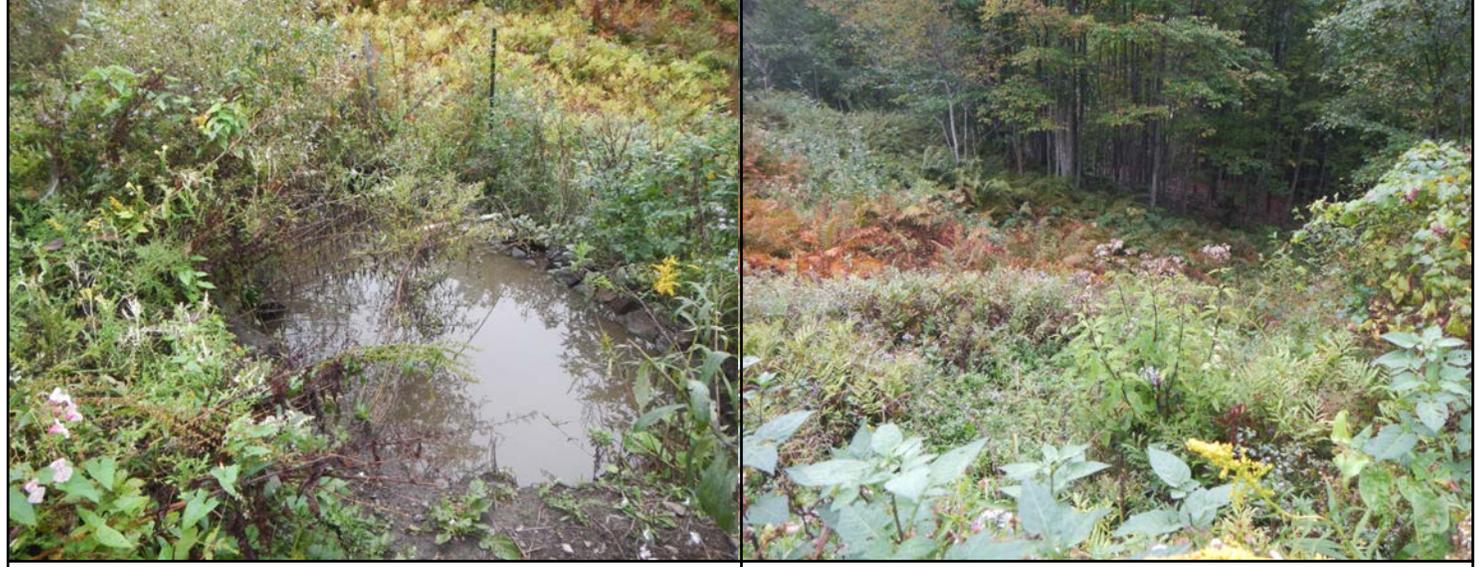
Photo 1. Pool about ¼ of the way down the slope in the back yard. Photo 2. View down the slope from the pond.

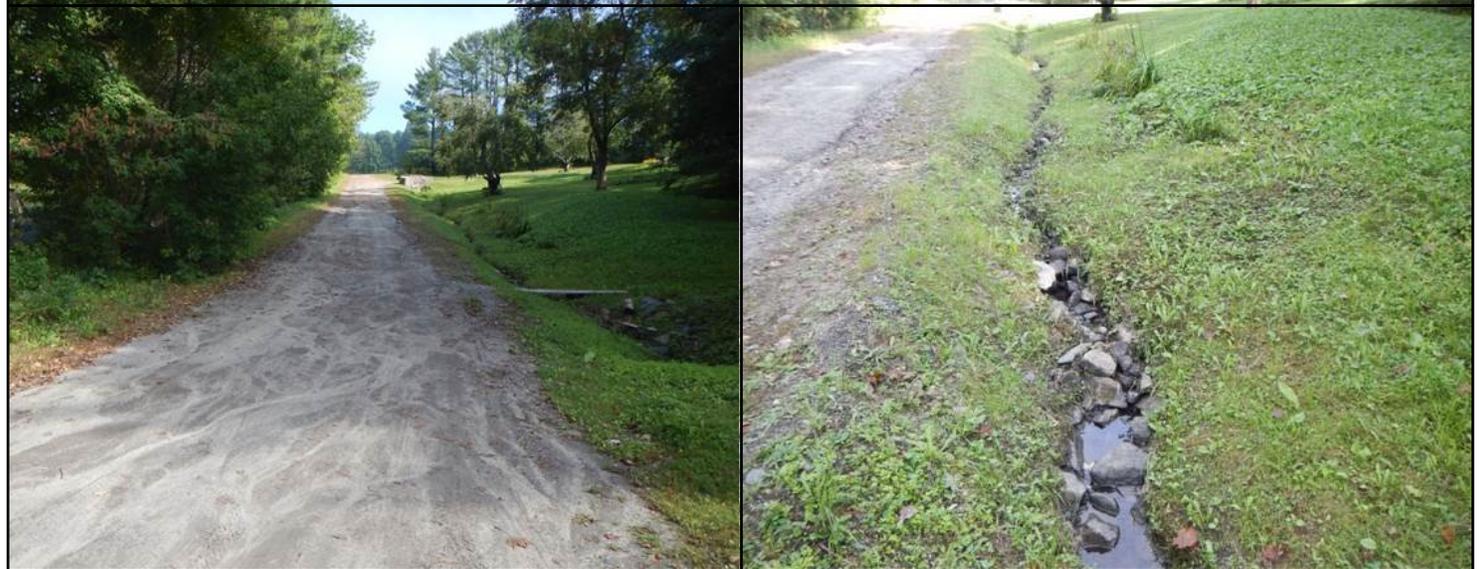
Photo 1. Easy Street and roadside ditch to the right. Photo 2. Ditch in need of repair.

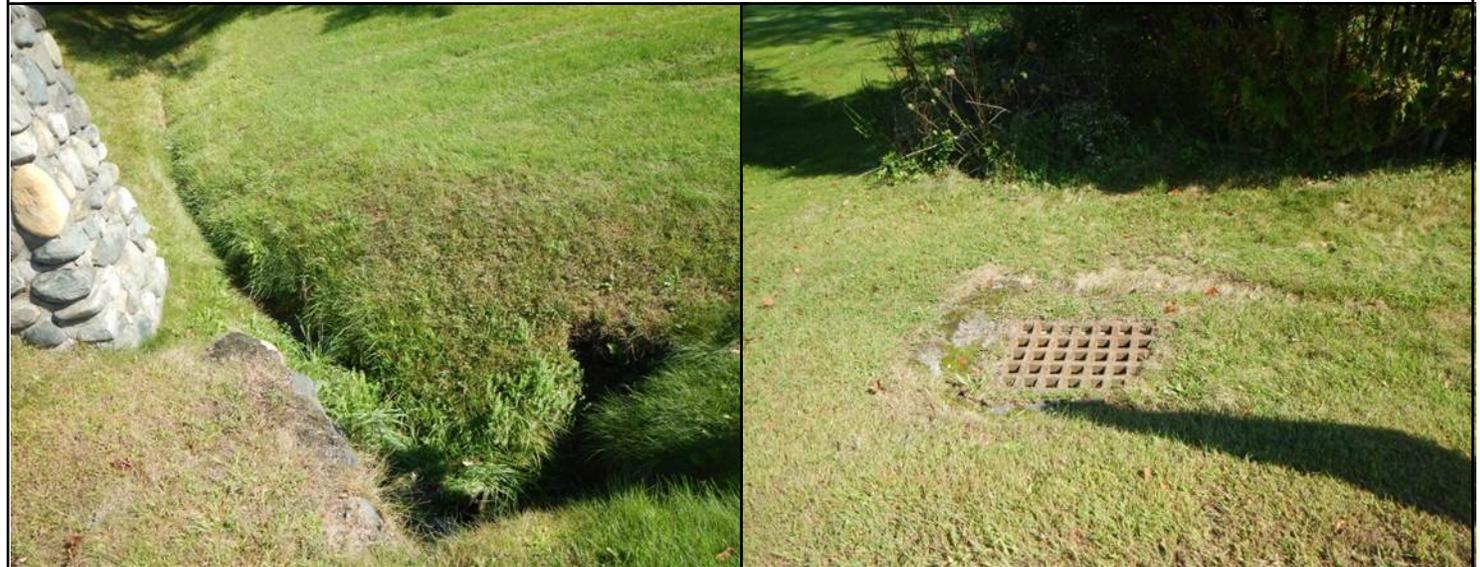
Photo 1. Narrow ditch that needs to be expanded. Photo 2. Erosion around catch basin.

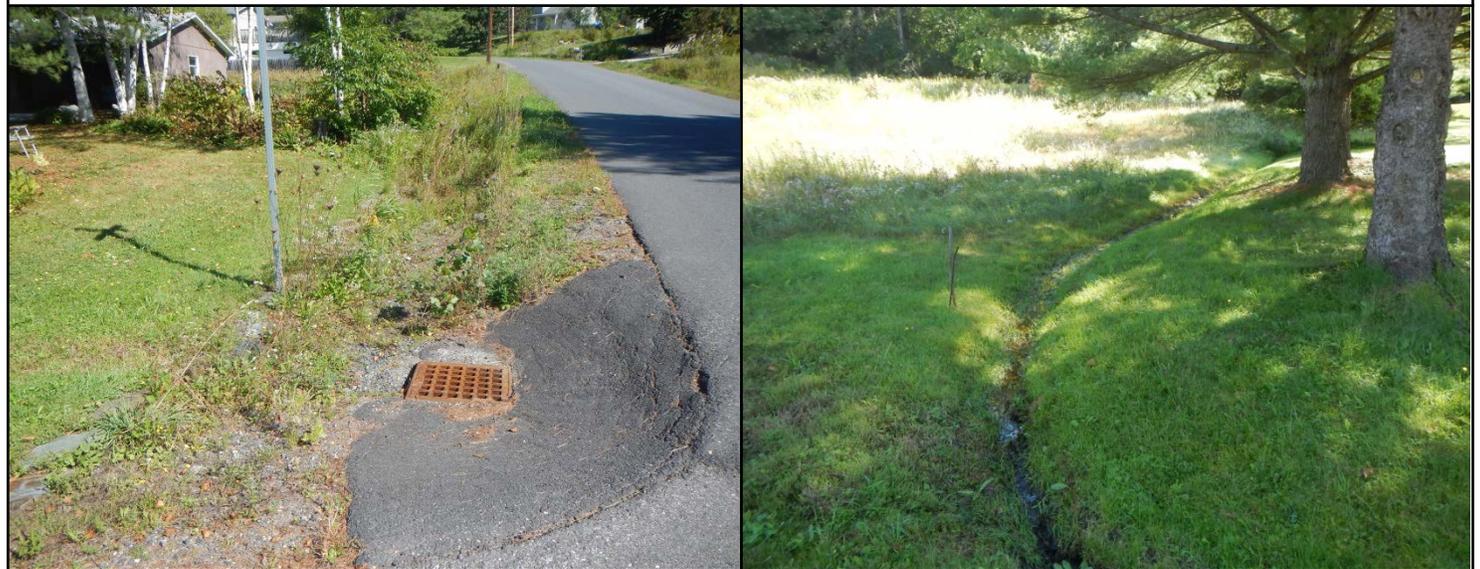
Photo 1. Catch basin and potential treatment area. Photo 2. Narrow ditch that could be reshaped.

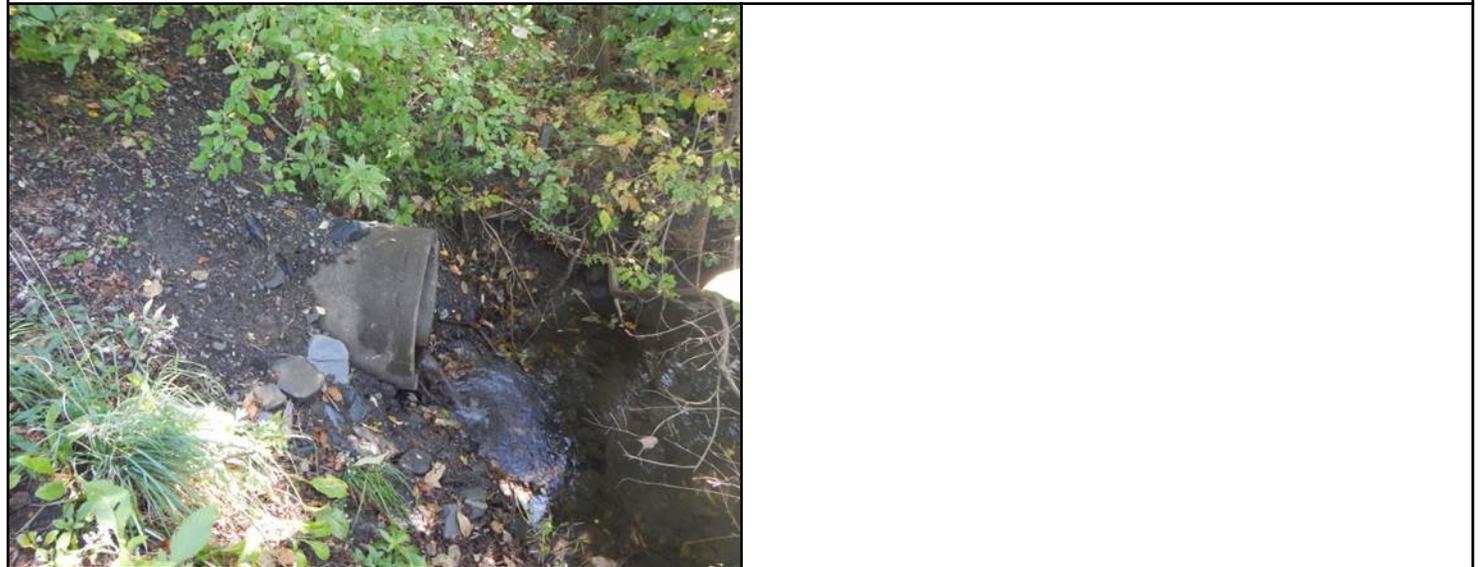
Photo 1. A splash pad at the outfall could reduce localized erosion.
