# **Black Creek Corridor Plan**

**Franklin County  
April 2009**

Re: Black Creek Corridor Plan  
Franklin County, Vermont  
JCO Project No. 3-1313-3

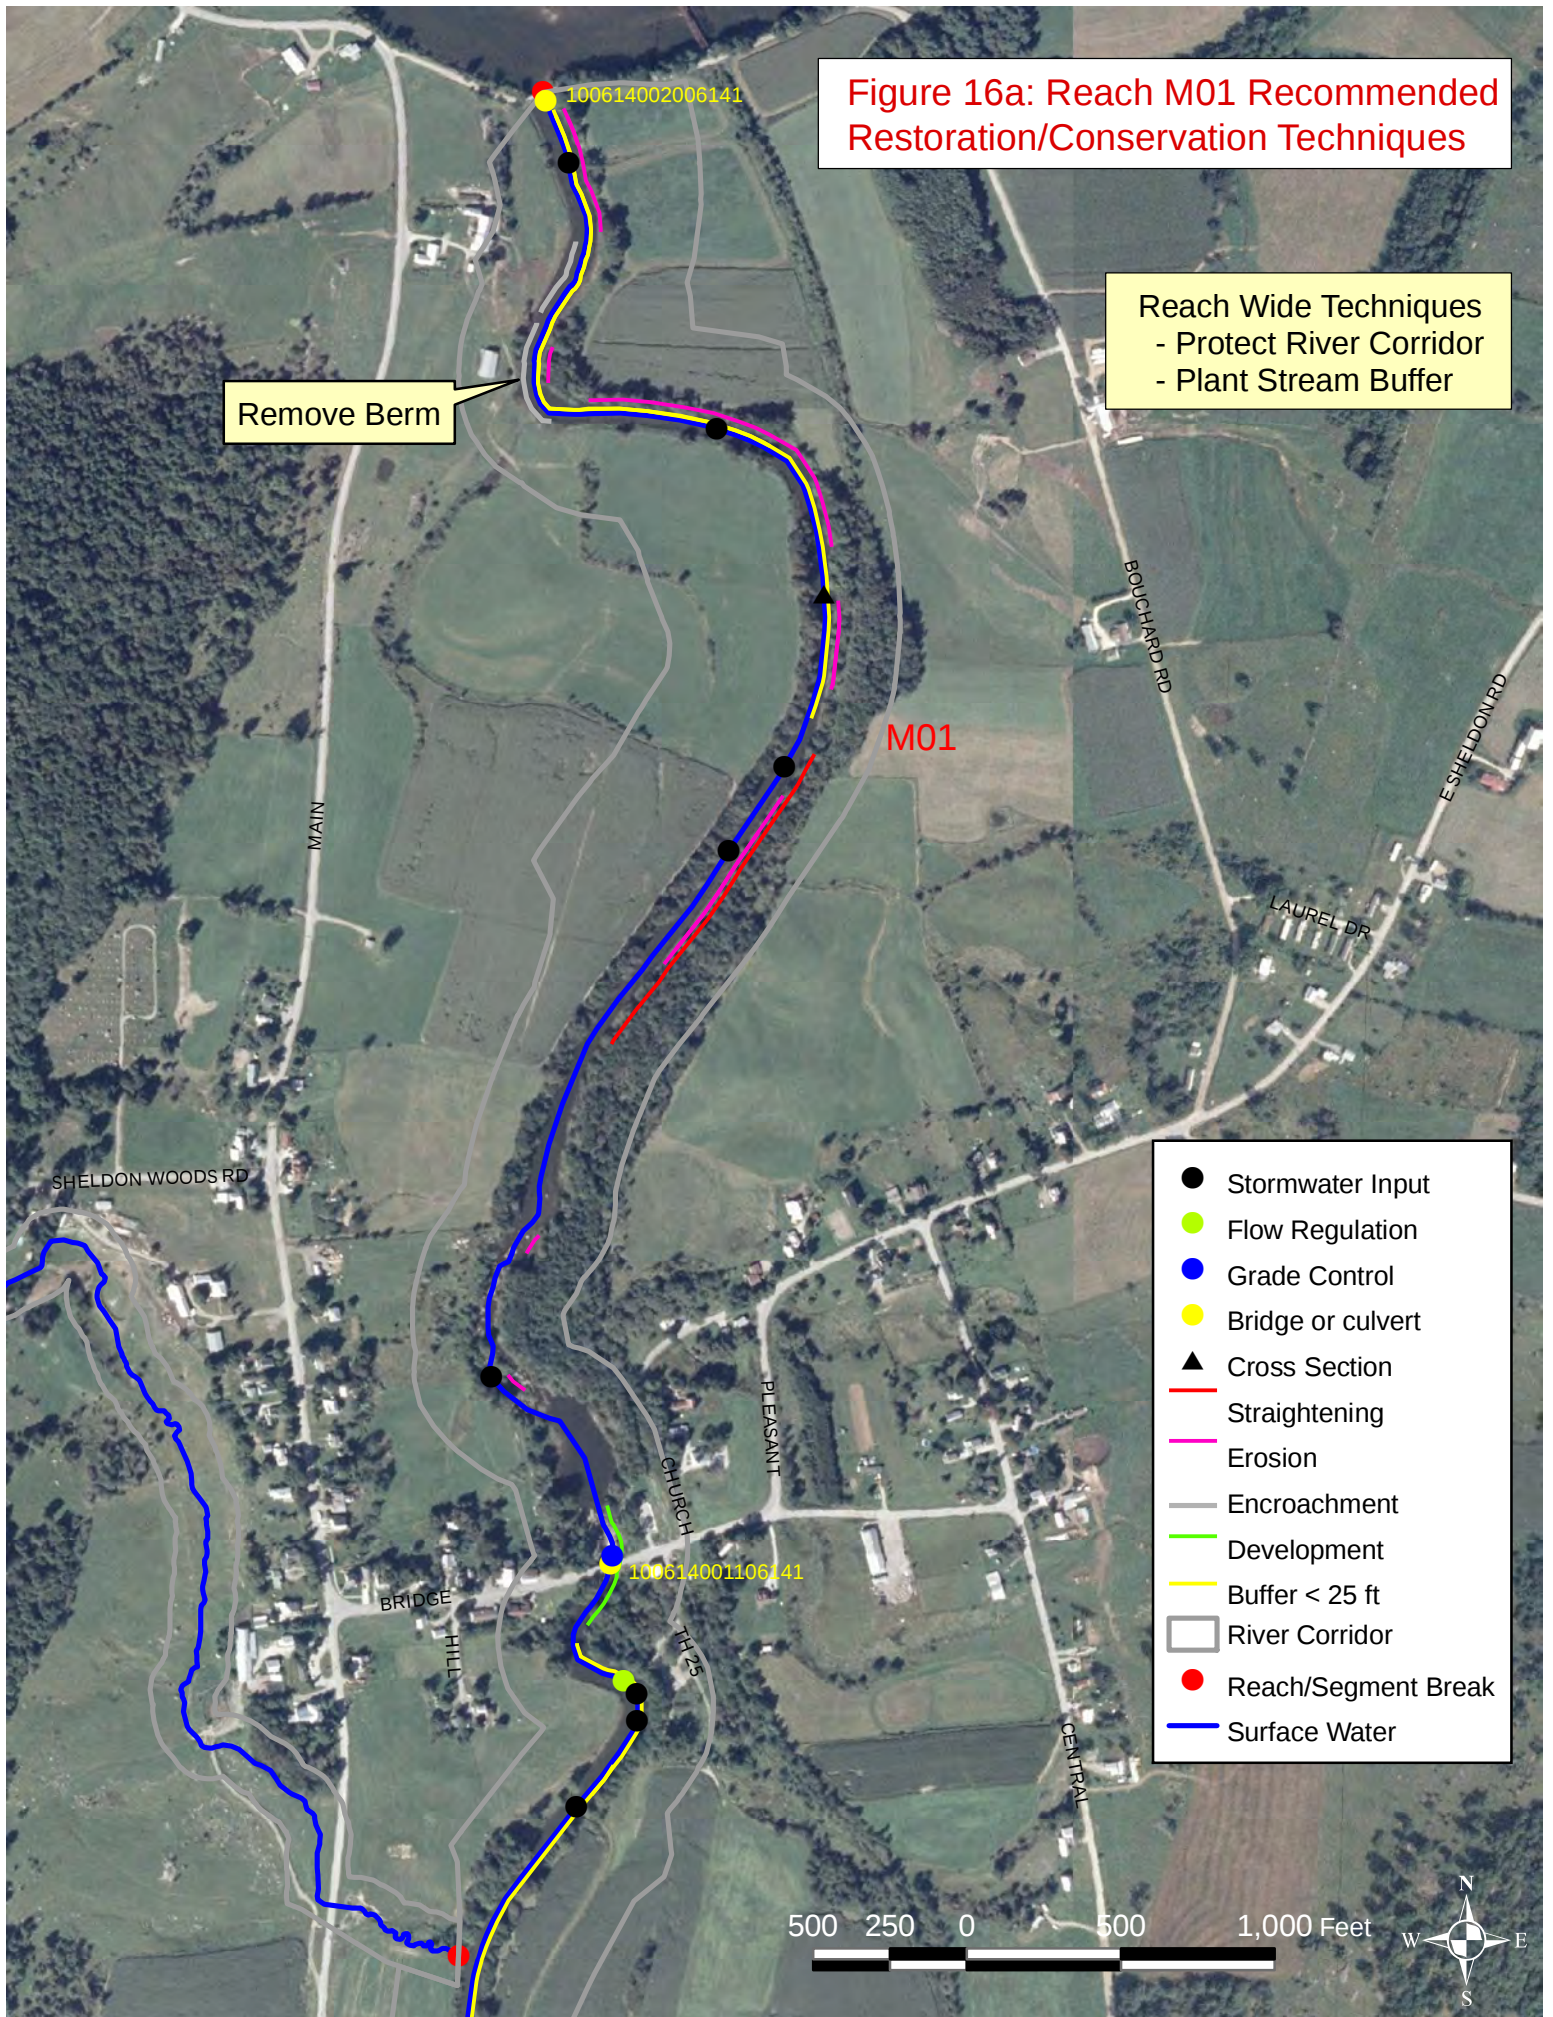
**Figure 16a: Reach M01 Recommended Restoration/Conservation Techniques**

Reach M01 is the furthest downstream reach in the study area and extends from the confluence with the Missisquoi River upstream for approximately 3 miles. This reach was found to be only slightly incised (incision ratio of 1.2) and still has access to its floodplain during most high flow events. The existing stream type of E5 Dune-Ripple was consistent with its reference stream type. Minor bank erosion was noted along small portions of the reach, though most of the banks were found to be relatively stable. The reach was found to be in Evolution Stage I, or Reference, with little active adjustments occurring and a rapid geomorphic score of 0.74 (good). The riparian corridor was dominated by hay and corn fields, with large areas of inadequate buffer of less than 25 feet. Sheldon Falls, a large bedrock gorge, is located in the middle of the segment. No major problems were identified with either of the assessed bridges. The habitat assessment showed fair aquatic habitat primarily due to embeddedness, lack of woody cover, and very few favorable sediment types and flow patterns.

Given the current, relatively stable condition of M01, the recommended remedial strategies are to protect the existing undeveloped river corridor to retain the reach's nutrient attenuation assets, and enhance the current buffer. The river corridor is defined as the area adjacent to the stream through which the stream would naturally meander over its lifetime to maintain equilibrium conditions. In most cases this is measured as three times the bankfull channel width on either side of the stream. As the furthest downstream reach, M01 receives all the inputs from upstream, and provides some attenuation of those inputs. Several large areas have riparian buffers of less than 25 feet, particularly upstream of Bridge Street. Buffer planting should be concentrated in these areas to reduce sediment and nutrient inputs, improve aquatic habitat, and improve bank stability. If possible, buffer establishment should be extended up the field ditches identified in the reach to reduce nutrient and sediment inputs. An aerial view of the reach is shown on Figures 16a and 16b, and descriptions of the recommended projects are shown in Table 5. A prioritized list of all identified projects for the watershed is shown in Table 22.

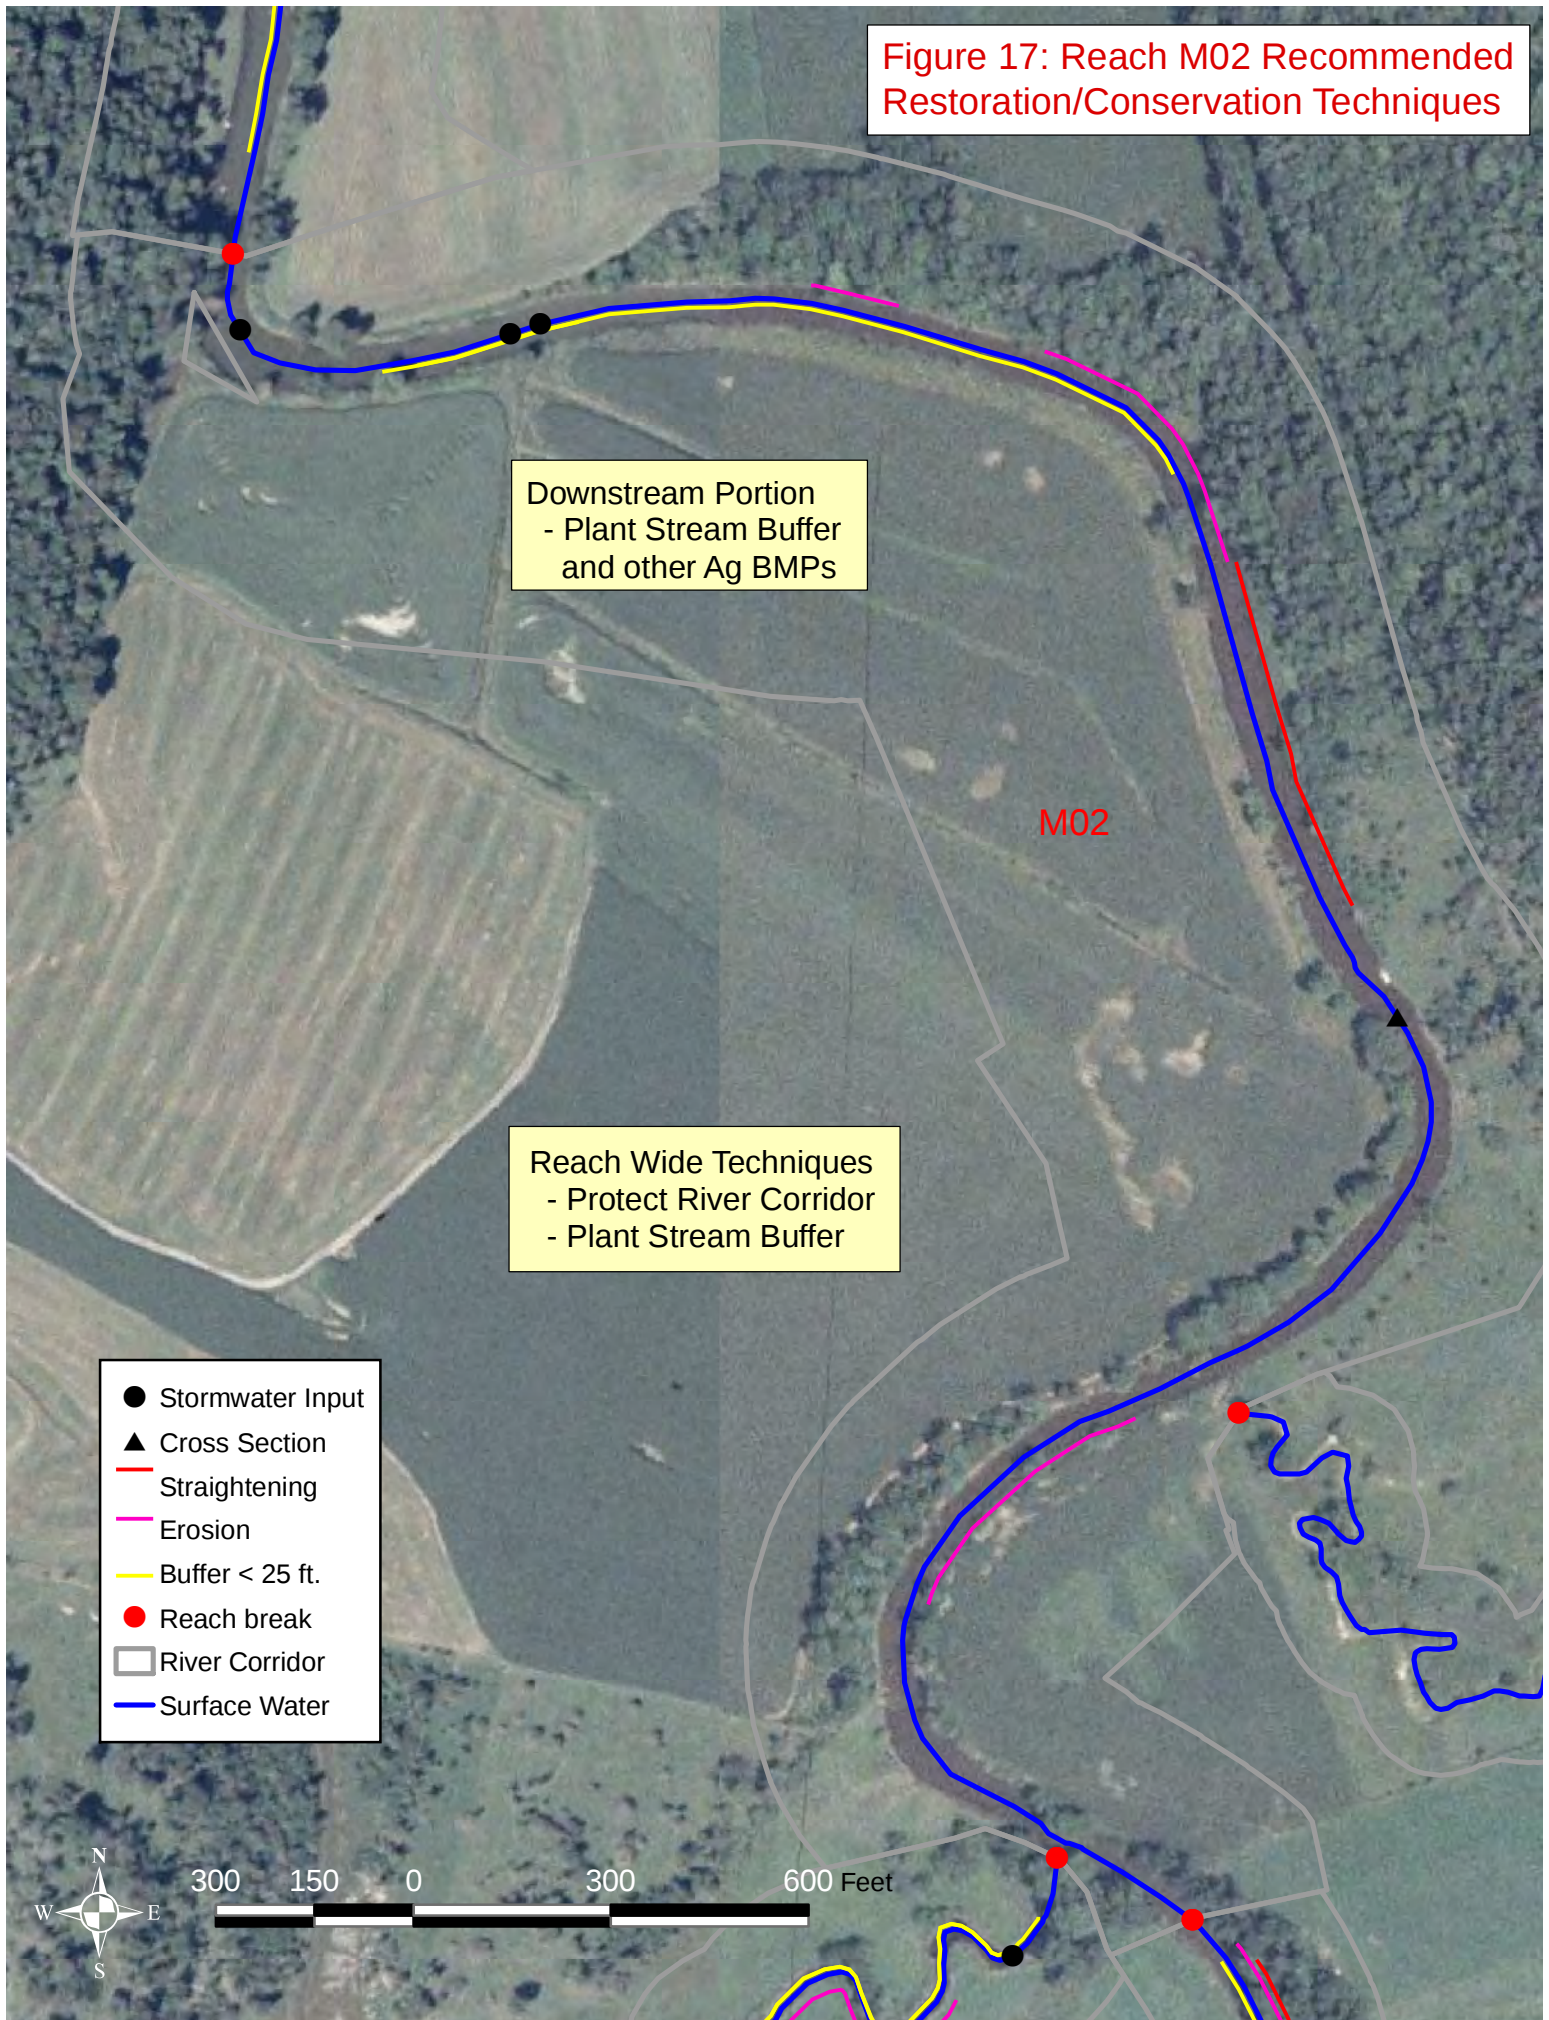
Figure 17: Reach M02 Recommended Restoration/Conservation Techniques

Reach M02 extends from the end of reach M01 upstream for approximately 0.8 miles to the confluence with Dead Creek. This reach was found to be only slightly incised (ratio of 1.1) and still has adequate floodplain access. The existing stream type of E5 Dune-Ripple was consistent with its reference stream type. Minor bank erosion was noted along small portions of the reach, though most of the banks were found to be relatively stable. The reach was found to be in channel evolution stage V, with little active adjustments occurring and a rapid geomorphic score of 0.73 (good). The riparian corridor was dominated by a mix of hay and crop with a large

area of forest on the right bank. Buffer widths were generally 0-25 feet, with approximately 1,500 feet having less than 25 foot buffers. The habitat assessment was fair primarily due to lack of woody cover, embeddedness, and very few favorable sediment types and flow patterns.

Given the current, relatively stable condition of M02, the recommended remedial strategies are to protect the existing undeveloped river corridor to retain the reach's nutrient attenuation assets, and enhance the current buffer. Several large areas have riparian buffers of less than 25 feet, particularly upstream of Bridge Street. Buffer planting should be concentrated in these areas to reduce sediment and nutrient inputs, improve aquatic habitat, and improve bank stability. Buffer establishment along the field ditches at the northern end of the reach is also important to reduce sediment and nutrient inputs. An aerial view of the reach is shown on Figure 17, and descriptions of the recommended projects are shown in Table 6. A prioritized list of all identified projects for the watershed is shown in Table 22.

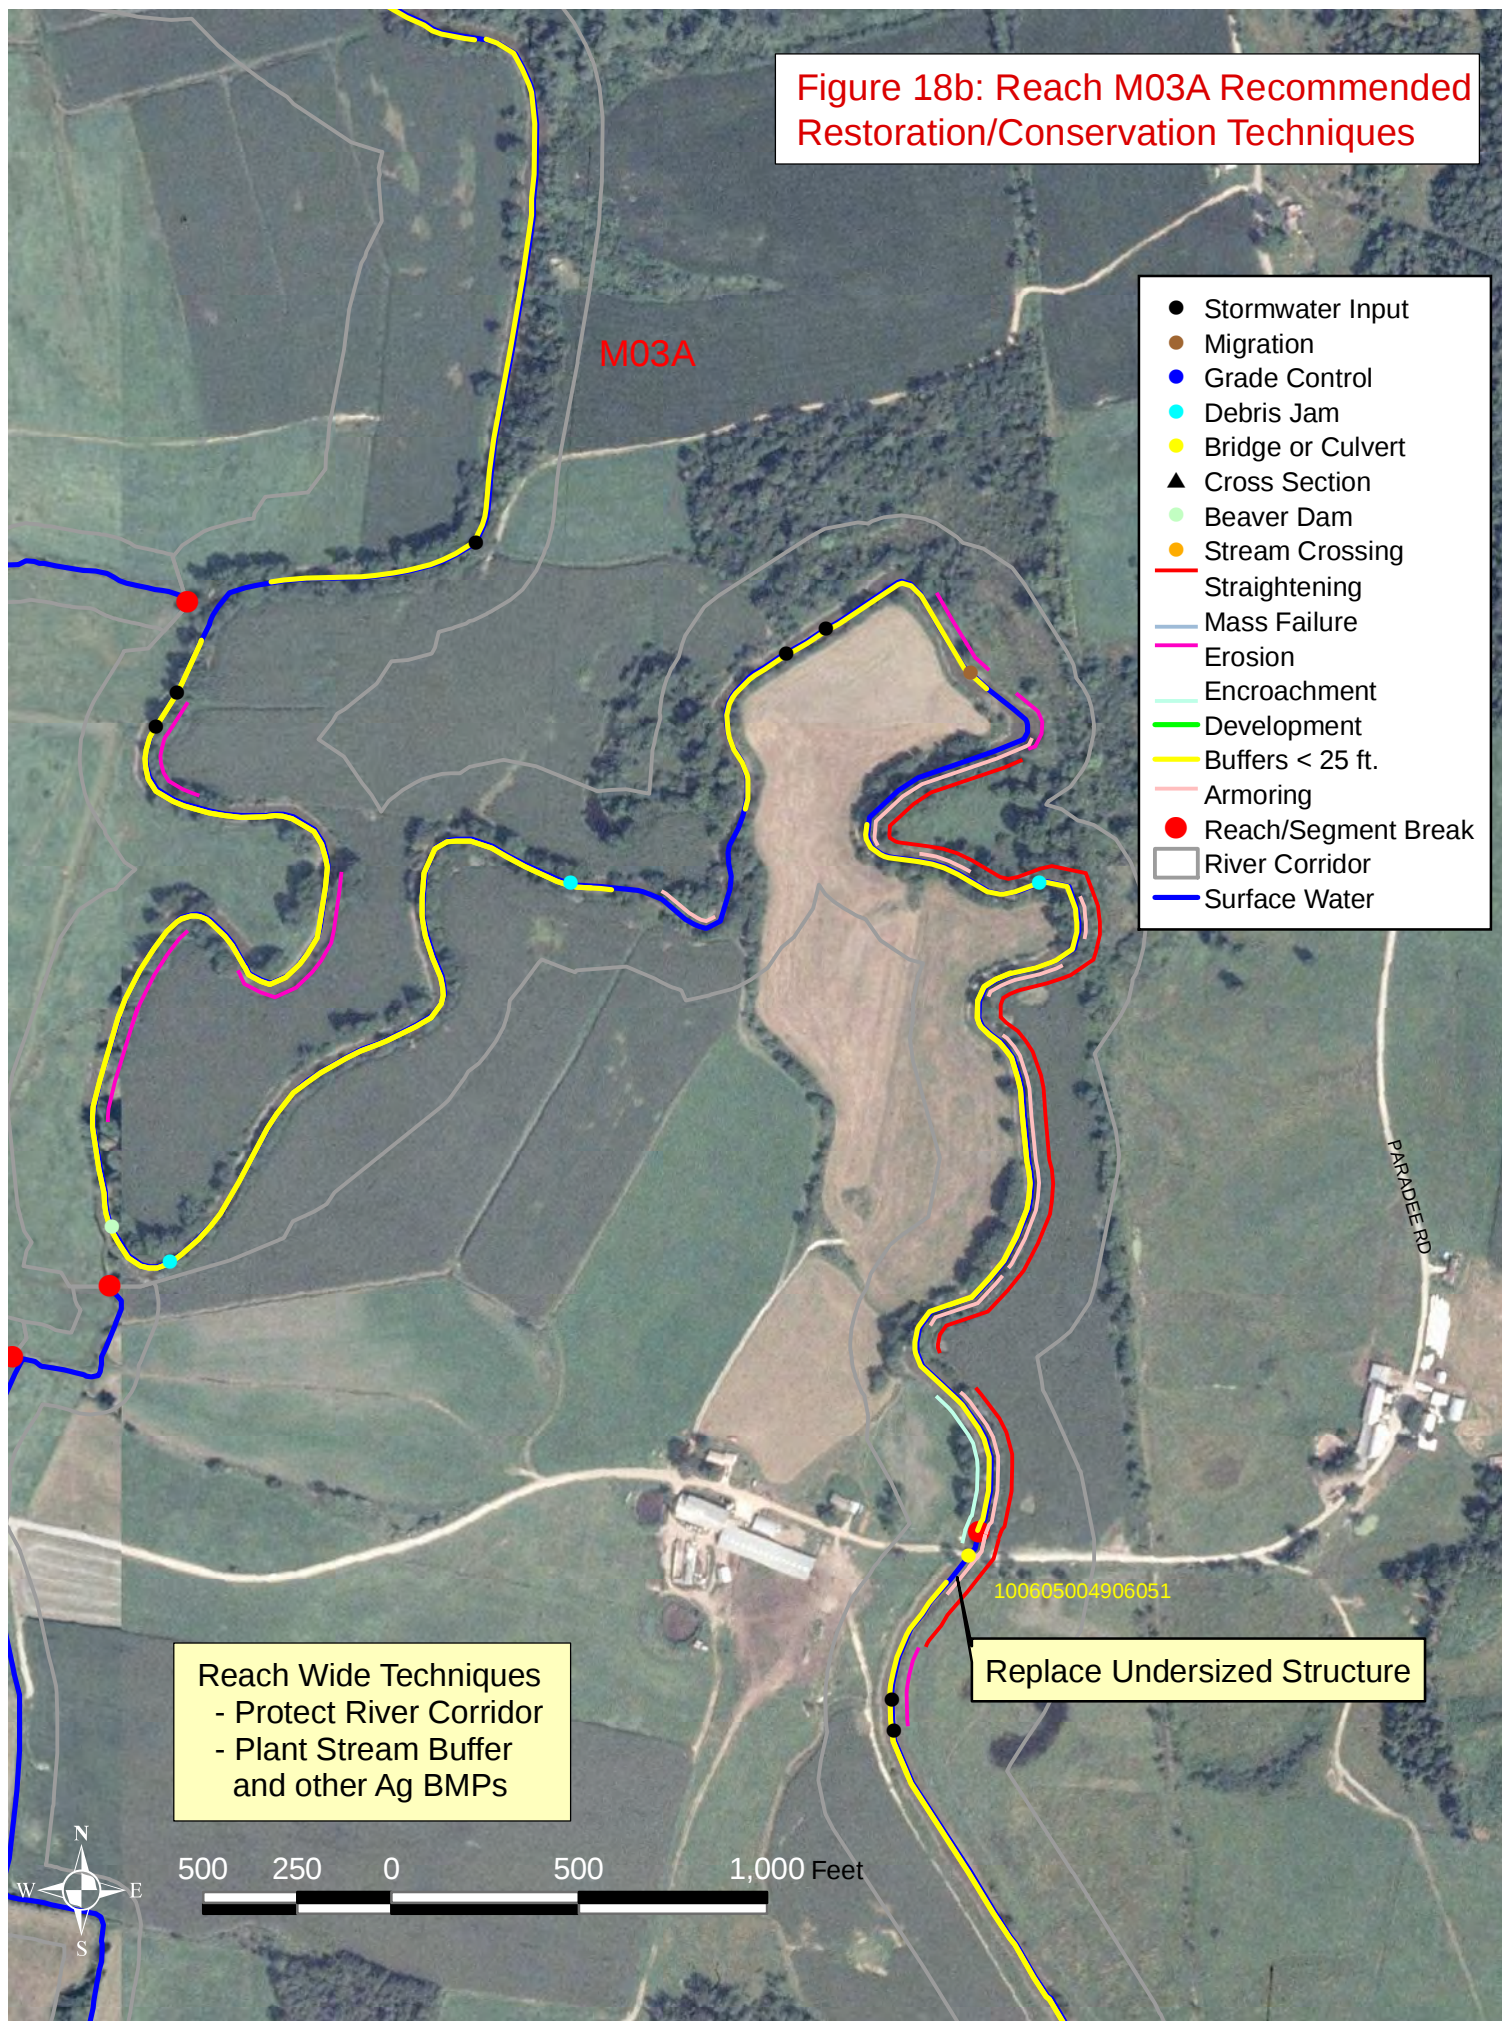
Figure 18b: Reach M03A Recommended Restoration/Conservation Techniques

Reach M03 extends upstream from the confluence with Dead Creek upstream for approximately 4.5 miles. The reach was segmented into two parts, M03A and M03B due to differences in channel dimensions and depositional features. M03A is the downstream end of the reach and extends from the confluence with Dead Creek upstream for approximately 3.5 miles. It was found to be only slightly incised (incision ratio of 1.2) and still has access to its floodplain during most high flow events. The existing stream type of E5 Dune-Ripple was consistent with its reference stream type. Minor bank erosion was noted along small portions of the reach, though most of the banks were found to be relatively stable. The segment was found to be in channel evolution stage I, or reference condition, with little active adjustments occurring and a rapid geomorphic score of 0.65 (good). The riparian corridor was dominated by a mix of corn fields and pasture, with large areas of inadequate buffer of less than 25 feet. Cows were observed in the stream channel just upstream of Pumpkin Village Road. The bridge on Paradee Road is undersized with a structure to channel width ratio of only 65%.

The recommended projects for segment A are to protect the river corridor to retain the existing sediment and nutrient attenuation assets. In addition, large areas of the segment have inadequate buffer, so woody vegetation planting is also required. Cattle fencing should be included in this effort to limit animal access to the stream channel near Pumpkin Village Road.

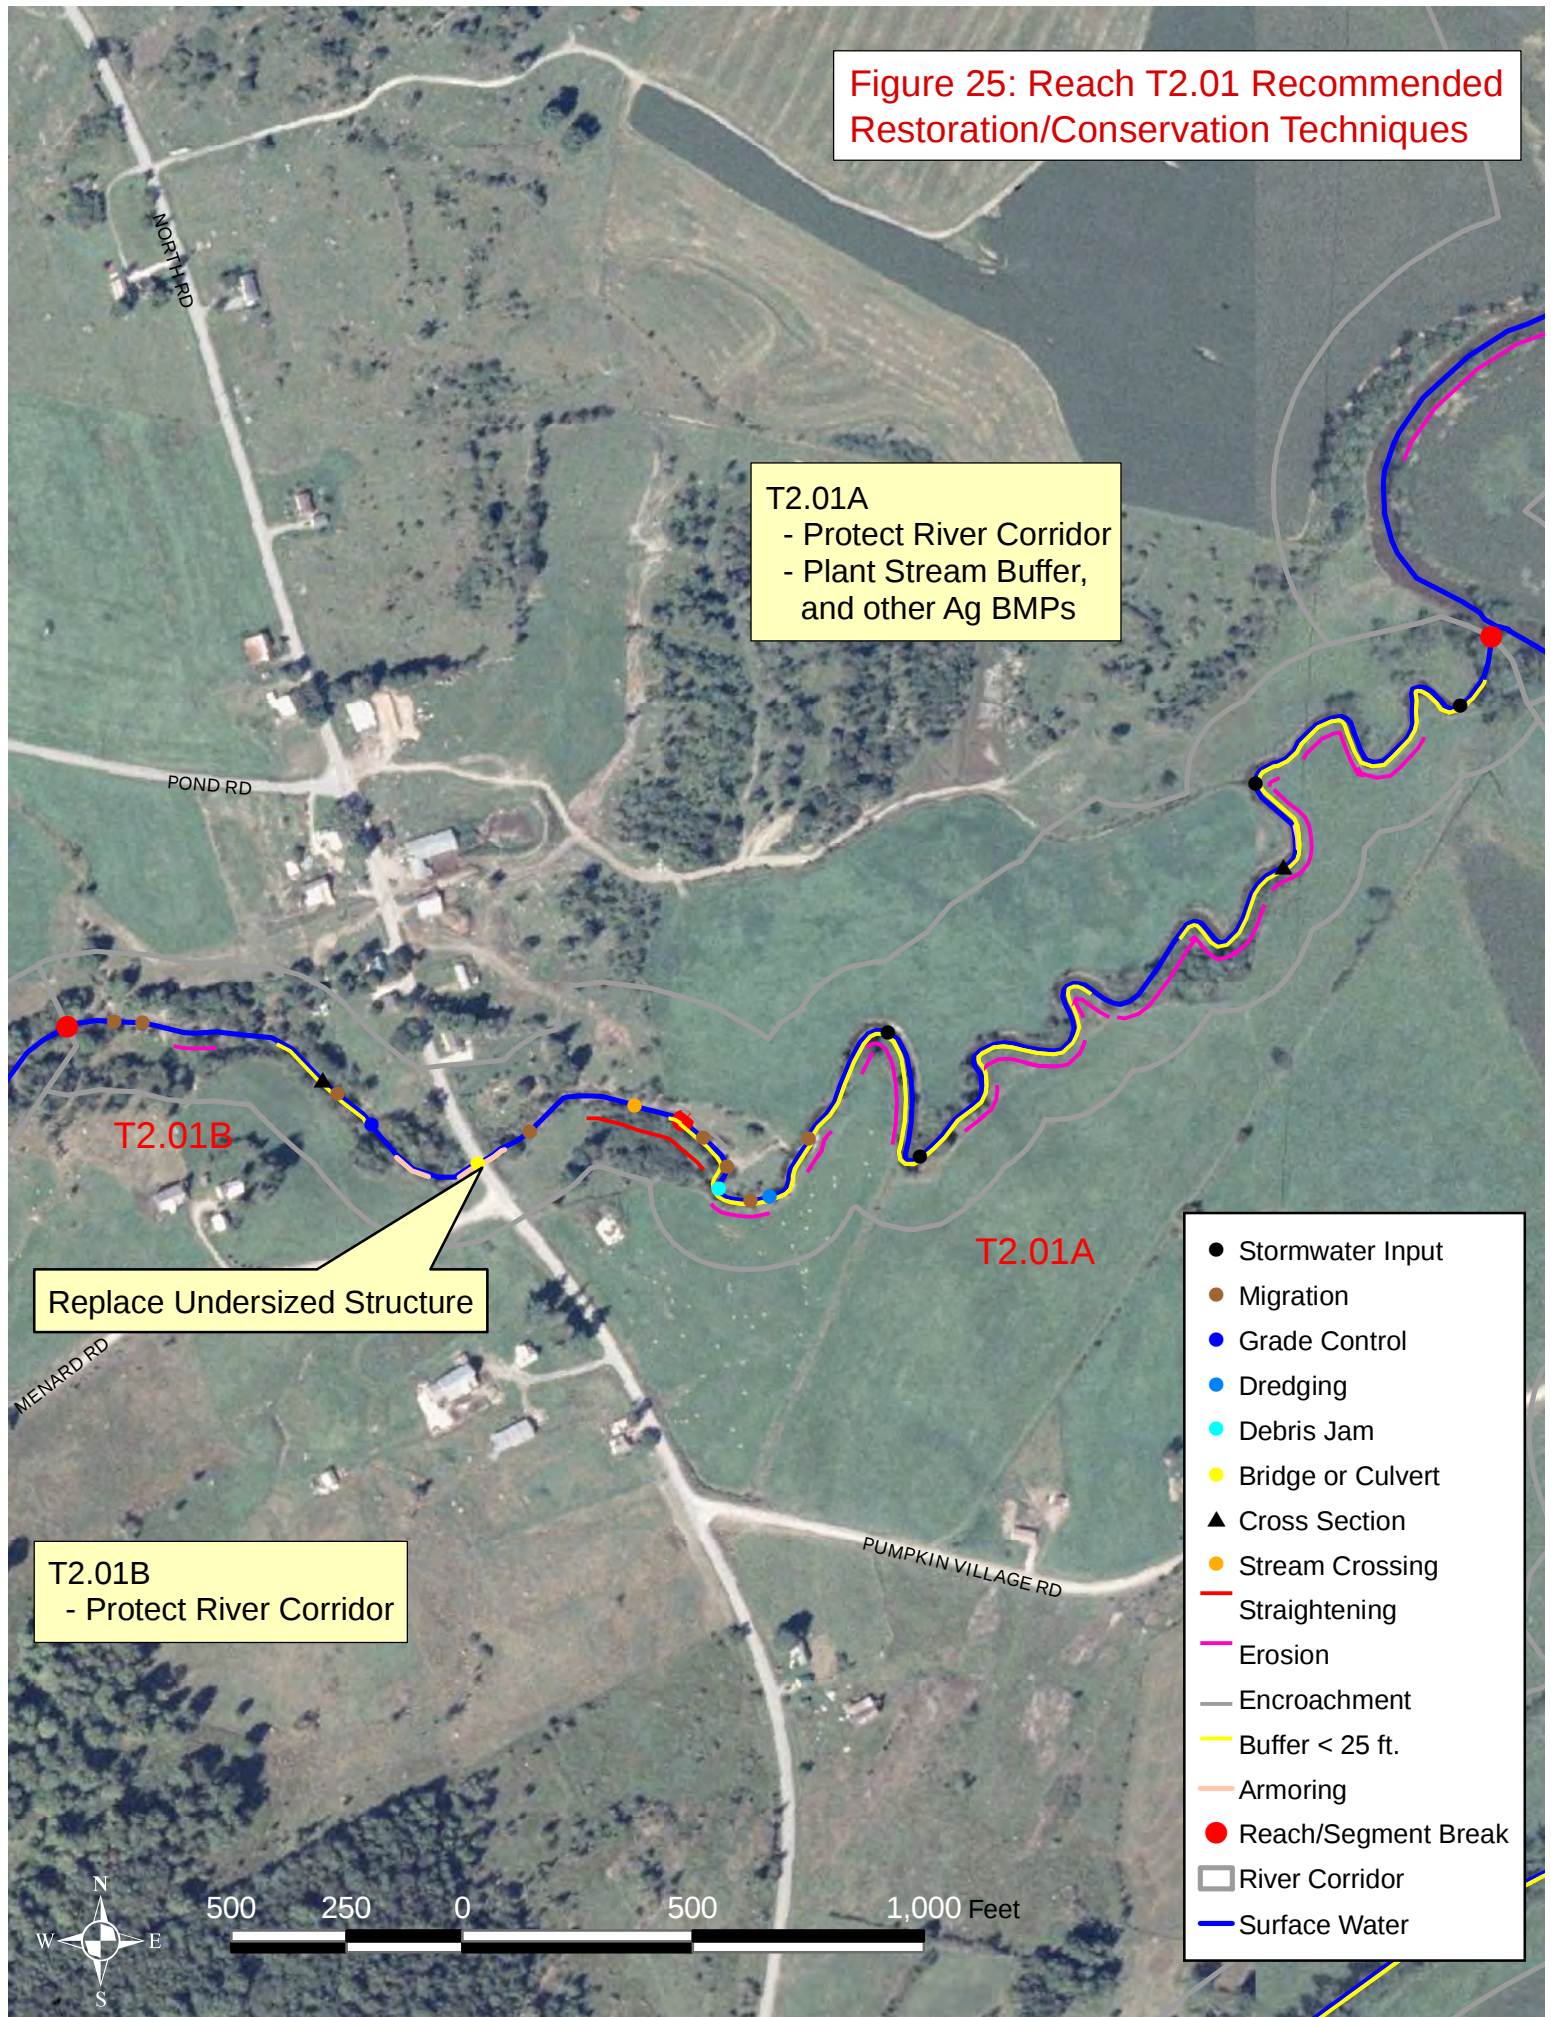
Figure 25: Reach T2.01 Recommended Restoration/Conservation Techniques

Reach T2.01 extends from its confluence with Black Creek north of Pumpkin Village Road upstream for approximately 1 mile. The reach was segmented into T2.01A and T2.01B due to differences in the channel dimensions and boundary conditions. Segment A is the downstream end of the reach and is approximately 0.7 miles long. The segment was classified as an E5 Dune-Ripple, consistent with its reference stream type, though due to minor historic channel degradation and active widening and aggradation it is in Evolution Stage IV (Widening). Only minor incision was noted (ratio of 1.2) and no active head cuts were observed. A

significant amount of bank erosion was observed. The riparian corridor was dominated by hay fields with little to no buffer. The habitat assessment showed relatively poor aquatic habitat conditions. T2.01B is the upstream portion of the reach and extends to approximately 0.2 miles upstream of the North Road crossing. This segment was naturally steeper and more confined, and was classified as a B3 – Step-pool system. It was relatively stable with no active adjustment processes. The riparian corridor was dominated by a mix of hay fields and residential development with buffers ranging from 26 to 50 feet in width. The habitat assessment showed good aquatic habitat. The culvert crossing North Road is severely undersized with a structure width to channel width ratio of only 21%.

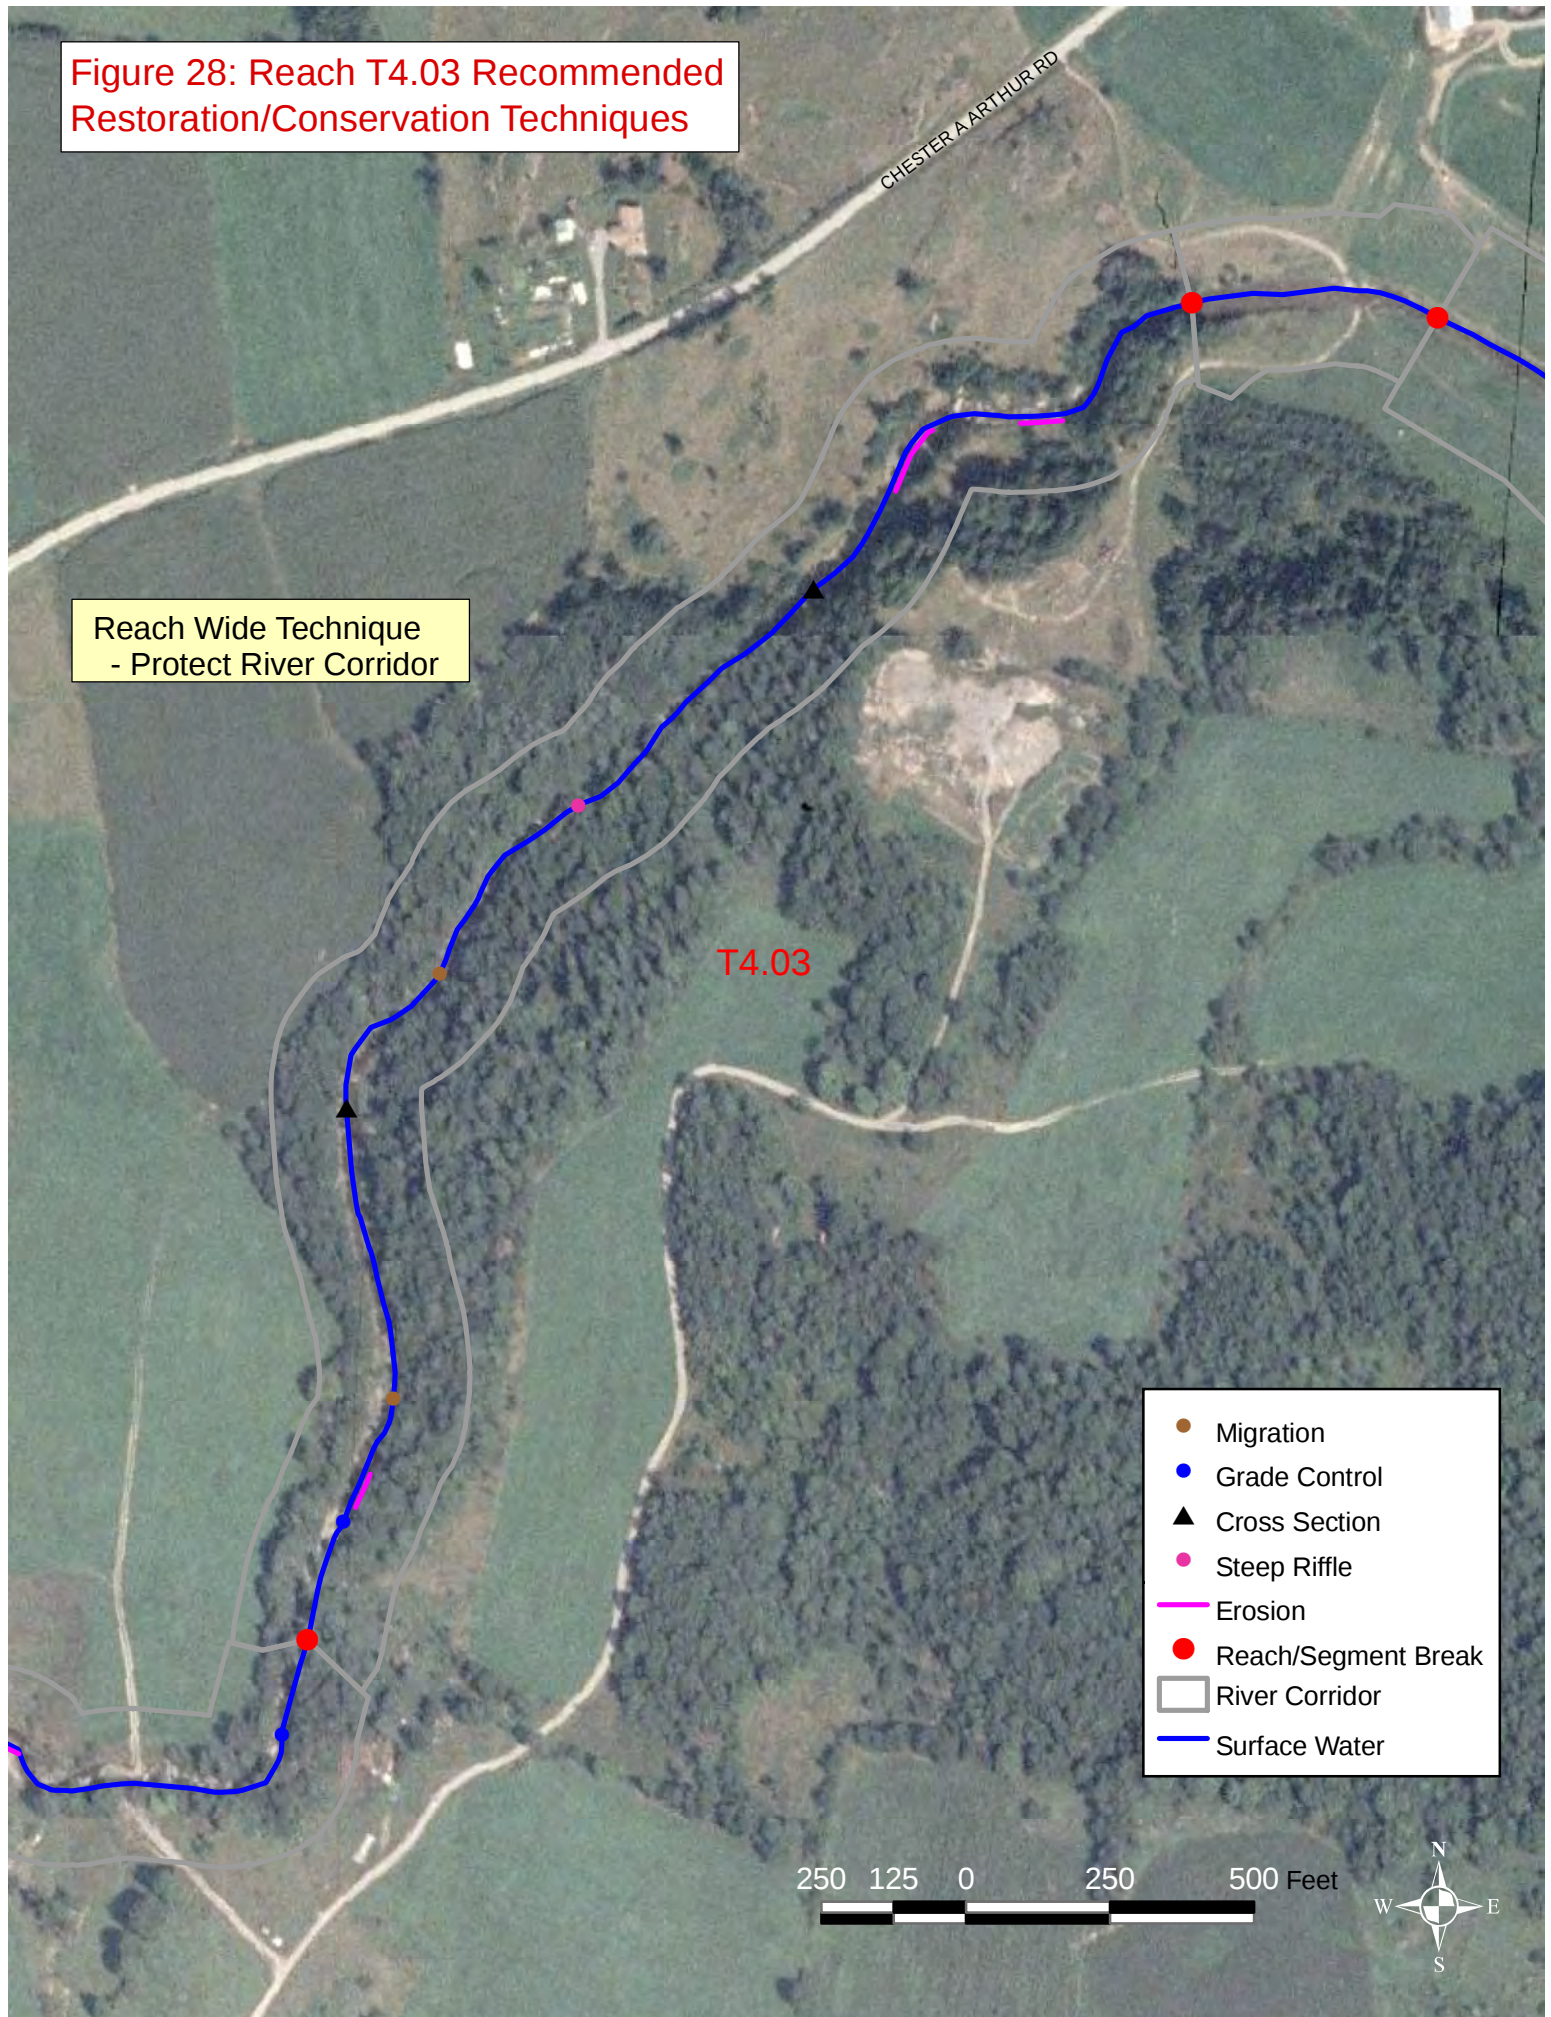
Figure 28: Reach T4.03 Recommended Restoration/Conservation Techniques

Reach T4.03 extends from the end of T4.02 (a very short reach not assessed during this project) upstream for approximately 0.6 miles. This reach was found to be relatively stable with little ongoing adjustments. It is located in a naturally narrow and steeper portion of the valley and was classified as a B3 – step-pool type stream. No erosion or other significant problems were noted. The riparian corridor was dominated by forest with no human impacts near the stream channel. The rapid habitat assessment showed relatively good aquatic habitat.

Given the location of T4.03 and relative stability there are no recommended projects. The reach is currently stable and undeveloped. This should be maintained through corridor protection, though because this reach is naturally a transport type environment, preference should be given to protecting those areas in other reaches that can improve or retain needed sediment and nutrient retention. An aerial view of the reach is shown on Figure 28, and descriptions of the recommended projects are shown in Table 17. A prioritized list of all identified projects for the watershed is shown in Table 22.
