# **Black Creek Corridor Plan**

**Franklin County  
April 2009**

Re: Black Creek Corridor Plan  
Franklin County, Vermont  
JCO Project No. 3-1313-3

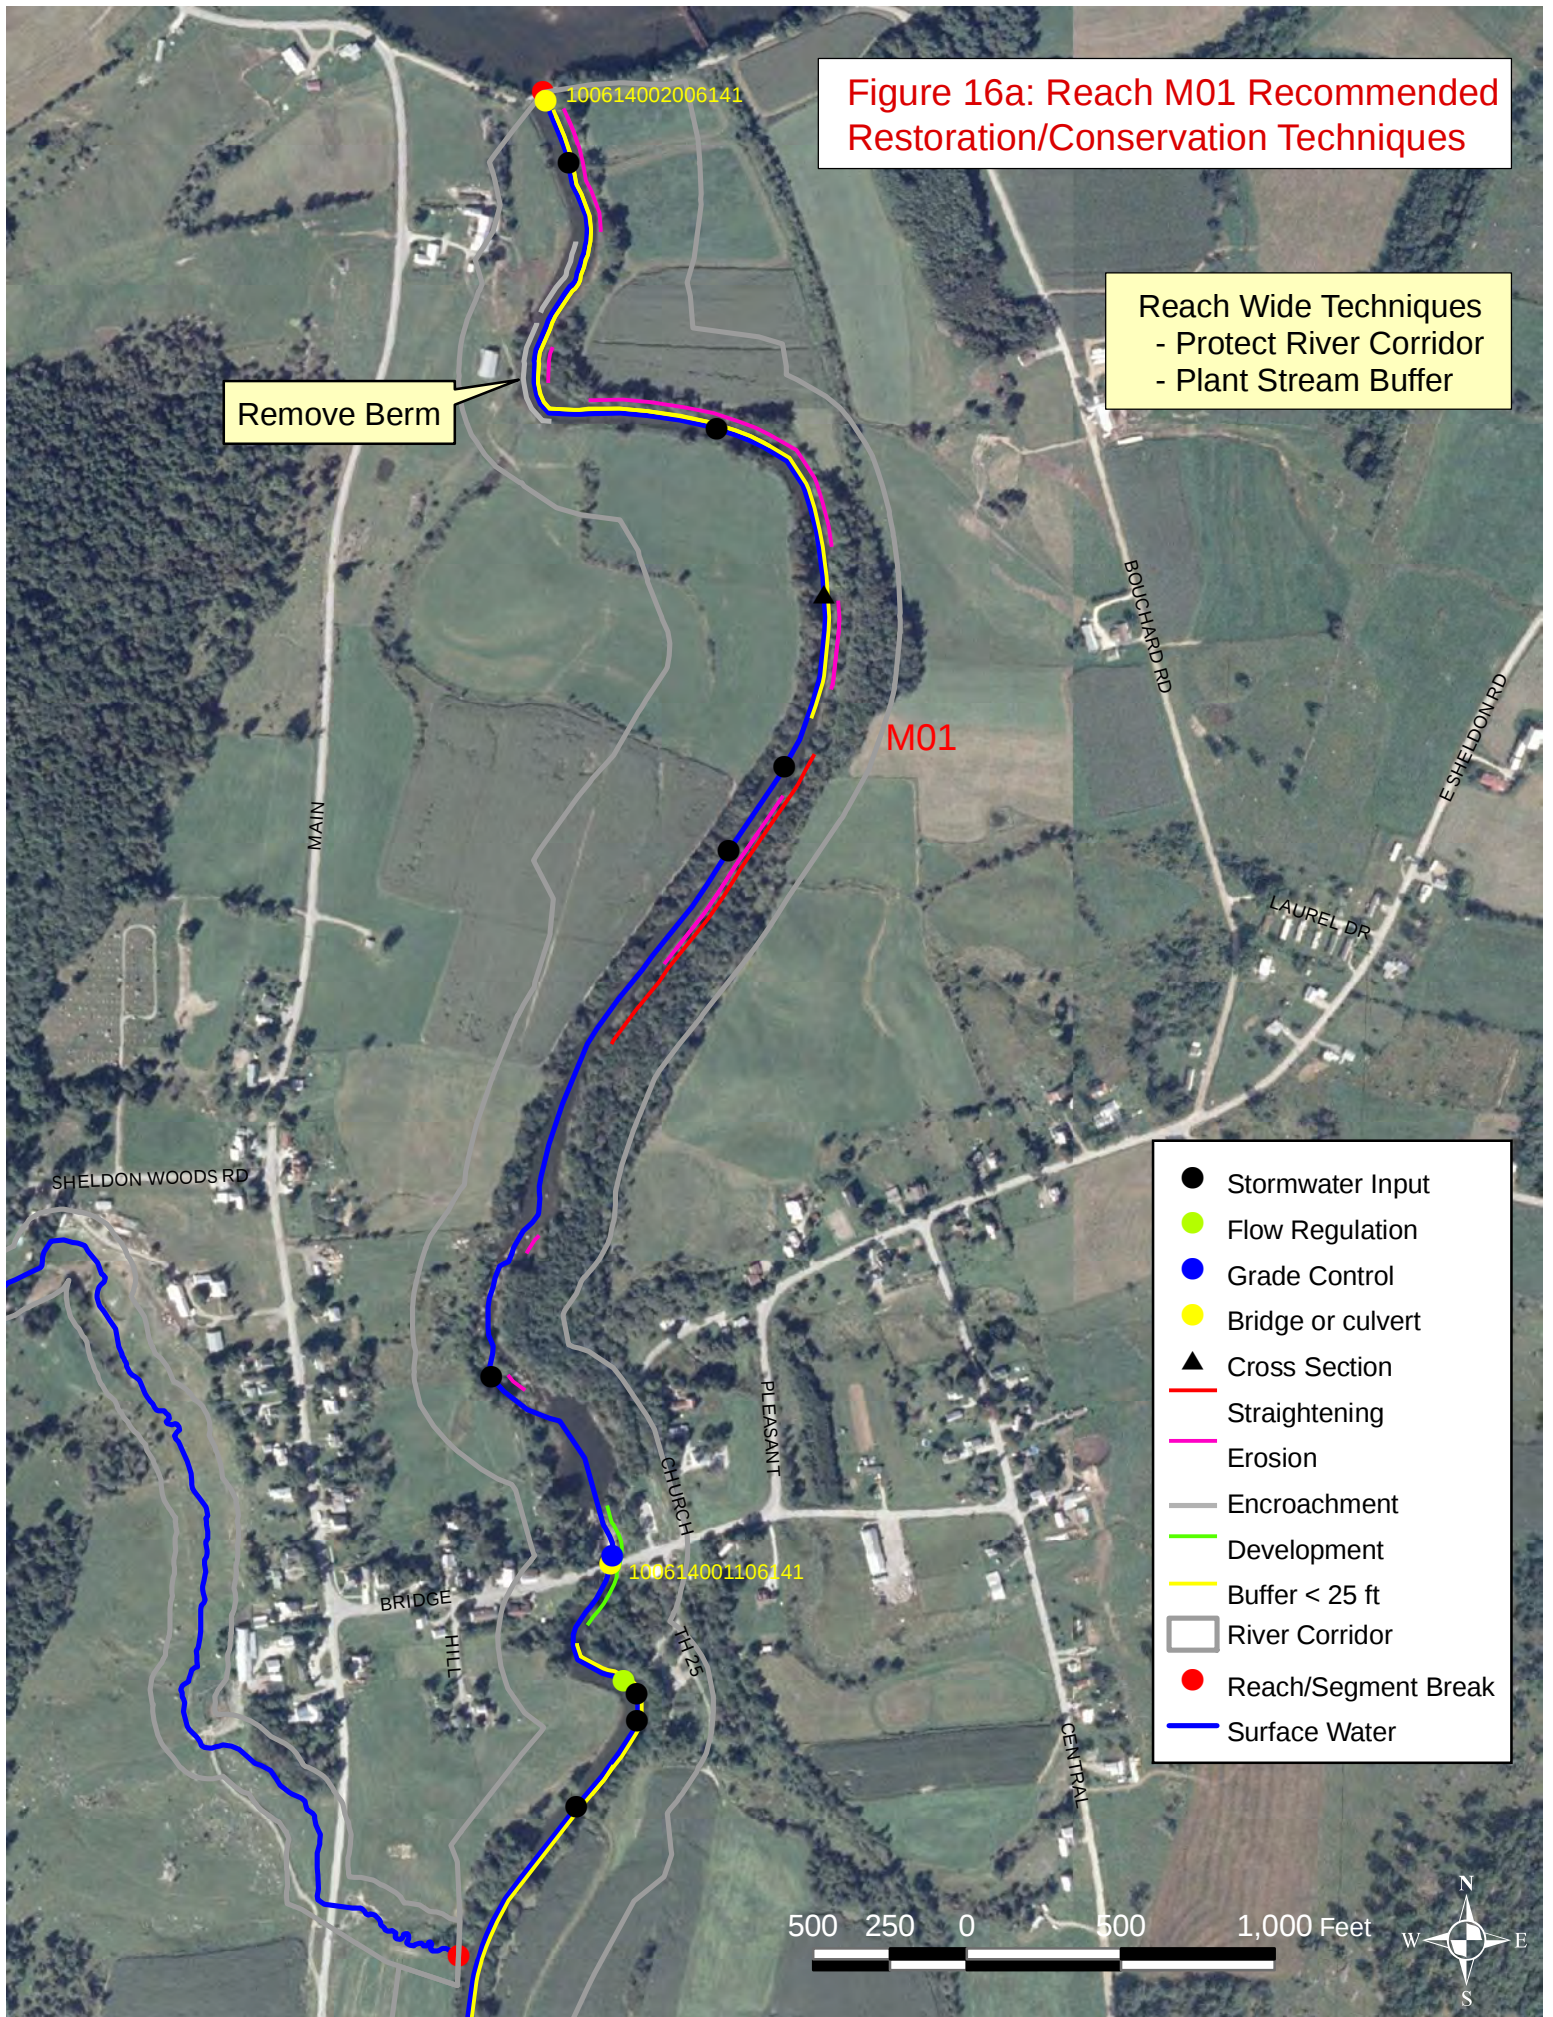
**Figure 16a: Reach M01 Recommended Restoration/Conservation Techniques**

Reach M01 is the furthest downstream reach in the study area and extends from the confluence with the Missisquoi River upstream for approximately 3 miles. This reach was found to be only slightly incised (incision ratio of 1.2) and still has access to its floodplain during most high flow events. The existing stream type of E5 Dune-Ripple was consistent with its reference stream type. Minor bank erosion was noted along small portions of the reach, though most of the banks were found to be relatively stable. The reach was found to be in Evolution Stage I, or Reference, with little active adjustments occurring and a rapid geomorphic score of 0.74 (good). The riparian corridor was dominated by hay and corn fields, with large areas of inadequate buffer of less than 25 feet. Sheldon Falls, a large bedrock gorge, is located in the middle of the segment. No major problems were identified with either of the assessed bridges. The habitat assessment showed fair aquatic habitat primarily due to embeddedness, lack of woody cover, and very few favorable sediment types and flow patterns.

Given the current, relatively stable condition of M01, the recommended remedial strategies are to protect the existing undeveloped river corridor to retain the reach's nutrient attenuation assets, and enhance the current buffer. The river corridor is defined as the area adjacent to the stream through which the stream would naturally meander over its lifetime to maintain equilibrium conditions. In most cases this is measured as three times the bankfull channel width on either side of the stream. As the furthest downstream reach, M01 receives all the inputs from upstream, and provides some attenuation of those inputs. Several large areas have riparian buffers of less than 25 feet, particularly upstream of Bridge Street. Buffer planting should be concentrated in these areas to reduce sediment and nutrient inputs, improve aquatic habitat, and improve bank stability. If possible, buffer establishment should be extended up the field ditches identified in the reach to reduce nutrient and sediment inputs. An aerial view of the reach is shown on Figures 16a and 16b, and descriptions of the recommended projects are shown in Table 5. A prioritized list of all identified projects for the watershed is shown in Table 22.

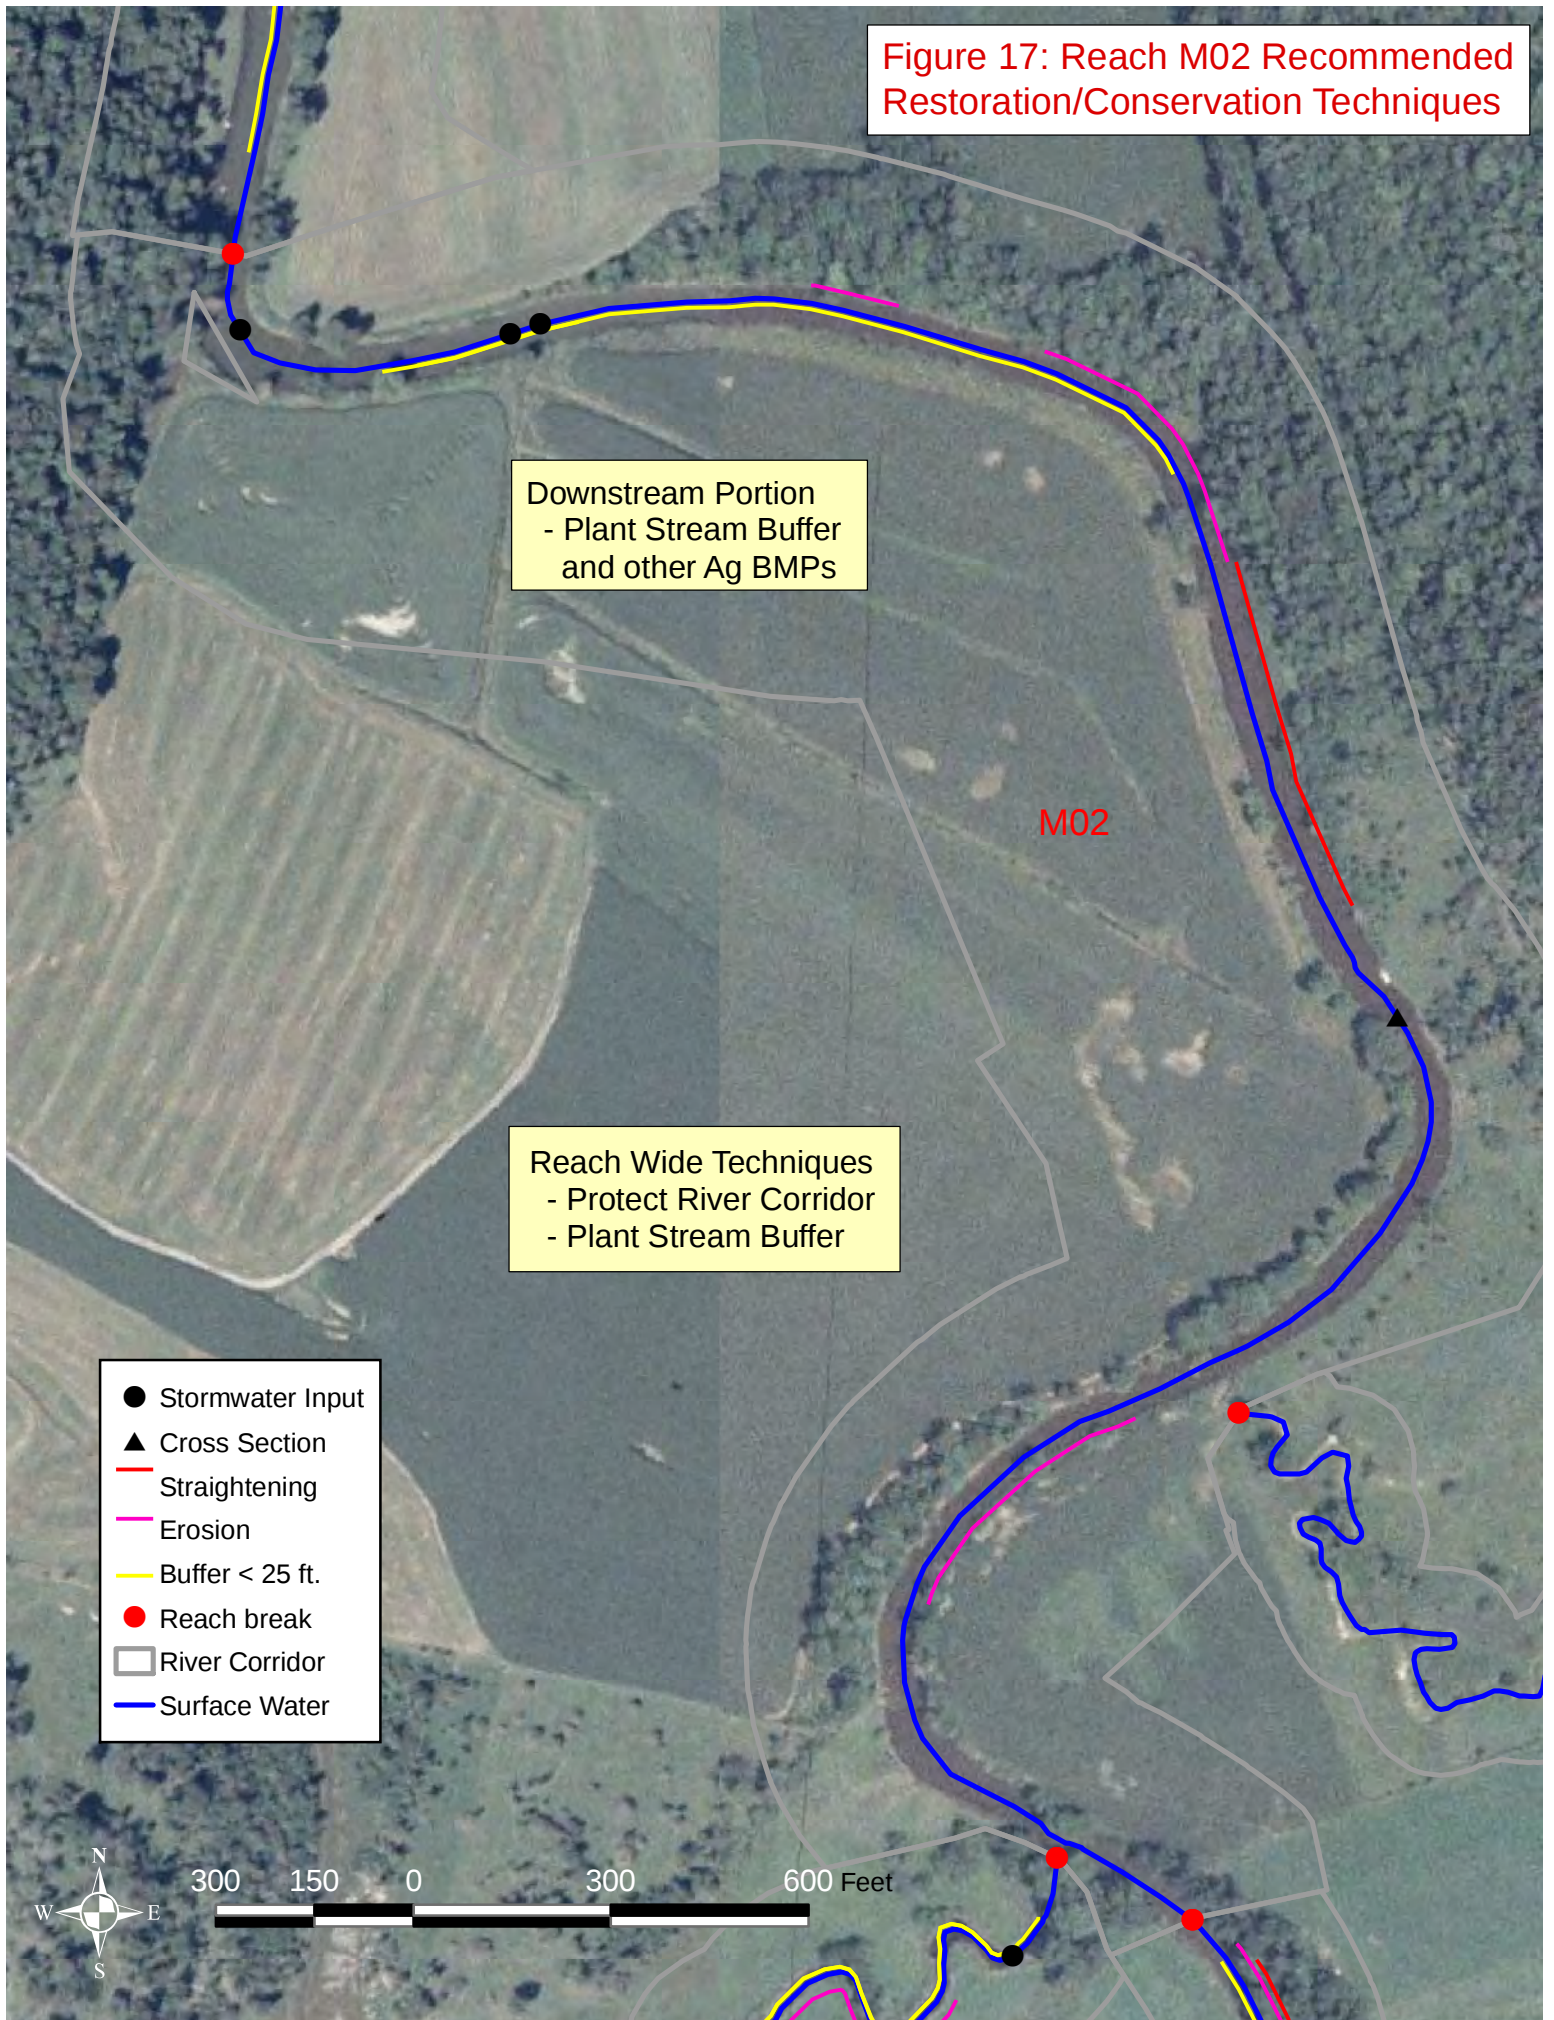
Figure 17: Reach M02 Recommended Restoration/Conservation Techniques

Reach M02 extends from the end of reach M01 upstream for approximately 0.8 miles to the confluence with Dead Creek. This reach was found to be only slightly incised (ratio of 1.1) and still has adequate floodplain access. The existing stream type of E5 Dune-Ripple was consistent with its reference stream type. Minor bank erosion was noted along small portions of the reach, though most of the banks were found to be relatively stable. The reach was found to be in channel evolution stage V, with little active adjustments occurring and a rapid geomorphic score of 0.73 (good). The riparian corridor was dominated by a mix of hay and crop with a large

area of forest on the right bank. Buffer widths were generally 0-25 feet, with approximately 1,500 feet having less than 25 foot buffers. The habitat assessment was fair primarily due to lack of woody cover, embeddedness, and very few favorable sediment types and flow patterns.

Given the current, relatively stable condition of M02, the recommended remedial strategies are to protect the existing undeveloped river corridor to retain the reach's nutrient attenuation assets, and enhance the current buffer. Several large areas have riparian buffers of less than 25 feet, particularly upstream of Bridge Street. Buffer planting should be concentrated in these areas to reduce sediment and nutrient inputs, improve aquatic habitat, and improve bank stability. Buffer establishment along the field ditches at the northern end of the reach is also important to reduce sediment and nutrient inputs. An aerial view of the reach is shown on Figure 17, and descriptions of the recommended projects are shown in Table 6. A prioritized list of all identified projects for the watershed is shown in Table 22.

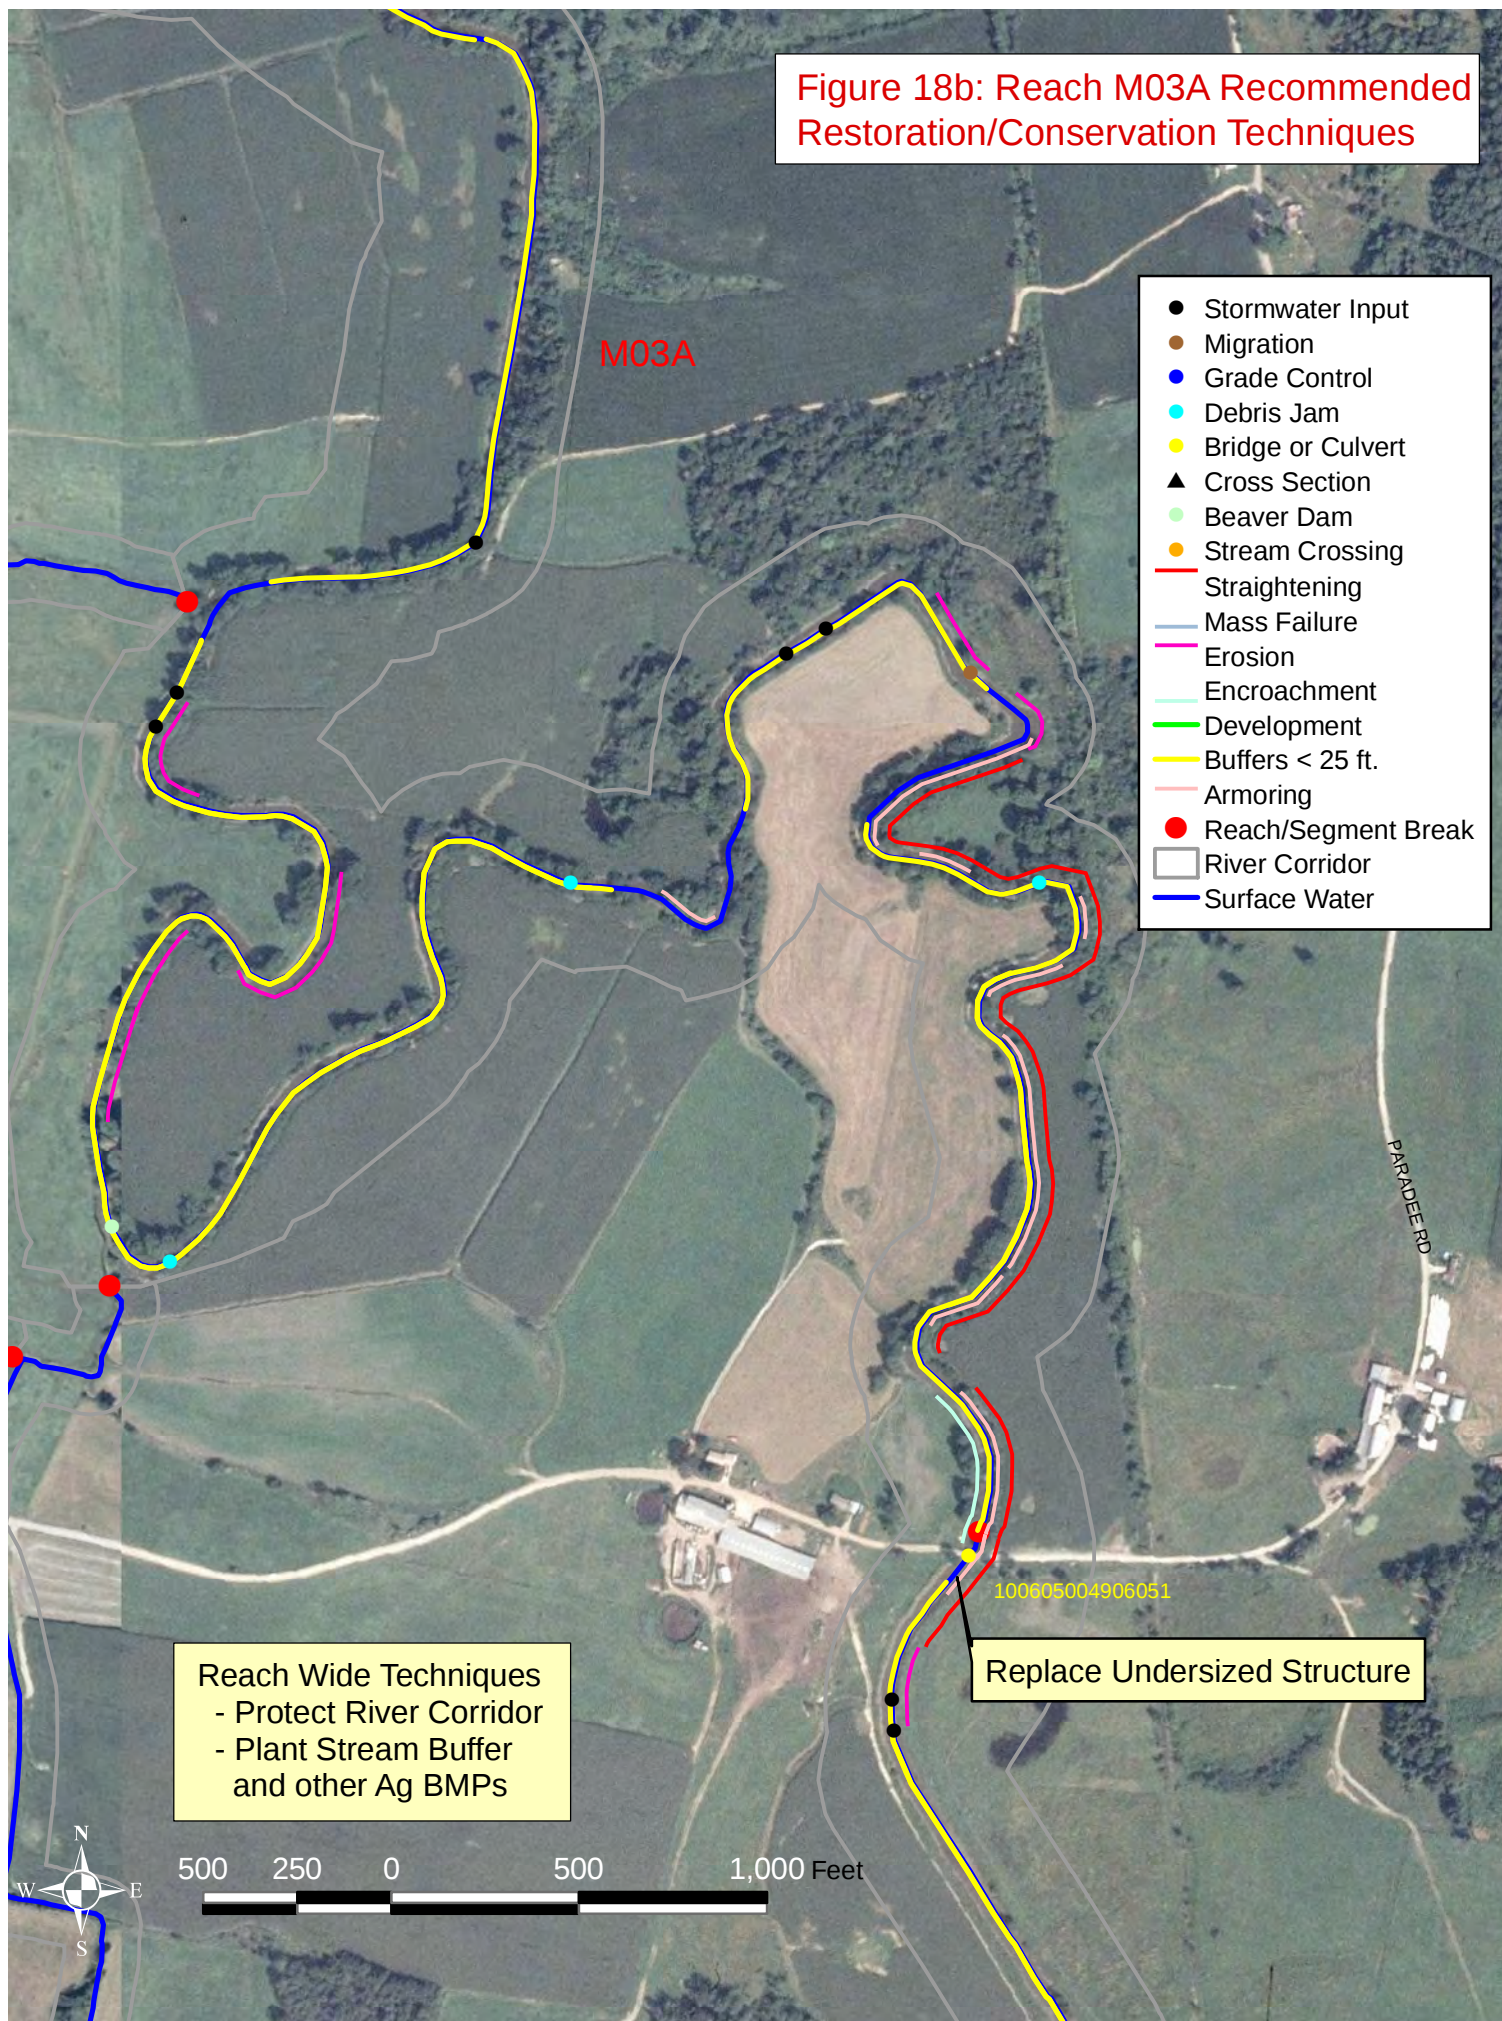
Figure 18a: Reach M03A Recommended Restoration/Conservation Techniques

Reach M03 extends upstream from the confluence with Dead Creek upstream for approximately 4.5 miles. The reach was segmented into two parts, M03A and M03B due to differences in channel dimensions and depositional features. M03A is the downstream end of the reach and extends from the confluence with Dead Creek upstream for approximately 3.5 miles. It was found to be only slightly incised (incision ratio of 1.2) and still has access to its floodplain during most high flow events. The existing stream type of E5 Dune-Ripple was consistent with its reference stream type. Minor bank erosion was noted along small portions of the reach, though most of the banks were found to be relatively stable. The segment was found to be in channel evolution stage I, or reference condition, with little active adjustments occurring and a rapid geomorphic score of 0.65 (good). The riparian corridor was dominated by a mix of corn fields and pasture, with large areas of inadequate buffer of less than 25 feet. Cows were observed in the stream channel just upstream of Pumpkin Village Road. The bridge on Paradee Road is undersized with a structure to channel width ratio of only 65%.

M03B extends from Paradee Road upstream for approximately 1 mile. This segment was highly incised (ratio of 1.6) and has lost much of its historic floodplain access. Despite the historic incision, its existing stream type of E4 Dune-Ripple was consistent with its reference type. The segment was found to be in channel evolution stage IV, as it has incised and is in the process of widening and aggrading to re-create floodplain access. The river corridor was dominated by a mix of crop, pasture, and forest with large portions having little to no riparian buffer. The abandoned elevated railroad bed runs through the upstream half of the segment and represents a major floodplain constriction.

The recommended projects for segment A are to protect the river corridor to retain the existing sediment and nutrient attenuation assets. In addition, large areas of the segment have inadequate buffer, so woody vegetation planting is also required. Cattle fencing should be included in this effort to limit animal access to the stream channel near Pumpkin Village Road.

The bridge on Paradee Road is significantly undersized and should be replaced to restore more normal flow patterns and reduce flooding and erosion hazards.

Segment M03B is highly incised (ratio of 1.6) so active floodplain restoration is recommended over corridor protection. Given the stream type and cohesive bank and bed soils, natural channel evolution would take significantly longer here than in a steeper, gravelly bedded stream which makes passive floodplain restoration a less desirable option. The active approach would involve lowering the existing bank heights with heavy equipment to re-create floodplain access and prevent future erosion of the existing stream banks. In combination with this, corridor protection and buffer establishment should be included to prevent future channel management which could impact the stream channel and establish a woody buffer to stabilize the streambanks, improve aquatic habitat, and reduce sediment and nutrient inputs. The abandoned railroad bed runs through a large portion of the stream corridor and represents a major floodplain constraint. Removing or retrofitting this berm with adequately sized culverts and/or bridges would restore the floodplain to a more normal size which could reduce flood hazards upstream and downstream of M03. Ideally all these strategies would be combined into one large project, but if that is not feasible they could be implemented separately to provide limited benefits. For example, if active floodplain restoration is not feasible, but the railroad berm could be removed or retrofitted, the stream would still regain some floodplain access and would be less likely to flood and/or erode the downstream portion of the reach. Table 7 and Figures 18a, b, and c below describe and show the locations of the recommended projects. A prioritized list of all identified projects for the watershed is shown in Table 22.

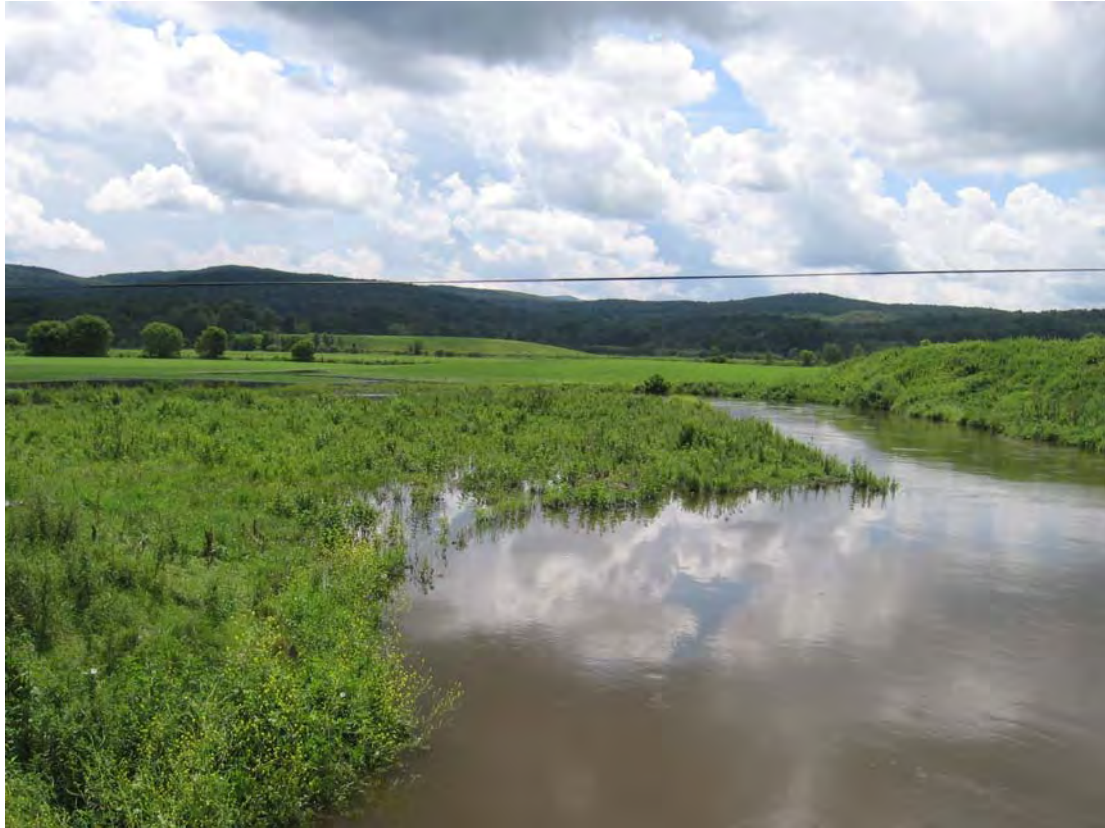
**Lack of buffers along Reach M04.**

The recommended remedial/conservation strategies for both M04A and M04B are to protect the existing river corridor to preserve the sediment and nutrient retention functions of the reach. A lack of adequate buffer dominates the reach so buffer planting is a high priority. If possible the planted buffers should extend up the field ditches to reduce sediment and nutrient inputs into the stream channel.

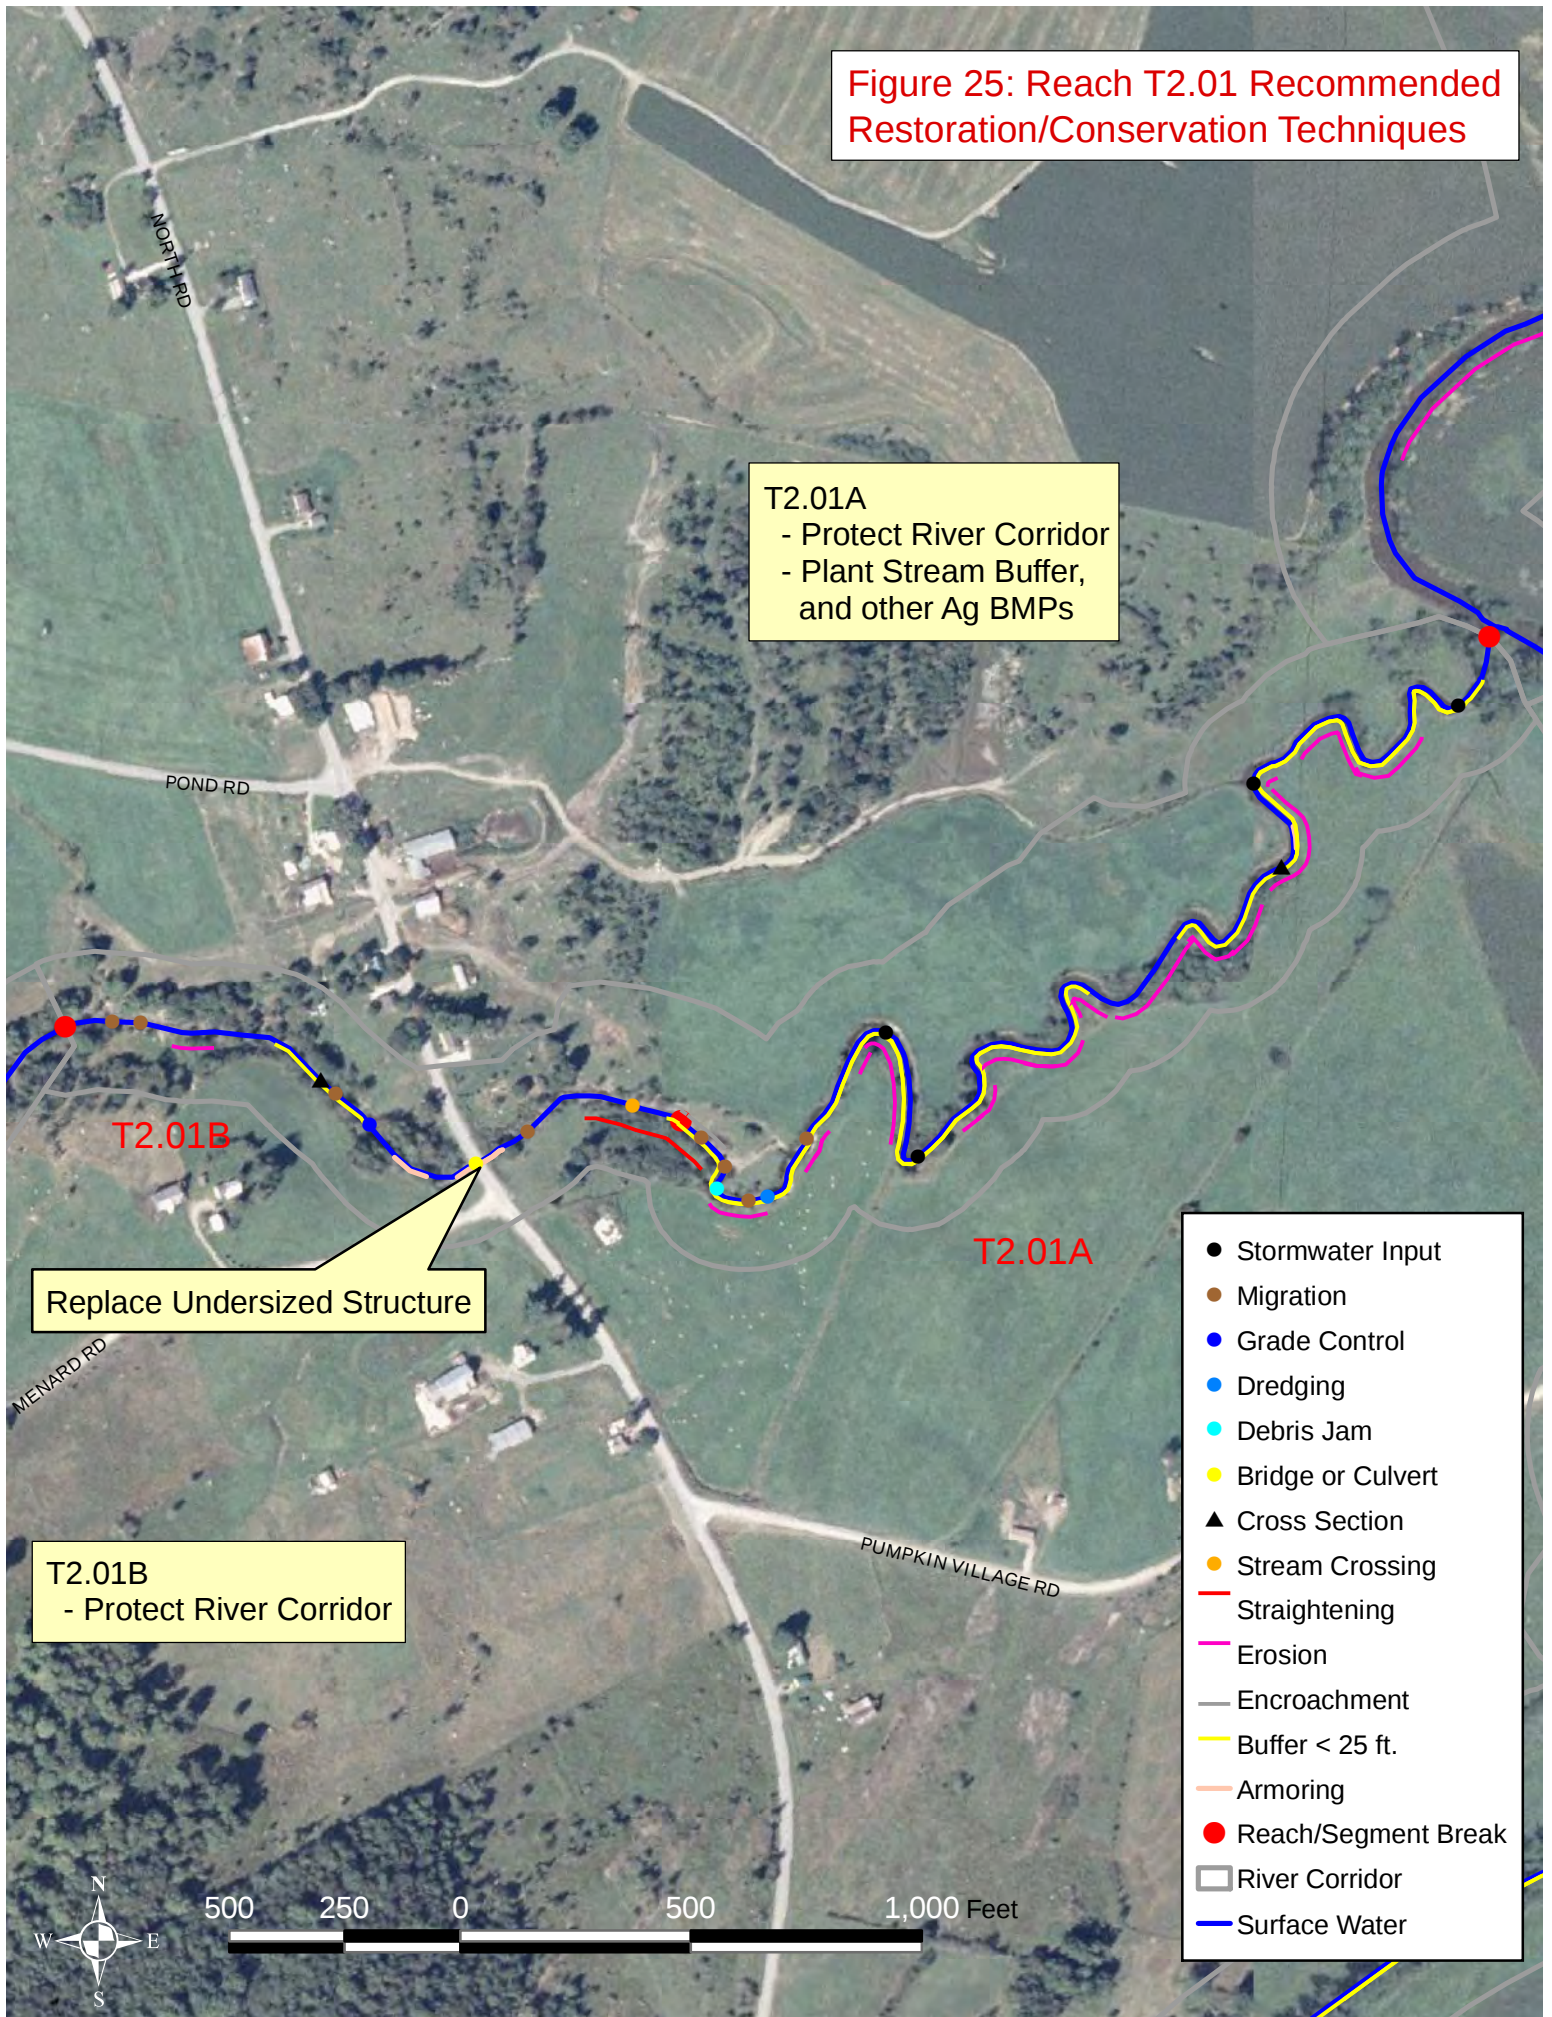
Figure 25: Reach T2.01 Recommended Restoration/Conservation Techniques

Reach T2.01 extends from its confluence with Black Creek north of Pumpkin Village Road upstream for approximately 1 mile. The reach was segmented into T2.01A and T2.01B due to differences in the channel dimensions and boundary conditions. Segment A is the downstream end of the reach and is approximately 0.7 miles long. The segment was classified as an E5 Dune-Ripple, consistent with its reference stream type, though due to minor historic channel degradation and active widening and aggradation it is in Evolution Stage IV (Widening). Only minor incision was noted (ratio of 1.2) and no active head cuts were observed. A

significant amount of bank erosion was observed. The riparian corridor was dominated by hay fields with little to no buffer. The habitat assessment showed relatively poor aquatic habitat conditions. T2.01B is the upstream portion of the reach and extends to approximately 0.2 miles upstream of the North Road crossing. This segment was naturally steeper and more confined, and was classified as a B3 – Step-pool system. It was relatively stable with no active adjustment processes. The riparian corridor was dominated by a mix of hay fields and residential development with buffers ranging from 26 to 50 feet in width. The habitat assessment showed good aquatic habitat. The culvert crossing North Road is severely undersized with a structure width to channel width ratio of only 21%.

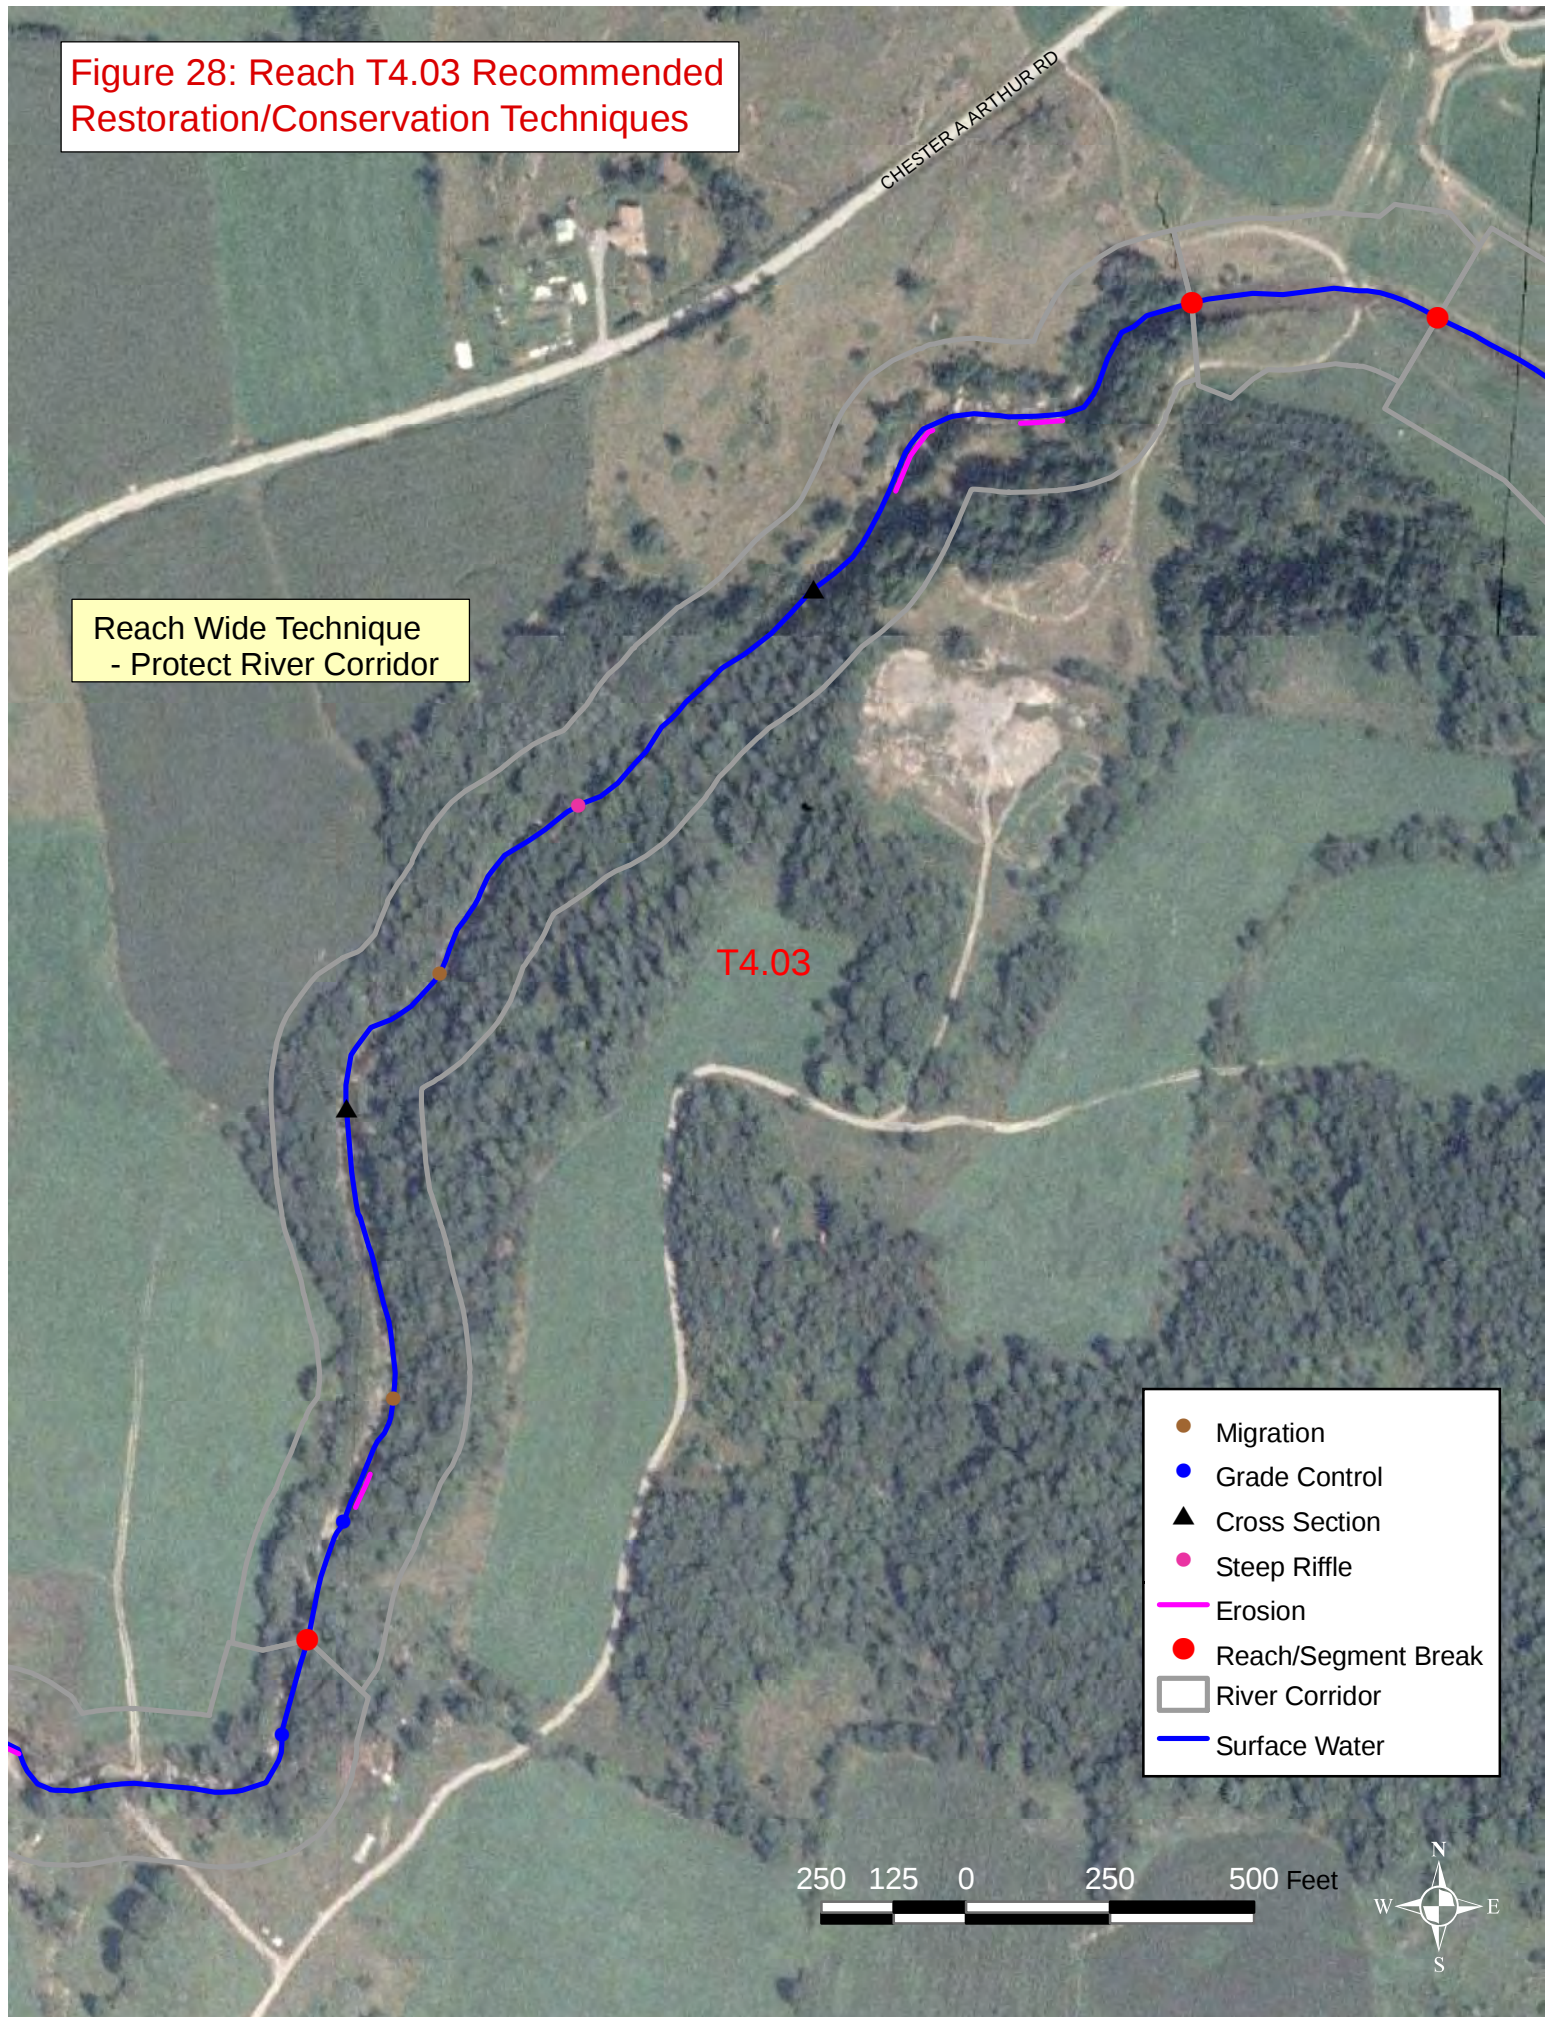
Figure 28: Reach T4.03 Recommended Restoration/Conservation Techniques

Reach T4.03 extends from the end of T4.02 (a very short reach not assessed during this project) upstream for approximately 0.6 miles. This reach was found to be relatively stable with little ongoing adjustments. It is located in a naturally narrow and steeper portion of the valley and was classified as a B3 – step-pool type stream. No erosion or other significant problems were noted. The riparian corridor was dominated by forest with no human impacts near the stream channel. The rapid habitat assessment showed relatively good aquatic habitat.

Given the location of T4.03 and relative stability there are no recommended projects. The reach is currently stable and undeveloped. This should be maintained through corridor protection, though because this reach is naturally a transport type environment, preference should be given to protecting those areas in other reaches that can improve or retain needed sediment and nutrient retention. An aerial view of the reach is shown on Figure 28, and descriptions of the recommended projects are shown in Table 17. A prioritized list of all identified projects for the watershed is shown in Table 22.
