Phase 2 Stream Geomorphic Assessment Browns River Watershed Chittenden and Franklin Counties, Vermont

April 17, 2008

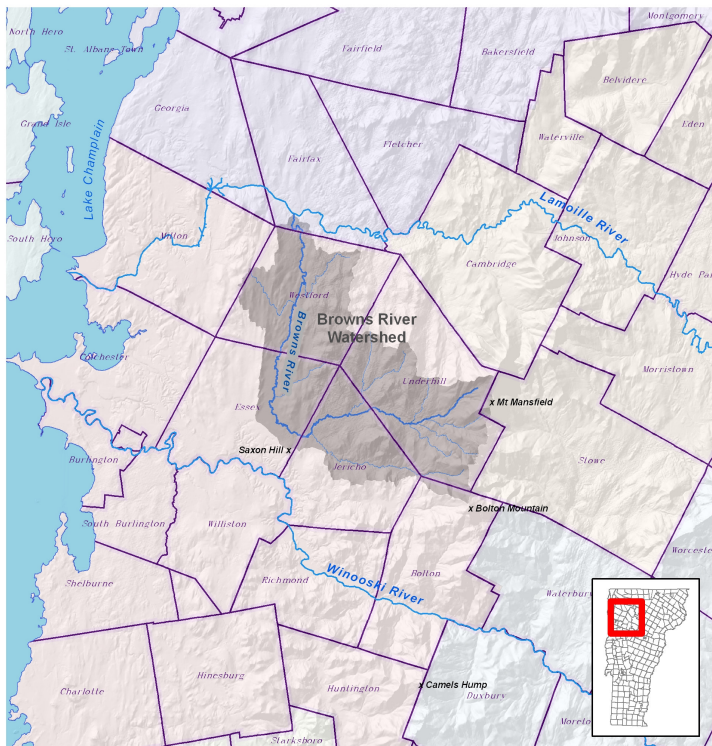
Figure a. Watershed Location Map

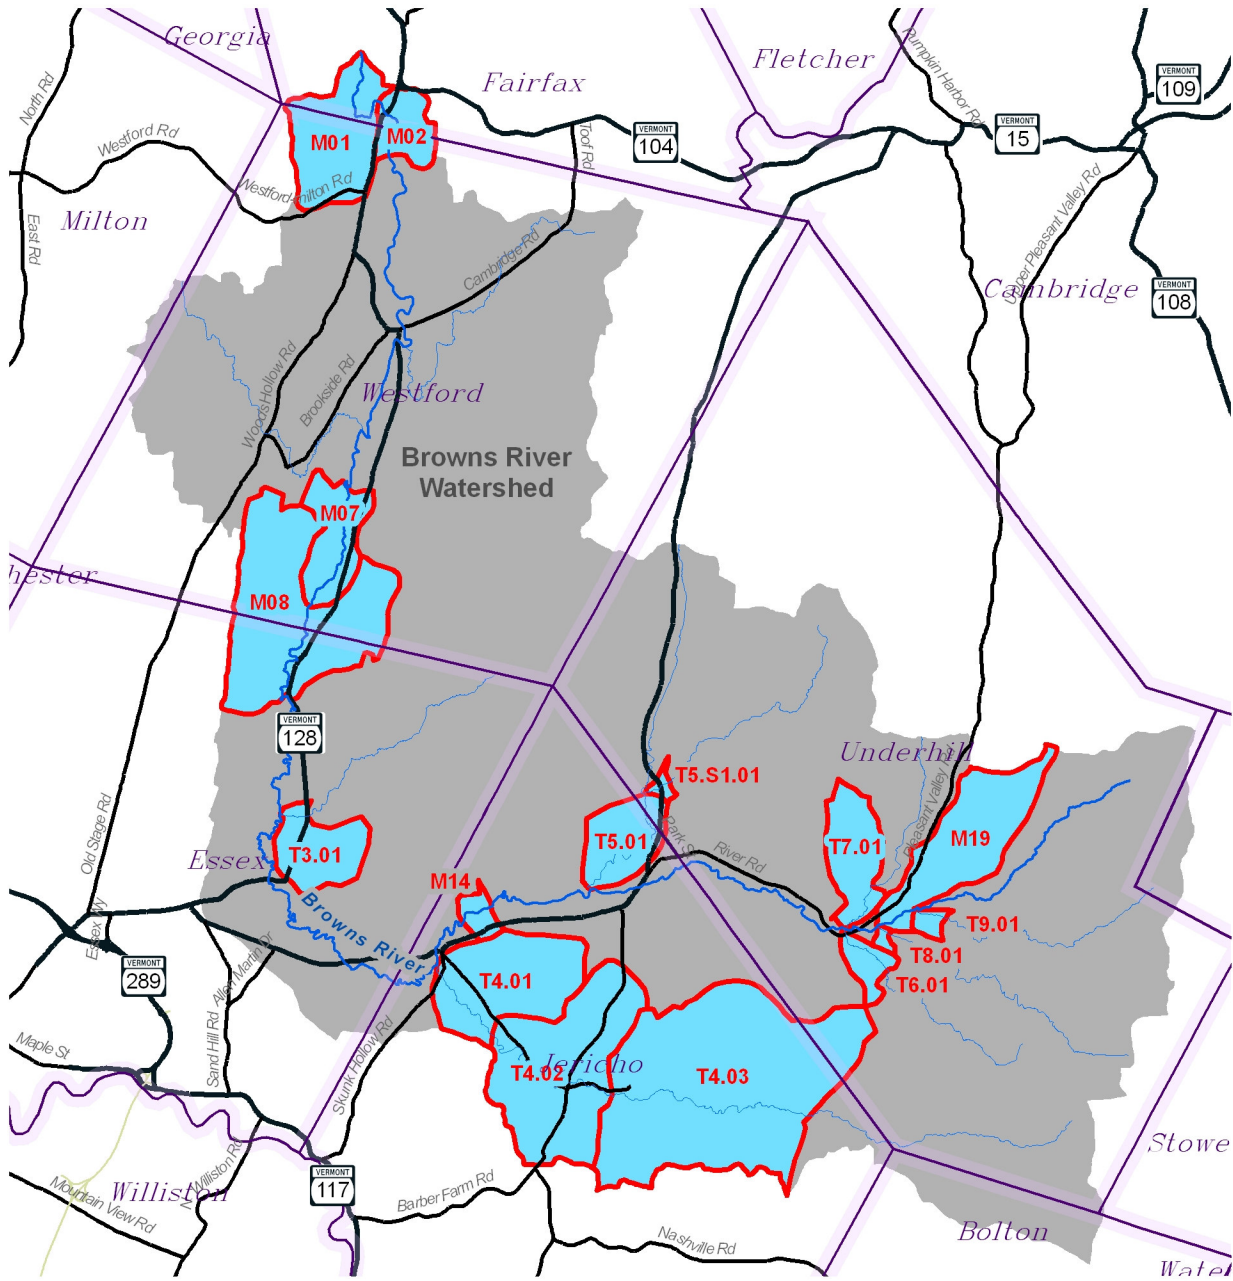
Figure b. Reach Location Map

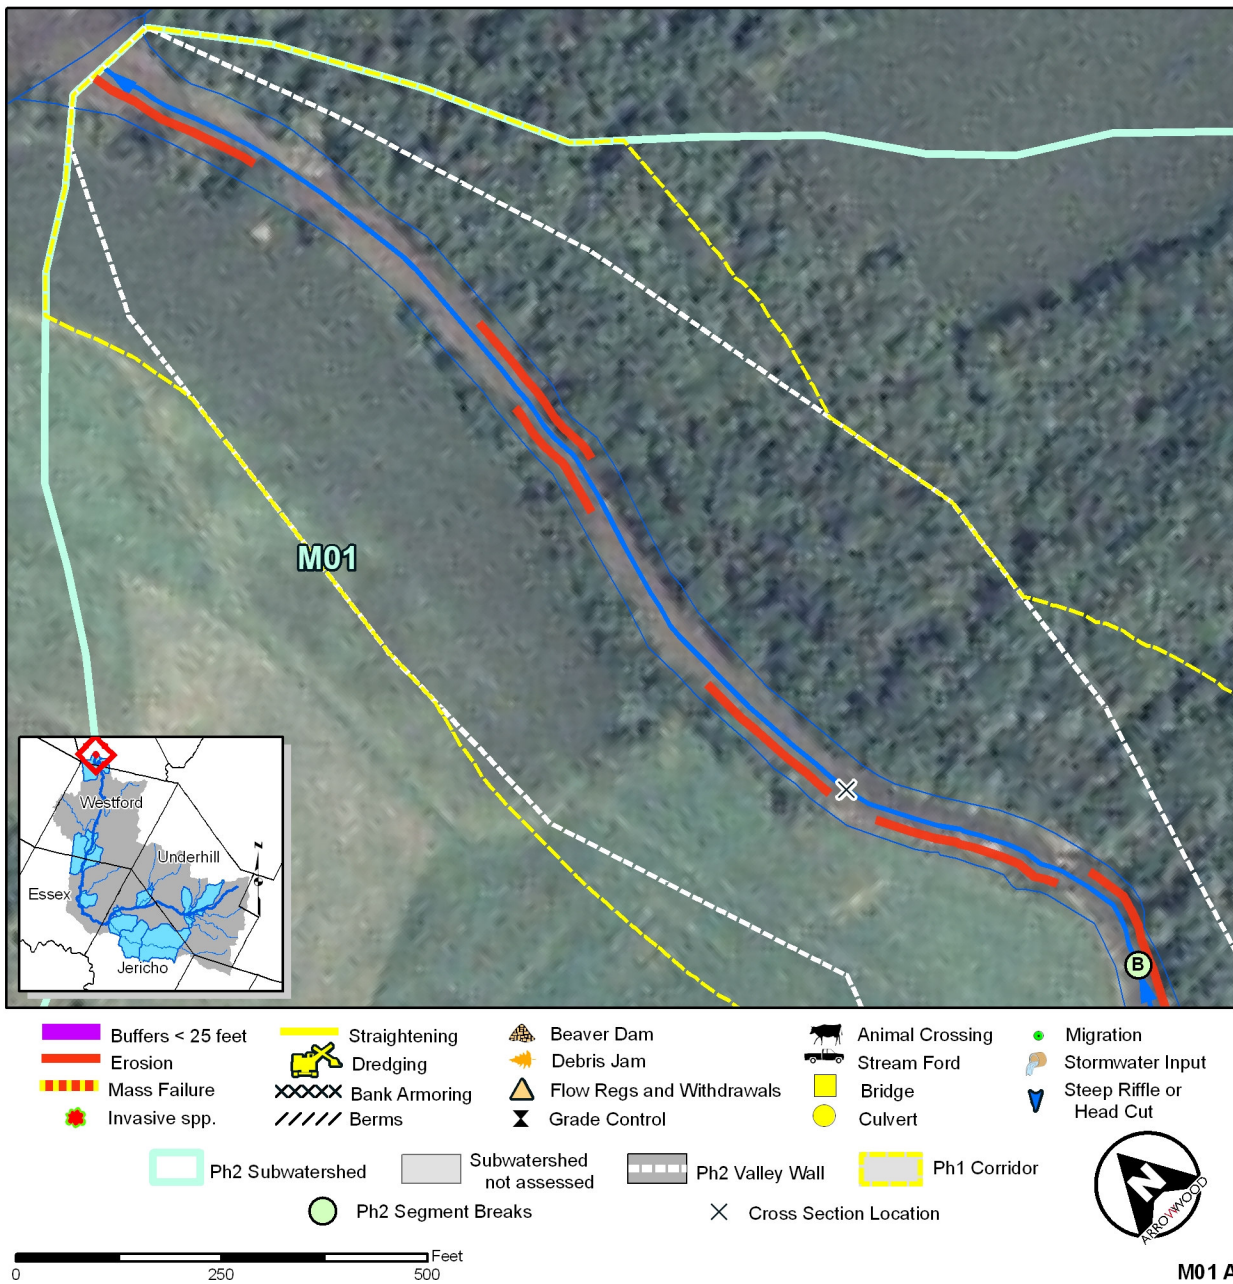
Figure c. Reach M01A Inventory Map

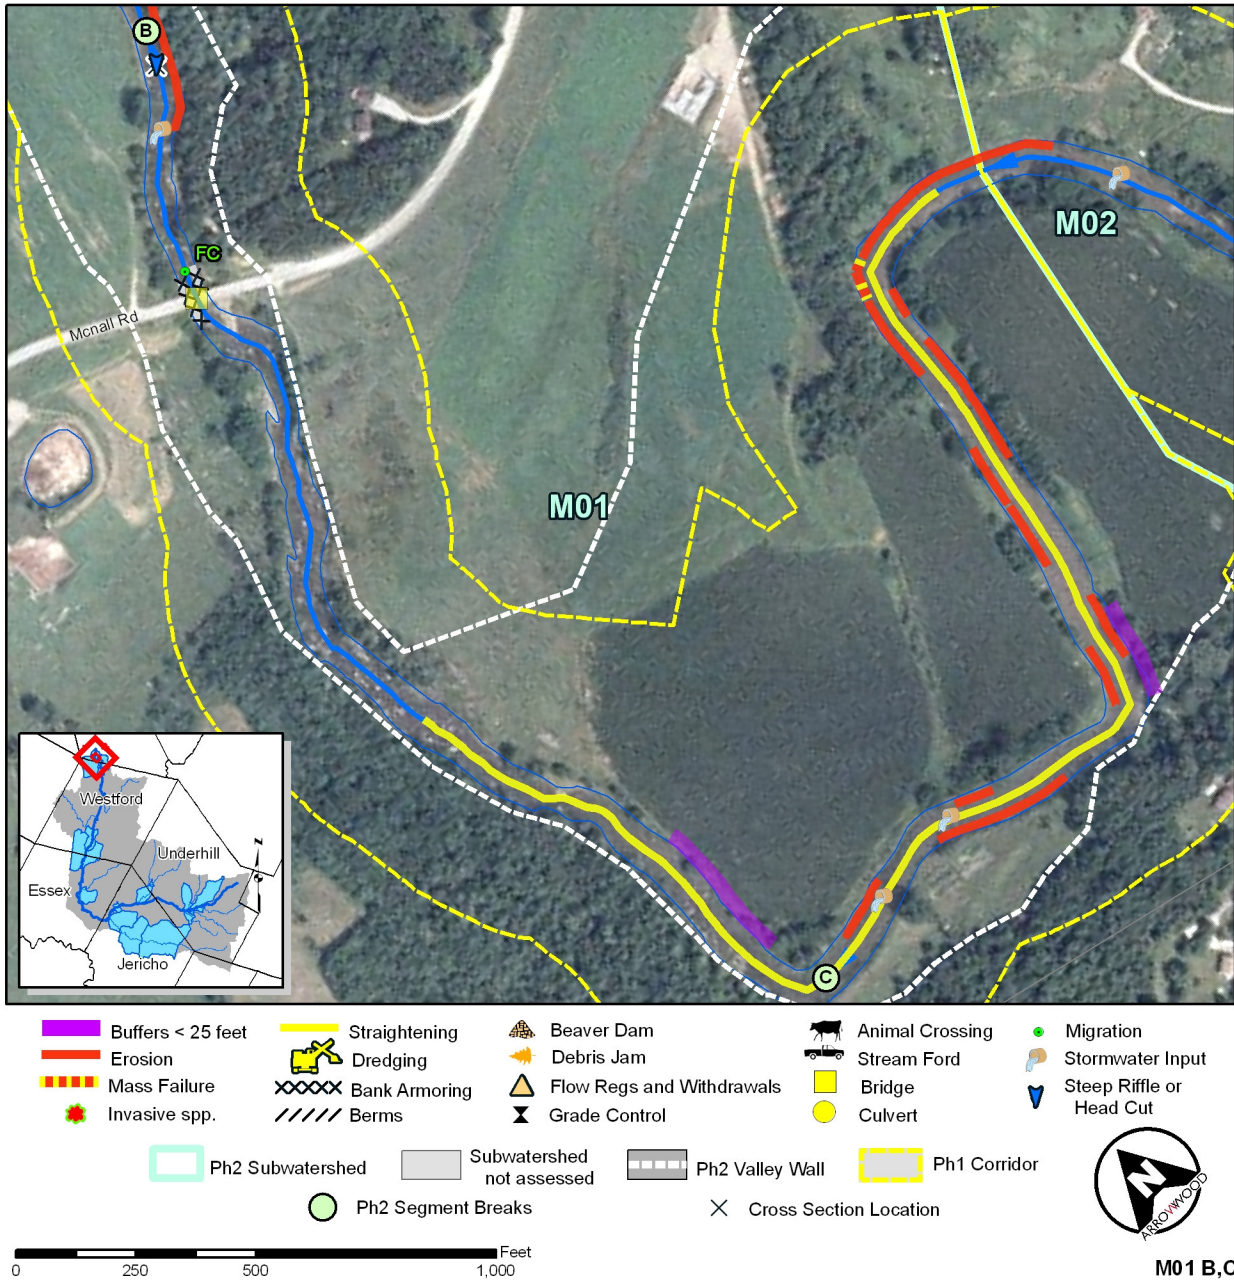
Figure d. Reach M01B,C Inventory Map

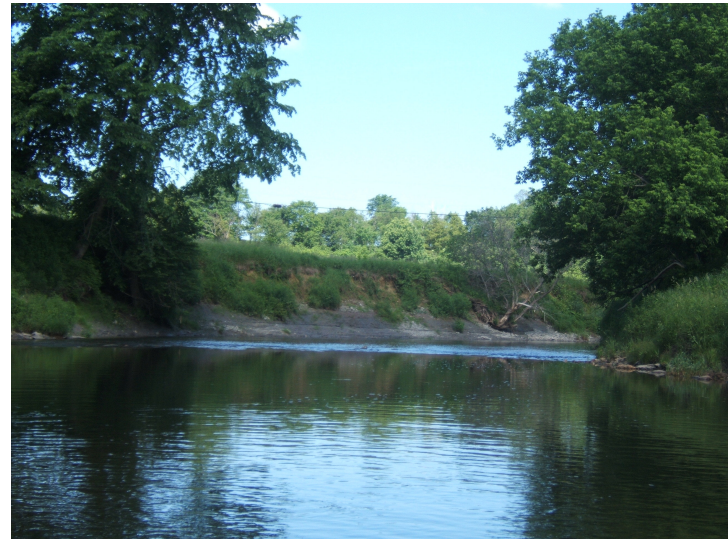
M02a Summary Data		Habitat Stressors	Reach Stressors
Reach/Segment Length	2902 ft	Invasive Plants Dump Sites Animal Crossings Dredging Poor Stream Bank Vegetation	Poor Buffers Erosion Mass Failures Encroachments Straightening Revetments Constrictions Rejuvenating Tributaries Dredging Stormwater inputs Headcuts
Valley Confinement	Broad		
Reference Stream Type	C5		
Existing Stream Type	C5		
Geomorphic Condition	Fair		
Channel Evolution Stage	III		
Adjustment Process	Widening/aggradation		
Habitat Condition	Fair		
Stream Sensitivity	Very High

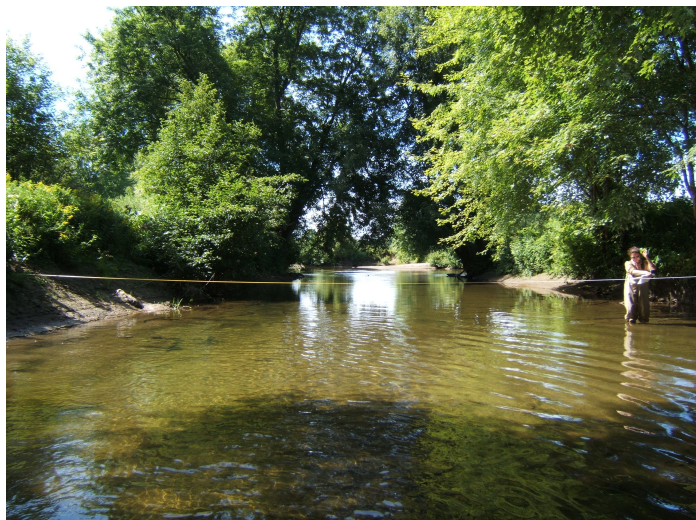
Preliminary project recommendations are presented in the following table.

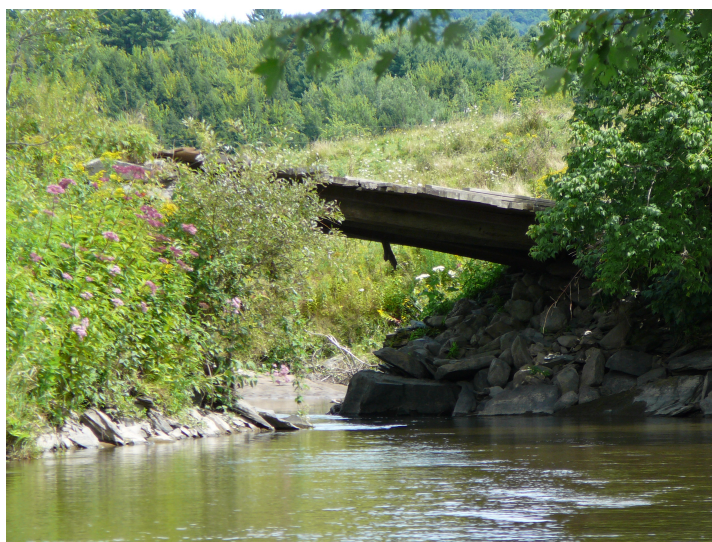
Figure m. Channel constriction, potential replacement project

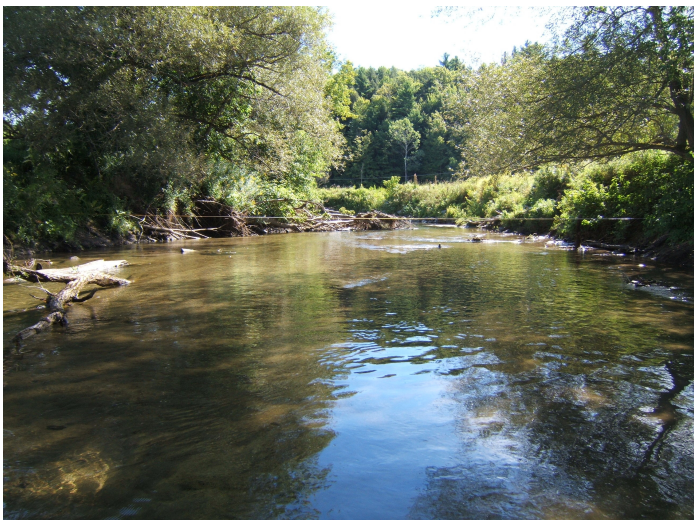
M08 Summary Data		Habitat Stressors	Reach Stressors
Reach/Segment Length	8456 ft	Invasive Plants Dump Sites Animal Crossings Dredging Poor Stream Bank Vegetation	Poor Buffers Erosion Mass Failures Encroachments Straightening Revetments Constrictions Rejuvenating Tributaries Dredging Stormwater inputs Headcuts
Valley Confinement	Very Broad		
Reference Stream Type	E5		
Existing Stream Type	F5		
Geomorphic Condition	Fair		
Channel Evolution Stage	III		
Adjustment Process	Widening		
Habitat Condition	Fair		
Stream Sensitivity	High

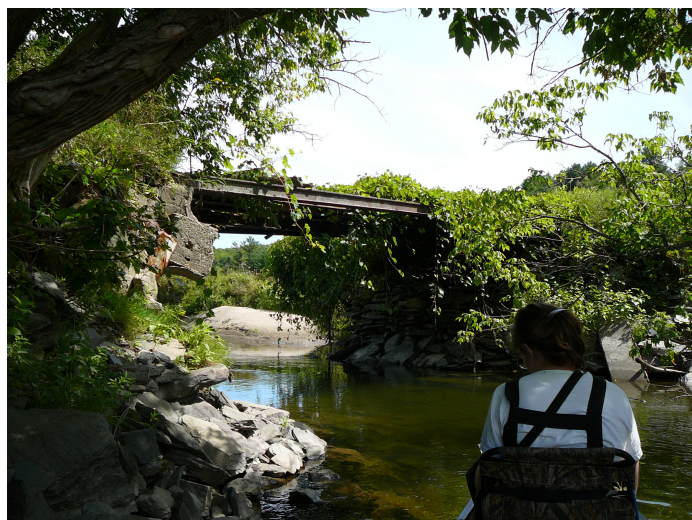
Figure p. Undermining abutments at structure downstream of junk car and Pettingill Road.

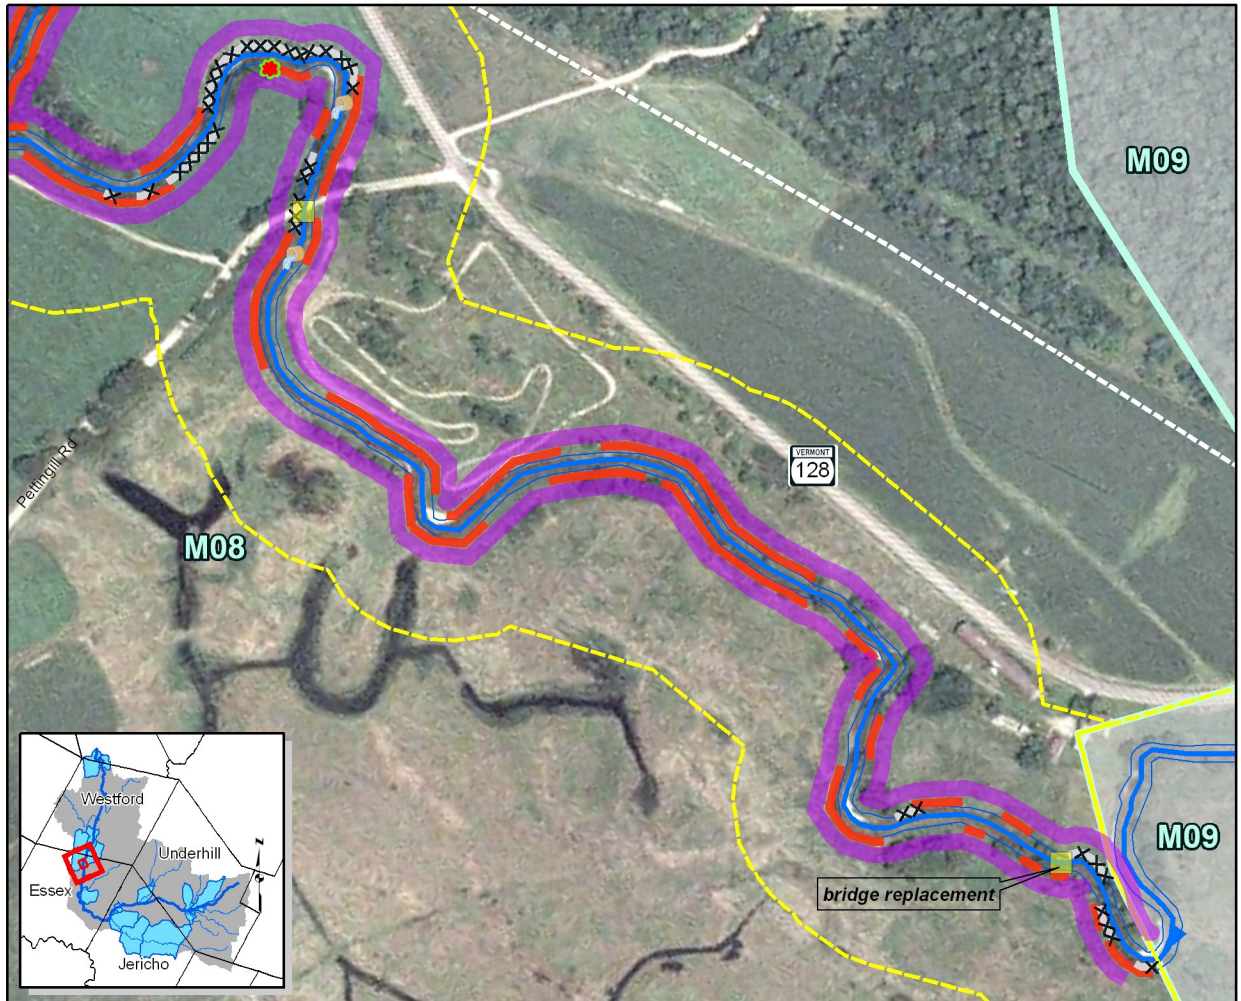
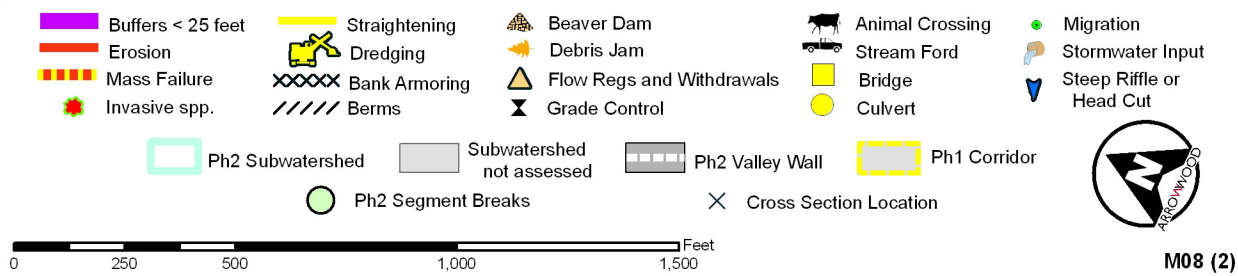
Figure q. Reach M08 Inventory Map

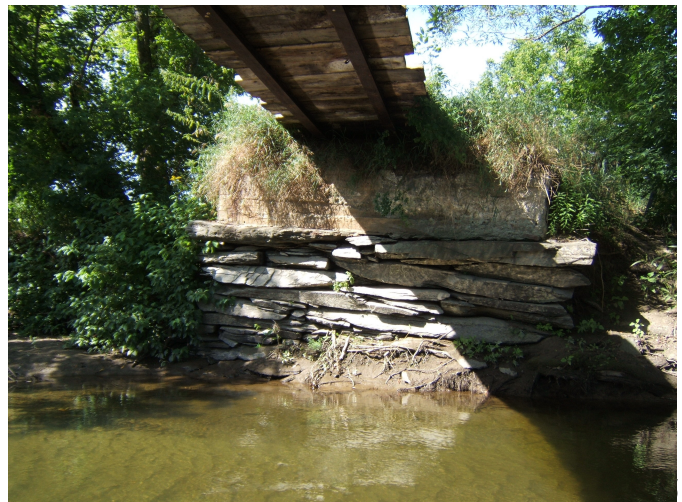
Figure r. Left abutment of recommended bridge replacement project just downstream of M09 reach boundary

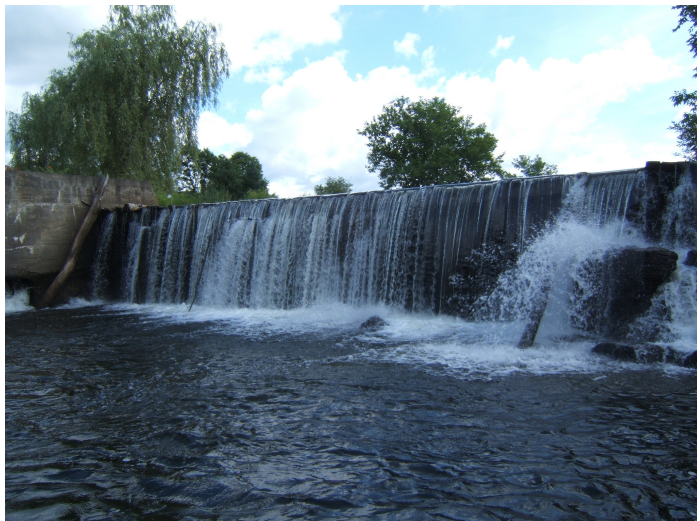
M14 Summary Data		Habitat Stressors	Reach Stressors
Reach/Segment Length	2388 ft	Invasive Plants Dump Sites Animal Crossings Dredging Poor Stream Bank Vegetation	Poor Buffers Erosion Mass Failures Encroachments Straightening Revetments Constrictions Rejuvenating Tributaries Dredging Stormwater inputs Headcuts
Valley Confinement	Very Broad		
Reference Stream Type	C3		
Existing Stream Type	C4		
Geomorphic Condition	Fair		
Channel Evolution Stage	IV		
Adjustment Process	Minor Adjustments		
Habitat Condition	Fair		
Stream Sensitivity	Very High

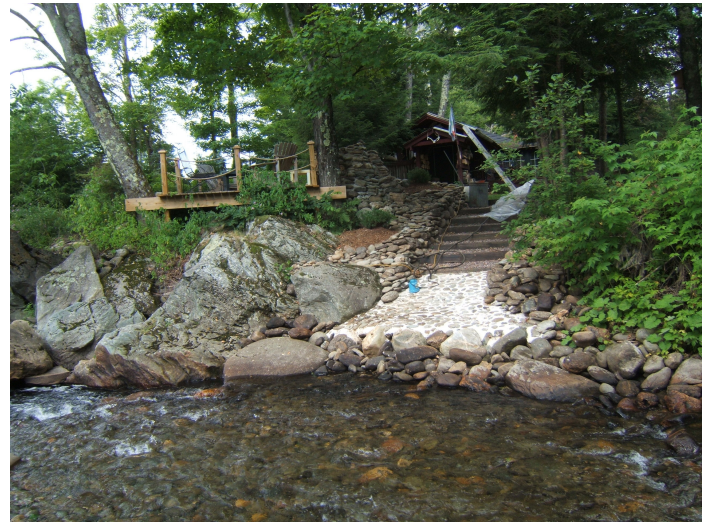
M19 Summary Data		Habitat Stressors	Reach Stressors
Reach/Segment Length	2724 ft	Invasive Plants Dump Sites Animal Crossings Dredging Poor Stream Bank Vegetation	Poor Buffers
Valley Confinement	Very Broad		Erosion
Reference Stream Type	C3		Mass Failures
Existing Stream Type	C3		Encroachments
Geomorphic Condition	Fair		Straightening
Channel Evolution Stage	III		Revetments
Adjustment Process	Widening		Constrictions
Habitat Condition	Good		Rejuvenating Tributaries
Stream Sensitivity	High		Dredging
			Headcuts

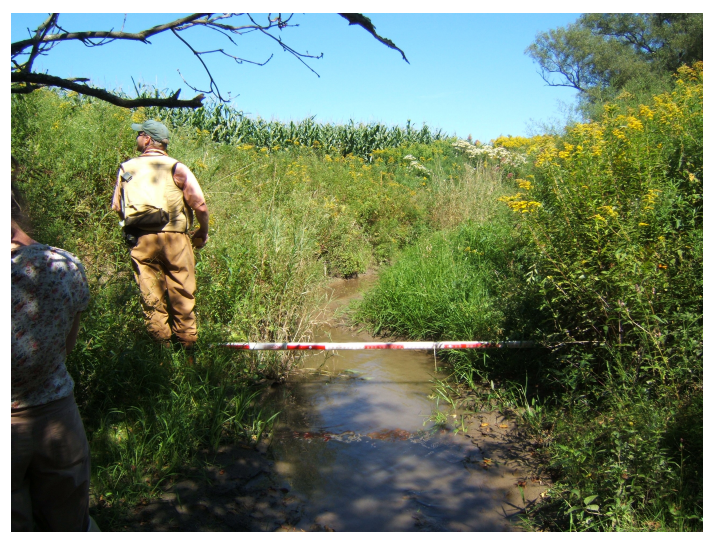
T3.01a Summary Data Abbey Brook	
Reach/Segment Length	503 ft
Valley Confinement	Very Broad
Reference Stream Type	C3
Existing Stream Type	G6
Geomorphic Condition	Fair
Channel Evolution Stage	III
Adjustment Process	Widening/ planform changes
Habitat Condition	Poor
Stream Sensitivity	Extreme

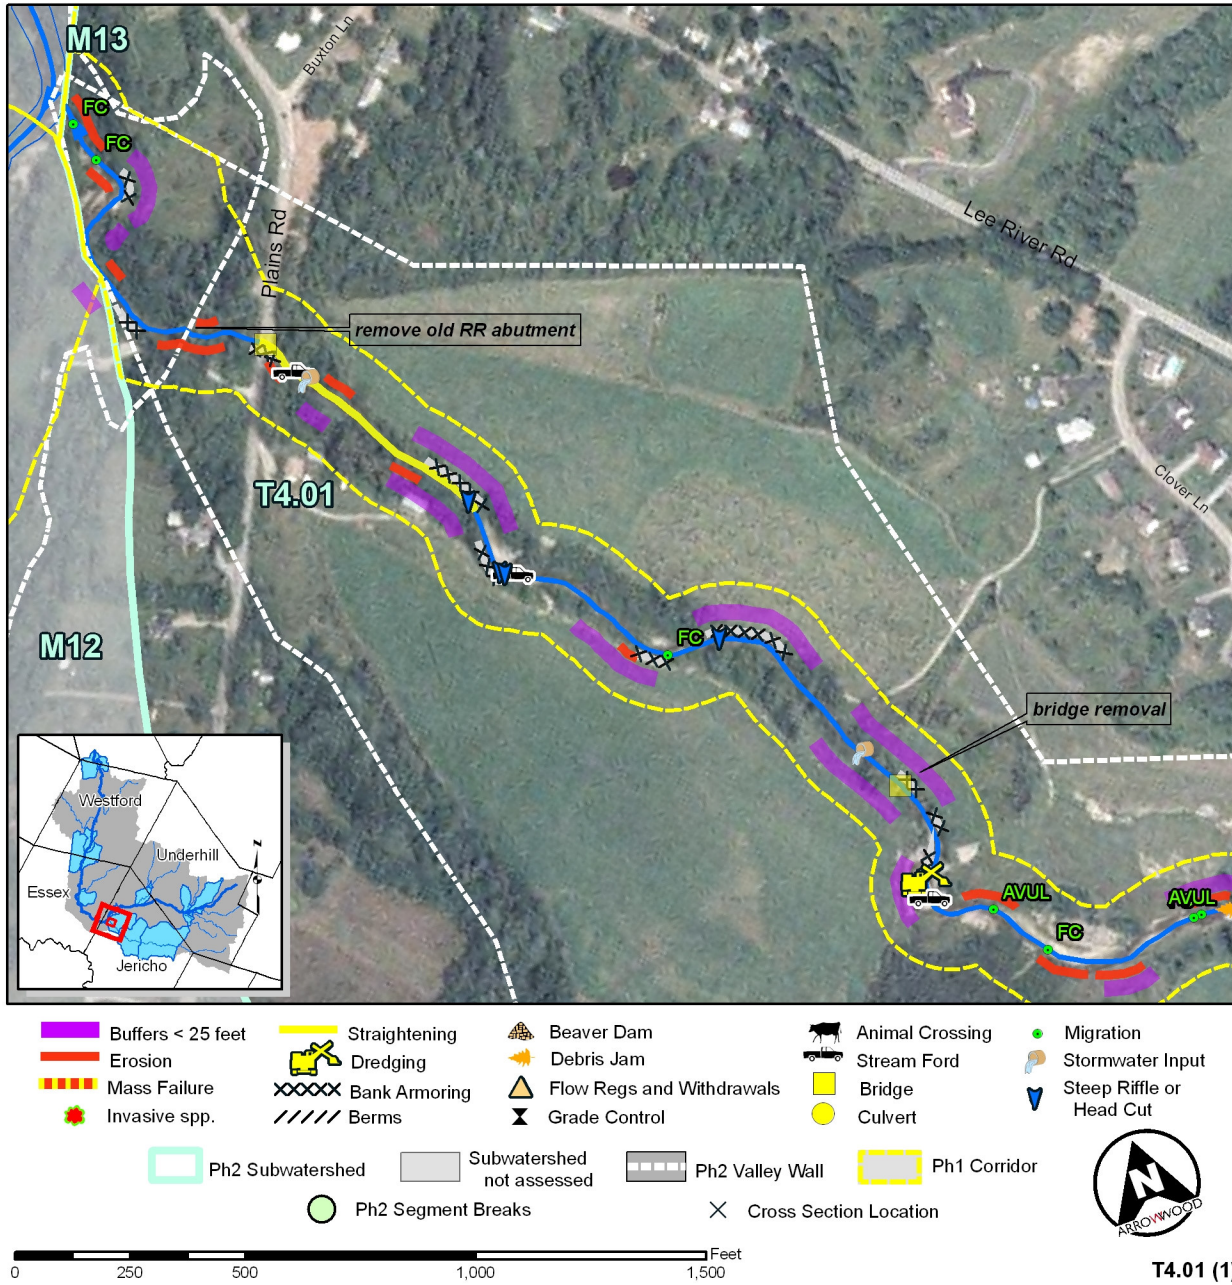
Figure aa. Reach T4.01 Inventory Map

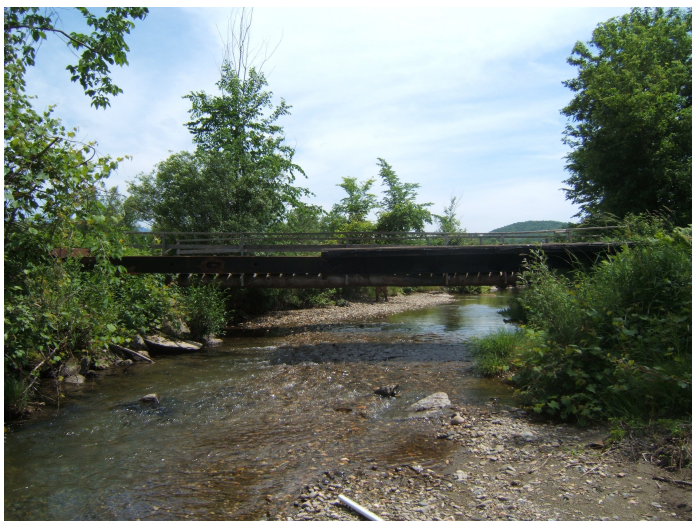
Figure bb. Recommended structure removal, steel bridge out of use upstream of Plains Road bridge

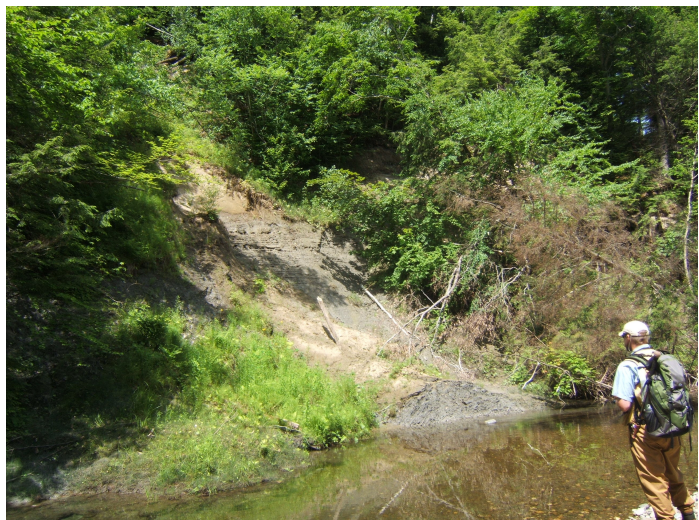
T4.02A Summary Data Lee River	
Reach/Segment Length	6373 ft
Valley Confinement	Broad
Reference Stream Type	C4
Existing Stream Type	C4
Geomorphic Condition	Fair
Channel Evolution Stage	III
Adjustment Process	Aggradation/ minor widening
Habitat Condition	Good
Stream Sensitivity	Very High

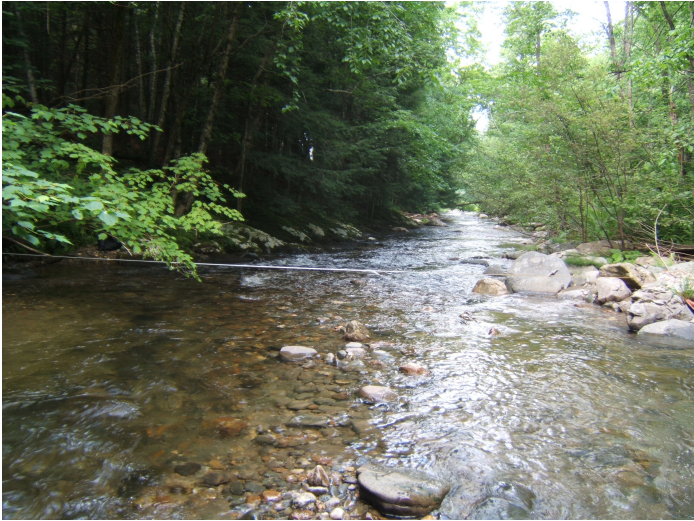
Figure gg. T4.02 Segment B channel cross section, upstream to downstream

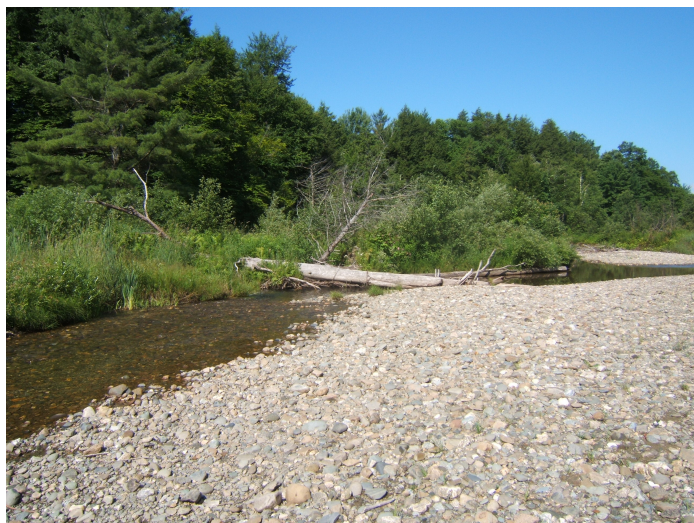
T4.02C Summary Data Lee River	
Reach/Segment Length	4904 ft
Valley Confinement	Broad
Reference Stream Type	C4
Existing Stream Type	C4
Geomorphic Condition	Fair
Channel Evolution Stage	III
Adjustment Process	Aggradation/ widening
Habitat Condition	Good
Stream Sensitivity	Very High

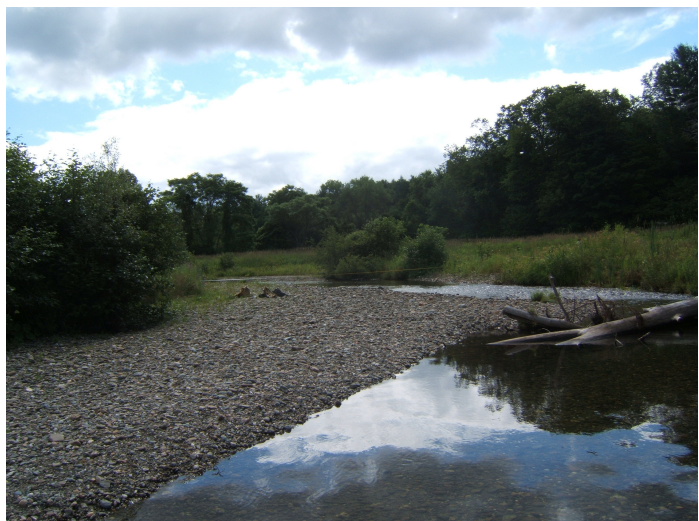
T4.03a Summary Data Lee River	
Reach/Segment Length	570 ft
Valley Confinement	Broad
Reference Stream Type	C4
Existing Stream Type	D4
Geomorphic Condition	Fair
Channel Evolution Stage	III
Adjustment Process	Widening, aggradation, planform changes
Habitat Condition	Fair
Stream Sensitivity	Extreme

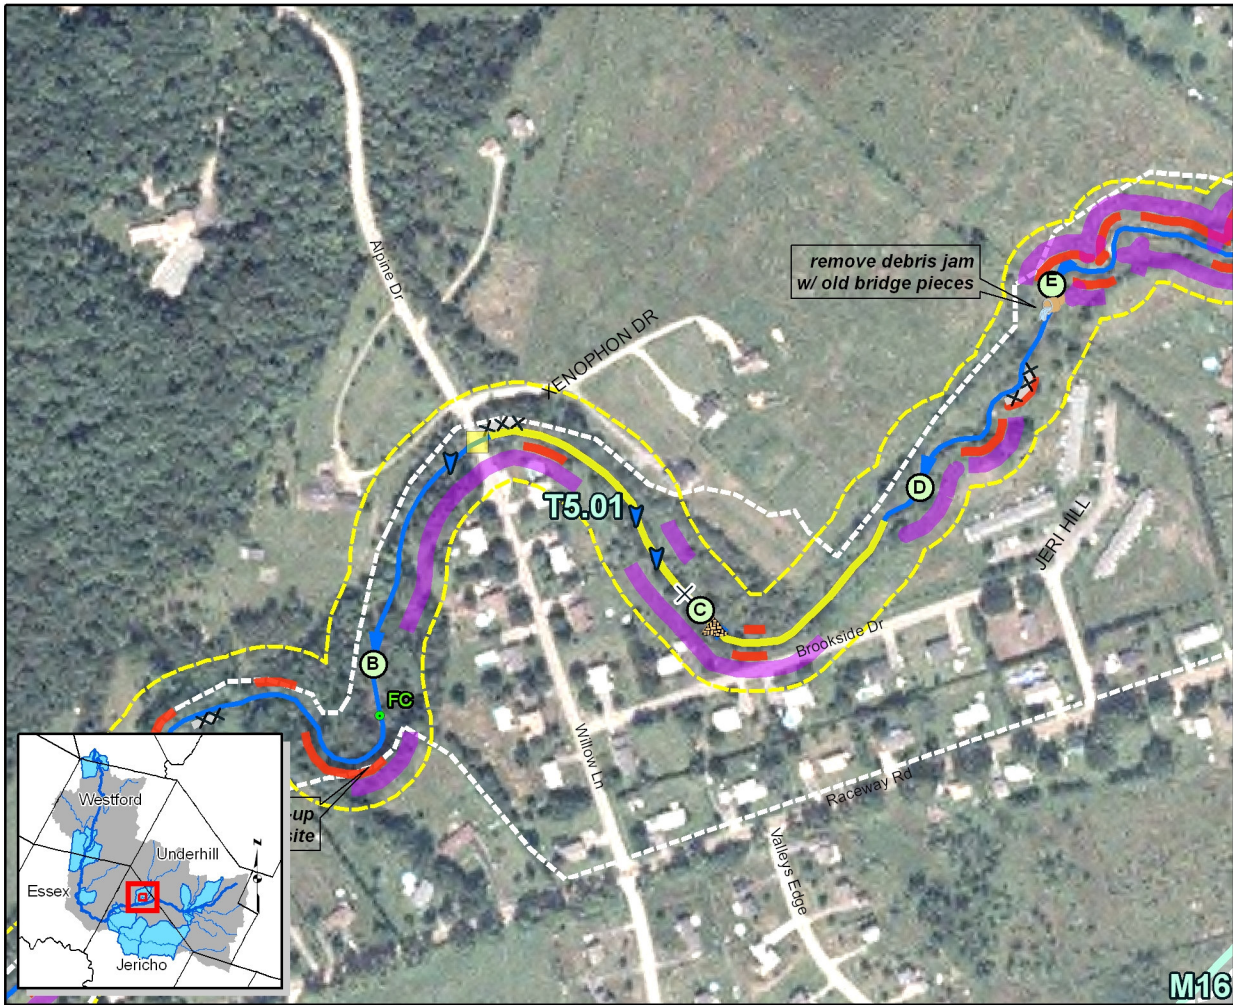
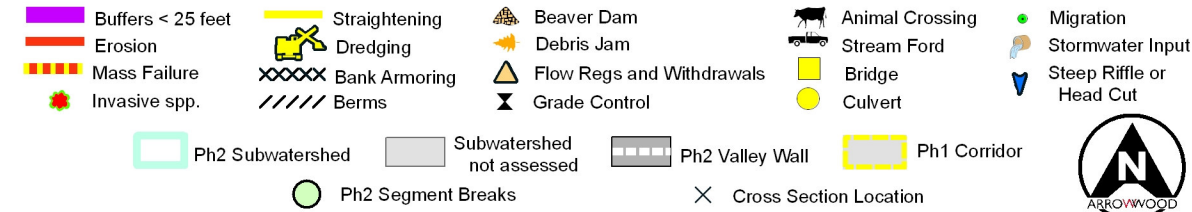
Reach Stressors
Poor Buffers
Erosion
Mass Failures
Encroachments
Straightening
Revetments
Constrictions
Rejuvenating
Tributaries
Dredging
Stormwater inputs
Headcuts

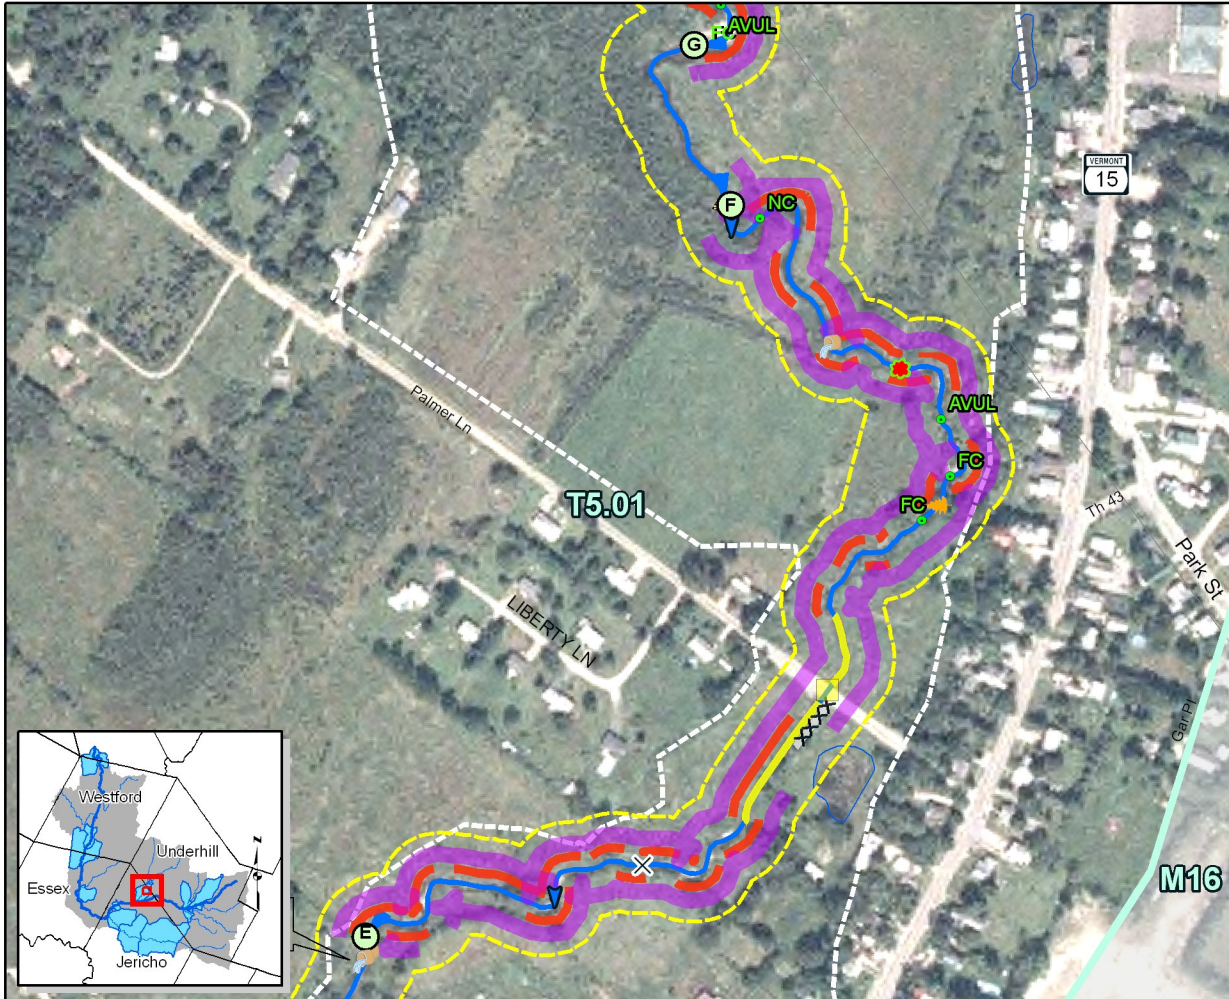
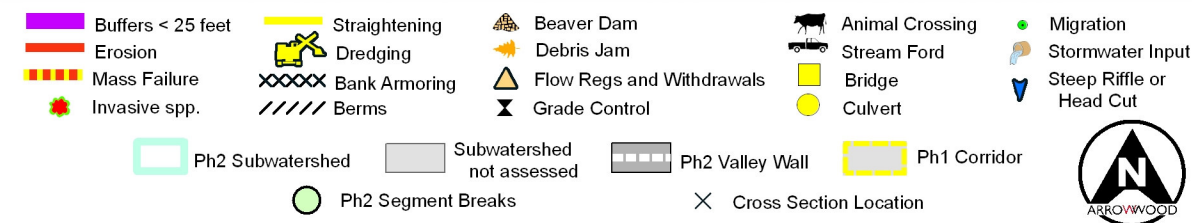
Poor Buffers Erosion
Mass Failures
Encroachments
Straightening
Revetments
Constrictions
Rejuvenating
Tributaries
Dredging
Stormwater inputs

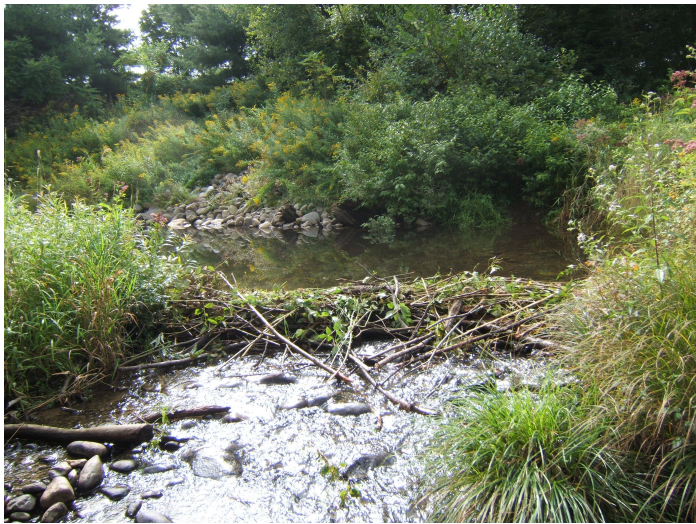
Figure nn. Segment A beaver dam

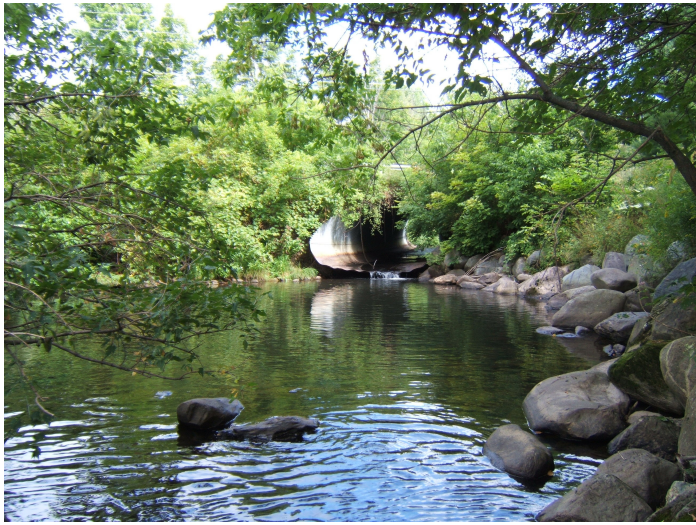
Figure oo. Segment A recommended culvert replacement project

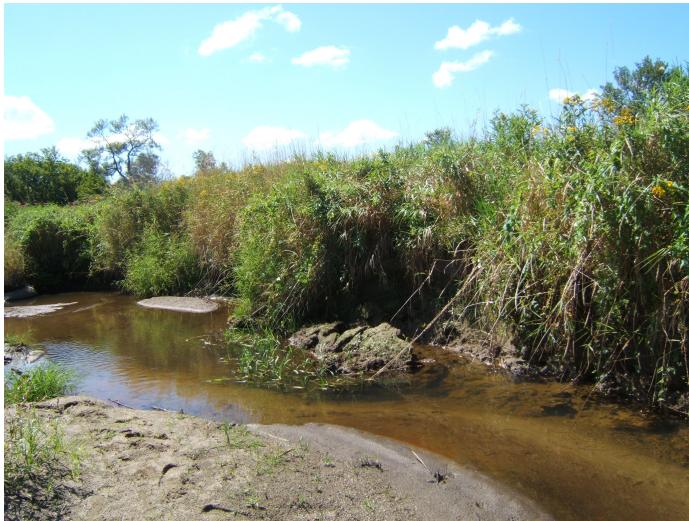
Figure pp. Segment E. Erosion and poor buffers

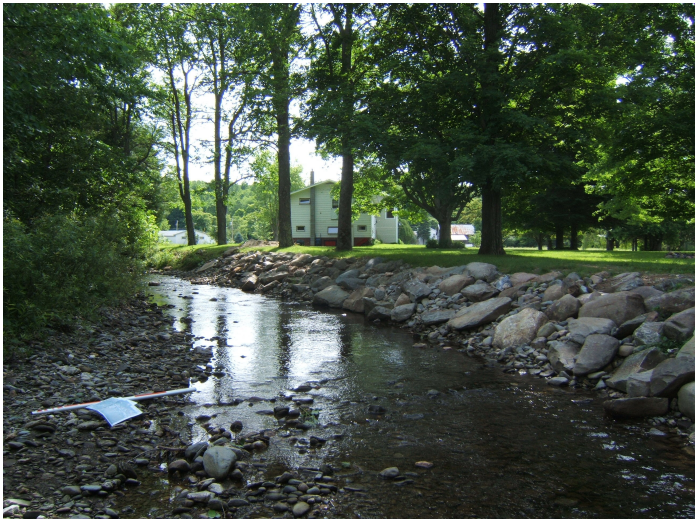
T5.S1.01 Summary Data Roaring Brook		Habitat Stressors	Reach Stressors
Reach/Segment Length	1892ft	Invasive Plants Dump Sites Animal Crossings Dredging Poor Stream Bank Vegetation	Poor Buffers
Valley Confinement	Very Broad		Erosion
Reference Stream Type	E3		Mass Failures
Existing Stream Type	E3		Encroachments
Geomorphic Condition	Fair		Straightening
Channel Evolution Stage	III		Revetments
Adjustment Process	Aggradation		Constrictions
Habitat Condition	Fair		Rejuvenating
Stream Sensitivity	High		Tributaries
			Dredging
		Stormwater inputs	
		Headcuts

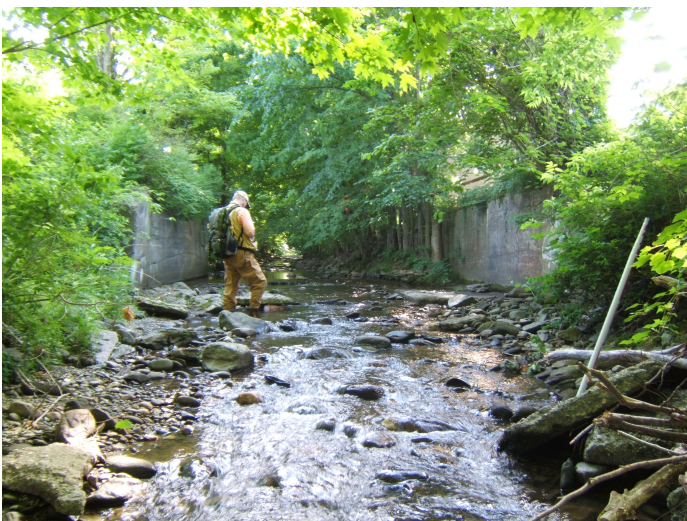
Figure ss. Old concrete abutment recommended for removal

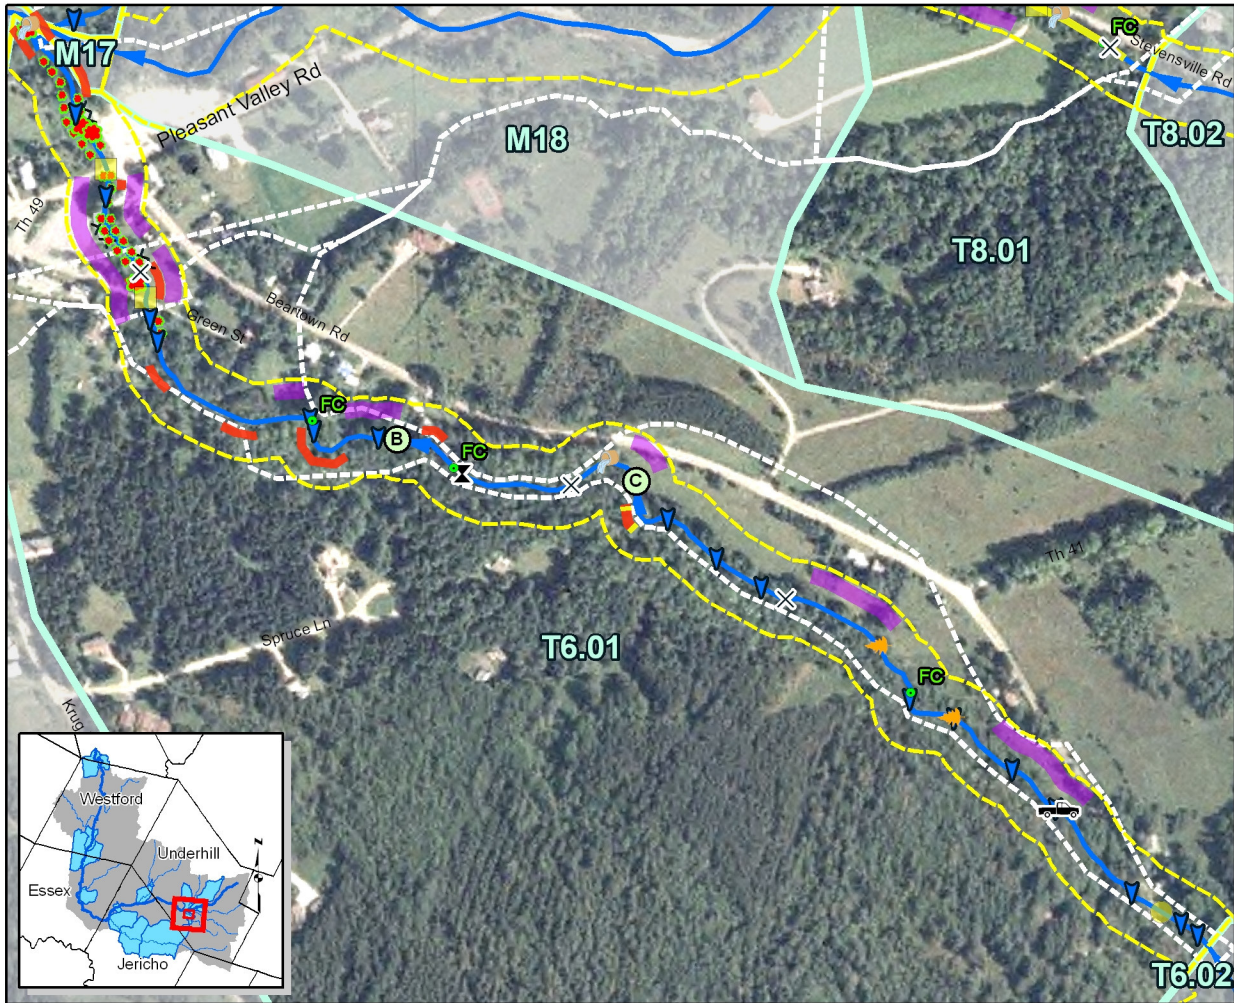
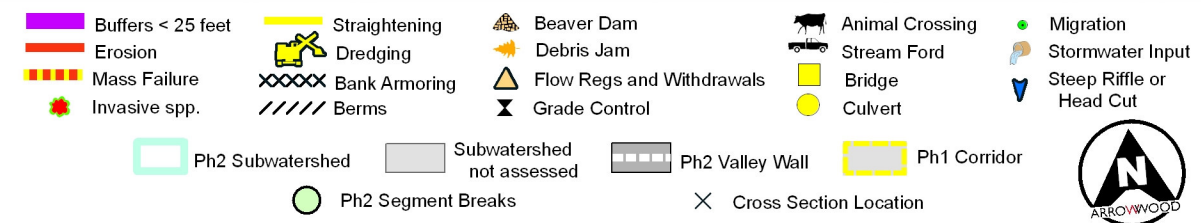
Figure tt. Reach T6.01 Inventory Map

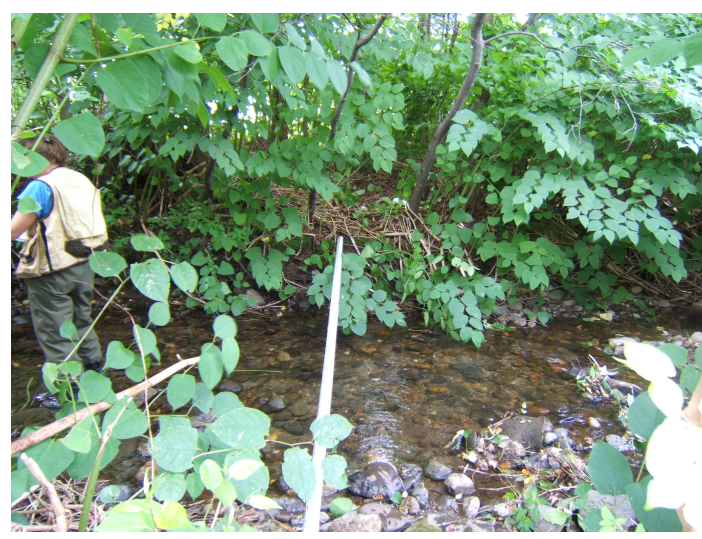
**T6.01a Summary Data
Steinhour Brook**

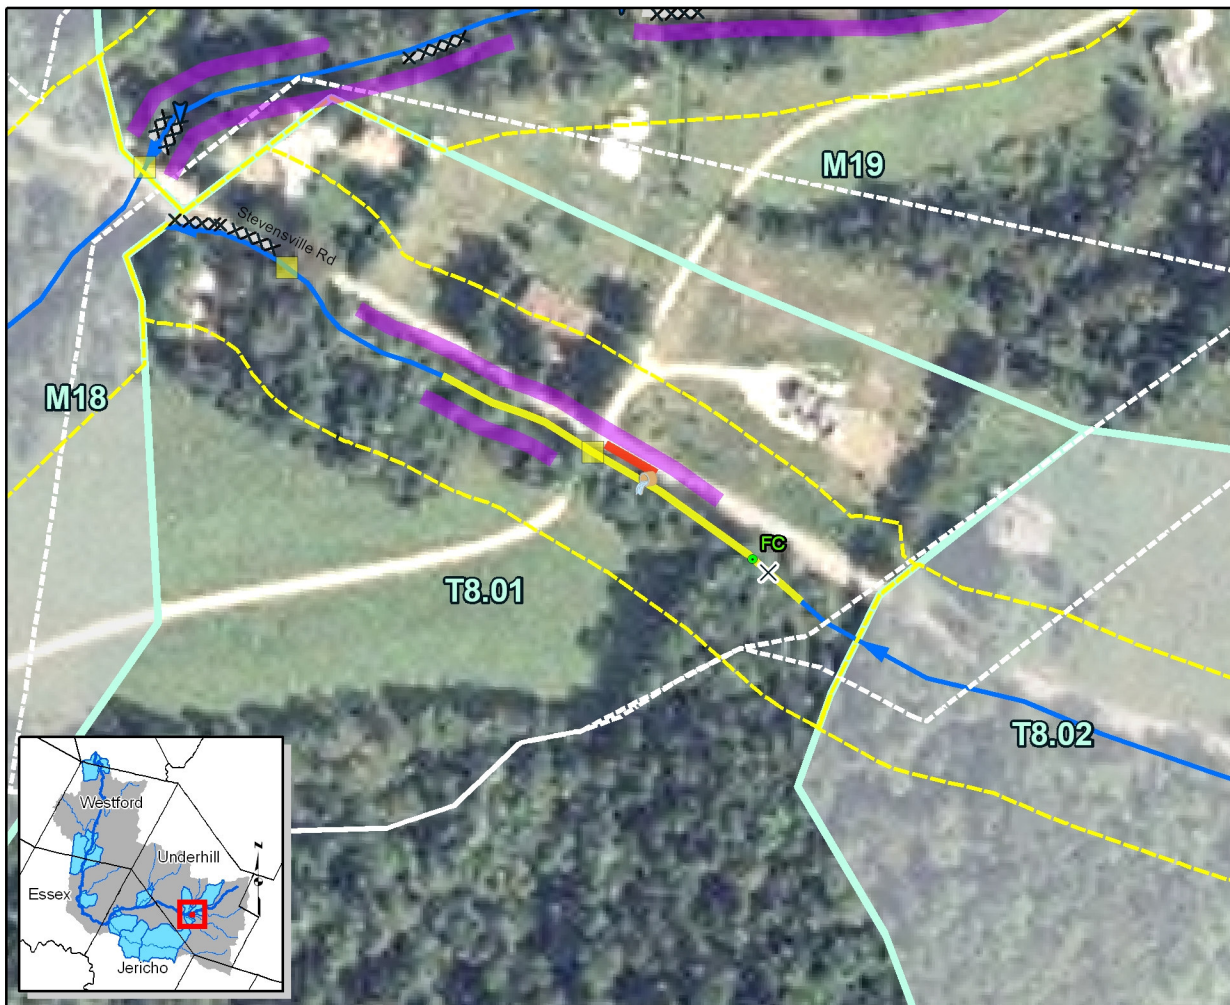
- Buffers < 25 feet
 - Erosion
 - Mass Failure
 - Invasive spp.
 - Straightening
 - Dredging
 - Bank Armoring
 - Berms
 - Beaver Dam
 - Debris Jam
 - Flow Regs and Withdrawals
 - Grade Control
 - Animal Crossing
 - Stream Ford
 - Bridge
 - Culvert
 - Migration
 - Stormwater Input
 - Steep Riffle or Head Cut
-
- Ph2 Subwatershed
 - Subwatershed not assessed
 - Ph2 Valley Wall
 - Ph1 Corridor
 - Ph2 Segment Breaks
 - Cross Section Location
