Friends of the Winooski River

Final Report for ERP-2015-1-06

Park Street - Stormwater Retrofit Study
Drainage Area Delineations
Barre City, VT

Park Street - Stormwater Retrofit Study
Barre City, VT

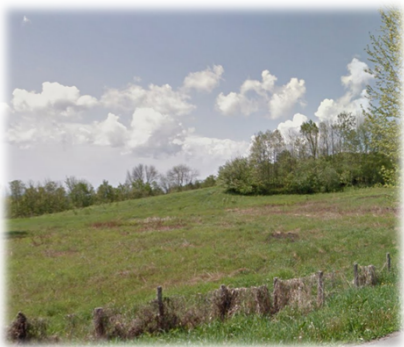
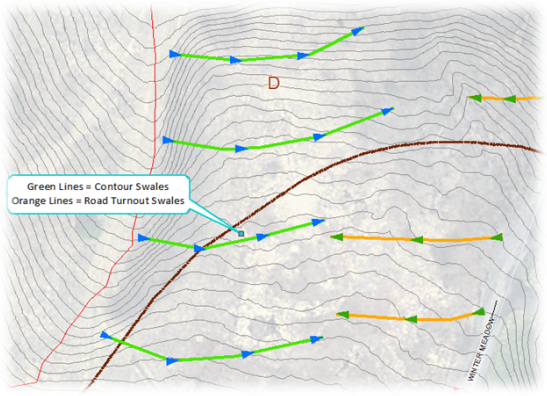
Site ID Code: Upper Meadow	Site Rating:
-----------------------------------	---------------------

E911 Address:	NA	
Date/Time Assessed:	1/8/2015	
Practice Concept: Vegetated swales could capture and disperse runoff from the upland meadow area, encourage infiltration and sheetflow to reduce potential gullyng and lowering peak flows to the downhill neighborhood. Increase plantings and tree canopy to intercept precipitation, encourage evapotranspiration, and increase infiltration.

Ownership:	Private	Contour swales in the upper meadow area would disperse flows from the hill above the residential area.
Site Contact:	Ann Smith

Impervious %:	None		
DA Usage:	Open		
Practice Area (sq. ft.):	UNK		
Soils (mapped):	HSG D		
Feasibility/Design Notes: HSG D soils may not have high infiltration capacity. Swales may only spread flow for vegetative uptake and evapotranspiration unless swale soils are amended with stone or other porous material. Planting of trees is highly encouraged at this site.

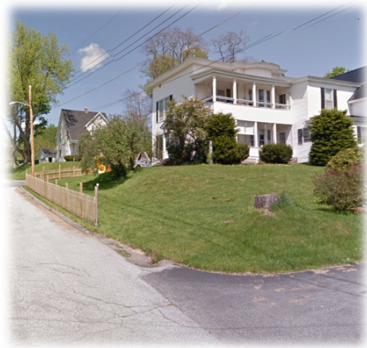
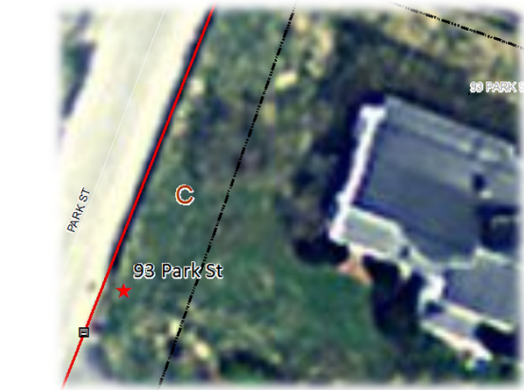
Site ID Code: 93 Park Street		Site Rating:	
Name:			
E911 Address:	93 Park Street		
Date/Time Assessed:	1/8/2015		
Practice Concept:			
Bioretention could be built into existing municipal ROW - would require terracing. The practice would be designed primarily for street runoff.

Site Contact: Ann Smith			
LID Practice Details		Site Information	
Practice 1:	Bioretention	Site Landuse 1:	Road ROW
Practice 2:	Vegetated Swale (terraced)	Site Landuse 2:	
Practice 3:		SW Practice On-Site?:	No
New/Retrofit?:	New	Pollutant Hotspot?:	No
Maintenance Burden:		Pollutant of Concern 1:	N/A
High	Medium	Pollutant of Concern 2:	N/A
	Low		
Design Considerations:		Location:	
Drainage Area (ac):	UNK		
Impervious %:	UNK		
DA Usage:	Residential		
Practice Area (sq. ft.):	~500		
Soils (mapped):	HSG C		
Feasibility/Design Notes:			
HSG C soils on site may not have sufficiently high infiltration capacity. Practice would likely require soil amendment to achieve desired infiltration rate. Practice could be built in road ROW but may require additional consideration for utilities.

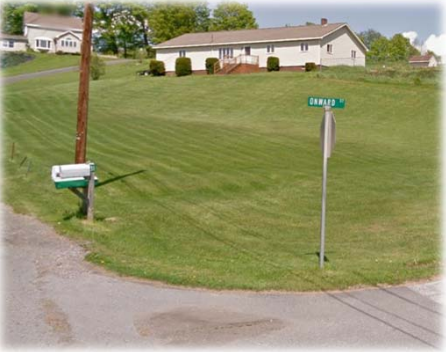
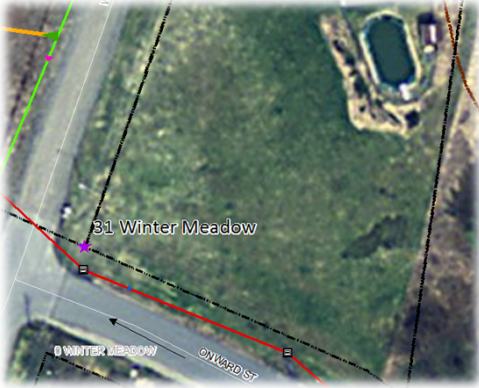
Site Contact: Ann Smith			
LID Practice Details		Site Information	
Practice 1:	Bioretention	Site Landuse 1:	Private Open Space
Practice 2:	Shallow Basin	Site Landuse 2:	Road ROW
Practice 3:		SW Practice On-Site?:	No
New/Retrofit?:	New	Pollutant Hotspot?:	No
Maintenance Burden:		Pollutant of Concern 1:	N/A
High	Medium	Pollutant of Concern 2:	N/A
	Low		
Design Considerations:		Location:	
Drainage Area (ac):	UNK		
Impervious %:	UNK		
DA Usage:	Residential		
Practice Area (sq. ft.):	~1000-1,500		
Soils (mapped):	HSG C

Feasibility/Design Notes:			
HSG C soils on site may not have sufficiently high infiltration capacity. Practice would likely require soil amendment to achieve desired infiltration rate. Practice could be built in road ROW but may require additional private land to adequately manage all runoff.

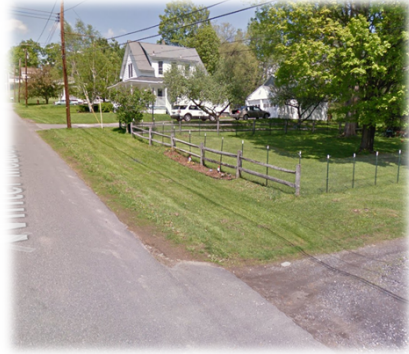
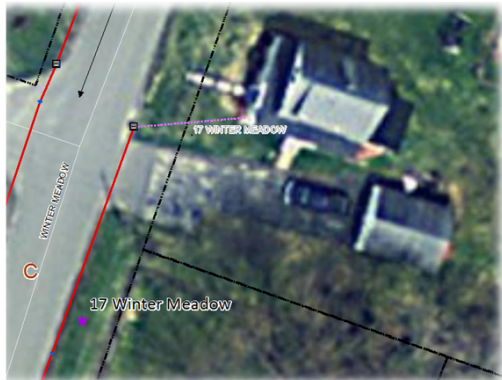
Site ID Code: 17 Winter Meadow		Site Rating:	
Name:			
E911 Address:	17 Winter Meadow		
Date/Time Assessed:	1/8/2015		
Practice Concept:			
Practice could take runoff from 17 Winter Meadow and associated street segment.

Site Contact:	Ann Smith		
LID Practice Details		Site Information	
Practice 1:	Bioretention	Site Landuse 1:	Road ROW
Practice 2:	Green Gutter	Site Landuse 2:	Private Open Space
Practice 3:		SW Practice On-Site?:	No
New/Retrofit?:	New	Pollutant Hotspot?:	No
Maintenance Burden:		Pollutant of Concern 1:	N/A
High	Medium	Pollutant of Concern 2:	N/A
Design Considerations:		Location:	
Drainage Area (ac):	UNK		
Impervious %:	UNK		
DA Usage:	Residential		
Practice Area (sq. ft.):	~600		
Soils (mapped):	HSG C		
Feasibility/Design Notes:			
HSG C soils on site may not have sufficiently high infiltration capacity. Practice would likely require soil amendment to achieve desired infiltration rate. Practice could be built in road ROW but may require additional private land to adequately manage all runoff.

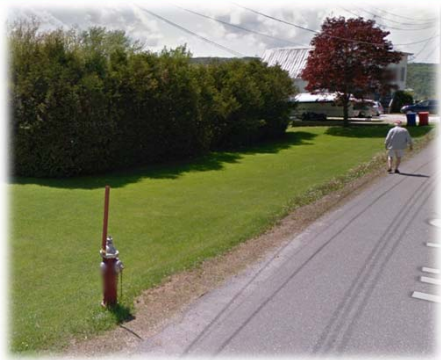
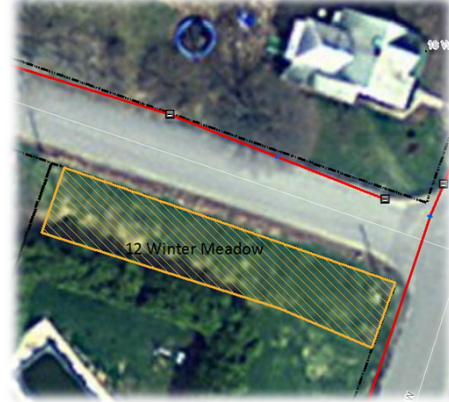
Site ID Code: 12 Winter Meadow	Site Rating:
---------------------------------------	---------------------

E911 Address:	12 Winter Meadow	
Date/Time Assessed:	1/8/2015	
Practice Concept: Underground infiltration gallery or chambers could take significant runoff from upper Winter Meadow street, as well as runoff associated with upland meadow above 18 Winter Meadow. This practice would be underground and would not aesthetically change the current landscaping.

Ownership:	Private	An underground stone gallery or manufactured infiltration chambers could handle runoff.
Site Contact:	Ann Smith

Impervious %:	UNK		
DA Usage:	Open / Residential		
Practice Area (sq. ft.):	~3000		
Soils (mapped):	HSG C		
Feasibility/Design Notes: Underground gallery or chambers could handle a relatively large runoff volume at this site. Chambers would provide a larger volume per footprint, but would potentially cost more. This practice could incorporate an underdrain with an overflow to the City's stormwater system.

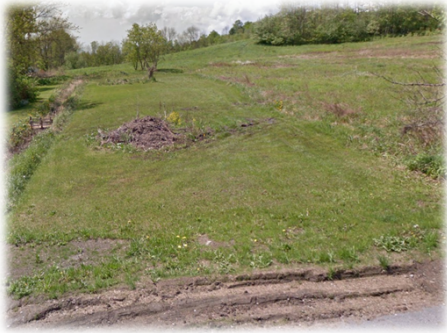
Site Contact:	Ann Smith		
LID Practice Details		Site Information	
Practice 1:	Underground Gallery	Site Landuse 1:	Open
Practice 2:	Detention Basin	Site Landuse 2:	
Practice 3:		SW Practice On-Site?:	No
New/Retrofit?:	New	Pollutant Hotspot?:	No
Maintenance Burden:		Pollutant of Concern 1:	N/A
High	Medium	Low	Pollutant of Concern 2:
			N/A
Design Considerations:		Location:	
Drainage Area (ac):	UNK	 	
Impervious %:	UNK		
DA Usage:	Open		
Practice Area (sq. ft.):	~2000 - 5000		
Soils (mapped):	HSG C		
Feasibility/Design Notes:	Installing an infiltration gallery or small detention basin to collect runoff from the open field would alleviate some of the downstream concerns with flooding. The existing swale (downhill of the site shown) could also be retrofitted to provide more infiltration or detention capacity.

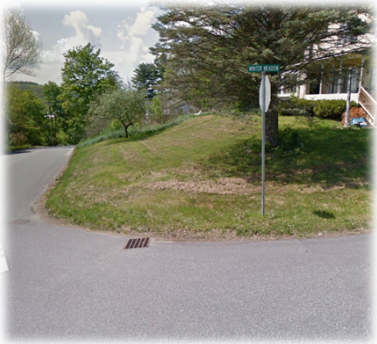
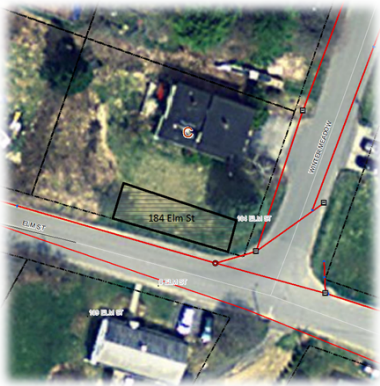
Impervious %:	UNK		
DA Usage:	Residential		
Practice Area (sq. ft.):	~1500		
Soils (mapped):	HSG C		
Feasibility/Design Notes:	This practice could potentially receive both overland flow runoff as well as runoff collected via catch basins and pipes. This would need to be verified with field surveying to confirm pipe inverts, etc. The practice would be underground and should have no effected on the current landscaping.

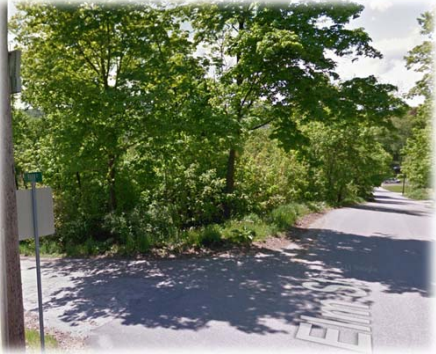
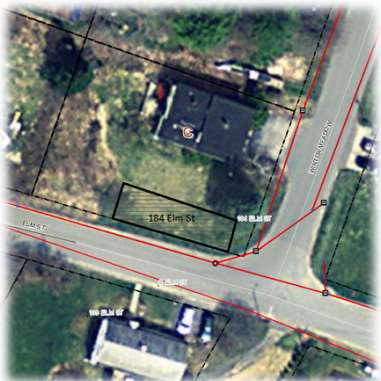
Feasibility/Design Notes:				
Slopes at this location are steep, which could present a challenge. Land would have to be acquired, or an easement negotiated, for installation. Infiltration may not be feasible here.

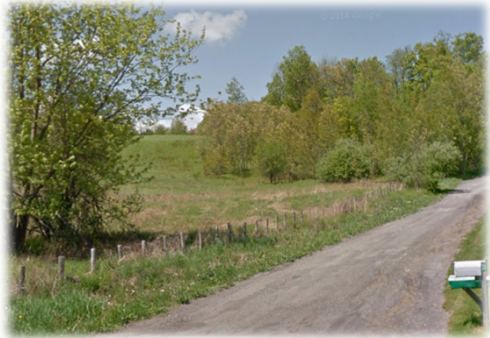
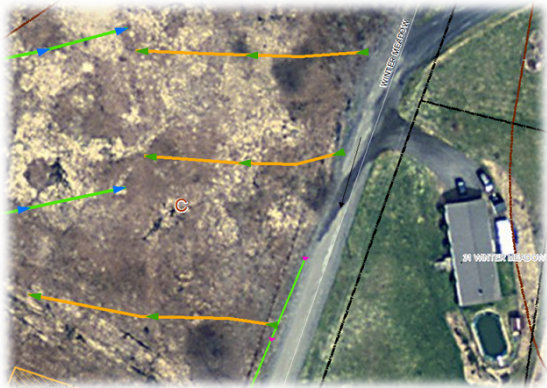
Site ID Code: Upper Meadow	Site Rating:
-----------------------------------	---------------------

E911 Address:	Upper Meadow	
Date/Time Assessed:	1/8/2015	
Practice Concept:		
Vegetated swales with stone-lined entrances could take runoff from upper Winter Meadow street, associate driveways, and residences and turn it across existing contours to infiltrate and spread out flows.

Ownership:	Private	Turn-out swales could reduce runoff running down the ditch to the municipal catch basins.
Site Contact:	Ann Smith

Impervious %:	UNK		
DA Usage:	Open / Residential		
Practice Area (sq. ft.):	N/A		
Soils (mapped):	HSG C		
Feasibility/Design Notes:			
Inlets to swales would have to be armored using stone rip-rap. Outlets could also use level spreaders to ensure erosion doesn't occur. Swales could be vegetated with trees and shrubs to encourage evapotranspiration.
