# Stormwater Master Plan Poultney River Watershed Featuring Projects in Benson, Fair Haven, Middletown Springs, Poultney, and West Haven, Vermont

March 15, 2022

**Fitzgerald Environmental Associates, LLC.** 18 Severance Green, Suite 203 Colchester, VT 05446 Fitzgerald Environmental

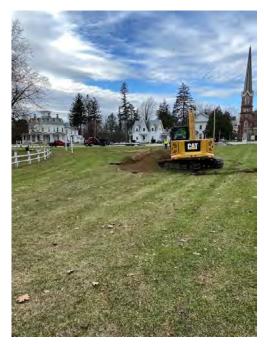
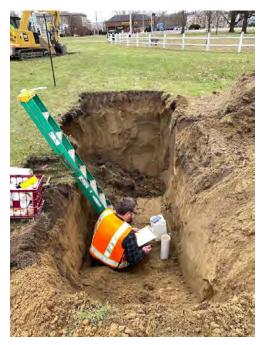
**Figure 3:** Project FHV-06 had the highest total score (31 out of 50) in the Unified Prioritization. The project is located on the north side of the Fair Haven. In fall of 2021 FEA and the Town performed test pits to verify soil suitability for a large underground infiltration practice.

- 4. FHV-06: Fair Haven Village Green (across from Town Hall) Install a pretreatment swirl separator and underground infiltration chambers to treat 25.37 acres (nearly 10 impervious) of downtown Fair Haven. The overflow will pipe to the existing stormdrain system. This project will treat 33 lbs/year of phosphorus at estimated \$9540 per pound (about half the estimated \$46,000 per kilogram estimated for stormwater projects in the Act 76 formula costs for stormwater projects).

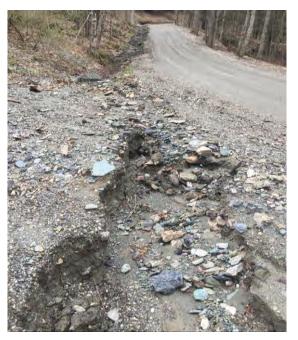
Figure 5: Rural roads can contribute gravel and nutrients to nearby streams. River Road in Poultney after a large spring storm (2019).

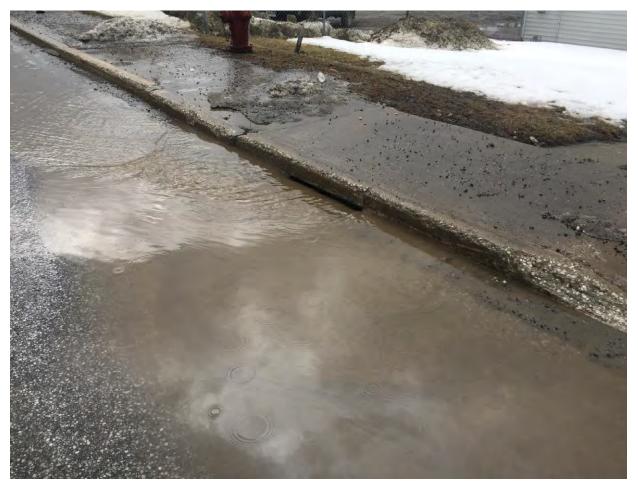
Figure 5: Road drainage to the Poultney Town Garage (PY-07).

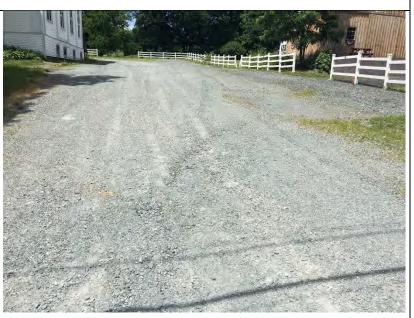
Site Description: Minor erosion in church parking lot leads into vegetated swale and then into a culvert.

**Photo 1:** Vegetated swale accepting **Photo 2:** Rill erosion in church parking lot. runoff from the church parking lot.

**BMP Description:** Divert runoff into infiltration basin for treatment before it enters the larger stormwater system for the town. The existing vegetated swale could be adapted to infiltrate and slow down runoff.

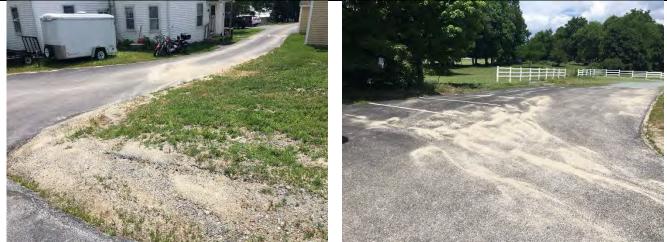
**Site Description:** This paved driveway for an apartment complex has no stormwater infrastructure in place. Water carries sediment across the paved surfaces and runs downhill. Stormwater picks up a lot of sediment by cutting through the steep corner shown in photo 1.

Photo 1: Corner of driveway being eroded and mobilizing sediment. Photo 2: Sediment from uphill deposited on paved driveway.

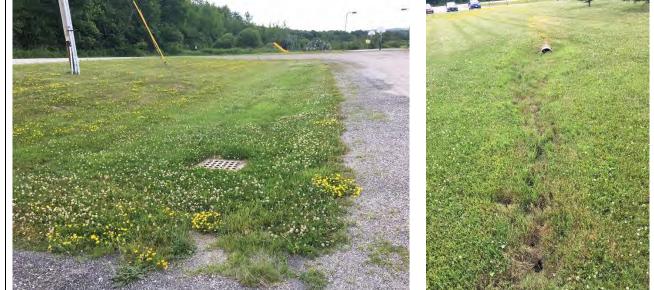
**Site Description:** Three catch basins collect stormwater from the school parking lot and surrounding areas. This includes rooves and gravel parking lots. The water is all drained through a small outlet in the lawn behind the school (Photo 2). There is minor erosion at the outlet, but it feeds a larger gully at the end of the field.

**Photo 1:** One of the three catch basins draining the school **Photo 2:** Minor erosion from outlet. driveway.

**BMP Description:** Raise catch basins to allow stormwater to pool and infiltrate before entering the system. The issue could also be addressed at the outlet by installing a vegetated swale to slow down and infiltrate stormwater.

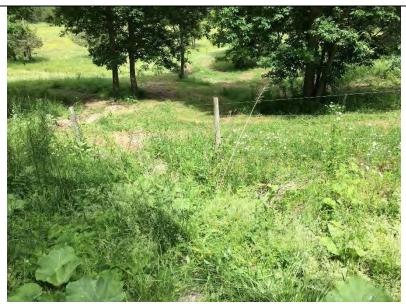
**Photo 1:** Gully Erosion alongside road.

Photo 2: Trail of Sediment deposited in field.

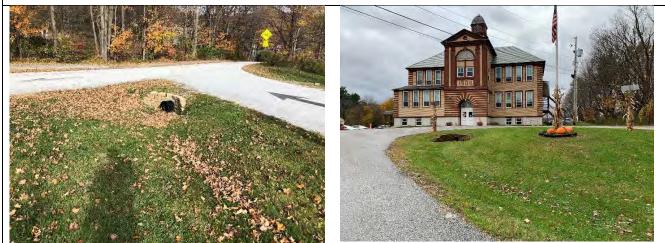
**Site Description:** Drainage area including school roof and parking drains through green space and under driveway through a culvert.

Photo 1: Culvert inlet where proposed BMP will be<br/>installed.Photo 2: Middletown Springs Elementary School and<br/>drainage area of the proposed BMP.

**BMP Description:** Install infiltration basin at culvert inlet to treat runoff before it leaves the school. This area drains to a vegetated hillside, so low priority for water quality remediation, but high educational value.

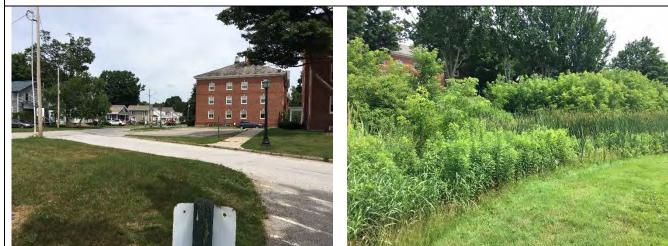
**Site Description:** This outfall drains most of the campus of the former Green Mountain College directly into a wetland/stream. The central area of the campus has dry wells and is therefore omitted from the drainage area of this site.

**Photo 1:** Paved area in the drainage area of the site

Photo 2: Green space into which the outfall drains

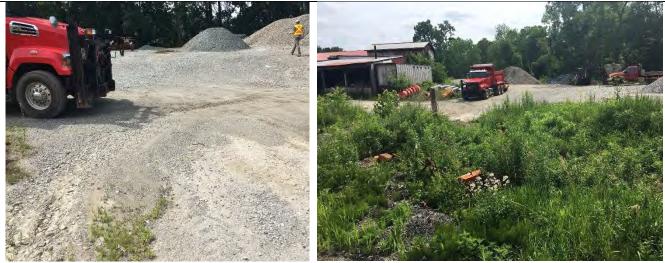
Site Description: Gravel piles and gravel parking lot behind the Poultney Town Garage. There is sheet erosion within the gravel parking lot. There is currently a vegetated swale through the area draining a large area including the school directly into the Poultney River.

Photo 1: Sheet erosion in the gravel parking lot Photo 2: Existing Vegetated swale that drains into the Poultney River.

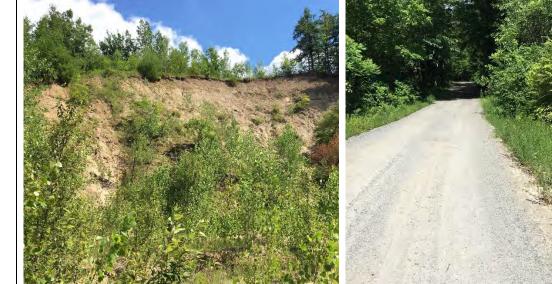
**Site Description:** Cross culvert draining gravel pit area is clogged with sediment. There is minor gully erosion at the outlet leading directly into the channel of the Poultney River.

Photo 1: Landslide uphill of site at old gravel pit.

**Photo 2:** Sediment build-up on right side of road completely blocking culvert inlet.

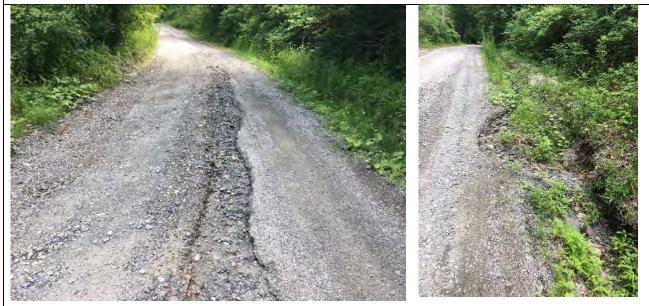
**Site Description:** Heavy erosion within the ROW on a 10% slope road segment. The road is impassable for small cars and only has two 8" culverts.

Photo 1: Gully erosion in center of the road from water flowing<br/>directly down ROW.Photo 2: Erosion from ditch overflowing<br/>into ROW.

**BMP Description:** Repair and stone line the ditch on the uphill side of the road. Replace and upsize the two existing culverts and potentially add more as needed

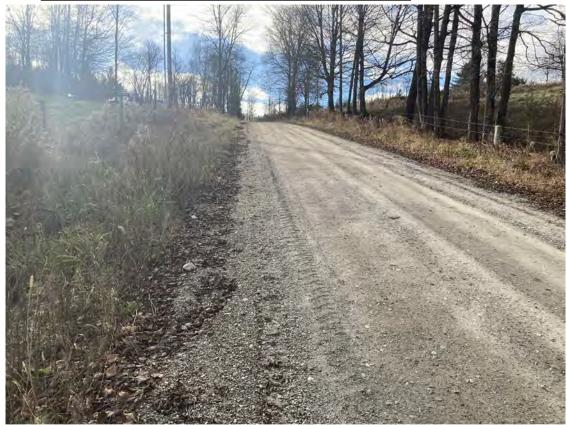
# Photo 1: View of Road with no Accessible Ditches

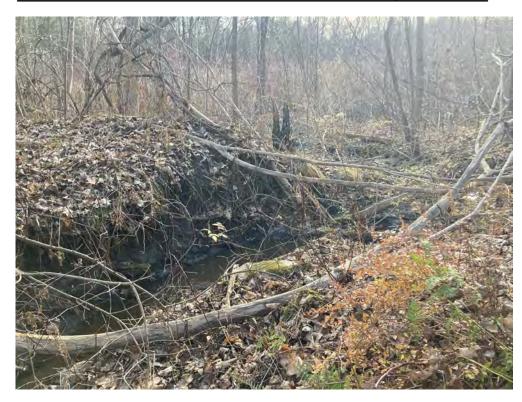
Photo 1: Break in berm to be filled in to create wet pond outline

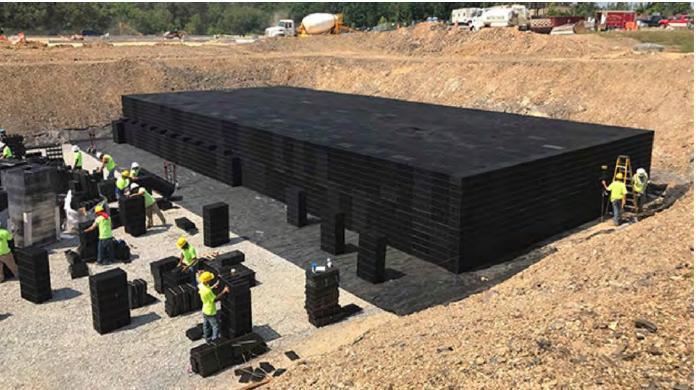
### Photo 1: R-Tank Installa

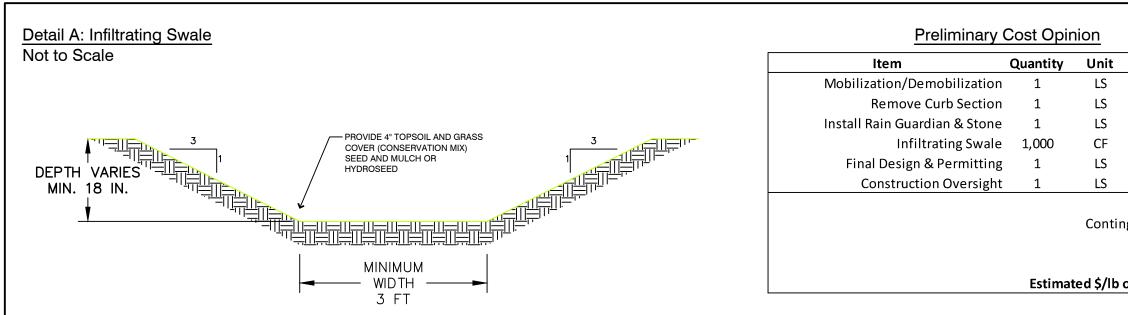
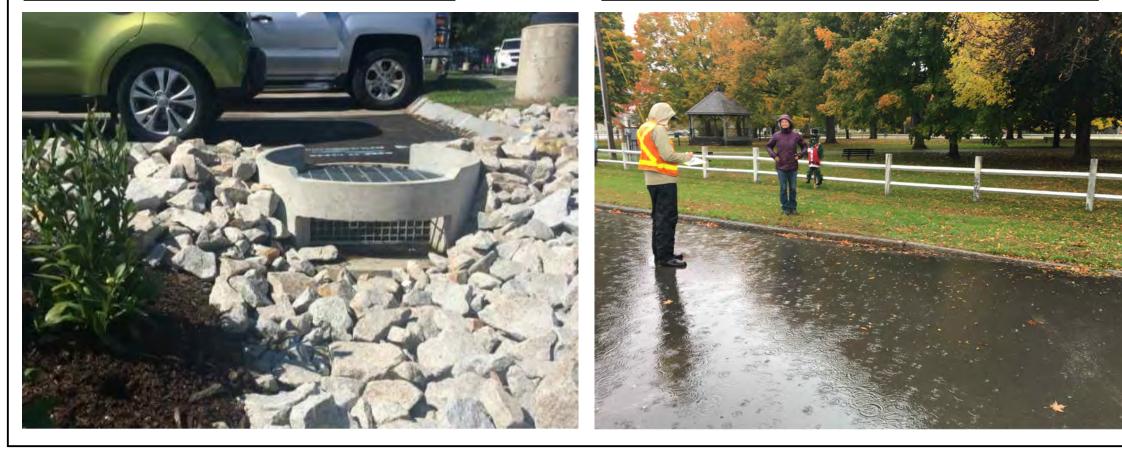
Photo 1: Rain Guardian Turret to be used for pretreatment

Photo 2: Water ponding along curb where proposed feature will be

- 6. FHV-11: Fair Haven Village Green (southeast corner) Removal of curb sections and installation of a rain garden will allow movement of stormwater from Main St into a proposed infiltration swale and catch basin. This project will need to be coordinated with new EV charging stations.

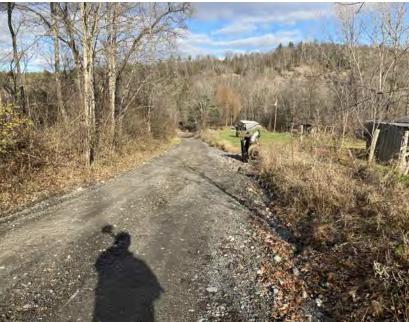
### Photo1: View of Road Section with very little space for D
