ENGLESBY BROOK FLOW RESTORATION PLAN

FINAL REPORT

BURLINGTON, VT

Stone Project ID: 14-171 December 5, 2017

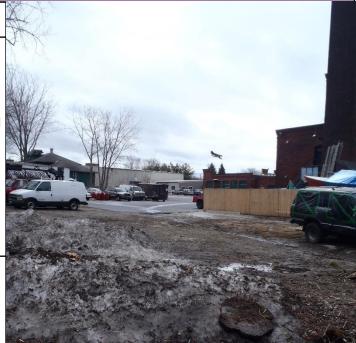
Feasible, but constraints including actual use of area by existing owner/tenant need to be more fully understood

GENERAL SITE INFORMATION		RETROFIT DETAILS	
Site Contact Info:		Project Candidate:	Υ
Ownership:	private	Retrofit of new or existing BM	IP: New BMP
Land Use Type:	Commercial/industrial	Proposed Retrofit Practice 1:	Underground storage
Land Use Detail:		Proposed Retrofit Practice 2:	Dry pond
Existing BMP on Site?	no	Non-Structural Controls:	none
Is site a hotspot?	no	Non-Structural Other:	none
Sources/pollutants:		Maintenance Burden:	
Soils:	Silt loam, poorly drained	Benefits:	Conflicts:
Use in Retrofit DA:		Storage: Yes Water Quality: Yes	Soils: No Access: Maybe
SIZING INFORMATION		Recharge: ?	Land Use: Maybe
Drainage Area (ac):	6.1	Demonstration: No Repair: Yes	Utilities: No Polluted: Maybe
Impervious Area (ac):	4.21	Reuse: No	High WT: No Wetlands: No
Practice Area Available (ft²): 13,000		Other:	Other:
Existing Head Available	? Y

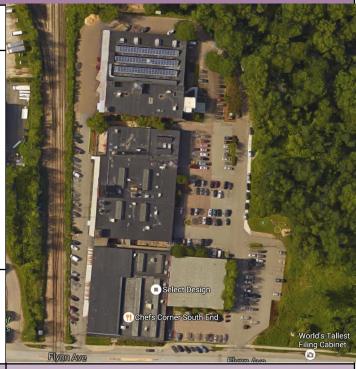
Name: 208 Flynn Ave, north end of parking lot

Daycare facility has outdoor play yard at the north end of the parcel; it would be important to ensure any practice did not interfere with their use of this area. It may be challenging to work within the railroad ROW.

GENERAL SITE INFORMATION	RETROFIT DETAILS
Site Contact Info:	Project Candidate: 2 nd tier
Ownership:	Retrofit of new or existing BMP: new
Land Use Type:	Proposed Retrofit Practice 1: Bioswale
Land Use Detail:	Proposed Retrofit Practice 2: Dry basin
Existing BMP on Site?	Non-Structural Controls:
Is site a hotspot?	Non-Structural Other:
Sources/pollutants:	Maintenance Burden:
Soils:	Benefits: Conflicts: Storage: Y Soils: Water Quality: Y Access: Recharge: Y Land Use:
Use in Retrofit DA:	Demonstration: N Utilities:
SIZING INFORMATION	Repair: N Polluted: Reuse: N High WT:
Drainage Area (ac): 2.60	Wetlands: Other: Other:
Impervious Area (ac): 2.50	Other.
Practice Area Available (ft²): 3,000	
Existing Head Available?

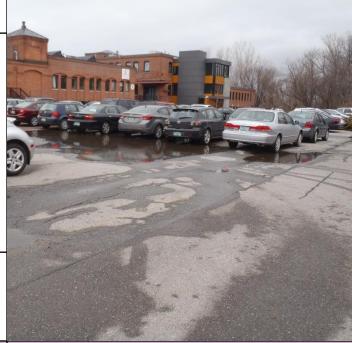
Currently stormwater runoff from parking is being diverted to rock-lined swale and conveyed to Englesby Brook. Evidence of erosion in stone-lined channel. Underground storage could be constructed at the northeast corner of the lot. Some runoff from parking lot will be captured and treated in stormwater facility planned for Champlain Parkway.

Field inspection found that it would be extremely challenging to convey sufficient runoff volume to the proposed facility.

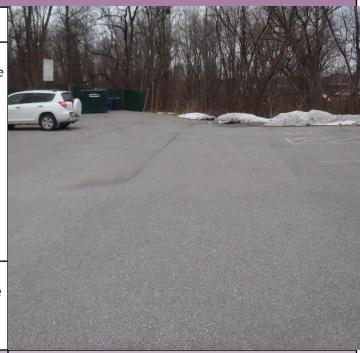
Name: Pine Street Counseling Center

Expired permit 1-1087. Area could also potentially be made to flow to M17.

GENERAL SITE INFORMATION	RETROFIT DETAILS
Site Contact Info:	Project Candidate: 1st tier
Ownership:	Retrofit of new or existing BMP: new
Land Use Type:	Proposed Retrofit Practice 1: Underground storage
Land Use Detail:	Proposed Retrofit Practice 2:
Existing BMP on Site?	Non-Structural Controls:
Is site a hotspot?	Non-Structural Other:
Sources/pollutants:	Maintenance Burden: High
Soils:	Benefits: Conflicts: Storage: Y Soils: Water Quality: N Access: Recharge: N Land Use:
Use in Retrofit DA:	Demonstration: N Utilities:
SIZING INFORMATION	Repair: N Polluted: Reuse: N High WT:
Drainage Area (ac): 0.42	Wetlands:
Impervious Area (ac): 0.30	Other: Other:
Practice Area Available (ft²): 3,000	
Existing Head Available?

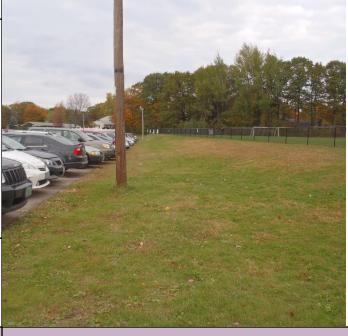
Runoff from Rice High School currently flows to O8 Pond, but a nested treatment practice could be built on-site at the school to create additional storage capacity in the O8 Pond.

Green space available both immediately adjacent to parking lot, as well as along access road.

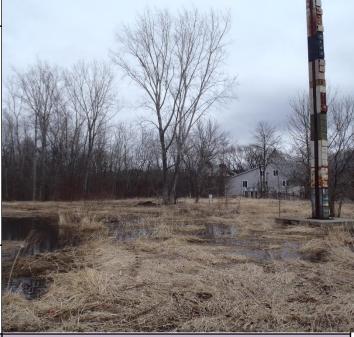
Stormwater management will be provided as part of the Champlain Parkway. Based on current plans for the roadway, a gravel wetland will be constructed to the west of the alignment in this area and will also provide treatment for a portion of the parking lot at 208 Flynn Ave. The timeline for the Champlain Pkwy is outside the purview of this project and therefore it has not been included as part of the FRP.

Were the Champlain Pkwy project to be abandoned there is an opportunity for a large, centralized facility on this site that could be expanded to include M17.

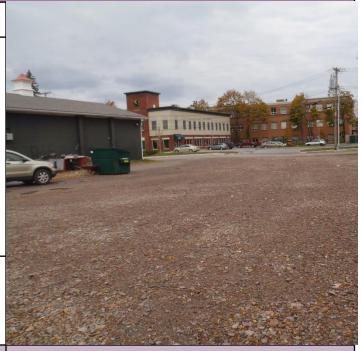
Stormwater runoff from existing parking lot at Walgreens and travel lane that connects through to Bacon St is unmanaged. The concept design for this site would involve underground storage to manage parking lot runoff.

Travel lane is unpaved and there was evidence of significant sediment transport to Bacon St. Runoff from this area ultimately ends up in the O8 Pond

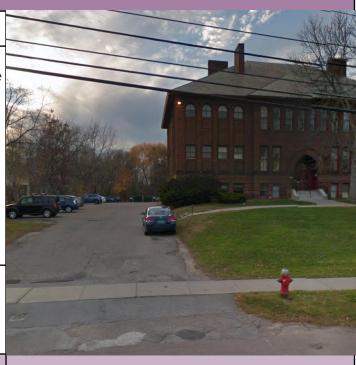
■ Gadue's Dry Cleaning

City infrastructure mapping suggests significant underground utility constrains are also likely present on this site.

GENERAL SITE INFORMATION	RETROFIT DETAILS
Site Contact Info:	Project Candidate: 3 rd tier
Ownership:	Retrofit of new or existing BMP: New
Land Use Type:	Proposed Retrofit Practice 1: Underground storage
Land Use Detail:	Proposed Retrofit Practice 2:
Existing BMP on Site?	Non-Structural Controls:
Is site a hotspot?	Non-Structural Other:
Sources/pollutants:	Maintenance Burden:
Soils:	Benefits: Conflicts: Storage: Y Soils: Water Quality: Y Access: Recharge: N Land Use:
Use in Retrofit DA:	Demonstration: N Utilities:
SIZING INFORMATION	Repair: N Polluted: Reuse: N High WT:
Drainage Area (ac): 1.59	Wetlands:
Impervious Area (ac): 1.09	Other: Other:
Practice Area Available (ft²): 3,900	
Existing Head Available?

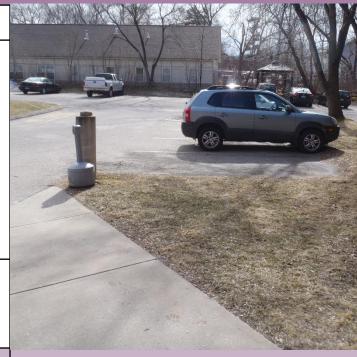
Expired permit 2-0999.

GENERAL SITE INFORMATION	RETROFIT DETAILS						
Site Contact Info:	Project Candidate:	N					
Ownership:	Retrofit of new or existing BMP:						
Land Use Type:	Proposed Retrofit Practice 1:						
Land Use Detail:	Proposed Retrofit Practice 2:						
Existing BMP on Site?	Non-Structural Controls:						
Is site a hotspot?	Non-Structural Other:						
Sources/pollutants:	Maintenance Burden:						
Soils:	Benefits: Storage: Water Quality:	Conflicts: Soils: Access: Land Use:					
Use in Retrofit DA:	Recharge: Demonstration:	Utilities:					
SIZING INFORMATION	Repair: Polluted: High WT:						
Drainage Area (ac):	Wetlands: Other:						
Impervious Area (ac):	-Other.	Other.					
Practice Area Available (ft²):]						
Existing Head Available?

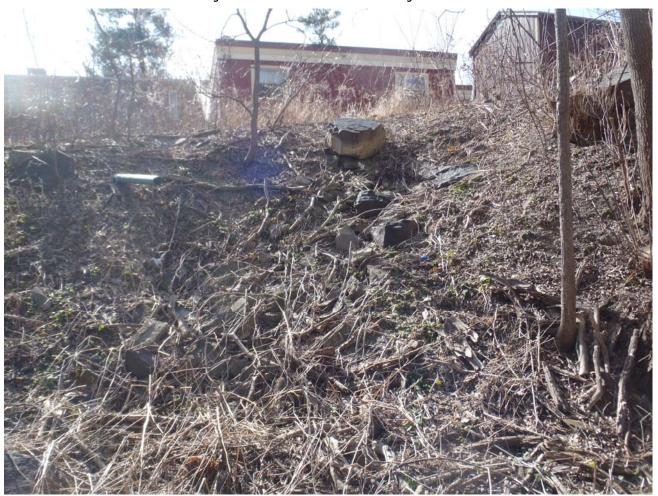
Photo 1: Presumed Location of Natural Drainage Swale and Unknown Subsurface Drainage Outlet

Permit covers the discharge of roof drainage via "stone lined ditch in natural drainage swale" to Englesby Brook; parking lot runoff does not appear to be regulated under the permit. During the site visit we found that the stone lined ditch is not well defined. The majority of flow leaving the site and discharging to Englesby Brook appears to occur via subsurface drain pipes not included in the permit; four outfalls were identified during the site visit that are not included in the City's stormwater GIS layer, including one of which appears to divert water directly from Pine Street. In order to bring this facility into compliance with its existing permit, the stone lined ditch would need to be improved. In addition, the source of the water draining to each of the subsurface drains should be confirmed. As part of the Englesby Brook Flow

Restoration Plan (FRP), a potential retrofit was identified for managing runoff from parking lots draining to the existing green space behind 300 Flynn Ave.

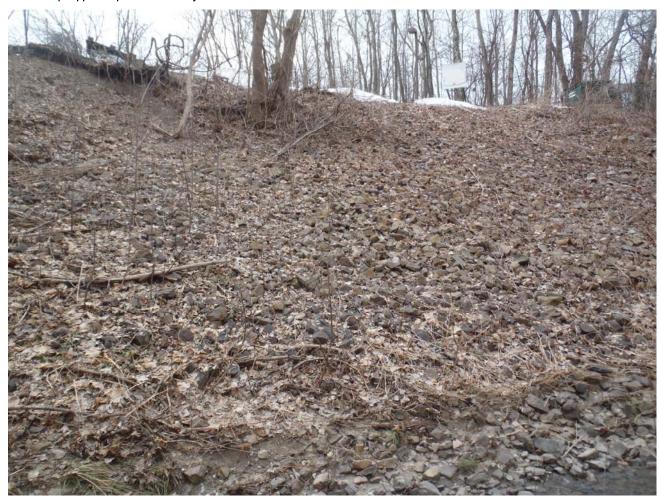
Photo 2: Rip-rapped Slope Behind 288 Flynn Ave

Permit covers the discharge of stormwater runoff from roofs and paved parking lots following treatment "via grass-lined swales, through rip-rapped areas at the top of bank of Englesby Ravine, and via overland flow across vegetated terrain..." During the site visit we found that there are grass-lined to the north of the apartment complex which appear to convey stormwater runoff to rip-rapped areas that lead down to the ravine. We also noted during our site visit that the parking lot catch basin indicated in the City's stormwater GIS layer does not exist. This site was generally found to be in compliance with its permit. As part of the Englesby Brook FRP, a significant potential retrofit was identified for in the green space immediately to the west of 288 Flynn Ave. and to the east of the proposed Champlain Parkway alignment.

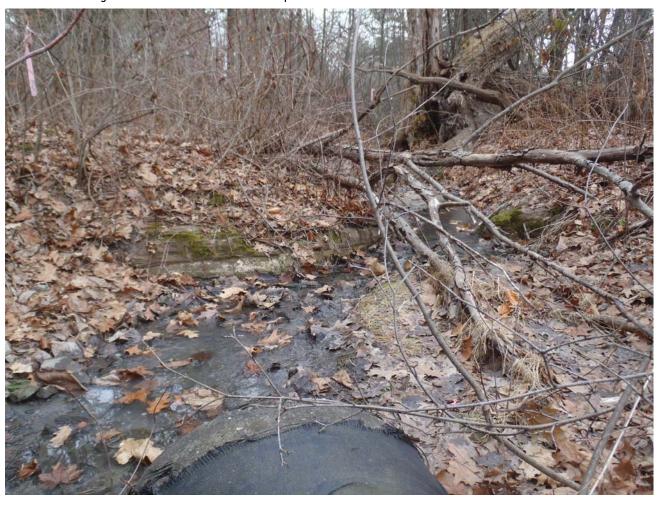
Photo 3: Looking Downstream from the 15" Concrete Pipe Outfall

Permit covers the discharge of stormwater runoff from paved road and parking lots after treatment by "passage through trap catch basins" to a stone bed and "approximately 1000 feet overland flow through wooded area and grassed drainage swale to the stream." During the site visit we observed that sediment levels in the catch basin were below the invert of the outlet pipe, but that the outlet lacked a trap or hood. In addition, we observed a PVC pipe passing through the basin (not draining into). The stone bed noted in the permit could not be located. A 15" concrete pipe and 6" PVC pipe were both located approximately 100 feet southeast of Prospect St, which discharged into a small wetland area (see Photo 3). We followed the outflow from the wetland area for a considerable distance but could not see where it connected to the stream; a portion of the flow appeared to cross Prospect Pkwy. In order to bring this facility into compliance with its existing permit, a trap or hood would need to be fitted onto the catch basin outlet and a stone bed or other

energy dissipation measures added at the outlet. In addition, it would also be prudent to determine the source of the water passing through the catch basin in the PVC pipe in order to guard against a potential illicit discharge were it to carry something other than stormwater. As part of the Englesby Brook FRP, a potential retrofit was identified for managing runoff in the green space at the southern end of the parcel.

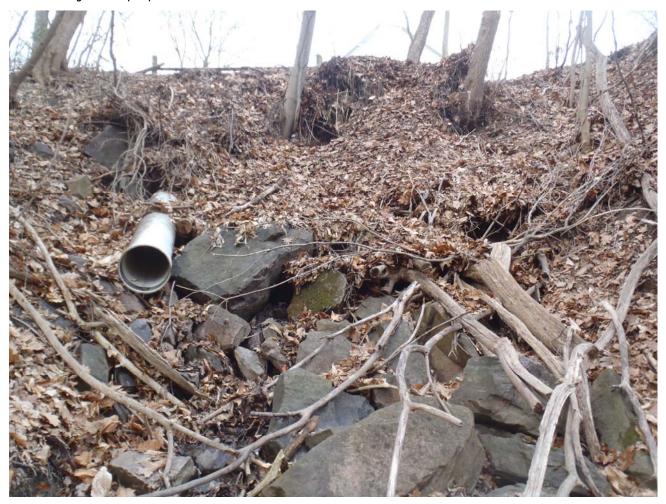
Photo 5: Large Stone Rip-Rap at Outfall

Permit covers the discharge of stormwater runoff from the paved roads and driveways, roofs and natural terrain, via overland flow across "grassed and/or vegetated terrain to a catch basin and rip-rapped outfall, prior to discharge to an unnamed tributary..." During our site visit we observed that sediment levels in the three catch basins indicated in the City's stormwater GIS layer were below the invert of the outlet pipes. The vegetated terrain and rip-rapped outfall were observed as described in the permit. This site was generally found to be in compliance with its permit. No specific retrofit for this site is currently contemplated at part of the Englesby Brook FRP, however this is a part of a neighborhood generally being evaluated for targeted disconnection.

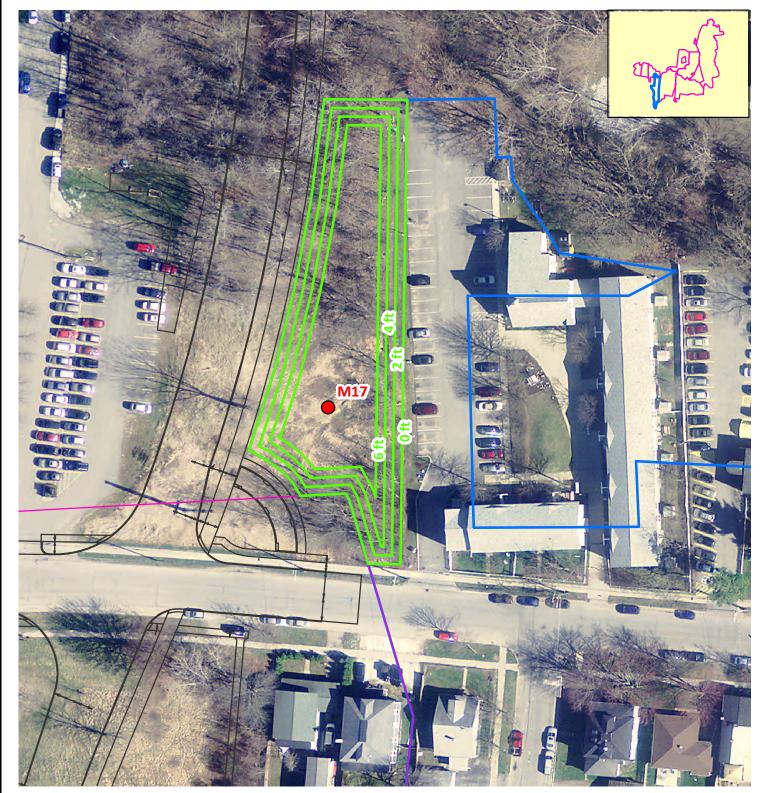
Date: 7/22/2016 Figure C.1

Proposed M17 BMP

M17 Concept Design

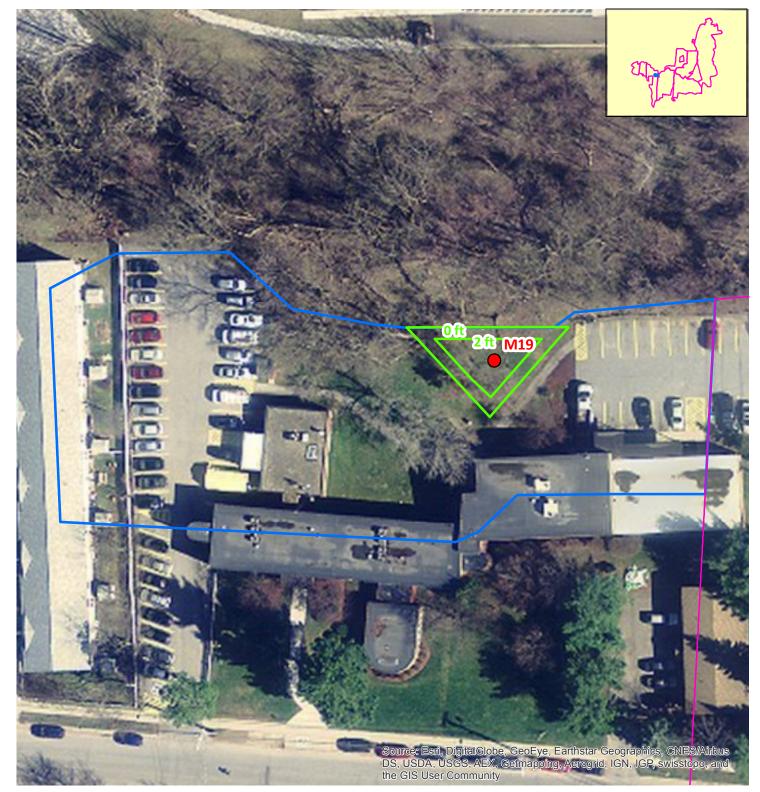
Date: 7/29/2016 Figure C.3

Proposed M19 BMP

- Proposed M19 Depth Contours

M19 Concept Design

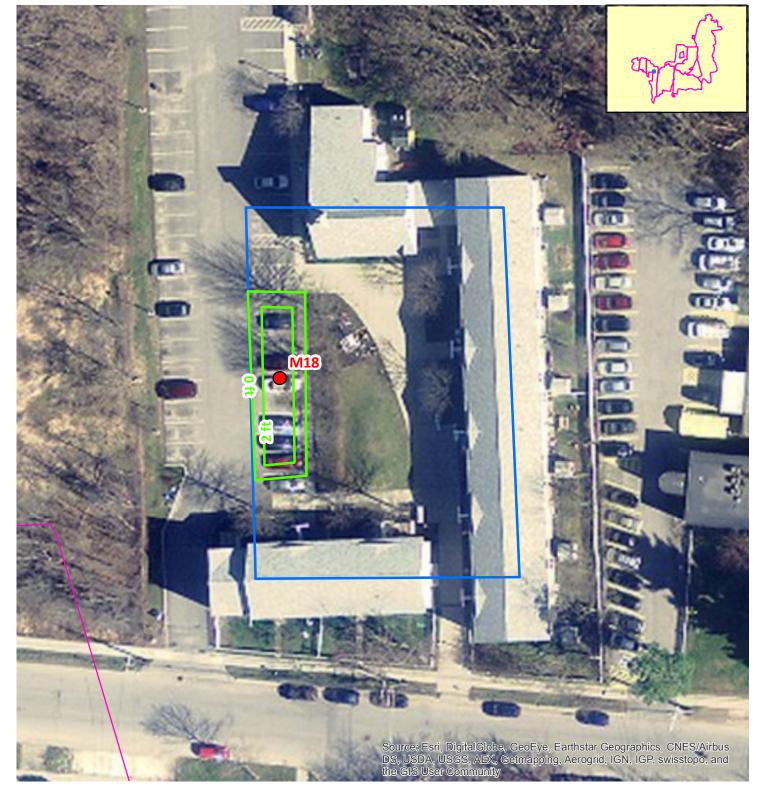
Date: 8/2/2016 Figure C.4

Proposed M18 BMP

M18 Concept Design

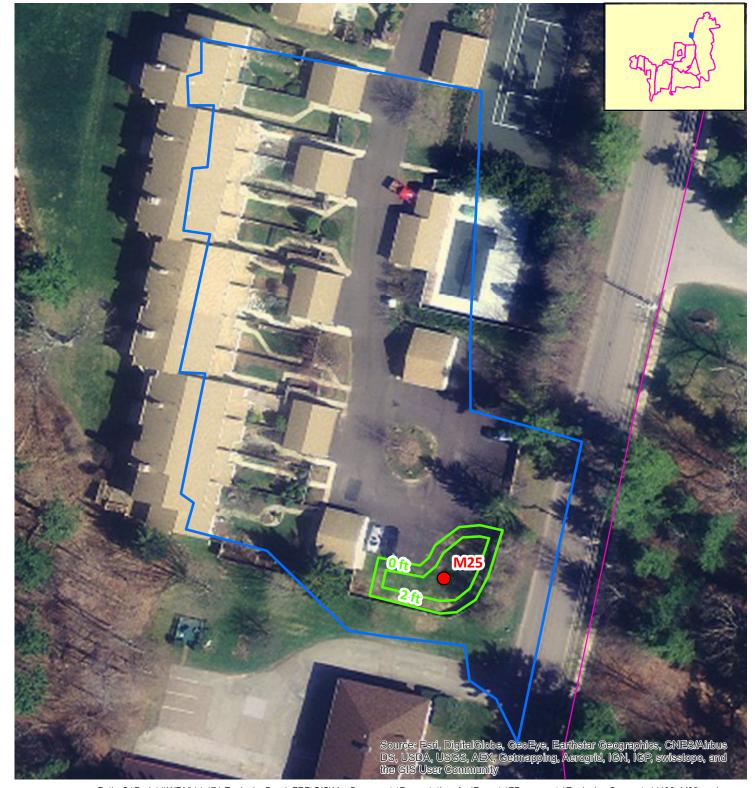
Date: 8/2/2016 Figure C.6

Proposed M25 BMP

M25 Concept Design

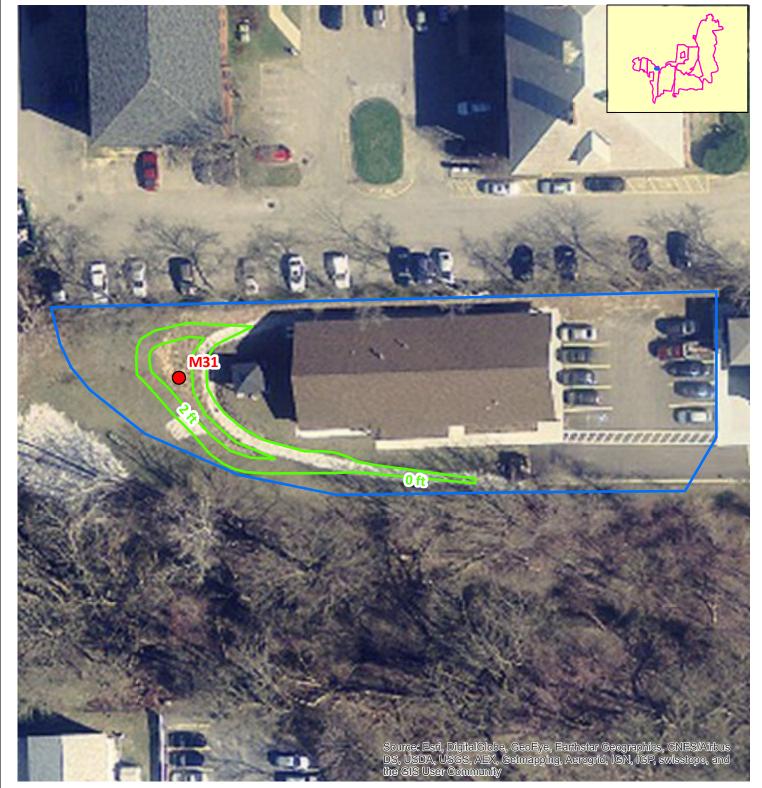
Proposed M31 BMP

- Proposed M31 Depth Contours
