PROJECT NO. PREPARED FOR:

17-061-A

Stormwater Master Plan Town of Richmond, Vermont

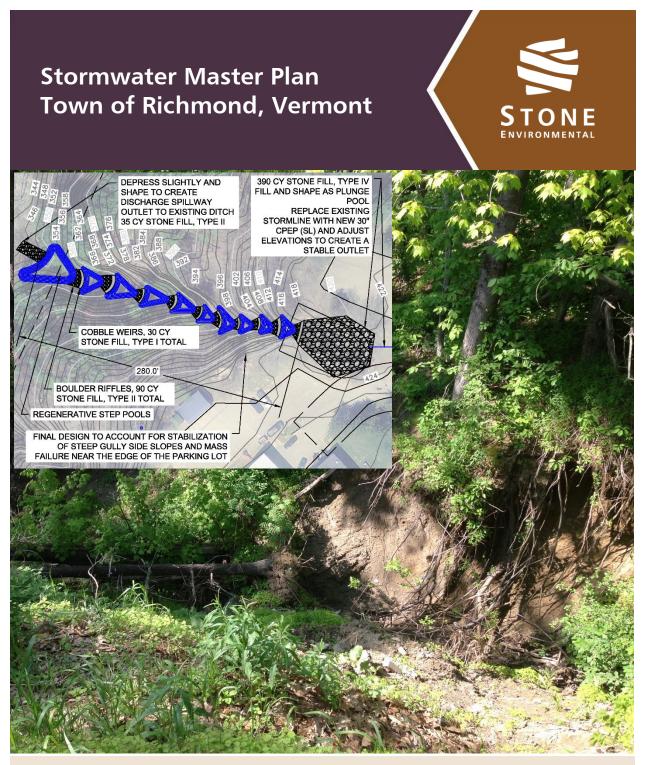
Cover: Gully erosion identified at the north end of the Richmond Elementary / Camel's Hump Middle School campus; and concept design for a regenerative conveyance retrofit to provide both water quality treatment and safe conveyance for runoff from both the school campus and a portion of I-89.

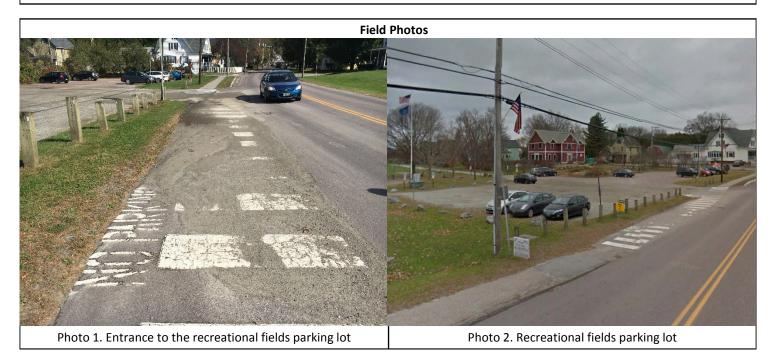
Pro	oblem Area ID: WR-05	Latitude: 44.40213°	Longitude: -72.99481°
Watershed:	Winooski River	THE CONTRACTOR	Richmond Free Library
Location:	USPS / Richmond Free Library		
Problem Type:	Water Quality and Erosion	- One Radish	United States Postal Service
Identification Source:	SWMP Field Assessments	Volunteers Green	
Ownership:	Town of Richmond		
Classification:	4		and an all the second sec
Base P Load:	4.15 lbs/yr		
Soil Type	В	Carlos 1	NET AND
Feasible BMPs	Bioretention		ALL REAL PROPERTY AND
Max. P Reduction	3.15 lbs/yr	-

Stormwater flows overland from the USPS and library roofs and parking lot to a collection point at the southeast corner of the parking lot. From there, drainage is conveyed via a closed pipe and a drainage ditch that outlets to a natural pond, and then to the Winooski River. There is substantial erosion occurring in the drainage ditch; if stormwater flow were reduced by installation of a bioretention basin or bioswale, stabilization of the currently eroding channel may also be possible.

WR-05	USPS / Richmond Free Library	Retrofit opportunity	Install a bioretention basin to the southeast of the municipal parking lot. The roughly 1.25 acre drainage area is mostly impervious and already drains to a single collection point in the northeast corner.	В	2	3	2	2	2	11	С	М	Y	Μ	Village - 6	
WR-06	Richmond Rescue	Retrofit opportunity	Install a wet pond/created wetland at the outlet adjacent to Richmond Rescue within the existing drainage pattern. There is not much capicity for infiltration at the site, though there is also no serious risk associated with overtopping the wet pond/created wetland that will convey stormwater to the Winooski River. The outfall is within the 100 year floodplain, which may preclude BMP implementation.	С	4	4	2	2	3	15	С	Н	Y	Н	Village - 1	*
WR-07	Railroad Tracks	Retrofit opportunity	Install a gravel wetland to treat stormwater from from a 120+-acre drainage area; even without the ability to fully infiltrate, substantial treatment is feasible. Floodplain and potential wetland constraints may preclude implementation.	A/D	3	5	1	1	3	13	В	Н	Y	Н	Village - 2	*

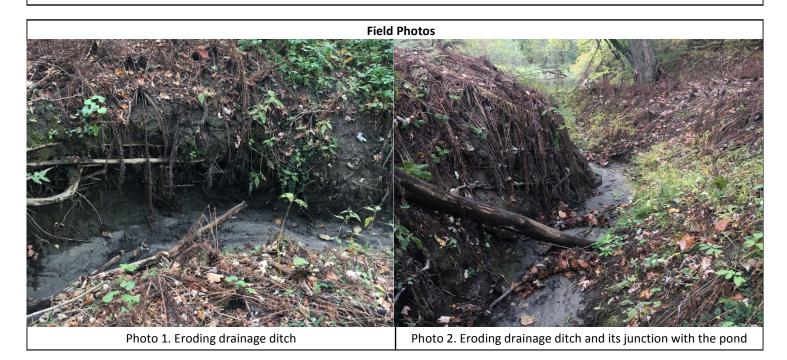
Pro	oblem Area ID: WR-06	Latitude: 44.40558°	Longitude:	-72.99800°
Watershed:	Winooski River	- Richmond Rescue		Holy Rosary Church
Location:	Richmond Rescue		nmond Home	Family Medicin
Problem Type:	Water Quality and Erosion		ply inc	a a sk
Identification Source:	SWMP Field Assessments	and and a set		Hatchet Tap and Table
Ownership:	Private	A A A A A A	St-	Richmond Food
Classification:	4			Richmond Market & Beverages
Base P Load:	68.2 lbs/yr		ه Richmond ongregational Church	
Soil Type	С			Contraction of the second
Feasible BMPs	Wet Pond / Created Wetland		Rich	mond Free Library
Max. P Reduction	35.5 lbs/yr	_

Stormwater runoff from an approximately 90-acre drainage area is conveyed via a closed drainage system and overland flow to a ditch to the southwest of Richmond Rescue. The ditch, which is actively eroding and filled with sediment, carries the stormwater to the Winooski River. Sufficient open land is present at the outlet of the closed drainage system to construct a sediment forebay and a water quality treatment practice, wet pond or created wetland. About 40 acres of the contributing drainage area can be managed by a separate water quality practice at WR-11 (Millet Street).

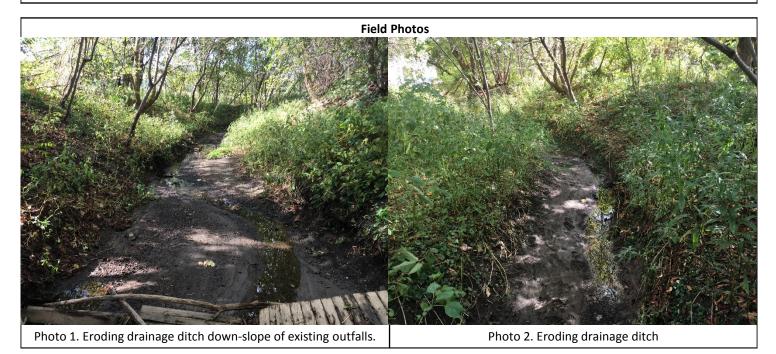
I	Problem Area ID: WR-07	Latitude: 44.40321°	Longitude:	-72.99320°
Watershed:	Winooski River		Hatchet Tap an	d Trable Greensea Systems
Location:	Railroad Tracks		Richmond Food Shelf & Thrift Store	Papa McKee's Pizzeria
Problem Type:	Water Quality, Erosion, and Damaged Infrastructure		Richmond Market & Beverage	
Identification Source:	SWMP Field Assessments			
Ownership:	Private	Richmond Congregational Church		
Classification:	3	State Rice	hmond Free Library	
Base P Load:	70.8 lbs/yr		CALE	
Soil Type	A / D	One Radish Unite Post	d States al Service	
Feasible BMPs	Gravel Wetland		a series	
Max. P Reduction	43.19 lbs/yr

Stormwater from an approximately 122-acre drainage area is conveyed via a closed drainage system and overland flow to a ditch south of the railroad tracks. The ditch, which is actively eroding and filling with sediment, carries stormwater to a natural pond that then drains to the Winooski River. Sufficient area likely exists for construction of end-of-pipe retrofit practices, including pre-treatment gravel wetlands, in at least two separate locations. Both the culvert that carries water beneath the railroad tracks, and the box culvert that carries water beneath the private drive are badly damaged and in need of replacement. Planned waterline replacement on Main Street and replacement of the drainage network between Main Street and the railroad tracks may represent a strategic opportunity to "bundle" needed improvements that benefit this larger drainage area.

Stormwater from an approximately 122-acre drainage area is conveyed via a closed drainage system and overland flow to a ditch south of the railroad tracks. The ditch is actively eroding and filling with sediment, and carrying stormwater to a natural pond that then drains to the Winooski River. Sufficient area likely exists for construction of end-of-pipe retrofit practices, including gravel wetlands, in at least two separate locations. Both the culvert that carries water beneath the railroad tracks, and the box culvert that carries water beneath the private drive are badly damaged and in need of replacement. Planned waterline replacement on Main Street and replacement of the drainage network between Main Street and the railroad tracks may represent a strategic opportunity to "bundle" needed improvements that benefit this larger drainage area. Constraints on the northern-most of the two sites, however, include proximity to the railroad tracks and right-of-way and active construction of Phase 1 improvements at the Richmond Creamery redevelopment project at 74 Jolina Court, on the parcel just south of the railroad tracks.

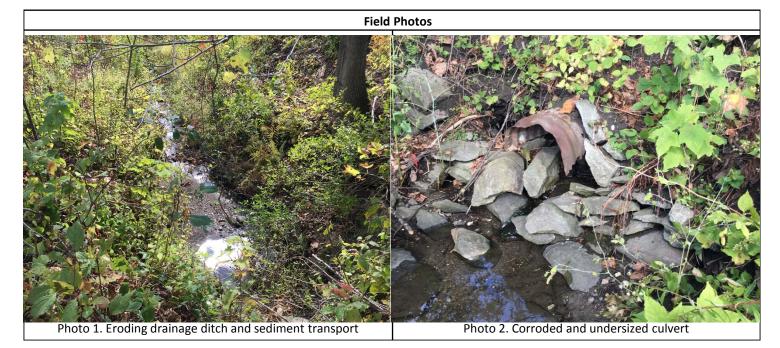
Р	roblem Area ID: WR-08	Latitude: 44.40653°	Longitude:	-72.99310°
Watershed:	Winooski River	HMC Advertisi	9	
Location:	Our Lady of the Holy Rosary Church	Phanes Our L	ady of the Rosary Church	
- Problem Type:	Water Quality	Holy	10	
- Identification Source:	SWMP Field Assessments	- 10 - 10 - 10 - 10 - 10 - 10 - 10 - 10	Richmond Family Medicine	
Ownership:	Private		Ski Ex	press
Classification:	6	Hatchet Tap and Tat	le Greensee	a Sustains
Base P Load:	1.51 lbs/yr		Papa MčKee's Pizze	
Soil Type	A / D	Richmond Food Shelf & Thrift Store		The Con
Feasible BMPs	Bioretention, Infiltration Trench	Richmond Market & Beverage		2
- Max. P Reduction	1.15 lbs/yr

Stormwater from the church roof and parking lot flows overland to the northwest, where existing green space could be utilized for stormwater capture and treatment. Opportunity to disconnect runoff from closed drainage system that outfalls at WR-07 project location.

WR-08	Our Lady Church	Retrofit opportunity	There is opportunity to utilize green space to the northwest of the parking lot for infiltration/bioretention. The parking lot already slopes that direction so capture and treatment can be achieved with relative ease.	A/D	2	2	2	2	2	10	А	L	Y	Μ	Village - 8	*

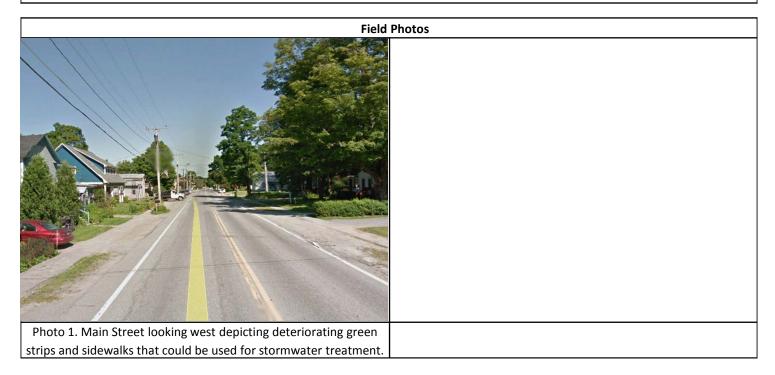
Problem Area ID: WR-11	Latitude: 44.40736°	Longitude: -72.99245°
Watershed:	Winooski River		
Location:	Millet Street		lidentAre
Problem Type:	Water Quality, Infrastructure Protection		The state of the s
Identification Source:	SWMP Field Assessments		
Ownership:	Private		
Classification:	6		
Base P Load:	18.05 lbs/yr	tchmond Home Supply Inc	Constant of the second
Soil Type	A / D		Papa McKee's Pizzeria
Feasible BMPs	Infiltration, Bioretention		chmond/Market
Max. P Reduction	13.72 lbs/yr

At this location, runoff from an approximately 39-acre drainage area enters the closed drainage system that outlets southwest of Richmond Rescue. Installing a water quality treatment practice, ideally one that can infiltrate some portion of the runoff reaching this location, would reduce the volume and improve quality of runoff currently causing damage at WR-07.

At this location, runoff from an approximately 39-acre drainage area enters the closed drainage system that outlets southwest of Richmond Rescue (WR-07). Installing a water quality treatment practice, ideally one that can infiltrate some portion of the runoff reaching this location, would reduce the volume and improve quality of runoff currently causing damage at the Richmond Rescue site.

The proposed retrofit for this site is a bioretention area just upstream from the existing inlet to the closed drainage system immediately north of the Millet Street – Tilden Avenue intersection to provide water quality treatment and limited infiltration capacity, with overflow to the existing closed drainage system and ultimately to the outlet at WR-07. The design standard used for this retrofit was best-fit treatment of the water quality volume for the contributing drainage area (39.1 acres). Full compliance with the WQv treatment standard would manage 1.0" of rain in a 24-hour period and at full water quality treatment, this practice has the potential to prevent 13.72 lbs/year of total phosphorus from entering receiving waters (Table 4) At this site, it is possible to site a bioretention area that will manage over 100% of the WQv or a total of 20.300 ft³ of runoff. A 30% design plan is provided in Appendix E.

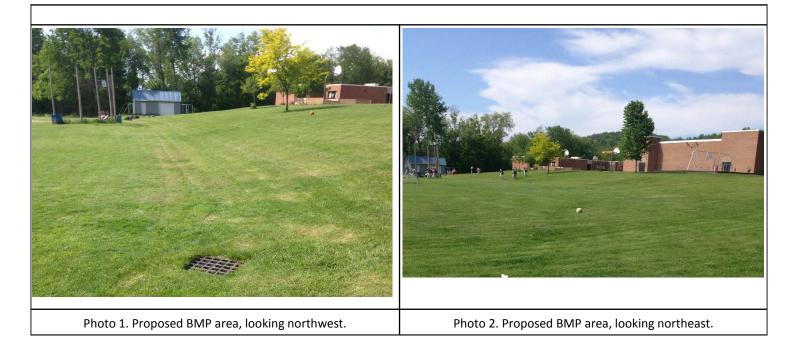
F	Problem Area ID: WR-16	Latitude: 44.41241°	Longitude:	-72.99339°
Watershed:	Winooski River		III .	
Location:	School Campus Elementary School		0	
Problem Type:	Water Quality			-
Identification Source:	SWMP Field Assessments, School Meetings			
Ownership:	USD 17			
Classification:	6	A Com		
Base P Load:	1.04 lbs/yr	E 22	33	
Soil Type	А		and the second	
Feasible BMPs	Infiltration trench along roof drip line	a last the		
Max. P Reduction	1.03 lbs/yr			
Date of Field Dat	a Collection: October 17, 20	17

The rooftop on the northeast side of the elementary school could be effectively disconnected into an infiltration trench along the roof's drip edge.

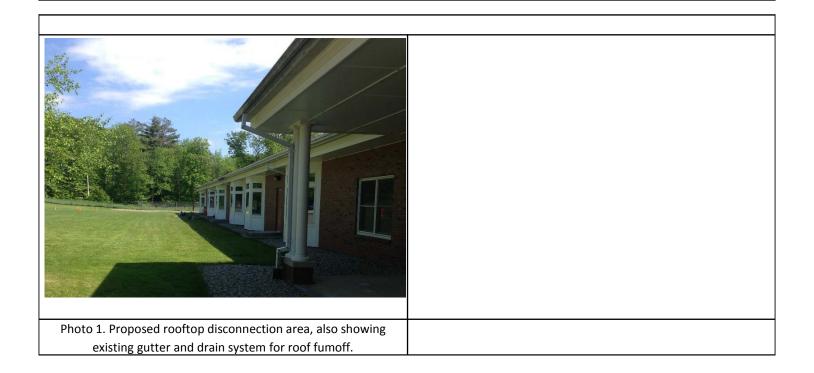
Р	roblem Area ID: WR-17	Latitude: 44.41241°	Longitude: -72.99289°
Watershed:	Winooski River		Still Contraction of the second secon
Location:	School Campus Elementary School		6
– Problem Type:	Water Quality		
_ Identification Source: _	SWMP Field Assessments, School Meetings		
Ownership:	USD 17		
- Classification: 	6	A. C. A.	
Base P Load:	1.97 lbs/yr		
Soil Type	А	and she	
Feasible BMPs	Gravel wetland	A ANT THE	
– Max. P Reduction	1.20 lbs/yr

Provide water quality treatment, and some peak storm flow reduction, prior to discharging into the existing gully to the south of the school property. Depending on soil infiltration capacity, either a bioretention or gravel wetland area may be suitable. Roof drainage from the elementary school could be directed to this BMP instead of to disconnection, as proposed in WR-16.

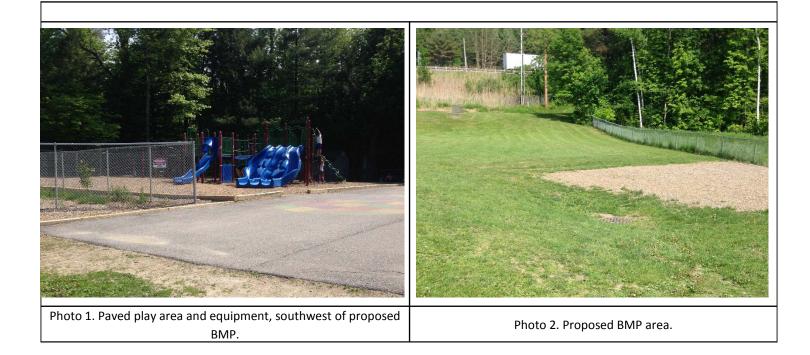
Р	roblem Area ID: WR-18	Latitude:	Longitude:
Watershed:	Winooski River		
- Location:	I-89 NB ROW, E2 Drainage Area, Interstate and Median	and the second	
- Problem Type:	Water Quality, Erosion	(ARM)	
_ Identification Source:	SWMP Field Assessments		
Ownership:	Vermont Agency of Transportation	No and the second	
- Classification:	6	TUS NO	
Base P Load:	7.72 lb/year		
– Soil Type	В		
– Feasible BMPs	Gravel wetland		
- Max. P Reduction	4.71 lb/year

Strategic retrofit to treat runoff from I-89 NB and SB, and a limited amount of VTrans-owned pervious surface associated with I-89. The proposed BMP treats and detains runoff that discharges northeast across I-89 north of the school property. Though this portion of I-89 is adjacent to the school property, this runoff is not contributing to the erosion issue at WR-14.

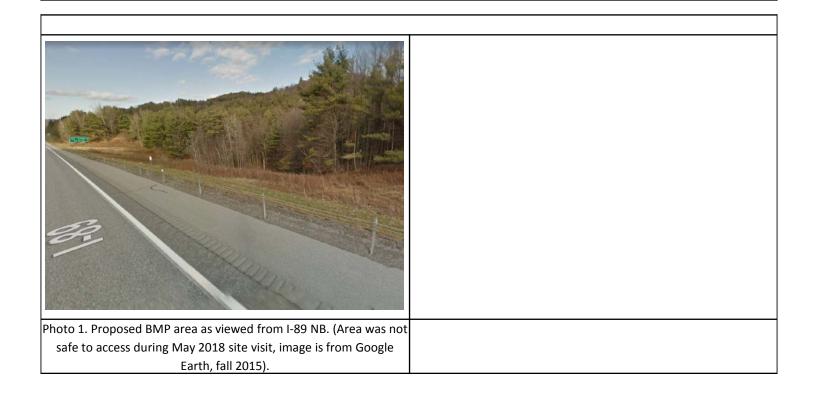
Problem Area ID: WR-19	Latitude:	Longitude:
Watershed:	Winooski River		
Location:	I-89 ROW, D5 Drainage Area, Interstate and Median		
Problem Type:	Water Quality, Erosion, Property Damage		
Identification Source:	SWMP Field Assessments, School Meetings		
Ownership:	Vermont Agency of Transportation		
Classification:	4		
Base P Load:	2.16 lb./year		
Soil Type	В		
Feasible BMPs	Gravel Wetland, potentially infiltration		
Max. P Reduction	1.32 lb./year

Runoff from the D5 drainage area travels through an 18" concrete culvert beneath the I-89 SB lanes and discharges, via overland flow, onto USD 17 property in the D3 drainage, where it causes gully erosion before reaching the existing swale along the northeast edge of the school's access road and parking area, and ultimately reaching the gully at the north end of the school campus (see sheets WR-22 and WR-14). There are two opportunities to improve water quality and reduce peak flows: one within the median prior to the culvert inlet (not pictured below), and one within the SB right-of-way upslope of the school property.

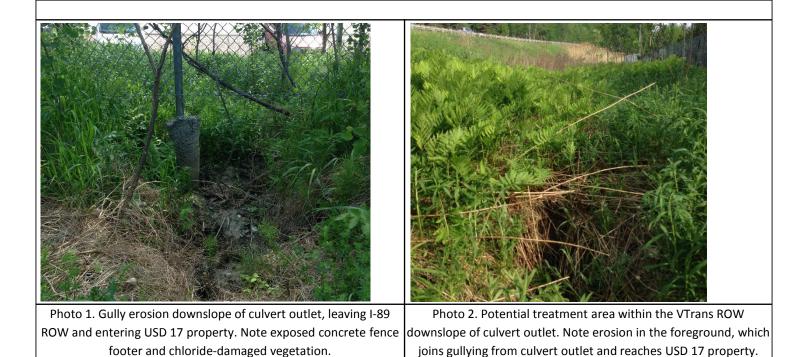
Problem Area ID: WR-20	Latitude:	Longitude:
Watershed:	Winooski River	and the second sec	
Location:	I-89 ROW F3 Drainage Area, Upslope of Interstate	19	
Problem Type:	Water Quality, Potential Erosion		A BALLER
Identification Source:	SWMP Field Assessments		
Ownership:	Vermont Agency of Transportation		
Classification:	3		
Base P Load:	10.02 lbs./year		and a second secon
Soil Type	D		
Feasible BMPs	Gravel Wetland		
Max. P Reduction	6.11 lbs./year

Strategic retrofit to treat runoff from upland areas draining to the VTrans right-of-way, and a limited amount of VTrans-owned impervious surface associated with I-89. The area draining to this proposed BMP location is substantial (about 37 acres) but the watershed contains very little impervious surface (~1 acre). The proposed BMP would treat runoff that discharges across I-89 south of the school property, not associated with the erosion issue at WR-14. Historic erosion issues in the drainage channels south of the school campus appeared stable during the May 2018 field visit.

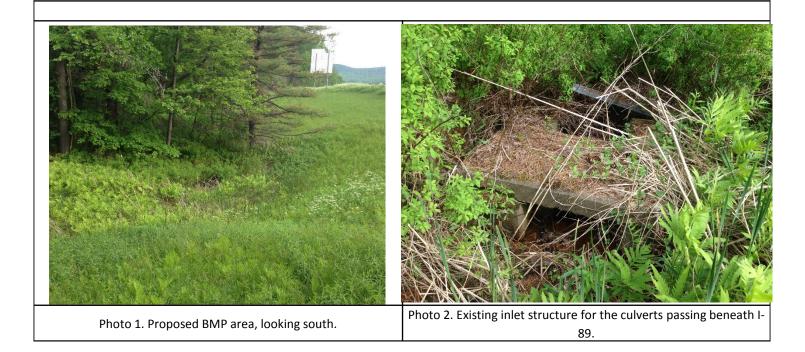
Problem Area ID: WR-21	Latitude:	Longitude:
Watershed:	Winooski River	and the second second	
Location:	I-89 ROW, F2 Drainage Area, Upslope of Interstate	3. 3	
Problem Type:	3	a start to	
Identification Source:	SWMP Field Assessments		
Ownership:	Vermont Agency of Transportation		
Classification:	3		
Base P Load:	2.94 lb./year		
Soil Type	D		
Feasible BMPs	Gravel Wetland		
/lax. P Reduction	1.79 lb./year

Runoff from the D5 drainage area (WR-19) discharges, onto USD 17 property in the D3 drainage, runs into the existing swale along the northeast edge of the school's access road and parking area, and ultimately reaches the gully at the north end of the school campus (WR-14). There is an opportunity to retrofit this swale improve water quality and reduce peak flows. A portion of the School parking lot and access drive draining to this swale is covered under operational stormwater permit 6615-9010; water quality treatment provided for 16,096 SF / 0.37 acres of impervious. It does not appear that the swale was sized to provide water quality treatment or safe conveyance for VTrans run-on. The existing swale is filled with sediment and cattails and is minimally maintained.
