Watershed Study Report

Stevens Brook & Rugg Brook

Prepared for the
**City of St. Albans, Town of St. Albans,
Town of Georgia & Town of Swanton**

July 11, 2003

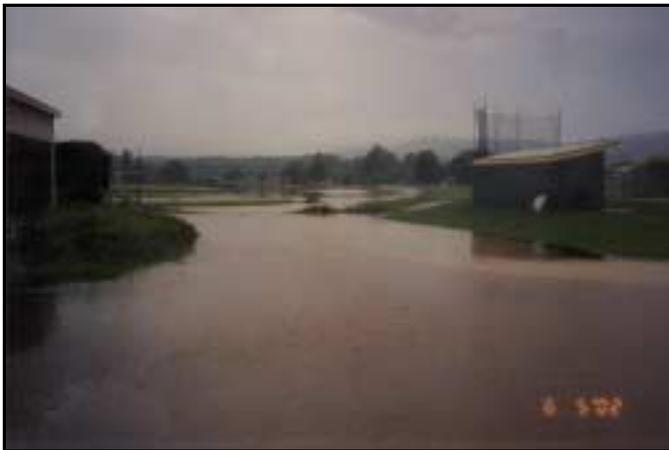
Flooding of the Collins-Perley Sports Complex on June 5, 2002.

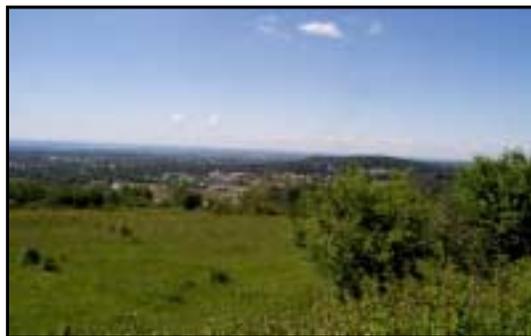
Westerly view from upper watershed

The land use throughout the headwaters of the Stevens Brook is predominately rural, with some residential housing and supporting roadways. The majority of this area is wooded with some open meadow. The topography is very steep, with an approximate slope of 18 percent. At the downstream border of the headwaters defined by I-89, there is a definitive change in the slope of the terrain.

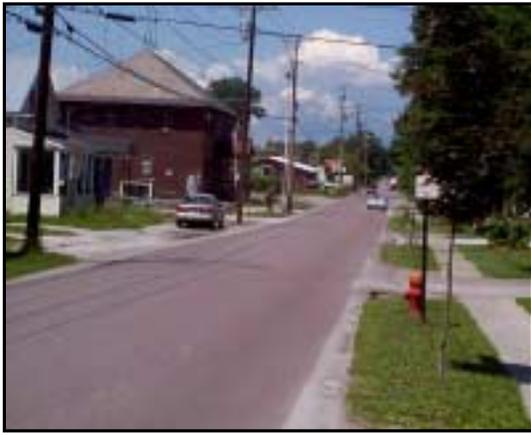
Typical developed area in the watershed.

The land use in the center section of the watershed is predominately urban. Medium to high-density residential development dominates the land use in the upstream (eastern) portion. Commercial and high-density residential land use exists from US 7 (Main Street) downstream to the wastewater treatment facility. The drainage area of Stevens Brook at Main Street is 1.8 square miles.

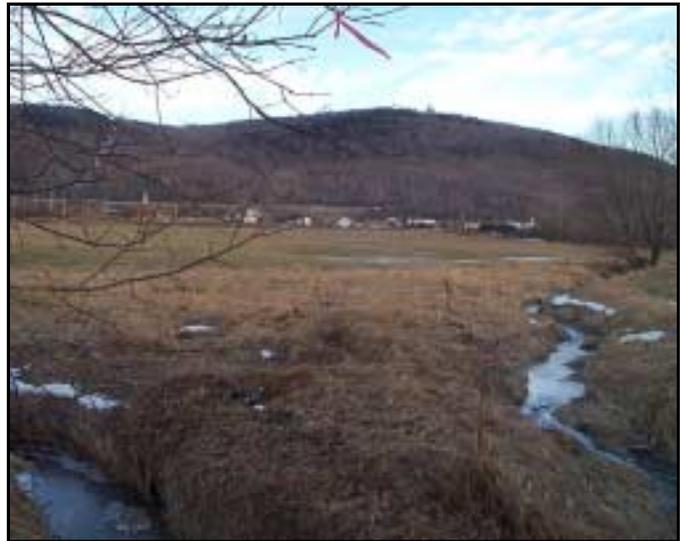
*Easterly view of the Rugg Brook headwaters.
Note the Interstate in middleview and the
abandoned radar station in the background.*

There are two primary branches of the Rugg that convey runoff through the headwaters, which are referred to in this report as the North Branch and the South Branch. The North Branch collects drainage primarily from the area east of Exit 19 of I-89 and joins the South Branch at Clyde Allen Drive. The South Branch is comprised of several small tributaries originating on Bellevue Hill and the farmland located on the Town of St. Albans and Fairfield town lines.

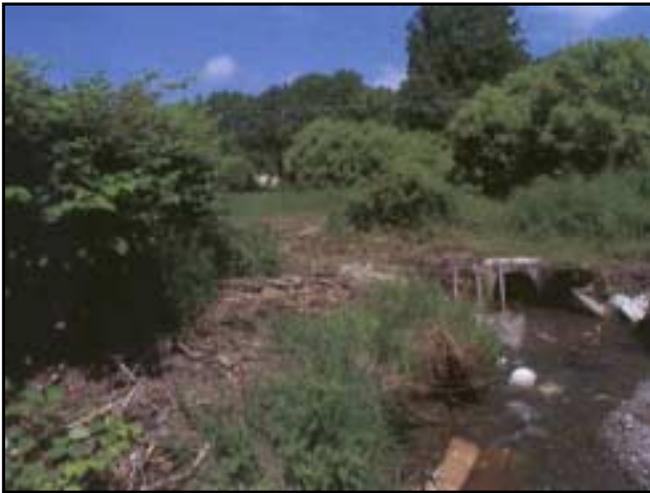
Inlet to diversion structure

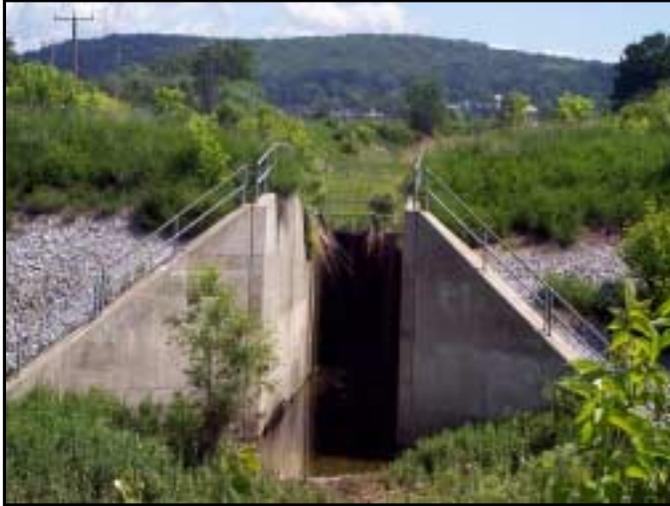
Outlet from the diversion structure.

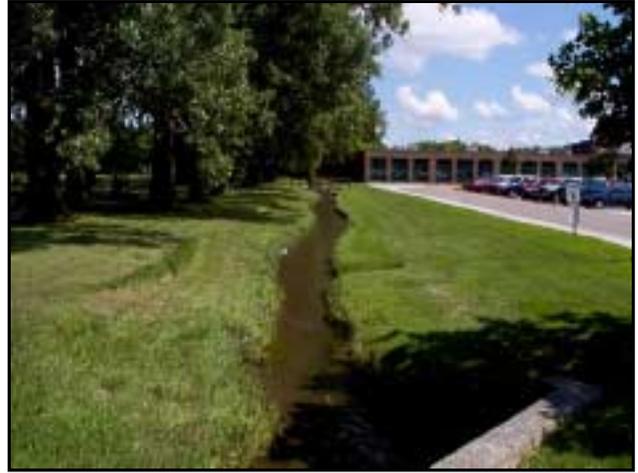
Straightened channels and lack of vegetated buffer reduces ability to filter pollutants from parking lots and contributes to flooding.

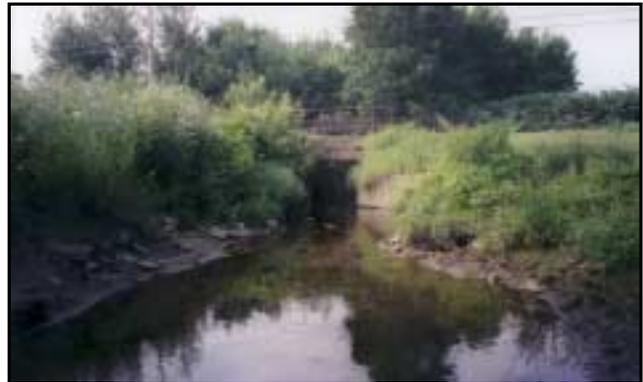
Severely constricted channels and structures trap flood borne debris, causing flooding.

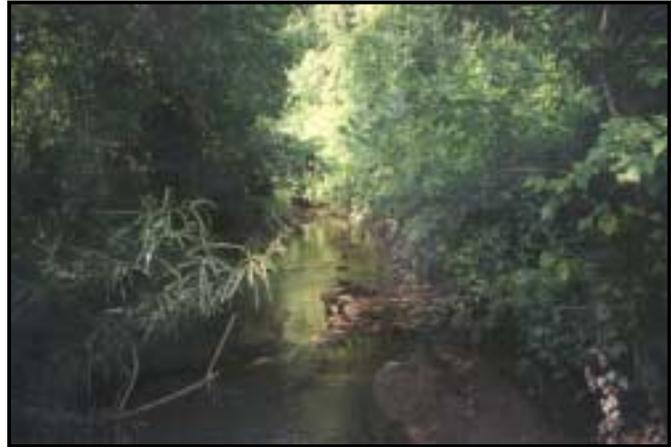
Examples of quality vegetated buffers do exist on the Stevens and Rugg brooks, and should be protected from future development.

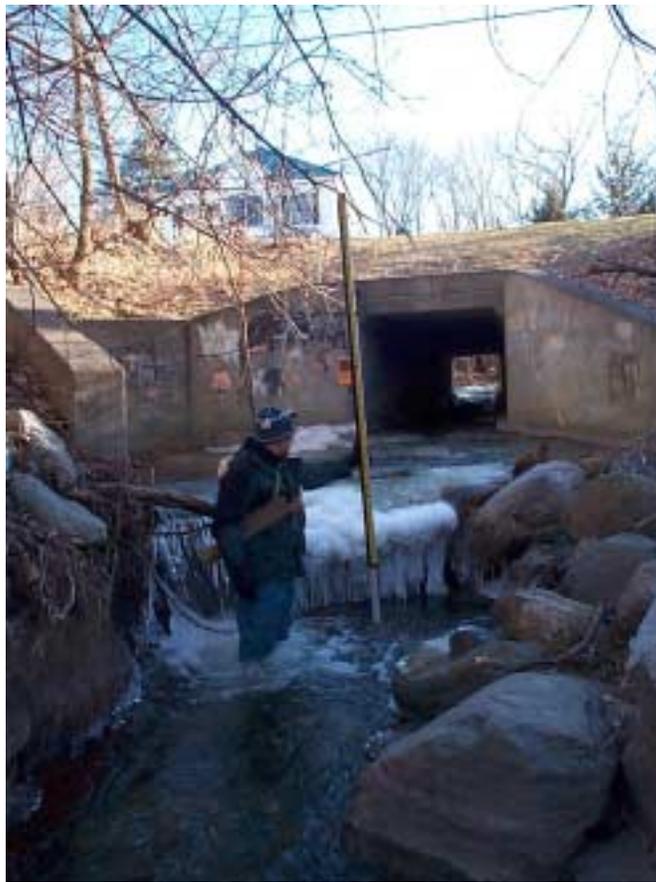
Upstream view of the Lincoln St. culvert. At the time it was constructed the streambed was level with the invert of the culvert. Note that within the past few years the bed has degraded approximately 3 feet.

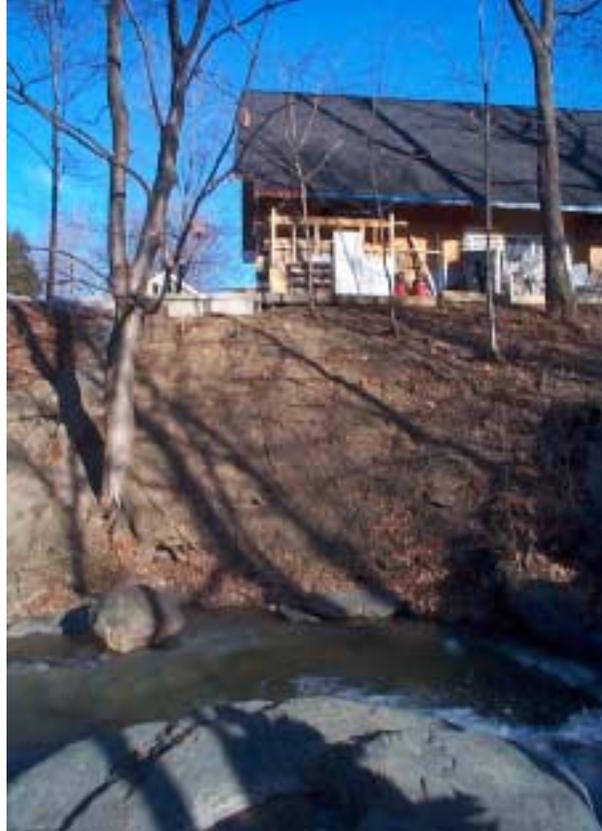
A view of the right bank of the Stevens Brook along the reach between Lincoln Ave. and Barlow St. The stormwater runoff from this residential property flows over the bank causing streambank erosion.

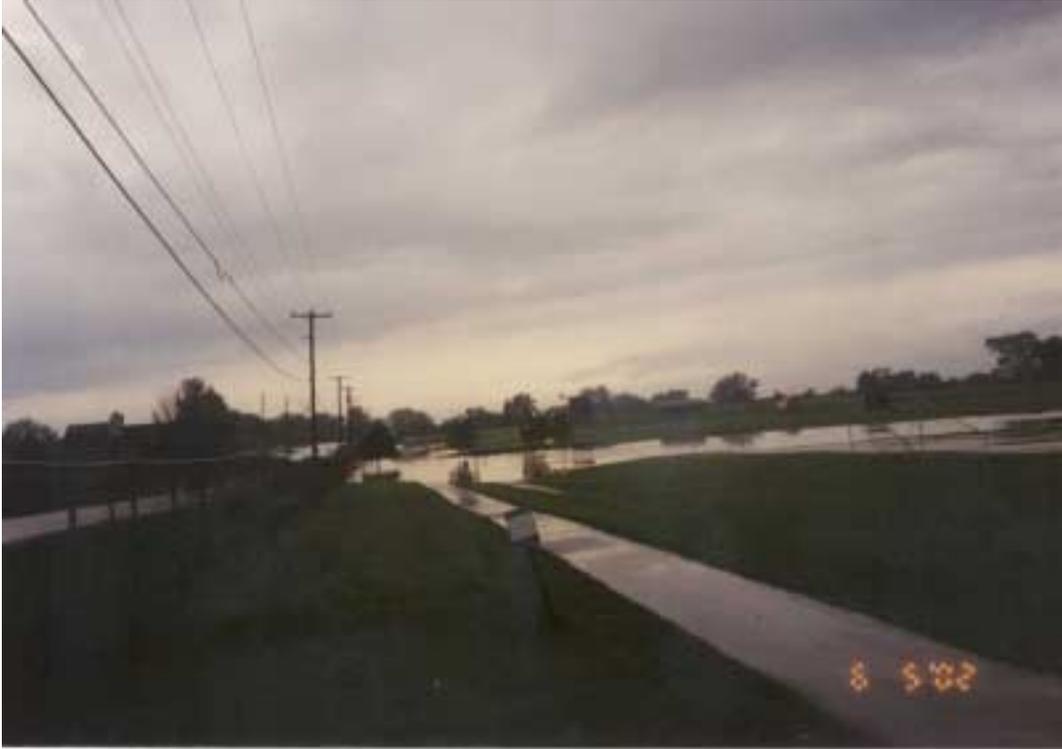
A westerly view of the Collins-Perley property with Fairfax St. to the left. This photo was taken in June of 2002 when significant storms overwhelmed the stormwater drainage systems and caused localized flooding. Note the backing up of stormwater at the Fairfax Street outlet, left center of photo.

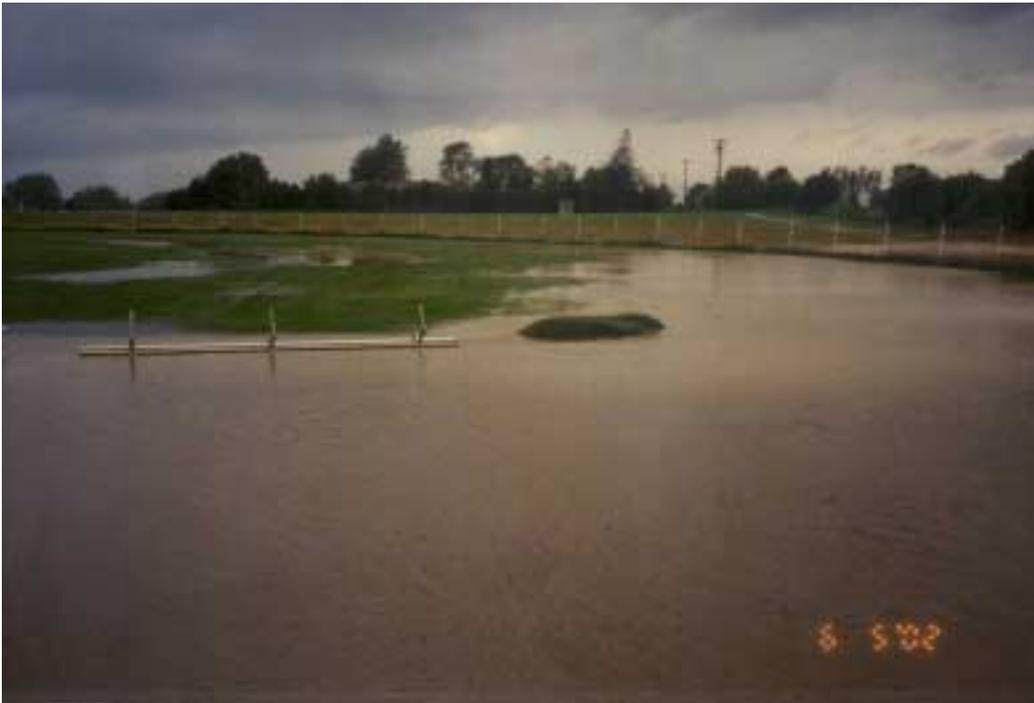
Another view of the localized flooding on the Collins-Perley property. Note the pitcher's mound in the center of the photo. This baseball field is located approximately 600 feet from the outlet at Fairfax Street.

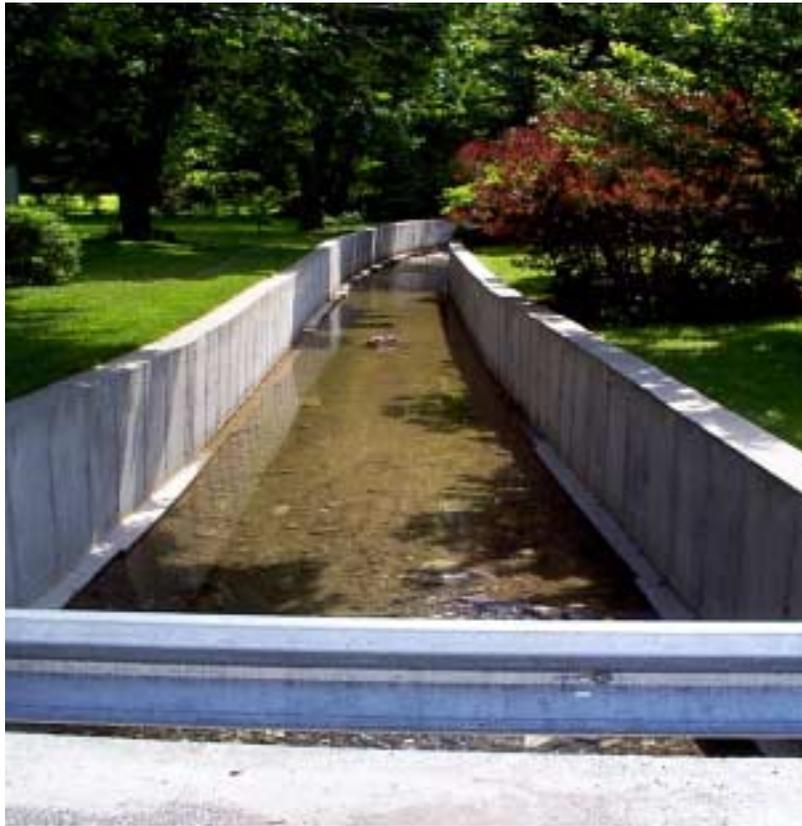
Looking upstream from Quinton Court at the channelization of the stream. This structure concentrates discharge velocities in the stream, which impacts the stream channel downstream.

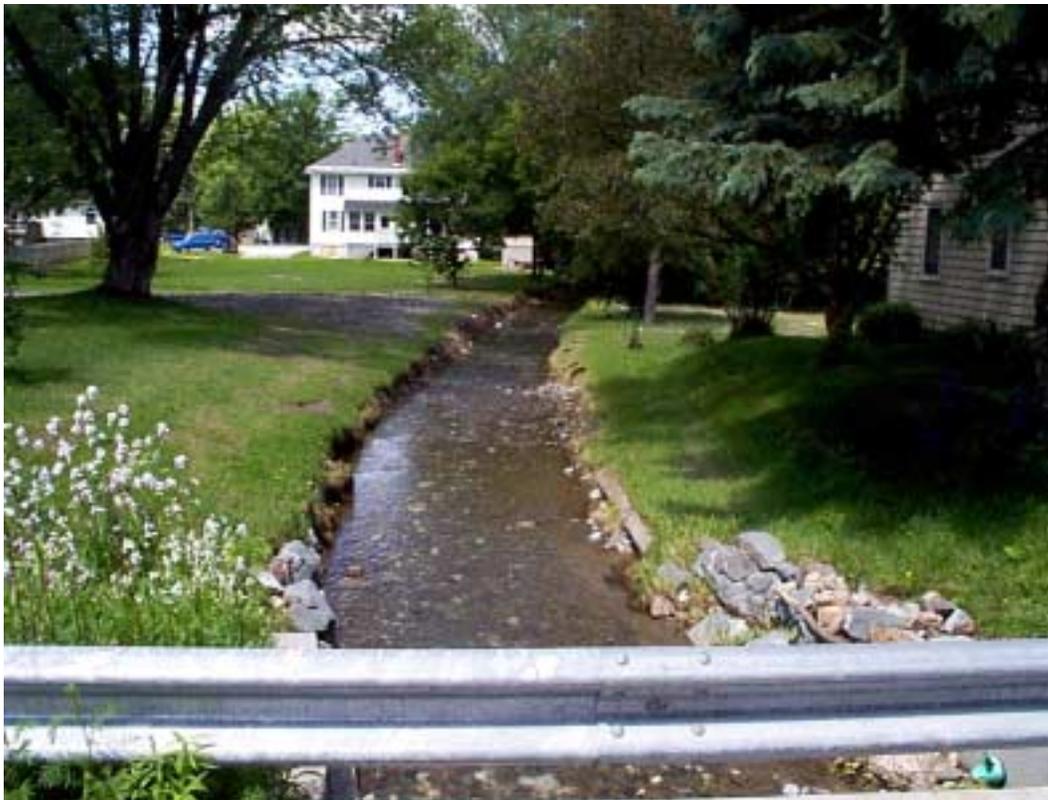
Downstream view from Quinton Court. It is in this area that flooding damage frequently occurs primarily from the limited floodplain access the stream has upstream of this location.

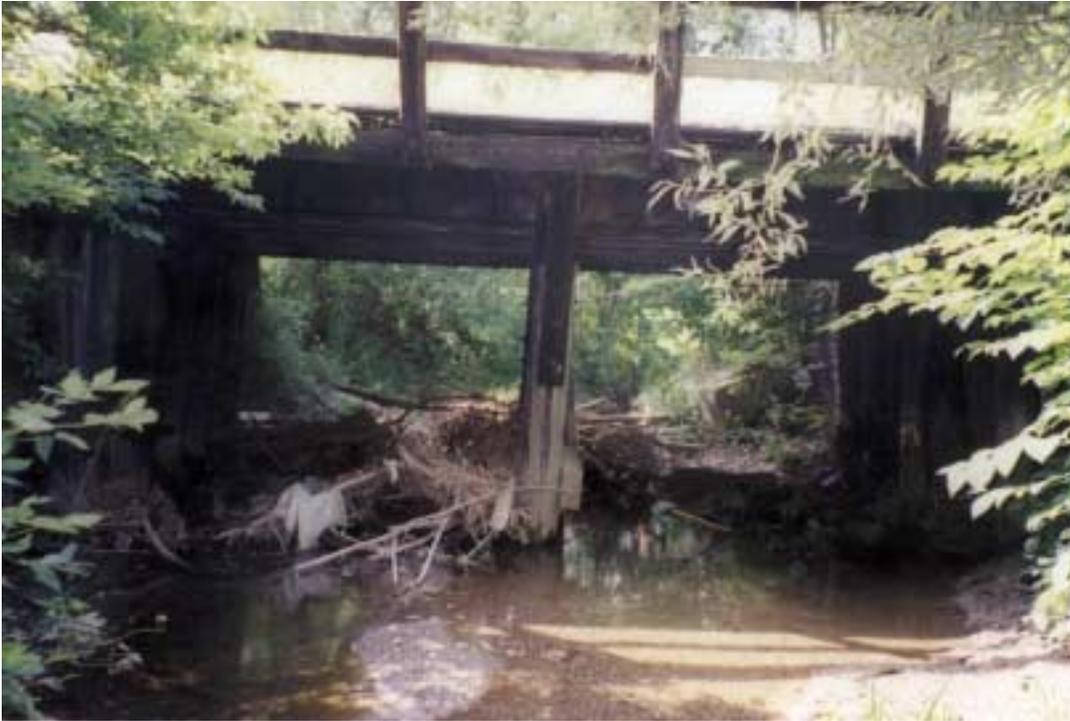
View looking upstream of a railroad bridge crossing the Stevens Brook. Note the debris accumulating in the stream due to the support pier.

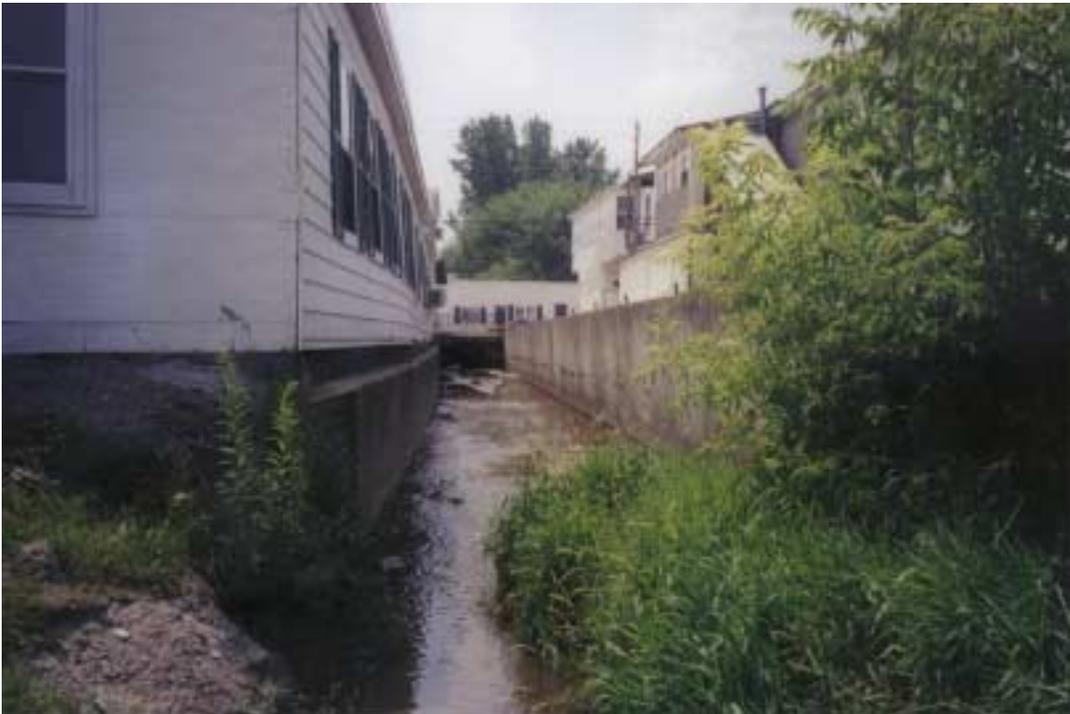
View looking upstream of the Lake Street crossing. The stream has been confined to this narrow channel because of the encroachment.

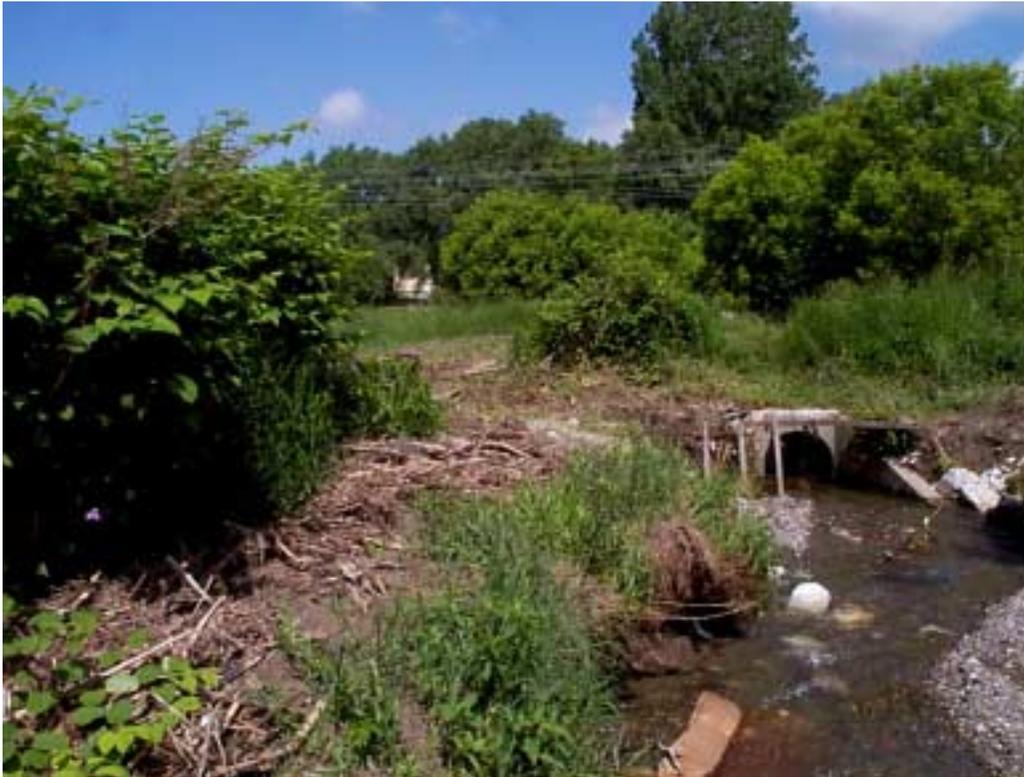
Inlet of the control culvert on Stevens Brook. When discharges exceed capacity of this culvert, water is diverted into the diversion structure and conveyed to the Rugg Brook outlet shown in the next photo.

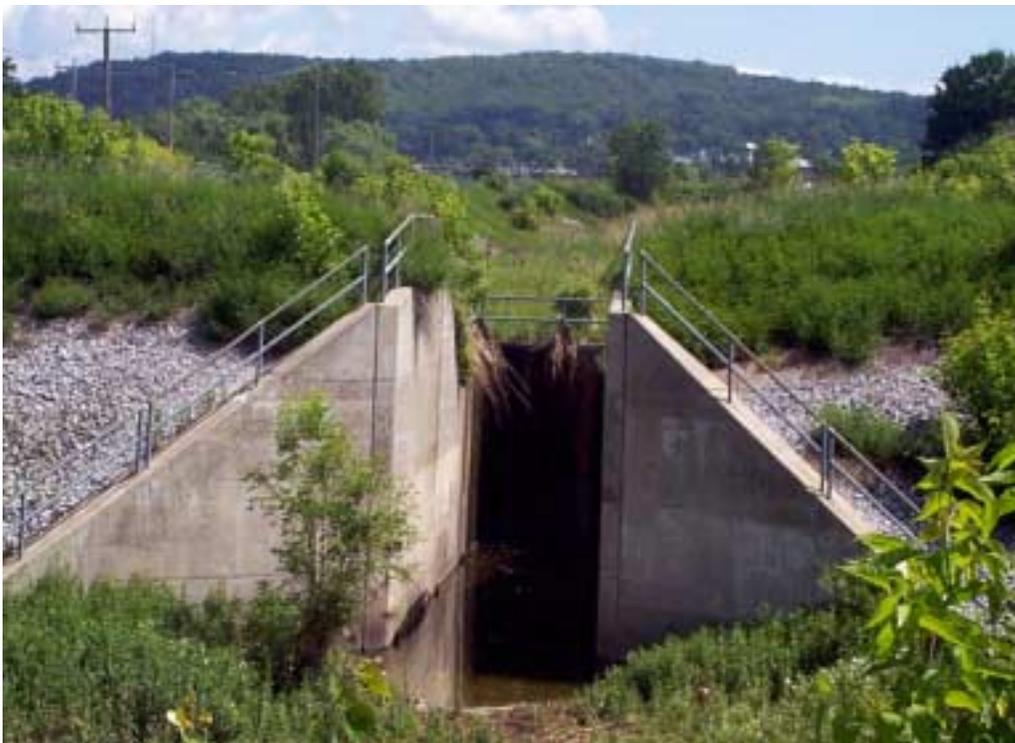
View of the diversion structure outlet. Here diverted water outlets into the Rugg Brook.

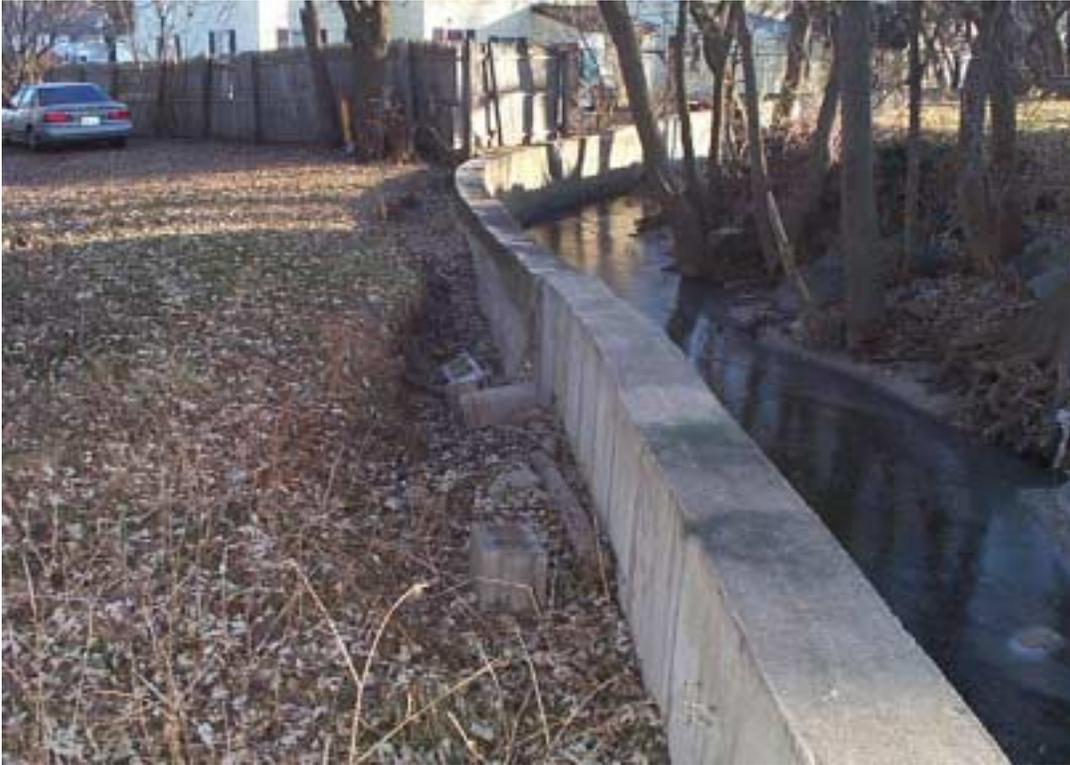
Upstream view of the flood wall along Lower Weldon Street. This floodwall is designed to protect the residential property at this location. Note the close proximity of the house (background) to the stream.

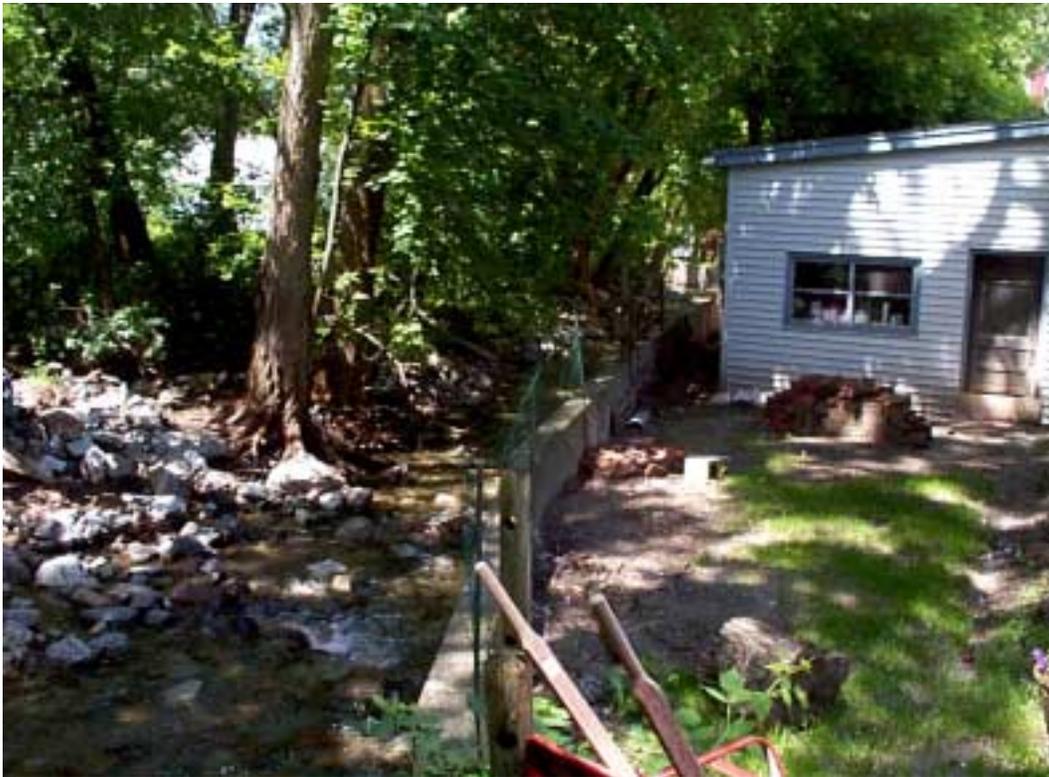
Another view of the floodwall along Lower Weldon Street. It is at this location that flooding frequently occurs. This area is a natural floodplain and the wall is marginally effective in containing the stream during significant discharges the stream overtops the wall and floods the property shown at the right.

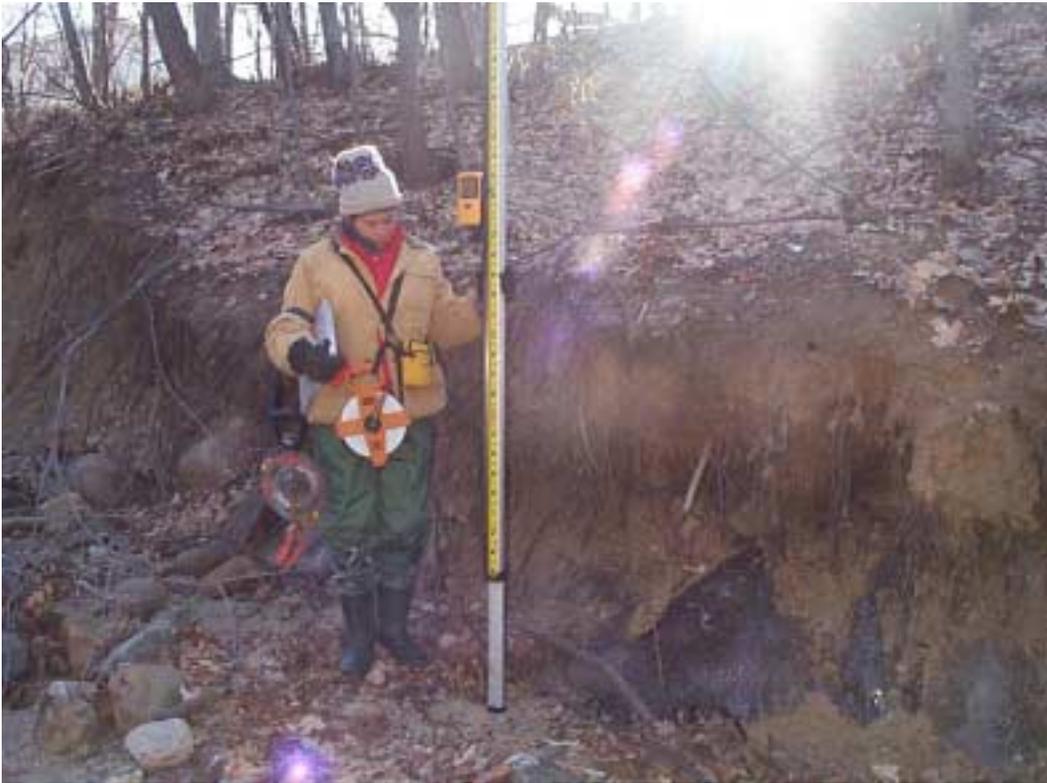
View of left bank of the Stevens Brook along the reach between Lincoln Ave. and Main St. Note the significant streambank erosion caused by excessive stormwater discharge.

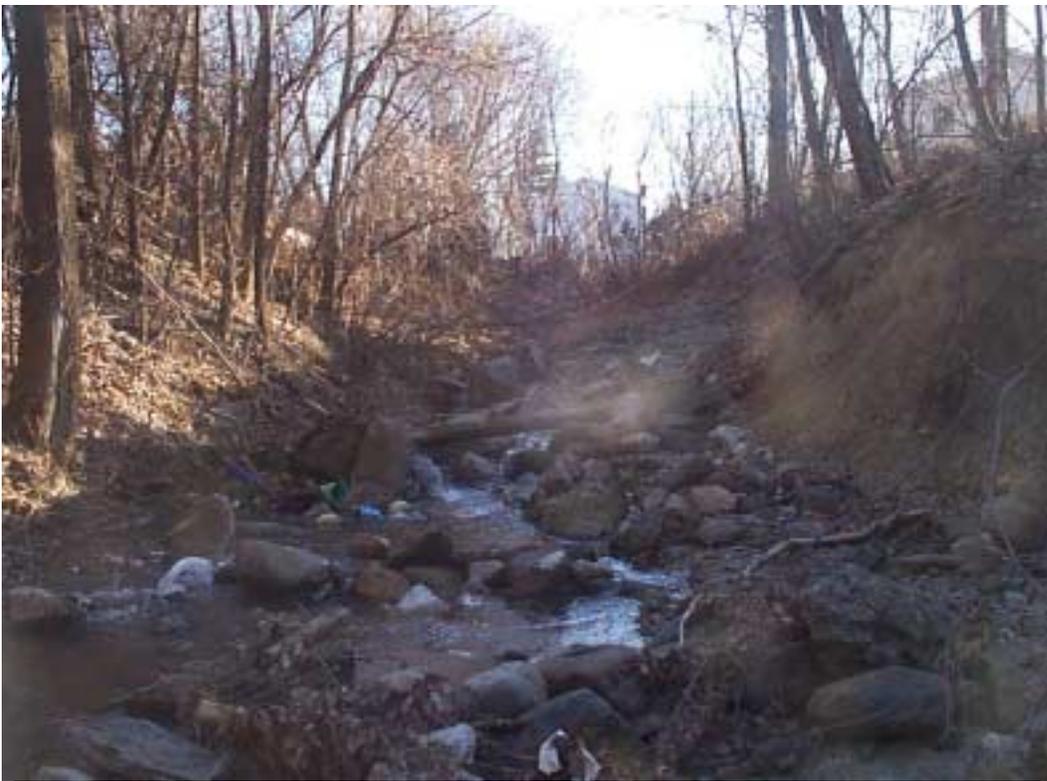
Another example of streambank erosion. This location is along the left bank of the Stevens Brook in the reach between Main St. and Lincoln Ave. Note that the streambank is vertical for approximately 6-8 feet.

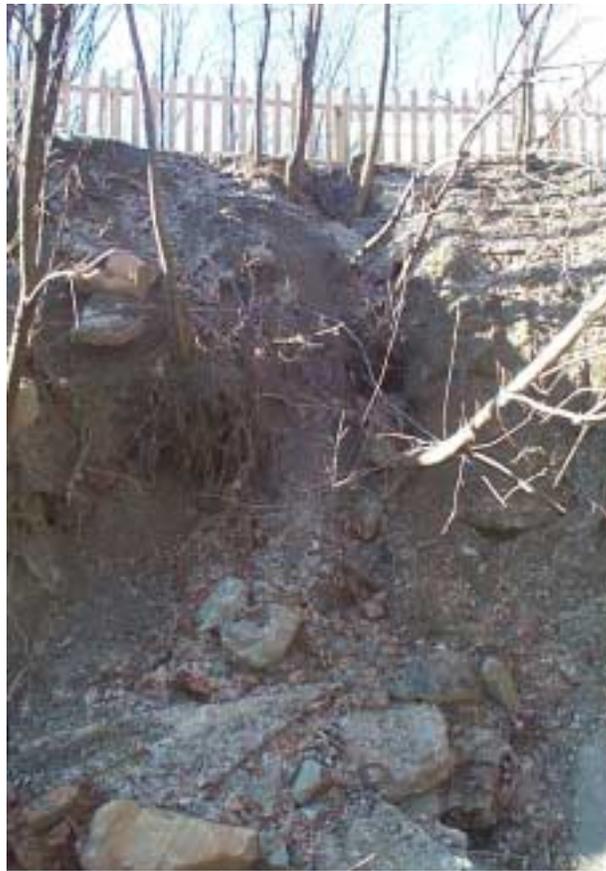
An example of significant streambank erosion caused by stormwater discharging from residential developments. This streambank is approximately 15 feet in height. Note the gully that is forming due to concentrated stormwater runoff from a residential property.

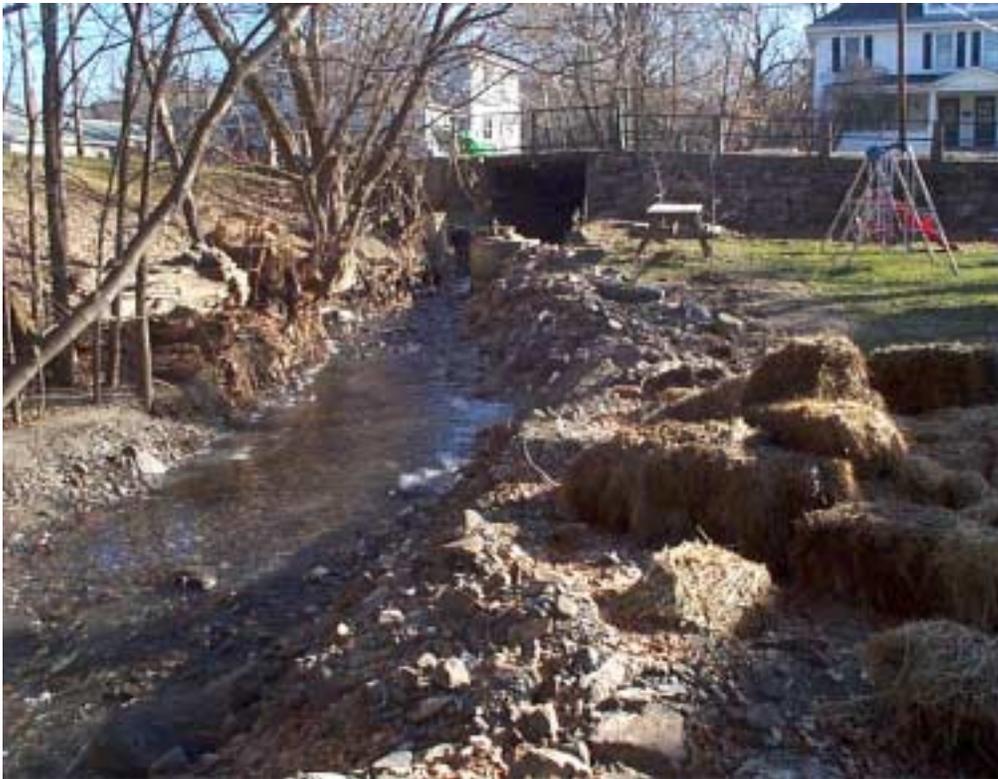
Upstream view of the Barlow St. culvert. This area is frequently inundated at which time sediment is deposited on the residential property. Note the absence of any riparian vegetation. Also note the berm adjacent to the stream, which was constructed by the property owner from sediment deposited by the stream.

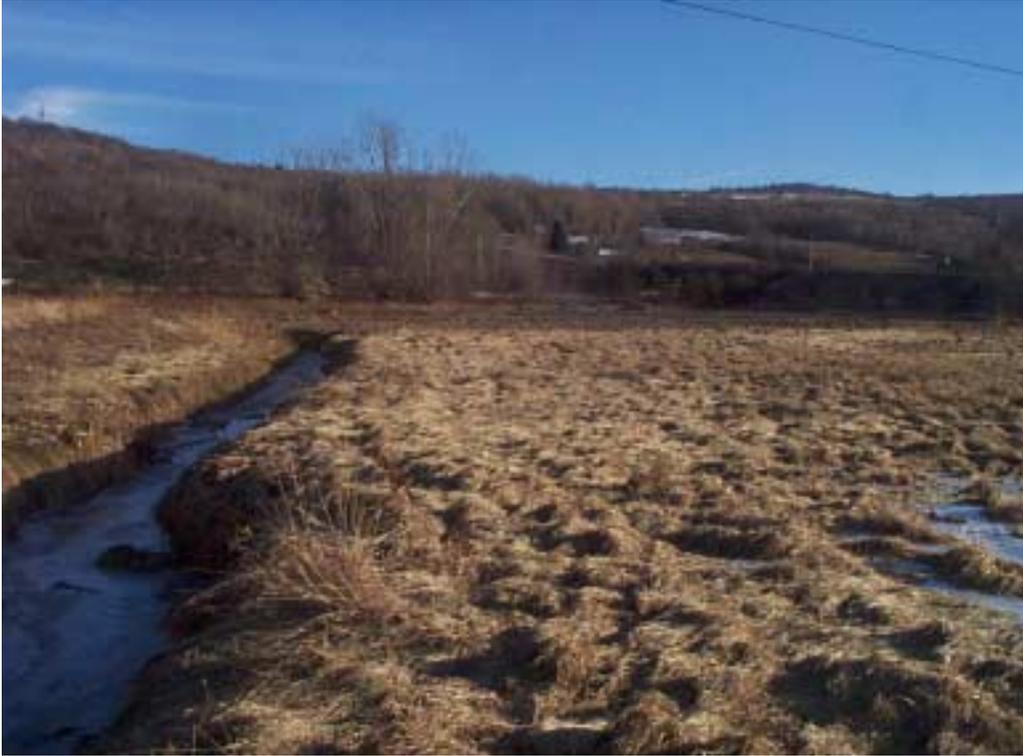
A view of undeveloped property at the intersection of Route 36 and 104. This is an ideal location for a community detention basin on the Stevens Brook.

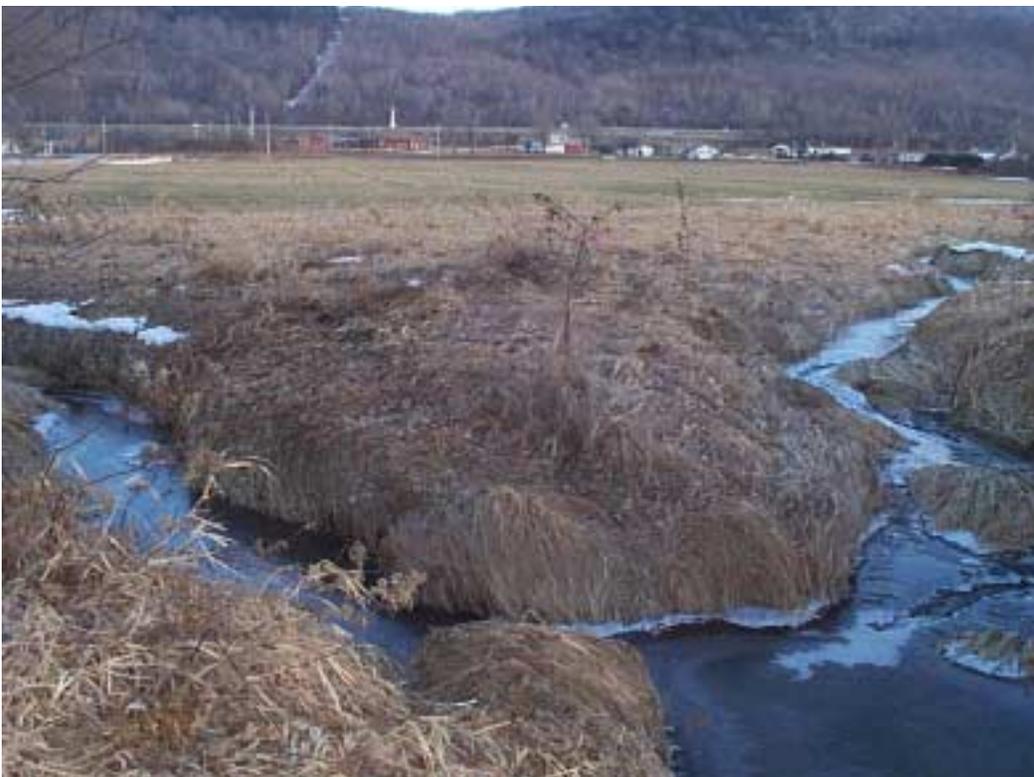
Another example of undeveloped land for which a community detention basin could be constructed. This location is at the confluence of the main stem and northern tributary of the Rugg Brook upstream of Clyde Allen Drive. Fairfax Road is in the background.

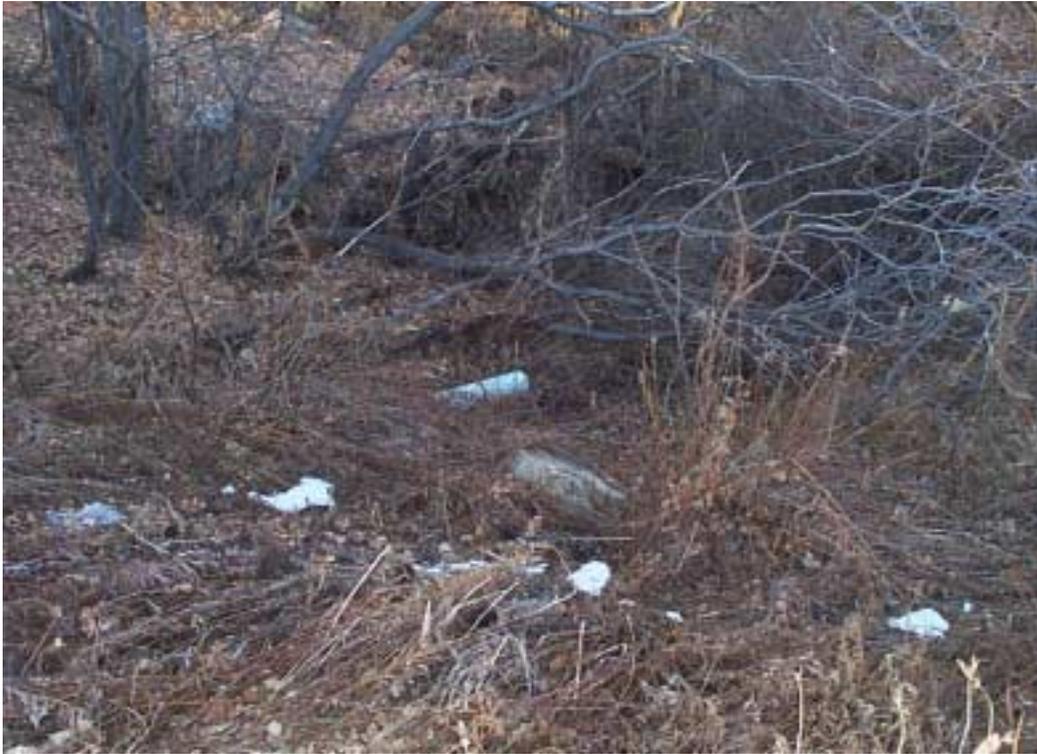
An example of direct discharge of stormwater into the stream. At this location runoff from a residential development is discharged through this pipe, into a drainage swale and then into the stream.

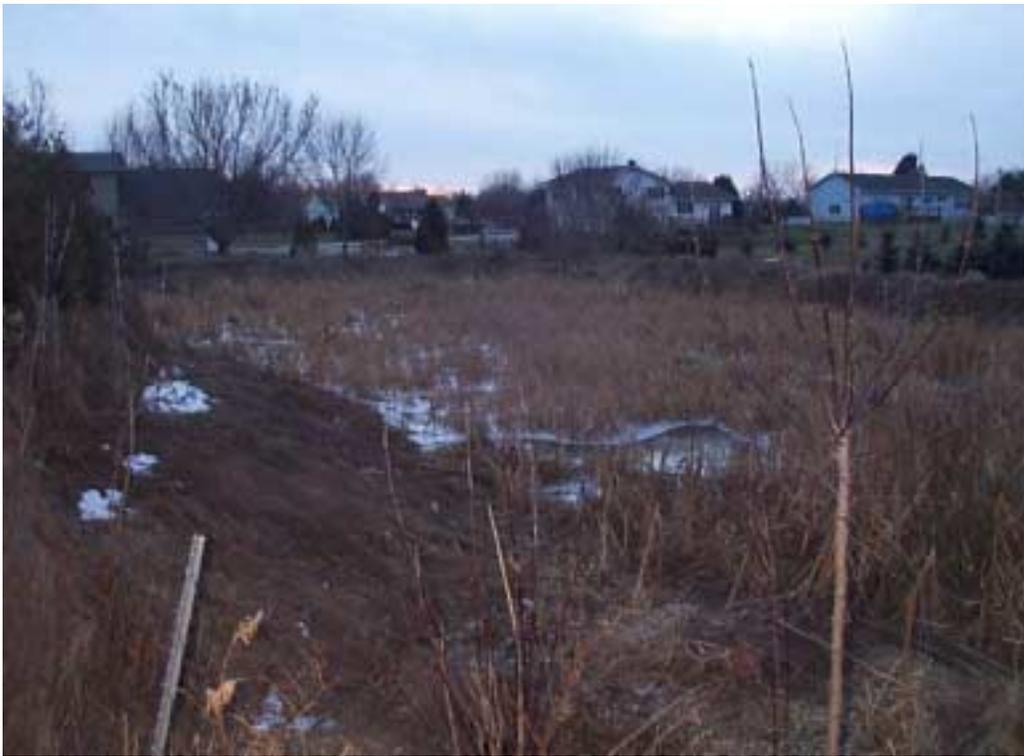
A view of an unmaintained detention basin. Unmaintained detention basins do not operate as intended and often result in localized flooding and adverse impacts on the receiving stream.
