**Stormwater Master Plan
Castleton River Headwaters
Castleton, Ira, West Rutland, and Pittsford, Vermont**

January 31, 2018

Fitzgerald Environmental Associates, LLC.
18 Severance Green, Suite 203
Colchester, VT 05446

**Poultney Mettowee Natural
Resources Conservation District**
PO Box 209
Poultney, VT 05764

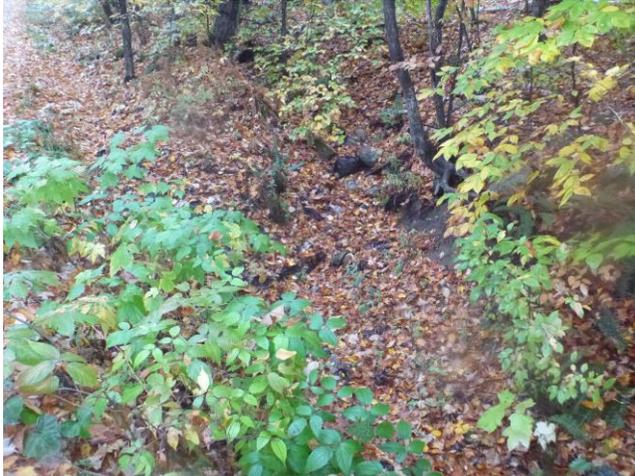
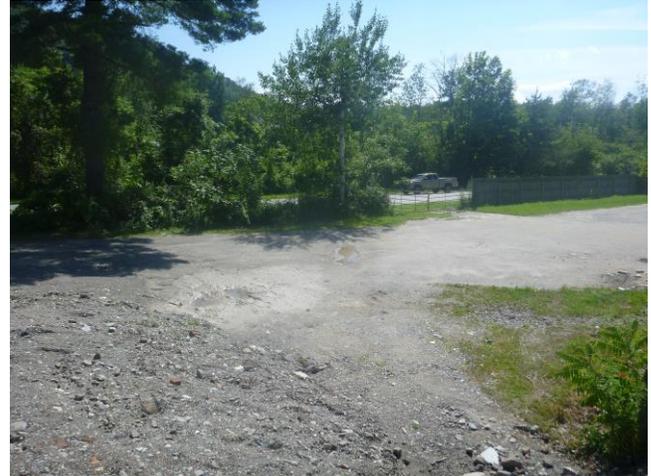
Figure 3: A previously stabilized gully on Upper Birdseye Road had the lowest score (left photo, Project CA-26). Erosion and transport of large volumes of sediment from the Castleton transfer station lot and a small culvert had the highest problem area score (right photo, Project CA-16).

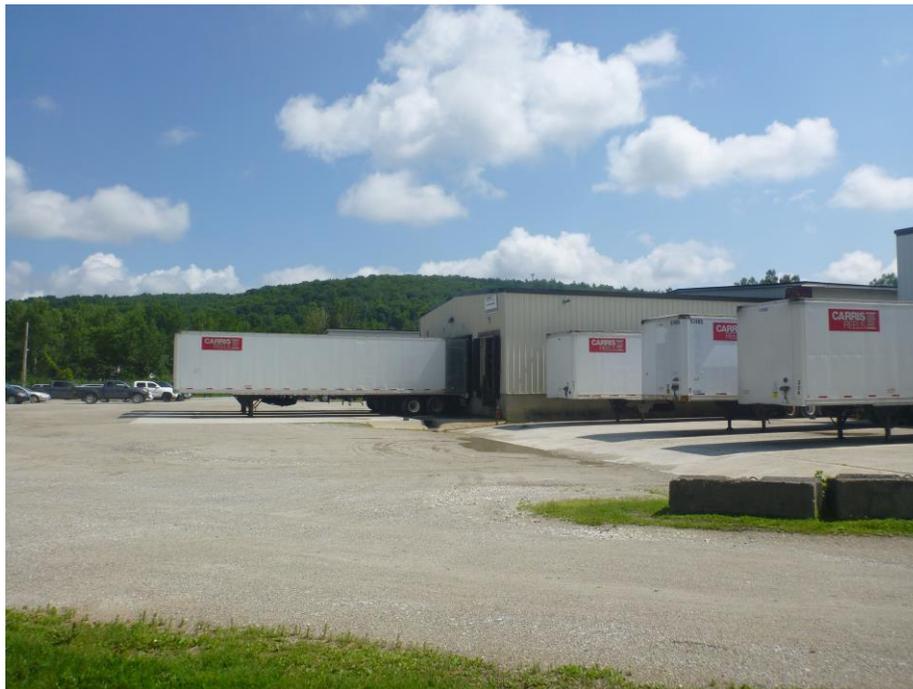
9. **Project WR-8: Carris Reels Property, West Rutland** – The rooftops and gravel parking areas present on the large commercial property (Figure 5) drain to two culverts. The culverts empty into a catch basin then discharge directly into the adjacent canal.

Figure 5: Large gravel parking area draining to the canal at project WR-8

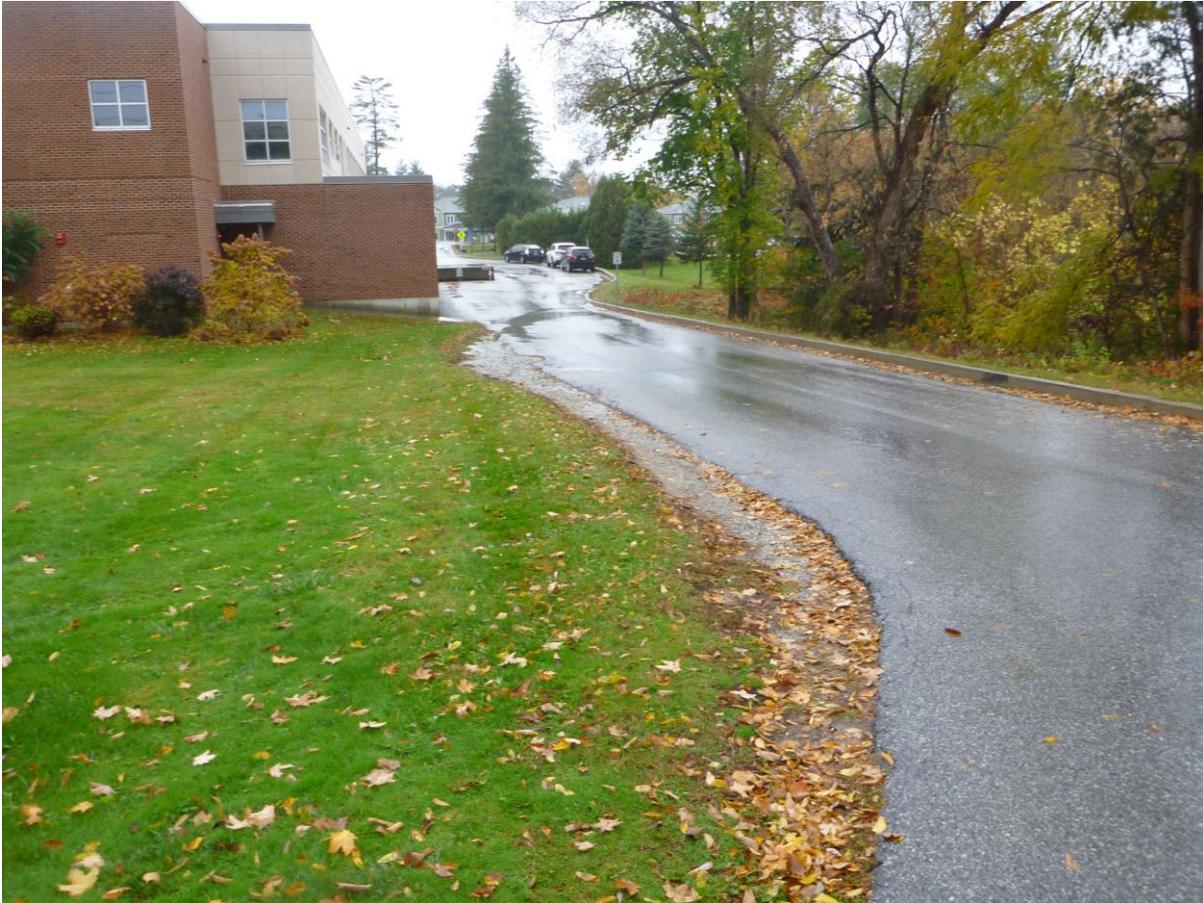
2. **Project CU-4: South Road, Castleton University** – Runoff from South Road bypasses a green space with an existing catch basin and flows into next basin to west. The shoulder is eroded and bare, and the runoff picks up fine sediment and carries it to the adjacent stream via the storm drain network along University Drive.

Figure 6: Eroding University Drive road shoulder observed during a storm event in October 2016. The concept design for this area (CU-4) describes a BMP retrofit that would treat this runoff.
