**MOREHOUSE BROOK STORMWATER
MANAGEMENT EVALUATION**

Prepared For:
Lake Champlain Basin Program
54 West Shore Rd
Grand Isle, Vermont 05458

December 1997

Prepared By:
James Pease
Vermont Department of Environmental Conservation
Water Quality Division
10 North Building
103 S. Main Street
Waterbury, VT 05676

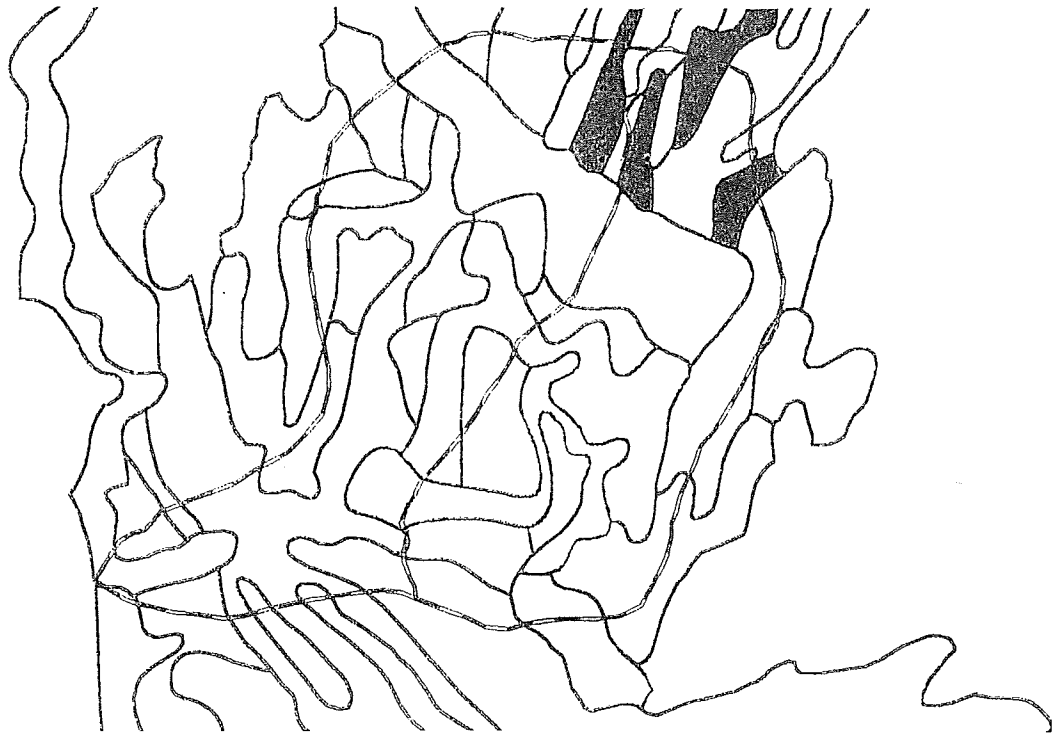
Figure 6.4: Morehouse Brook watershed - areas of highly erodible soils. These soils are easily displaced.

Highly erodible clays (Vergennes and Covington) exist in the developing Water Tower Hill area and erosion during construction should be avoided. Soils suitable for infiltration of stormwater (Adams) are abundant and should be utilized (Figures 6.3-5).

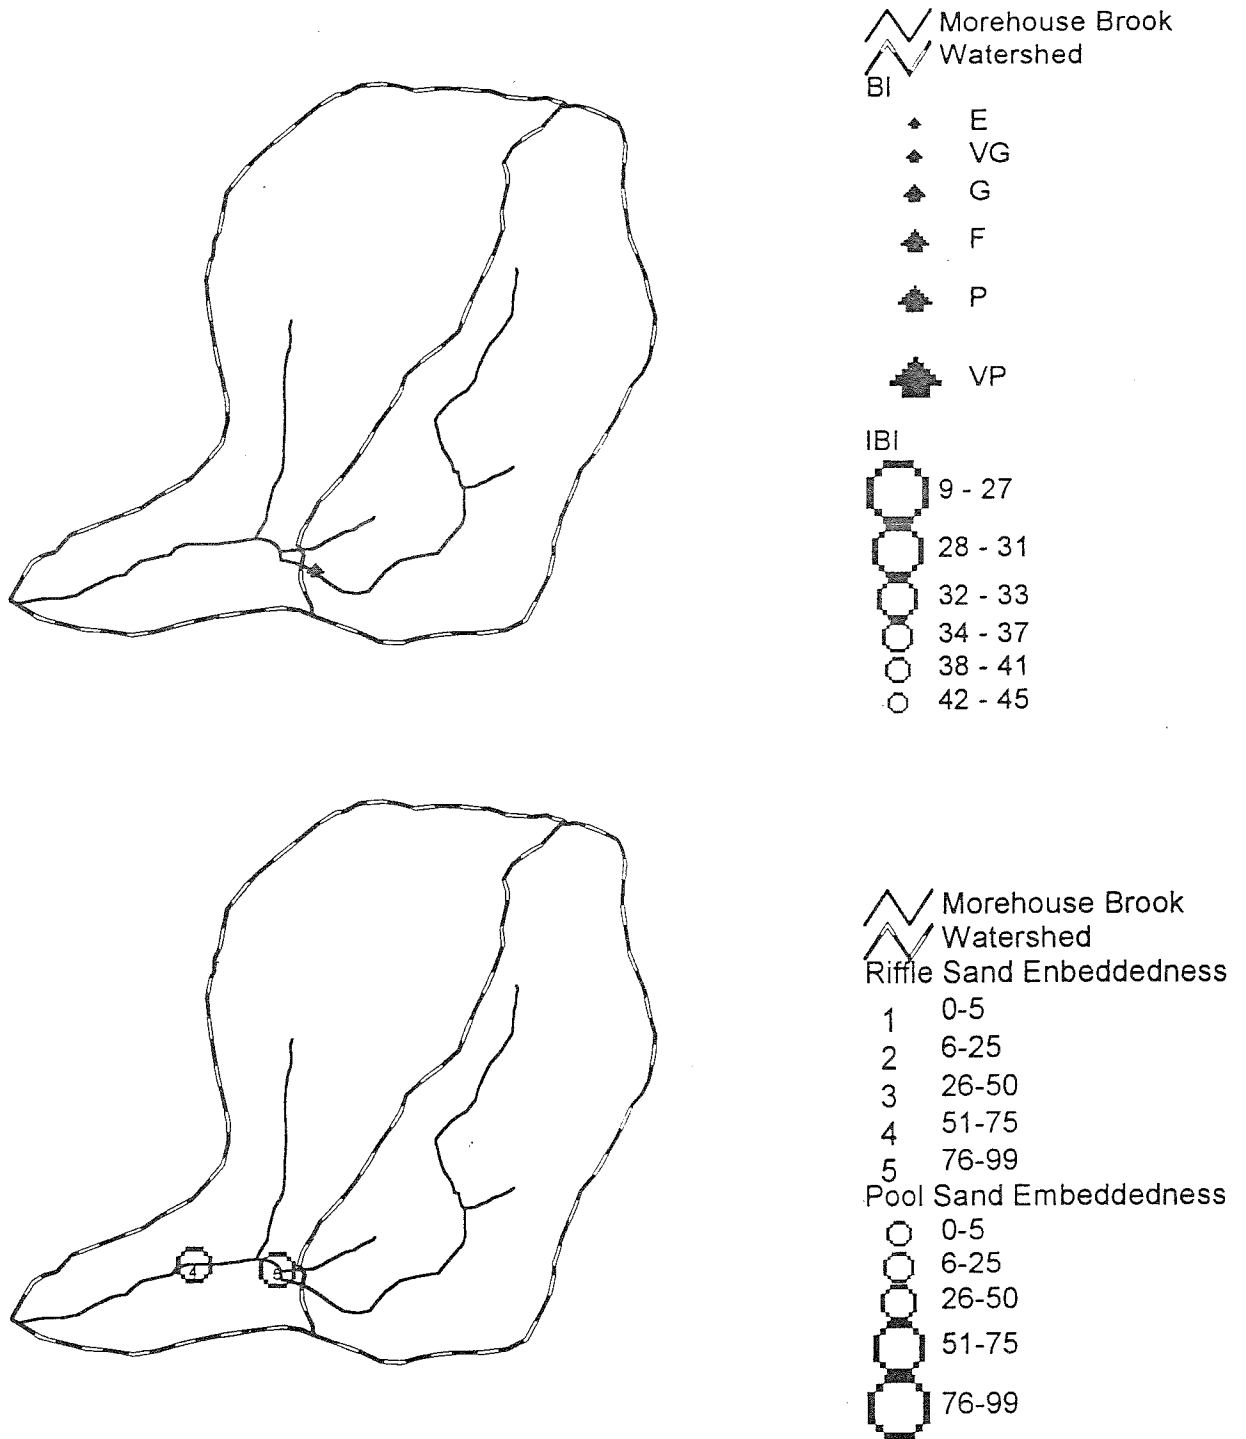
Figure 6.8: Morehouse Brook watershed - biological condition. Fish and macroinvertebrate community measures of integrity. A macroinvertebrate biotic index (BI) rating of less than good is indicative of sub-Class B condition. A fish Index of Biotic Integrity (IBI) rating of less than 31 is indicative of sub-Class B condition.

Watershed measure of pool and riffle sedimentation. A high degree of sand embeddedness indicates excessive erosion and impairs aquatic habitat and the biological communities that are supported by that habitat.

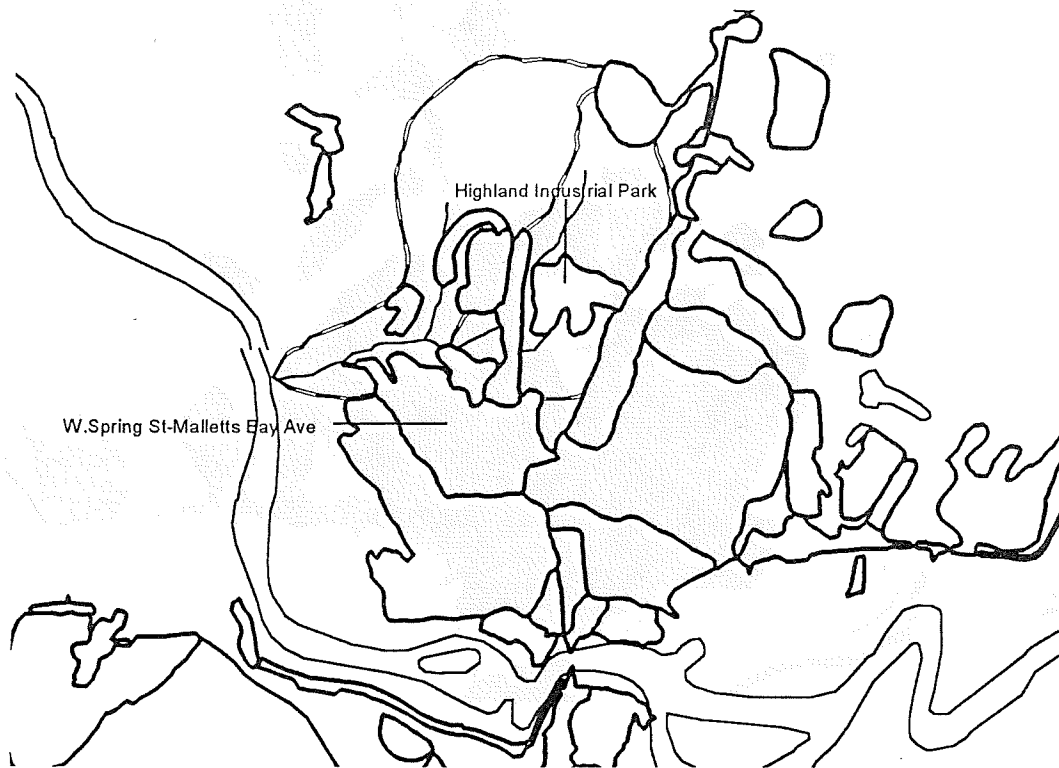
Targeted Stormwater Sewersheds
Morehouse Brook Watershed

Figure 6.9: Targeted Stormwater Sewersheds in Morehouse Brook Watershed - Sewersheds were targeted based on exceedences of loading thresholds as described in Table 2.2. BMP recommendations are made for each targeted sewershed. One sewershed in the Morehouse Brook watershed has been targeted.

There is one targeted storm sewer: W.Spring St-Malletts Bay Ave (**Table 6.2, Figures 6.9-6.12**). An infiltration BMP is recommended for this site (map 6; Part 1). TSS reduction from this BMP would be 12,472 kg/yr; TP reduction would be 17 kg/yr.

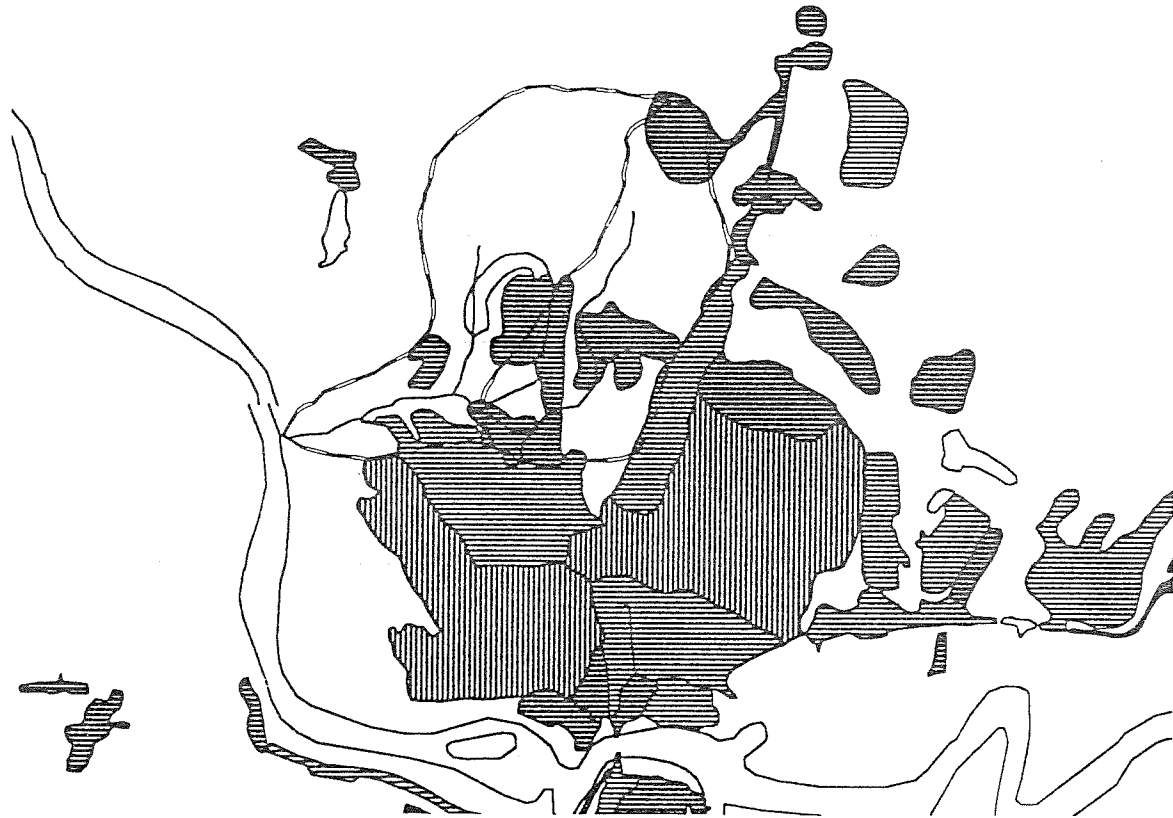
Figure 6.10: Estimated total suspended solids loading from sewersheds in the Morehouse Brook watershed.

<u>Recwater</u>	<u>Storm sewershed</u>	<u>Treatment (Appendix 4)</u>	<u>EIA%</u>	<u>Loading kg/yr</u>
Highest Total Suspended Solids (Figure 6.10)				
Morehouse	W.Spring St-Malletts Bay Ave	CB	32.1	17,817
<i>Morehouse</i>	<i>Highland Industrial Park</i>	<i>CG/GS/RS</i>	20.3	3,856
Highest Total Phosphorus (Figure 6.11)				
Morehouse	W.Spring St-Malletts Bay Ave			28
<i>Morehouse</i>	<i>Highland Industrial Park</i>			6
Highest Total PAH (Commercial Landuses Only)				
Morehouse	W.Spring St-Malletts Bay Ave			191
<i>Morehouse</i>	<i>Highland Industrial Park</i>	<i>CB/GS/RS</i>	20.3	41
Highest Total Metals (Figure 6.12)				
Morehouse	W.Spring St-Malletts Bay Ave			22

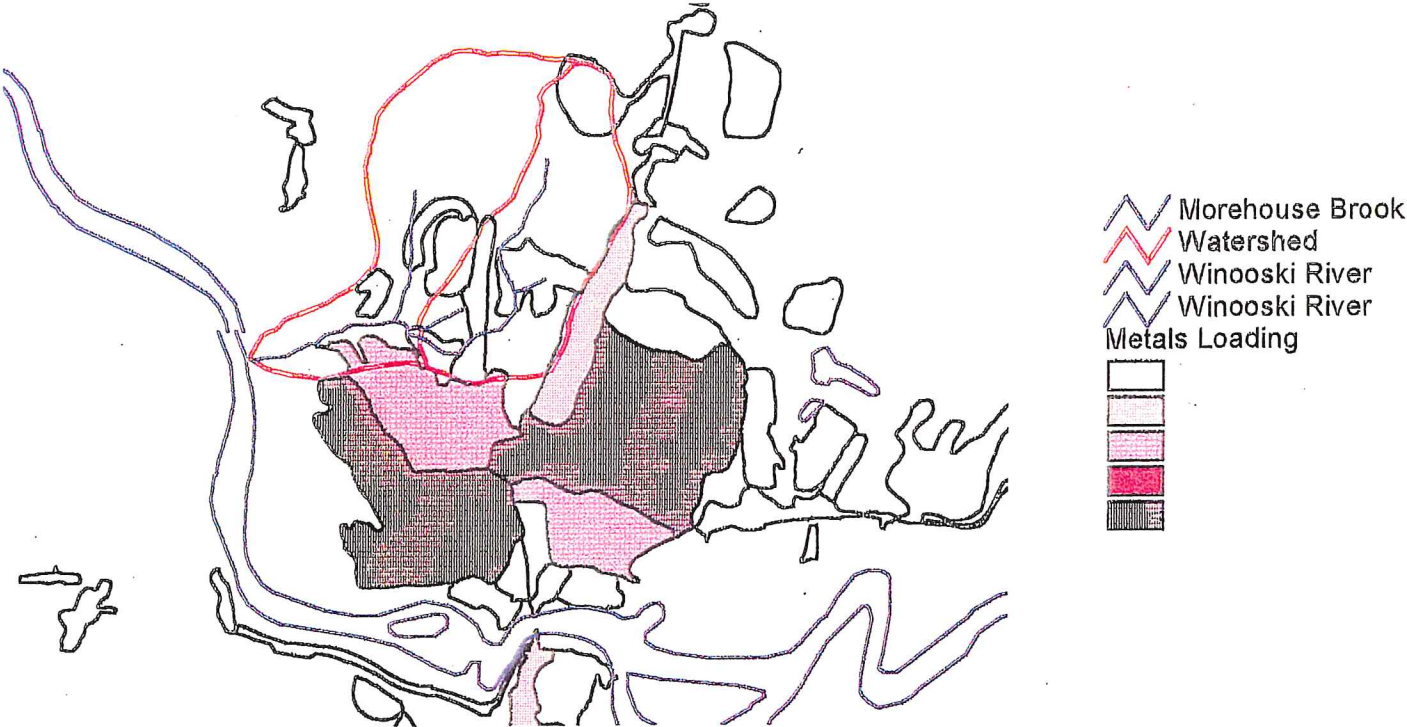
Figure 6.12: Estimated total metals loading from sewersheds in the Morehouse Brook watershed.
